Weekly Environmental Compliance Summary

Sudbury to Hudson Transmission Reliability Project (USEPA Tracking # MAR1003UW)

Sudbury, Hudson, and Stow, MA

Week of: August 19, 2024 to August 24, 2024

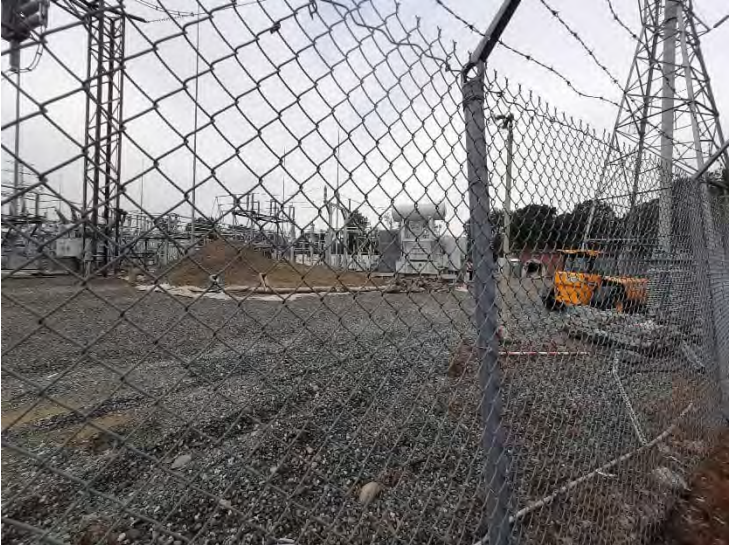
<p>Description:</p> <p>Spoil pile within Sudbury substation surrounded by compost filter tubes, looking southward.</p>

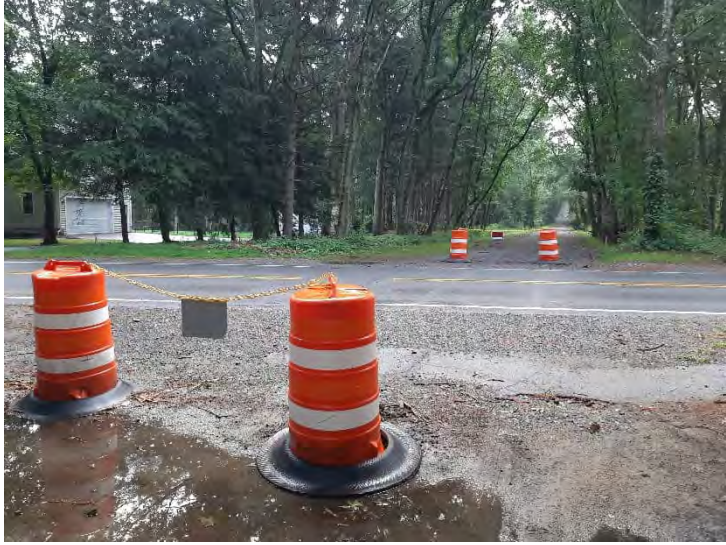
Description: Segments 10 and 11, barriers along Horse Pond Road, looking eastward.

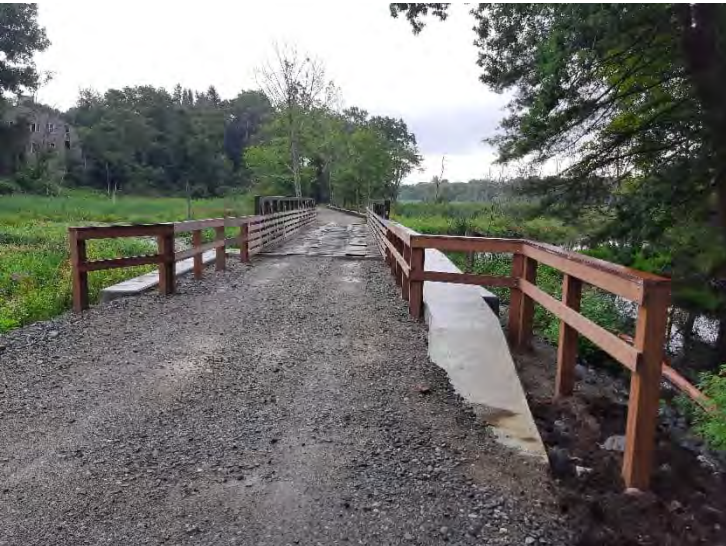
Description: Segments 13/14, Bridge 127, existing erosion controls, looking eastward.

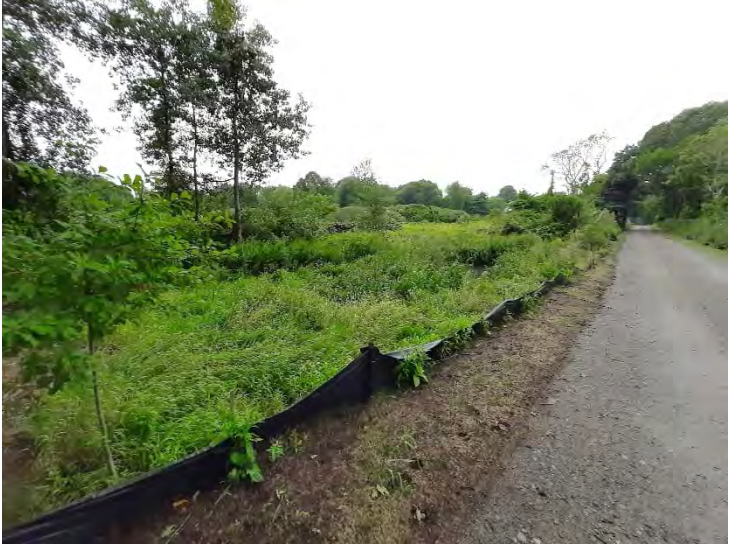
<p>Description:</p> <p>Segment 14, wetland replication area, existing erosion controls, looking westward.</p>

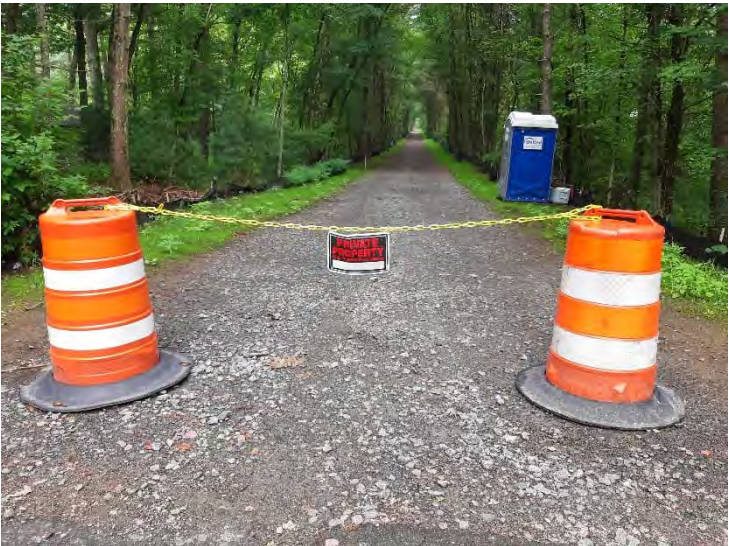
<p>Description:</p> <p>Segment 9, barriers along Peakham Road, existing erosion controls, looking westward.</p>

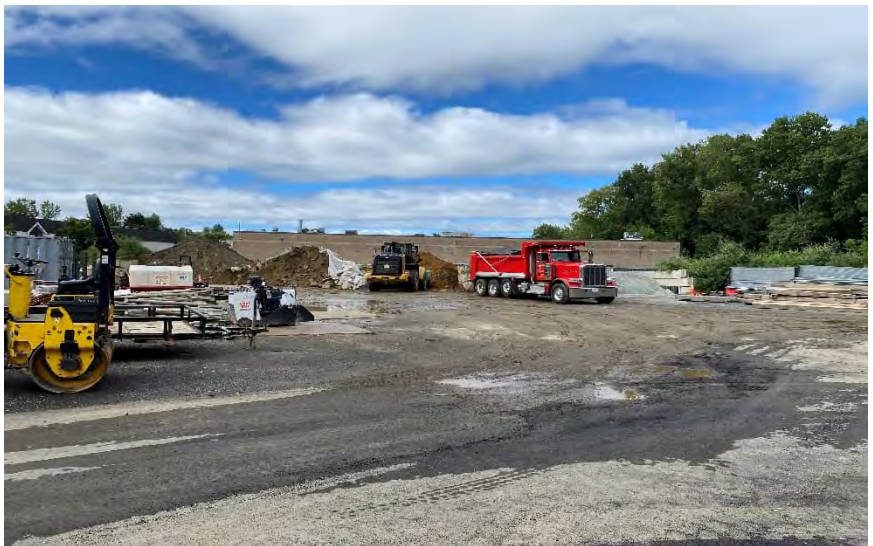
Description: Bonazzoli laydown yard, existing spoil piles, looking westward.

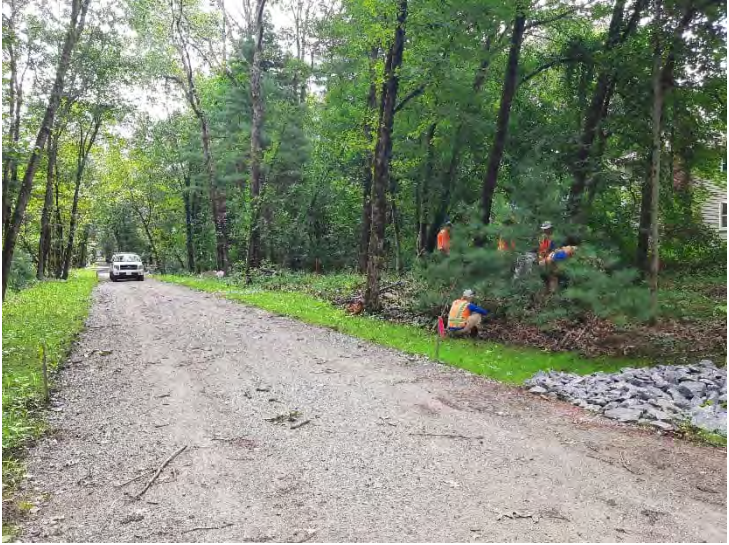
Description: SWCA invasives removal crew, Segment 9, existing check dam, looking eastward.

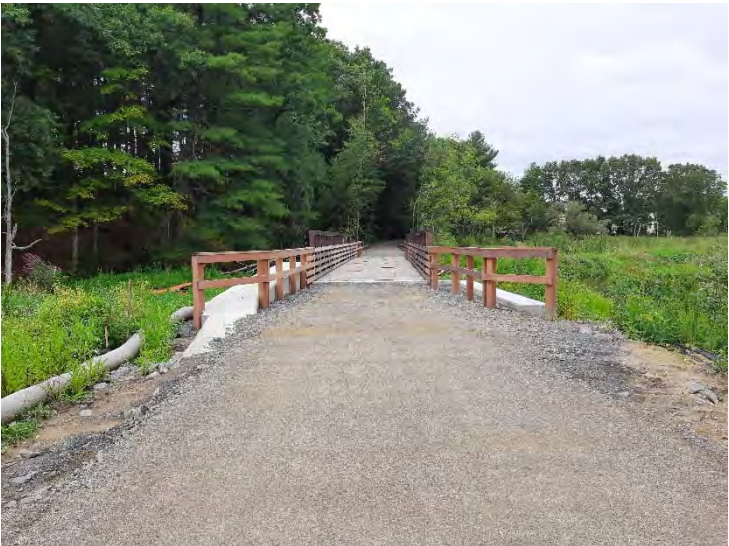
<p>Description:</p> <p>Bridge 127, Segments 14/13, existing erosion controls, looking westward.</p>

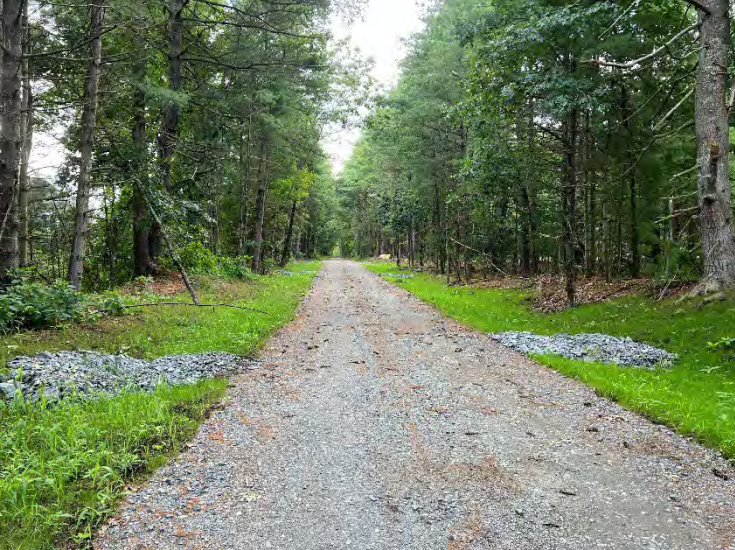
<p>Description: View of installed rock check dams in segment 9. Facing east.</p>

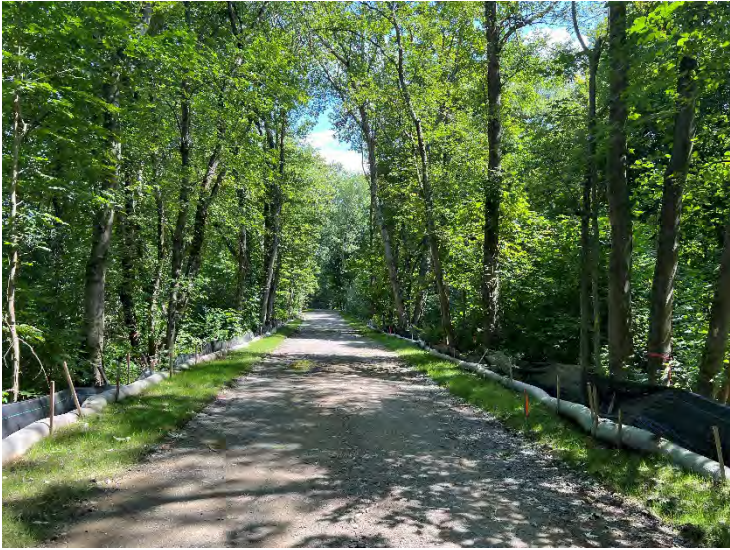
Description: View of E&S controls in segment 13. Facing east.

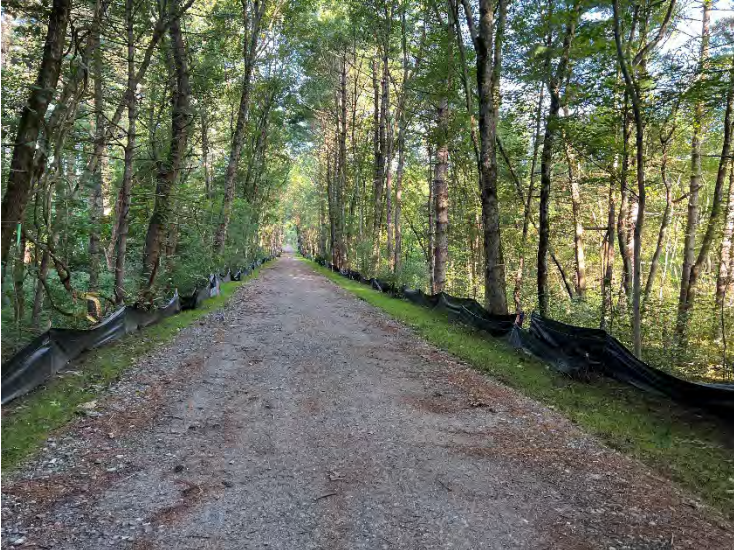
- Silt fencing in need of repairs in segment 10 at Sta. #540+00. Silt fencing has fallen down slope with sediment greater than half the height of the fencing. Contractors are aware of the issue and will be addressing.

Description: View of E&S controls in segment 10. Facing east.

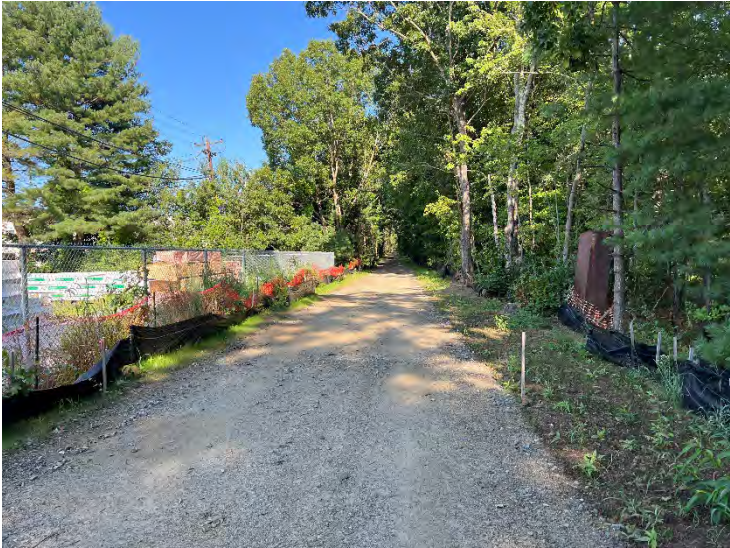
<p>Description: View of E&S controls in segment 11. Facing west.</p>

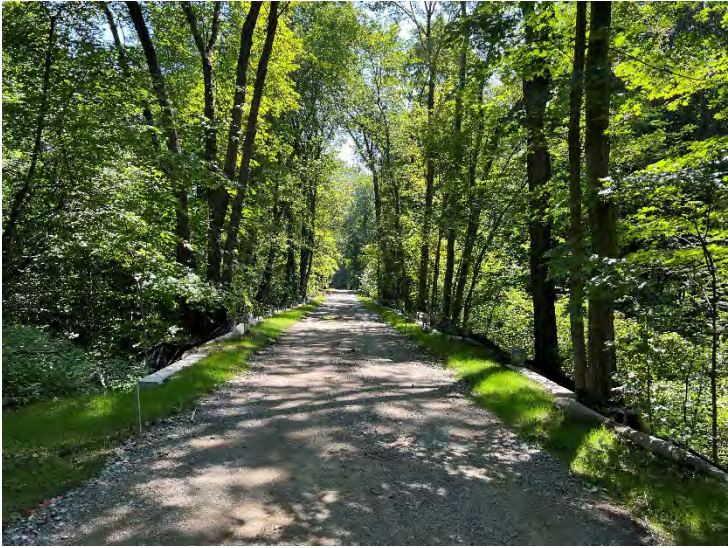
<p>PHOTOGRAPHIC LOG</p>	
<p>Client Name: Eversource</p>		<p>Site Location: Sudbury to Hudson Transmission Reliability Project</p>	<p>Town: Sudbury</p>
<p>Photo No.: 8</p>	<p>Date: 8/23/2024</p>

<p>Description: View of E&S controls in segment 13. Facing west.</p>

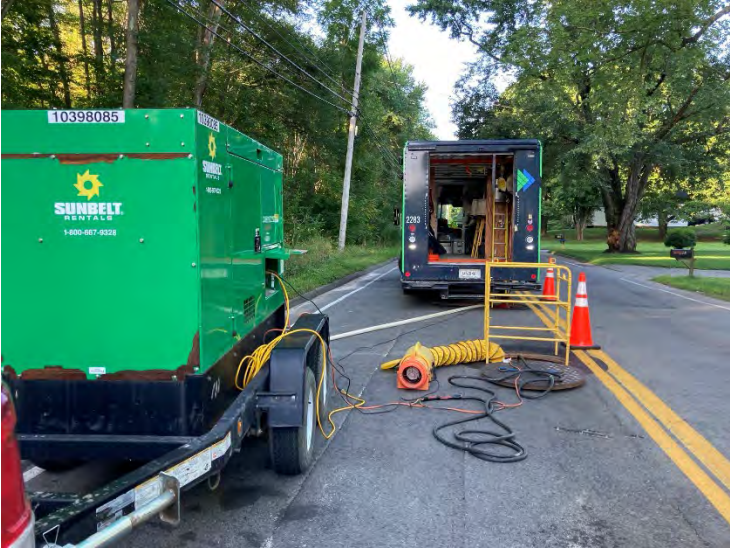
<p>PHOTOGRAPHIC LOG</p>	
<p>Client Name: Eversource</p>		<p>Site Location: Sudbury to Hudson Transmission Reliability Project</p>	<p>Town: Hudson</p>
<p>Photo No.: 1</p>	<p>Date: 8/24/2024</p>

<p>Description: View of Haugland's work area at MH #4 on Forest Ave. Facing south.</p>

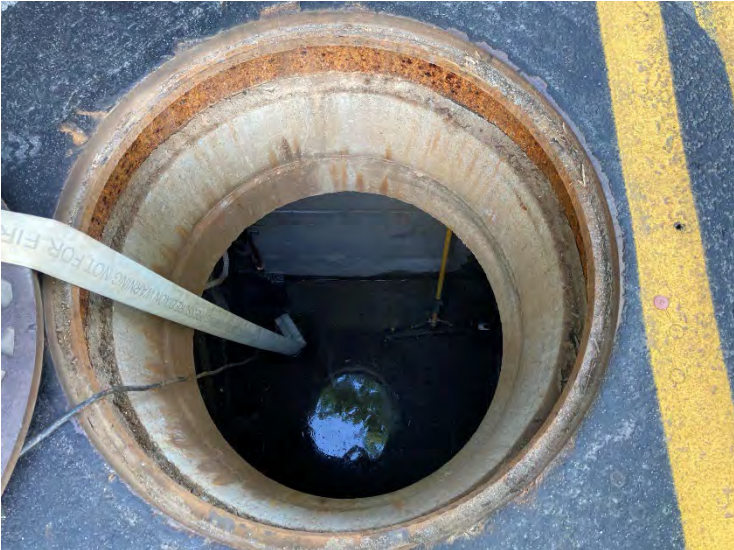
<p>PHOTOGRAPHIC LOG</p>	
<p>Client Name: Eversource</p>		<p>Site Location: Sudbury to Hudson Transmission Reliability Project</p>	<p>Town: Hudson</p>
<p>Photo No.: 2</p>	<p>Date: 8/24/2024</p>

<p>Description: View of pump in MH #4. See additional dewatering inspection report.</p>

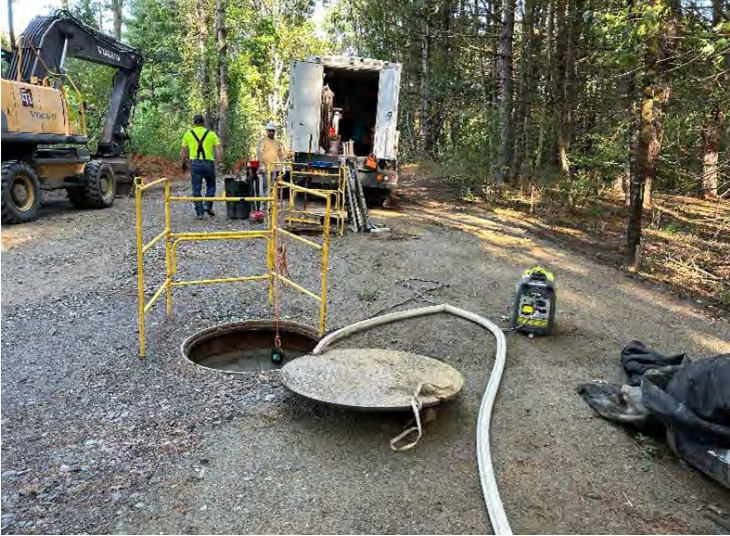
PHOTOGRAPHIC LOG	
Client Name: Eversource		Site Location: Sudbury to Hudson Transmission Reliability Project	Town: Sudbury
Photo No.: 3	Date: 8/24/2024

Description: View of Haugland's work area at MH #17 in segment 8. See additional dewatering inspection report. Facing west.

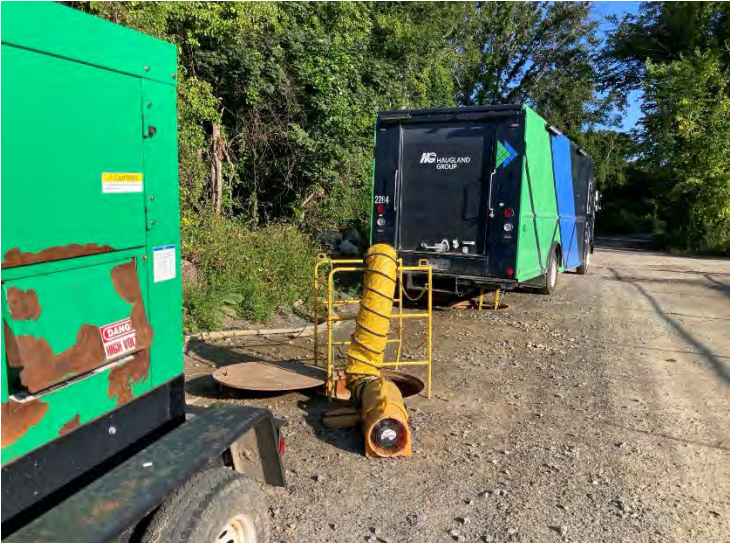
PHOTOGRAPHIC LOG	
Client Name: Eversource		Site Location: Sudbury to Hudson Transmission Reliability Project	Town: Sudbury
Photo No.: 4	Date: 8/24/2024

Description: View of Haugland's work area at MH #28 outside Sudbury Substation. Facing north.

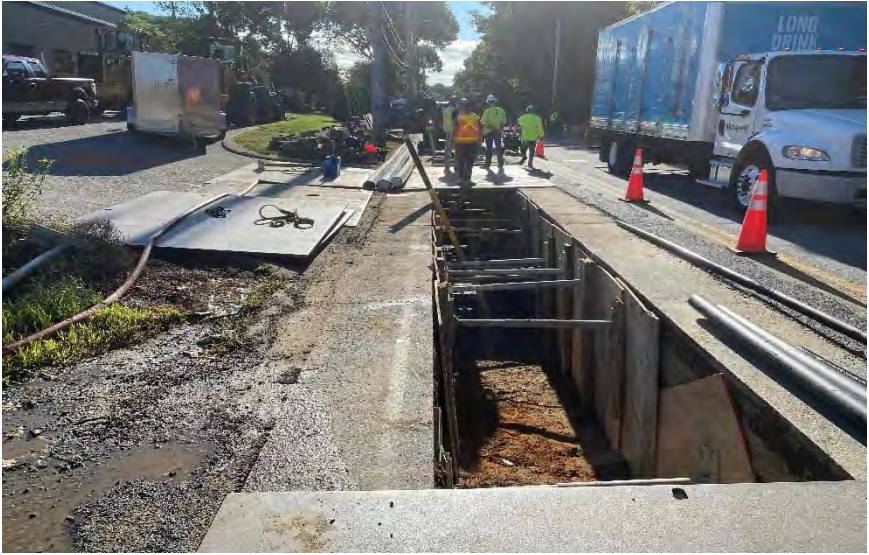
PHOTOGRAPHIC LOG	
Client Name: Eversource		Site Location: Sudbury to Hudson Transmission Reliability Project	Town: Hudson
Photo No.: 3	Date: 8-22-24

Description: Bond conducting conduit work within Forest Avenue near 106 Forest, looking northward.

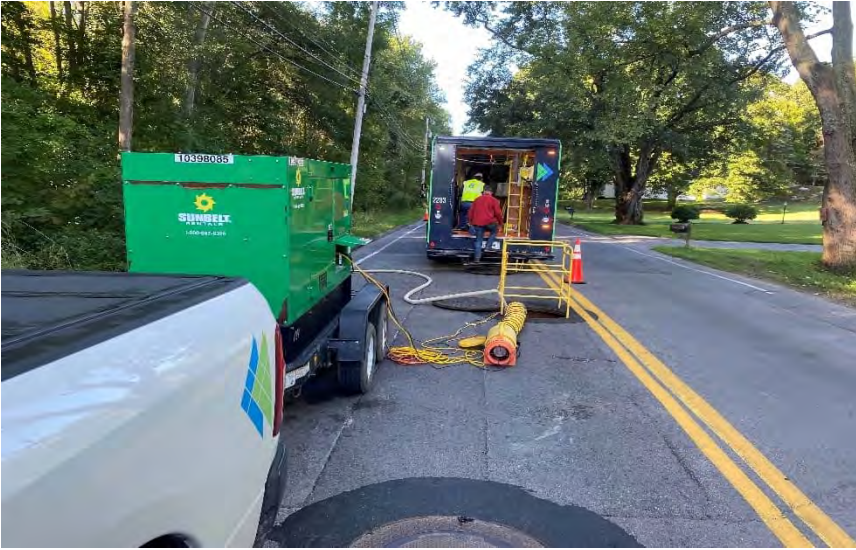
PHOTOGRAPHIC LOG	
Client Name: Eversource		Site Location: Sudbury to Hudson Transmission Reliability Project	Town: Hudson
Photo No.: 8	Date: 8-22-24

Description: Haugland splicing work at manhole #4, Forest Avenue, looking southward.

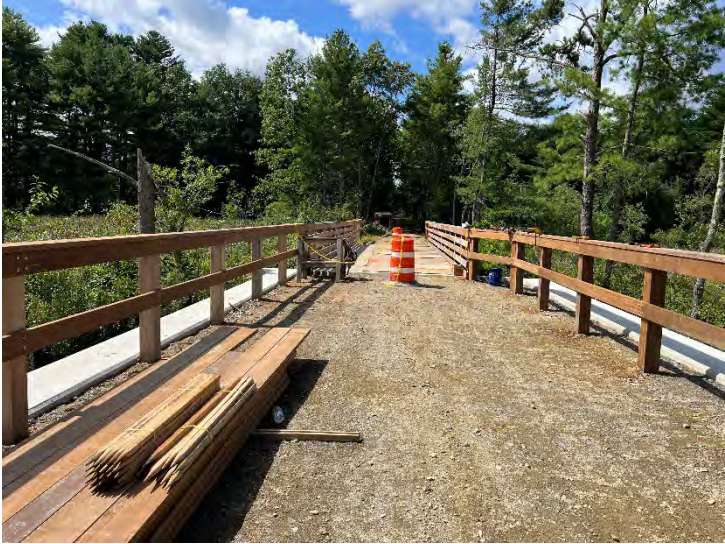
PHOTOGRAPHIC LOG	
Client Name: Eversource		Site Location: Sudbury to Hudson Transmission Reliability Project	Town: Sudbury
Photo No.: 2	Date: 8-22-24

Description: View of ET&L work area at Bridge 128. Facing west.

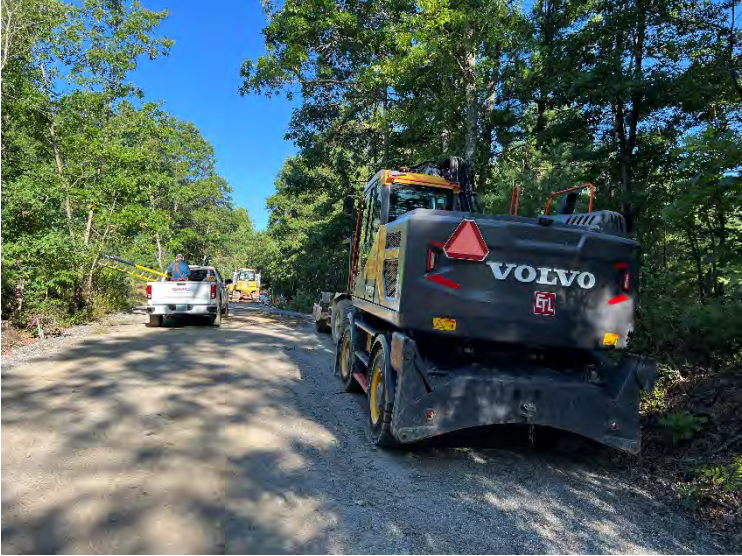
PHOTOGRAPHIC LOG	
Client Name: Eversource		Site Location: Sudbury to Hudson Transmission Reliability Project	Town: Sudbury
Photo No.: 3	Date: 8-22-24

Description: View of ET&L machinery staging in segment 14 near the town line. Crew actively working within segment 6 (Hudson). Facing west.

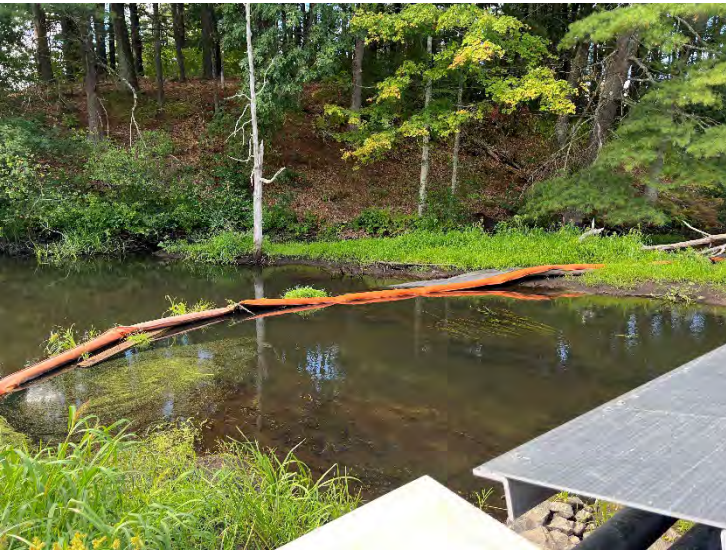
PHOTOGRAPHIC LOG	
Client Name: Eversource		Site Location: Sudbury to Hudson Transmission Reliability Project	Town: Sudbury
Photo No.: 6	Date: 8-22-24

Description: View of floating turbidity curtain at Bridge 127. Facing west.

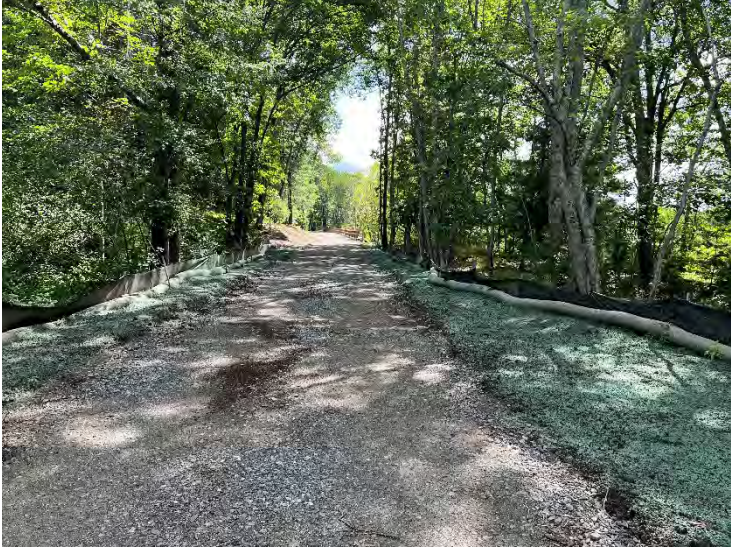
PHOTOGRAPHIC LOG	
Client Name: Eversource		Site Location: Sudbury to Hudson Transmission Reliability Project	Town: Sudbury
Photo No.: 7	Date: 8-22-24

Description: View of E&S controls and hydroseeding in segment 14. Facing east.

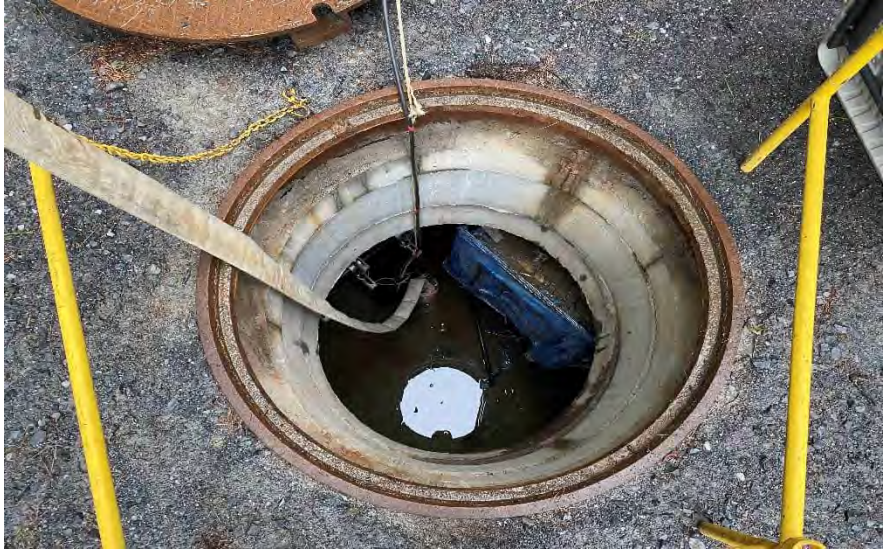
PHOTOGRAPHIC LOG	
Client Name: Eversource		Site Location: Sudbury to Hudson Transmission Reliability Project	Town: Hudson
Photo No.: 1	Date: 8/19/2024

Description: View of area being pumped from manhole #9 segment 3.

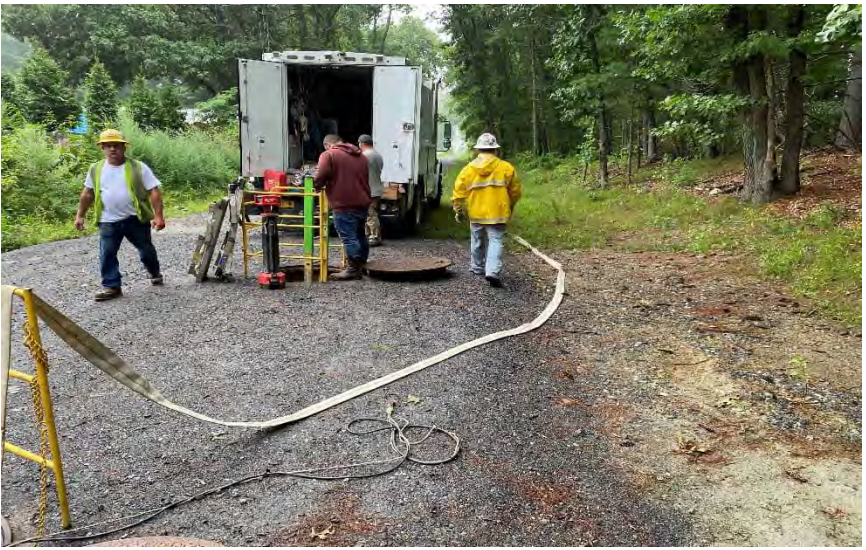
PHOTOGRAPHIC LOG	
Client Name: Eversource		Site Location: Sudbury to Hudson Transmission Reliability Project	Town: Hudson
Photo No.: 2	Date: 8/19/2024

Description: Manhole #9. View of dewatering operation. Looking westward.

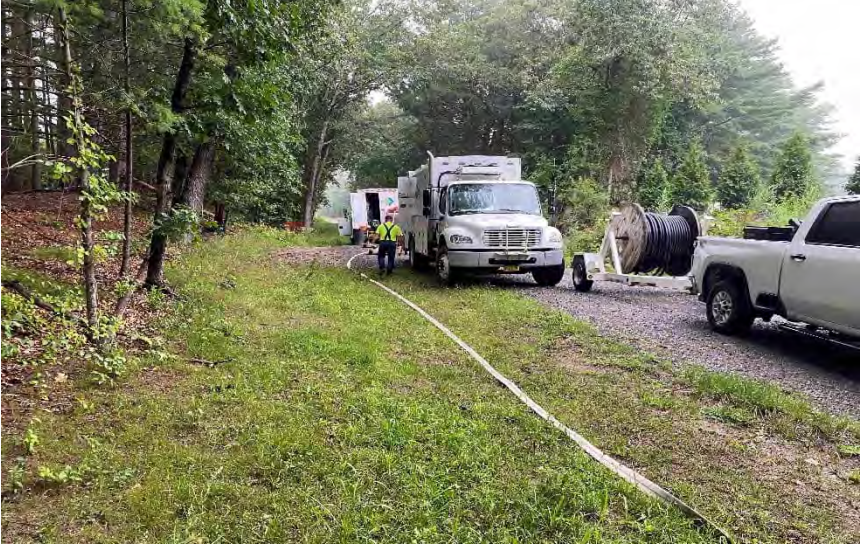
PHOTOGRAPHIC LOG	
Client Name: Eversource		Site Location: Sudbury to Hudson Transmission Reliability Project	Town: Hudson
Photo No.: 3	Date: 8/19/2024

Description: Manhole #9 View of dewatering operation, looking eastward.

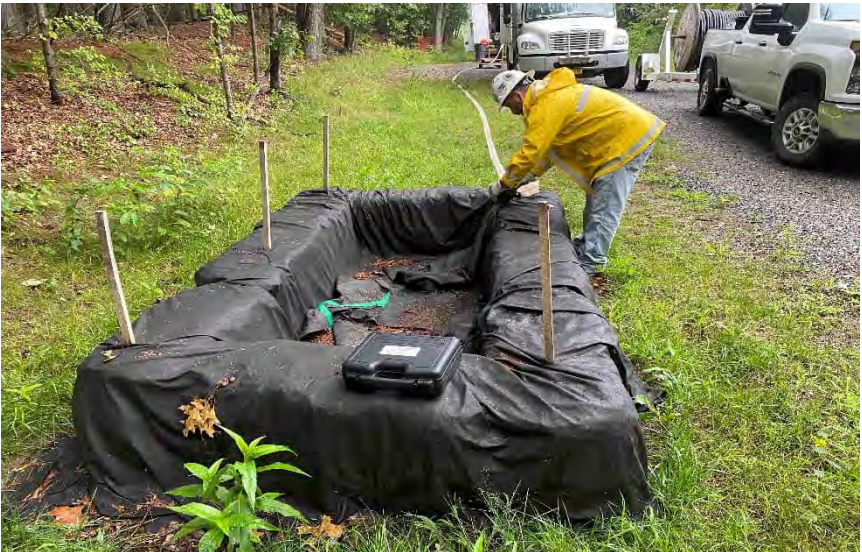
PHOTOGRAPHIC LOG	
Client Name: Eversource		Site Location: Sudbury to Hudson Transmission Reliability Project	Town: Hudson
Photo No.: 4	Date: 8/19/2024

Description: Manhole #9. View of discharge bag/corral. Water from bag/corral discharged to adjacent area, looking eastward.

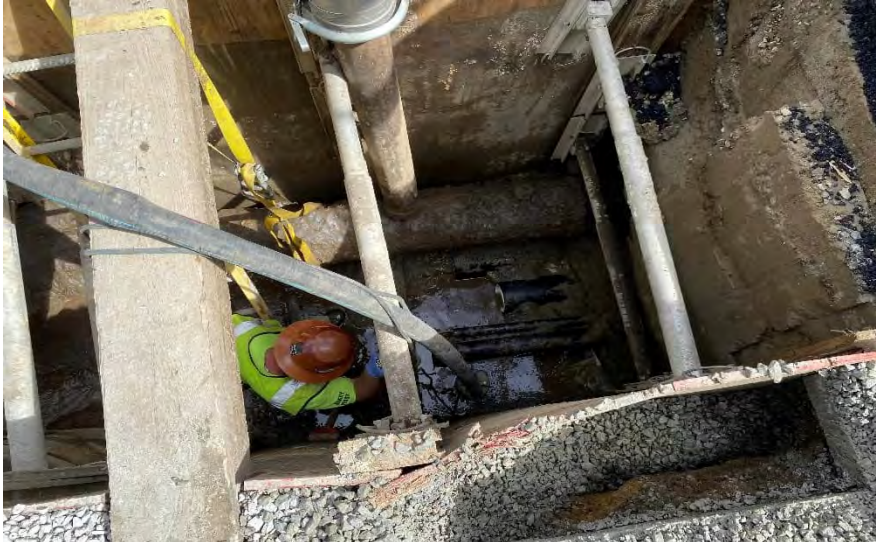
PHOTOGRAPHIC LOG	
Client Name: Eversource		Site Location: Sudbury to Hudson Transmission Reliability Project	Town: Hudson
Photo No.: 1	Date: 8/20/2024

Description: View of area being pumped from trench close to 106 Forest Avenue.

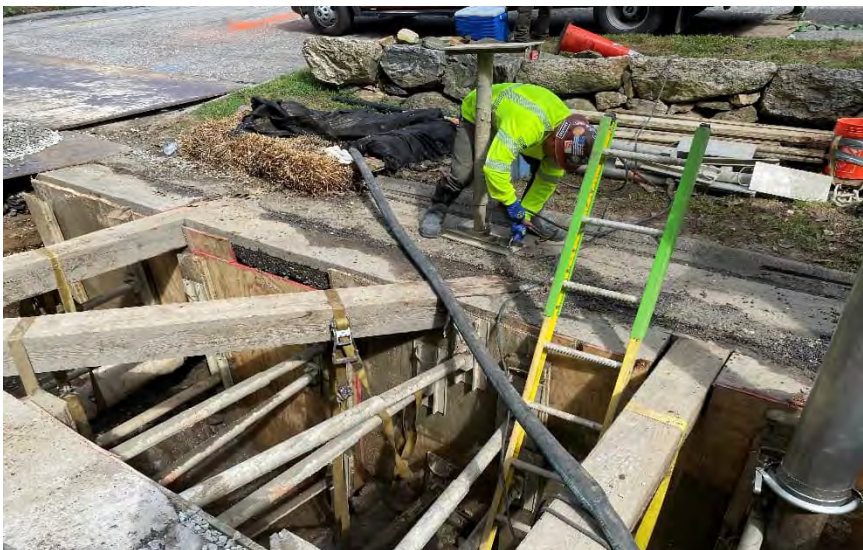
PHOTOGRAPHIC LOG	
Client Name: Eversource		Site Location: Sudbury to Hudson Transmission Reliability Project	Town: Hudson
Photo No.: 2	Date: 8/20/2024

Description: Trench near 106 Forest Avenue. View of dewatering operation. Looking eastward.

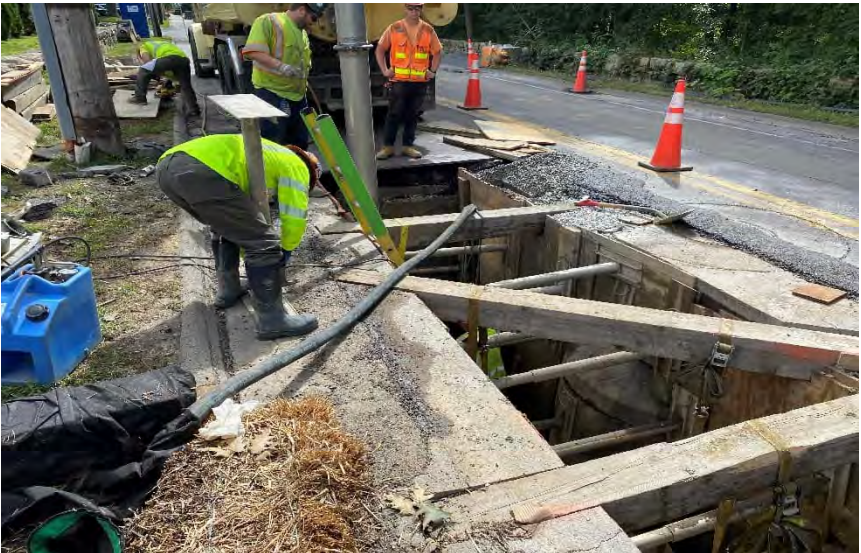
PHOTOGRAPHIC LOG	
Client Name: Eversource		Site Location: Sudbury to Hudson Transmission Reliability Project	Town: Hudson
Photo No.: 3	Date: 8/20/2024

Description: Near 106 Forest Avenue. View of dewatering operation, looking northward.

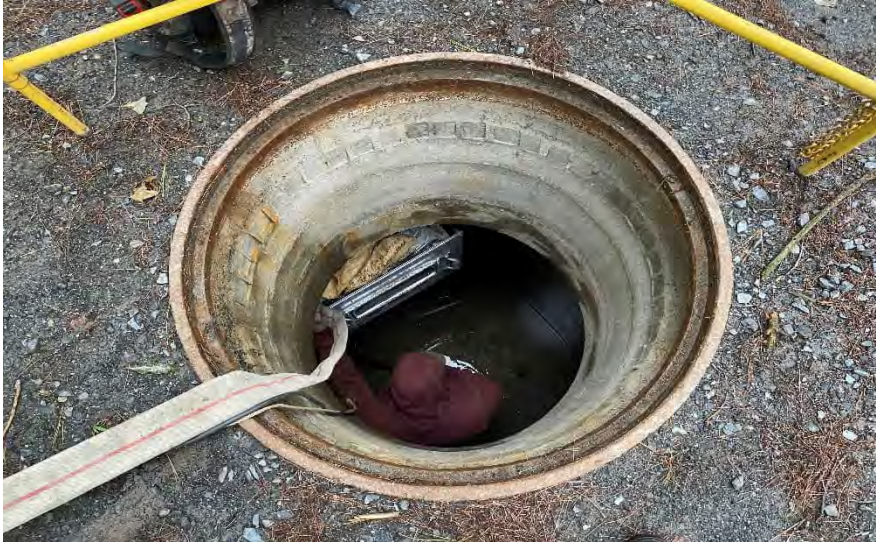
PHOTOGRAPHIC LOG	
Client Name: Eversource		Site Location: Sudbury to Hudson Transmission Reliability Project	Town: Hudson
Photo No.: 1	Date: 8/20/2024

Description: View of area being pumped from manhole #10 segment 4.

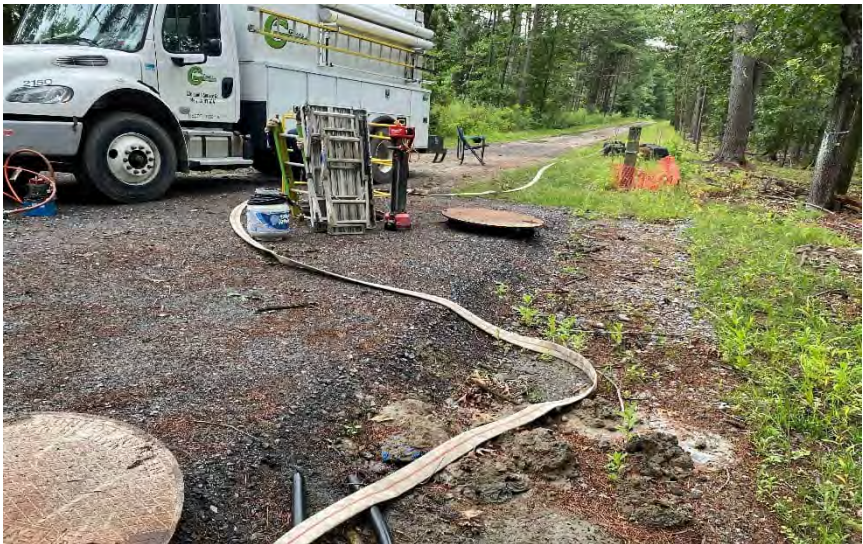
PHOTOGRAPHIC LOG	
Client Name: Eversource		Site Location: Sudbury to Hudson Transmission Reliability Project	Town: Hudson
Photo No.: 2	Date: 8/20/2024

Description: Manhole #10. View of dewatering operation. Looking westward.

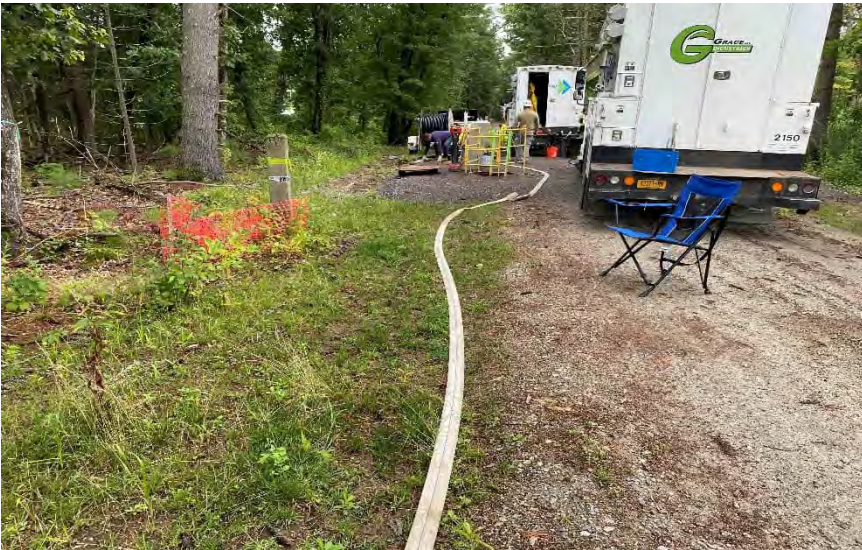
PHOTOGRAPHIC LOG	
Client Name: Eversource		Site Location: Sudbury to Hudson Transmission Reliability Project	Town: Hudson
Photo No.: 3	Date: 8/20/2024

Description: Manhole #10. View of dewatering operation, looking eastward.

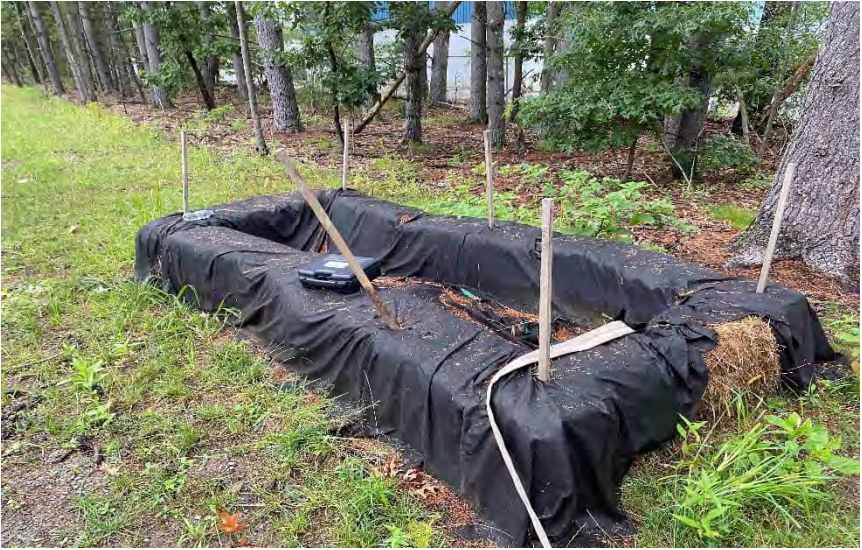
PHOTOGRAPHIC LOG	
Client Name: Eversource		Site Location: Sudbury to Hudson Transmission Reliability Project	Town: Hudson
Photo No.: 4	Date: 8/20/2024

Description: Manhole #10. View of discharge bag/corral. Water from bag/corral discharged to adjacent area, looking westward.

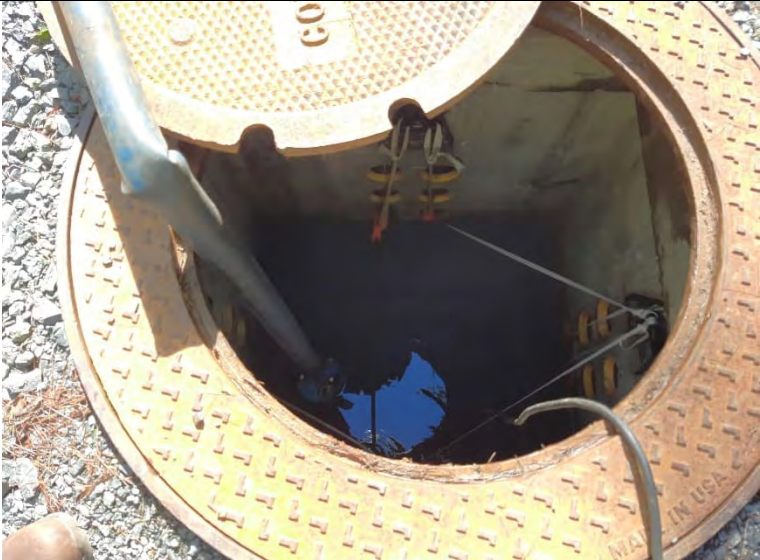
PHOTOGRAPHIC LOG	
Client Name: Eversource		Site Location: Sudbury to Hudson Transmission Reliability Project	Town: Sudbury
Photo No.: 1	Date: 8/20/2024

Description: View of handhole #15 (segment 7), area being pumped, looking down.

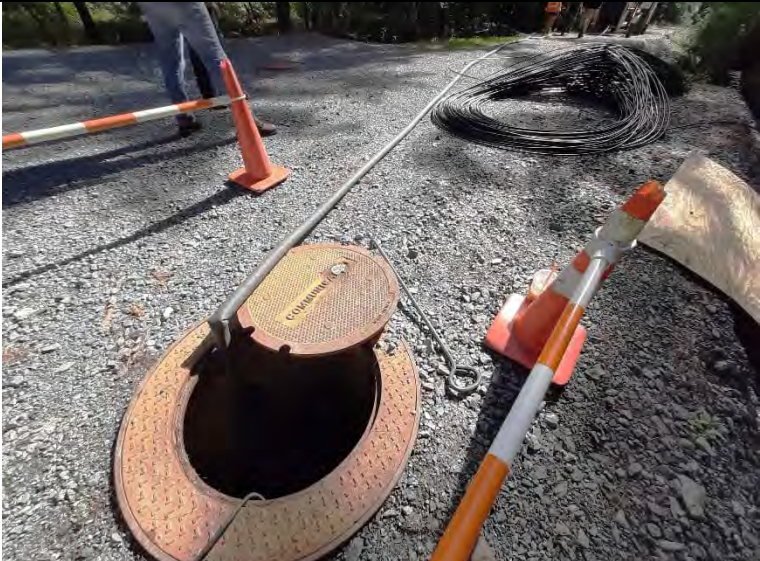
PHOTOGRAPHIC LOG	
Client Name: Eversource		Site Location: Sudbury to Hudson Transmission Reliability Project	Town: Sudbury
Photo No.: 2	Date: 8/20/2024

Description: Handhole #15. View of dewatering operation, looking eastward.

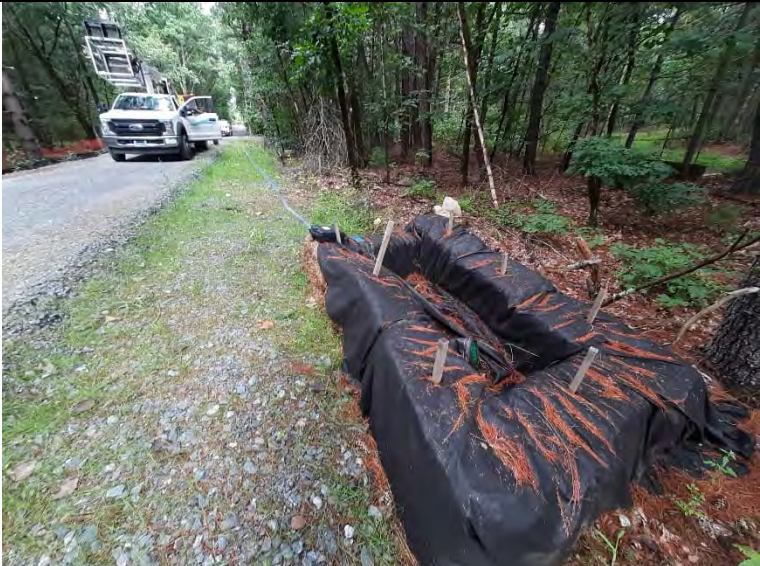
PHOTOGRAPHIC LOG	
Client Name: Eversource		Site Location: Sudbury to Hudson Transmission Reliability Project	Town: Sudbury
Photo No.: 3	Date: 8/20/2024

Description: View of dewatering operation for handhole #15, looking westward.

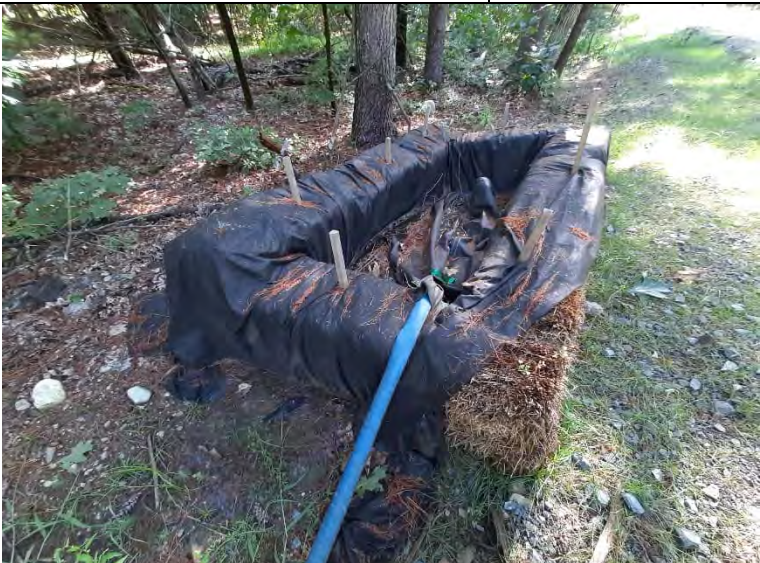
PHOTOGRAPHIC LOG	
Client Name: Eversource		Site Location: Sudbury to Hudson Transmission Reliability Project	Town: Sudbury
Photo No.: 4	Date: 8/20/2024

Description: Handhole #15. View of discharge bag/corral, looking eastward, corral discharging to the surrounding area.

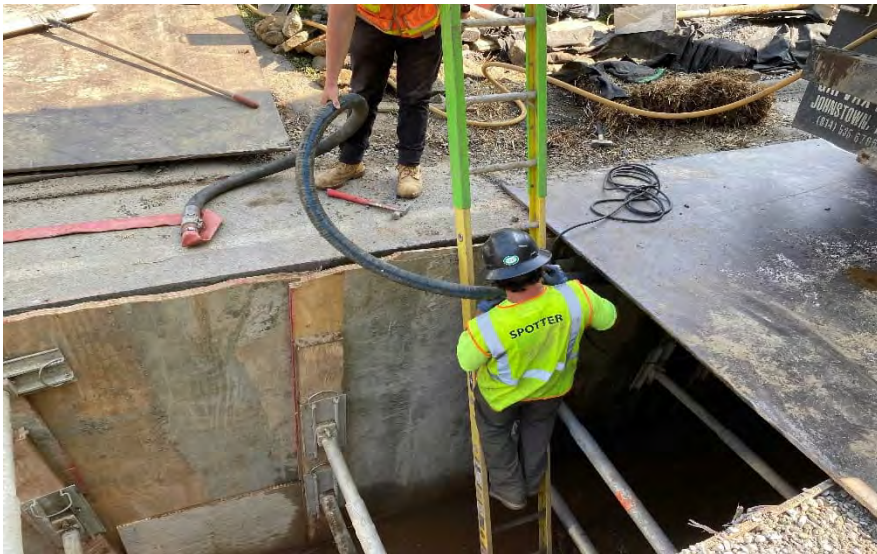
PHOTOGRAPHIC LOG	
Client Name: Eversource		Site Location: Sudbury to Hudson Transmission Reliability Project	Town: Hudson
Photo No.: 1	Date: 8/21/2024

Description: View of area being pumped from trench close to 106 Forest Avenue.

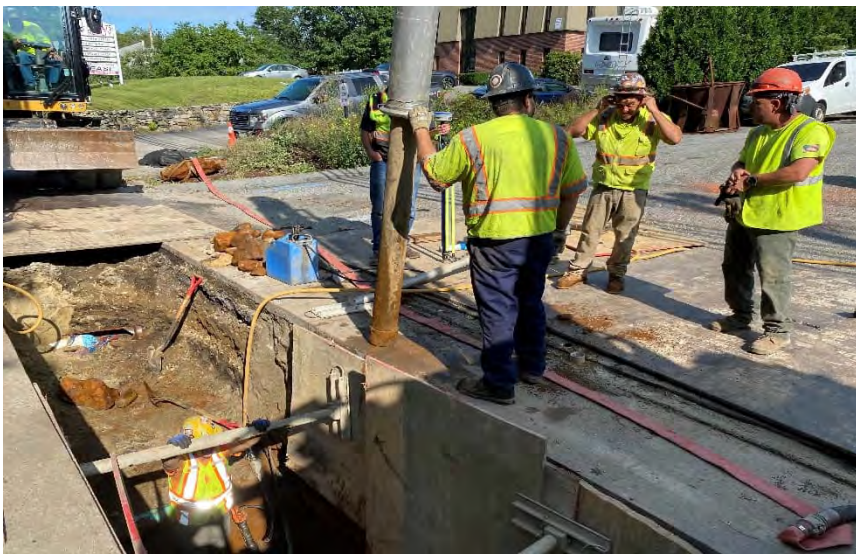
PHOTOGRAPHIC LOG	
Client Name: Eversource		Site Location: Sudbury to Hudson Transmission Reliability Project	Town: Hudson
Photo No.: 2	Date: 8/21/2024

Description: Trench near 106 Forest Avenue. View of dewatering operation. Looking southward.

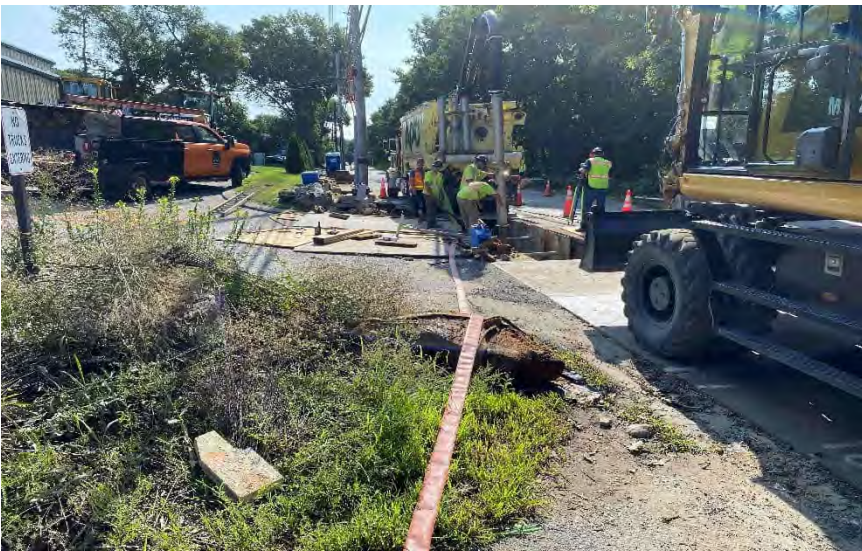
PHOTOGRAPHIC LOG	
Client Name: Eversource		Site Location: Sudbury to Hudson Transmission Reliability Project	
Town: Hudson			
Photo No.: 3	Date: 8/21/2024

Description: Near 106 Forest Avenue. View of dewatering operation, looking northward.

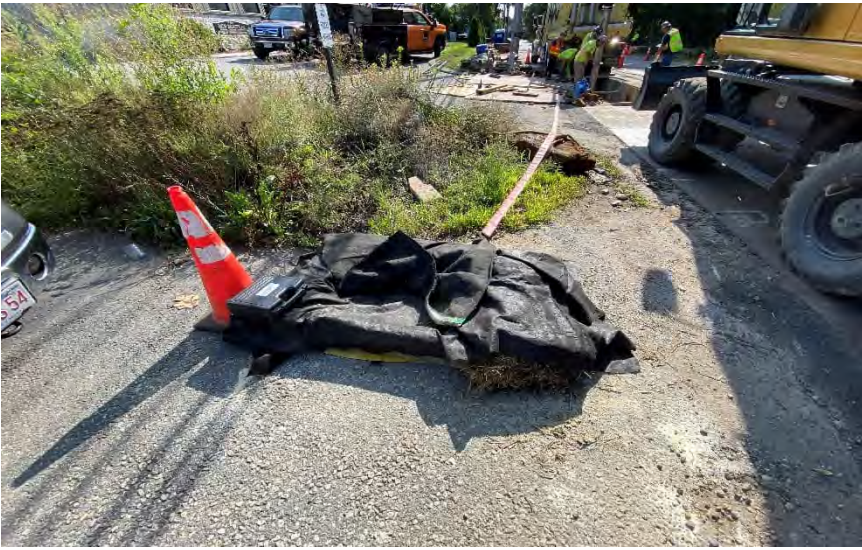
PHOTOGRAPHIC LOG	
Client Name: Eversource		Site Location: Sudbury to Hudson Transmission Reliability Project	
Town: Hudson			
Photo No.: 4	Date: 8/21/2024

Description: Near 106 Forest Avenue. View of discharge to corral over catch basin. Looking northward.

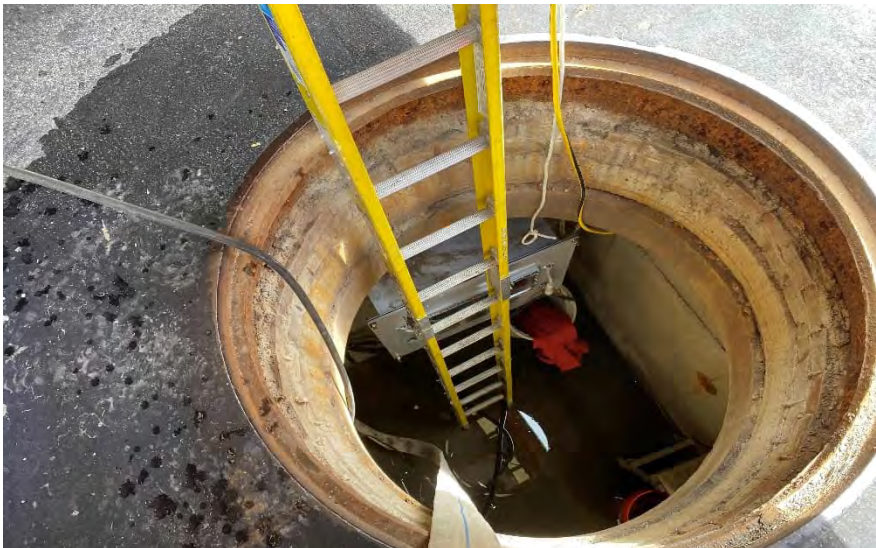
PHOTOGRAPHIC LOG	
Client Name: Eversource		Site Location: Sudbury to Hudson Transmission Reliability Project	Town: Hudson
Photo No.: 1	Date: 8/21/2024

Description: View of area being pumped from manhole #3 Forest Avenue.

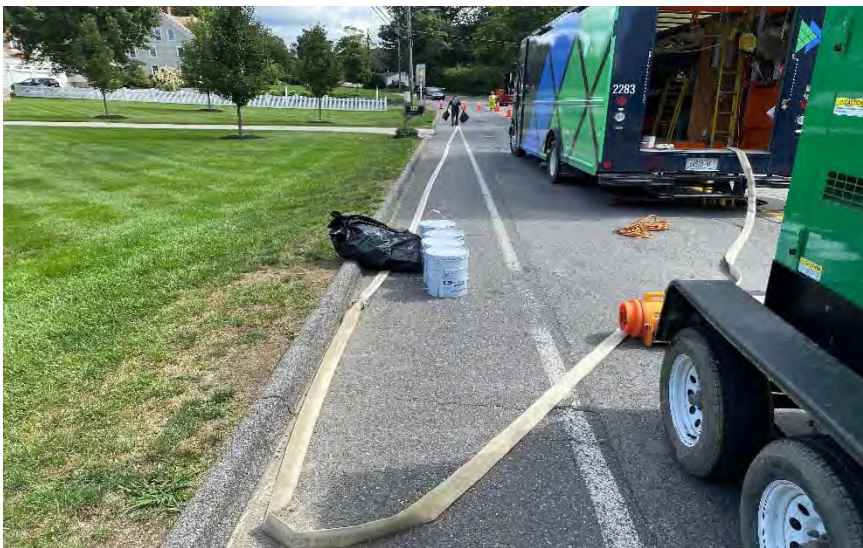
PHOTOGRAPHIC LOG	
Client Name: Eversource		Site Location: Sudbury to Hudson Transmission Reliability Project	Town: Hudson
Photo No.: 2	Date: 8/21/2024

Description: Manhole #3. View of dewatering operation. Looking northward.

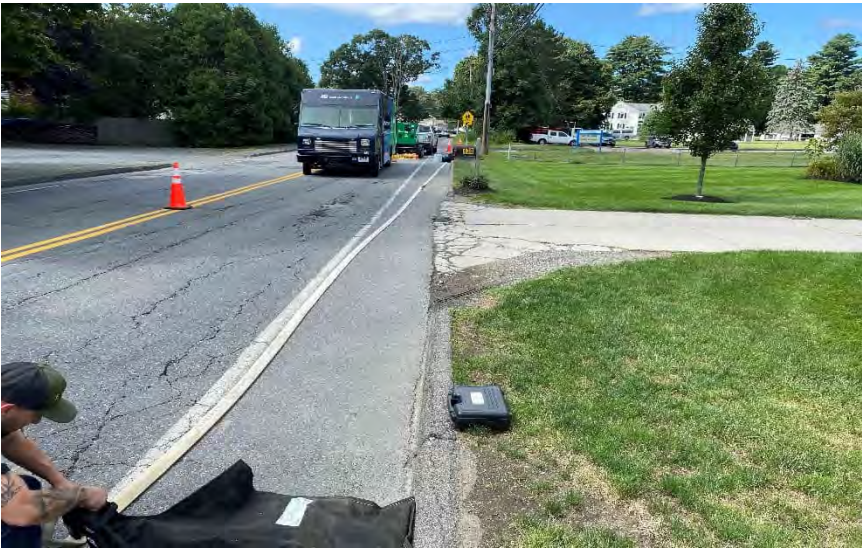
PHOTOGRAPHIC LOG	
Client Name: Eversource		Site Location: Sudbury to Hudson Transmission Reliability Project	Town: Hudson
Photo No.: 3	Date: 8/21/2024

Description: Manhole #3. View of dewatering operation, looking southward.

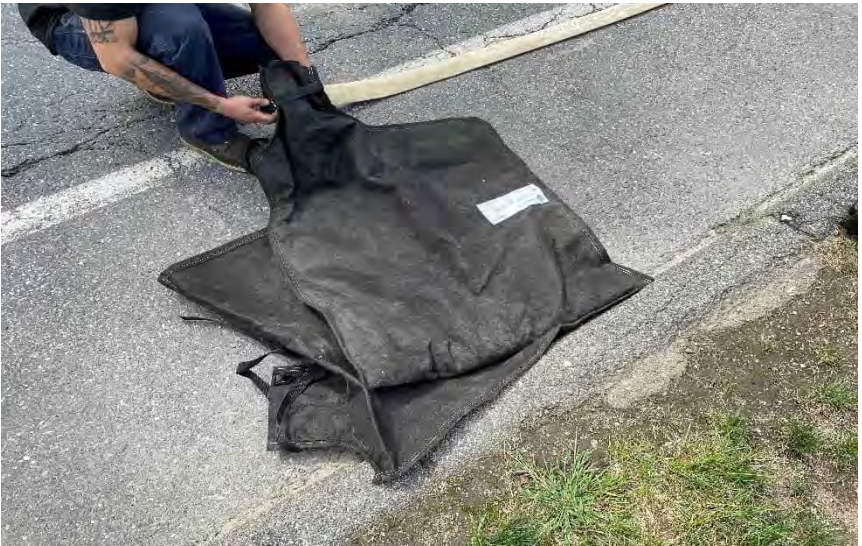
PHOTOGRAPHIC LOG	
Client Name: Eversource		Site Location: Sudbury to Hudson Transmission Reliability Project	Town: Hudson
Photo No.: 4	Date: 8/21/2024

Description: Manhole #3. View of discharge bag. Water from bag discharged to underlying catch basin in road.
