Weekly Environmental Compliance Summary

Sudbury to Hudson Transmission Reliability Project (USEPA Tracking # MAR1003UW)

Sudbury, Hudson, and Stow, MA

Week of: August 19, 2024 to August 24, 2024

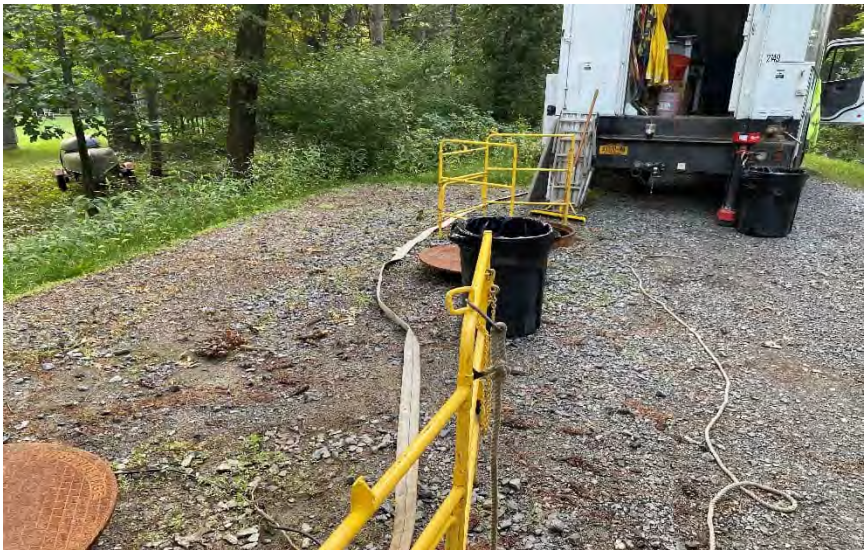
PHOTOGRAPHIC LOG	
Client Name: Eversource		Site Location: Sudbury to Hudson Transmission Reliability Project	Town: Hudson
Photo No.: 2	Date: 8/21/2024

Description: Manhole #11. View of dewatering operation. Looking eastward.

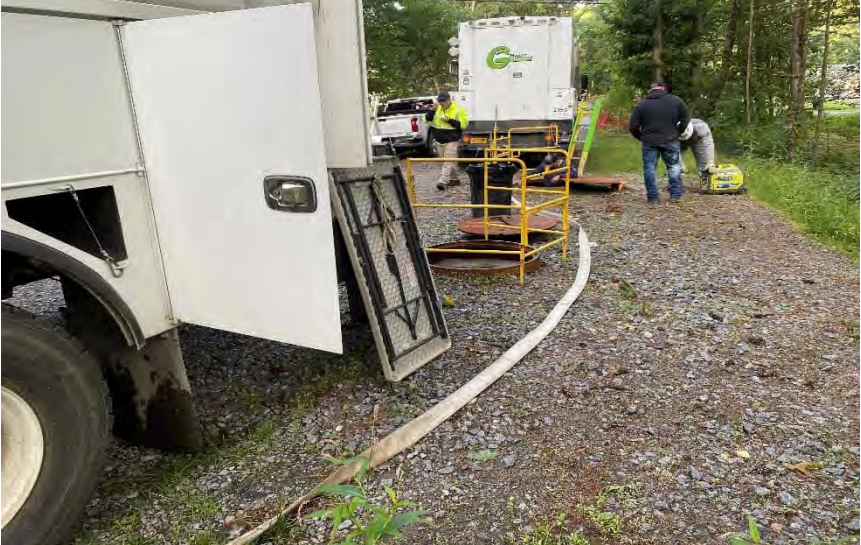
PHOTOGRAPHIC LOG	
Client Name: Eversource		Site Location: Sudbury to Hudson Transmission Reliability Project	Town: Hudson
Photo No.: 3	Date: 8/21/2024

Description: Manhole #11. View of dewatering operation, looking westward.

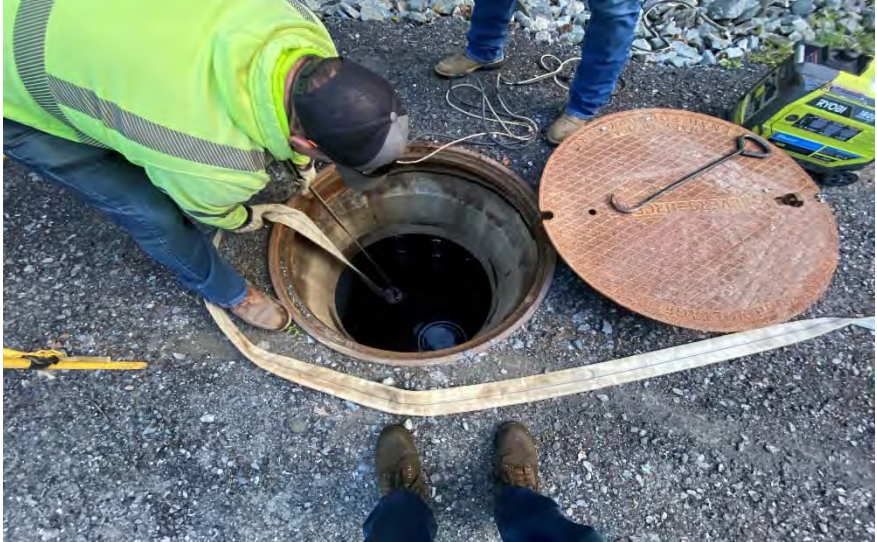
PHOTOGRAPHIC LOG	
Client Name: Eversource		Site Location: Sudbury to Hudson Transmission Reliability Project	Town: Hudson
Photo No.: 1	Date: 8/22/2024

Description: View of area being pumped from manhole #12 segment 5.

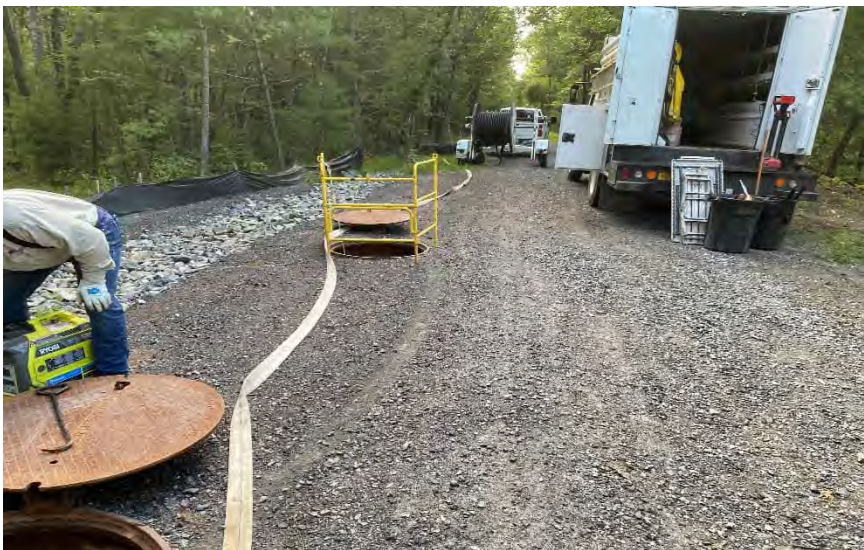
PHOTOGRAPHIC LOG	
Client Name: Eversource		Site Location: Sudbury to Hudson Transmission Reliability Project	Town: Hudson
Photo No.: 2	Date: 8/22/2024

Description: Manhole #12. View of dewatering operation. Looking eastward.

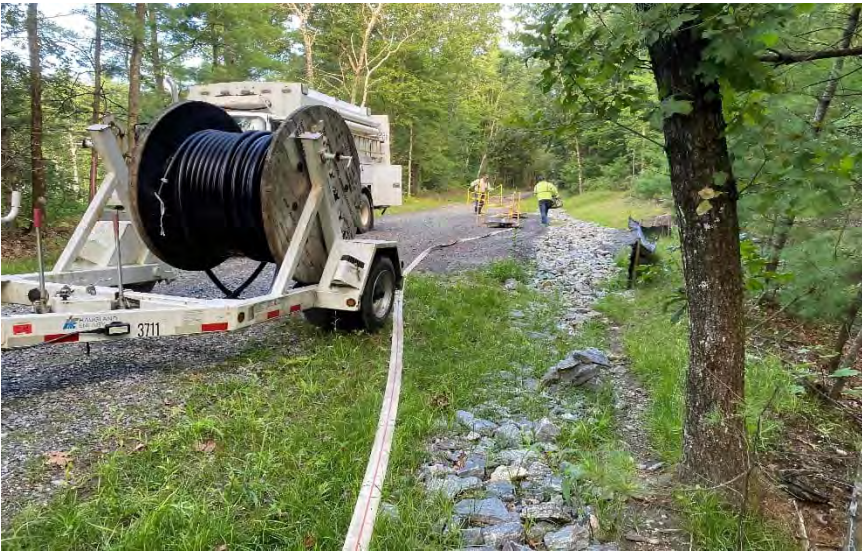
PHOTOGRAPHIC LOG	
Client Name: Eversource		Site Location: Sudbury to Hudson Transmission Reliability Project	Town: Hudson
Photo No.: 3	Date: 8/22/2024

Description: Manhole #12. View of dewatering operation, looking westward.

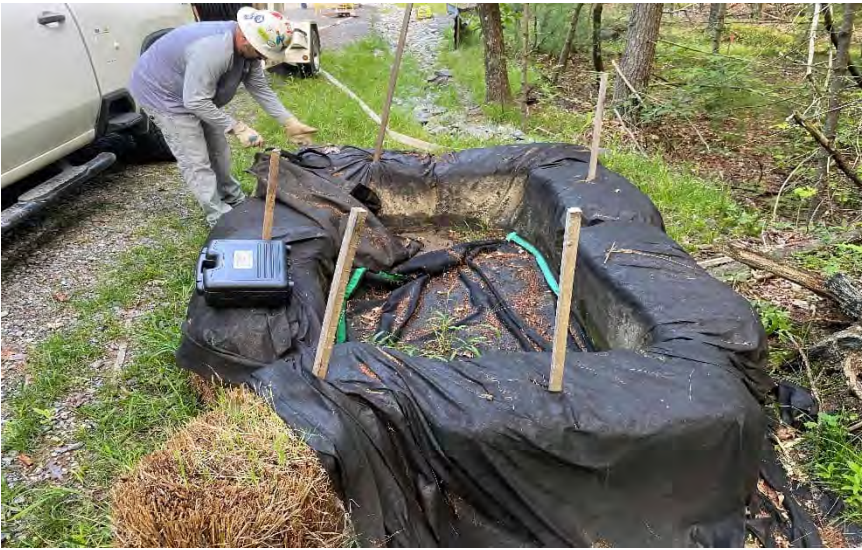
PHOTOGRAPHIC LOG	
Client Name: Eversource		Site Location: Sudbury to Hudson Transmission Reliability Project	Town: Hudson
Photo No.: 4	Date: 8/22/2024

Description: Manhole #12. View of discharge bag/corral. Water from bag/corral discharged to adjacent area, looking westward.

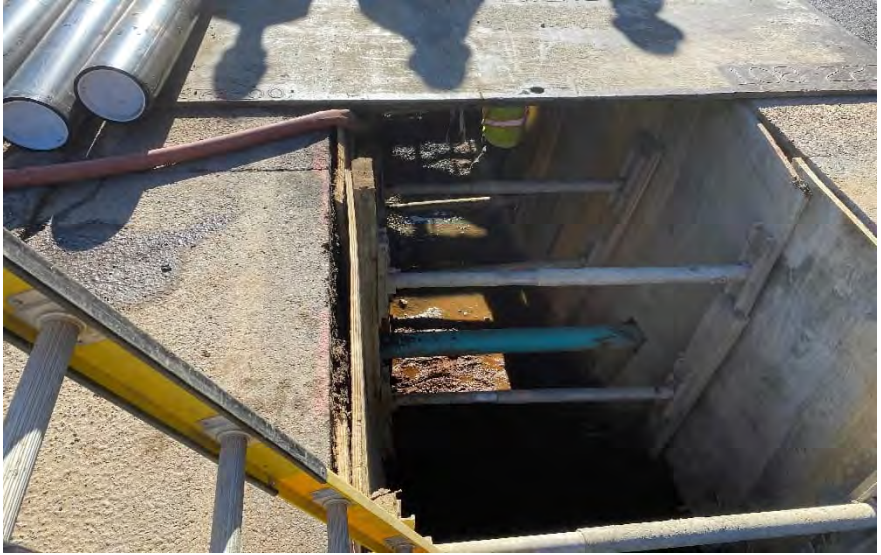
PHOTOGRAPHIC LOG	
Client Name: Eversource		Site Location: Sudbury to Hudson Transmission Reliability Project	Town: Hudson
Photo No.: 1	Date: 8/22/2024

Description: View of area being pumped from trench close to 106 Forest Avenue.

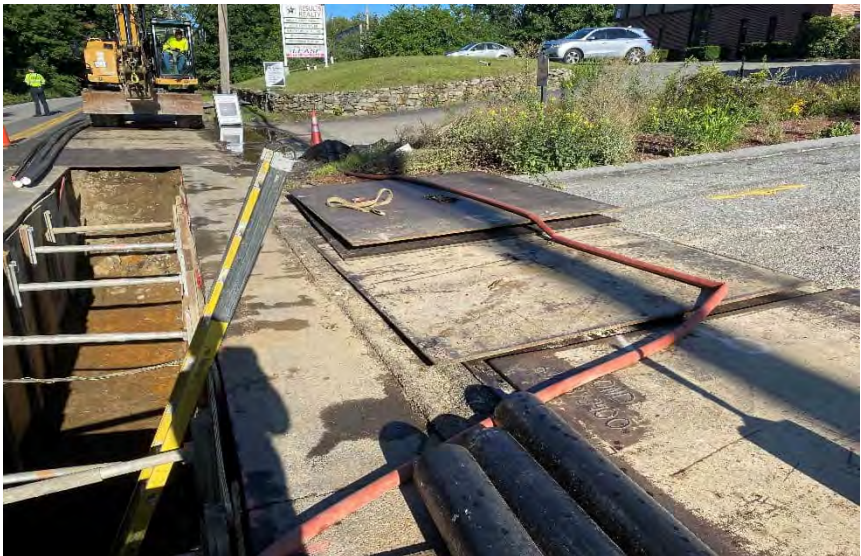
PHOTOGRAPHIC LOG	
Client Name: Eversource		Site Location: Sudbury to Hudson Transmission Reliability Project	Town: Hudson
Photo No.: 2	Date: 8/22/2024

Description: Trench near 106 Forest Avenue. View of dewatering operation. Looking southward.

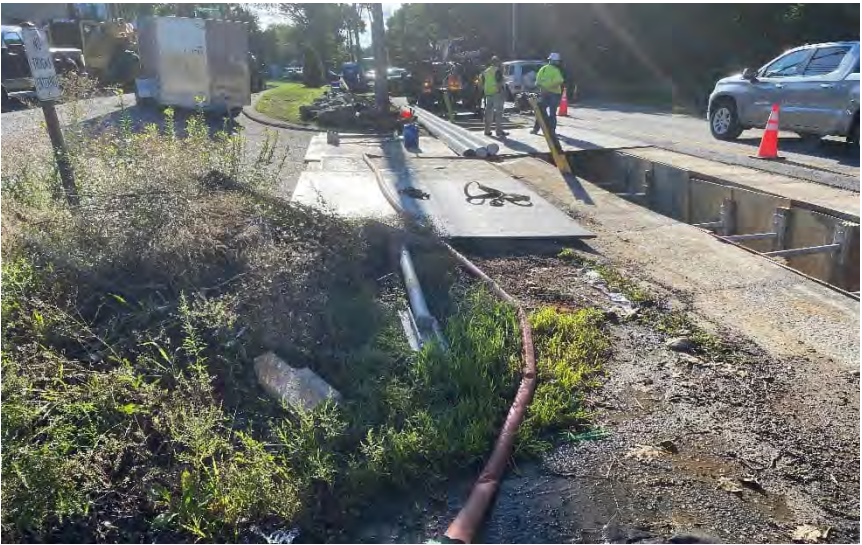
PHOTOGRAPHIC LOG	
Client Name: Eversource		Site Location: Sudbury to Hudson Transmission Reliability Project	Town: Hudson
Photo No.: 3	Date: 8/22/2024

Description: Near 106 Forest Avenue. View of dewatering operation, looking northward.

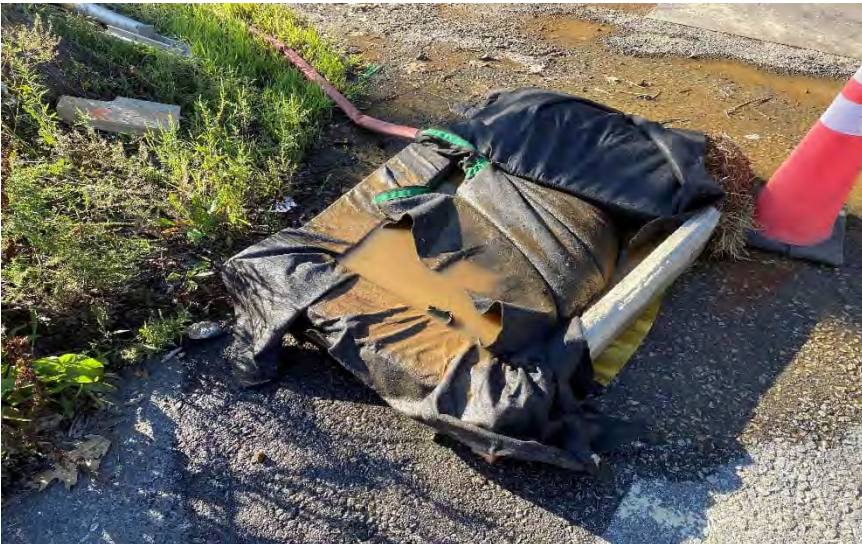
PHOTOGRAPHIC LOG	
Client Name: Eversource		Site Location: Sudbury to Hudson Transmission Reliability Project	Town: Hudson
Photo No.: 4	Date: 8/22/2024

Description: Near 106 Forest Avenue. View of discharge to corral over catch basin. Looking northward.

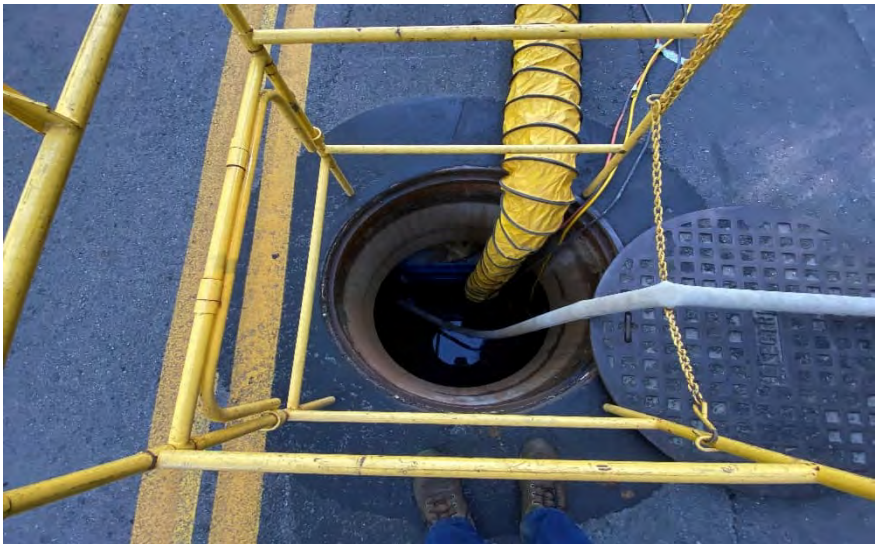
PHOTOGRAPHIC LOG	
Client Name: Eversource		Site Location: Sudbury to Hudson Transmission Reliability Project	Town: Hudson
Photo No.: 1	Date: 8/22/2024

Description: View of area being pumped from manhole #4 Forest Avenue.

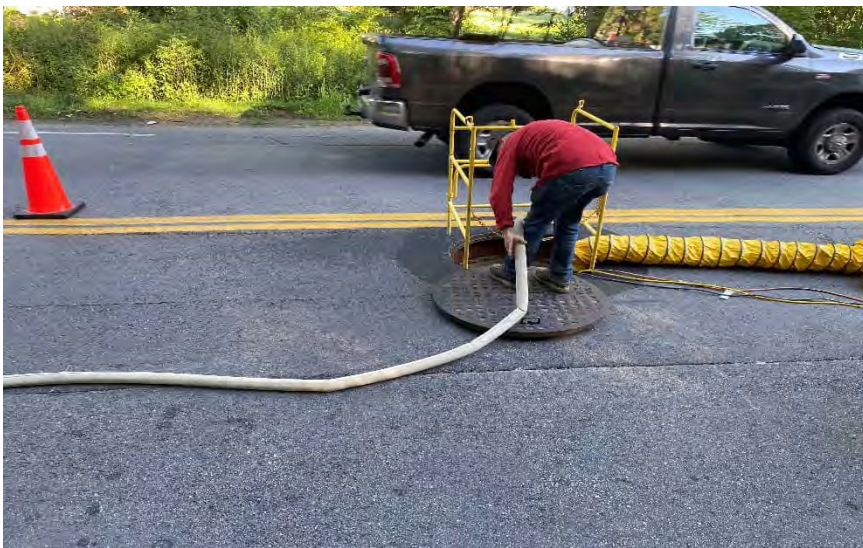
PHOTOGRAPHIC LOG	
Client Name: Eversource		Site Location: Sudbury to Hudson Transmission Reliability Project	Town: Hudson
Photo No.: 2	Date: 8/22/2024

Description: Manhole #4. View of dewatering operation. Looking westward.

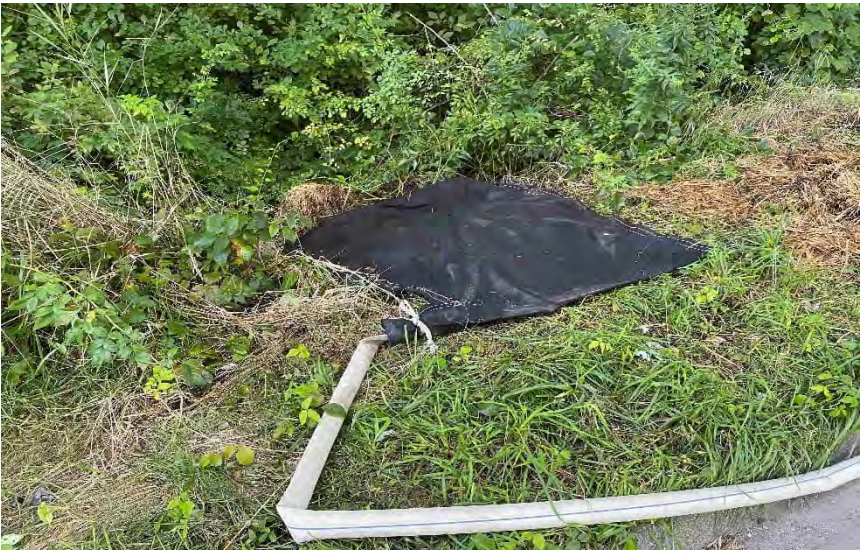
PHOTOGRAPHIC LOG	
Client Name: Eversource		Site Location: Sudbury to Hudson Transmission Reliability Project	Town: Hudson
Photo No.: 4	Date: 8/22/2024

Description: Manhole #4. View of discharge bag. Water from bag discharged to vegetated area adjacent to work area.

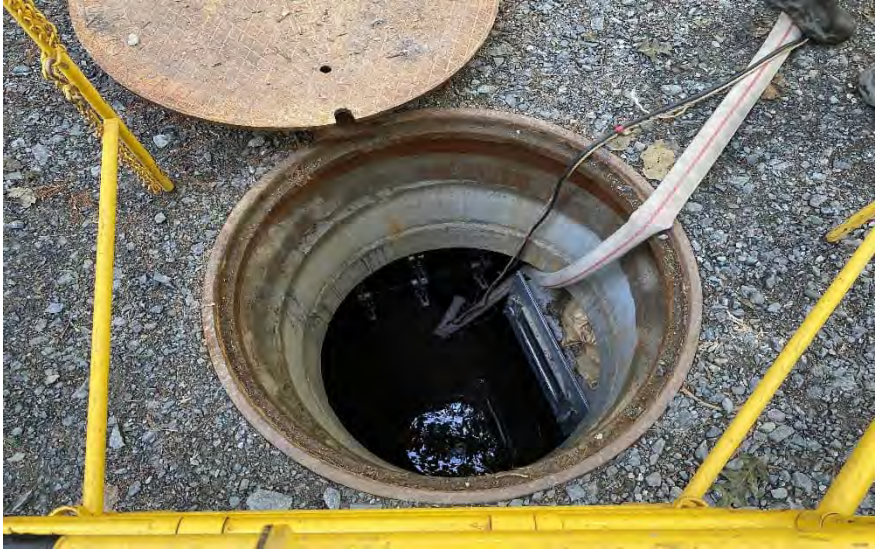
PHOTOGRAPHIC LOG	
Client Name: Eversource		Site Location: Sudbury to Hudson Transmission Reliability Project	Town: Hudson
Photo No.: 1	Date: 8/23/2024

Description: View of area being pumped from manhole #13 segment 5.

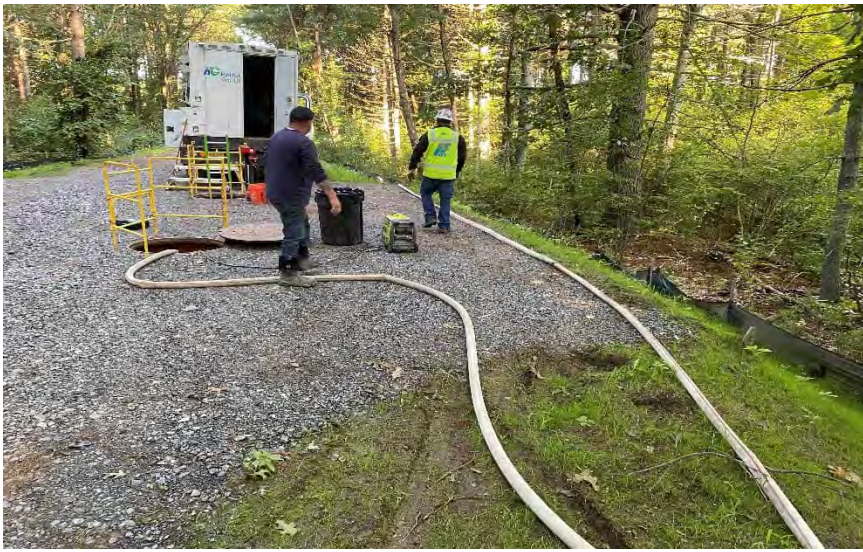
PHOTOGRAPHIC LOG	
Client Name: Eversource		Site Location: Sudbury to Hudson Transmission Reliability Project	Town: Hudson
Photo No.: 2	Date: 8/23/2024

Description: Manhole #13. View of dewatering operation. Looking westward.

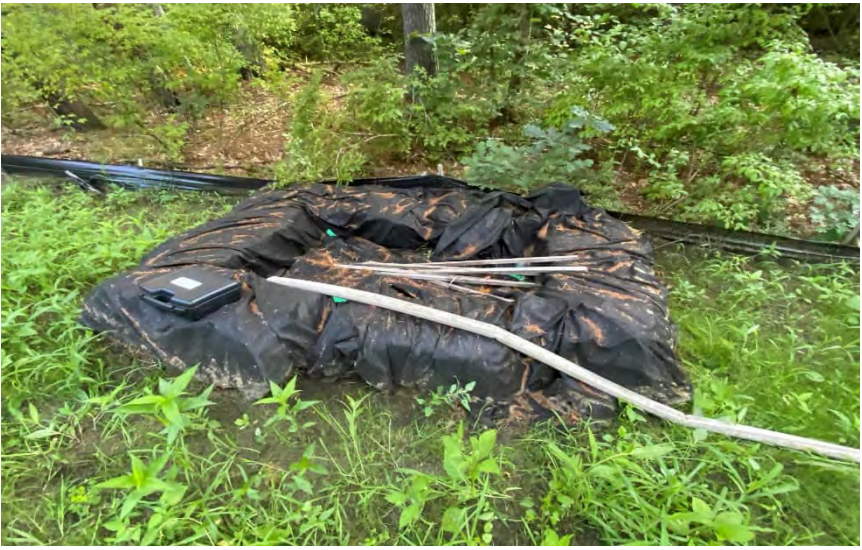
PHOTOGRAPHIC LOG	
Client Name: Eversource		Site Location: Sudbury to Hudson Transmission Reliability Project	Town: Hudson
Photo No.: 4	Date: 8/23/2024

Description: Manhole #13. View of discharge bag/corral. Water from bag/corral discharged to adjacent area, looking northward.

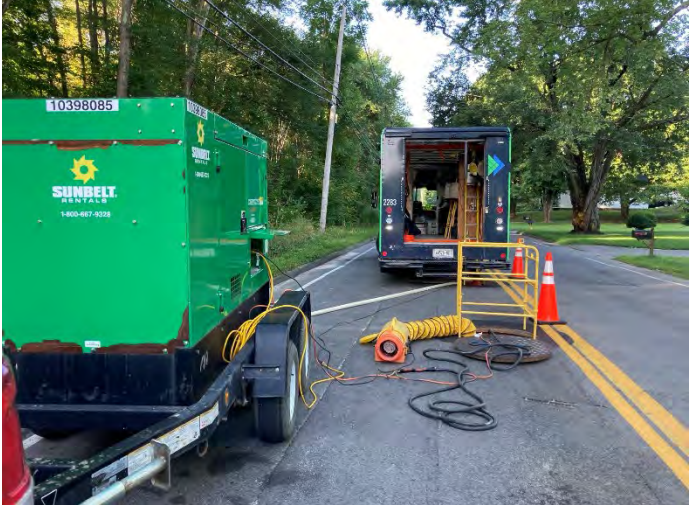
PHOTOGRAPHIC LOG	
Client Name: Eversource		Site Location: Sudbury to Hudson Transmission Reliability Project	Town: Hudson
Photo No.: 1	Date: 8/24/2024

Description: View of Haugland working at MH #4 on Forest Ave. Facing south.

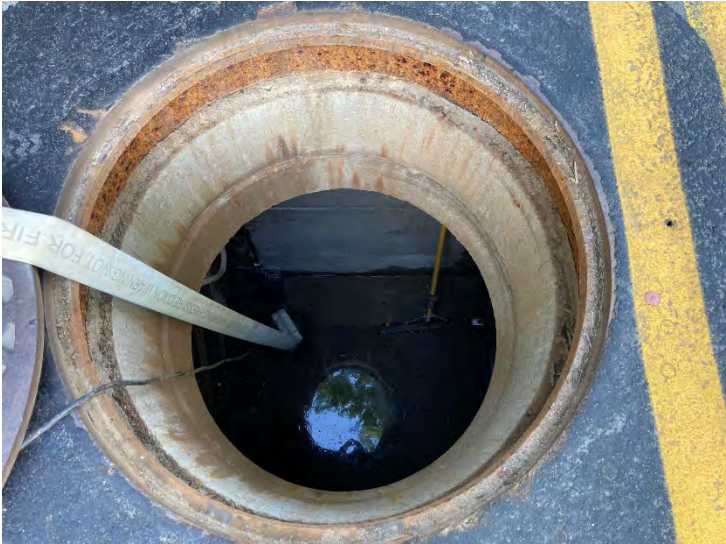
PHOTOGRAPHIC LOG	
Client Name: Eversource		Site Location: Sudbury to Hudson Transmission Reliability Project	Town: Hudson
Photo No.: 2	Date: 8/24/2024

Description: View of pump in MH #4.

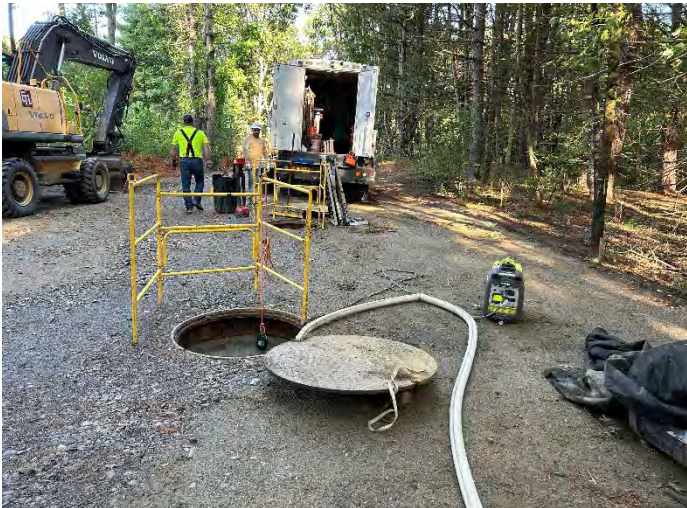
Epsilon <small>ASSOCIATES INC.</small>		PHOTOGRAPHIC LOG	
Client Name: Eversource		Site Location: Sudbury to Hudson Transmission Reliability Project	Town: Sudbury
Photo No.: 1	Date: 8/24/2024

Description: View of Haugland working at MH #17 within segment 8. Facing west.

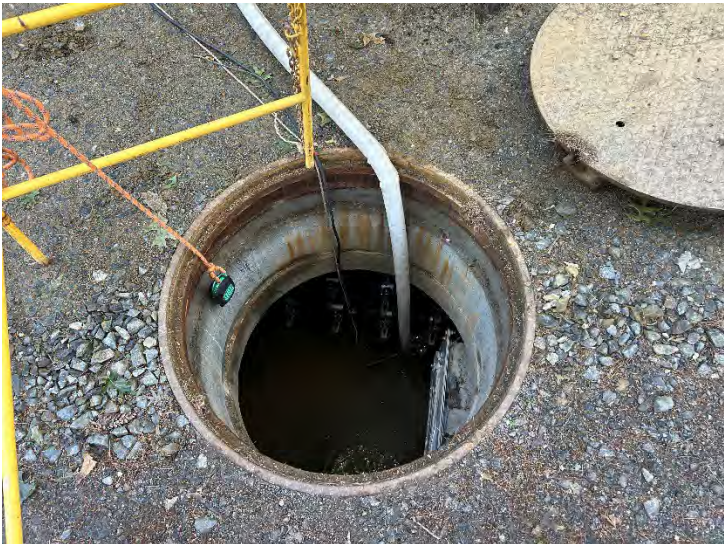
Epsilon <small>ASSOCIATES INC.</small>		PHOTOGRAPHIC LOG	
Client Name: Eversource		Site Location: Sudbury to Hudson Transmission Reliability Project	Town: Sudbury
Photo No.: 2	Date: 8/24/2024

Description: View of pump in MH #17. Facing north.

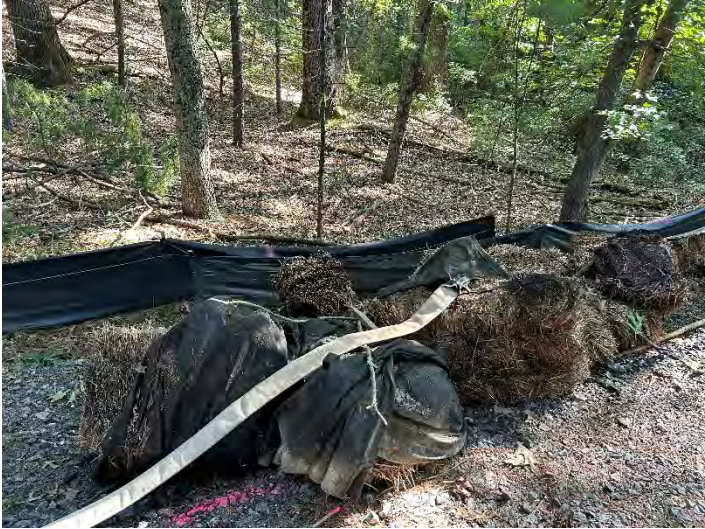
PHOTOGRAPHIC LOG	
Client Name: Eversource		Site Location: Sudbury to Hudson Transmission Reliability Project	Town: Sudbury
Photo No.: 3	Date: 8/24/2024

Description: View of dewatering controls (straw bale corral with filter fabric and silt bag). Facing north.

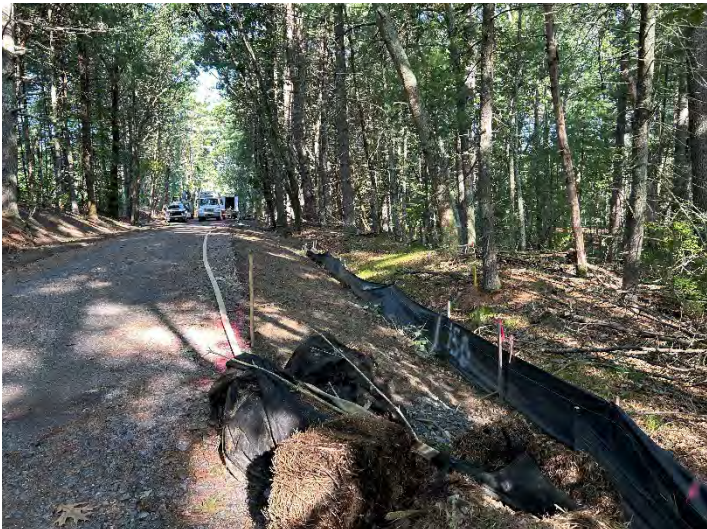
PHOTOGRAPHIC LOG	
Client Name: Eversource		Site Location: Sudbury to Hudson Transmission Reliability Project	Town: Sudbury
Photo No.: 4	Date: 8/24/2024

Description: View of dewatering controls (straw bale corral with filter fabric and silt bag) and discharge from corral. Discharge appeared slightly cloudy and turbidity reading was above 50 NTUs. Discharge did not appear to reach any jurisdictional resource areas. Facing west.
