**Environmental Monitor Construction Site Inspection Report
MassDOT Project #608164 Construction Contract # 119678
EM Report #11**

Project Name:	Bruce Freeman Rail Trail - Phase 2d - Sudbury
Date of Inspections:	7/8/2024
Bi Weekly/ Monthly Period Covered:	July Weekly Inspection #1
Inspector's Name(s):	Anna Haznar
Inspectors' Contact Information:	ahaznar@beta-inc.com

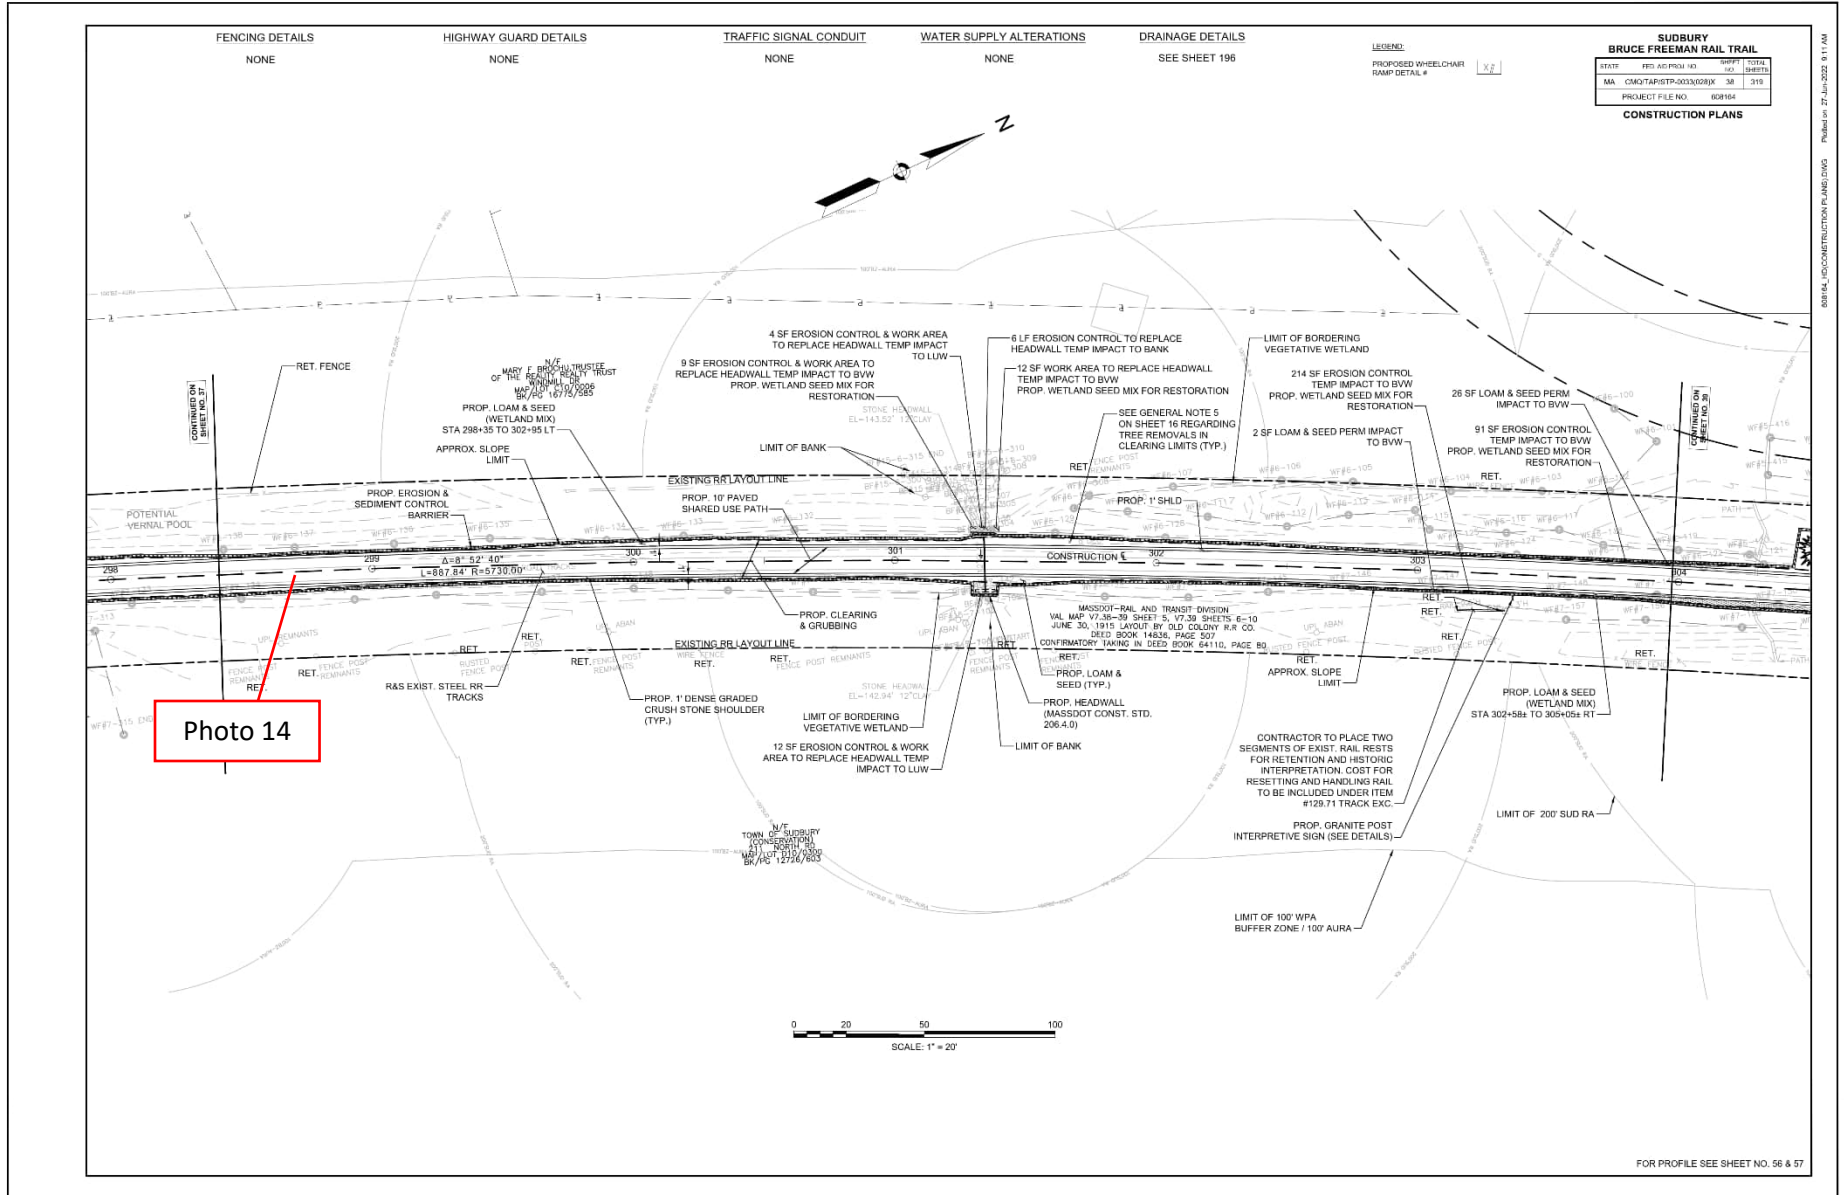
Photo 14

Photo No. 14	Date: 7/8/2024	 
Direction Photo Taken: Toward the East		
Description: View of an area at Station 299+00 where gravel should be removed from the wetland per Compliance Action Item 26.
