Weekly Environmental Compliance Summary

Sudbury to Hudson Transmission Reliability Project (USEPA Tracking # MAR1003UW)

Week of: September 3, 2024 to September 7, 2024

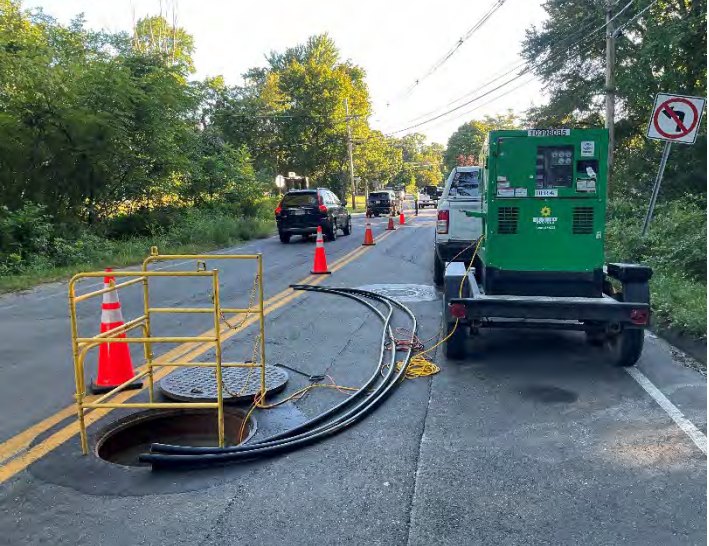
<p>PHOTOGRAPHIC LOG</p>	
<p>Client Name: Eversource</p>		<p>Site Location: Sudbury to Hudson Transmission Reliability Project</p>	<p>Town: Hudson</p>
<p>Photo No.: 2</p>	<p>Date: 9-3-24</p>

<p>Description:</p> <p>View of Haugland cable splicers at MH#4 on Forest Avenue. See additional dewatering report. Facing northeast.</p>

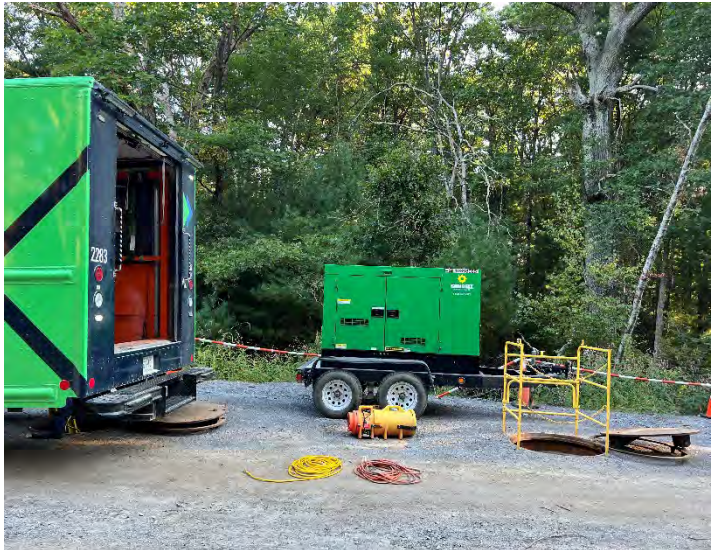
<p>PHOTOGRAPHIC LOG</p>	
<p>Client Name: Eversource</p>		<p>Site Location: Sudbury to Hudson Transmission Reliability Project</p>	<p>Town: Hudson</p>
<p>Photo No.: 2</p>	<p>Date: 9-4-24</p>

<p>Description:</p> <p>View of Haugland cable splicers at MH#14 in segment 6. See additional dewatering report. Facing north.</p>

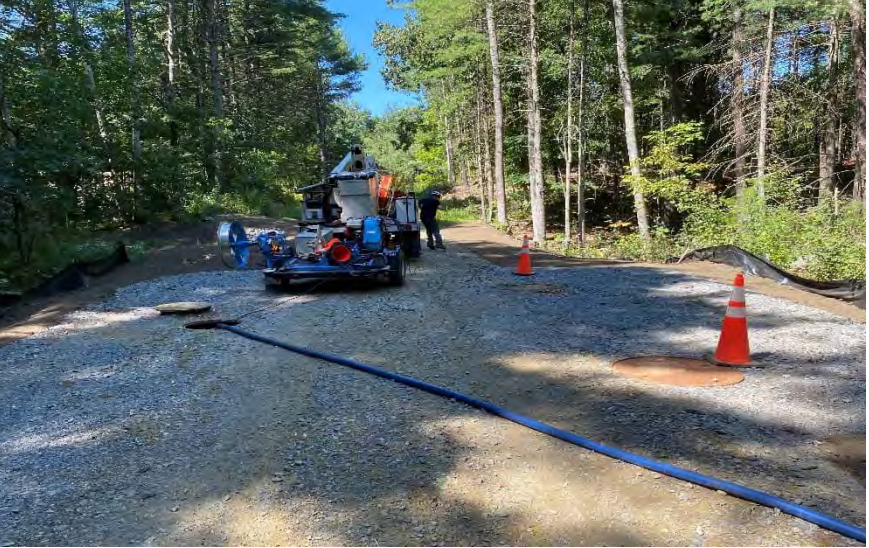
PHOTOGRAPHIC LOG	
Client Name: Eversource		Site Location: Sudbury to Hudson Transmission Reliability Project	
Photo No.: 2 Date: 9-4-24		Town: Sudbury	
Description: New Wave conducting fiber optics work at handhole #20, existing erosion control, looking westward

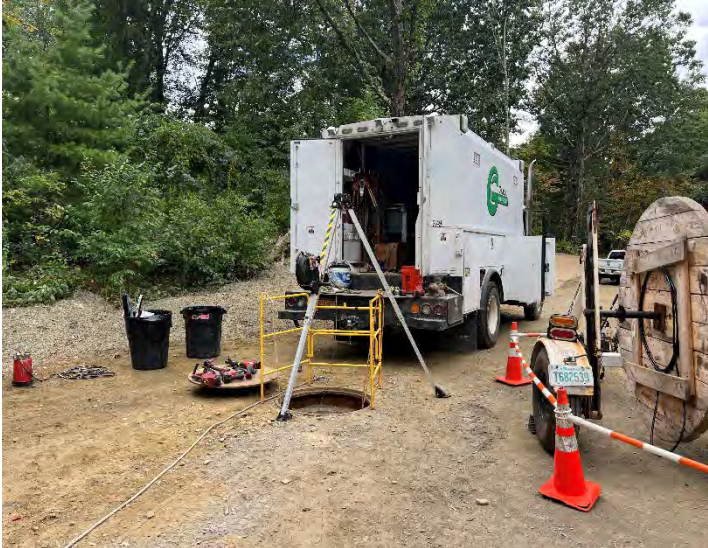
<p align="center">PHOTOGRAPHIC LOG</p>	
<p>Client Name: Eversource</p>		<p>Site Location: Sudbury to Hudson Transmission Reliability Project</p>	<p>Town: Hudson</p>
<p>Photo No.: 2</p>	<p>Date: 9-6-24</p>

<p>Description:</p> <p>View of Haugland cable splicers at MH#5 in segment 1. See additional dewatering report. Facing northeast.</p>

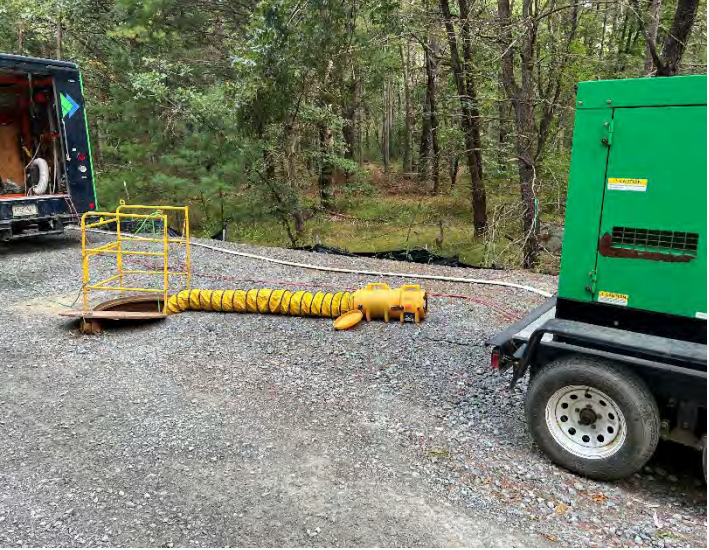
<p align="center">PHOTOGRAPHIC LOG</p>	
<p>Client Name: Eversource</p>		<p>Site Location: Sudbury to Hudson Transmission Reliability Project</p>	<p>Town: Sudbury</p>
<p>Photo No.: 2</p>	<p>Date: 9-7-24</p>

<p>Description:</p> <p>View of Haugland cable splicers at MH#15 in segment 7. Facing northeast.</p>

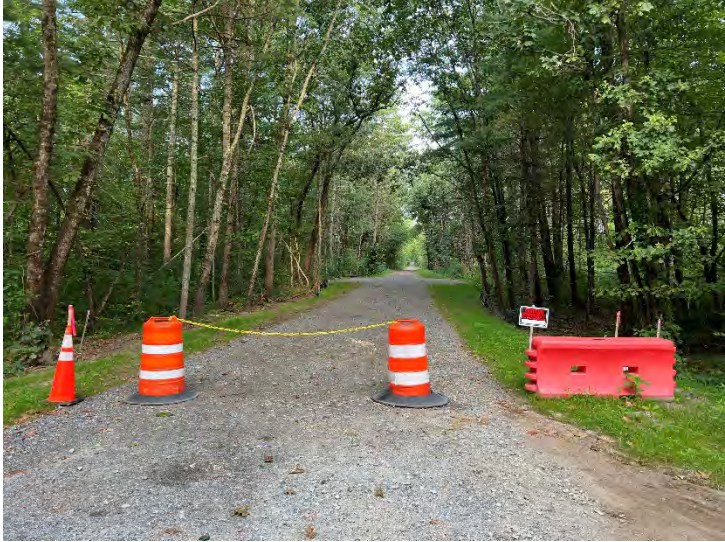
<p align="center">PHOTOGRAPHIC LOG</p>	
<p>Client Name: Eversource</p>		<p>Site Location: Sudbury to Hudson Transmission Reliability Project</p>	<p>Town: Hudson</p>
<p>Photo No.: 7</p>	<p>Date: 9-6-24</p>

<p>Description:</p> <p>View of construction entrance to segment 5. Facing west.</p>

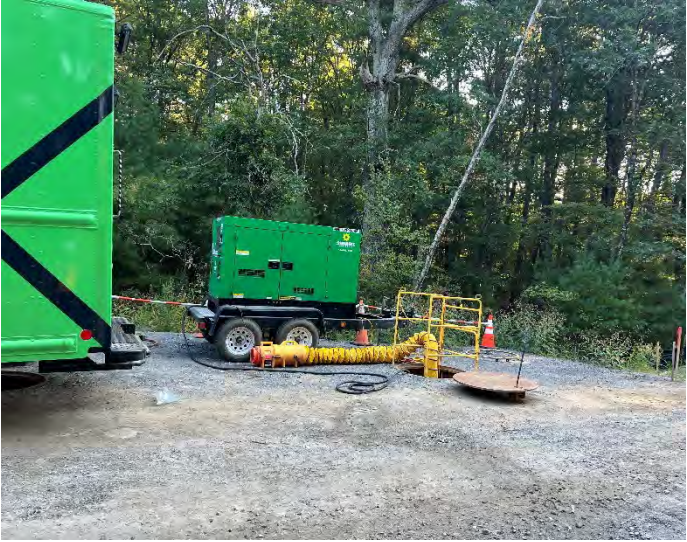
PHOTOGRAPHIC LOG	
Client Name: Eversource		Site Location: Sudbury to Hudson Transmission Reliability Project	Town: Hudson
Photo No.: 1	Date: 9-5-2024

Description: View of Haugland cable splicers working at MH #14 in segment 6. Facing north.

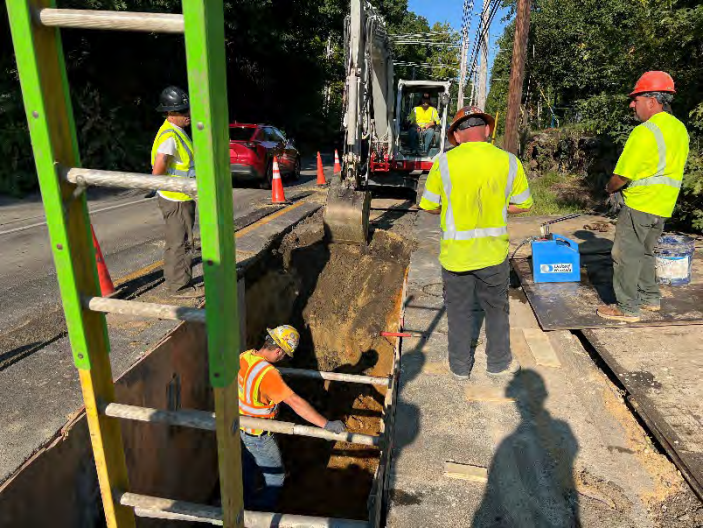
PHOTOGRAPHIC LOG	
Client Name: Eversource		Site Location: Sudbury to Hudson Transmission Reliability Project	Town: Hudson
Photo No.: 2	Date: 9-5-2024

Description: View of Bond trenching in Forest Ave by MH #1. Facing west.

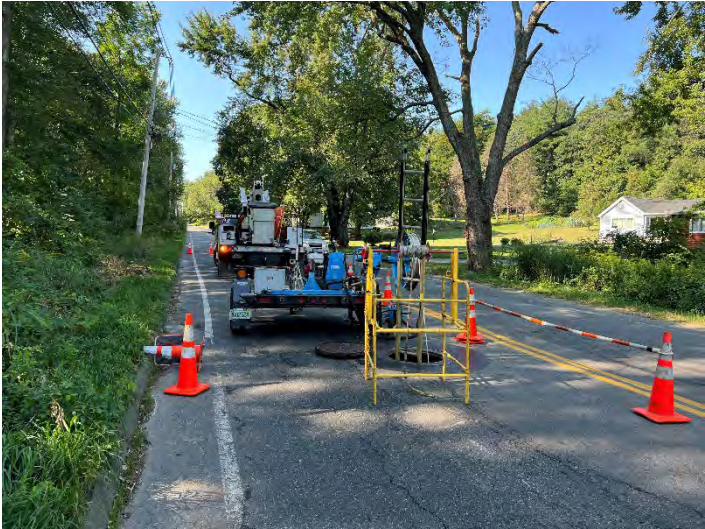
Epsilon ASSOCIATES INC.		PHOTOGRAPHIC LOG	
Client Name: Eversource		Site Location: Sudbury to Hudson Transmission Reliability Project	Town: Hudson
Photo No.: 3	Date: 9-5-2024

Description: View of New Wave installing fiber optics at HH#4 in Forest Ave. Facing south.

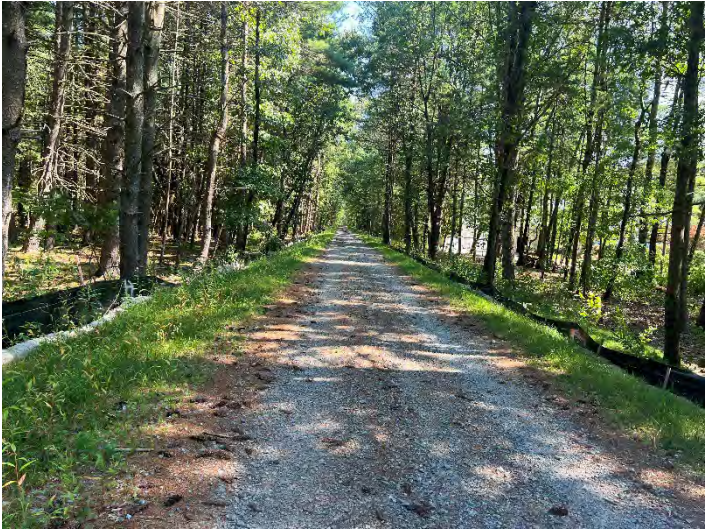
Epsilon ASSOCIATES INC.		PHOTOGRAPHIC LOG	
Client Name: Eversource		Site Location: Sudbury to Hudson Transmission Reliability Project	Town: Hudson
Photo No.: 4	Date: 9-5-2024

Description: View of E&S controls in segment 5. Facing east.

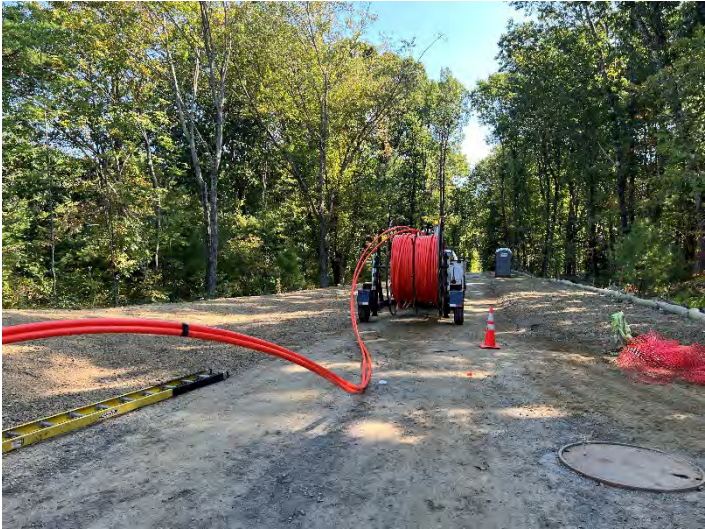
Epsilon ASSOCIATES INC.		PHOTOGRAPHIC LOG	
Client Name: Eversource		Site Location: Sudbury to Hudson Transmission Reliability Project	Town: Hudson
Photo No.: 5	Date: 9-5-2024

Description: View of New Wave work space at HH#5 in segment 1. Facing east.

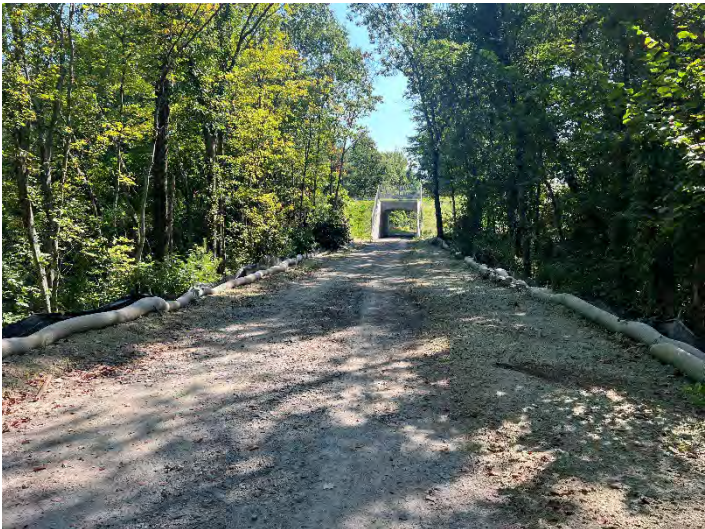
Epsilon ASSOCIATES INC.		PHOTOGRAPHIC LOG	
Client Name: Eversource		Site Location: Sudbury to Hudson Transmission Reliability Project	Town: Hudson
Photo No.: 6	Date: 9-5-2024

Description: View of E&S controls in segment 1. Facing east.

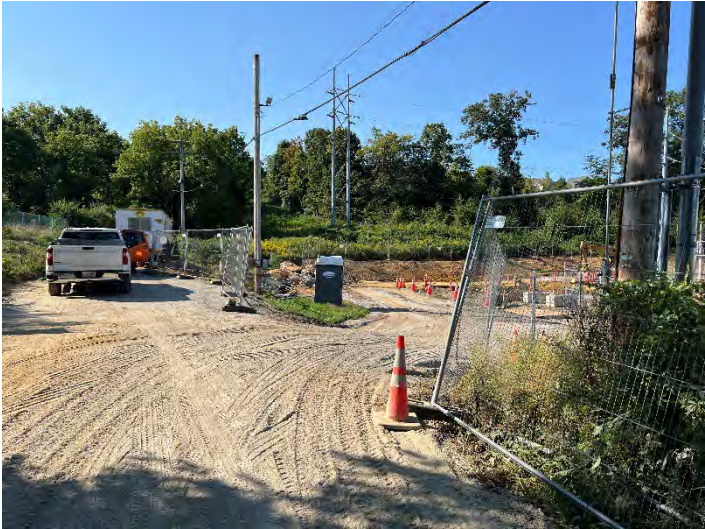
PHOTOGRAPHIC LOG	
Client Name: Eversource		Site Location: Sudbury to Hudson Transmission Reliability Project	Town: Hudson
Photo No.: 7	Date: 9-5-2024

Description: View of previous location of filter tubes south of MH#1 behind Hudson Light & Power. Filter tubes have been removed for Hudson Substation access. Facing south.

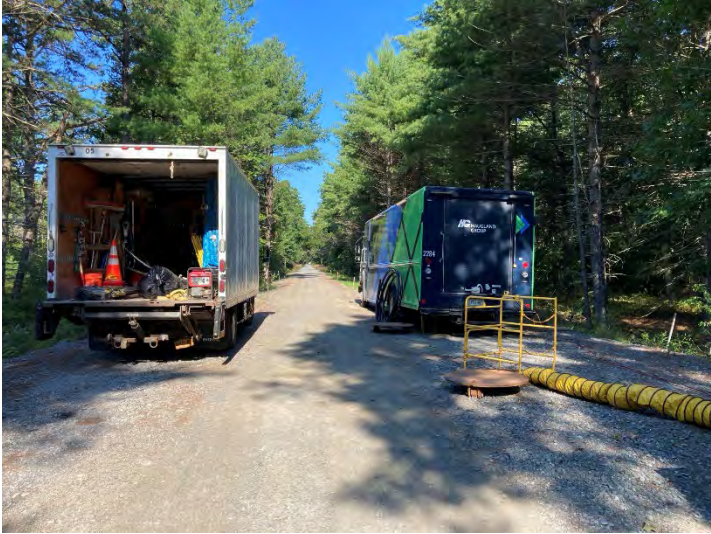
PHOTOGRAPHIC LOG	
Client Name: Eversource		Site Location: Sudbury to Hudson Transmission Reliability Project	Town: Sudbury
Photo No.: 1	Date: 9-05-24

Description: View of Haugland cable splicers at MH #16 in segment 7. Facing west.

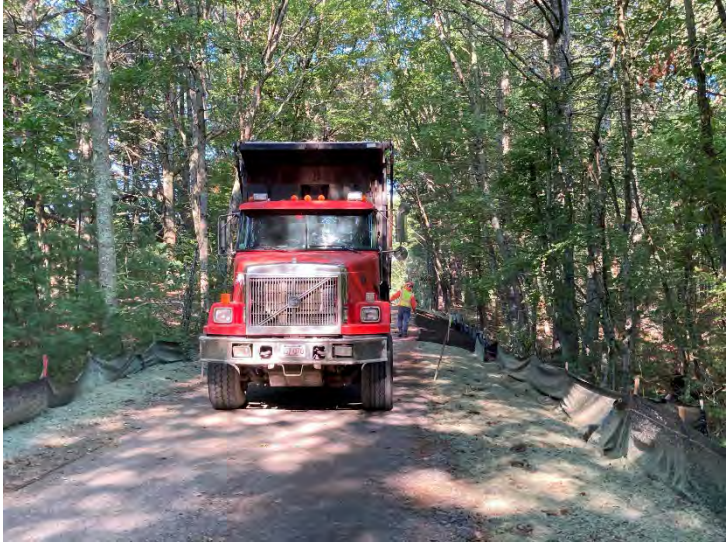
PHOTOGRAPHIC LOG	
Client Name: Eversource		Site Location: Sudbury to Hudson Transmission Reliability Project	Town: Sudbury
Photo No.: 2	Date: 9-05-24

Description: View of ET&L applying planting soil in segment 8. Facing west.

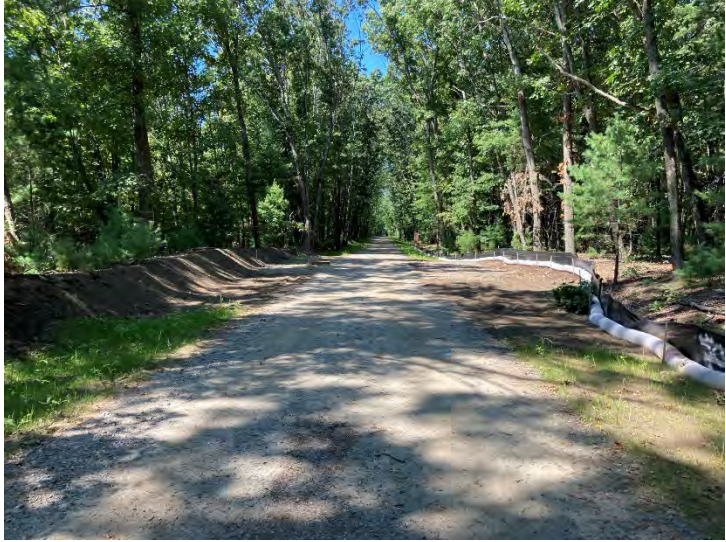
PHOTOGRAPHIC LOG	
Client Name: Eversource		Site Location: Sudbury to Hudson Transmission Reliability Project	Town: Sudbury
Photo No.: 5	Date: 9-05-24

Description: View of E&S controls at MH #23 in segment 11. Facing west.

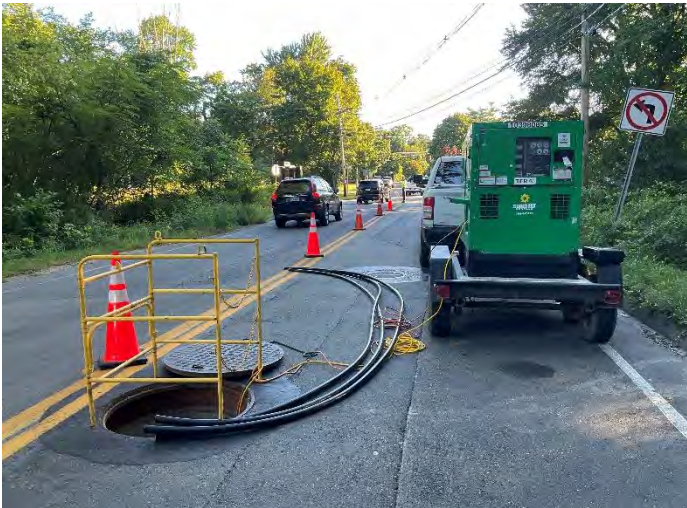
PHOTOGRAPHIC LOG	
Client Name: Eversource		Site Location: Sudbury to Hudson Transmission Reliability Project	Town: Hudson
Photo No.: 1	Date: 9/3/2024

Description: View of Haugland workspace at MH#4 within Forest Ave. Facing northeast.

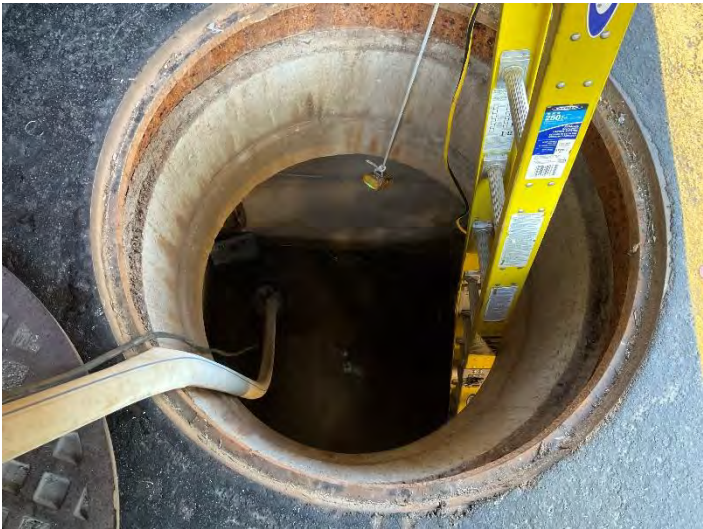
PHOTOGRAPHIC LOG	
Client Name: Eversource		Site Location: Sudbury to Hudson Transmission Reliability Project	Town: Hudson
Photo No.: 2	Date: 9/3/2024

Description: View of pump within MH#4. Water appeared to be turbid prior to treatment.

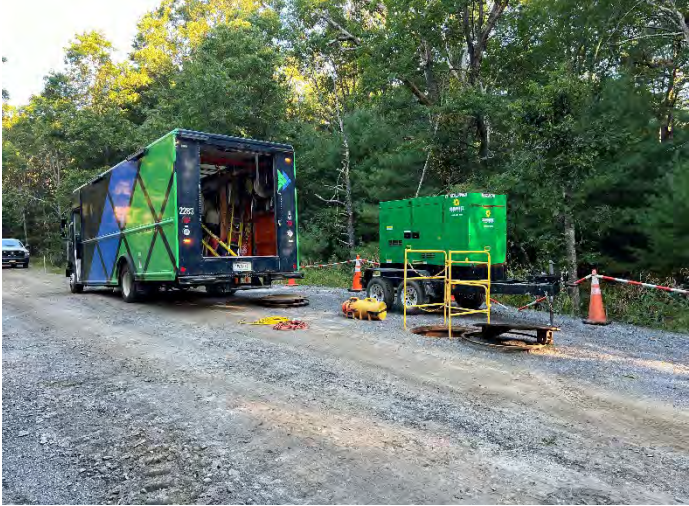
PHOTOGRAPHIC LOG	
Client Name: Eversource		Site Location: Sudbury to Hudson Transmission Reliability Project	Town: Hudson
Photo No.: 1	Date: 9/4/2024

Description: View of Haugland work area at MH#14 in segment 6. Facing northwest.

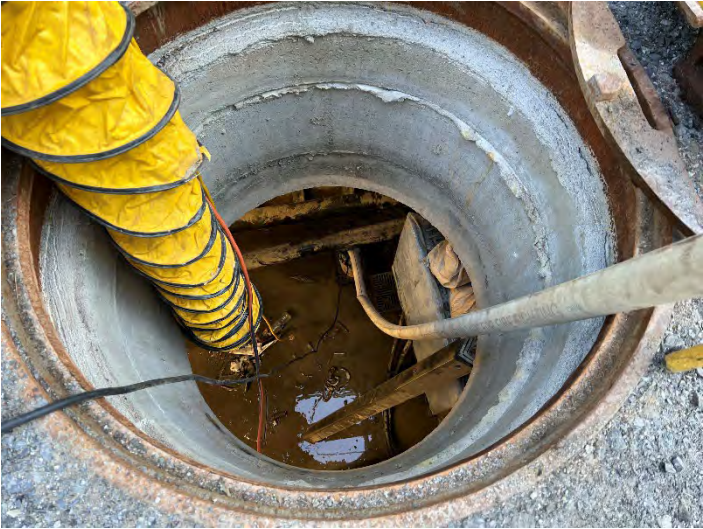
PHOTOGRAPHIC LOG	
Client Name: Eversource		Site Location: Sudbury to Hudson Transmission Reliability Project	Town: Hudson
Photo No.: 2	Date: 9/4/2024

Description: View of pump in MH#14.

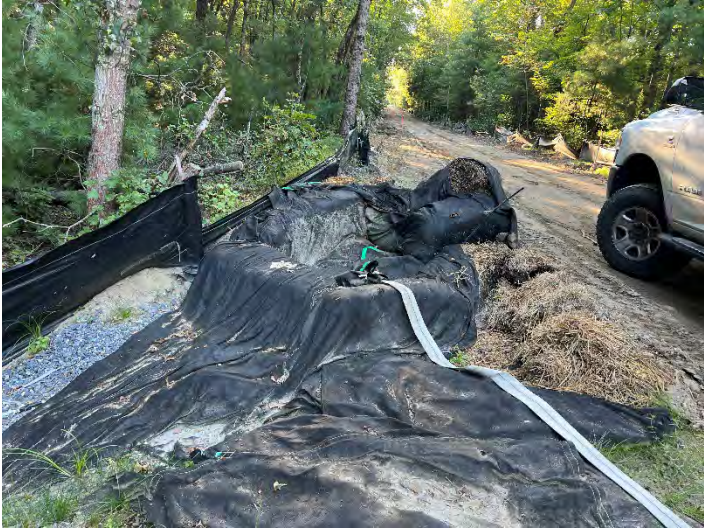
PHOTOGRAPHIC LOG	
Client Name: Eversource		Site Location: Sudbury to Hudson Transmission Reliability Project	Town: Hudson
Photo No.: 3	Date: 9/4/2024

Description: View of dewatering controls (straw bale corral with filter fabric and silt bag). Facing east.

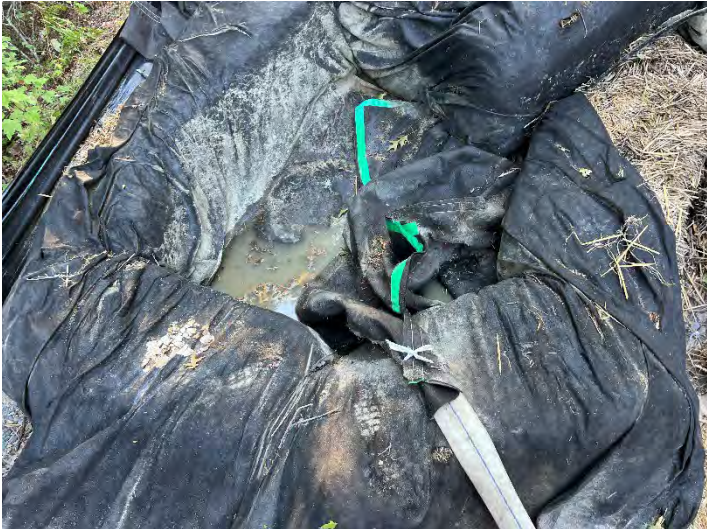
PHOTOGRAPHIC LOG	
Client Name: Eversource		Site Location: Sudbury to Hudson Transmission Reliability Project	Town: Hudson
Photo No.: 4	Date: 9/4/2024

Description: View of discharging water within corral. Discharge appeared turbid and turbidity reading was above 50 NTUs. Discharge did not leave the corral.

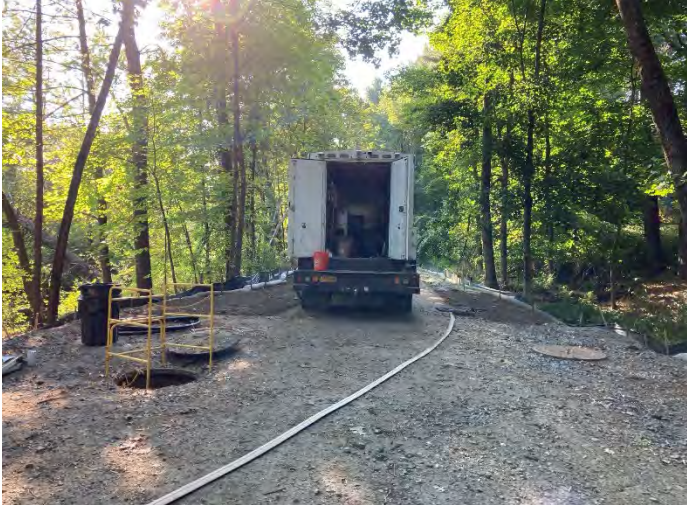
PHOTOGRAPHIC LOG	
Client Name: Eversource		Site Location: Sudbury to Hudson Transmission Reliability Project	
		Town: Sudbury	
Photo No.: 1	Date: 9/05/2024

Description: View of Haugland working at MH #25 in segment 13. Facing east.

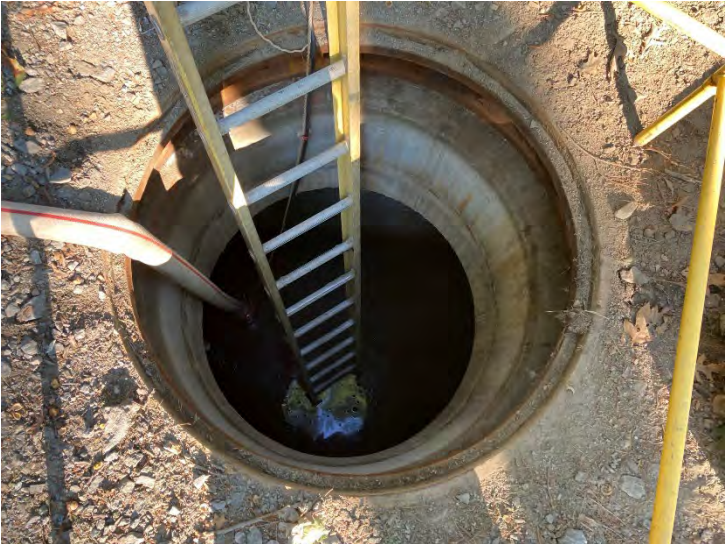
PHOTOGRAPHIC LOG	
Client Name: Eversource		Site Location: Sudbury to Hudson Transmission Reliability Project	
		Town: Sudbury	
Photo No.: 2	Date: 9/05/2024

Description: View of pump in MH #25. Water appeared mostly clear prior to treatment.

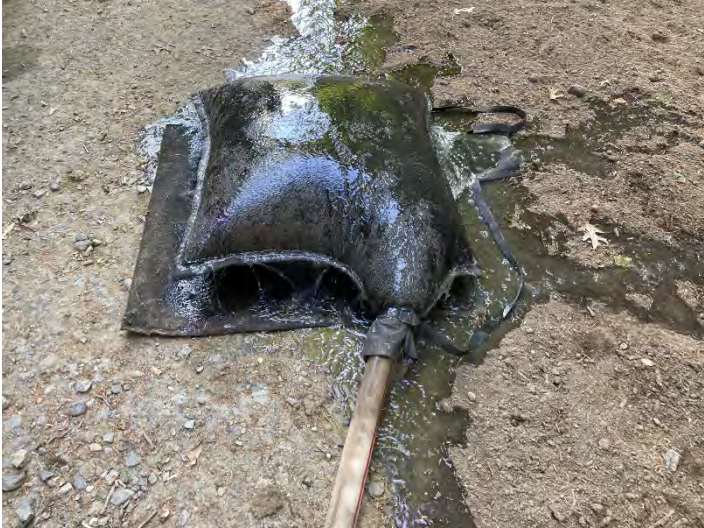
PHOTOGRAPHIC LOG	
Client Name: Eversource		Site Location: Sudbury to Hudson Transmission Reliability Project	
Town: Sudbury			
Photo No.: 3	Date: 9/05/2024

Description: View of dewatering controls (silt bags). Facing east.

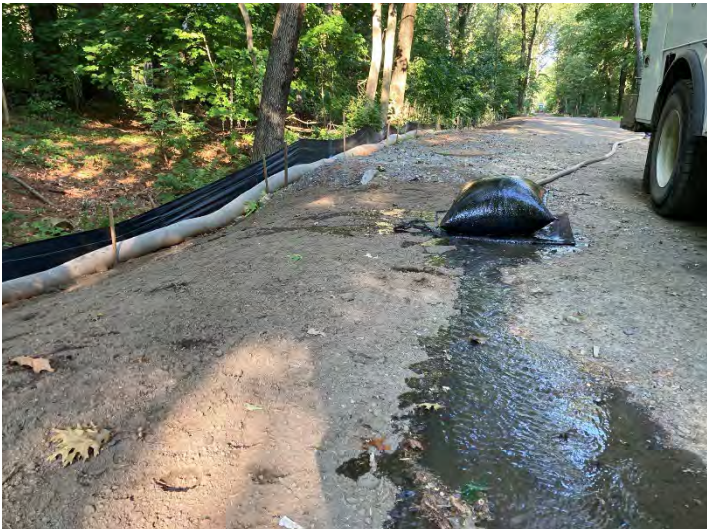
PHOTOGRAPHIC LOG	
Client Name: Eversource		Site Location: Sudbury to Hudson Transmission Reliability Project	
Town: Sudbury			
Photo No.: 4	Date: 9/05/2024

Description: View of dewatering controls (silt bags) and discharge from controls. Discharge appeared clear and turbidity reading was below 50 NTUs. Discharge did not appear to reach any jurisdictional resource areas. Facing west.

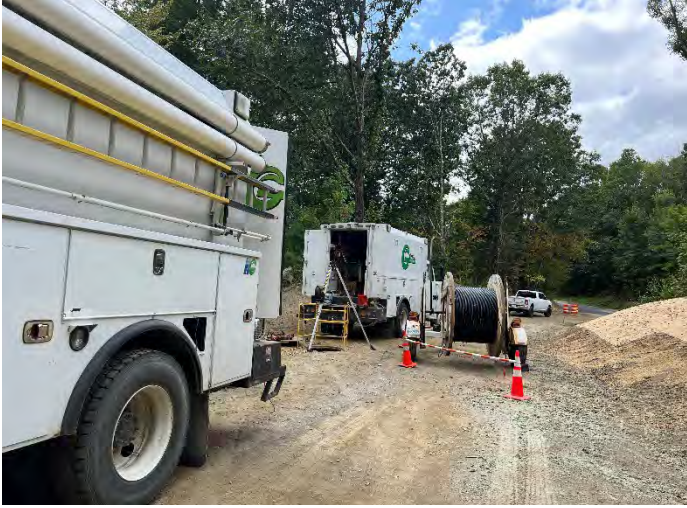
PHOTOGRAPHIC LOG	
Client Name: Eversource		Site Location: Sudbury to Hudson Transmission Reliability Project	Town: Hudson
Photo No.: 1	Date: 9/6/2024

Description: View of Haugland work area at MH#5 in segment 1. Facing southwest.

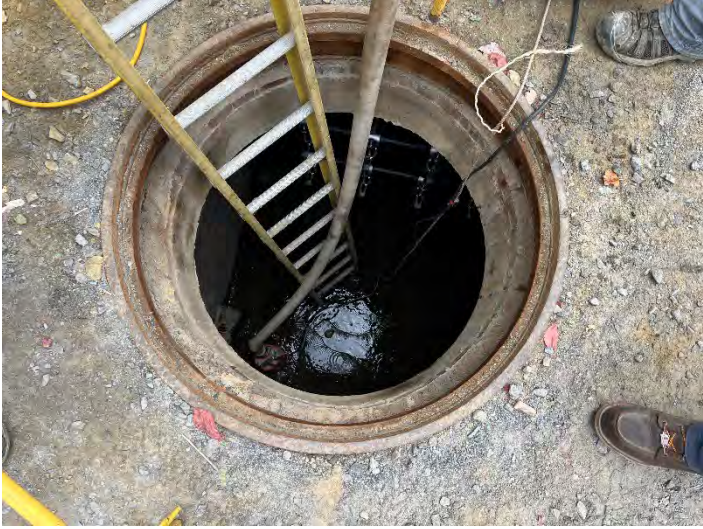
PHOTOGRAPHIC LOG	
Client Name: Eversource		Site Location: Sudbury to Hudson Transmission Reliability Project	Town: Hudson
Photo No.: 2	Date: 9/6/2024

Description: View of pump in MH#5.

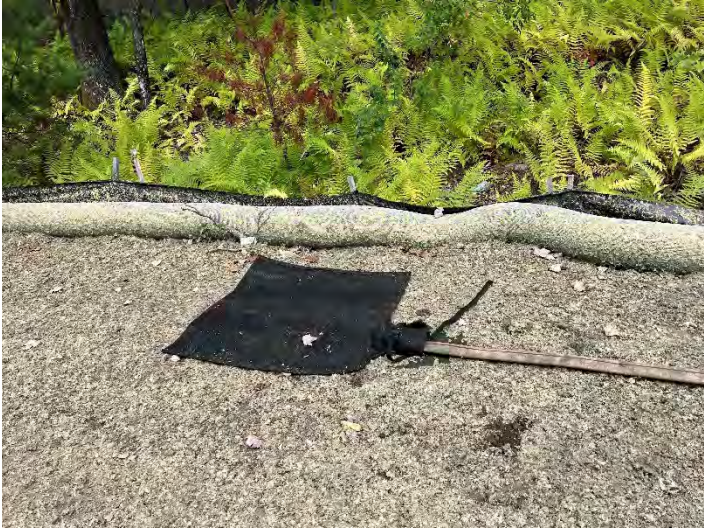
PHOTOGRAPHIC LOG	
Client Name: Eversource		Site Location: Sudbury to Hudson Transmission Reliability Project	Town: Hudson
Photo No.: 3	Date: 9/6/2024

Description: View of dewatering controls (silt bag). Facing south.

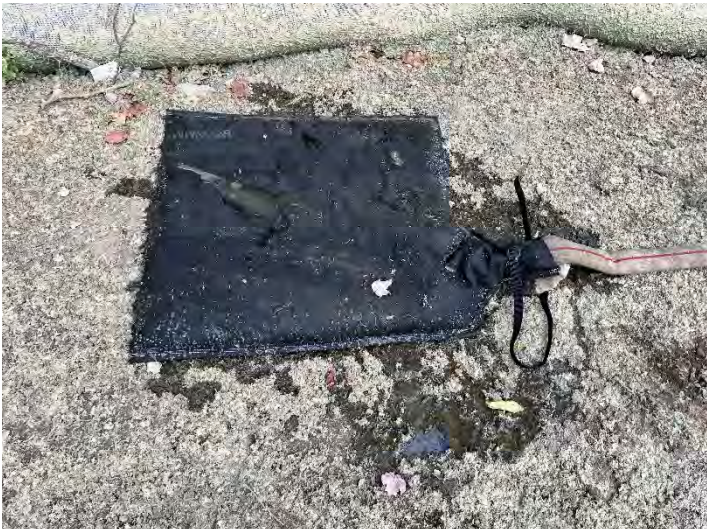
PHOTOGRAPHIC LOG	
Client Name: Eversource		Site Location: Sudbury to Hudson Transmission Reliability Project	Town: Hudson
Photo No.: 4	Date: 9/6/2024

Description: View of discharging water from silt bag. Discharge appeared mostly clear, but turbidity reading was above 50 NTUs. Discharge did not appear to reach any jurisdictional areas.
