Weekly Environmental Compliance Summary

Sudbury to Hudson Transmission Reliability Project (USEPA Tracking # MAR1003UW)

Sudbury, Hudson, and Stow, MA

Week of: September 9, 2024 to September 13, 2024

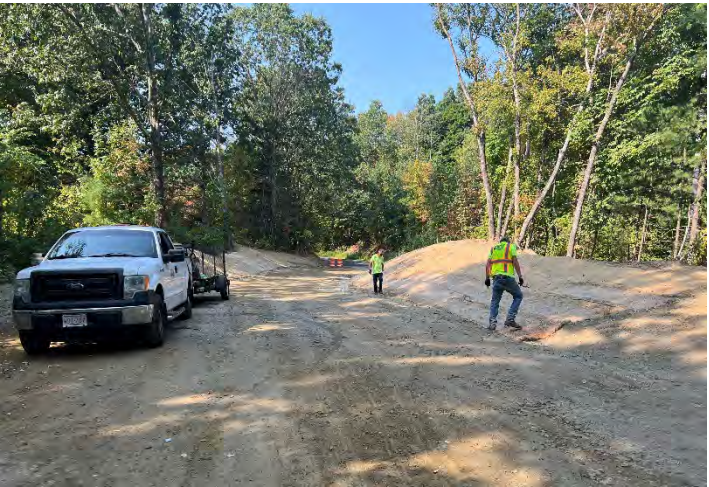
<p align="right">PHOTOGRAPHIC LOG</p>	
<p>Client Name: Eversource</p>		<p>Site Location: Sudbury to Hudson Transmission Reliability Project</p>	<p>Town: Hudson</p>
<p>Photo No.: 2</p>	<p>Date: 9-13-24</p>

<p>Description:</p> <p>View of MON in segment 1 at the entrance working on the erosion control blanket. Facing west.</p>

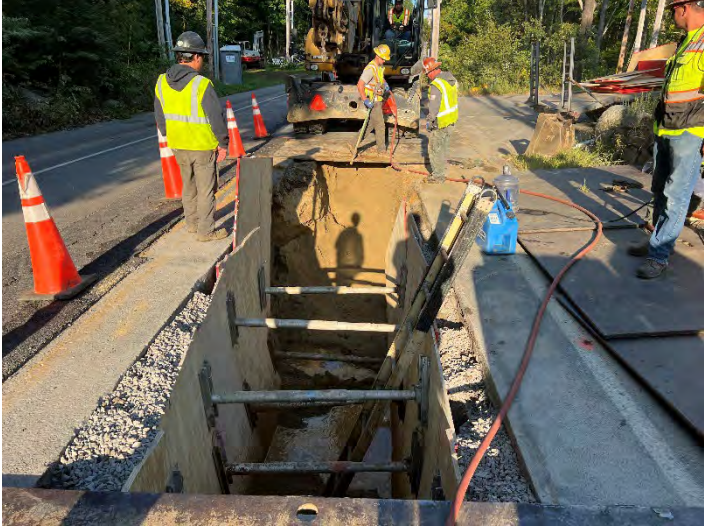
PHOTOGRAPHIC LOG	
Client Name: Eversource		Site Location: Sudbury to Hudson Transmission Reliability Project	Town: Hudson
Photo No.: 2	Date: 9-11-2024

Description: View of Bond trenching in Forest Ave by MH #1. Facing west.

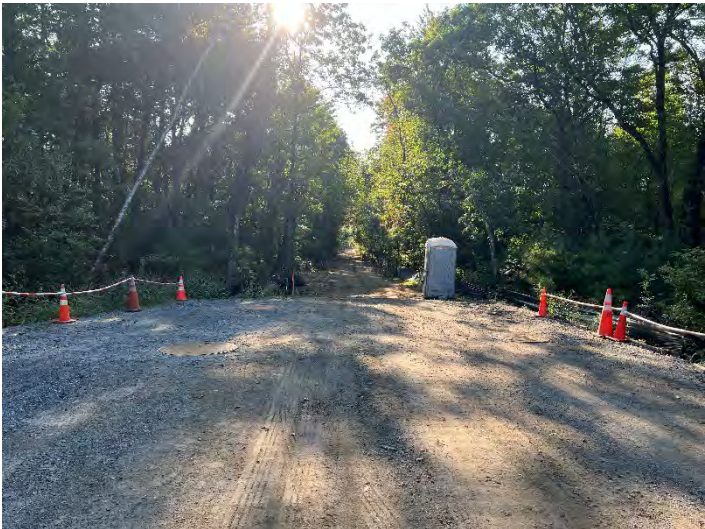
PHOTOGRAPHIC LOG	
Client Name: Eversource		Site Location: Sudbury to Hudson Transmission Reliability Project	Town: Hudson
Photo No.: 6	Date: 9-11-2024

Description: View of MH#14 in segment 6. Haugland splicers finished MH work and maintenance of MH was completed. Facing east.

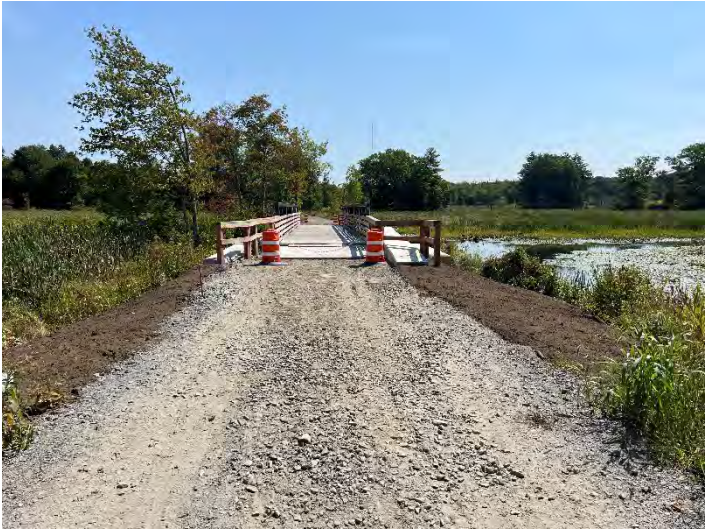
PHOTOGRAPHIC LOG	
Client Name: Eversource		Site Location: Sudbury to Hudson Transmission Reliability Project	Town: Hudson
Photo No.: 7	Date: 9-11-2024

Description: View of Bridge 127. ET&L has done prepwork at the bridge for paving scheduled next week. Facing east.

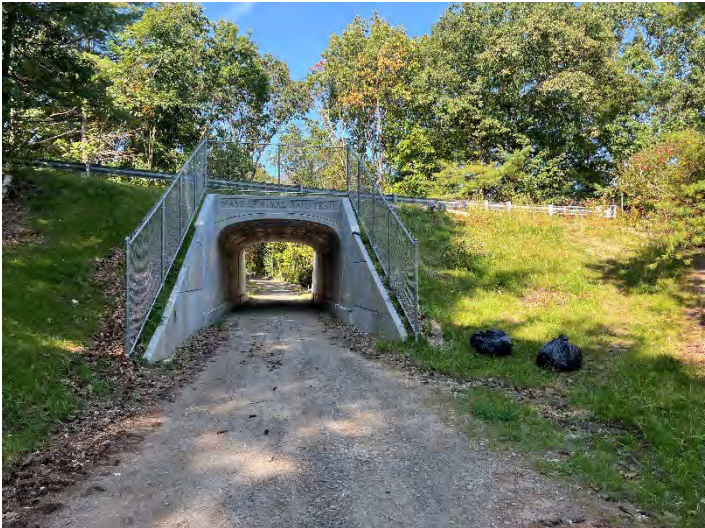
PHOTOGRAPHIC LOG	
Client Name: Eversource		Site Location: Sudbury to Hudson Transmission Reliability Project	Town: Hudson
Photo No.: 8	Date: 9-11-2024

Description: View of Chestnut Street underpass and seeded slopes. Trash bags are nonproject related. Facing west.
