Weekly Environmental Compliance Summary

Sudbury to Hudson Transmission Reliability Project (USEPA Tracking # MAR1003UW)

Week of: September 16, 2024 to September 20, 2024

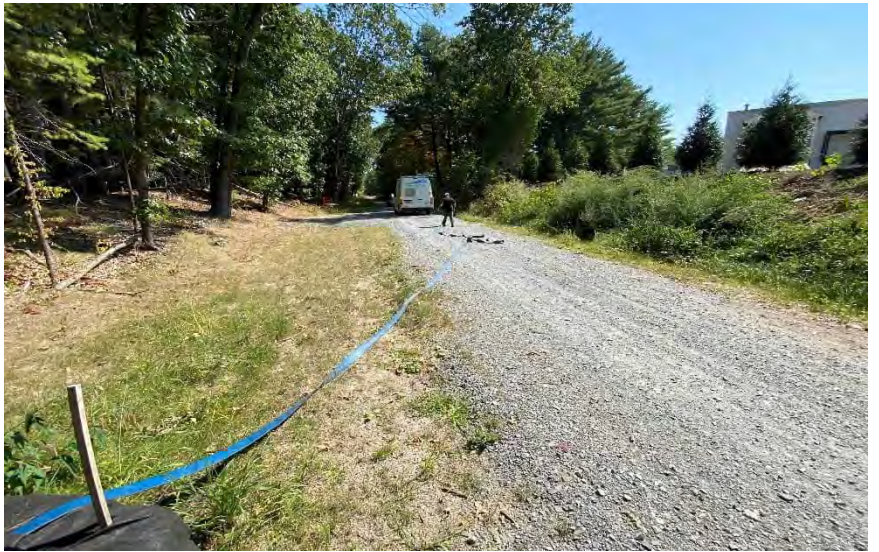
<p align="right">PHOTOGRAPHIC LOG</p>	
<p>Client Name: Eversource</p>		<p>Site Location: Sudbury to Hudson Transmission Reliability Project</p>	<p>Town: Hudson</p>
<p>Photo No.: 8</p>	<p>Date: 9-16-24</p>

<p>Description:</p> <p>New Wave working within segment 3 at handhole #9, dewatering prior to fiber optics work, existing erosion control, looking eastward.</p>

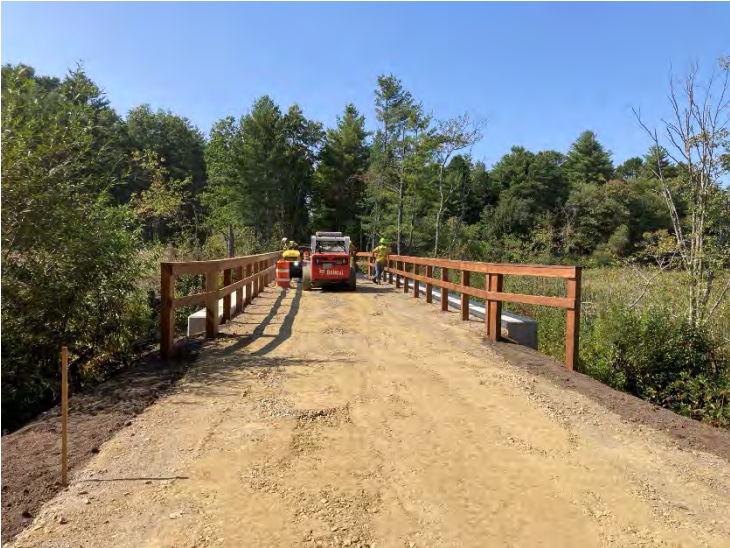
PHOTOGRAPHIC LOG	
Client Name: Eversource		Site Location: Sudbury to Hudson Transmission Reliability Project	Town: Sudbury
Photo No.: 1	Date: 9/16/2024

Description: View of paving work at bridge 128. Facing west.

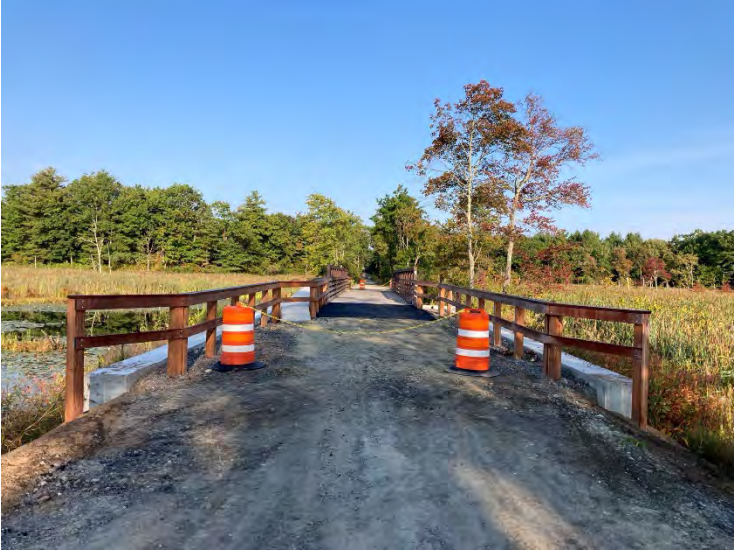
PHOTOGRAPHIC LOG	
Client Name: Eversource		Site Location: Sudbury to Hudson Transmission Reliability Project	Town: Hudson
Photo No.: 3	Date: 9/17/2024

Description: View of bridge 130. Paving took place yesterday (9/16/2024). Facing west.

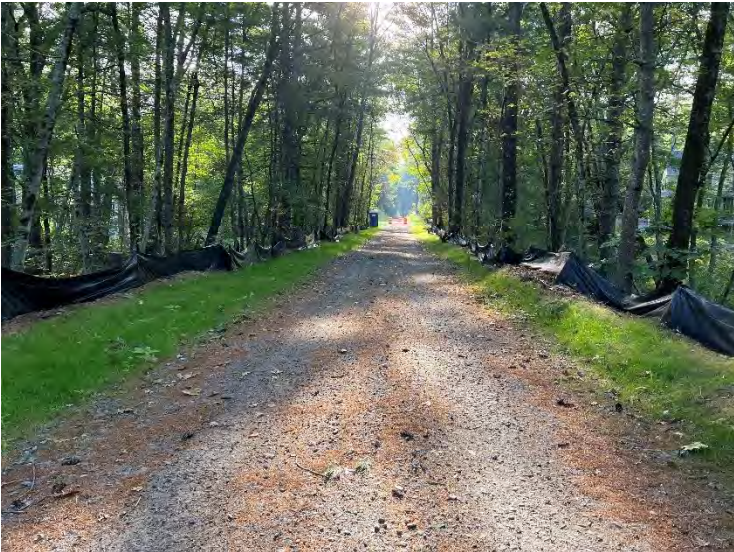
<p>PHOTOGRAPHIC LOG</p>	
<p>Client Name: Eversource</p>		<p>Site Location: Sudbury to Hudson Transmission Reliability Project</p>	<p>Town: Sudbury</p>
<p>Photo No.: 2</p>	<p>Date: 9/19/2024</p>

<p>Description: View of E&S controls in segment 9. SWCA team removing invasive plants in segment 9 & 8. Facing east.</p>

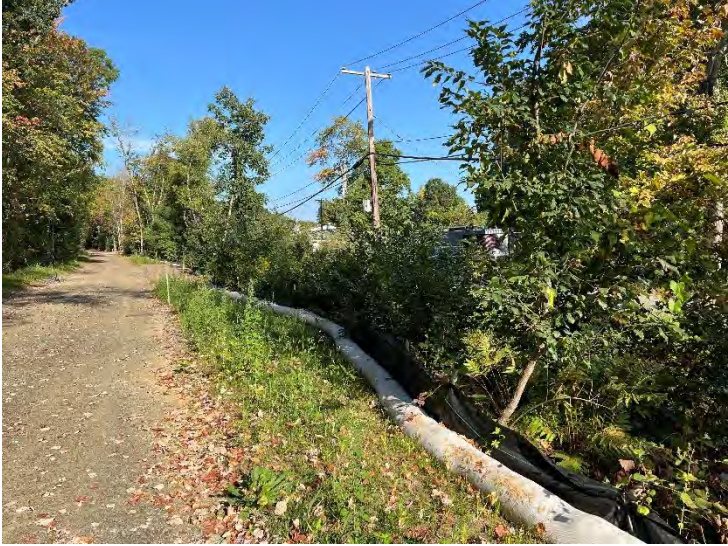
<p>PHOTOGRAPHIC LOG</p>	
<p>Client Name: Eversource</p>		<p>Site Location: Sudbury to Hudson Transmission Reliability Project</p>	<p>Town: Sudbury</p>
<p>Photo No.: 8</p>	<p>Date: 9/19/2024</p>

<p>Description: View of E&S controls in segment 12. Facing west.</p>

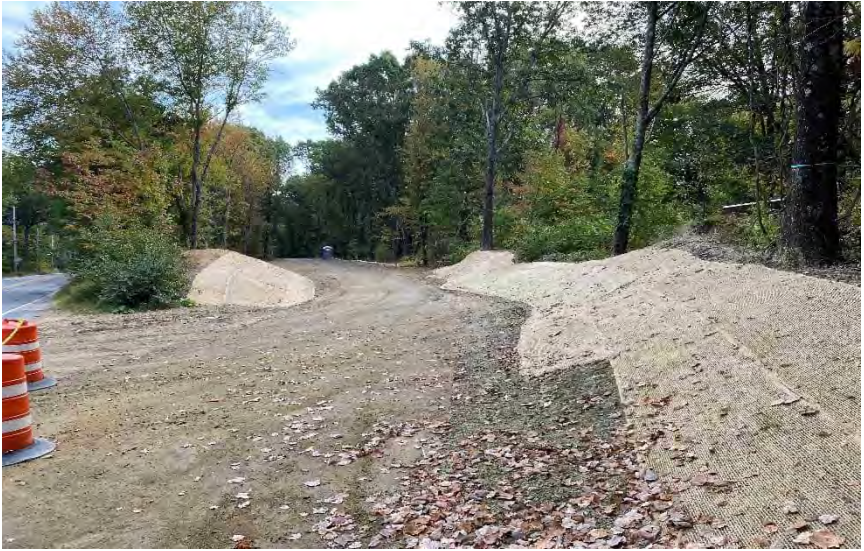
PHOTOGRAPHIC LOG	
Client Name: Eversource		Site Location: Sudbury to Hudson Transmission Reliability Project	Town: Hudson
Photo No.: 7	Date: 9-18-24

Description: Work area within segment 1, jute netting on top of previously loamed & hydro seeded slope areas, existing erosion control, looking eastward.

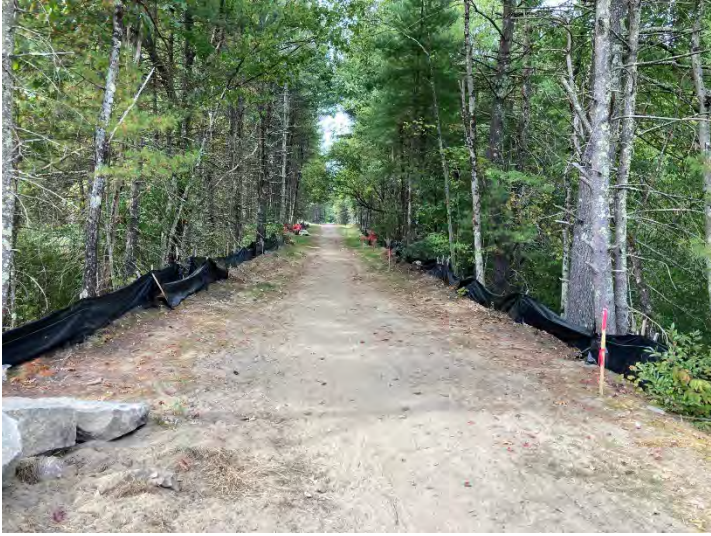
PHOTOGRAPHIC LOG	
Client Name: Eversource		Site Location: Sudbury to Hudson Transmission Reliability Project	Town: Sudbury
Photo No.: 1	Date: 9-18-24

Description: View of E&S controls at east end of segment 7. Facing west.

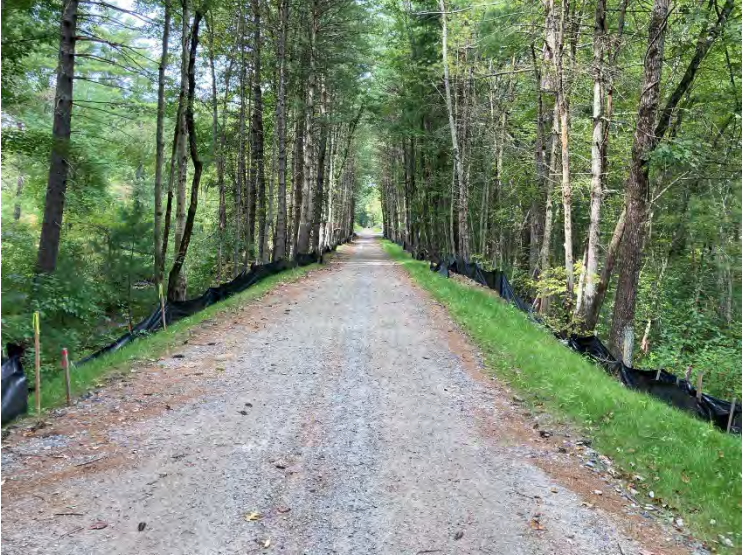
PHOTOGRAPHIC LOG	
Client Name: Eversource		Site Location: Sudbury to Hudson Transmission Reliability Project	Town: Sudbury
Photo No.: 3	Date: 9-18-24

Description: View of E&S controls at Dudley Brook culvert in segment 10. Facing west.

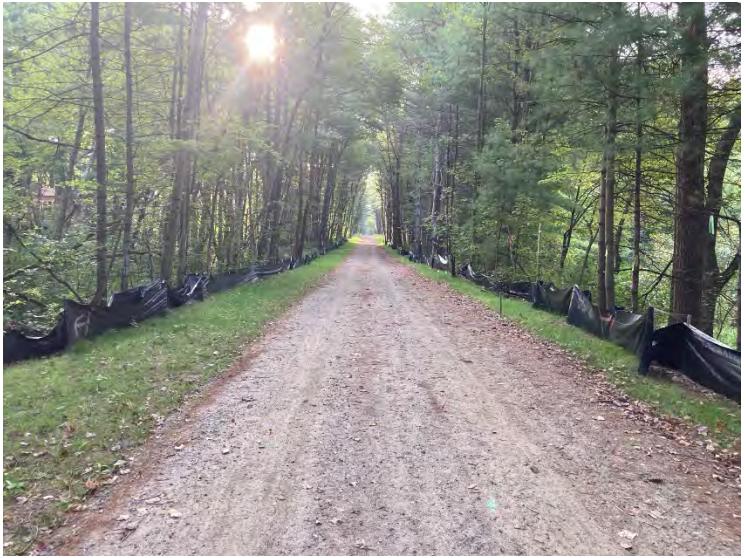
PHOTOGRAPHIC LOG	
Client Name: Eversource		Site Location: Sudbury to Hudson Transmission Reliability Project	Town: Sudbury
Photo No.: 4	Date: 9-18-24

Description: View of E&S controls in segment 11. Facing east.

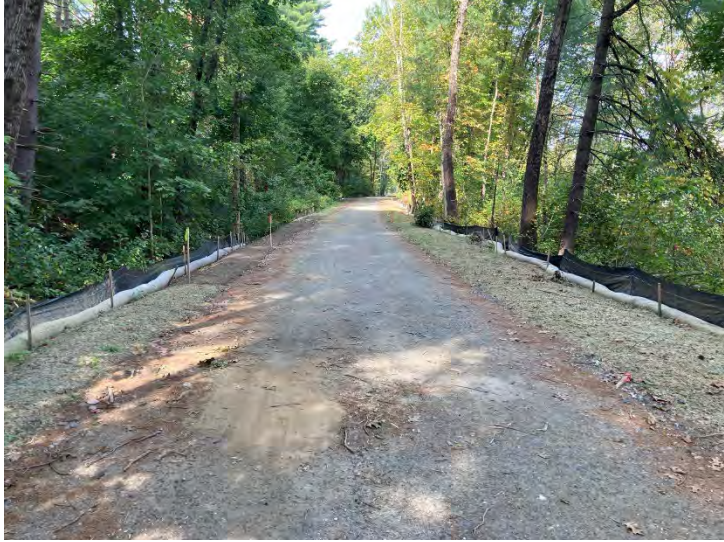
PHOTOGRAPHIC LOG	
Client Name: Eversource		Site Location: Sudbury to Hudson Transmission Reliability Project	Town: Sudbury
Photo No.: 5	Date: 9-18-24

Description: View of E&S controls and hydroseed in segment 13. Facing west.

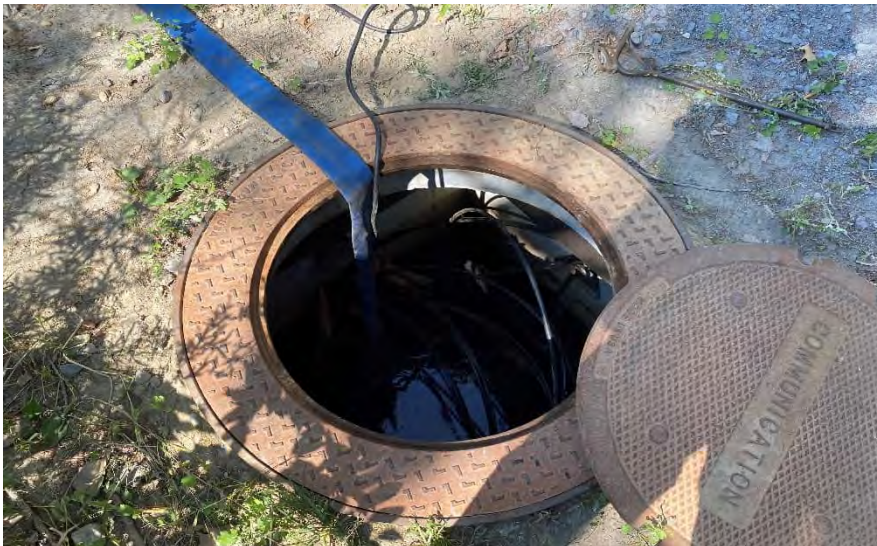
PHOTOGRAPHIC LOG	
Client Name: Eversource		Site Location: Sudbury to Hudson Transmission Reliability Project	Town: Hudson
Photo No.: 1	Date: 9/16/2024

Description: View of area being pumped from handhole #9, segment 3.

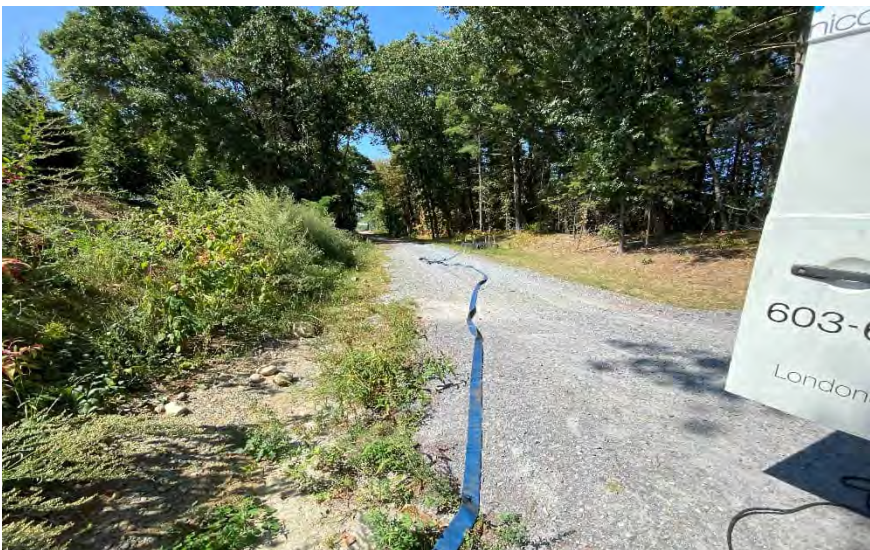
PHOTOGRAPHIC LOG	
Client Name: Eversource		Site Location: Sudbury to Hudson Transmission Reliability Project	Town: Hudson
Photo No.: 2	Date: 9/16/2024

Description: Handhole #9. View of dewatering operation. Looking westward.

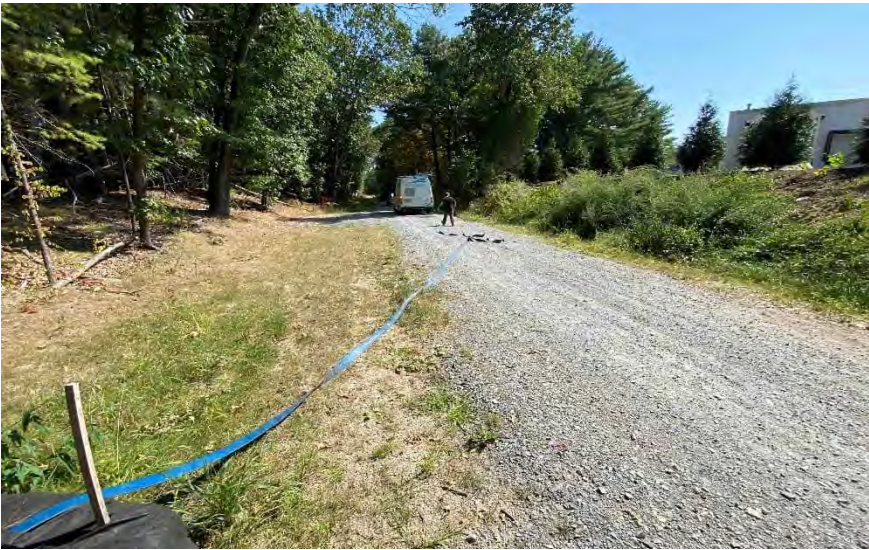
PHOTOGRAPHIC LOG	
Client Name: Eversource		Site Location: Sudbury to Hudson Transmission Reliability Project	Town: Hudson
Photo No.: 3	Date: 9/16/2024

Description: Handhole #9. View of dewatering operation, looking eastward.

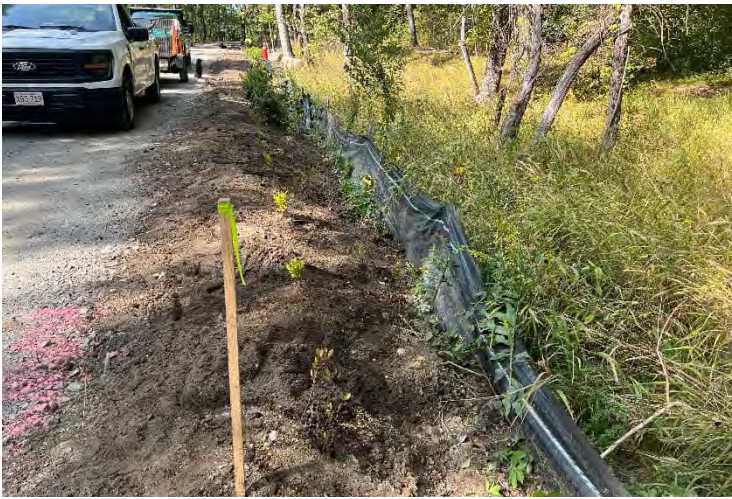
PHOTOGRAPHIC LOG	
Client Name: Eversource		Site Location: Sudbury to Hudson Transmission Reliability Project	Town: Sudbury
Photo No.: 4	Date: 9/18/24

Description: View of installed plantings between Sta. #s 738+75 & 739+75. 10 GB shown are quite small but have buds. Facing west.

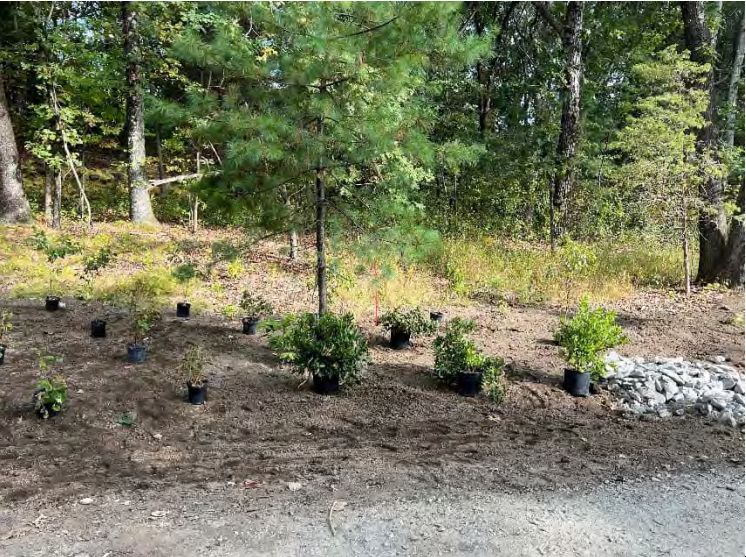
PHOTOGRAPHIC LOG	
Client Name: Eversource		Site Location: Sudbury to Hudson Transmission Reliability Project	Town: Sudbury
Photo No.: 1	Date: 9/18/24

Description: View of Pine tree located within the planting area. Plant placement/spacing was adjusted accordingly. <i>Facing north.</i>

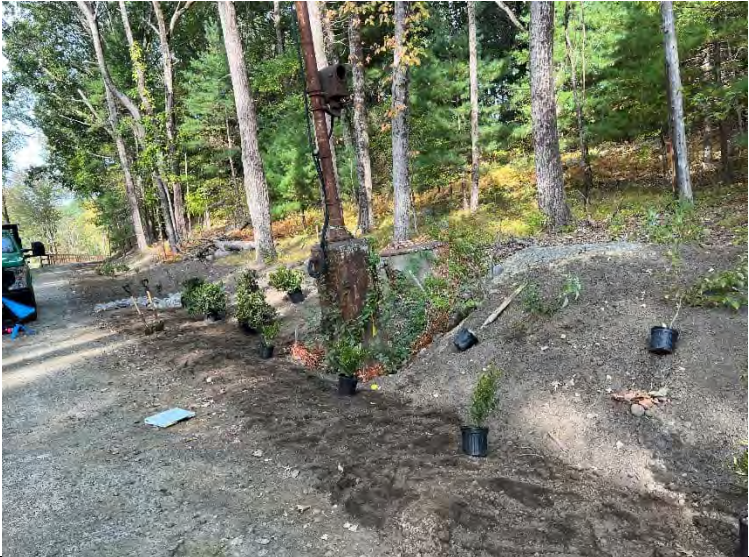
PHOTOGRAPHIC LOG	
Client Name: Eversource		Site Location: Sudbury to Hudson Transmission Reliability Project	Town: Sudbury
Photo No.: 1	Date: 9/18/24

Description: View of train artifact within planting area. Plant spacing was adjusted to account for the artifact. <i>Facing west.</i>

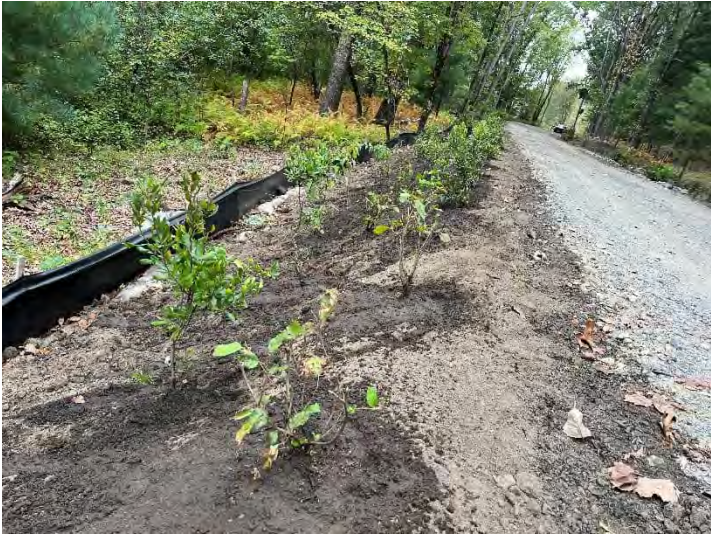
<p>PHOTOGRAPHIC LOG</p>	
<p>Client Name: Eversource</p>		<p>Site Location: Sudbury to Hudson Transmission Reliability Project</p>	<p>Town: Sudbury</p>
<p>Photo No.: 3</p>	<p>Date: 9/20/24</p>

<p>Description: View of installed plantings. Facing west.</p>

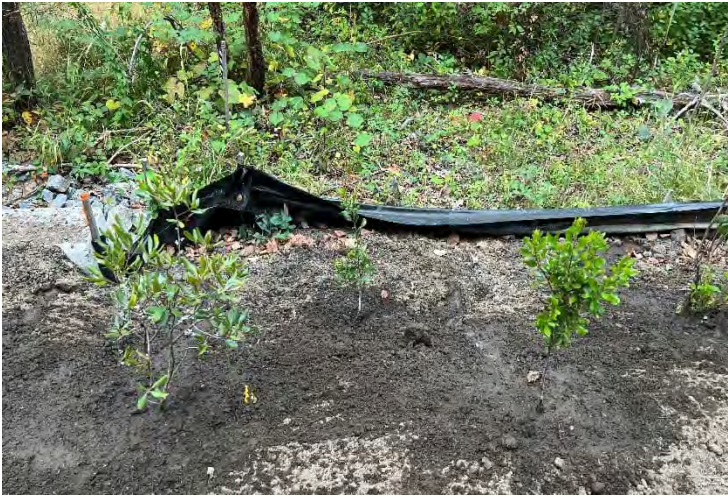
<p>PHOTOGRAPHIC LOG</p>	
<p>Client Name: Eversource</p>		<p>Site Location: Sudbury to Hudson Transmission Reliability Project</p>	<p>Town: Sudbury</p>
<p>Photo No.: 4</p>	<p>Date: 9/20/24</p>

<p>Description: View of some installed <i>Myrica pensylvanica</i> (Northern bayberry). Some plants smaller than drawn on plans. Facing south.</p>

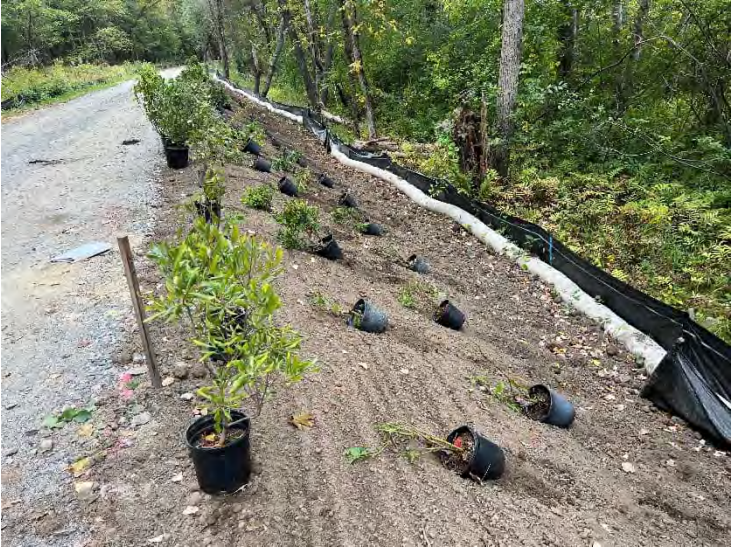
<p>PHOTOGRAPHIC LOG</p>	
<p>Client Name: Eversource</p>		<p>Site Location: Sudbury to Hudson Transmission Reliability Project</p>	<p>Town: Sudbury</p>
<p>Photo No.: 2</p>	<p>Date: 9/20/24</p>

<p>Description: View of plants laid out according to planting scheme. <i>Facing east.</i></p>

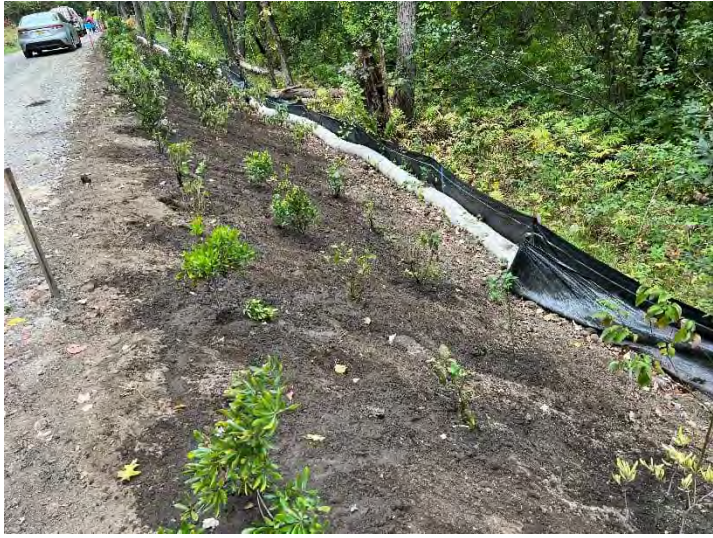
PHOTOGRAPHIC LOG	
Client Name: Eversource		Site Location: Sudbury to Hudson Transmission Reliability Project	Town: Sudbury
Photo No.: 3	Date: 9/20/24

Description: View of installed plantings. Facing east.

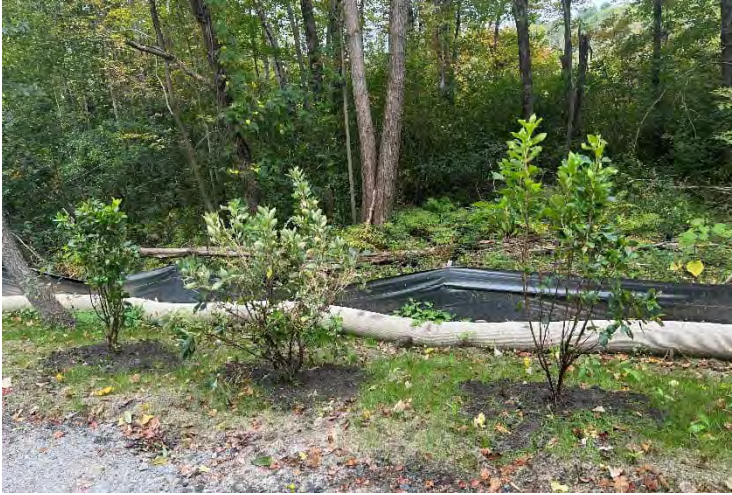
PHOTOGRAPHIC LOG	
Client Name: Eversource		Site Location: Sudbury to Hudson Transmission Reliability Project	Town: Sudbury
Photo No.: 4	Date: 9/20/24

Description: View of installed Clethra alnifolia (Sweet pepperbush) within extended planting area to account for proper spacing between plants. Facing south.
