Weekly Environmental Compliance Summary

Sudbury to Hudson Transmission Reliability Project (USEPA Tracking # MAR1003UW)

Week of: September 30, 2024 to October 4, 2024

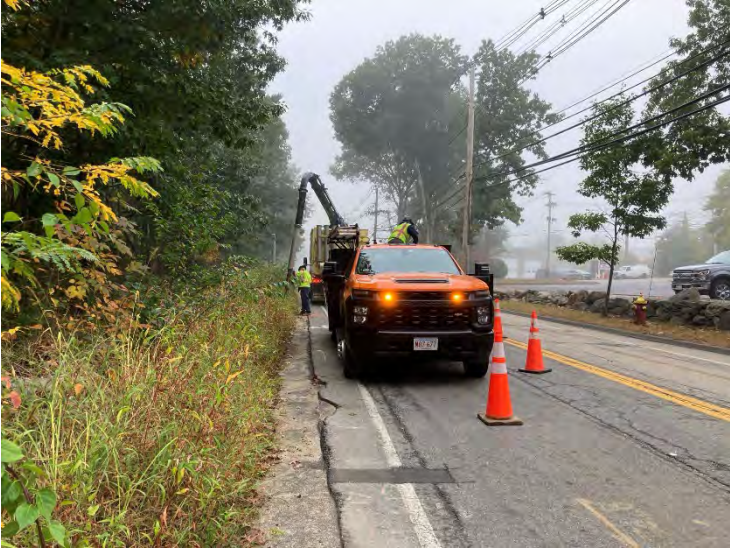
<p>PHOTOGRAPHIC LOG</p>	
<p>Client Name: Eversource</p>		<p>Site Location: Sudbury to Hudson Transmission Reliability Project</p>	<p>Town: Hudson</p>
<p>Photo No.: 1</p>	<p>Date: 10/01/2024</p>

<p>Description: View of Bond working between MH #1 and MH #2 on Forest Ave. Facing west.</p>

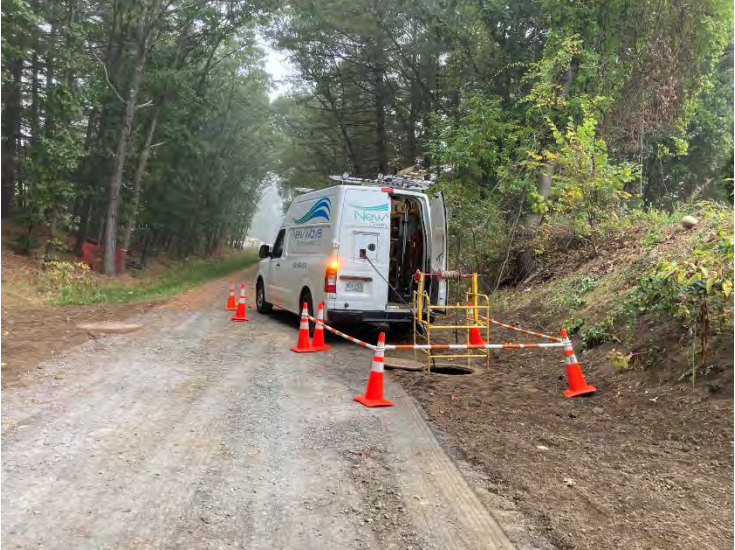
<p>PHOTOGRAPHIC LOG</p>	
<p>Client Name: Eversource</p>		<p>Site Location: Sudbury to Hudson Transmission Reliability Project</p>	<p>Town: Hudson</p>
<p>Photo No.: 3</p>	<p>Date: 10/01/2024</p>

<p>Description: View of New Wave working at MH #9 in segment 3. Facing east.</p>

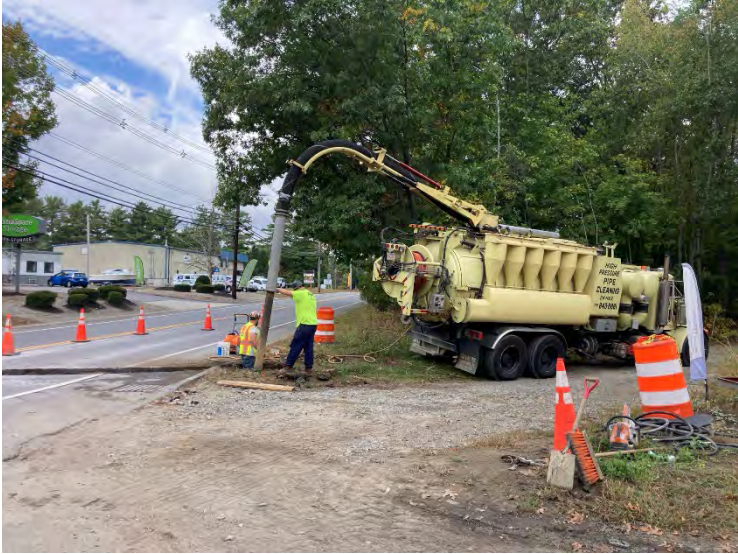
<p>PHOTOGRAPHIC LOG</p>	
<p>Client Name: Eversource</p>		<p>Site Location: Sudbury to Hudson Transmission Reliability Project</p>	<p>Town: Hudson</p>
<p>Photo No.: 4</p>	<p>Date: 10/01/2024</p>

<p>Description: View of Bond preparing to install crosswalk signal infrastructure within Main St between segments 3 and 4. Facing south.</p>

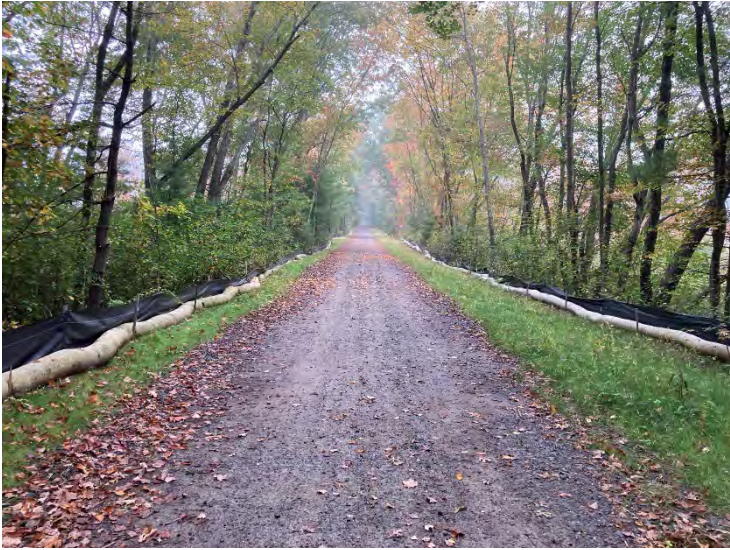
<p>PHOTOGRAPHIC LOG</p>	
<p>Client Name: Eversource</p>		<p>Site Location: Sudbury to Hudson Transmission Reliability Project</p>	<p>Town: Hudson</p>
<p>Photo No.: 5</p>	<p>Date: 10/01/2024</p>

<p>Description: View of E&S controls in segment 5. Facing west.</p>

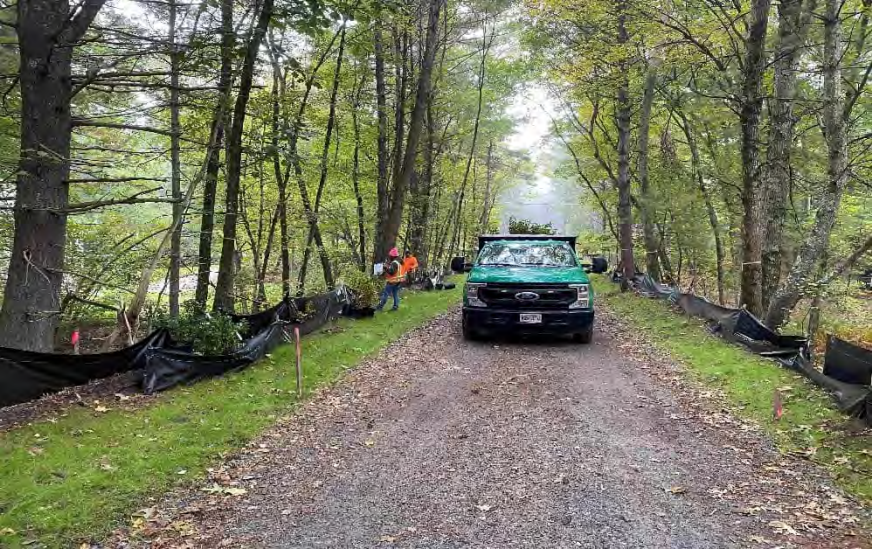
<p>PHOTOGRAPHIC LOG</p>	
<p>Client Name: Eversource</p>		<p>Site Location: Sudbury to Hudson Transmission Reliability Project</p>	<p>Town: Sudbury</p>
<p>Photo No.: 1</p>	<p>Date: 10-01-24</p>

<p>Description:</p> <p>Segment 9, planting work area within the shoulders, existing erosion control, looking eastward.</p>

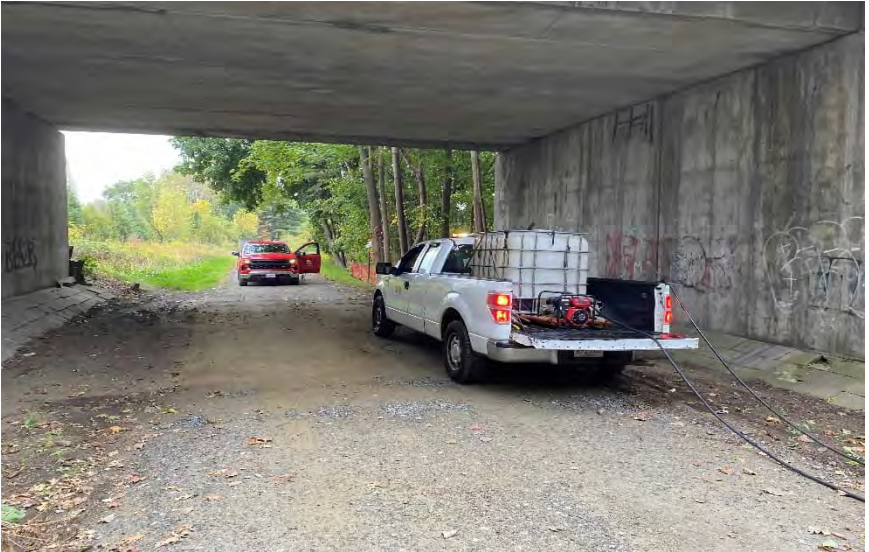
<p>PHOTOGRAPHIC LOG</p>	
<p>Client Name: Eversource</p>		<p>Site Location: Sudbury to Hudson Transmission Reliability Project</p>	<p>Town: Sudbury</p>
<p>Photo No.: 3</p>	<p>Date: 10-01-24</p>

<p>Description:</p> <p>Work area within segment 14 at Landham overpass, ET&L survey, looking westward</p>

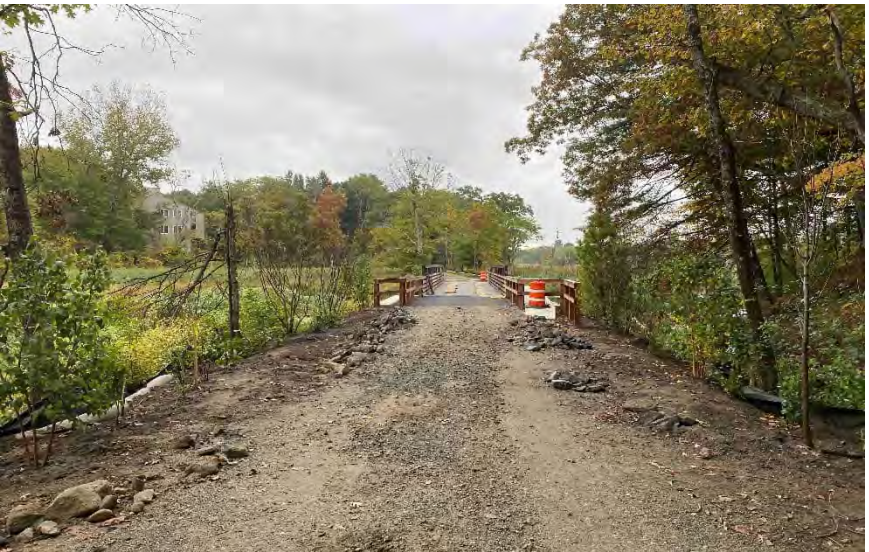
<p>PHOTOGRAPHIC LOG</p>	
<p>Client Name: Eversource</p>		<p>Site Location: Sudbury to Hudson Transmission Reliability Project</p>	<p>Town: Sudbury</p>
<p>Photo No.: 4</p>	<p>Date: 10-01-24</p>

<p>Description:</p> <p>Work area within segment 13, Bridge 127 with prior plantings, existing erosion control, looking eastward</p>

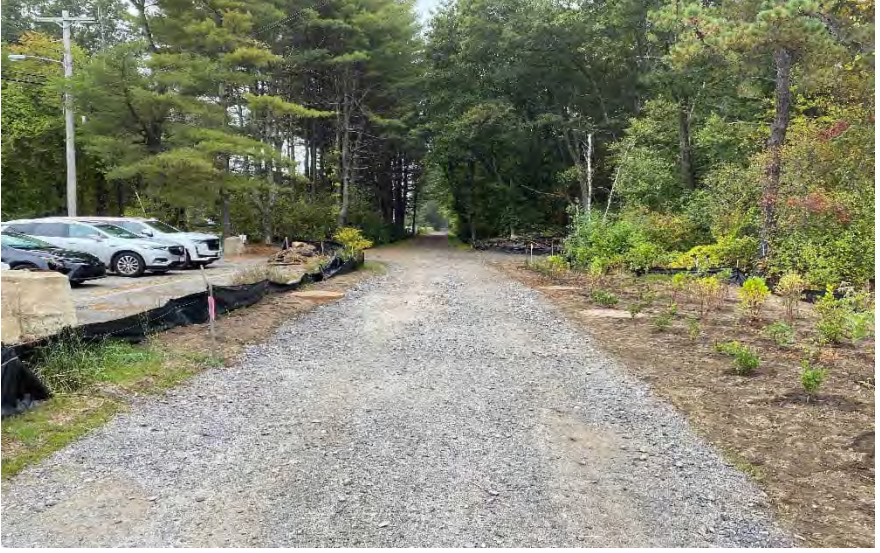
<p>PHOTOGRAPHIC LOG</p>	
<p>Client Name: Eversource</p>		<p>Site Location: Sudbury to Hudson Transmission Reliability Project</p>	<p>Town: Sudbury</p>
<p>Photo No.: 5</p>	<p>Date: 10-01-24</p>

<p>Description:</p> <p>Work area within segment 11 recent restoration plantings, existing erosion control, looking westward.</p>

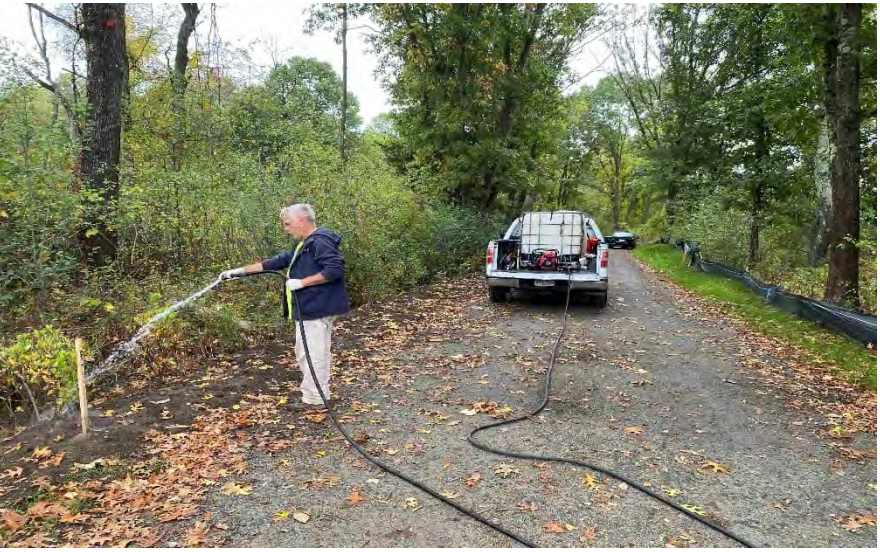
<p>PHOTOGRAPHIC LOG</p>	
<p>Client Name: Eversource</p>		<p>Site Location: Sudbury to Hudson Transmission Reliability Project</p>	<p>Town: Sudbury</p>
<p>Photo No.: 6</p>	<p>Date: 10-01-24</p>

<p>Description:</p> <p>Work area within segment 14, MON watering recent plantings, existing erosion control, looking westward.</p>

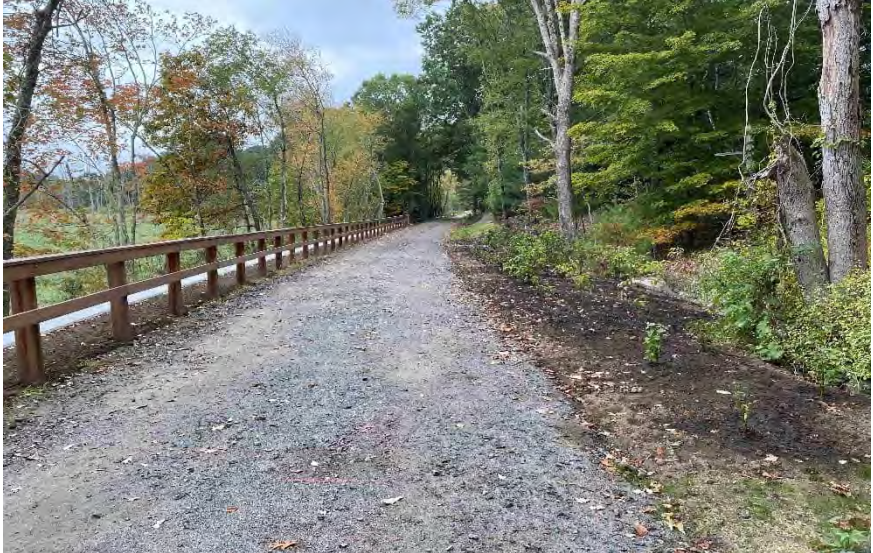
<p>PHOTOGRAPHIC LOG</p>	
<p>Client Name: Eversource</p>		<p>Site Location: Sudbury to Hudson Transmission Reliability Project</p>	<p>Town: Sudbury</p>
<p>Photo No.: 7</p>	<p>Date: 10-01-24</p>

<p>Description:</p> <p>Work area within segment 14, recent planting near wall 13, existing erosion control, looking westward</p>

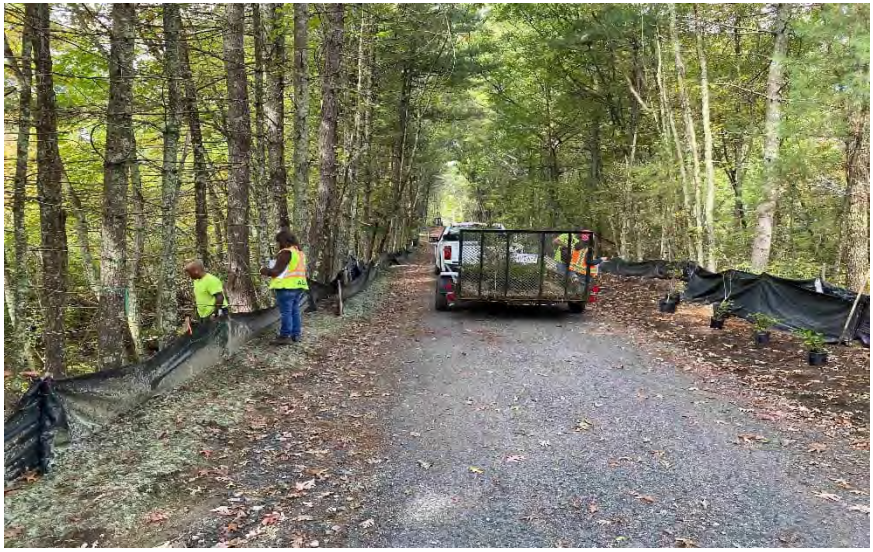
<p>PHOTOGRAPHIC LOG</p>	
<p>Client Name: Eversource</p>		<p>Site Location: Sudbury to Hudson Transmission Reliability Project</p>	<p>Town: Sudbury</p>
<p>Photo No.: 8</p>	<p>Date: 10-01-24</p>

<p>Description:</p> <p>Work area within segment 8, planting activities outside work area, existing erosion control, looking westward.</p>

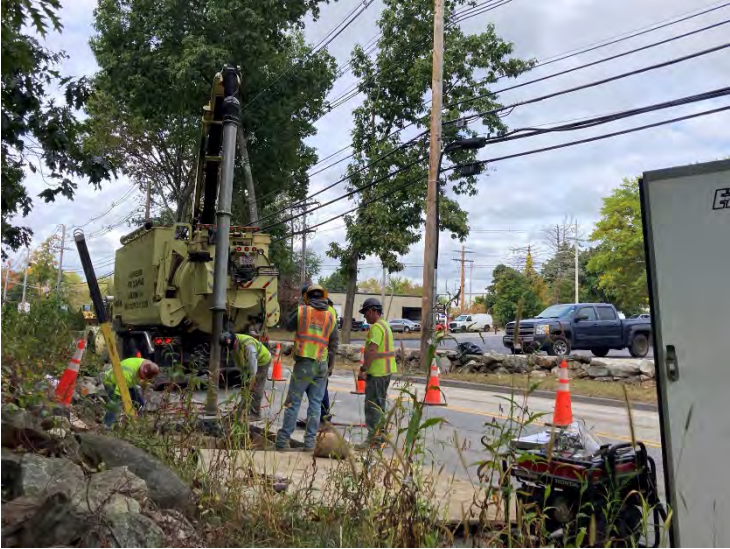
PHOTOGRAPHIC LOG	
Client Name: Eversource		Site Location: Sudbury to Hudson Transmission Reliability Project	Town: Hudson
Photo No.: 1	Date: 10/02/2024

Description: View of Bond working between MH #1 and MH #2 on Forest Ave. Facing northwest.

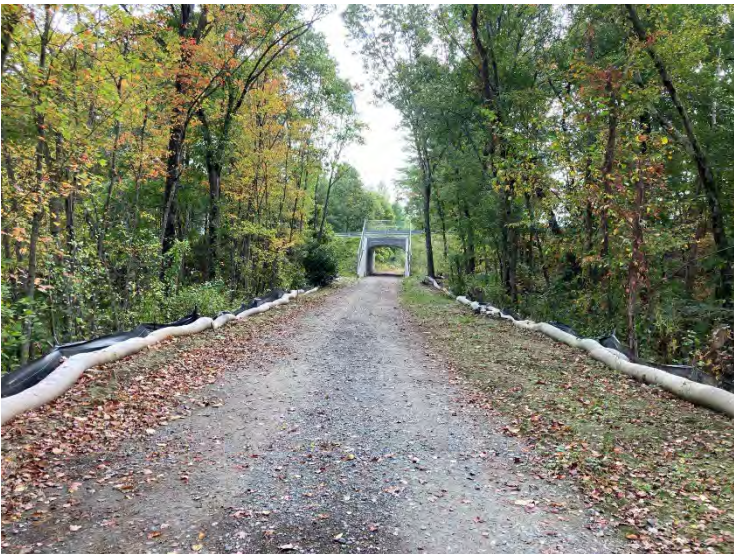
PHOTOGRAPHIC LOG	
Client Name: Eversource		Site Location: Sudbury to Hudson Transmission Reliability Project	Town: Hudson
Photo No.: 2	Date: 10/02/2024

Description: View of E&S controls in segment 1 leading to Chestnut St tunnel. Facing east.

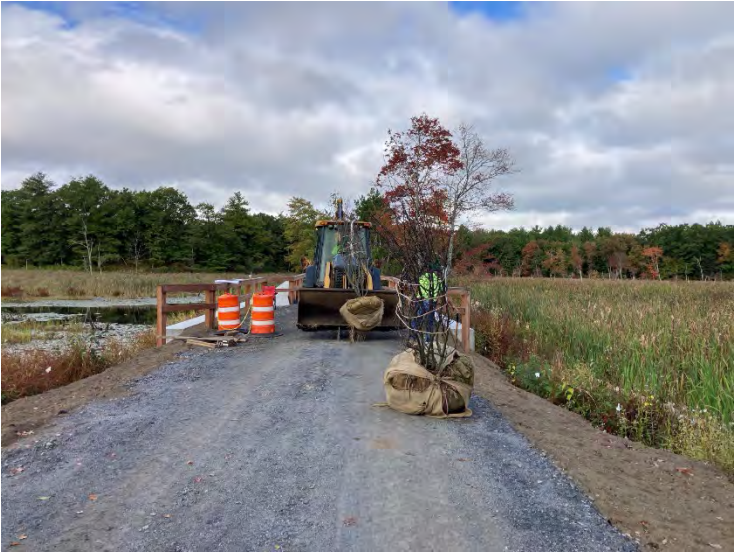
PHOTOGRAPHIC LOG	
Client Name: Eversource		Site Location: Sudbury to Hudson Transmission Reliability Project	Town: Hudson
Photo No.: 3	Date: 10/02/2024

Description: View of MON planting crew at bridge 130. Facing west.

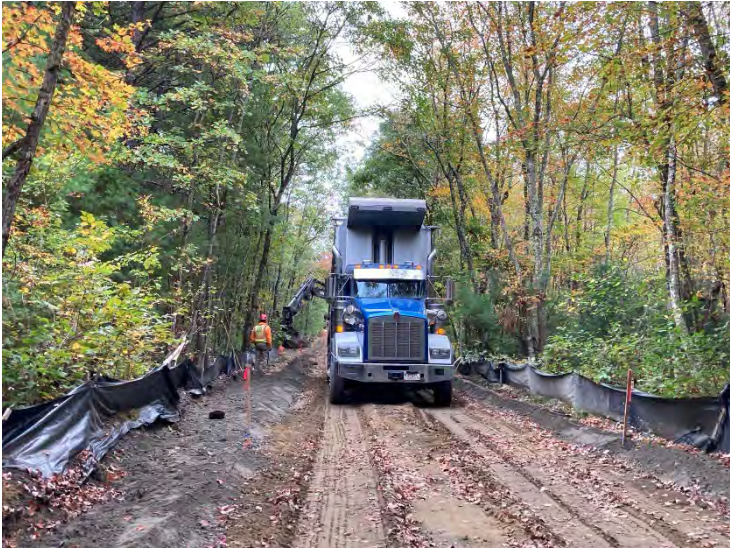
<p>PHOTOGRAPHIC LOG</p>	
<p>Client Name: Eversource</p>		<p>Site Location: Sudbury to Hudson Transmission Reliability Project</p>	<p>Town: Hudson</p>
<p>Photo No.: 5</p>	<p>Date: 10/02/2024</p>

<p>Description: View of ET&L grading in segment 6. Facing east.</p>

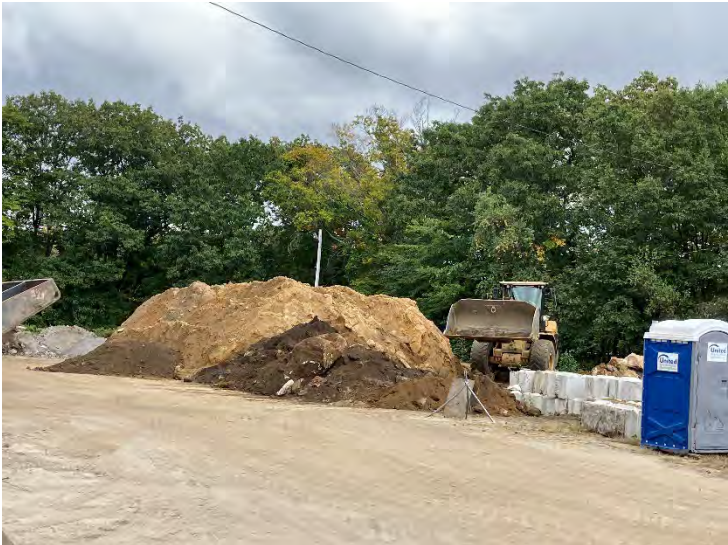
<p>PHOTOGRAPHIC LOG</p>	
<p>Client Name: Eversource</p>		<p>Site Location: Sudbury to Hudson Transmission Reliability Project</p>	<p>Town: Hudson</p>
<p>Photo No.: 6</p>	<p>Date: 10/02/2024</p>

<p>Description: View of activities at Stowe Ct laydown yard. Facing east.</p>

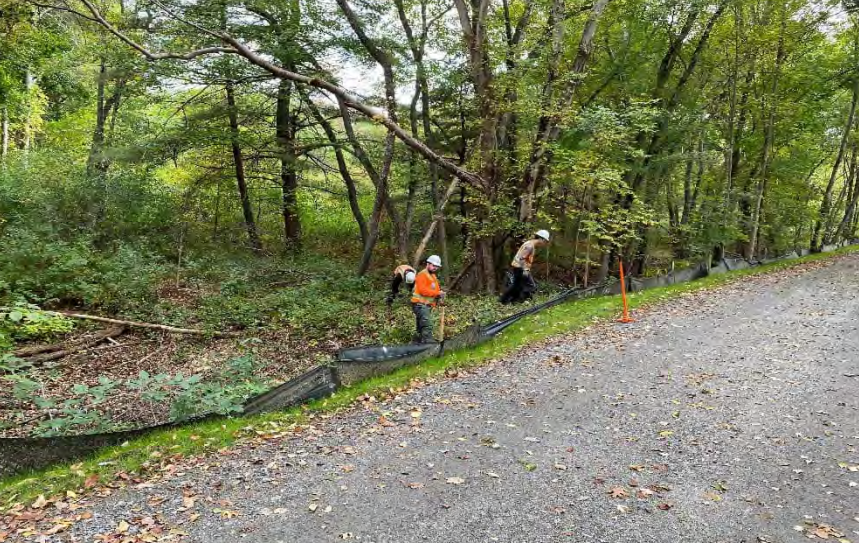
<p align="center">PHOTOGRAPHIC LOG</p>	
<p>Client Name: Eversource</p>		<p>Site Location: Sudbury to Hudson Transmission Reliability Project</p>	<p>Town: Sudbury</p>
<p>Photo No.: 2</p>	<p>Date: 10-02-24</p>

<p>Description:</p> <p>Work area within segment 14, SWCA Invasives crew removing plants, existing erosion control, looking eastward</p>

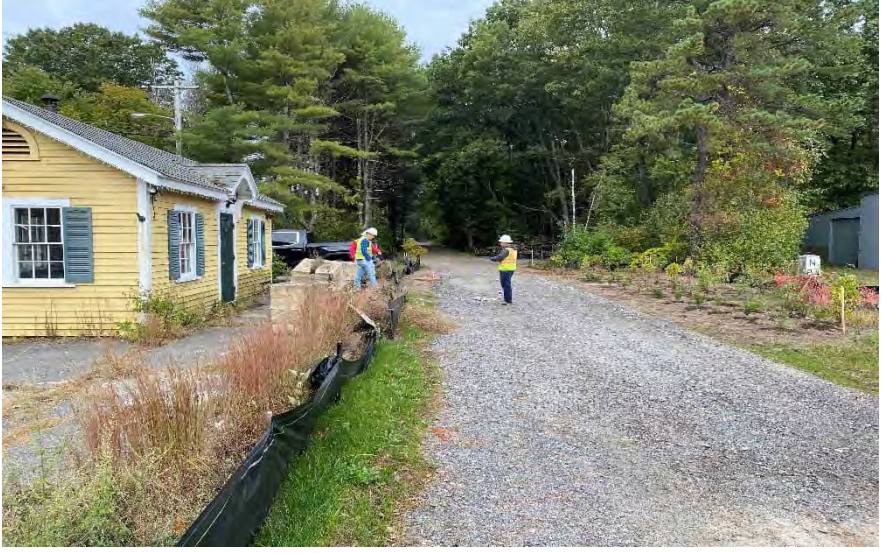
<p>PHOTOGRAPHIC LOG</p>	
<p>Client Name: Eversource</p>		<p>Site Location: Sudbury to Hudson Transmission Reliability Project</p>	<p>Town: Sudbury</p>
<p>Photo No.: 5</p>	<p>Date: 10-02-24</p>

<p>Description:</p> <p>Work area within segment 11 manhole #24, archeological review, existing erosion control, looking westward.</p>

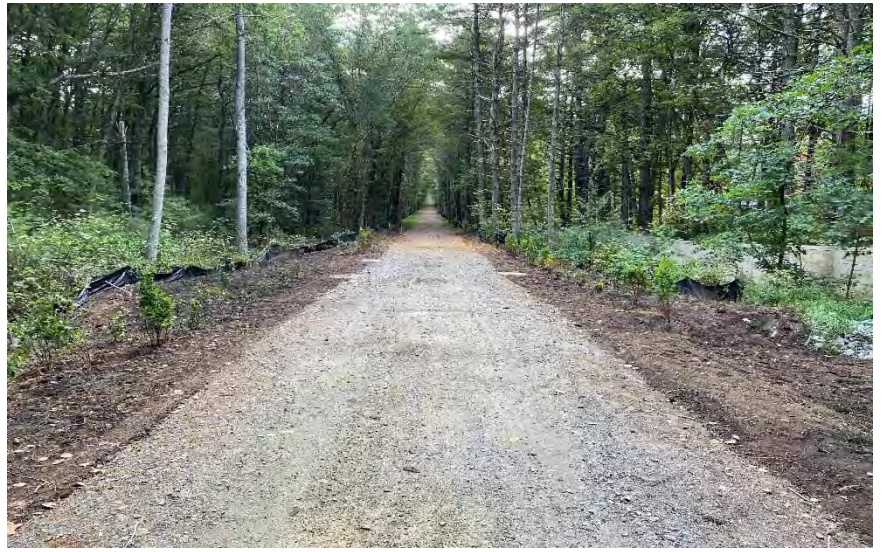
<p>PHOTOGRAPHIC LOG</p>	
<p>Client Name: Eversource</p>		<p>Site Location: Sudbury to Hudson Transmission Reliability Project</p>	<p>Town: Sudbury</p>
<p>Photo No.: 6</p>	<p>Date: 10-02-24</p>

<p>Description:</p> <p>Work area within segment 10, recent plantings, existing erosion control, looking eastward.</p>

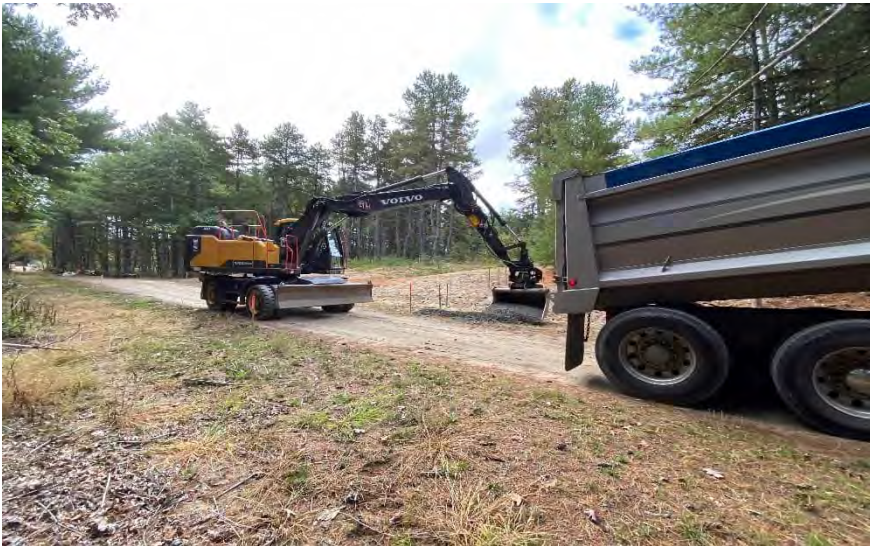
<p>PHOTOGRAPHIC LOG</p>	
<p>Client Name: Eversource</p>		<p>Site Location: Sudbury to Hudson Transmission Reliability Project</p>	<p>Town: Sudbury</p>
<p>Photo No.: 8</p>	<p>Date: 10-02-24</p>

<p>Description:</p> <p>Work area within segment 7, graveling activities adjacent to the work area, existing erosion control, looking eastward.</p>

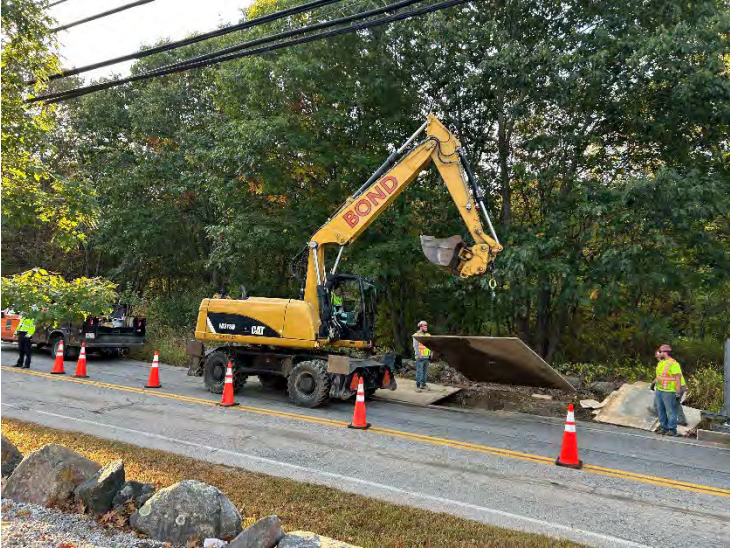
PHOTOGRAPHIC LOG	
Client Name: Eversource		Site Location: Sudbury to Hudson Transmission Reliability Project	Town: Hudson
Photo No.: 1	Date: 10/04/2024

Description: View of Bond working in Forest Ave. Facing southeast.

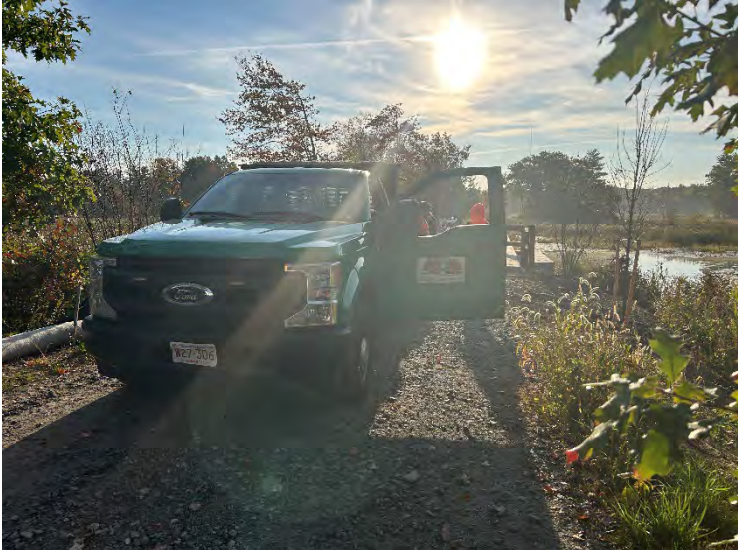
PHOTOGRAPHIC LOG	
Client Name: Eversource		Site Location: Sudbury to Hudson Transmission Reliability Project	Town: Hudson
Photo No.: 4	Date: 10/04/2024

Description: View of MON working at bridge 130. Facing east.

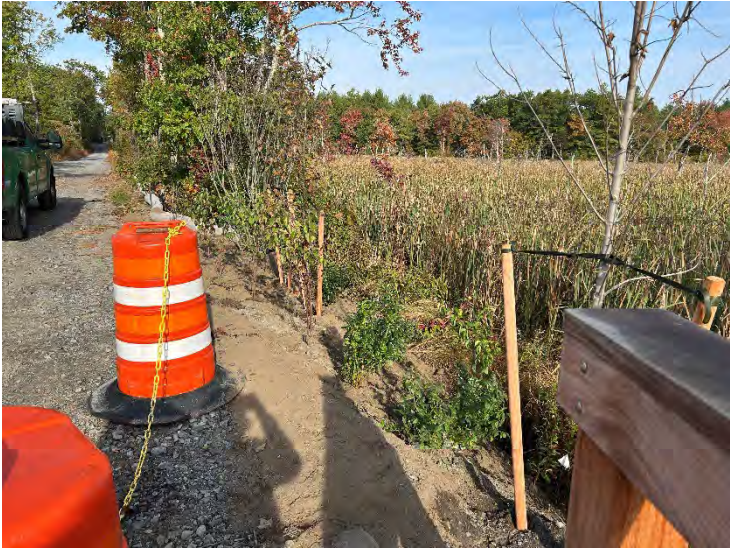
<p>PHOTOGRAPHIC LOG</p>	
<p>Client Name: Eversource</p>		<p>Site Location: Sudbury to Hudson Transmission Reliability Project</p>	<p>Town: Hudson</p>
<p>Photo No.: 5</p>	<p>Date: 10/04/2024</p>

<p>Description: View of plantings at bridge 130. Facing west.</p>

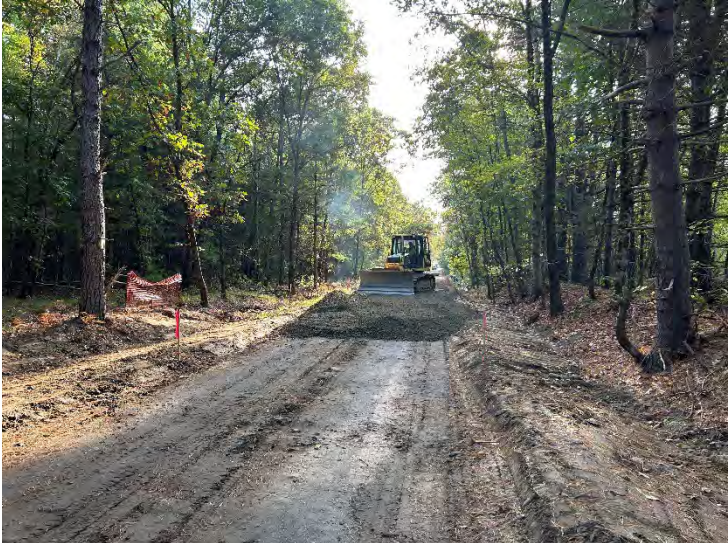
<p>PHOTOGRAPHIC LOG</p>	
<p>Client Name: Eversource</p>		<p>Site Location: Sudbury to Hudson Transmission Reliability Project</p>	<p>Town: Hudson</p>
<p>Photo No.: 6</p>	<p>Date: 10/04/2024</p>

<p>Description: View of ET&L working in segment 6. Facing east.</p>

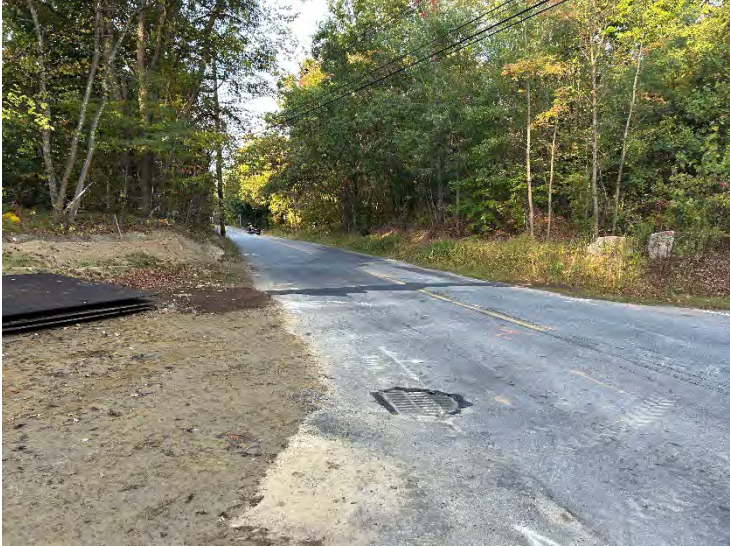
PHOTOGRAPHIC LOG	
Client Name: Eversource		Site Location: Sudbury to Hudson Transmission Reliability Project	Town: Hudson
Photo No.: 7	Date: 10/04/2024

Description: View of completed road crossing work in Wilkins Ave. Facing southwest.

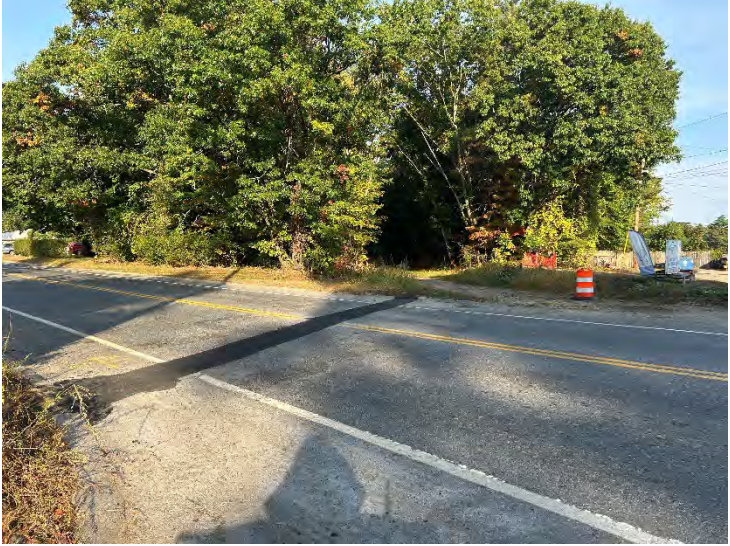
PHOTOGRAPHIC LOG	
Client Name: Eversource		Site Location: Sudbury to Hudson Transmission Reliability Project	Town: Hudson
Photo No.: 8	Date: 10/04/2024

Description: View of completed road crossing work in Main Street. Facing northwest.

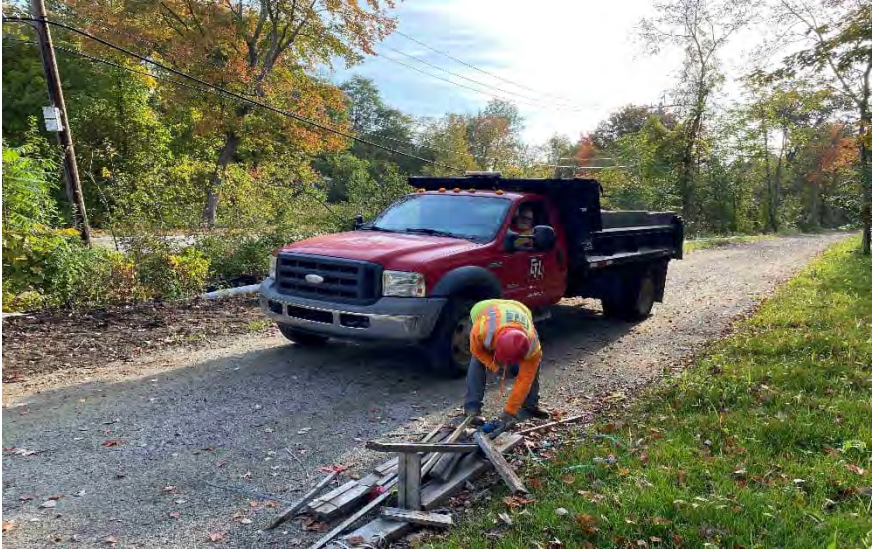
<p align="center">PHOTOGRAPHIC LOG</p>	
<p>Client Name: Eversource</p>		<p>Site Location: Sudbury to Hudson Transmission Reliability Project</p>	<p>Town: Sudbury</p>
<p>Photo No.: 1</p>	<p>Date: 10-04-24</p>

<p>Description:</p> <p>Segment 12, ET&L conducting clean-up work, existing erosion control, looking eastward.</p>

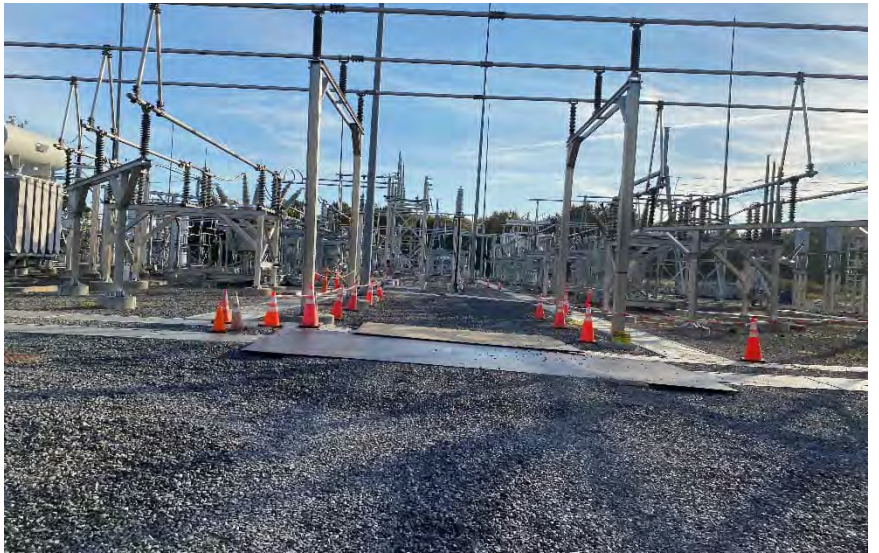
<p align="center">PHOTOGRAPHIC LOG</p>	
<p>Client Name: Eversource</p>		<p>Site Location: Sudbury to Hudson Transmission Reliability Project</p>	<p>Town: Sudbury</p>
<p>Photo No.: 2</p>	<p>Date: 10-04-24</p>

<p>Description:</p> <p>Work area within substation, termination structure, looking eastward</p>

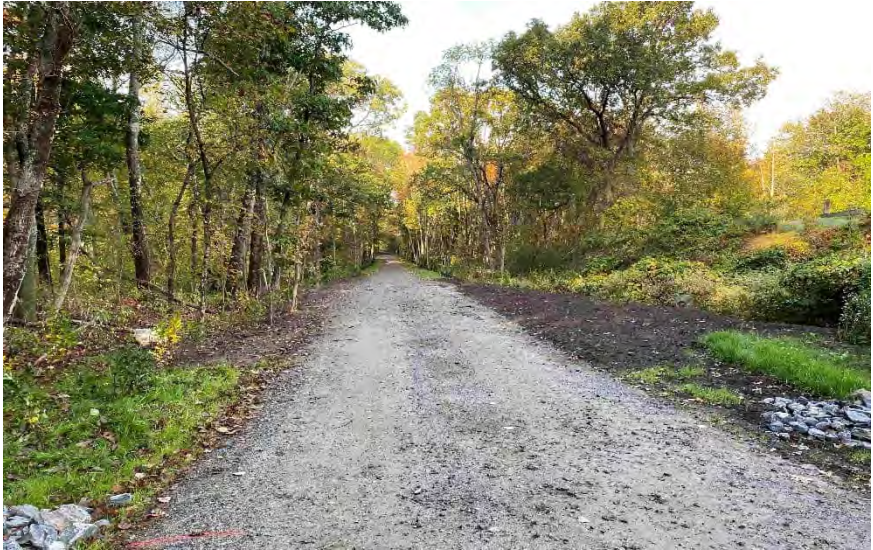
<p align="center">PHOTOGRAPHIC LOG</p>	
<p>Client Name: Eversource</p>		<p>Site Location: Sudbury to Hudson Transmission Reliability Project</p>	<p>Town: Sudbury</p>
<p>Photo No.: 3</p>	<p>Date: 10-04-24</p>

<p>Description:</p> <p>Work area within segment 14 at manhole #27, recently planted area - to be hydro seeded, existing erosion control, looking westward</p>

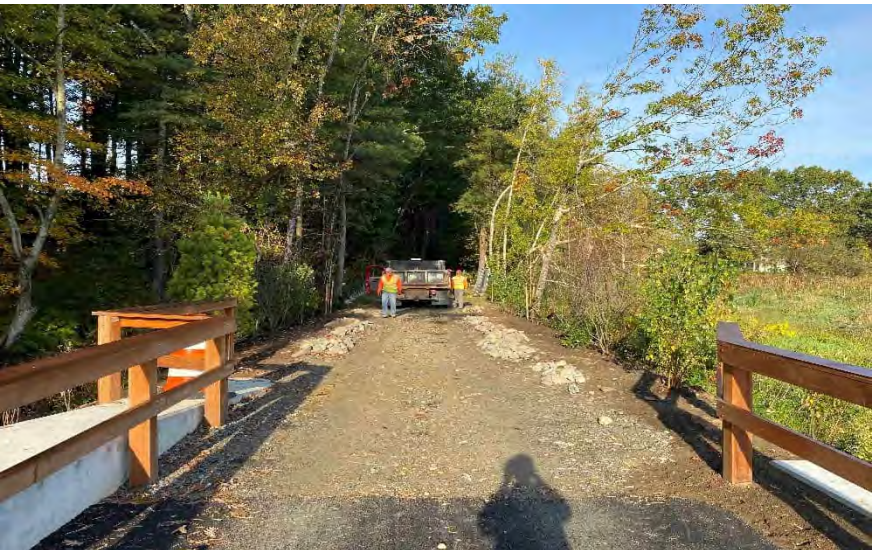
<p align="center">PHOTOGRAPHIC LOG</p>	
<p>Client Name: Eversource</p>		<p>Site Location: Sudbury to Hudson Transmission Reliability Project</p>	<p>Town: Sudbury</p>
<p>Photo No.: 4</p>	<p>Date: 10-04-24</p>

<p>Description:</p> <p>Work area within segment 13, Bridge 127 area showing recent plantings, ET&L conducting clean-up work, existing erosion control, looking westward</p>

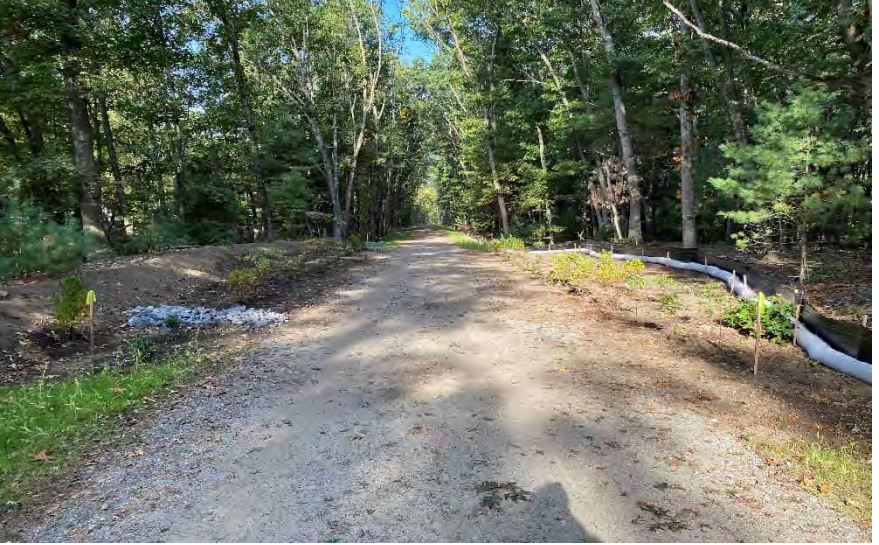
PHOTOGRAPHIC LOG	
Client Name: Eversource		Site Location: Sudbury to Hudson Transmission Reliability Project	Town: Sudbury
Photo No.: 5	Date: 10-04-24

Description: Work area within segment 11 manhole #23, recently planted area - to be hydro seeded, existing erosion control, looking westward.

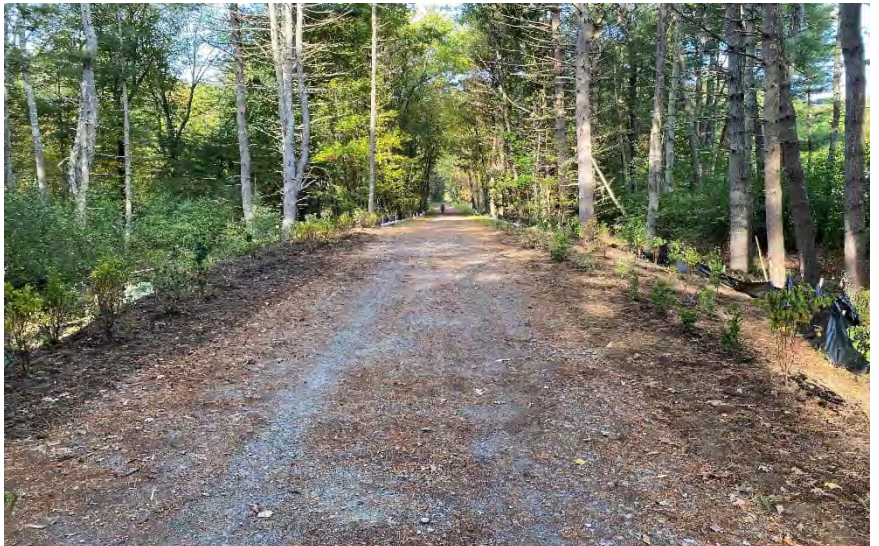
PHOTOGRAPHIC LOG	
Client Name: Eversource		Site Location: Sudbury to Hudson Transmission Reliability Project	Town: Sudbury
Photo No.: 6	Date: 10-04-24

Description: Work area within segment 10 manhole #21, recently planted area - to be hydro seeded, existing erosion control, looking westward.

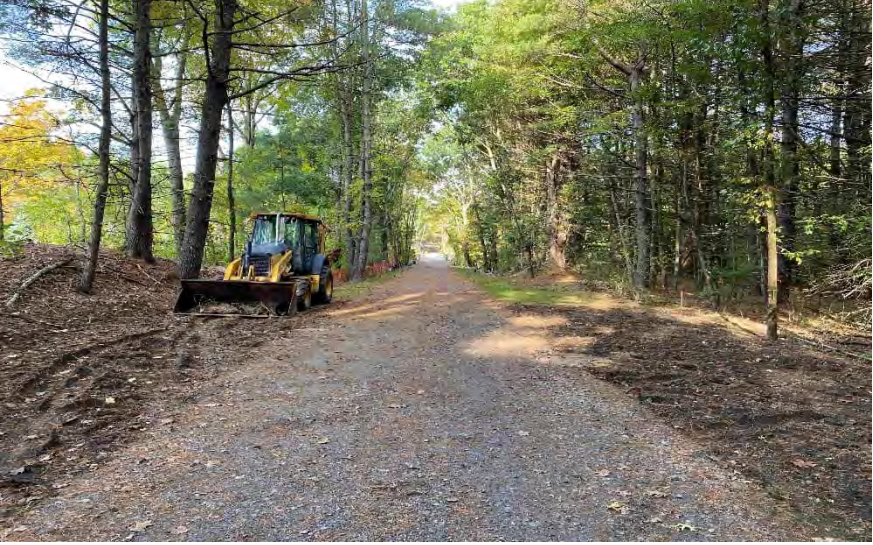
PHOTOGRAPHIC LOG	
Client Name: Eversource		Site Location: Sudbury to Hudson Transmission Reliability Project	Town: Sudbury
Photo No.: 7	Date: 10-04-24

Description: Work area within segment 8 manhole #17, recently planted area - to be hydro seeded, MON equipment staged, existing erosion control, looking westward.

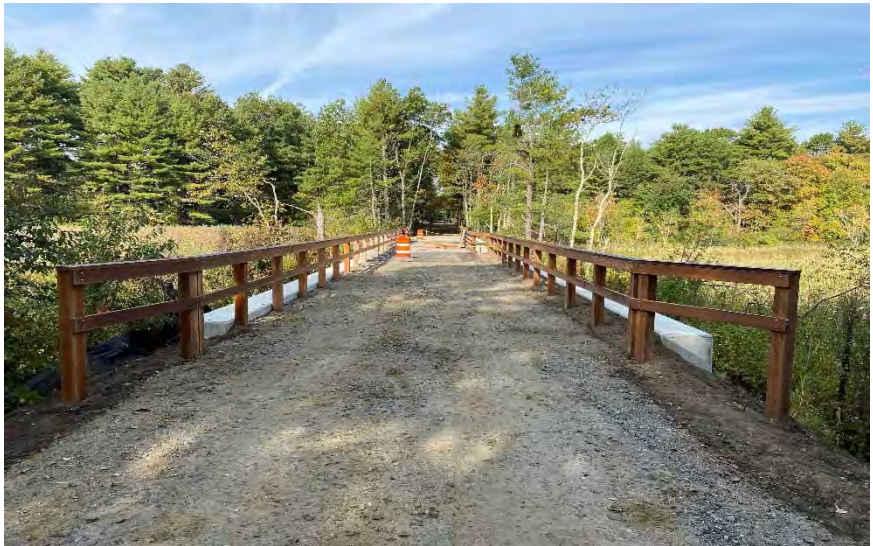
PHOTOGRAPHIC LOG	
Client Name: Eversource		Site Location: Sudbury to Hudson Transmission Reliability Project	Town: Sudbury
Photo No.: 8	Date: 10-04-24

Description: Work area within segment 8 Bridge 128, recently planted area – further plantings & to be hydro seeded, existing erosion control, looking westward.

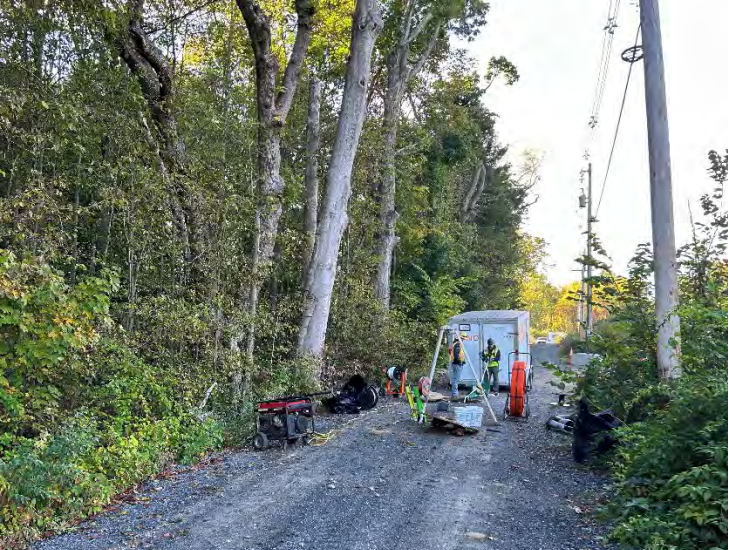
PHOTOGRAPHIC LOG	
Client Name: Eversource		Site Location: Sudbury to Hudson Transmission Reliability Project	Town: Hudson
Photo No.: 1	Date: 9-30-2024

Description: View of Bond at MH #1. Facing south.

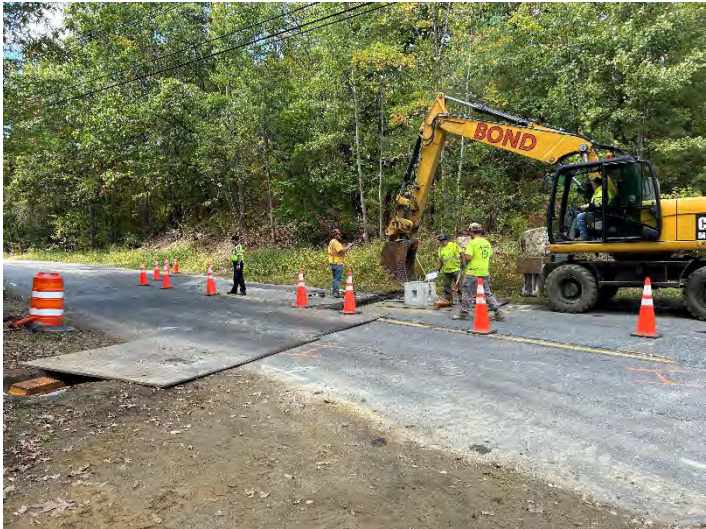
PHOTOGRAPHIC LOG	
Client Name: Eversource		Site Location: Sudbury to Hudson Transmission Reliability Project	Town: Hudson
Photo No.: 2	Date: 9-30-2024

Description: View of Bond working in Wilkins St. Facing northwest.

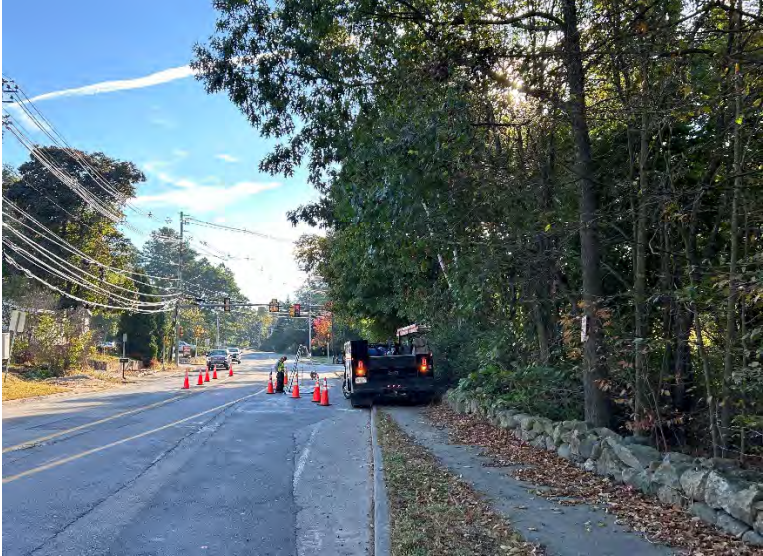
PHOTOGRAPHIC LOG	
Client Name: Eversource		Site Location: Sudbury to Hudson Transmission Reliability Project	Town: Hudson
Photo No.: 3	Date: 9-30-2024

Description: View of Bond working in MH #2 on Forest Ave. Facing east.

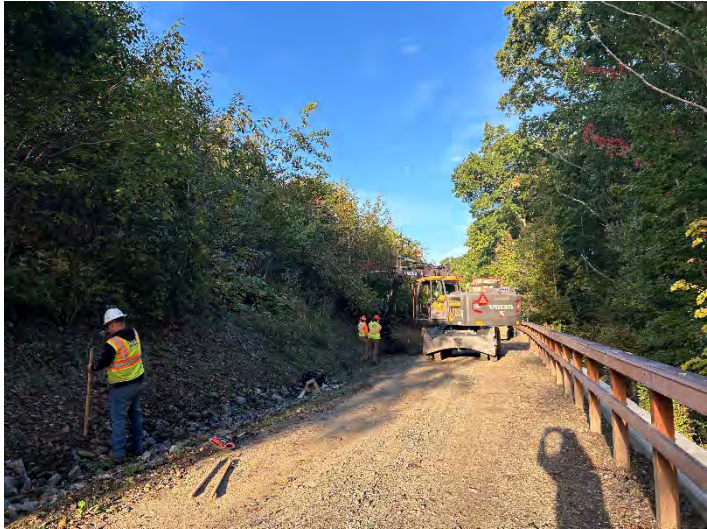
PHOTOGRAPHIC LOG	
Client Name: Eversource		Site Location: Sudbury to Hudson Transmission Reliability Project	Town: Hudson
Photo No.: 4	Date: 9-30-2024

Description: View of ET&L spreading loam at MH#6 in segment 1. Facing west.

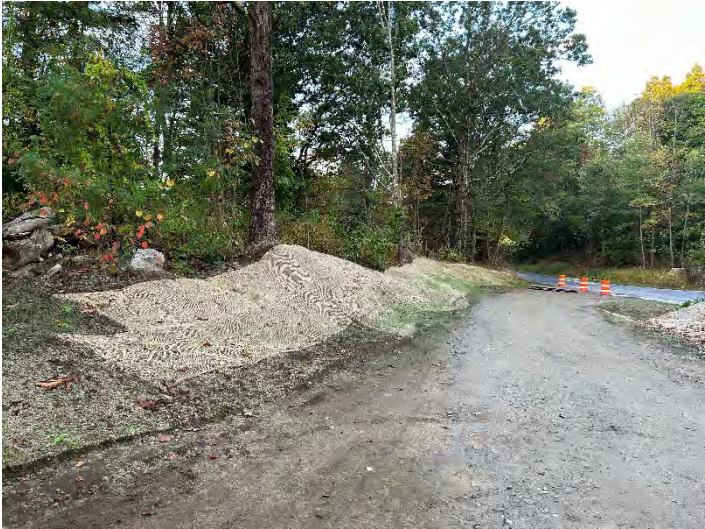
Epsilon ASSOCIATES INC.		PHOTOGRAPHIC LOG	
Client Name: Eversource		Site Location: Sudbury to Hudson Transmission Reliability Project	Town: Hudson
Photo No.: 5	Date: 9-30-2024

Description: View of erosion control matting along slope at the entrance to segment 1 from Wilkins St. Facing northwest.

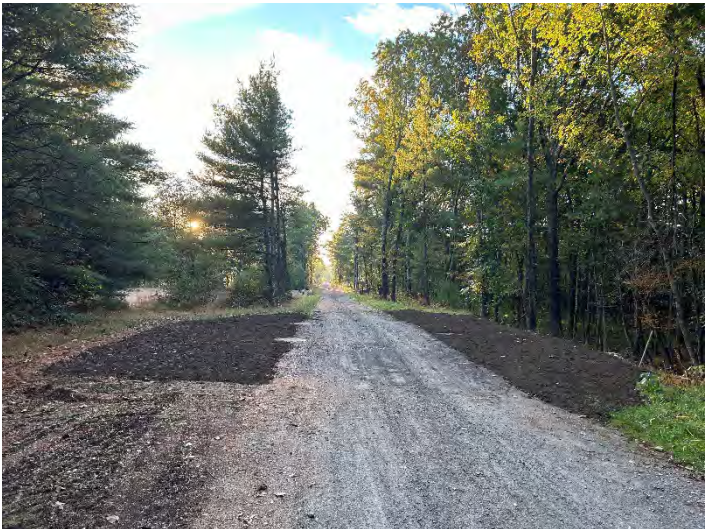
Epsilon ASSOCIATES INC.		PHOTOGRAPHIC LOG	
Client Name: Eversource		Site Location: Sudbury to Hudson Transmission Reliability Project	Town: Hudson
Photo No.: 6	Date: 9-30-2024

Description: View of loamed area at MH #7 in segment 2. Facing east.

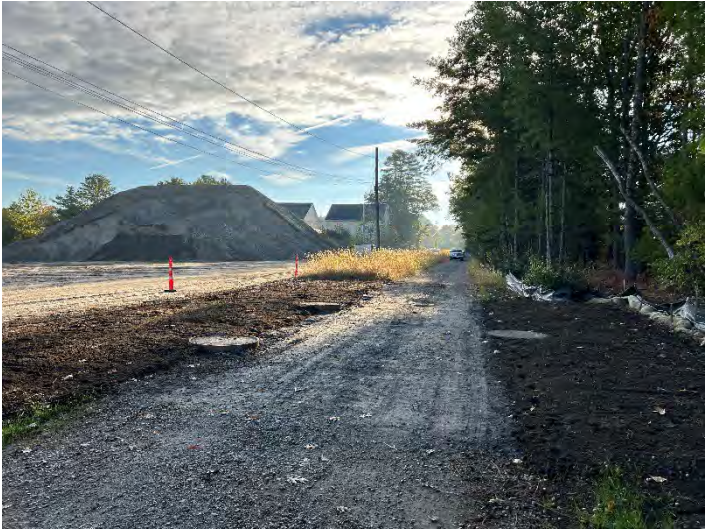
PHOTOGRAPHIC LOG	
Client Name: Eversource		Site Location: Sudbury to Hudson Transmission Reliability Project	Town: Hudson
Photo No.: 7	Date: 9-30-2024

Description: View of loamed area at MH #8 within segment 3. Facing east.

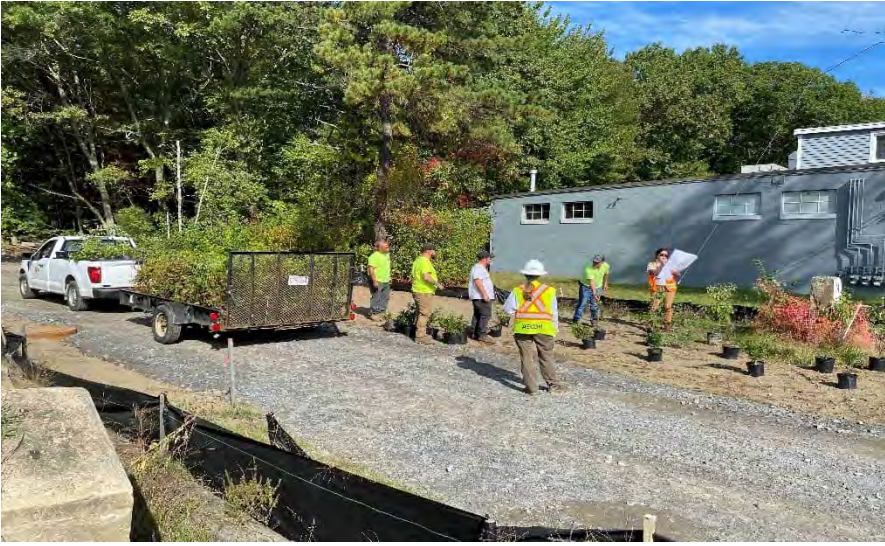
PHOTOGRAPHIC LOG	
Client Name: Eversource		Site Location: Sudbury to Hudson Transmission Reliability Project	Town: Sudbury
Photo No.: 1	Date: 9-30-24

Description: Work area within segment 11, MON conducting planting work at manhole #24, existing erosion control, looking westward.

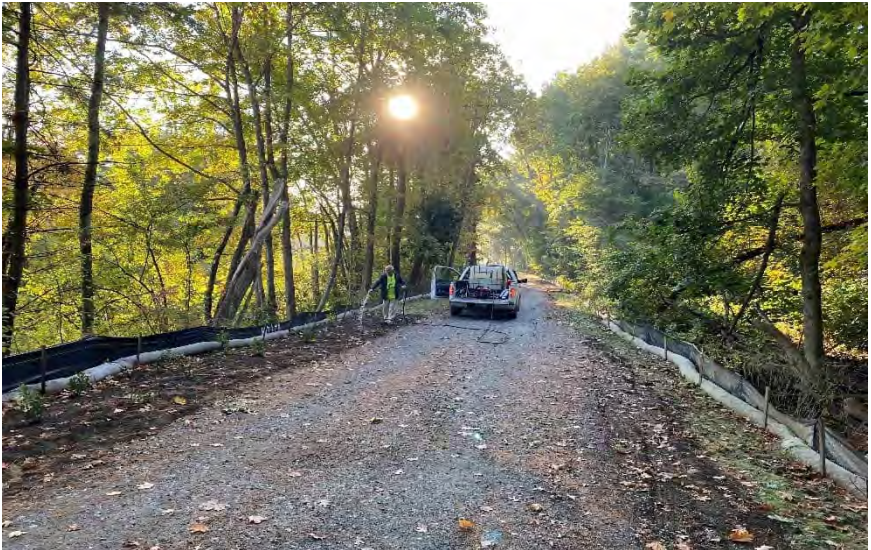
PHOTOGRAPHIC LOG	
Client Name: Eversource		Site Location: Sudbury to Hudson Transmission Reliability Project	Town: Sudbury
Photo No.: 2	Date: 9-30-24

Description: Work area within segment 14, MON watering recently placed plantings, existing erosion control, looking westward.

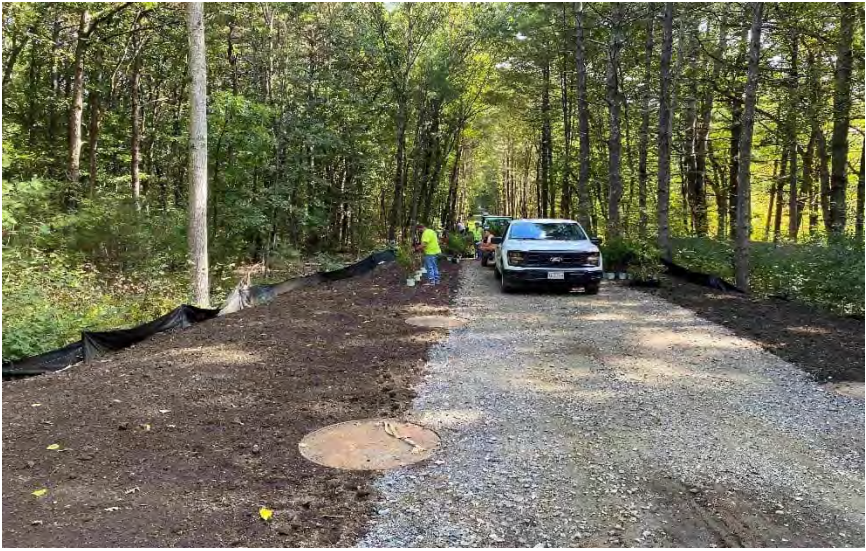
PHOTOGRAPHIC LOG	
Client Name: Eversource		Site Location: Sudbury to Hudson Transmission Reliability Project	Town: Sudbury
Photo No.: 3	Date: 9-30-24

Description: Work area within segment 10, manhole #20 MON planting, existing erosion control, looking eastward.
