Weekly Environmental Compliance Summary

Sudbury to Hudson Transmission Reliability Project (USEPA Tracking # MAR1003UW)

Week of: September 30, 2024 to October 4, 2024

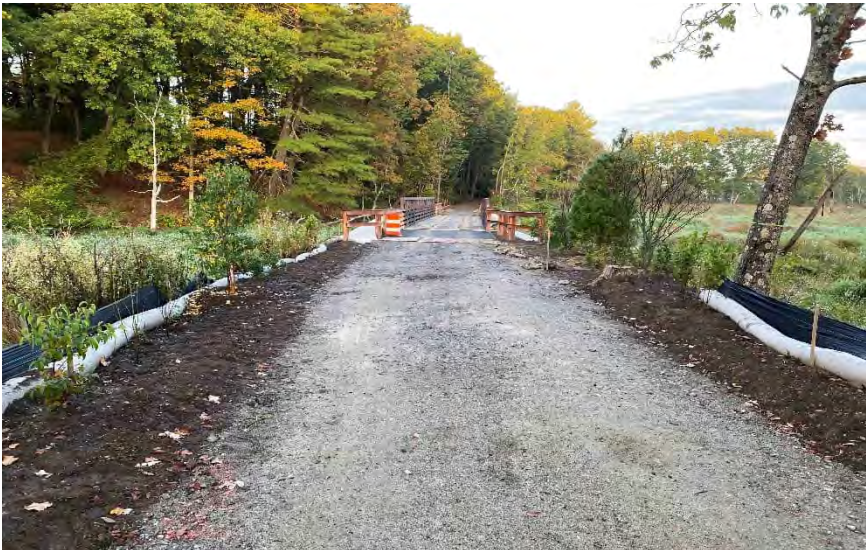
PHOTOGRAPHIC LOG	
Client Name: Eversource		Site Location: Sudbury to Hudson Transmission Reliability Project	Town: Sudbury
Photo No.: 4	Date: 9-30-24

Description: Work area within segment 14 recently loamed/hydroseeded area & plantings at bridge 127, existing erosion control, looking westward.

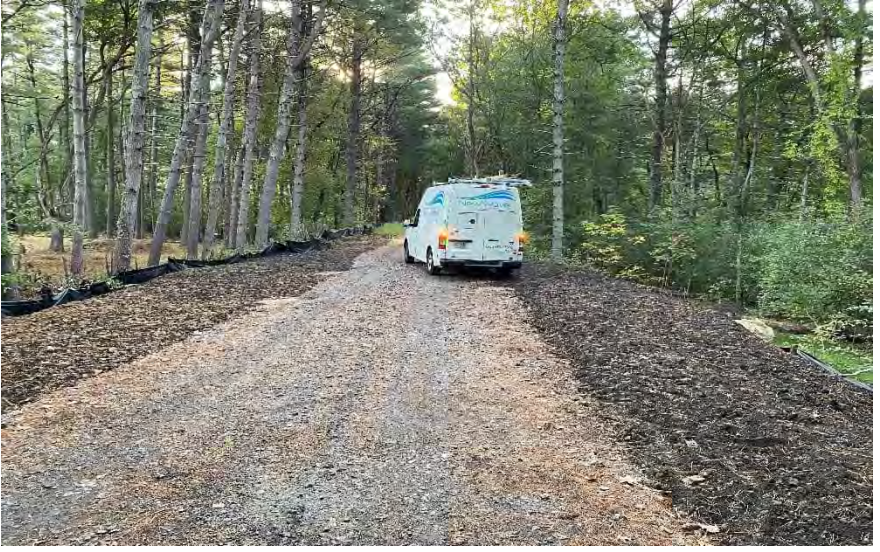
PHOTOGRAPHIC LOG	
Client Name: Eversource		Site Location: Sudbury to Hudson Transmission Reliability Project	Town: Sudbury
Photo No.: 5	Date: 9-30-24

Description: Work area within segment 9, handhole #19 New Wave conducting splicing, existing erosion control, looking eastward.

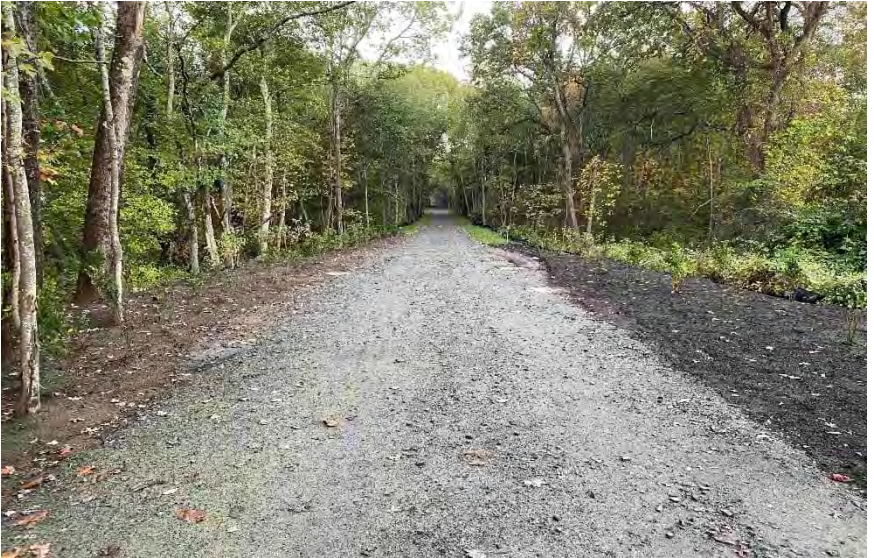
PHOTOGRAPHIC LOG	
Client Name: Eversource		Site Location: Sudbury to Hudson Transmission Reliability Project	Town: Sudbury
Photo No.: 7	Date: 9-30-24

Description: Work area within segment 14, recent plantings near manhole #27, existing erosion control, looking westward.

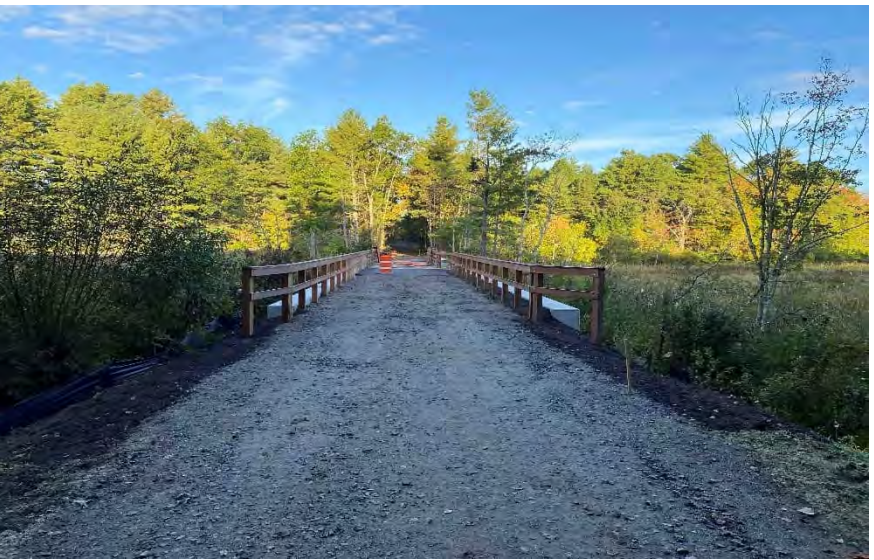
PHOTOGRAPHIC LOG	
Client Name: Eversource		Site Location: Sudbury to Hudson Transmission Reliability Project	Town: Sudbury
Photo No.: 8	Date: 9-30-24

Description: Bridge 128 segment 8 recently completed post/rails & placement of planting loam, existing erosion control, looking westward.

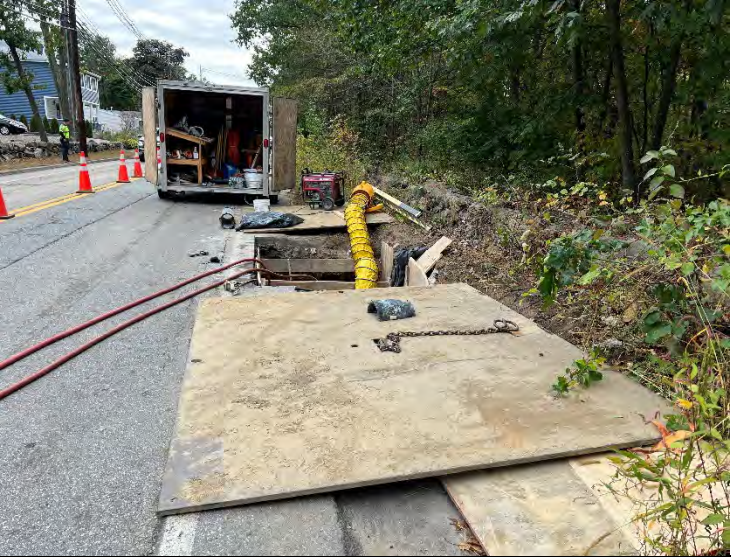
PHOTOGRAPHIC LOG	
Client Name: Eversource		Site Location: Sudbury to Hudson Transmission Reliability Project	Town: Hudson
Photo No.: 1	Date: 10-3-2024

Description: View of Bond work area on Forest Ave by MH#2. Facing east.

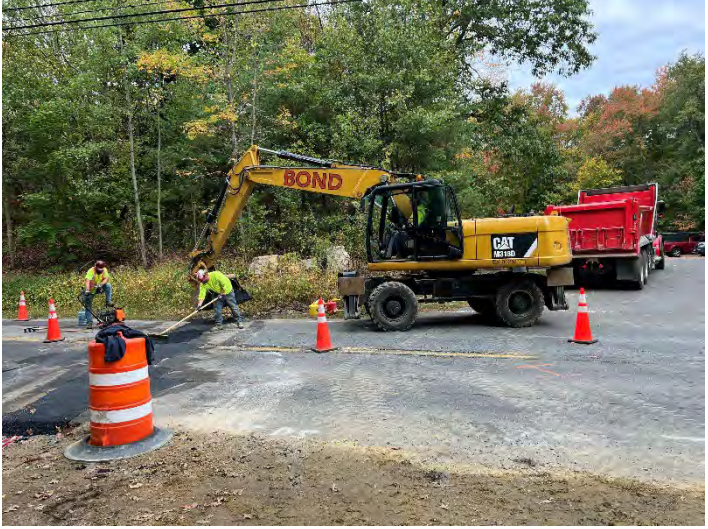
PHOTOGRAPHIC LOG	
Client Name: Eversource		Site Location: Sudbury to Hudson Transmission Reliability Project	Town: Hudson
Photo No.: 2	Date: 10-3-2024

Description: View of Bond paving Wilkins St crossing. Facing northwest.

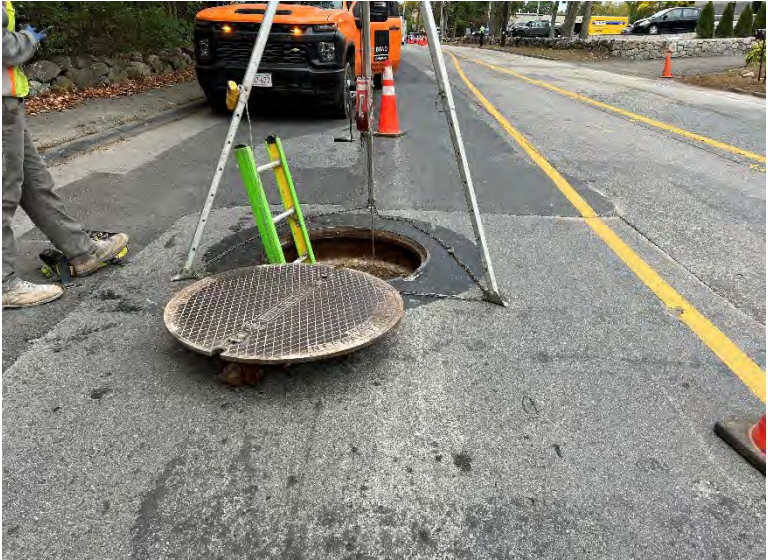
PHOTOGRAPHIC LOG	
Client Name: Eversource		Site Location: Sudbury to Hudson Transmission Reliability Project	Town: Hudson
Photo No.: 3	Date: 10-3-2024

Description: View of Bond working in MH #2 on Forest Ave. Facing west.

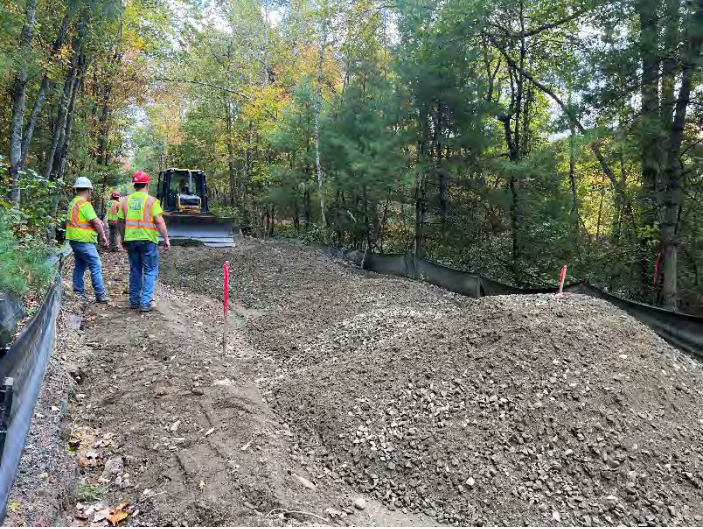
PHOTOGRAPHIC LOG	
Client Name: Eversource		Site Location: Sudbury to Hudson Transmission Reliability Project	Town: Hudson
Photo No.: 4	Date: 10-3-2024

Description: View of ET&L applying gravel for the hardening of segment 6. Facing east.

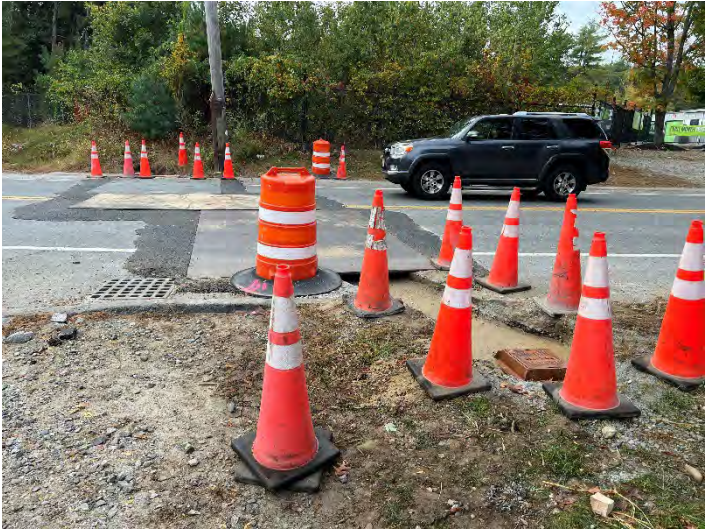
Epsilon ASSOCIATES INC.		PHOTOGRAPHIC LOG	
Client Name: Eversource		Site Location: Sudbury to Hudson Transmission Reliability Project	Town: Hudson
Photo No.: 5	Date: 10-3-2024

Description: View of steel plates across Main Street crossing. Plates were removed and area paved. Facing east.

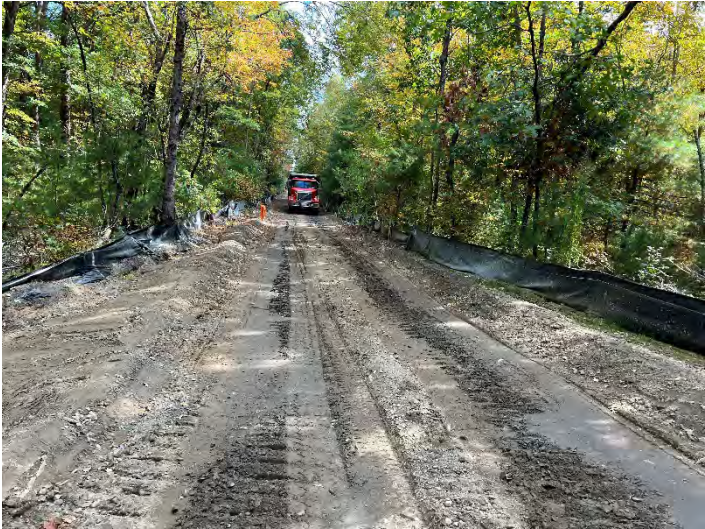
Epsilon ASSOCIATES INC.		PHOTOGRAPHIC LOG	
Client Name: Eversource		Site Location: Sudbury to Hudson Transmission Reliability Project	Town: Hudson
Photo No.: 6	Date: 10-3-2024

Description: View of E&S controls down segment 6. Truck delivery of gravel for ET&L hardening of ROW. Facing east.

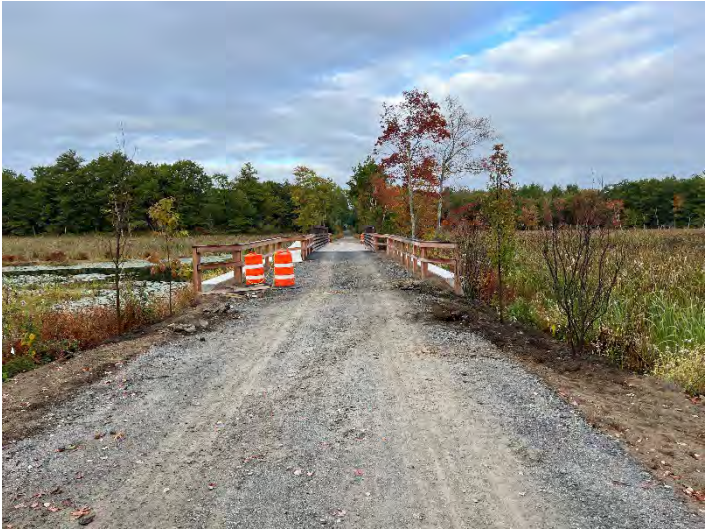
Epsilon ASSOCIATES INC.		PHOTOGRAPHIC LOG	
Client Name: Eversource		Site Location: Sudbury to Hudson Transmission Reliability Project	Town: Hudson
Photo No.: 7	Date: 10-3-2024

Description: View of Bridge 130. Facing west.

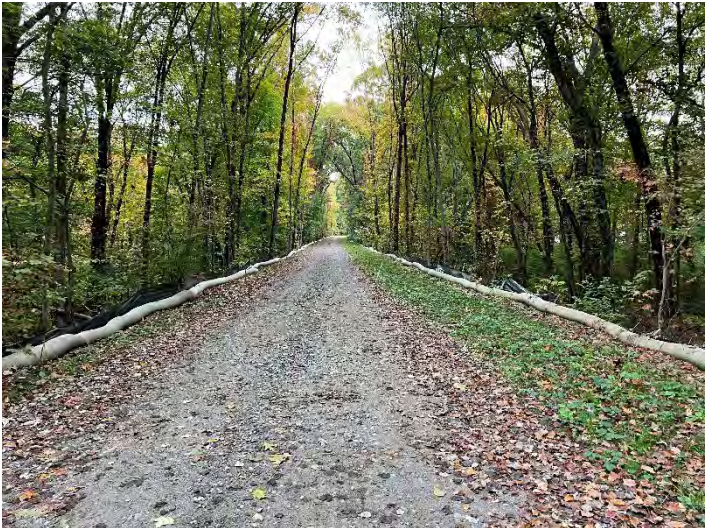
Epsilon ASSOCIATES INC.		PHOTOGRAPHIC LOG	
Client Name: Eversource		Site Location: Sudbury to Hudson Transmission Reliability Project	Town: Hudson
Photo No.: 8	Date: 10-3-2024

Description: View of E&S controls in segment 1. Facing east.

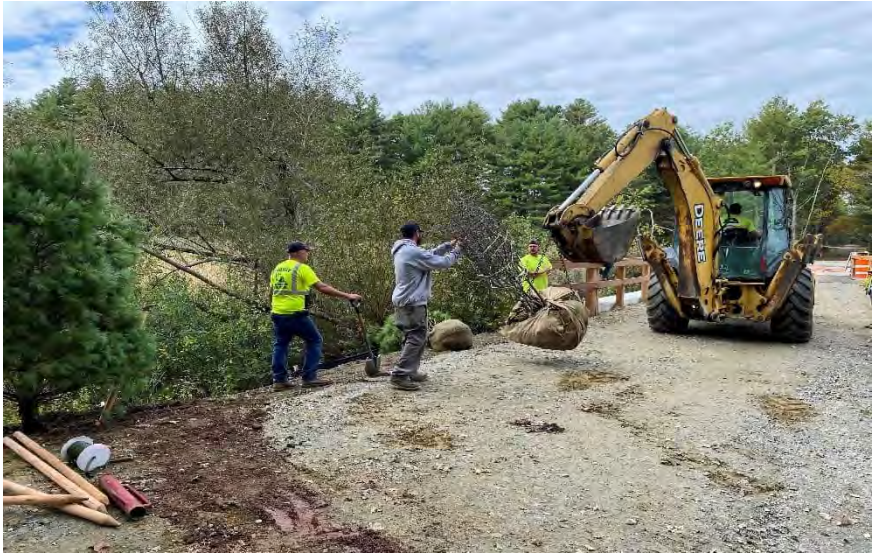
PHOTOGRAPHIC LOG	
Client Name: Eversource		Site Location: Sudbury to Hudson Transmission Reliability Project	Town: Sudbury
Photo No.: 1	Date: 10-03-24

Description: Work area within segment 8, MON conducting tree planting work, existing erosion control, looking westward.

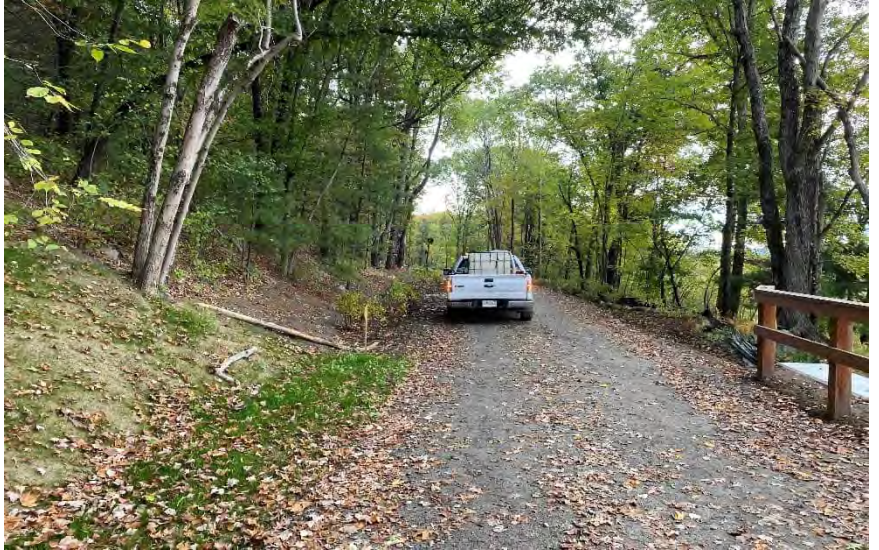
PHOTOGRAPHIC LOG	
Client Name: Eversource		Site Location: Sudbury to Hudson Transmission Reliability Project	Town: Sudbury
Photo No.: 2	Date: 10-03-24

Description: Work area within segment 14, MON watering recently placed plantings, existing erosion control, looking eastward.

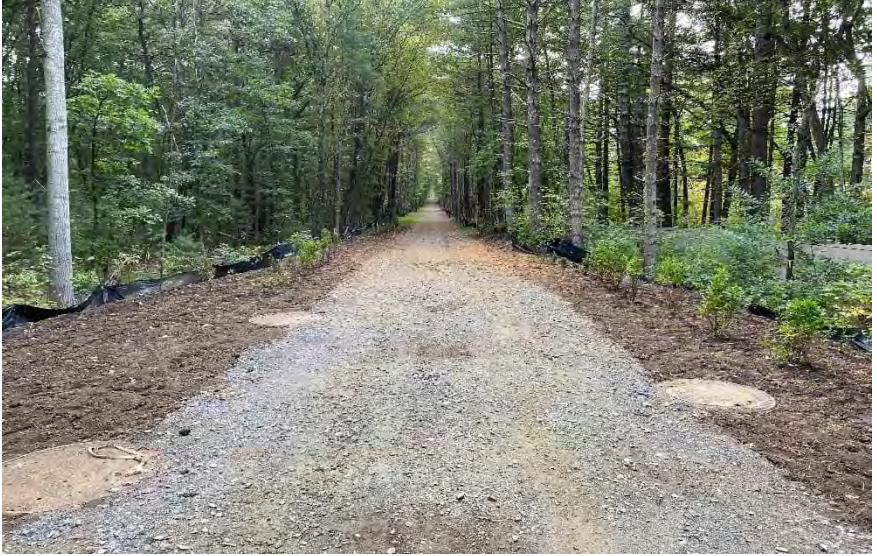
PHOTOGRAPHIC LOG	
Client Name: Eversource		Site Location: Sudbury to Hudson Transmission Reliability Project	Town: Sudbury
Photo No.: 3	Date: 10-03-24

Description: Work area within segment 10, manhole #20 recent planting, existing erosion control, looking eastward.

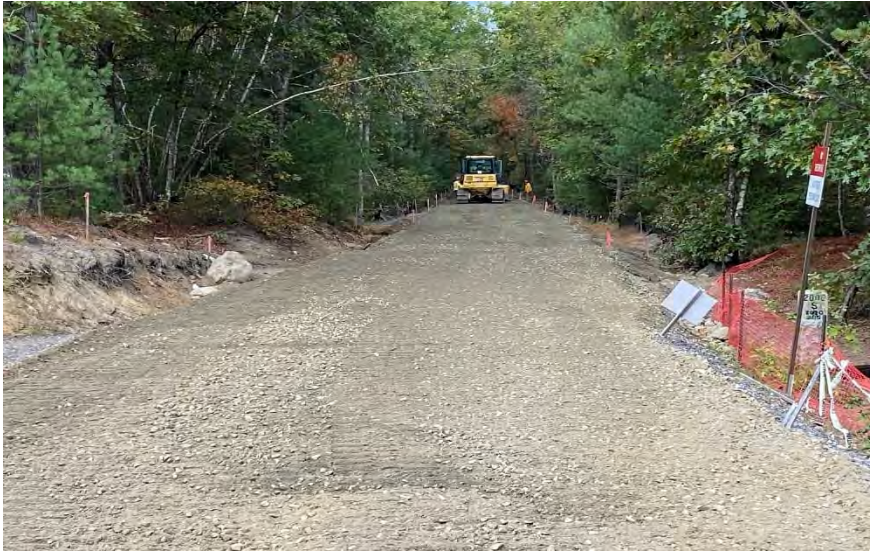
PHOTOGRAPHIC LOG	
Client Name: Eversource		Site Location: Sudbury to Hudson Transmission Reliability Project	Town: Sudbury
Photo No.: 4	Date: 10-03-24

Description: Work area within segment 7, ET&L grading on into segment 6, existing erosion control, looking westward.

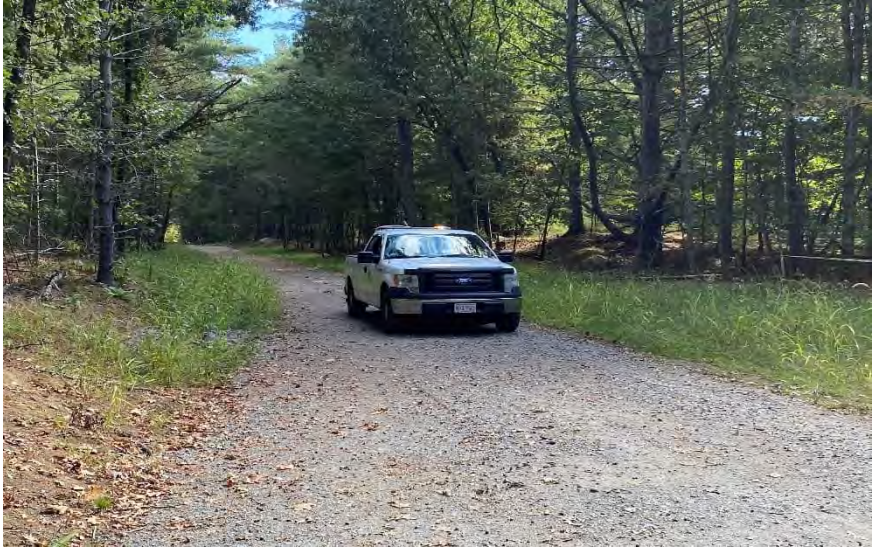
PHOTOGRAPHIC LOG	
Client Name: Eversource		Site Location: Sudbury to Hudson Transmission Reliability Project	Town: Sudbury
Photo No.: 5	Date: 10-03-24

Description: Work area within segment 9, MON conducting watering activities, existing erosion control, looking eastward.

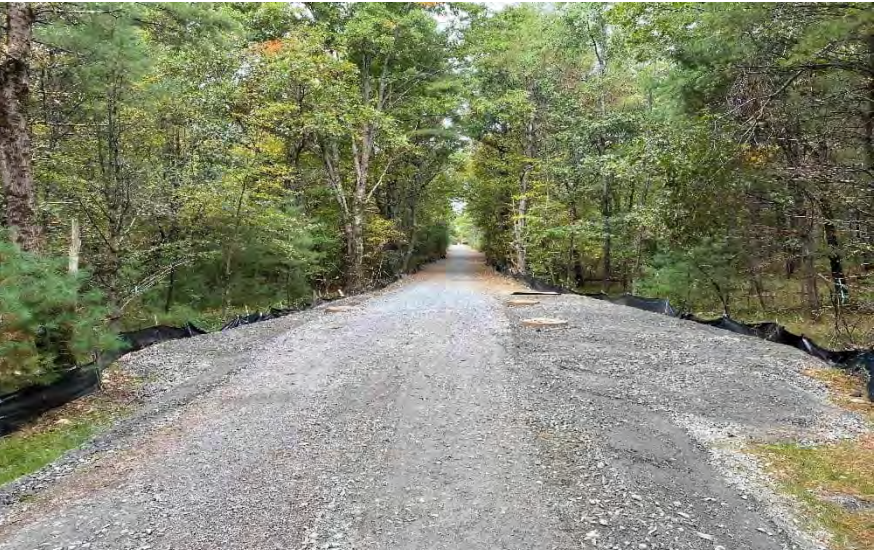
PHOTOGRAPHIC LOG	
Client Name: Eversource		Site Location: Sudbury to Hudson Transmission Reliability Project	Town: Sudbury
Photo No.: 6	Date: 10-03-24

Description: Work area within segment 7, removal of pad gravels at manhole #15, existing erosion control, looking westward.

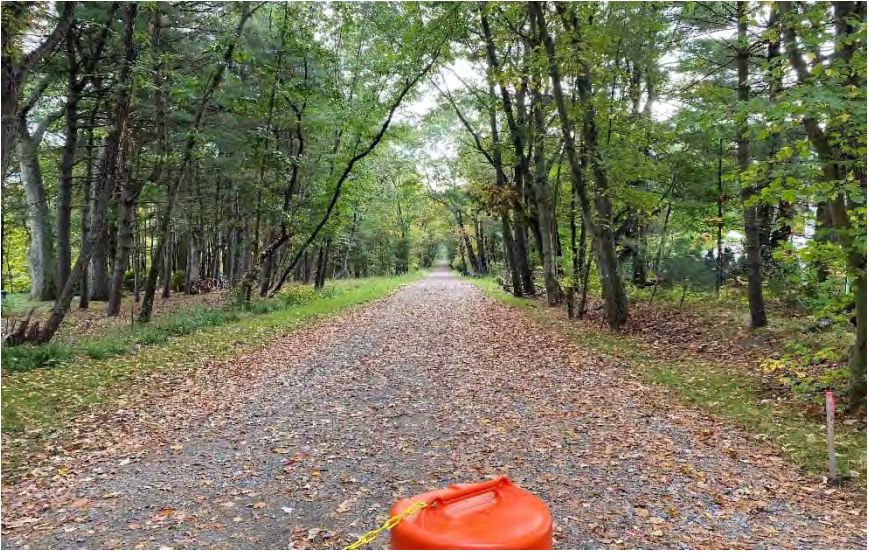
PHOTOGRAPHIC LOG	
Client Name: Eversource		Site Location: Sudbury to Hudson Transmission Reliability Project	Town: Sudbury
Photo No.: 7	Date: 10-03-24

Description: Work area within segment 11, existing erosion control, looking eastward.

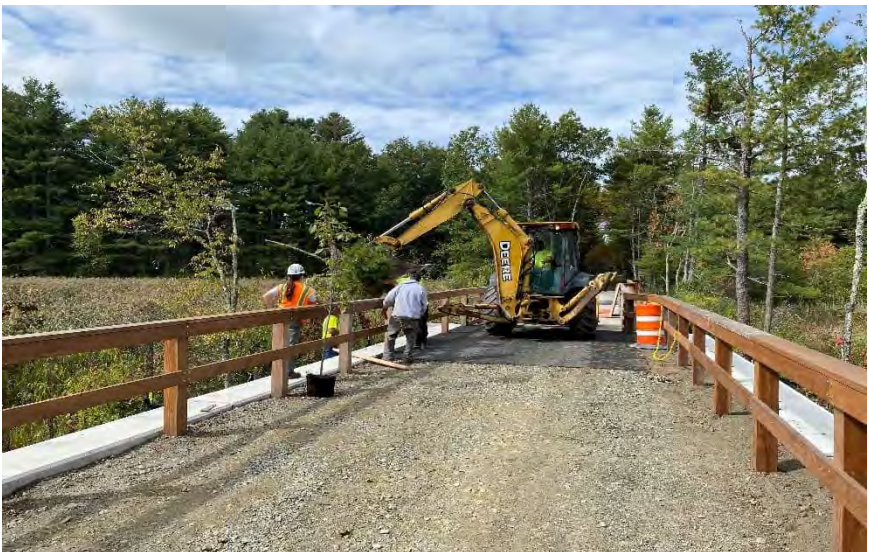
PHOTOGRAPHIC LOG	
Client Name: Eversource		Site Location: Sudbury to Hudson Transmission Reliability Project	Town: Sudbury
Photo No.: 8	Date: 10-03-24

Description: Bridge 128 segment 8, MON planting trees, existing erosion control, looking westward.

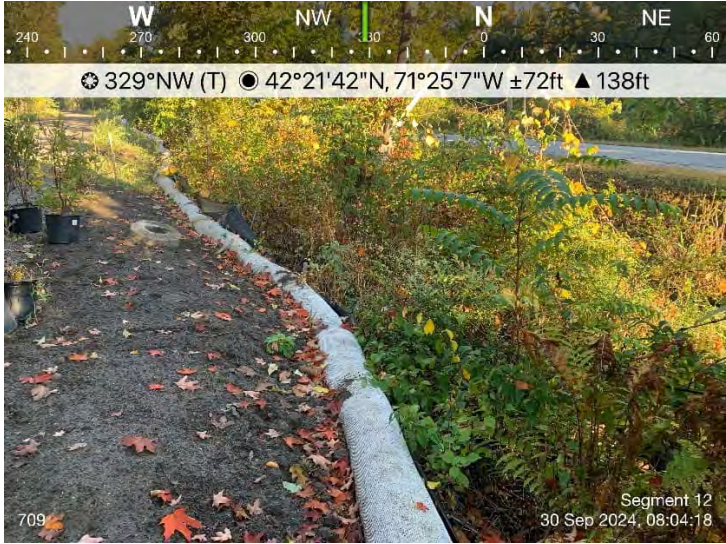
<p>PHOTOGRAPHIC LOG</p>	
<p>Client Name: Eversource</p>		<p>Site Location: Sudbury to Hudson Transmission Reliability Project</p>	<p>Town: Sudbury</p>
<p>Photo No.: 3</p>	<p>Date: 9/30/2024</p>

<p>Description: Bed prior to planting in Segment 12 approximately between Stations 709+00 – 709+25 on the northern side of the work area.</p>

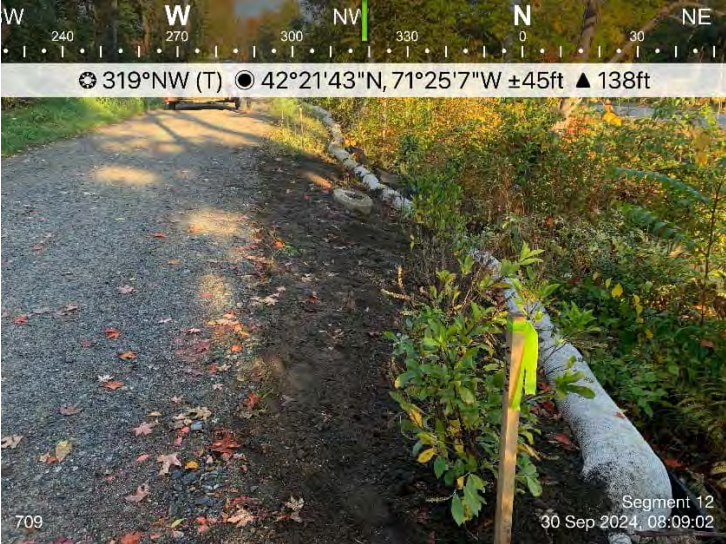
<p>PHOTOGRAPHIC LOG</p>	
<p>Client Name: Eversource</p>		<p>Site Location: Sudbury to Hudson Transmission Reliability Project</p>	<p>Town: Sudbury</p>
<p>Photo No.: 4</p>	<p>Date: 9/30/2024</p>

<p>Description: Bed after planting in Segment 12 approximately between Stations 709+00 – 709+25 on the northern side of the work area.</p>

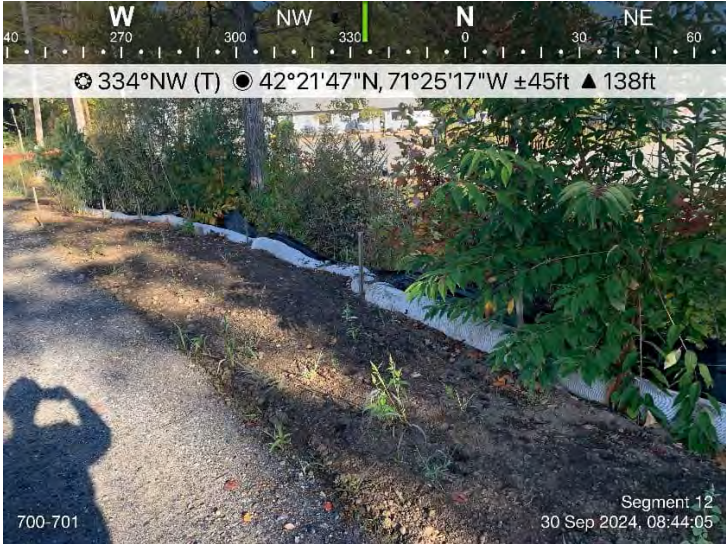
<p>PHOTOGRAPHIC LOG</p>	
<p>Client Name: Eversource</p>		<p>Site Location: Sudbury to Hudson Transmission Reliability Project</p>	<p>Town: Sudbury</p>
<p>Photo No.: 1</p>	<p>Date: 9/30/2024</p>

<p>Description: Bed prior to planting in Segment 12 near Stations 700+00 – 700+75 on the northern side of the work area.</p>		<p>700-701</p> <p>Segment 12 30 Sep 2024, 08:44:05</p>

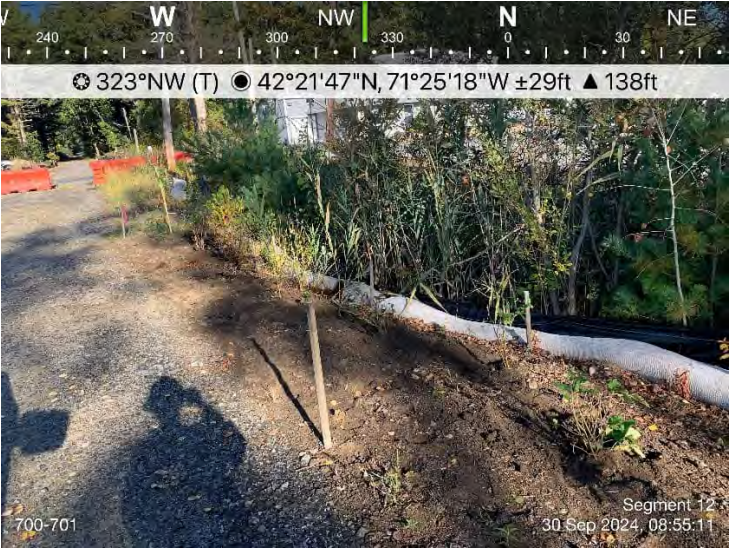
<p>PHOTOGRAPHIC LOG</p>	
<p>Client Name: Eversource</p>		<p>Site Location: Sudbury to Hudson Transmission Reliability Project</p>	<p>Town: Sudbury</p>
<p>Photo No.: 3</p>	<p>Date: 9/30/2024</p>

<p>Description: Western side of bed after planting in Segment 12 near Stations 700+00-700+75 on the northern side of the work area.</p>		<p>700-701 Segment 12 30 Sep 2024, 08:55:11</p>

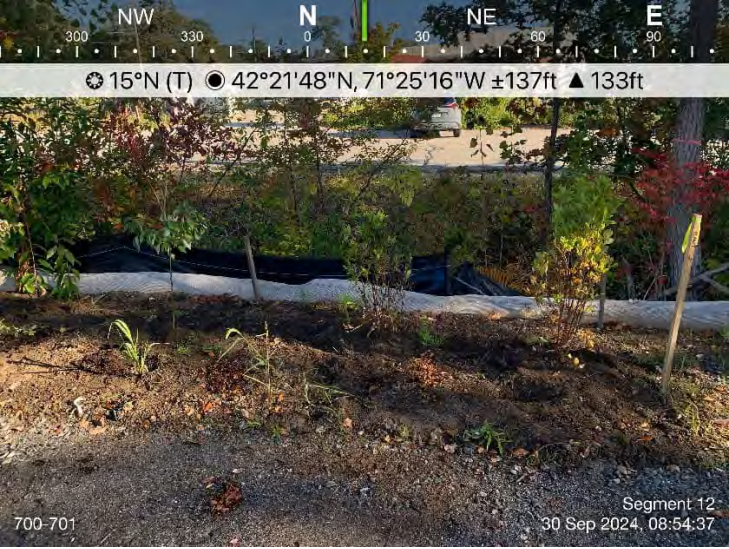
<p>PHOTOGRAPHIC LOG</p>	
<p>Client Name: Eversource</p>		<p>Site Location: Sudbury to Hudson Transmission Reliability Project</p>	<p>Town: Sudbury</p>
<p>Photo No.: 4</p>	<p>Date: 9/30/2024</p>

<p>Description: Eastern side of bed after planting in Segment 12 near Stations 700+00-700+75 on the northern side of the work area.</p>		<p>700-701 Segment 12 30 Sep 2024, 08:54:37</p>

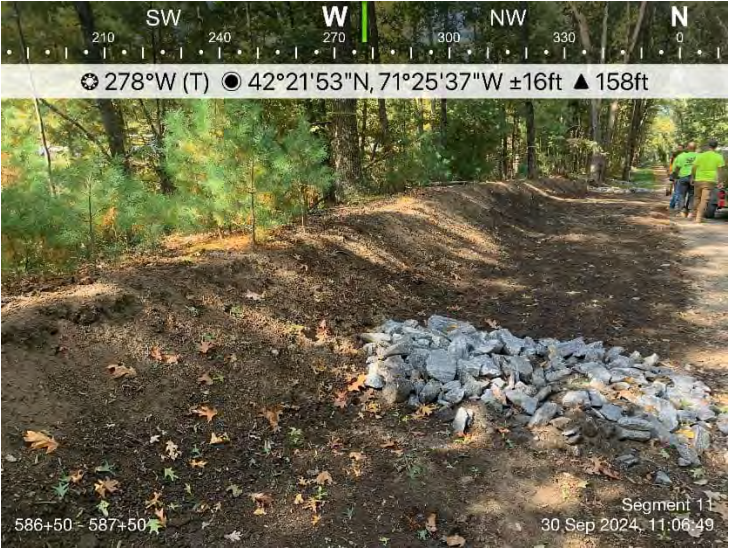
<p>PHOTOGRAPHIC LOG</p>	
<p>Client Name: Eversource</p>		<p>Site Location: Sudbury to Hudson Transmission Reliability Project</p>	<p>Town: Sudbury</p>
<p>Photo No.: 1</p>	<p>Date: 9/30/2024</p>

<p>Description: Bed prior to planting in Segment 11 approximately between Stations 586+50 – 587+50 on the southern side of the work area.</p>

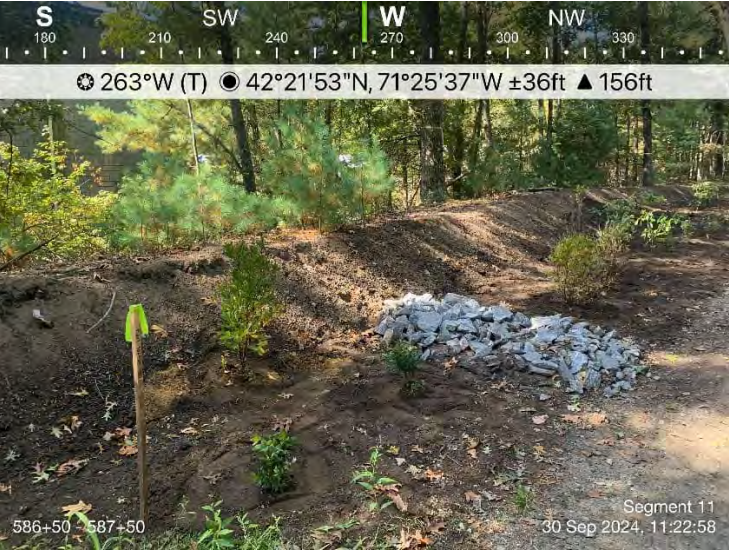
<p>PHOTOGRAPHIC LOG</p>	
<p>Client Name: Eversource</p>		<p>Site Location: Sudbury to Hudson Transmission Reliability Project</p>	<p>Town: Sudbury</p>
<p>Photo No.: 3</p>	<p>Date: 9/30/2024</p>

<p>Description: Eastern side of bed after planting in Segment 11 approximately between Stations 586+50 – 587+50 on the southern side of the work area.</p>		<p>586+50 - 587+50</p> <p>Segment 11 30 Sep 2024, 11:22:58</p>

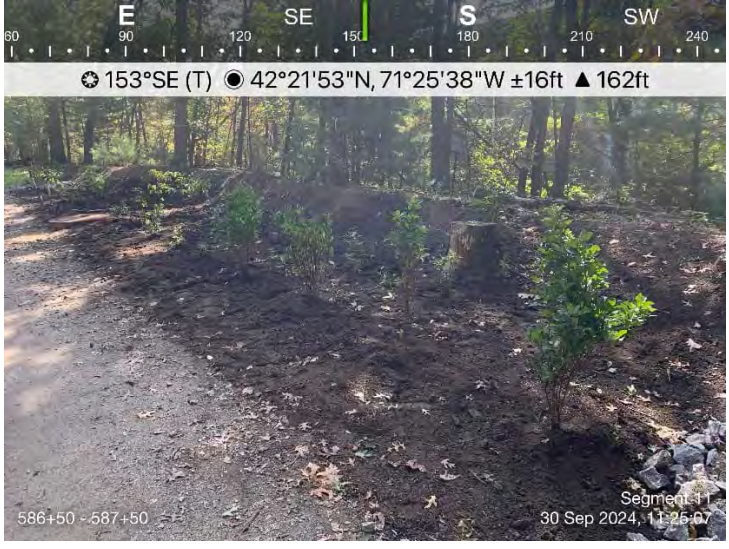
<p>PHOTOGRAPHIC LOG</p>	
<p>Client Name: Eversource</p>		<p>Site Location: Sudbury to Hudson Transmission Reliability Project</p>	<p>Town: Sudbury</p>
<p>Photo No.: 4</p>	<p>Date: 9/30/2024</p>

<p>Description: Bed after planting in Segment 11 approximately between Stations 586+50 – 587+50 on the southern side of the work area.</p>		<p>586+50 - 587+50</p> <p>Segment 11 30 Sep 2024, 11:25:07</p>

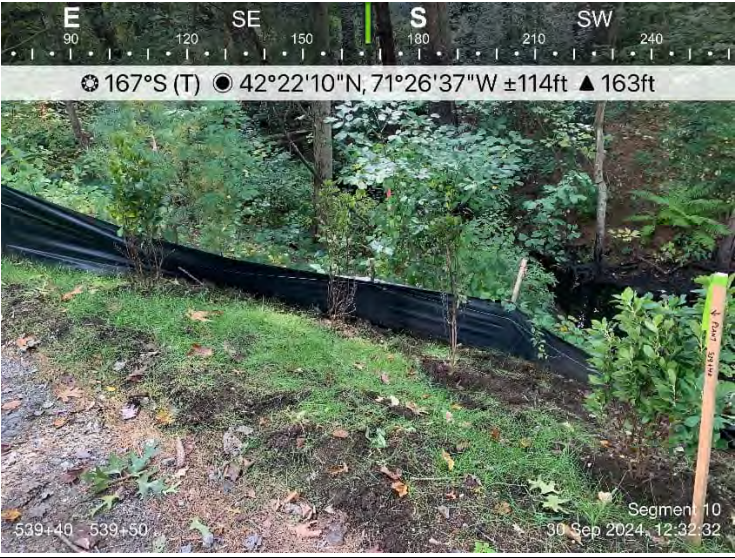
<p>PHOTOGRAPHIC LOG</p>	
<p>Client Name: Eversource</p>		<p>Site Location: Sudbury to Hudson Transmission Reliability Project</p>	<p>Town: Sudbury</p>
<p>Photo No.: 3</p>	<p>Date: 9/30/2024</p>

<p>Description: Bed after planting in Segment 10 approximately between Stations 539+40 – 539+50 on the southern side of the work area.</p>

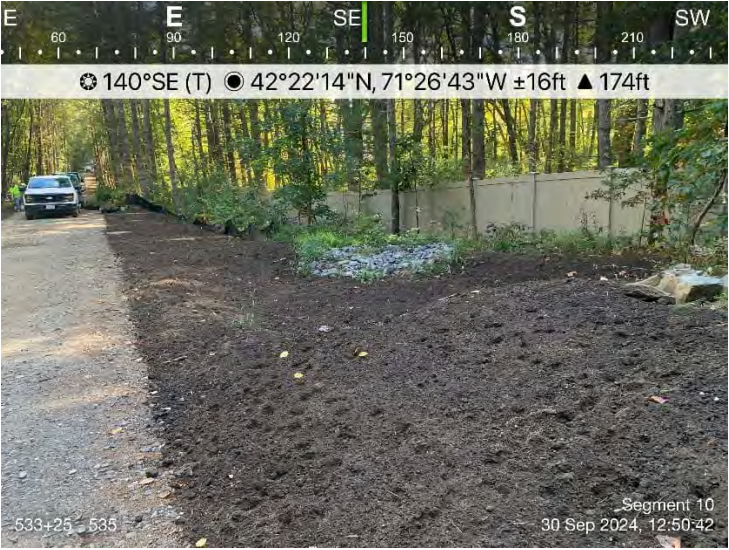
<p>PHOTOGRAPHIC LOG</p>	
<p>Client Name: Eversource</p>		<p>Site Location: Sudbury to Hudson Transmission Reliability Project</p>	<p>Town: Sudbury</p>
<p>Photo No.: 1</p>	<p>Date: 9/30/2024</p>

<p>Description: Bed prior to planting in Segment 10 approximately between Stations 533+25 – 535+00 on the southern side of the work area.</p>

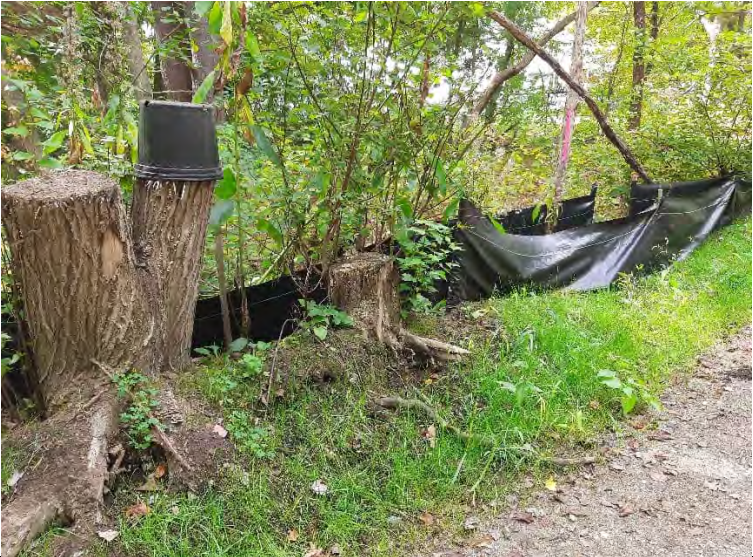
<p>Description: Segment 11, near STA 560+00, north side. Vernal pool downhill of visible silt fence; highbush blueberries (VC) planted along edge of vernal pool. Looking northward.</p>

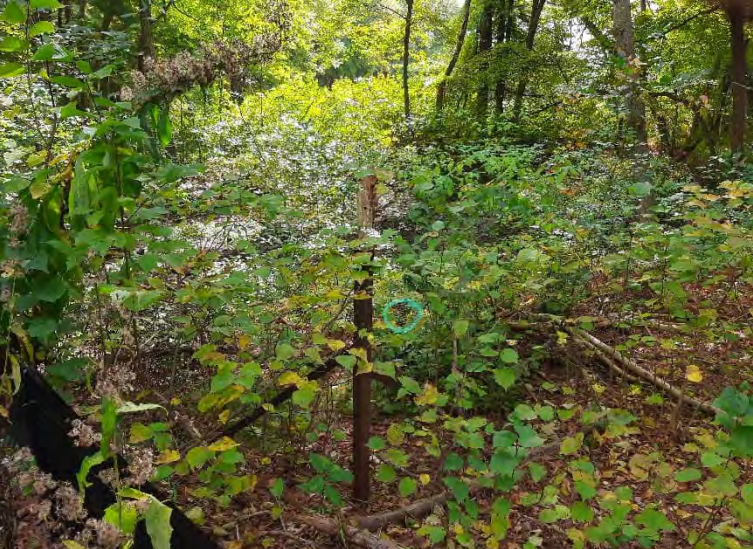
<p>Description: Segment 11, STA 560+00, north side. VC plantings mostly obscured from ROW by pre-existing foliage. Example of just-visible VC circled. Looking northward.</p>

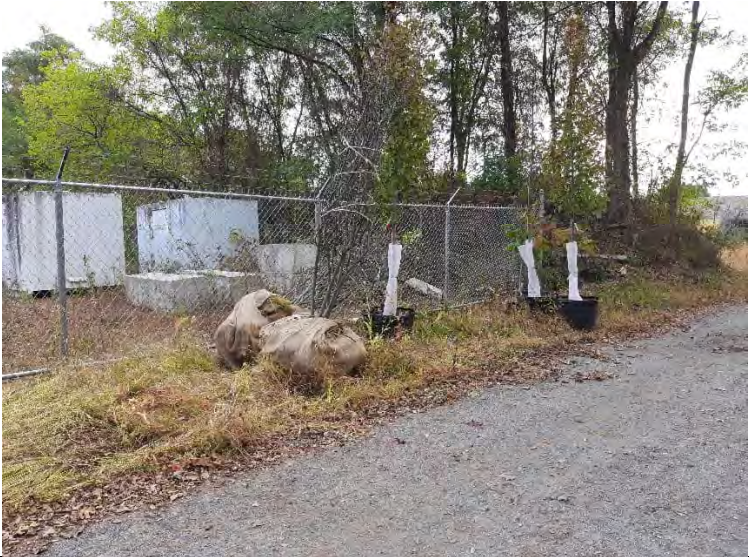
<p>Description: Segment 3, near blasting area, north side. Trees transported for planting at Bridge 130. Difference in size between serviceberry (burlap) and maple/oak root balls (pots) distinctly visible. Looking eastward.</p>

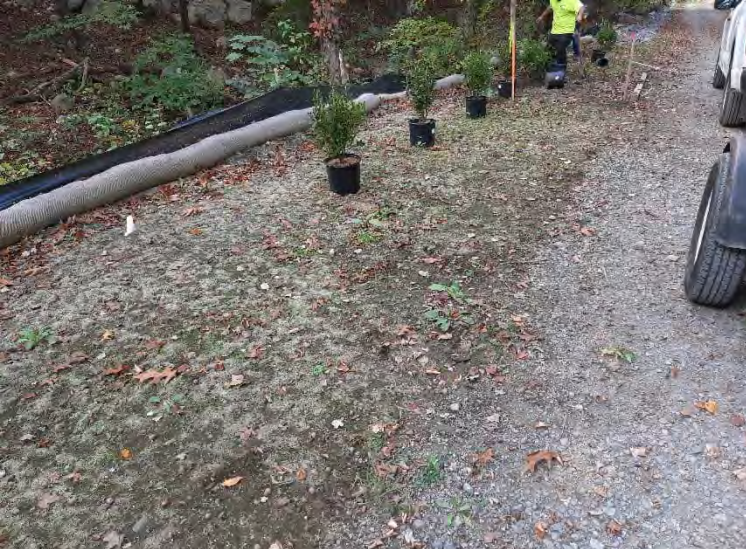
Description: Segment 1, STAs ~129+10 to ~130+10, south side. MON laying out planting installation, including leaving space for absent plants. Looking westward.

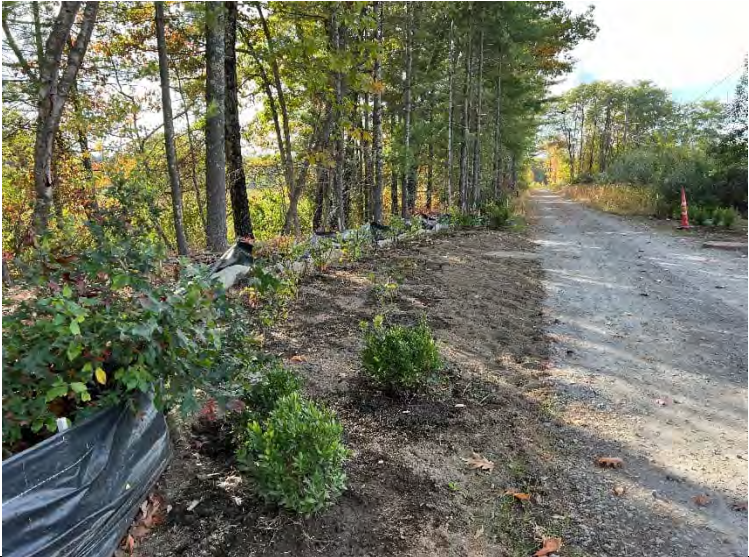
PHOTOGRAPHIC LOG	
Client Name: Eversource		Site Location: Sudbury to Hudson Transmission Reliability Project	Town: Hudson
Photo No.: 3	Date: 10/2/24

Description: View of installed plants. <i>Facing west.</i>

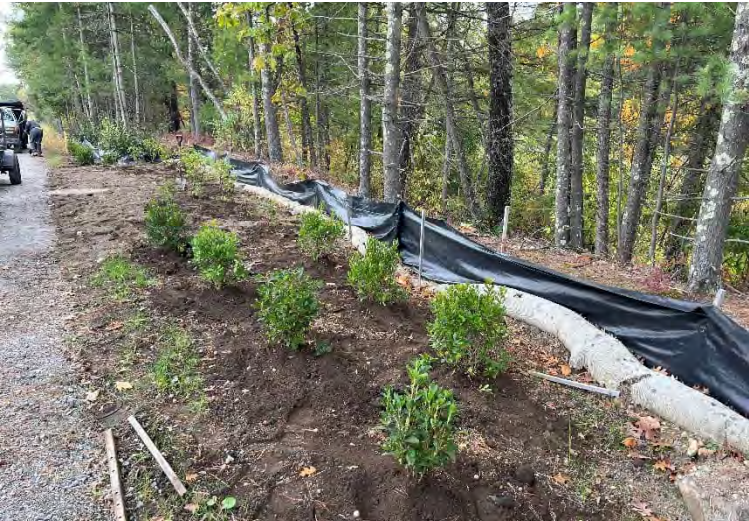
PHOTOGRAPHIC LOG	
Client Name: Eversource		Site Location: Sudbury to Hudson Transmission Reliability Project	Town: Hudson
Photo No.: 4	Date: 10/2/24

Description: Another view of installed plants. <i>Facing east.</i>

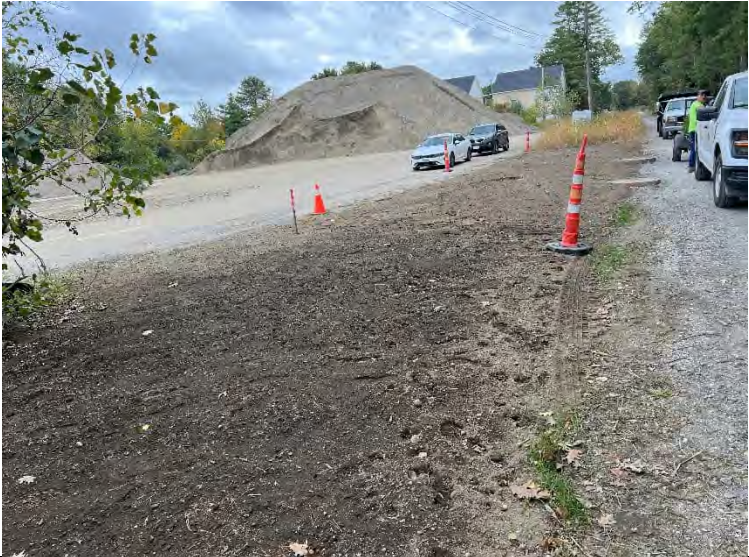
<p>PHOTOGRAPHIC LOG</p>	
<p>Client Name: Eversource</p>		<p>Site Location: Sudbury to Hudson Transmission Reliability Project</p>	<p>Town: Hudson</p>
<p>Photo No.: 1</p>	<p>Date: 10/2/24</p>

<p>Description: View of loamed planting area at manhole #8. Facing northeast.</p>

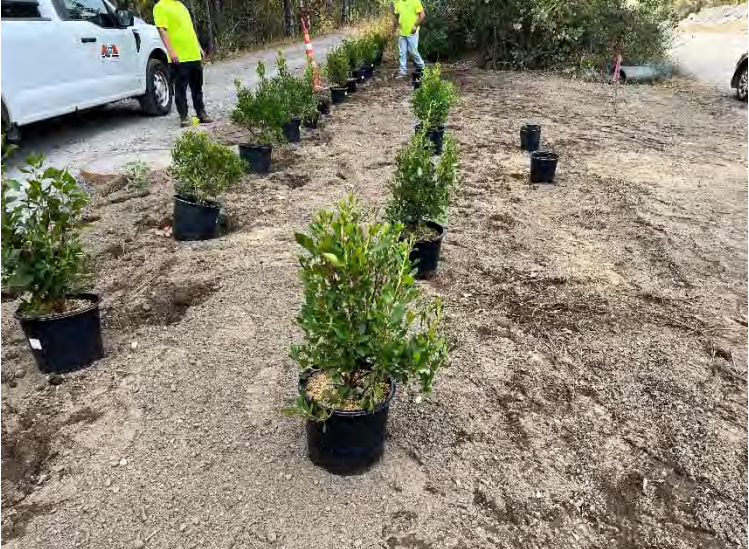
<p>PHOTOGRAPHIC LOG</p>	
<p>Client Name: Eversource</p>		<p>Site Location: Sudbury to Hudson Transmission Reliability Project</p>	<p>Town: Hudson</p>
<p>Photo No.: 2</p>	<p>Date: 10/2/24</p>

<p>Description: View of plants laid out according to plans. Facing west.</p>

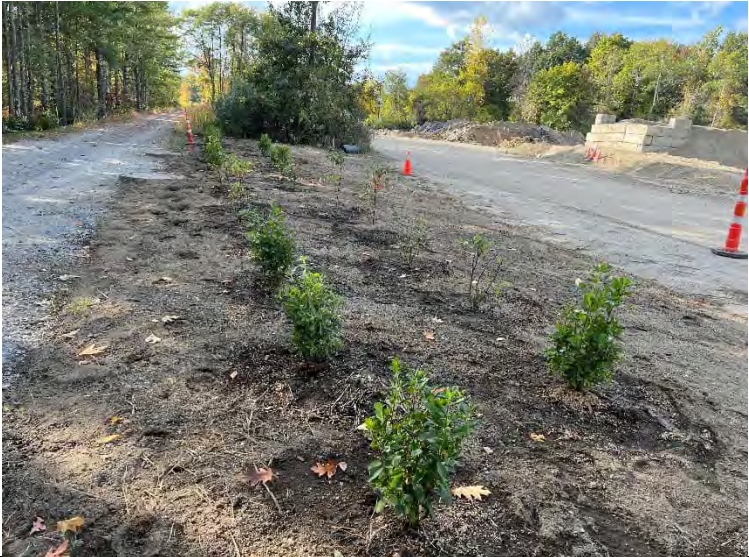
PHOTOGRAPHIC LOG	
Client Name: Eversource		Site Location: Sudbury to Hudson Transmission Reliability Project	Town: Hudson
Photo No.: 3	Date: 10/2/24

Description: View of installed plants. Plants were watered after installation. <i>Facing west.</i>

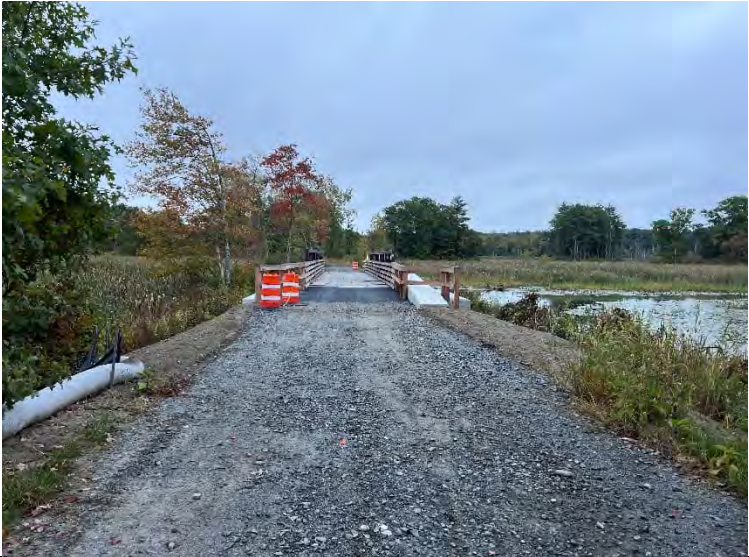
PHOTOGRAPHIC LOG	
Client Name: Eversource		Site Location: Sudbury to Hudson Transmission Reliability Project	Town: Hudson
Photo No.: 1	Date: 10/2/24

Description: View of loamed planting areas along northern and southern sides west of Bridge 130. Facing east.

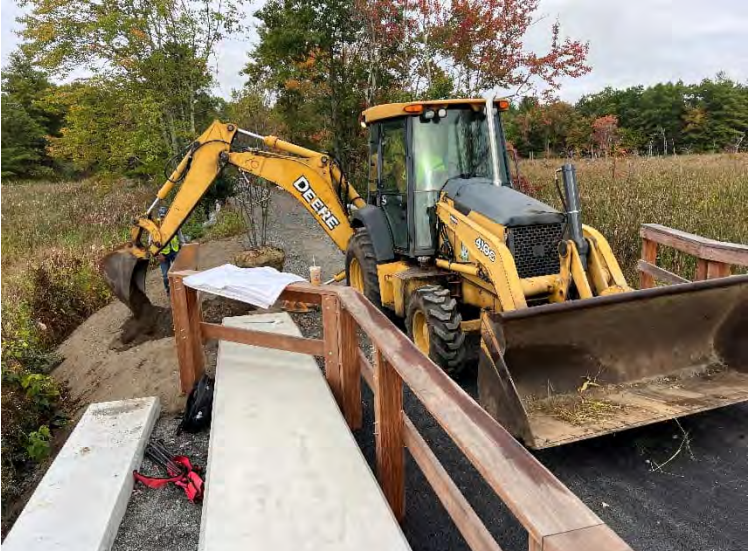
PHOTOGRAPHIC LOG	
Client Name: Eversource		Site Location: Sudbury to Hudson Transmission Reliability Project	Town: Hudson
Photo No.: 2	Date: 10/2/24

Description: View of MON using excavator to install trees by Bridge 130. Facing northeast.

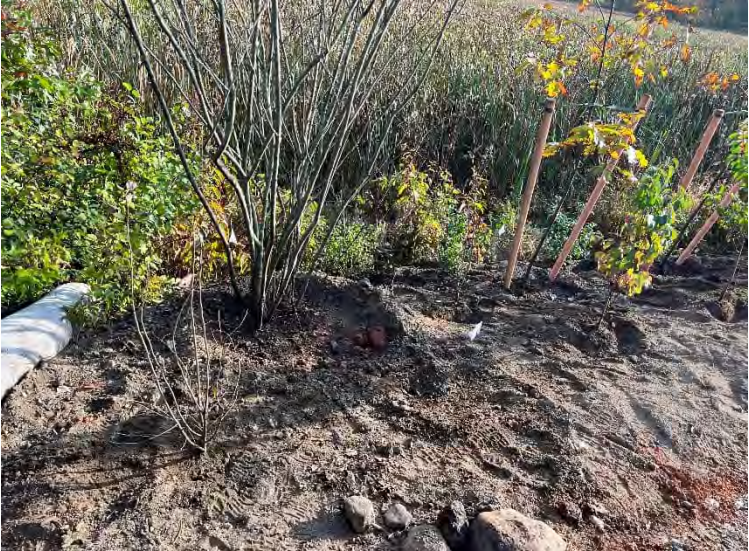
<p>PHOTOGRAPHIC LOG</p>	
<p>Client Name: Eversource</p>		<p>Site Location: Sudbury to Hudson Transmission Reliability Project</p>	<p>Town: Hudson</p>
<p>Photo No.: 2</p>	<p>Date: 10/4/24</p>

- Plant positions shifted within northern planting bed to fit within loamed area.
- Missing 1 SA, 7 IV, & 1 BP to finish northern planting bed.
- 3 VC planted in southern planting bed.

<p>Description: View of installed plants. Plants had to be shifted slightly to fit planting bed. Facing north.</p>

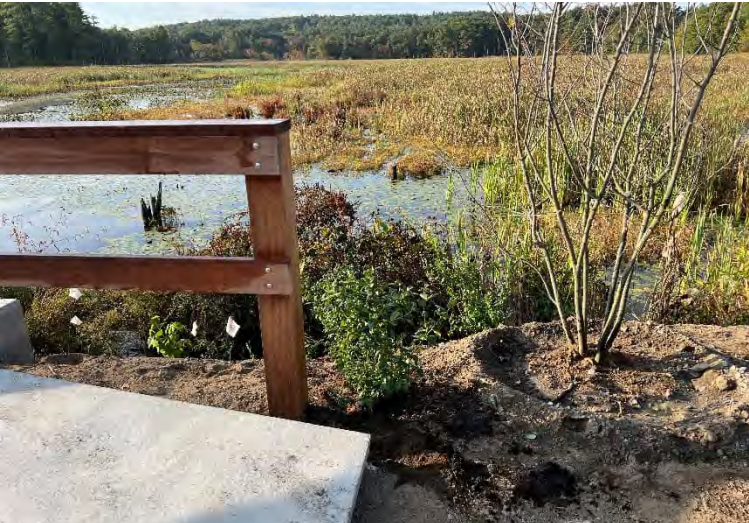
PHOTOGRAPHIC LOG	
Client Name: Eversource		Site Location: Sudbury to Hudson Transmission Reliability Project	Town: Hudson
Photo No.: 4	Date: 10/4/24

Description: View of 3 VC planted within southern planting bed. <i>Facing south.</i>

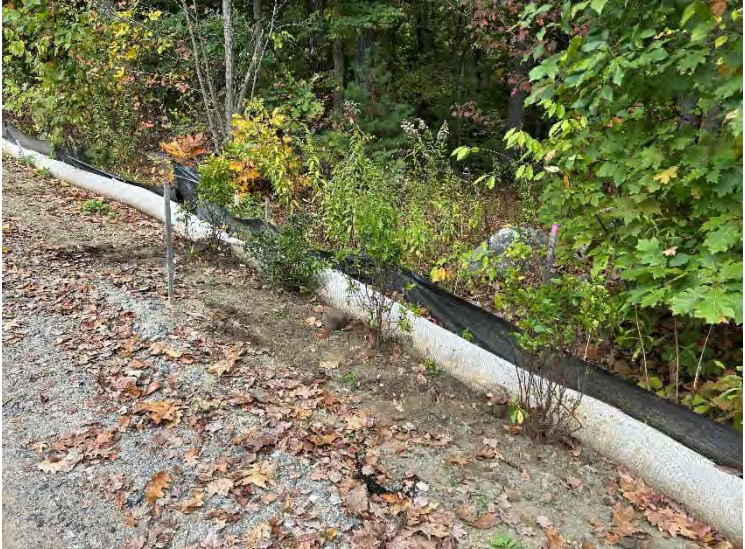
PHOTOGRAPHIC LOG	
Client Name: Eversource		Site Location: Sudbury to Hudson Transmission Reliability Project	Town: Hudson
Photo No.: 2	Date: 10/03/24

Description: View of group of completed plantings in this section. <i>Facing northwest.</i>

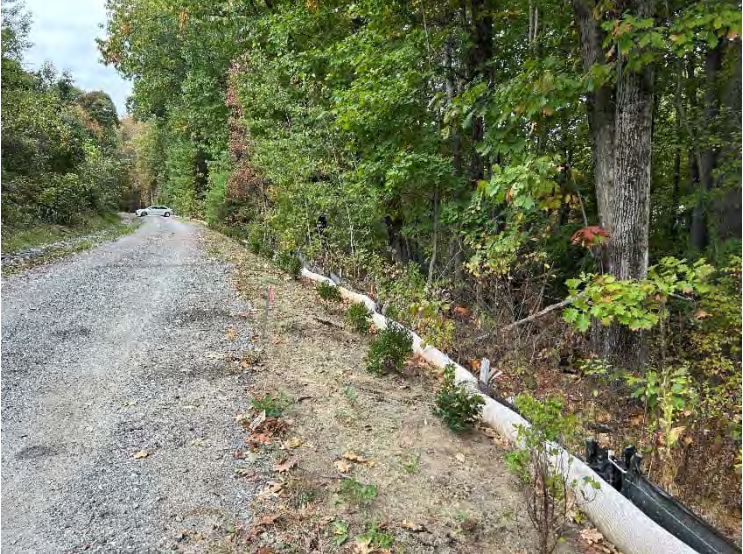
PHOTOGRAPHIC LOG	
Client Name: Eversource		Site Location: Sudbury to Hudson Transmission Reliability Project	Town: Hudson
Photo No.: 3	Date: 10/03/24

Description: View of completed plantings. Facing west.
