Weekly Environmental Compliance Summary

Sudbury to Hudson Transmission Reliability Project (USEPA Tracking # MAR1003UW)

Week of: September 30, 2024 to October 4, 2024

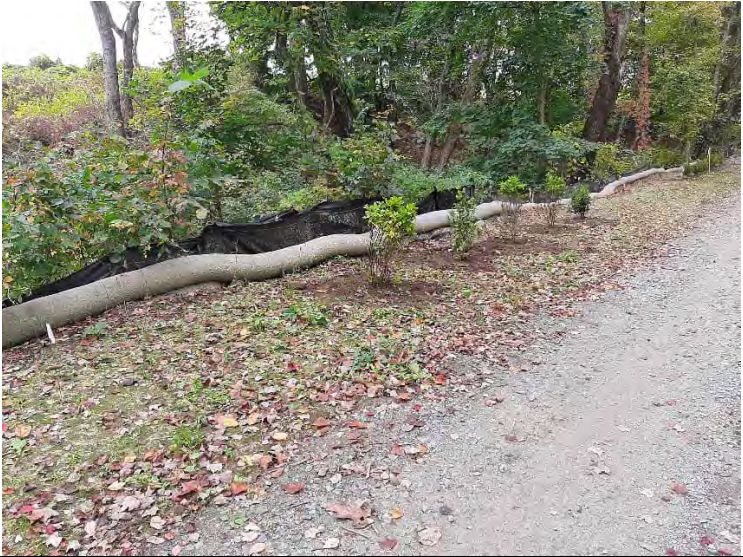
PHOTOGRAPHIC LOG	
Client Name: Eversource		Site Location: Sudbury to Hudson Transmission Reliability Project	Town: Hudson
Photo No.: 1	Date: 10/03/24

Loam shallow in Segment 1. As noted yesterday, bed shifted eastward due to swale extension on west side.

<p>Description:</p> <p>Segment 1, STA ~130+10 to ~130+30, south side. Four (4) pepperbushes (CA) installed (nearest 4), completing non-huckleberry (GB) installations for this bed. Gaps for GBs visible in midground and immediate foreground. Looking westward.</p>

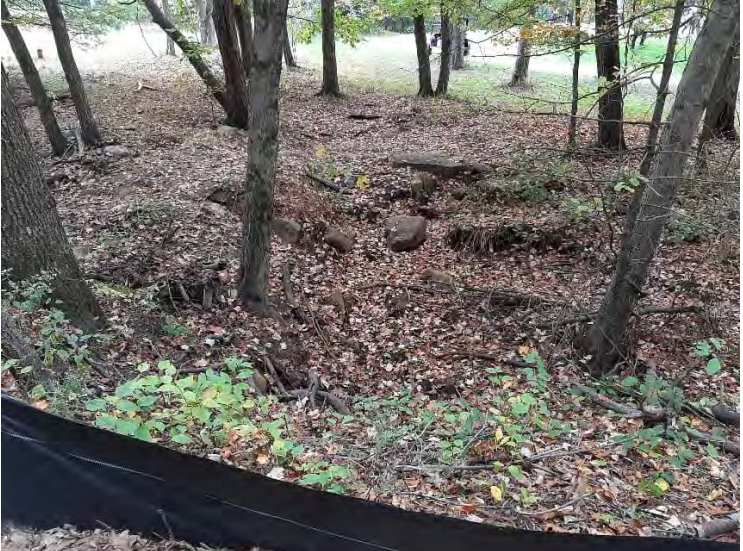
PHOTOGRAPHIC LOG	
Client Name: Eversource		Site Location: Sudbury to Hudson Transmission Reliability Project	Town: Hudson
Photo No.: 2	Date: 10/03/24

<p>Description:</p> <p>Segment 4, STA ~206+00, south side. Culvert outlet and planting area for two (2) CAs. Looking southward.</p>
