Weekly Environmental Compliance Summary

Sudbury to Hudson Transmission Reliability Project (USEPA Tracking # MAR1003UW)

Week of: November 4, 2024 to November 9, 2024

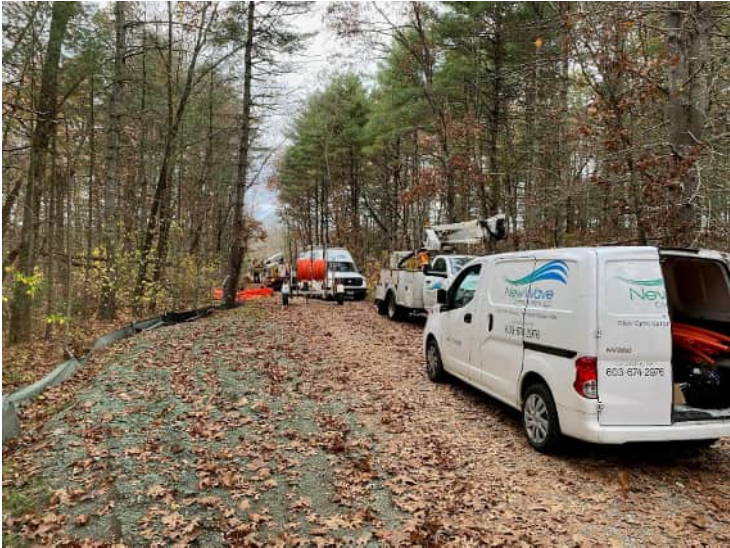
PHOTOGRAPHIC LOG	
Client Name: Eversource		Site Location: Sudbury to Hudson Transmission Reliability Project	
Town: Hudson			
Photo No.: 5	Date: 11/04/2024

Description: View of New Wave working at HH #13 in segment 5. Portions of segment 5 have been hydroseeded. Facing west.

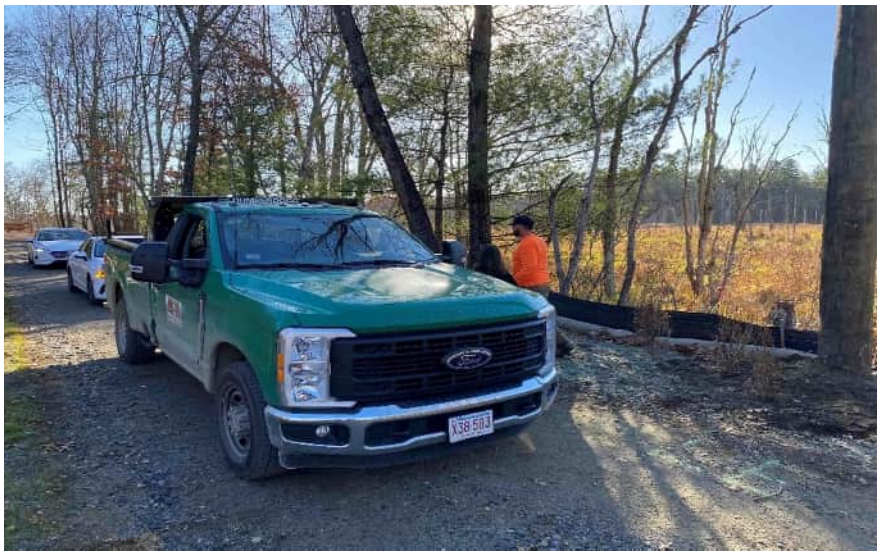
<p align="center">PHOTOGRAPHIC LOG</p>	
<p>Client Name: Eversource</p>		<p>Site Location: Sudbury to Hudson Transmission Reliability Project</p>	<p>Town: Sudbury</p>
<p>Photo No.: 2</p>	<p>Date: 11-6-24</p>

<p>Description:</p> <p>Work area within segment 14, MON re-planting at area of new osprey platform (original plantings moved), existing erosion control, looking eastward.</p>

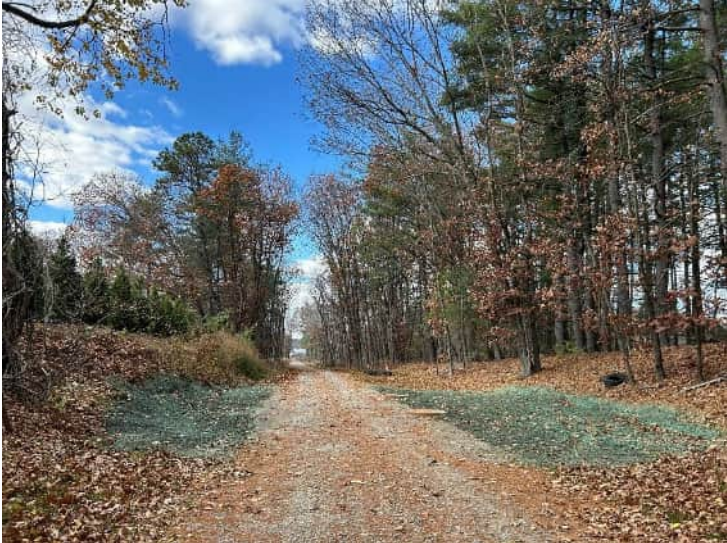
PHOTOGRAPHIC LOG	
Client Name: Eversource		Site Location: Sudbury to Hudson Transmission Reliability Project	Town: Hudson
Photo No.: 6	Date: 11/07/2024

Description: View of hydroseeded area around MH #9 in segment 3. Facing northwest.

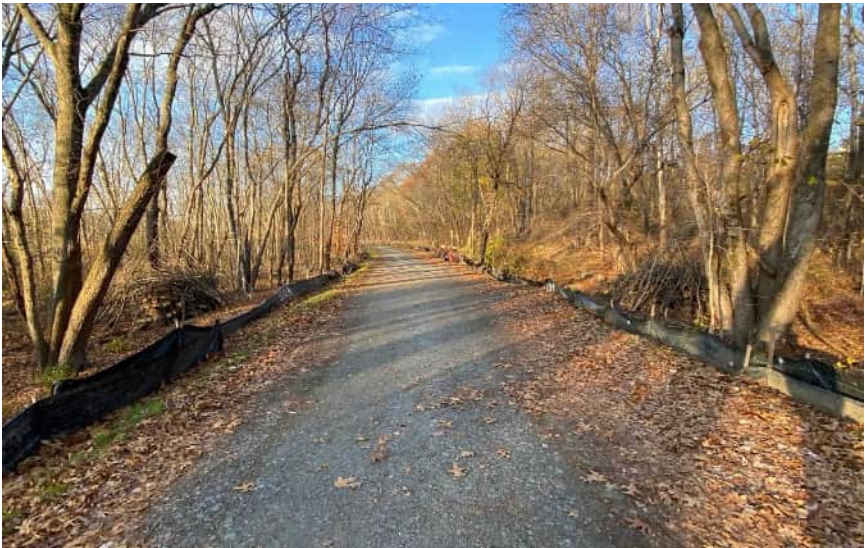
<p align="center">PHOTOGRAPHIC LOG</p>	
<p>Client Name: Eversource</p>		<p>Site Location: Sudbury to Hudson Transmission Reliability Project</p>	<p>Town: Sudbury</p>
<p>Photo No.: 2</p>	<p>Date: 11-7-24</p>

<p>Description:</p> <p>Work area within segment 14, recent brush piles on both sides, existing erosion control, looking westward.</p>

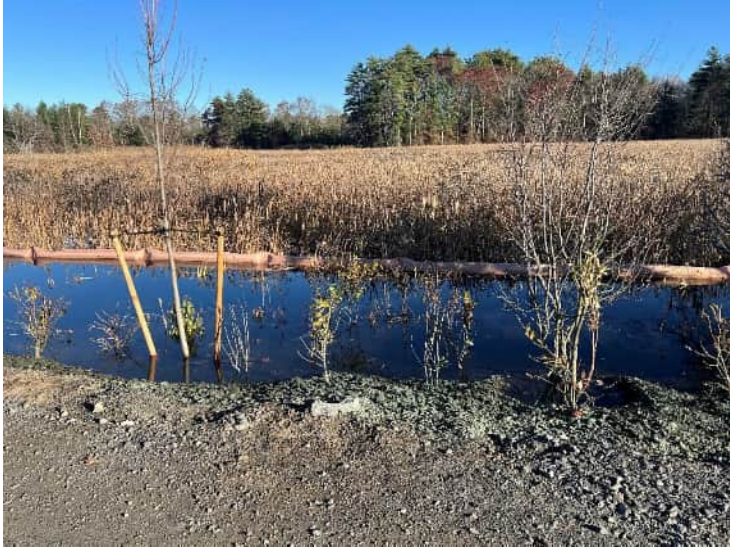
<p>PHOTOGRAPHIC LOG</p>	
<p>Client Name: Eversource</p>		<p>Site Location: Sudbury to Hudson Transmission Reliability Project</p>	<p>Town: Hudson</p>
<p>Photo No.: 5</p>	<p>Date: 11/08/2024</p>

<p>Description: View of turbidity curtain at Bridge 130. Water levels have risen and installed plantings downslope are underwater. Facing north.</p>

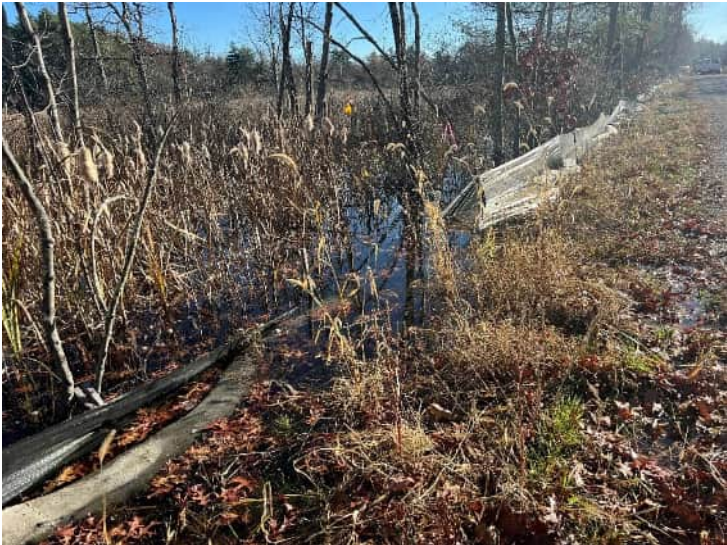
<p>PHOTOGRAPHIC LOG</p>	
<p>Client Name: Eversource</p>		<p>Site Location: Sudbury to Hudson Transmission Reliability Project</p>	<p>Town: Hudson</p>
<p>Photo No.: 6</p>	<p>Date: 11/08/2024</p>

- Fort Meadow Brook water levels at Bridge 130 have risen. Water has seeped through erosion controls in both segment 2 & 3, with water levels greater than height of silt fencing in segment 2 (see photo 6).
- High water levels have caused installed plantings on both sides of Bridge 130 to be under water. Approximately 30 plants were under water, by the end of the day water levels were receding but approximately 13 plants remained under water.

<p>Description: View of E&S controls in segment 2. High water levels were greater than controls height. Facing northeast.</p>

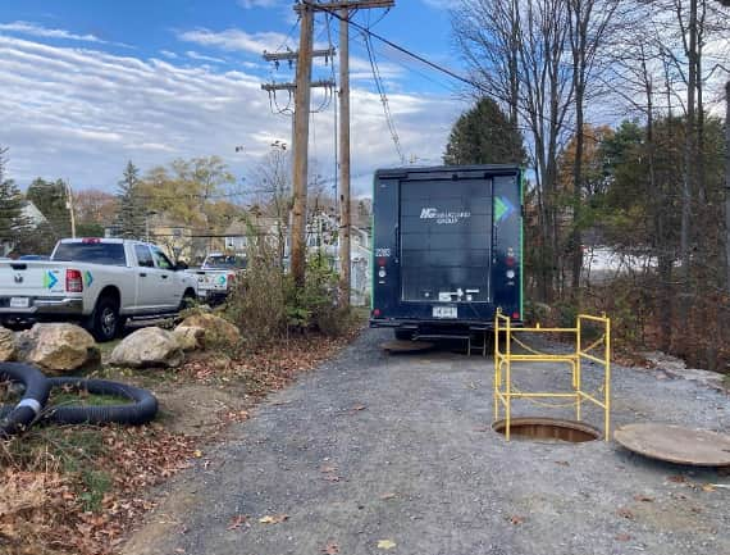
PHOTOGRAPHIC LOG	
Client Name: Eversource		Site Location: Sudbury to Hudson Transmission Reliability Project	Town: Hudson
Photo No.: 1	Date: 11-05-2024

Description: View of Haugland splicing crew at MH #1. Facing north.

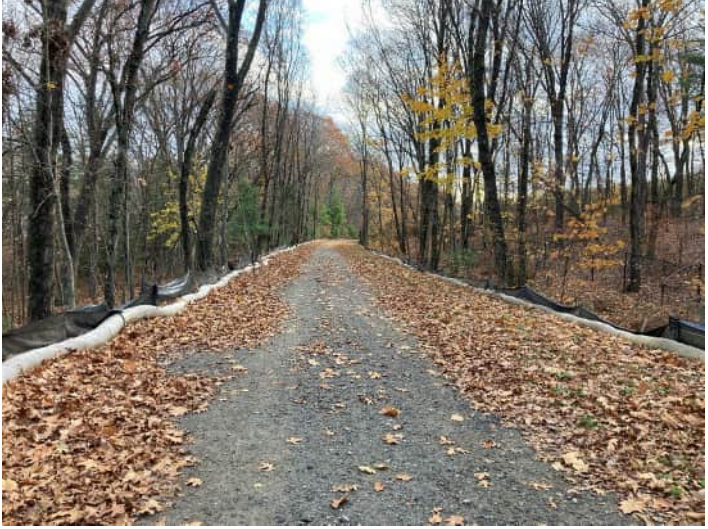
PHOTOGRAPHIC LOG	
Client Name: Eversource		Site Location: Sudbury to Hudson Transmission Reliability Project	Town: Hudson
Photo No.: 2	Date: 11-05-2024

Description: View of E&S controls in segment 1. Facing east.

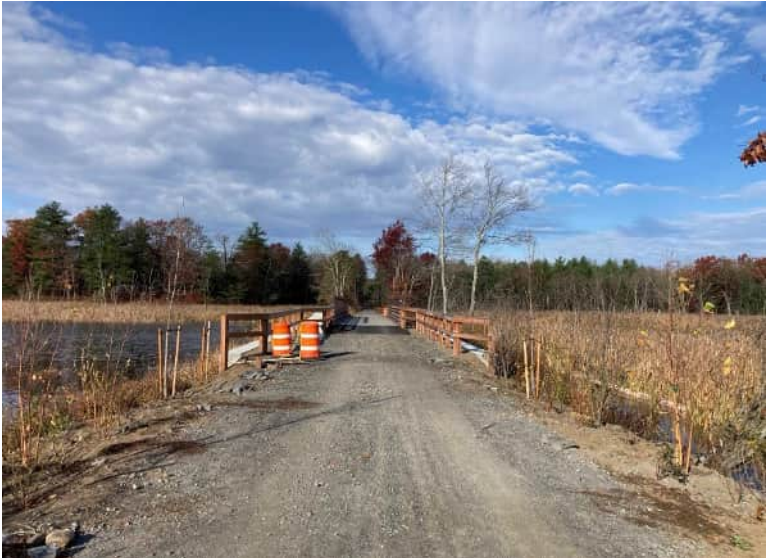
Epsilon ASSOCIATES INC.		PHOTOGRAPHIC LOG	
Client Name: Eversource		Site Location: Sudbury to Hudson Transmission Reliability Project	Town: Hudson
Photo No.: 3	Date: 11-05-2024

Description: View of bridge 130. Facing west.

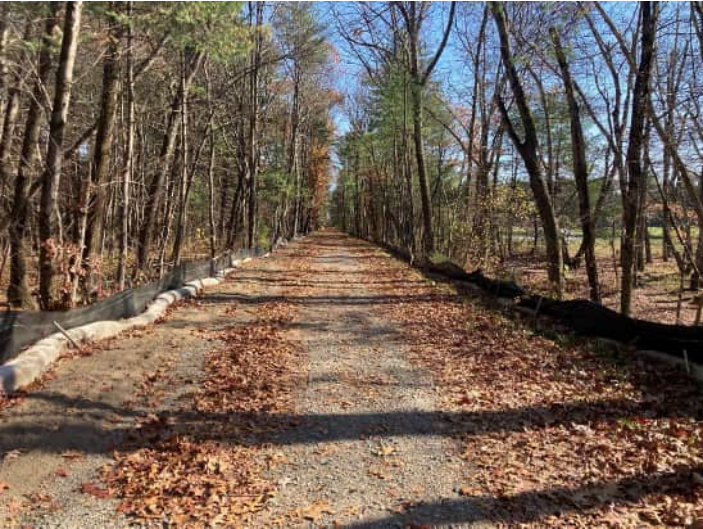
Epsilon ASSOCIATES INC.		PHOTOGRAPHIC LOG	
Client Name: Eversource		Site Location: Sudbury to Hudson Transmission Reliability Project	Town: Hudson
Photo No.: 4	Date: 11-05-2024

Description: View of E&S controls in segment 4. Facing east.

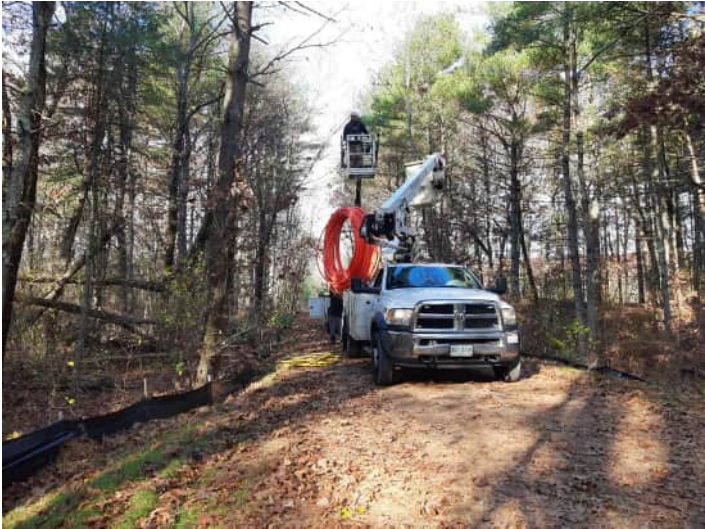
Epsilon ASSOCIATES INC.		PHOTOGRAPHIC LOG	
Client Name: Eversource		Site Location: Sudbury to Hudson Transmission Reliability Project	Town: Hudson
Photo No.: 5	Date: 11-05-2024

Description: View of New Wave working at HH #13 in segment 5. Facing west.

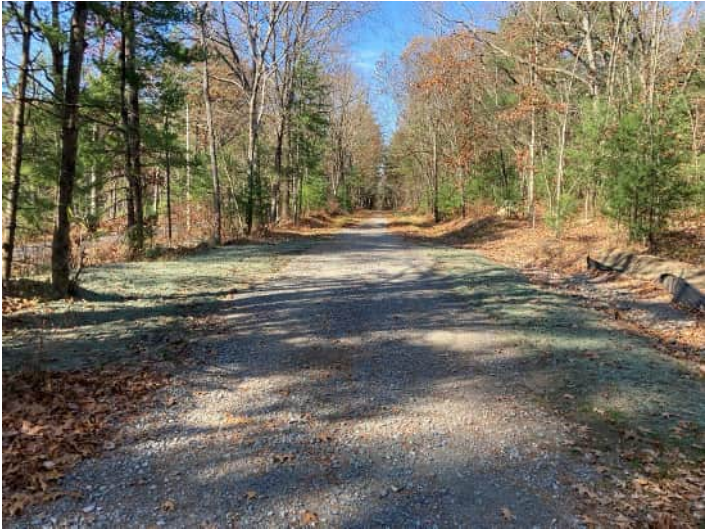
Epsilon ASSOCIATES INC.		PHOTOGRAPHIC LOG	
Client Name: Eversource		Site Location: Sudbury to Hudson Transmission Reliability Project	Town: Hudson
Photo No.: 6	Date: 11-05-2024

Description: View of newly hydroseeded area at MH #12 in segment 5. Facing west.

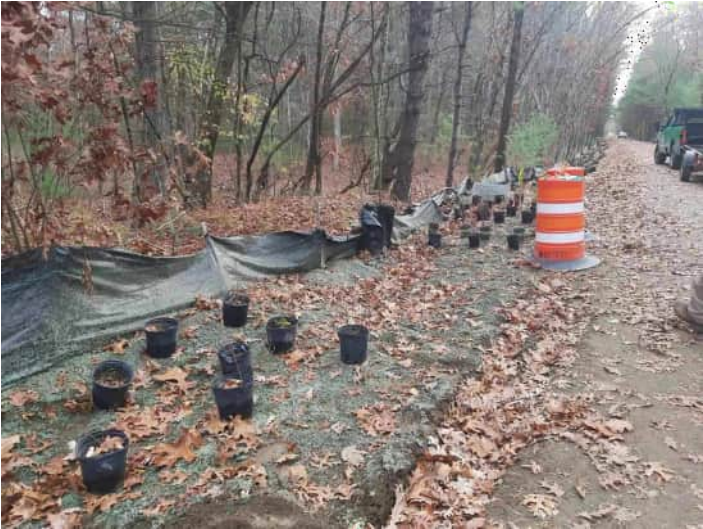
Epsilon ASSOCIATES INC.		PHOTOGRAPHIC LOG	
Client Name: Eversource		Site Location: Sudbury to Hudson Transmission Reliability Project	Town: Hudson
Photo No.: 7	Date: 11-05-2024

Description: View of MON's planting activities in segment 6. Facing east.

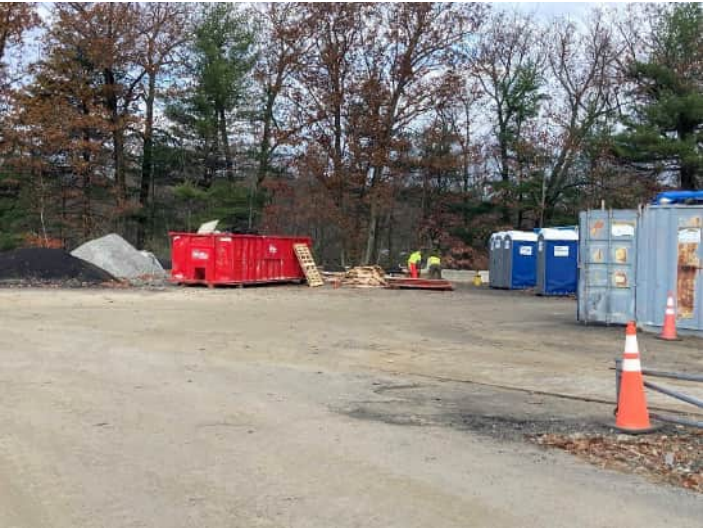
Epsilon ASSOCIATES INC.		PHOTOGRAPHIC LOG	
Client Name: Eversource		Site Location: Sudbury to Hudson Transmission Reliability Project	Town: Hudson
Photo No.: 8	Date: 11-05-2024

Description: View of Bond's clean-up activities at Bonazzoli laydown yard. Facing northwest.

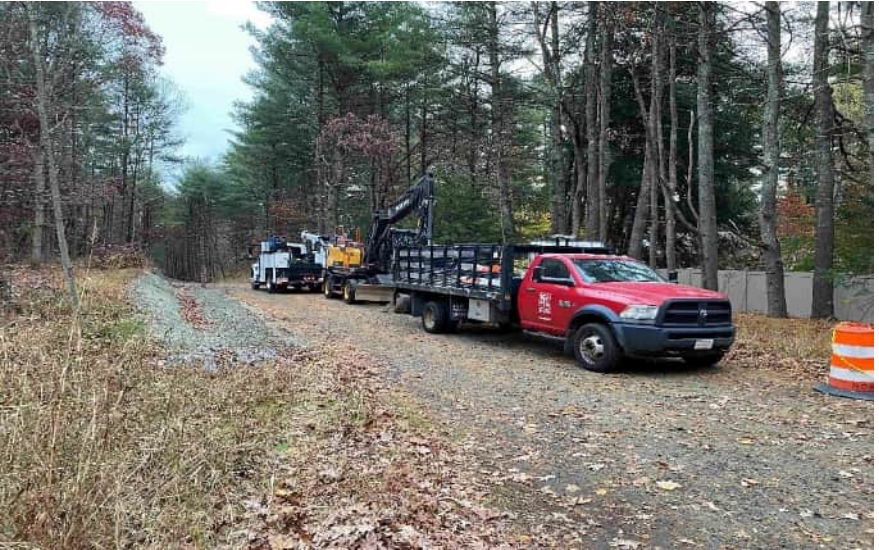
PHOTOGRAPHIC LOG	
Client Name: Eversource		Site Location: Sudbury to Hudson Transmission Reliability Project	Town: Sudbury
Photo No.: 1	Date: 11-5-24

Description: Work area within segment 10, ET&L equipment staged, existing erosion control, looking eastward.

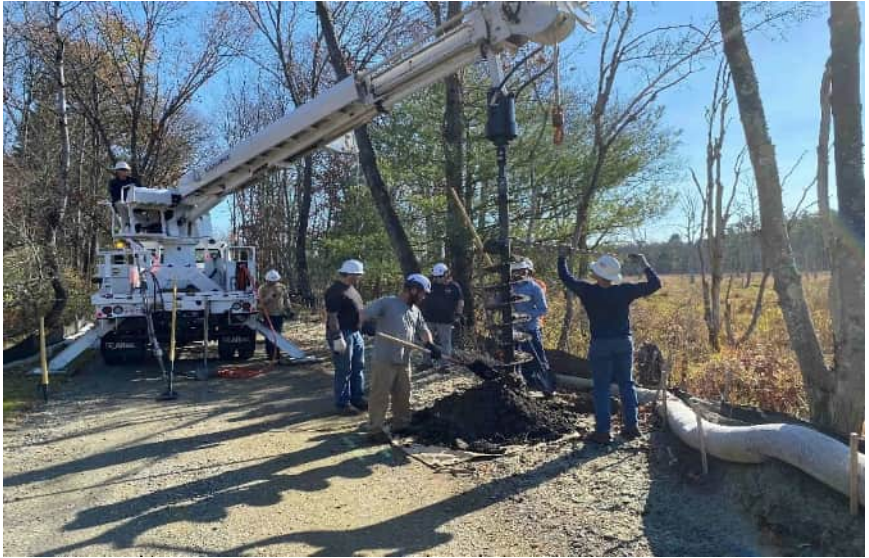
PHOTOGRAPHIC LOG	
Client Name: Eversource		Site Location: Sudbury to Hudson Transmission Reliability Project	Town: Sudbury
Photo No.: 3	Date: 11-5-24

Description: Work area within segment 14, Eversource drilling for osprey platform, existing erosion control, looking eastward.

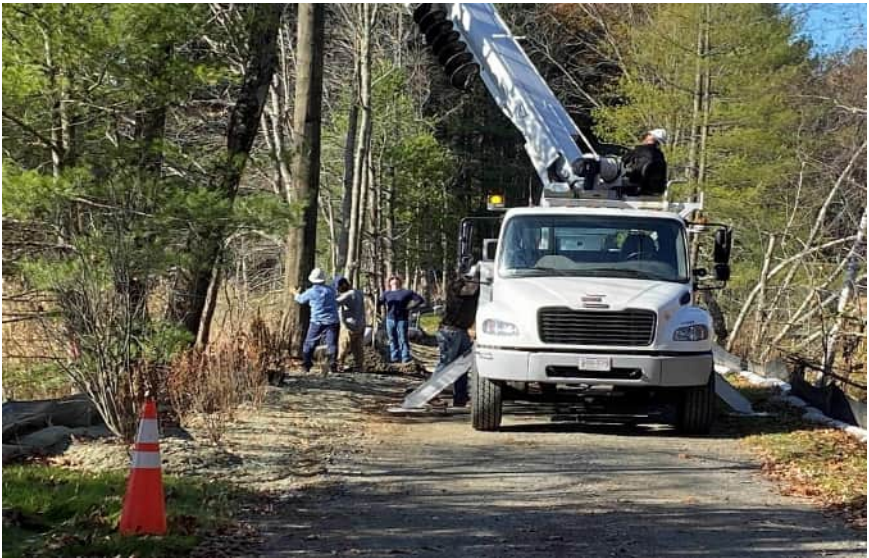
PHOTOGRAPHIC LOG	
Client Name: Eversource		Site Location: Sudbury to Hudson Transmission Reliability Project	Town: Sudbury
Photo No.: 4	Date: 11-5-24

Description: Work area within segment 14, Eversource setting pole for osprey platform, existing erosion control, looking westward.

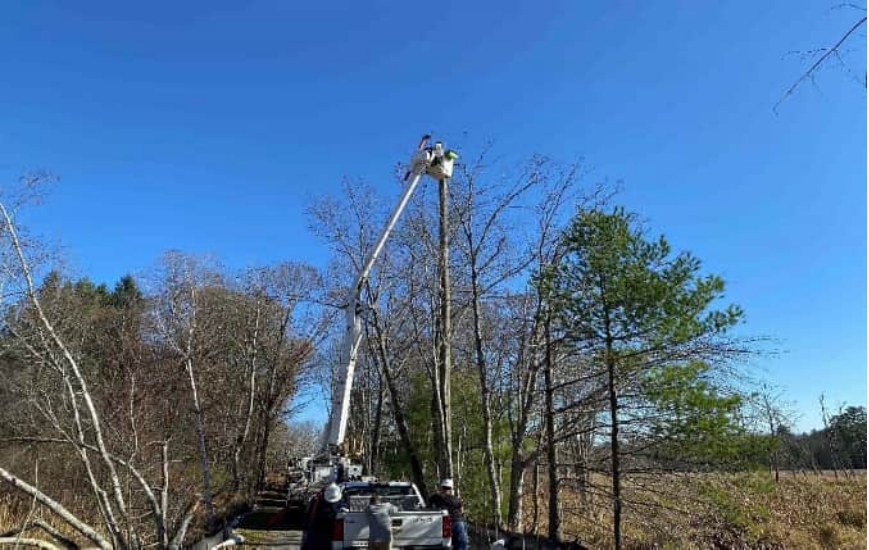
PHOTOGRAPHIC LOG	
Client Name: Eversource		Site Location: Sudbury to Hudson Transmission Reliability Project	Town: Sudbury
Photo No.: 5	Date: 11-5-24

Description: Work area within segment 14, Eversource adding platform for osprey platform, existing erosion control, looking eastward.

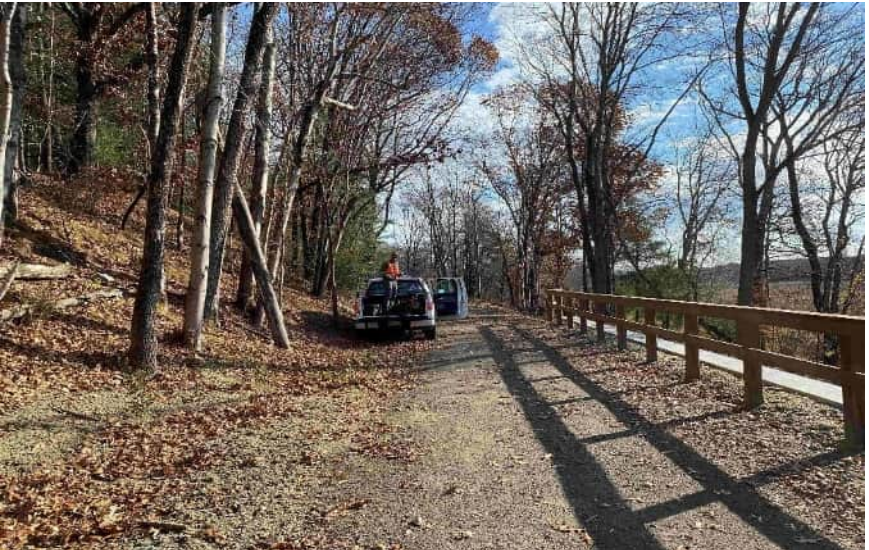
PHOTOGRAPHIC LOG	
Client Name: Eversource		Site Location: Sudbury to Hudson Transmission Reliability Project	Town: Sudbury
Photo No.: 6	Date: 11-5-24

Description: Work area within segment 14, SWCA removing invasive species, looking eastward.

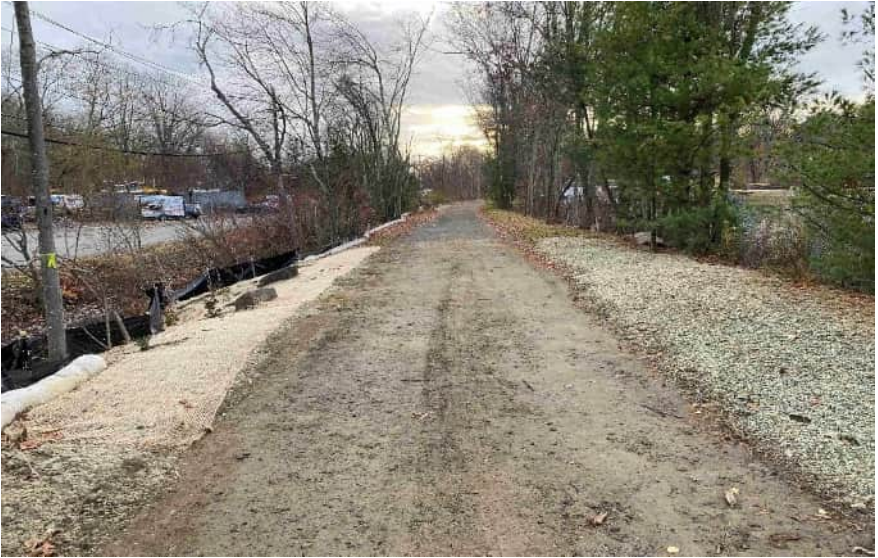
PHOTOGRAPHIC LOG	
Client Name: Eversource		Site Location: Sudbury to Hudson Transmission Reliability Project	Town: Sudbury
Photo No.: 7	Date: 11-5-24

Description: Work area within segment 12, recently hydroseeded, jute netting added & supplemental plantings completed area at culvert extension area, existing erosion control, looking eastward.

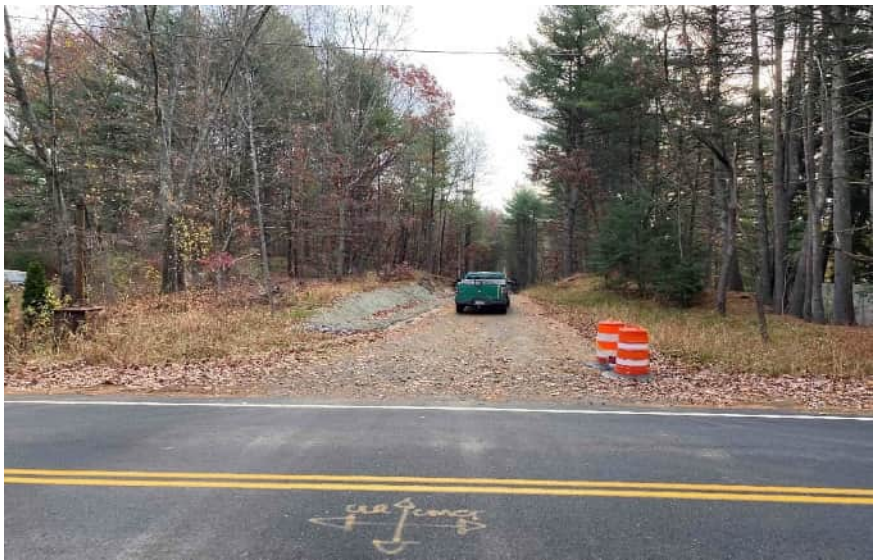
PHOTOGRAPHIC LOG	
Client Name: Eversource		Site Location: Sudbury to Hudson Transmission Reliability Project	Town: Sudbury
Photo No.: 8	Date: 11-5-24

Description: Work area within segment 10 MON planting, looking eastward.

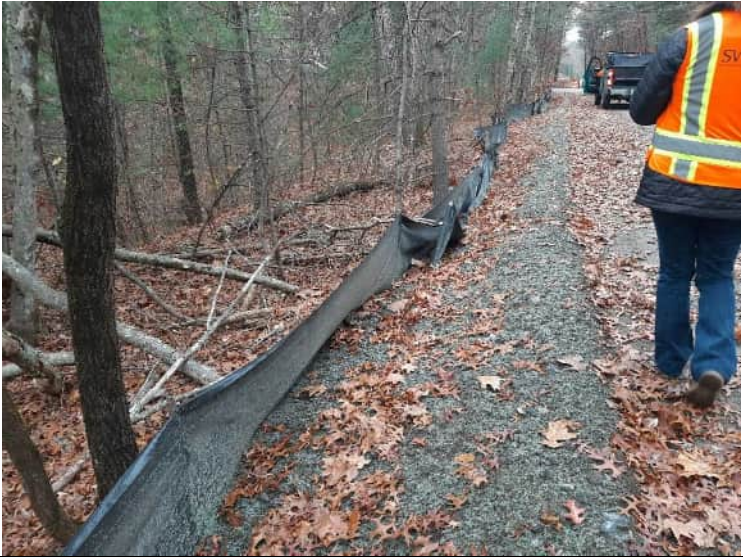
<p>PHOTOGRAPHIC LOG</p>	
<p>Client Name: Eversource</p>		<p>Site Location: Sudbury to Hudson Transmission Reliability Project</p>	<p>Town: Hudson</p>
<p>Photo No.: 1</p>	<p>Date: 11/04/24</p>

<p>Description: Segment 6, south side, near White Pond Road, ~STA 339 + 75. Bed prior to planting, White Pond Road and Segment 5 visible in upper right-hand corner. Looking westward.</p>

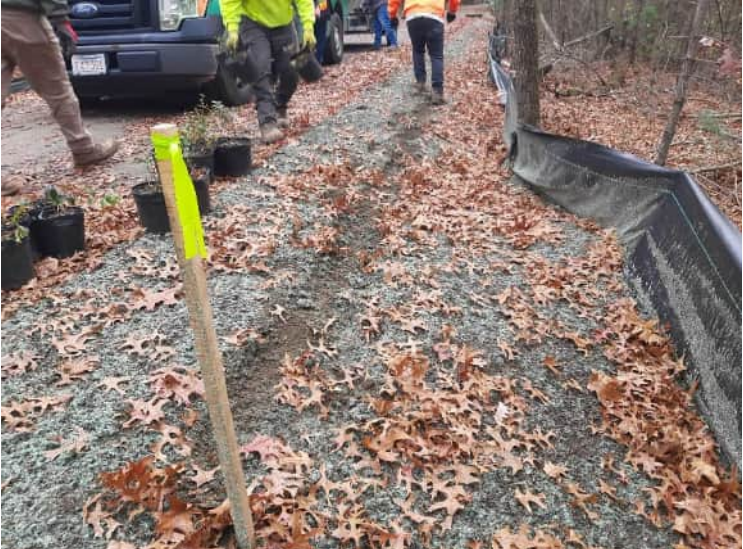
<p>PHOTOGRAPHIC LOG</p>	
<p>Client Name: Eversource</p>		<p>Site Location: Sudbury to Hudson Transmission Reliability Project</p>	<p>Town: Hudson</p>
<p>Photo No.: 2</p>	<p>Date: 11/04/24</p>

<p>Description: Segment 6, south side, near White Pond Road, ~STA 338 + 25. Bed prior to plant installation, MON marking out 3' from ROW and staging plantings. Looking eastward.</p>

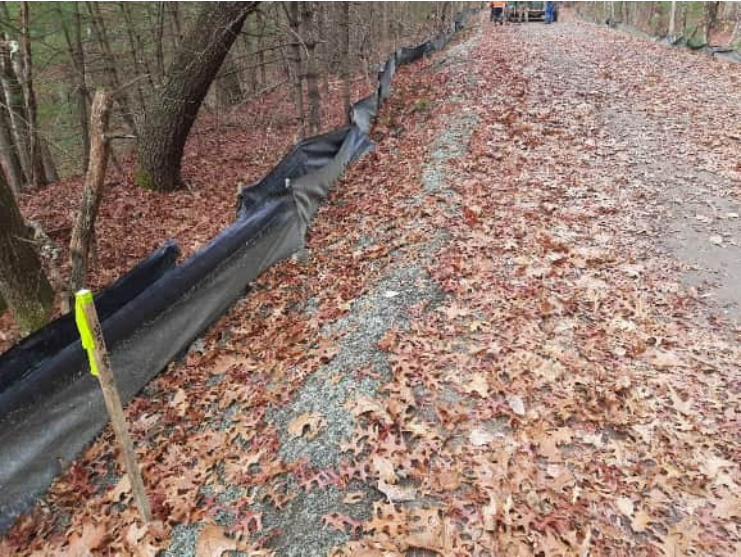
PHOTOGRAPHIC LOG	
Client Name: Eversource		Site Location: Sudbury to Hudson Transmission Reliability Project	Town: Hudson
Photo No.: 3	Date: 11/04/24

<p>Description:</p> <p>Segment 6, south side, near STA 339 + 75. Installed plantings (midground and background) and gap for remaining 22 sedges (CS) (foreground) to be installed after additional CS delivered. Looking westward.</p>

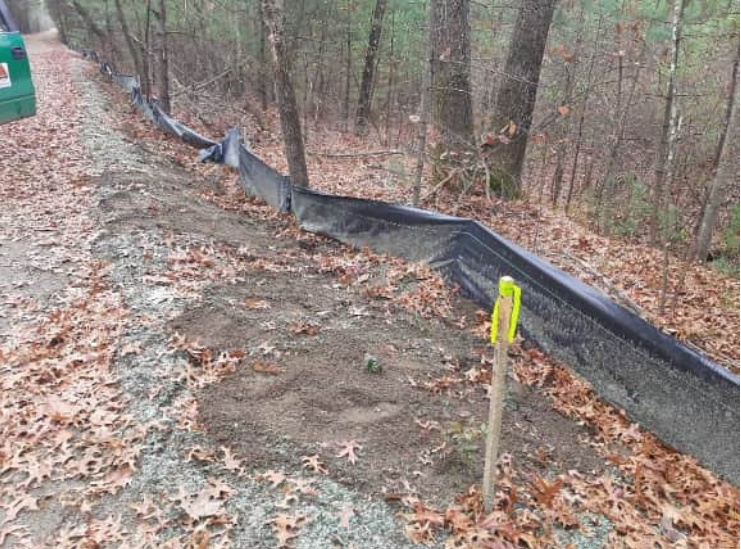
PHOTOGRAPHIC LOG	
Client Name: Eversource		Site Location: Sudbury to Hudson Transmission Reliability Project	Town: Hudson
Photo No.: 4	Date: 11/04/24

<p>Description:</p> <p>Segment 6, south side, -STA 338 + 25. Installed plantings, plantings nearest to White Pond Road on south side of ROW. Looking eastward.</p>

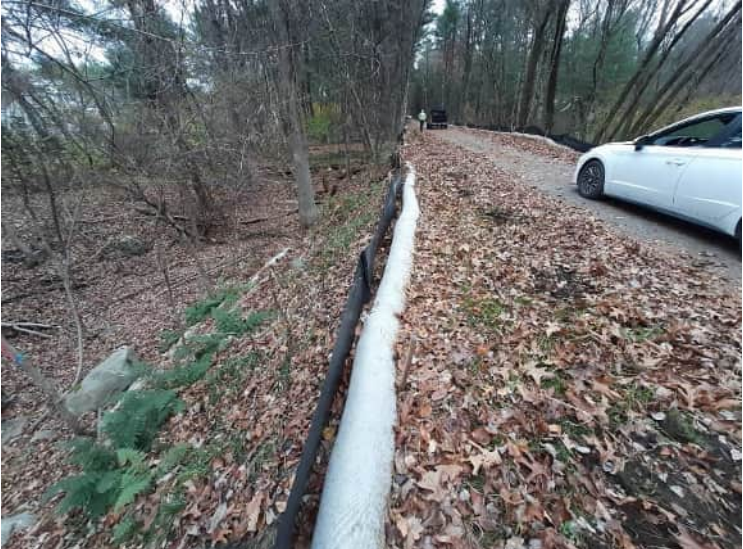
<p>PHOTOGRAPHIC LOG</p>	
<p>Client Name: Eversource</p>		<p>Site Location: Sudbury to Hudson Transmission Reliability Project</p>	<p>Town: Sudbury</p>
<p>Photo No.: 4</p>	<p>Date: 11/04/24</p>

<p>Description: Segment 9, north side, ~STA 518 + 50 to 519 + 50. Area of installed plantings along the slope downhill of the silt fence, and within the bounds of the silt fence. Looking eastward.</p>

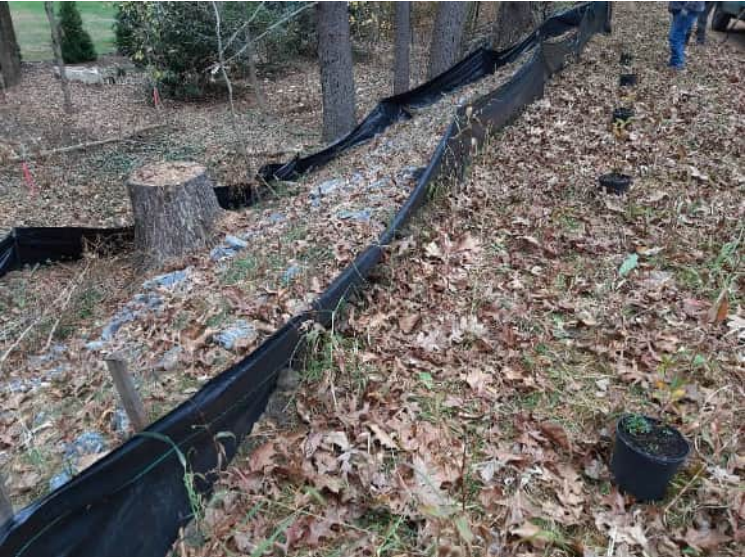
<p>PHOTOGRAPHIC LOG</p>	
<p>Client Name: Eversource</p>		<p>Site Location: Sudbury to Hudson Transmission Reliability Project</p>	<p>Town: Sudbury</p>
<p>Photo No.: 1</p>	<p>Date: 11/04/24</p>

<p>Description: Segment 9, north side, ~STA 521 + 50 to ~522 + 50. Supplemental planting area prior to planting, MON laying out plantings. Looking eastward.</p>

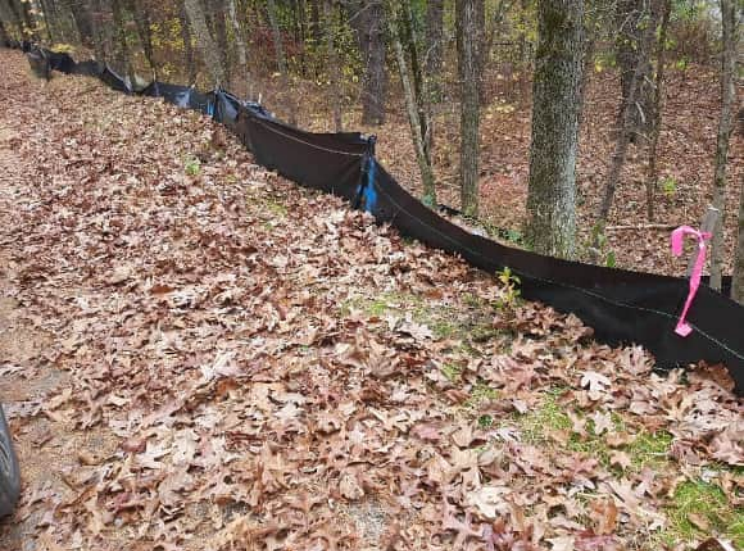
<p>PHOTOGRAPHIC LOG</p>	
<p>Client Name: Eversource</p>		<p>Site Location: Sudbury to Hudson Transmission Reliability Project</p>	<p>Town: Sudbury</p>
<p>Photo No.: 4</p>	<p>Date: 11/04/24</p>

<p>Description:</p> <p>Segment 9, north side, ~STA 521 + 50 to ~522 + 50. Area of installed plantings. Planting location based on provided station numbers and loamed or otherwise plantable area (i.e., not on riprap). Looking eastward.</p>

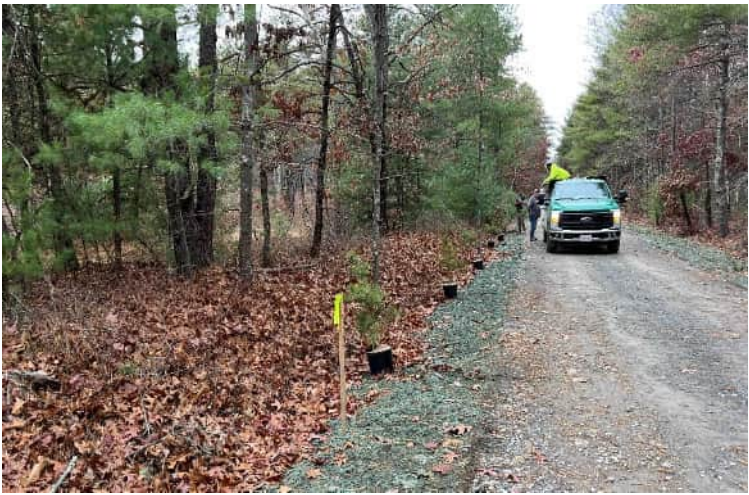
<p>PHOTOGRAPHIC LOG</p>	
<p>Client Name: Eversource</p>		<p>Site Location: Sudbury to Hudson Transmission Reliability Project</p>	<p>Town: Sudbury</p>
<p>Photo No.: 2</p>	<p>Date: 11/4/24</p>

<p>Description: View of Pitch pines laid out according to plans. Facing west.</p>

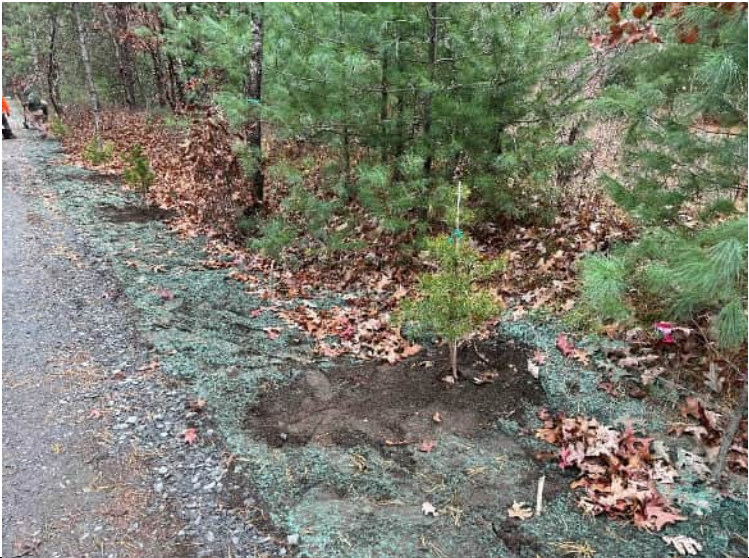
PHOTOGRAPHIC LOG	
Client Name: Eversource		Site Location: Sudbury to Hudson Transmission Reliability Project	Town: Sudbury
Photo No.: 3	Date: 11/4/24

Description: View of installed plants. Facing east.

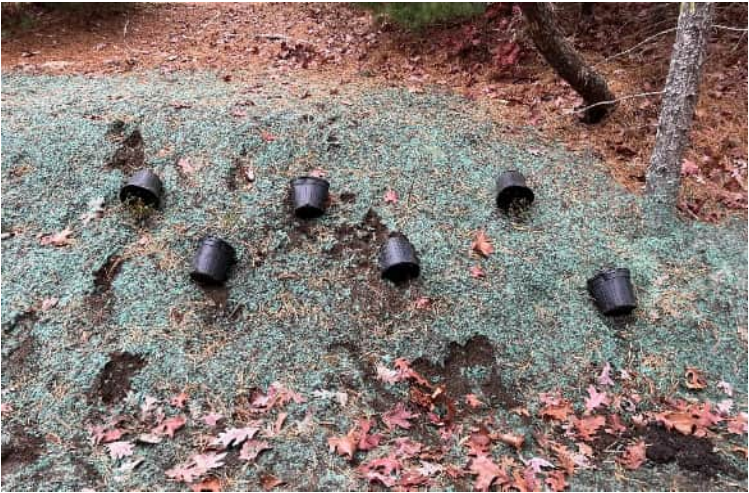
PHOTOGRAPHIC LOG	
Client Name: Eversource		Site Location: Sudbury to Hudson Transmission Reliability Project	Town: Sudbury
Photo No.: 2	Date: 11/4/24

Description: View of plants laid out prior to installation. Plants installed east of rock check dam as shown on plans. Facing south.

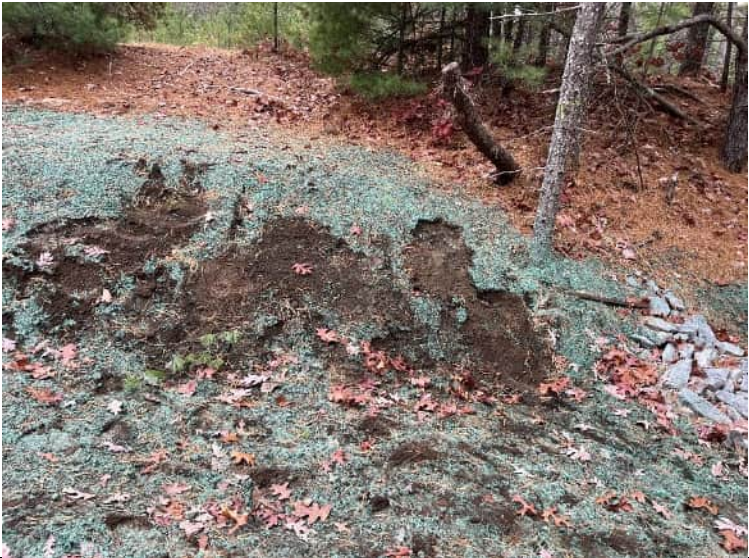
PHOTOGRAPHIC LOG	
Client Name: Eversource		Site Location: Sudbury to Hudson Transmission Reliability Project	Town: Sudbury
Photo No.: 3	Date: 11/4/24

Description: View of installed plants. Facing south.

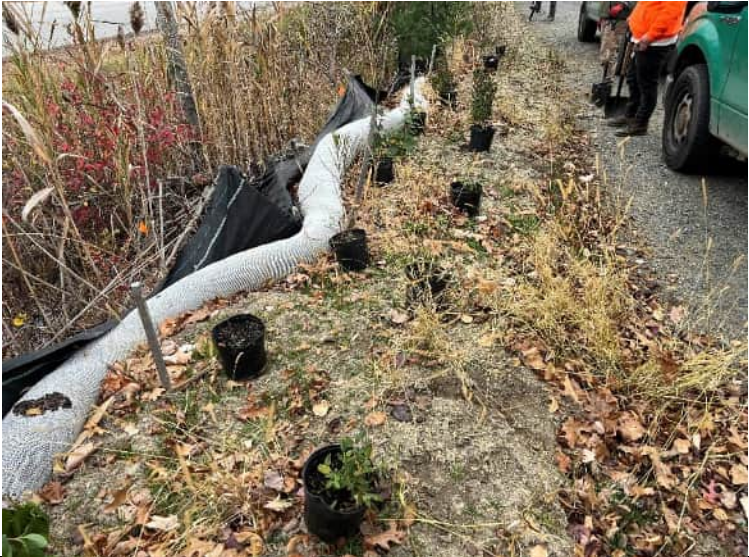
PHOTOGRAPHIC LOG	
Client Name: Eversource		Site Location: Sudbury to Hudson Transmission Reliability Project	Town: Sudbury
Photo No.: 1	Date: 11/4/24

Description: View of plants laid out prior to installation at entrance to segment 12. <i>Facing east.</i>

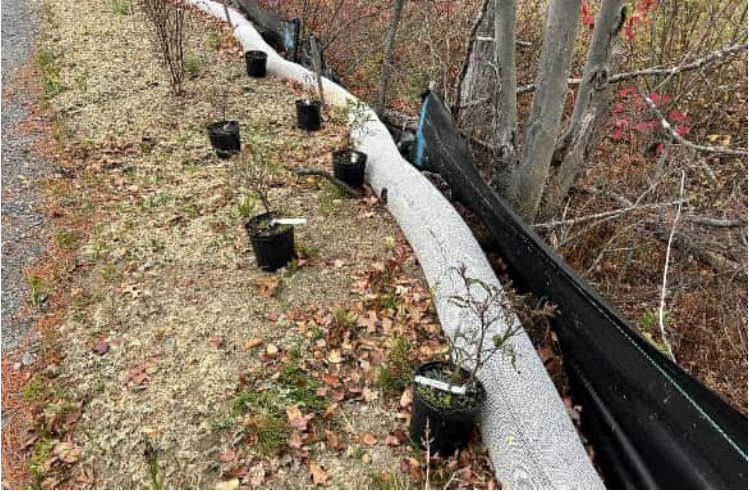
PHOTOGRAPHIC LOG	
Client Name: Eversource		Site Location: Sudbury to Hudson Transmission Reliability Project	Town: Sudbury
Photo No.: 2	Date: 11/4/24

Description: View of sweet ferns laid out prior to installation. <i>Facing west.</i>

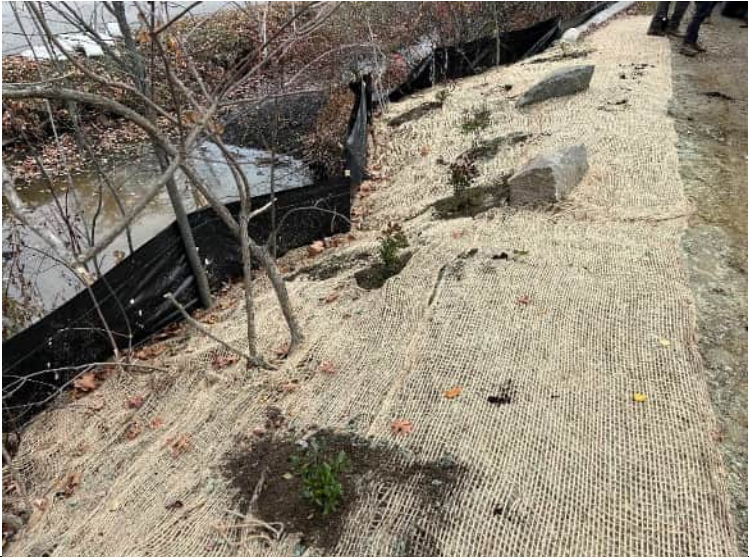
<p>PHOTOGRAPHIC LOG</p>	
<p>Client Name: Eversource</p>		<p>Site Location: Sudbury to Hudson Transmission Reliability Project</p>	<p>Town: Sudbury</p>
<p>Photo No.: 3</p>	<p>Date: 11/4/24</p>

<p>Description: View of installed plants at culvert extension, jute netting installed prior to plantings. Facing east.</p>

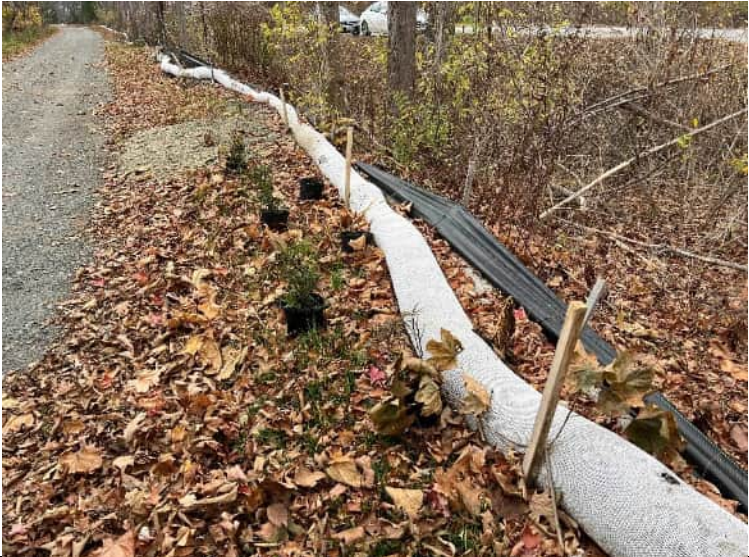
<p>PHOTOGRAPHIC LOG</p>	
<p>Client Name: Eversource</p>		<p>Site Location: Sudbury to Hudson Transmission Reliability Project</p>	<p>Town: Sudbury</p>
<p>Photo No.: 5</p>	<p>Date: 11/4/24</p>

<p>Description: View of laid out plants along northern side of work area at Sta#711+00. Facing west.</p>

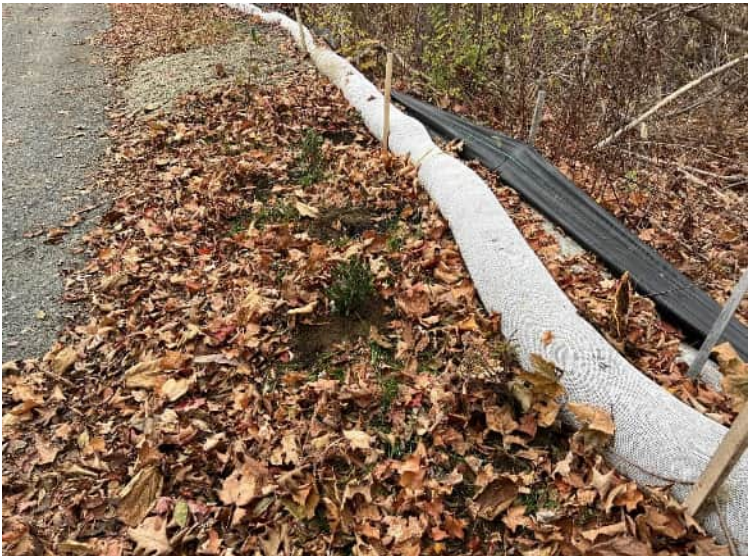
<p>PHOTOGRAPHIC LOG</p>	
<p>Client Name: Eversource</p>		<p>Site Location: Sudbury to Hudson Transmission Reliability Project</p>	<p>Town: Sudbury</p>
<p>Photo No.: 6</p>	<p>Date: 11/4/24</p>

<p>Description: View of installed plants along northern side of the work area at Sta#711+00. Facing west.</p>

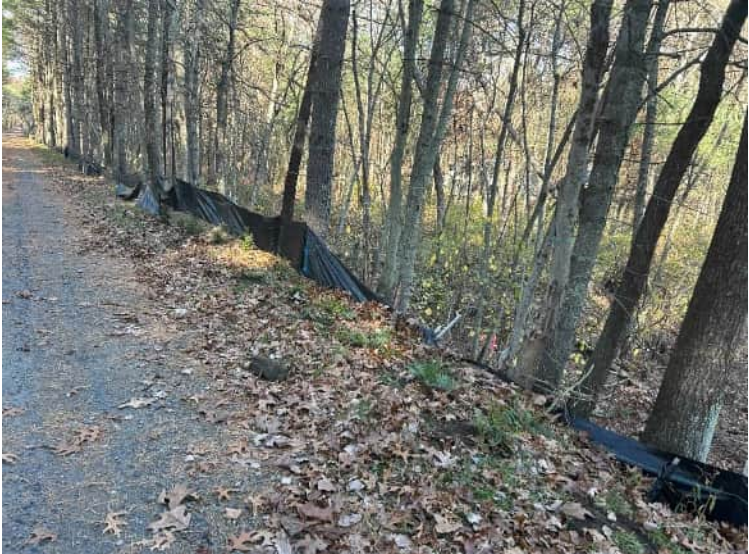
PHOTOGRAPHIC LOG	
Client Name: Eversource		Site Location: Sudbury to Hudson Transmission Reliability Project	Town: Sudbury
Photo No.: 4	Date: 11/05/24

Description: View of completed plantings. <i>Facing northwest.</i>

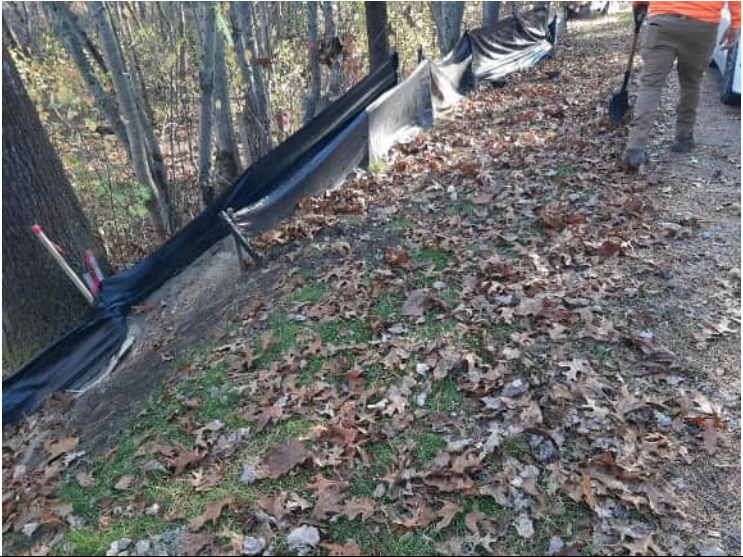
<p>PHOTOGRAPHIC LOG</p>	
<p>Client Name: Eversource</p>		<p>Site Location: Sudbury to Hudson Transmission Reliability Project</p>	<p>Town: Sudbury</p>
<p>Photo No.: 1</p>	<p>Date: 11/06/24</p>

<p>Description:</p> <p>Segment 10, north side, STA ~ 539 + 50. Potted hay-scented fern and supplemental area prior to today's installation. Looking eastward.</p>

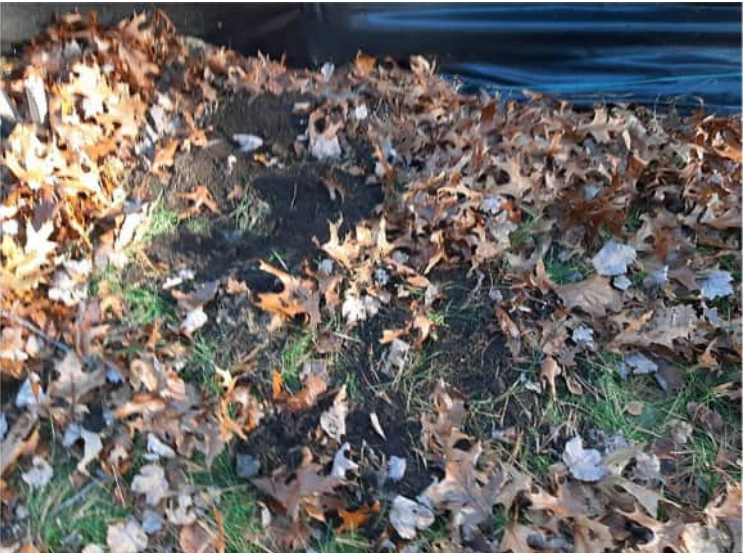
<p>PHOTOGRAPHIC LOG</p>	
<p>Client Name: Eversource</p>		<p>Site Location: Sudbury to Hudson Transmission Reliability Project</p>	<p>Town: Sudbury</p>
<p>Photo No.: 2</p>	<p>Date: 11/06/24</p>

<p>Description:</p> <p>Segment 10, north side, ~STA 539 + 50. Ferns installed today. Looking northward.</p>

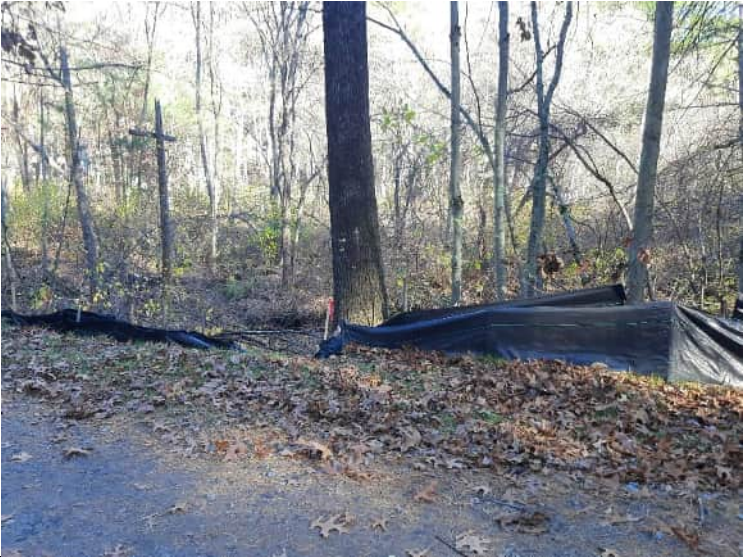
<p>PHOTOGRAPHIC LOG</p>	
<p>Client Name: Eversource</p>		<p>Site Location: Sudbury to Hudson Transmission Reliability Project</p>	<p>Town: Sudbury</p>
<p>Photo No.: 3</p>	<p>Date: 11/06/24</p>

<p>Description: Segment 10, north side, ~STA 539 + 50. Area of plant install today. Looking northward.</p>

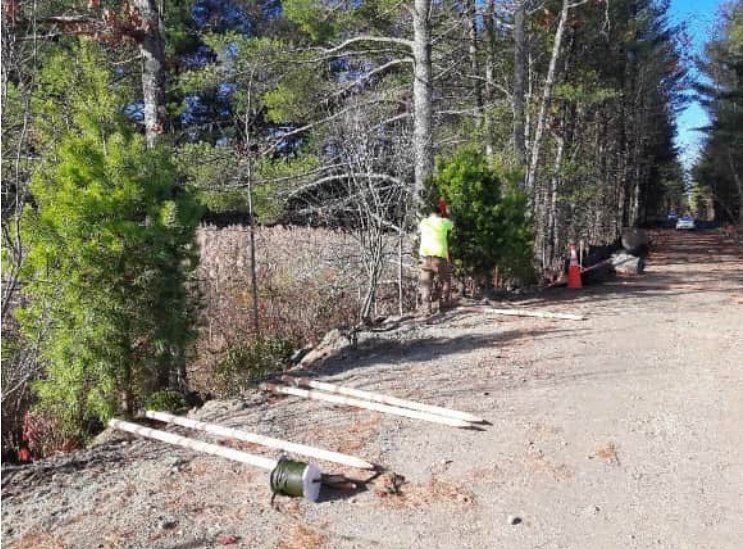
<p>PHOTOGRAPHIC LOG</p>	
<p>Client Name: Eversource</p>		<p>Site Location: Sudbury to Hudson Transmission Reliability Project</p>	<p>Town: 11/06/24</p>
<p>Photo No.: 4</p>	<p>Date: Sudbury</p>

<p>Description: Segment 7, south side, beside Bridge 128. MON installing stakes around single-trunk tree plantings. Looking westward.</p>

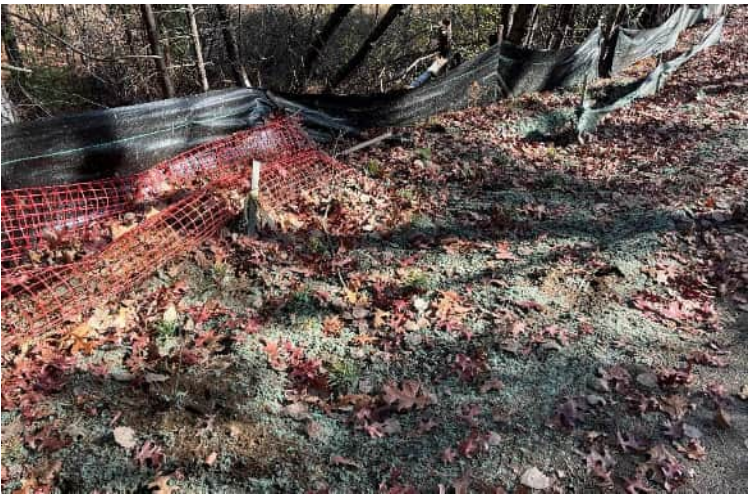
<p>PHOTOGRAPHIC LOG</p>	
<p>Client Name: Eversource</p>		<p>Site Location: Sudbury to Hudson Transmission Reliability Project</p>	<p>Town: Sudbury</p>
<p>Photo No.: 2</p>	<p>Date: 11/6/24</p>

<p>Description: View of northern planting bed after plants relocation. All plants installed in front of trail head moved either eastward or westward within bed. <i>Facing northeast.</i></p>

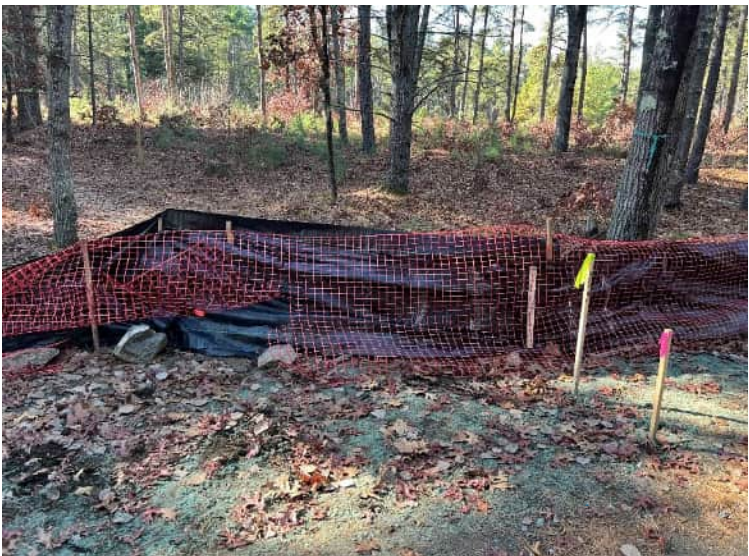
<p>PHOTOGRAPHIC LOG</p>	
<p>Client Name: Eversource</p>		<p>Site Location: Sudbury to Hudson Transmission Reliability Project</p>	<p>Town: Sudbury</p>
<p>Photo No.: 4</p>	<p>Date: 11/6/24</p>

<p>Description: View of southern trail head access after plant relocation. <i>Facing south.</i></p>

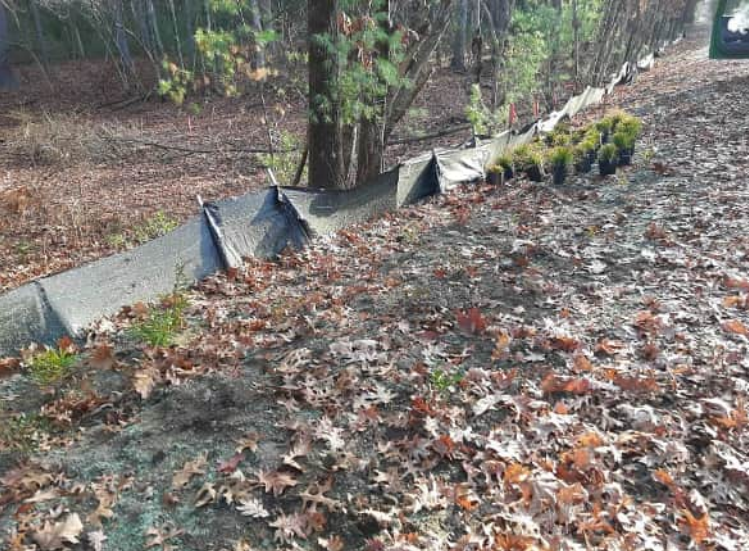
<p>PHOTOGRAPHIC LOG</p>	
<p>Client Name: Eversource</p>		<p>Site Location: Sudbury to Hudson Transmission Reliability Project</p>	<p>Town: Hudson</p>
<p>Photo No.: 2</p>	<p>Date: 11/07/24</p>

<p>Description:</p> <p>Segment 6, north side, ~STAs 337 + 30 to 340 + 75, adjacent to VP 1. MON staging and installing remaining plantings (sedge (CS), sweetfern (CP), some blueberry (VA) in gaps left for then-missing plants. Looking eastward.</p>

Installing plants missing during previous planting in this area. 22 sedges (CS) to south side, remainder of plants on north side. 29 total CS along north side moved eastward in bed due to space restrictions.
