Weekly Environmental Compliance Summary

Sudbury to Hudson Transmission Reliability Project (USEPA Tracking # MAR1003UW)

Week of: November 4, 2024 to November 9, 2024

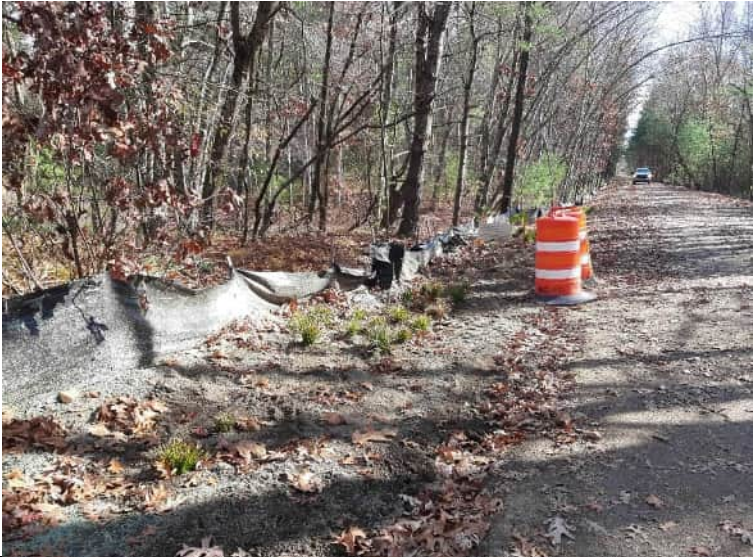
<p>PHOTOGRAPHIC LOG</p>	
<p>Client Name: Eversource</p>		<p>Site Location: Sudbury to Hudson Transmission Reliability Project</p>	<p>Town: Hudson</p>
<p>Photo No.: 3</p>	<p>Date: 11/07/24</p>

<p>Description: Segment 6, north side, -STAs 337 + 30 to 340 + 75, adjacent to VP 1 and White Pond Road. North side area following installation of remaining plantings, bed completed. Looking eastward.</p>

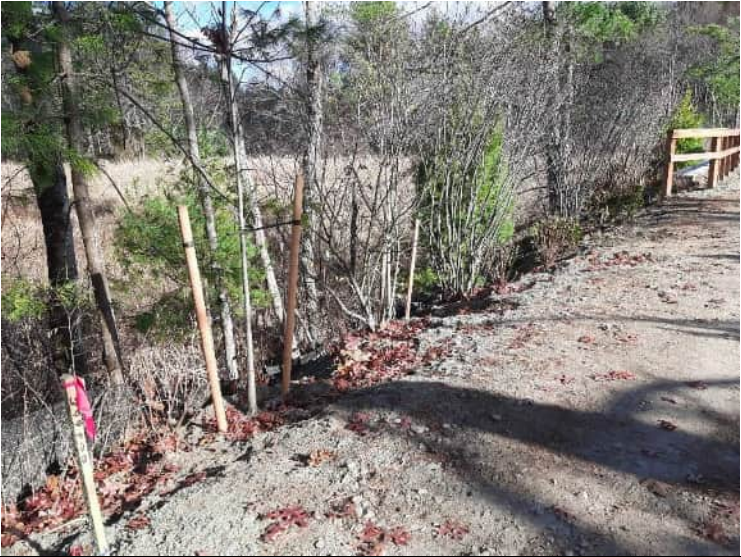
<p>PHOTOGRAPHIC LOG</p>	
<p>Client Name: Eversource</p>		<p>Site Location: Sudbury to Hudson Transmission Reliability Project</p>	<p>Town: Sudbury</p>
<p>Photo No.: 3</p>	<p>Date: 11/07/24</p>

<p>Description: Segment 7, north side, STAs ~399 + 00 to 400 + 00, west abutment of Bridge 128. Area after planting MPs, majority of MPs downslope and/or behind previous plantings. Looking eastward.</p>

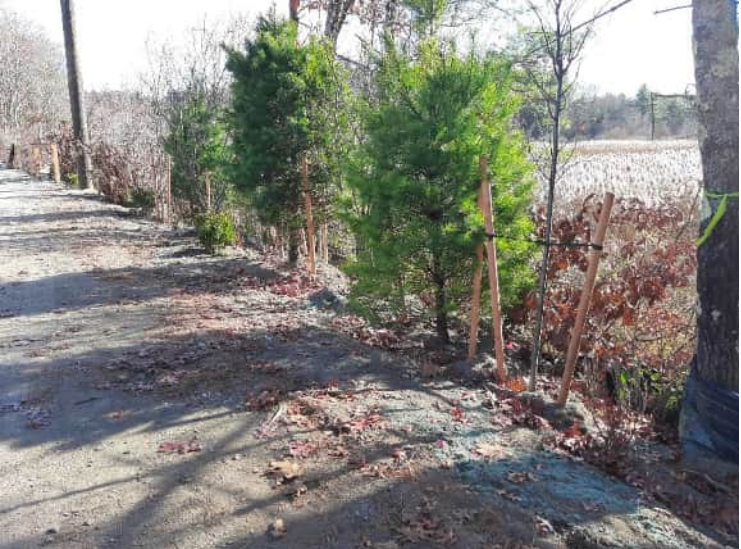
<p>PHOTOGRAPHIC LOG</p>	
<p>Client Name: Eversource</p>		<p>Site Location: Sudbury to Hudson Transmission Reliability Project</p>	<p>Town: Sudbury</p>
<p>Photo No.: 4</p>	<p>Date: 11/07/24</p>

<p>Description: Segment 7, south side, STAs ~399 + 00 to 400 + 00, west abutment of Bridge 128. Area after planting MPs, majority of MPs behind previous plantings. Looking eastward.</p>
