<b>Environmental Monitor Construction Site Inspection Report</b> <b>MassDOT Project #608164 Construction Contract # 119678</b> <b>EM Report #49</b>						
Project Description: Bruce Freeman Rail Trail Right-of-Way Permit Description(s): Order of Conditions (MGL Chapter 131, Section 40 and 310 CMR 10.00, Mass DEP File No. 301-1362); 2022 EPA NPDES General Permit for Discharges from Construction Areas; U.S. Army Corps of Engineers Permit No NAE-2021-01975.

I. General Project Information						
Project Name:	Bruce Freeman Rail Trail - Phase 2d - Sudbury					
Date of Inspections:	4/2/2025					
Bi Weekly/ Monthly Period Covered:	April Weekly Inspection #1					
Inspector's Name(s):	Anna Haznar					
Inspectors' Contact Information:	ahaznar@beta-inc.com					
II. Weather Information						
	Inspection #1	Inspection #2	Inspection #3	Inspection #4	Inspection #5	Inspection #6
<a href="#">WeatherUnderground</a>	Inspector: Anna Haznar 4/2/2025	Inspector:	Inspector:	Inspector:	Inspector:	Inspector:
Type of Inspection (i.e. non-storm event, pre-storm event, during-storm event or post-storm event):	Post-storm					
Number of days since last rain event greater than .25"	1					
Has there been a storm ev

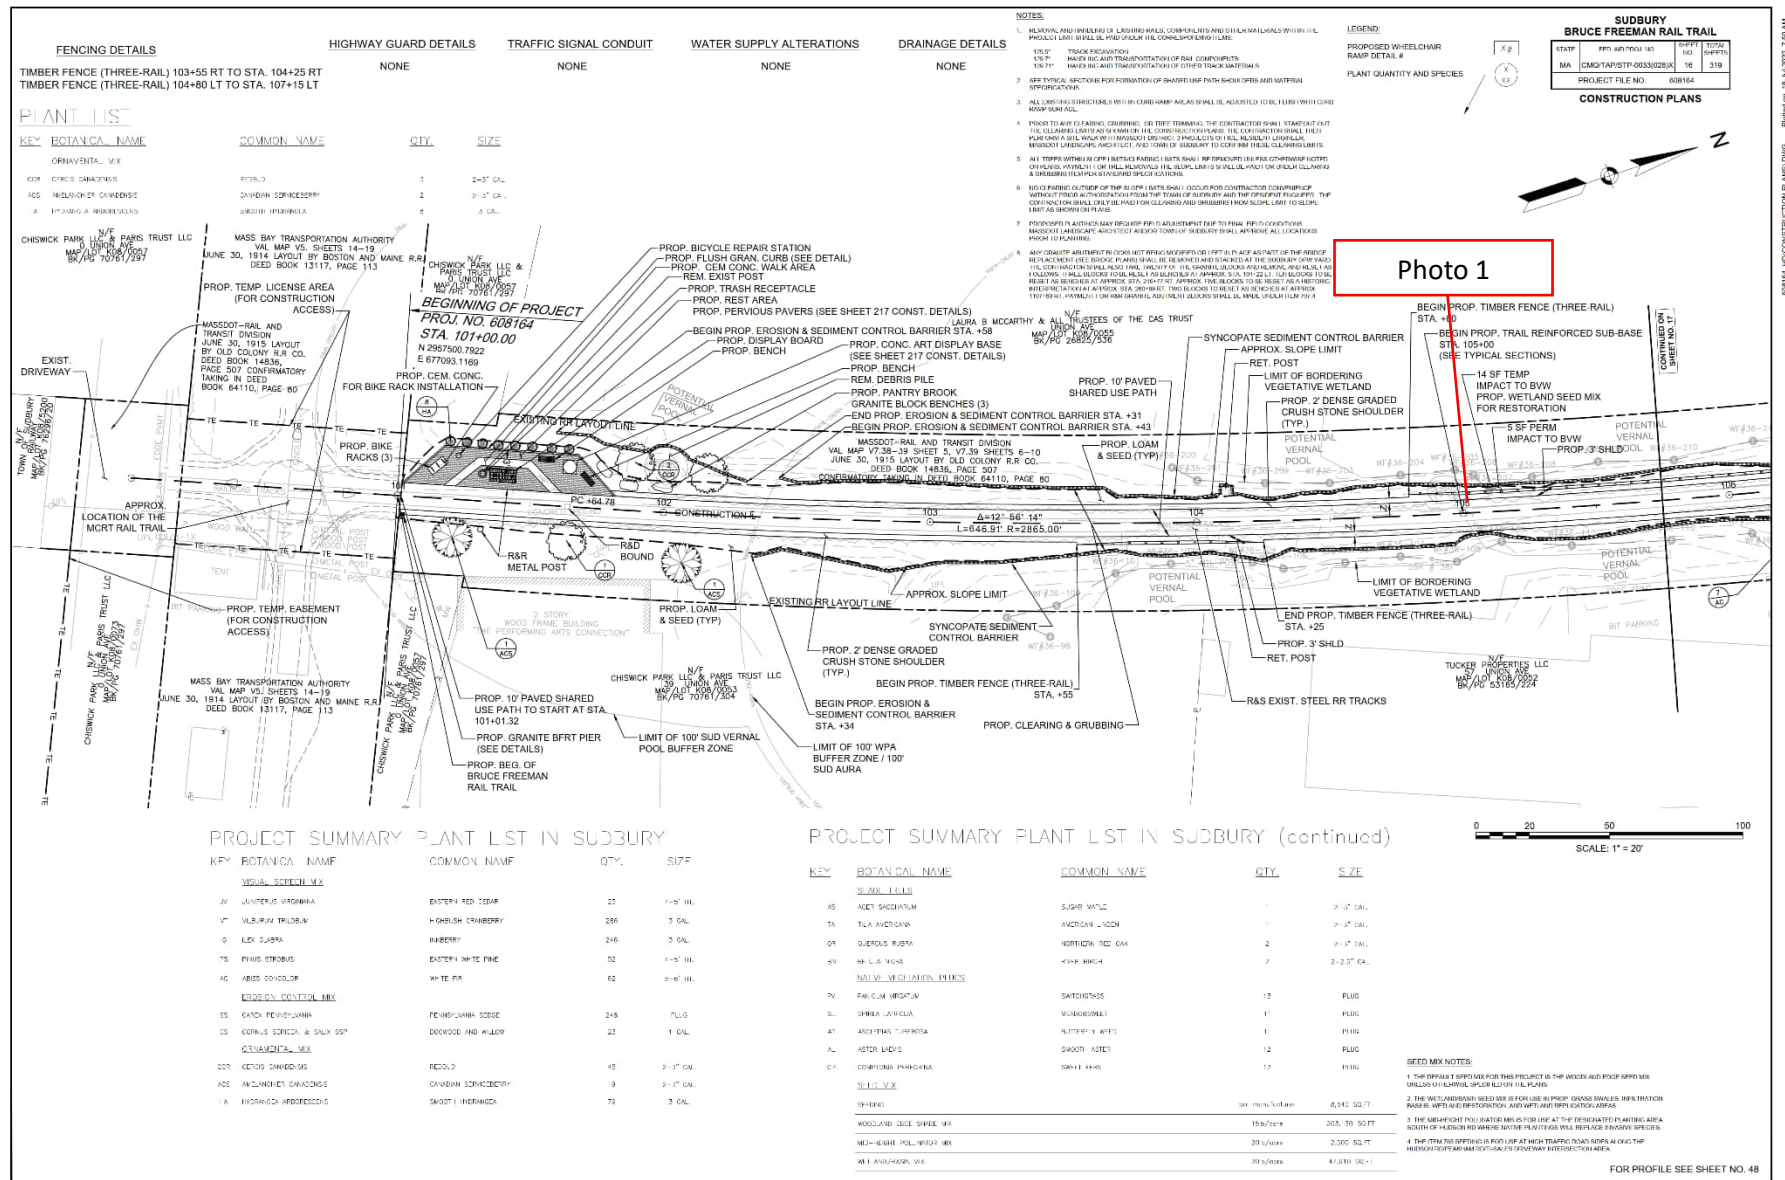
Site Location		Bruce Freeman Rail Trail Right-of-Way	BETA Project No. 24.10326.23
Photo No. 1	Date: 4/2/2025	 	
Direction Photo Taken:  Toward the North			
Description:  View of the location of the overtopped compost filter tube and exposed soils beyond the limits of work at Station 105+00 per Compliance Action Item 43.			
Photo No. 2	Date: 4/2/2025	 	
Direction Photo Taken:  Toward the North			
Description:  View of the location of exposed soil at Station 139+00 that requires stabilization per Long Term Compliance Action item 59.

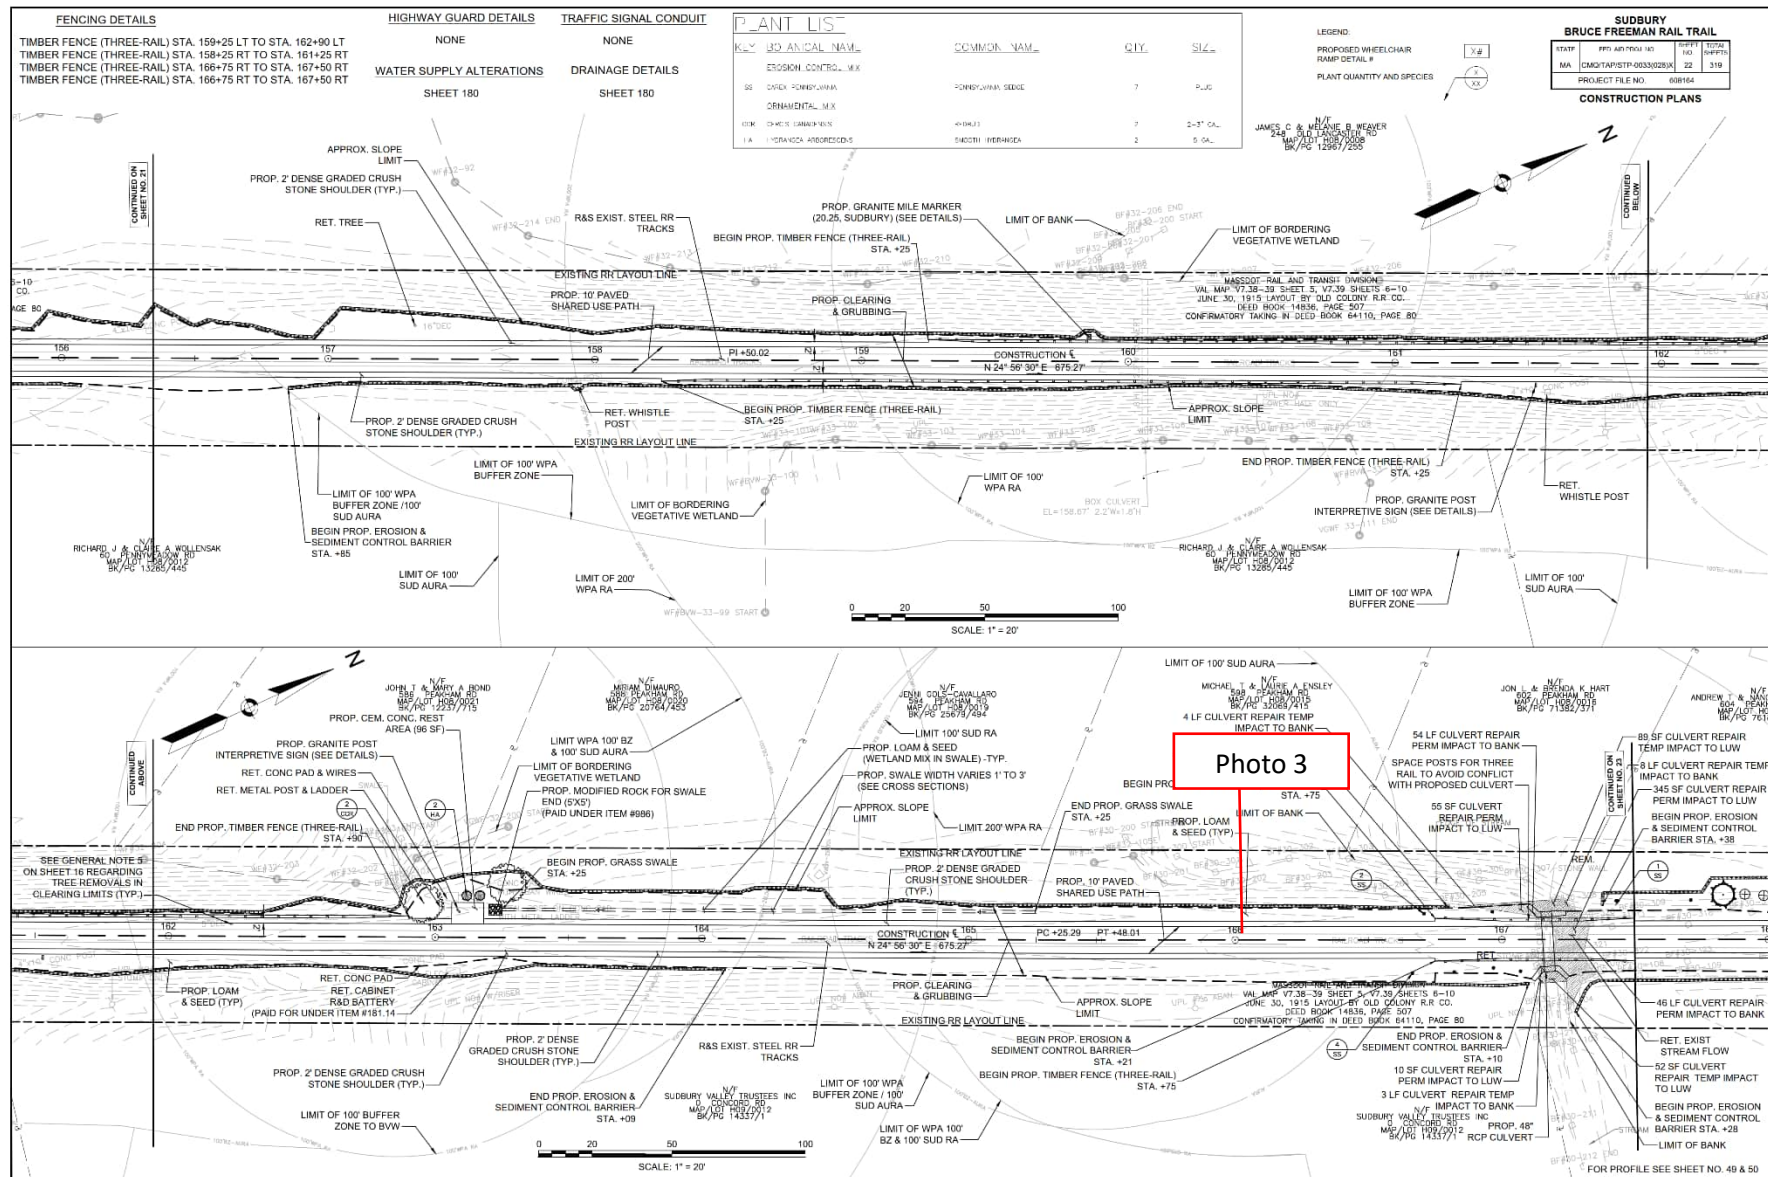
Site Location		Bruce Freeman Rail Trail Right-of-Way	BETA Project No. 24.10326.23
Photo No. 3	Date: 4/2/2025	 	
Direction Photo Taken:  Toward the South			
Description:  View of the location of exposed soil at Station 166+00 that requires stabilization per Long Term Compliance Action item 59.			
Photo No. 4	Date: 4/2/2025	 	
Direction Photo Taken:  Toward the Southwest			
Description:  View of the location of exposed soil that requires stabilization and crushed stone that has migrated off of the path at Station 178+00 per Long Term Compliance Action item 59 and 58.
