Environmental Monitor Construction Site Inspection Report MassDOT Project #608164 Construction Contract # 119678 EM Report #51						
Project Description: Bruce Freeman Rail Trail Right-of-Way Permit Description(s): Order of Conditions (MGL Chapter 131, Section 40 and 310 CMR 10.00, Mass DEP File No. 301-1362); 2022 EPA NPDES General Permit for Discharges from Construction Areas; U.S. Army Corps of Engineers Permit No NAE-2021-01975.

I. General Project Information						
Project Name:	Bruce Freeman Rail Trail - Phase 2d - Sudbury					
Date of Inspections:	4/14/2025					
Bi Weekly/ Monthly Period Covered:	April Weekly Inspection #3					
Inspector's Name(s):	Anna Haznar					
Inspectors' Contact Information:	ahaznar@beta-inc.com					
II. Weather Information						
	Inspection #1	Inspection #2	Inspection #3	Inspection #4	Inspection #5	Inspection #6
<a href="#">WeatherUnderground</a>	Inspector: Anna Haznar 4/2/2025	Inspector: Anna Haznar 4/7/2025	Inspector: Anna Haznar 4/14/2025	Inspector:	Inspector:	Inspector:
Type of Inspection (i.e. non-storm event, pre-storm event, during-storm event or post-storm event):	Post-storm	Post-storm	Post-storm			
Number of days since last rain event greater

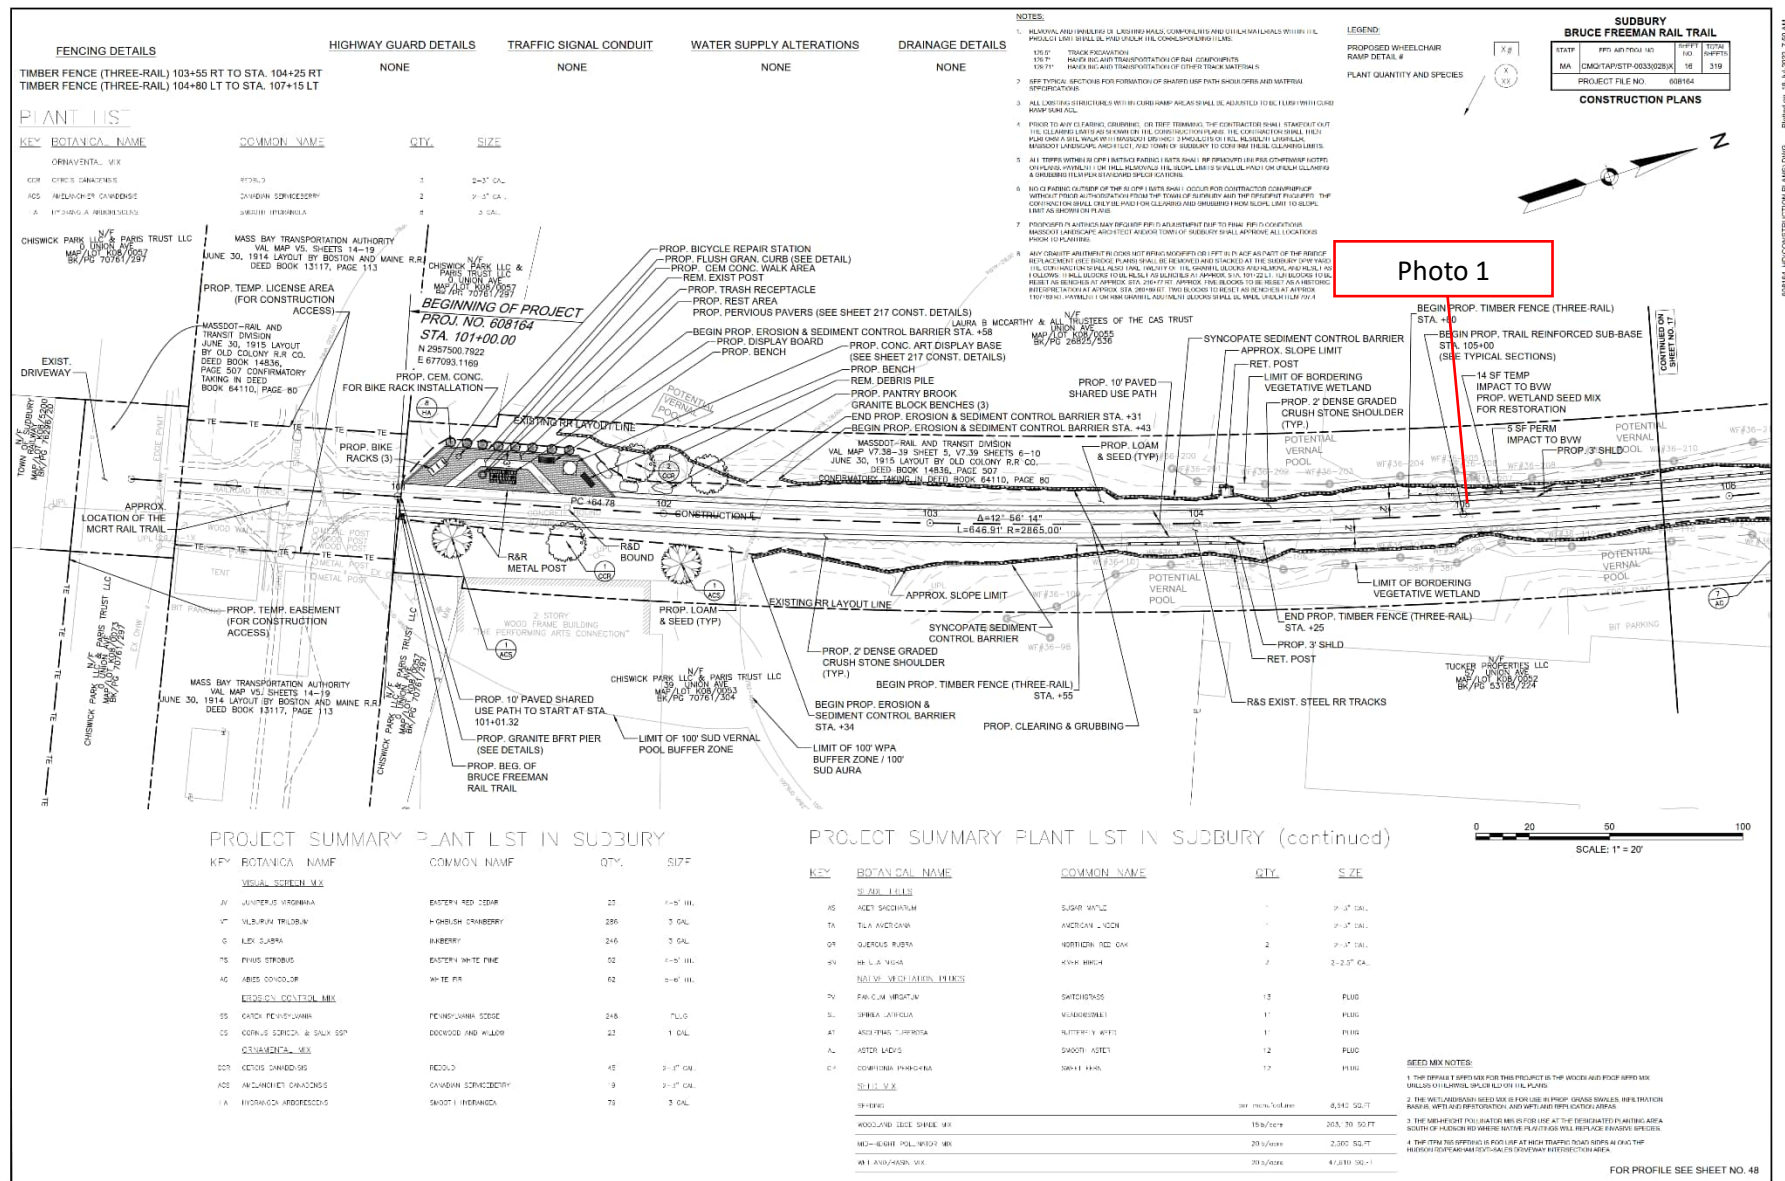
<b>Site Location</b> Bruce Freeman Rail Trail Right-of-Way		<b>BETA Project No.</b> 24.10326.23
<b>Photo No. 1</b>	<b>Date:</b> 4/14/2025	 
<b>Direction Photo Taken:</b>  Toward the North		
<b>Description:</b>  View of the location of the overtopped compost filter tube and exposed soils beyond the limits of work at Station 105+00 per Compliance Action Item 43.		
<b>Photo No. 2</b>	<b>Date:</b> 4/14/2025	 
<b>Direction Photo Taken:</b>  Toward the North		
<b>Description:</b>  View of exposed soil at Station 139+00 per Long Term Compliance Action Item 59.
