Environmental Monitor Construction Site Inspection Report MassDOT Project #608164 Construction Contract # 119678 EM Report #63						
Project Description: Bruce Freeman Rail Trail Right-of-Way Permit Description(s): Order of Conditions (MGL Chapter 131, Section 40 and 310 CMR 10.00, Mass DEP File No. 301-1362); 2022 EPA NPDES General Permit for Discharges from Construction Areas; U.S. Army Corps of Engineers Permit No NAE-2021-01975.

I. General Project Information						
Project Name:	Bruce Freeman Rail Trail - Phase 2d - Sudbury					
Date of Inspections:	9/10/2025					
Bi Weekly/ Monthly Period Covered:	September Inspection					
Inspector's Name(s):	Anna Haznar					
Inspectors' Contact Information:	<a href="mailto:ahaznar@beta-inc.com">ahaznar@beta-inc.com</a>					
II. Weather Information						
	Inspection #1	Inspection #2	Inspection #3	Inspection #4	Inspection #5	Inspection #6
<a href="#">WeatherUnderground</a>	Inspector: Anna Haznar 7/1/2025	Inspector: Anna Haznar 8/8/2025	Inspector: Anna Haznar 9/10/2025	Inspector:	Inspector:	Inspector:
Type of Inspection (i.e. non-storm event, pre-storm event, during-storm event or post-storm event):	Non-storm	Non-storm	Non-storm			
Number of d

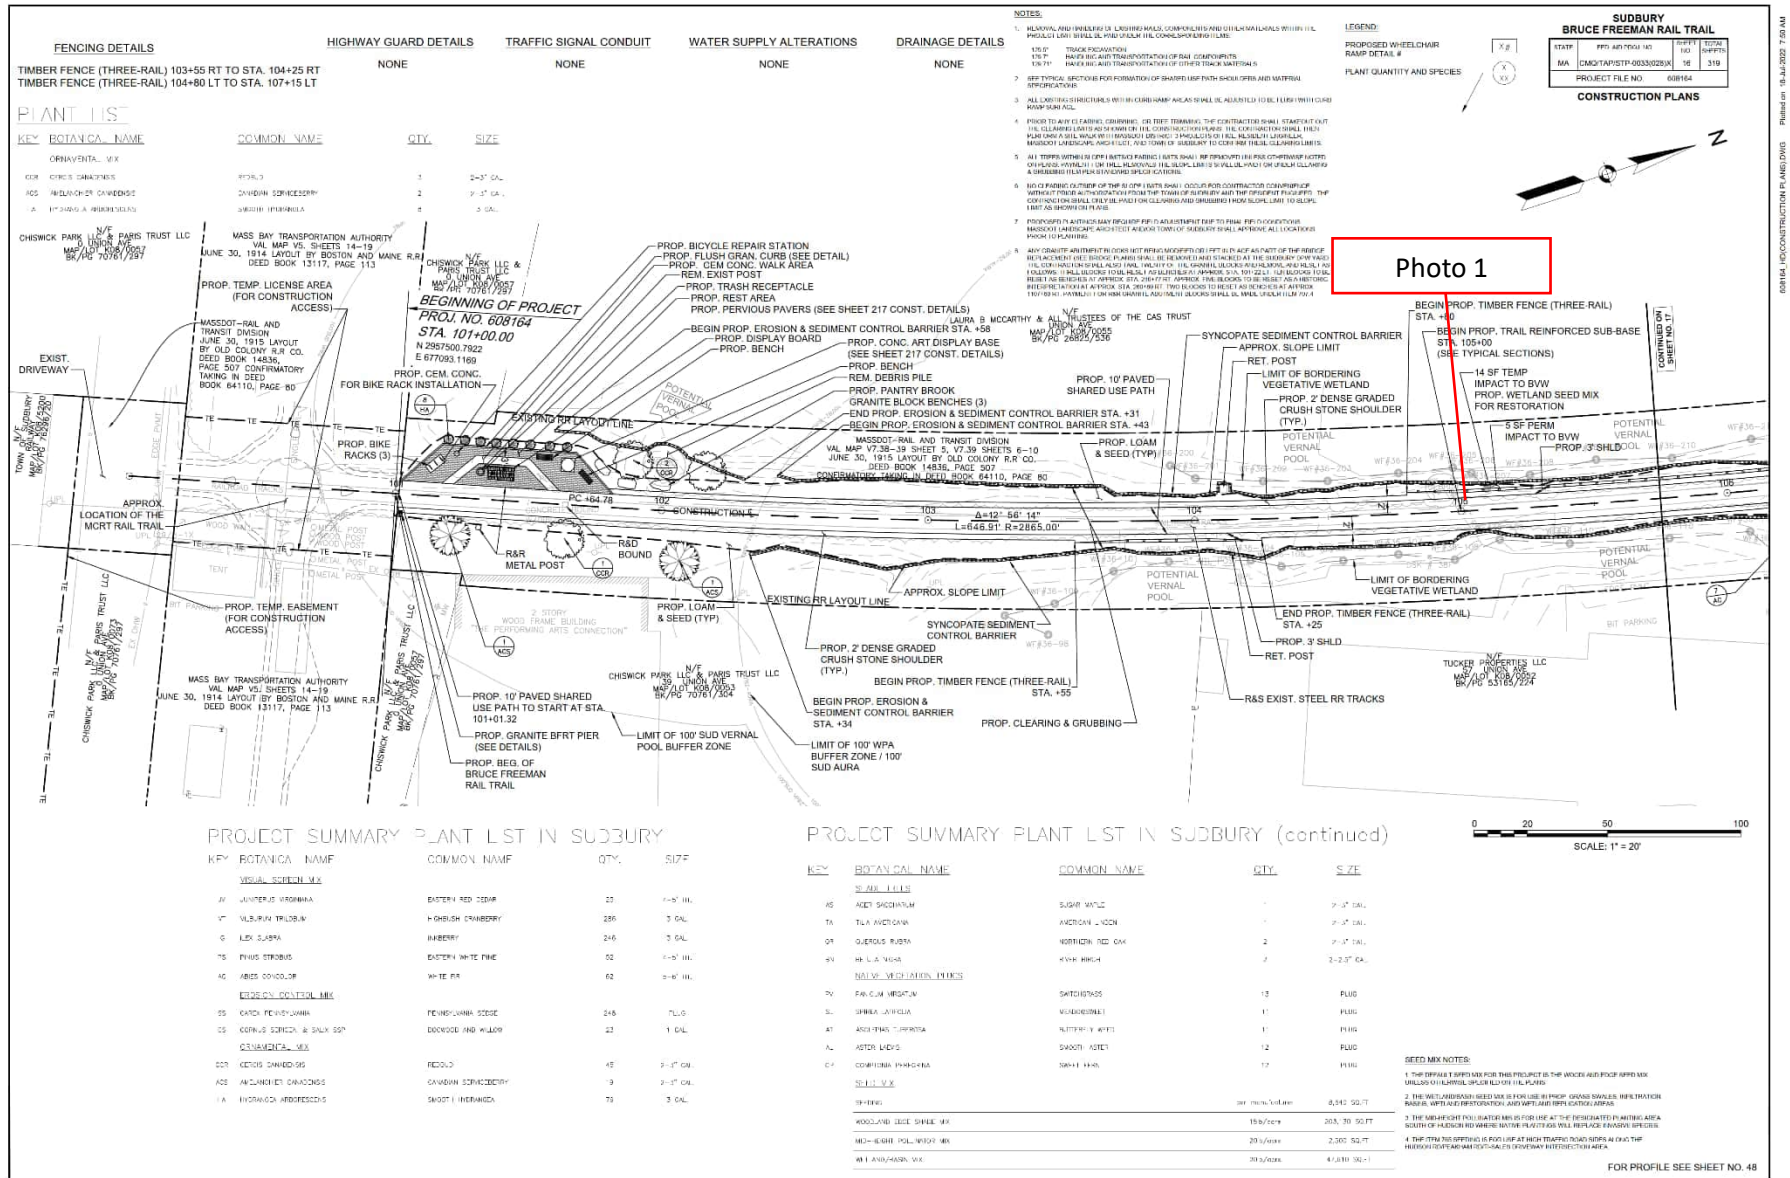
<b>Site Location</b>		Bruce Freeman Rail Trail Right-of-Way	<b>BETA Project No.</b> 24.10326.23
<b>Photo No. 1</b>	<b>Date:</b> 9/10/2025	 	
<b>Direction Photo Taken:</b>  Toward the East			
<b>Description:</b>  View of the location of the overtopped compost filter tube and exposed soils beyond the limits of work at Station 105+00 per Compliance Action Item 43.			
<b>Photo No. 2</b>	<b>Date:</b> 9/10/2025	 	
<b>Direction Photo Taken:</b>  Toward the North			
<b>Description:</b>  View of exposed soil that requires stabilization at Station 138+00 per Long Term Compliance Action item 59.
