November 24, 2025

## Re: Hop Brook Ponds (Stearns Millpond, Carding Millpond, and Grist Millpond), Sudbury, MA (DEP#301-1283) – 2025 Year End Report

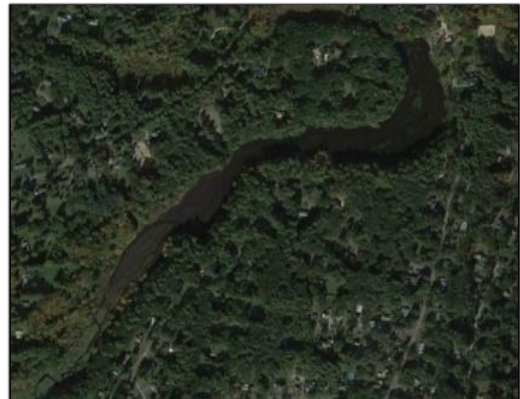
*Figure 3: Stearns Millpond - Sudbury, MA*

Stearns Millpond (Figure 3) is the northernmost waterbody of the three Hop Brook Ponds and is approximately 16.8 acres. This pond is primarily surrounded by woodlands with developed properties scattered on both the northern and southern shorelines. The inlet (which is Hop Brook) to Stearns Millpond is found along the southwestern point. Water flows from west to east within the waterbody, with the outlet noted at the northeastern point (adjacent to the public parking lot). This outlet is a constructed dam that flows back into Hop Brook. The pond is fairly shallow, with an average depth of roughly 2.5-3 feet. Access to this waterbody is gained from the public parking lot off of Dutton Road.
