## DPW Offices and Garage

## Town of Sudbury ADA Transition Plan

October 2020

Institute for Human Centered Design

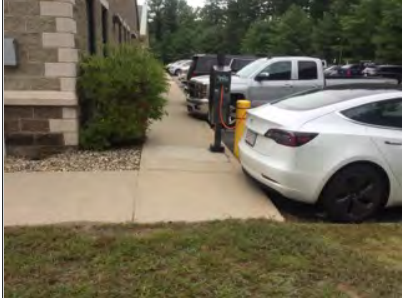
The sidewalk in front of the building on the west side narrows to less than 36 inches due to a vehicle charging station, untrimmed hedges and cars that project over the sidewalk due to lack of wheel stops.

| ID | Location | Floor | Room | Element | Type | Photo | Issues | Current Measure | Recommendations | Quantity | Price | Cost Estimation |
|---|---|---|---|---|---|--|---|---|---|---|---|---|
| 1 | Front Walkway | Ext. | | Exterior Access Route | Sidewalk | | Exterior route < 36" wide<br>Exterior route < 48" wide | 27.75"<br>- | Ensure that a clear width of 36" min. is maintained at the accessible route with 48" preferred per 521 CMR. Relocate car charging station so that there is 36" clear min. Trim hedges and install wheel stops so that vehicles do not block the sidewalk.<br>(Cost is beyond the scope of the project.) | 1 | - | \$0 |

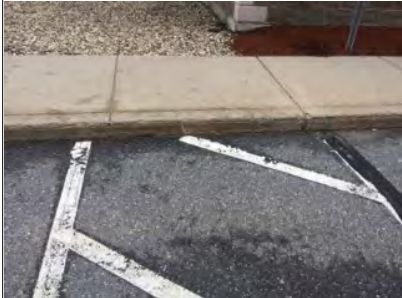
The access aisle from the car accessible parking space does not lead to an accessible route and lacks a curb ramp.

| ID | Location | Floor | Room | Element | Type | Photo | Issues | Current Measure | Recommendations | Quantity | Price | Cost Estimation |
|---|---|---|---|---|---|--|---|---|---|---|---|---|
| 2 | Parking Lot - Car Accessible Space Access Aisle | Ext. | | Off-Street Parking Lot or Garage | Visitor | | Access aisle does not adjoin an accessible route | - | Ensure the access aisle by the car accessible space adjoins an accessible route. Provide a curb ramp. | 1 | 2800 | \$2800 |

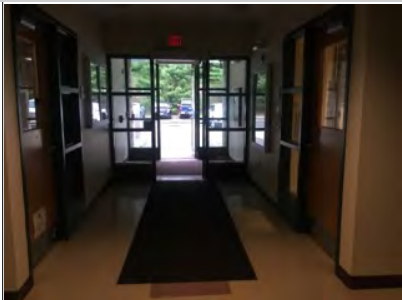
| ID | Location | Floor | Room | Element | Type | Photo | Issues | Current Measure | Recommendations | Quantity | Price | Cost Estimation |
|---|---|---|---|---|---|--|---|---|---|---|---|---|
| 3 | Central Exit | 1 | | Emergency Exit | N/A | | Tactile sign not provided at exit<br>Illuminated Int. Symbol of Acc. not provided (MAAB)<br>Mat not securely attached | -<br>-<br>- | Provide tactile exit signs with raised characters and braille at exit doors. Mount signs between 48"- 60" above the finished floor located on the latch side of the door.<br>Provide an illuminated sign with the International Symbol of Accessibility.<br>Secure the mat. | 1 | 432 Labor | \$432 |

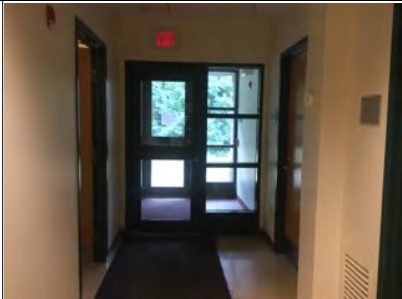
| ID | Location | Floor | Room | Element | Type | Photo | Issues | Current Measure | Recommendations | Quantity | Price | Cost Estimation |
|---|---|---|---|---|---|--|---|---|---|---|---|---|
| 4 | South Exit | 1 | | Emergency Exit | N/A | | Tactile sign not provided at exit<br>Illuminated Int. Symbol of Acc. not provided (MAAB)<br>Mat not securely attached | -<br>-<br>- | Provide tactile exit signs with raised characters and braille at exit doors. Mount signs between 48"- 60" above the finished floor located on the latch side of the door.<br>Provide an illuminated sign with the International Symbol of Accessibility.<br>Secure the mat. | 1 | 432 Labor | \$432 |

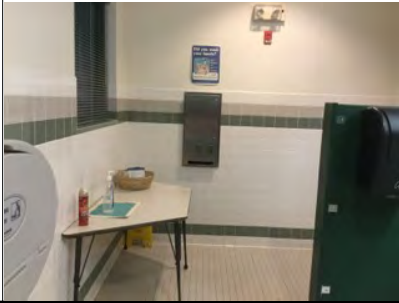
| ID | Location | Floor | Room | Element | Type | Photo | Issues | Current Measure | Recommendations | Quantity | Price | Cost Estimation |
|---|---|---|---|---|---|--|---|---|---|---|---|---|
| 6 | Women's Toilet Room | 1 | | Interior Access Route | N/A | | Route < 36" wide | 30" | Relocate table to ensure that a clear width of 36" min. is maintained at the accessible route. Route is allowed to narrow to narrow to 32" for a depth of 24". | 1 | Labor | \$0 |

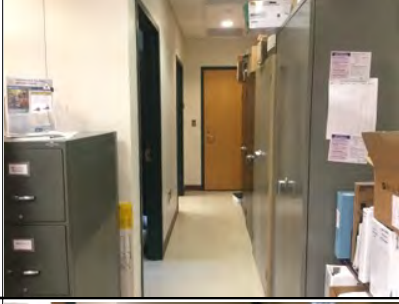
| ID | Location | Floor | Room | Element | Type | Photo | Issues | Current Measure | Recommendations | Quantity | Price | Cost Estimation |
|---|---|---|---|---|---|--|---|---|---|---|---|---|
| 7 | Board of Health | 1 | | Interior Access Route | N/A | | Route < 36" wide | 35.25" | Relocate cabinets to ensure that a clear width of 36" min. is maintained at the accessible route. | 1 | Labor | \$0 |

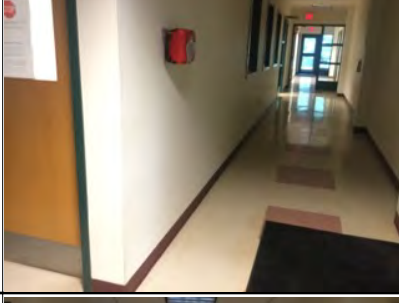
| ID | Location | Floor | Room | Element | Type | Photo | Issues | Current Measure | Recommendations | Quantity | Price | Cost Estimation |
|---|---|---|---|---|---|--|---|---|---|---|---|---|
| 8 | Corridor by Main Entrance | 1 | | Interior Access Route | N/A | | Obstructed by protruding objects | 5" | Relocate or recess fire alarm box. | 1 | 256 | \$256 |

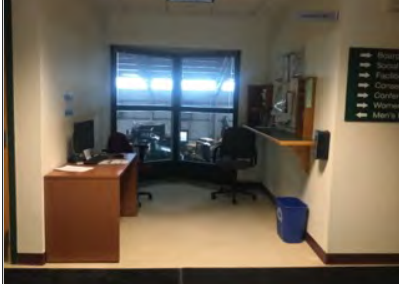
| ID | Location | Floor | Room | Element | Type | Photo | Issues | Current Measure | Recommendations | Quantity | Price | Cost Estimation |
|---|---|---|---|---|---|--|---|---|---|---|---|---|
| 9 | Application Forms Area/Overlook | 1 | | Interior Access Route | N/A | | Obstructed by protruding objects | 41.5" | Provide a cane-detectable barrier on the open side of the high counter. | 1 | 306 | \$306 |

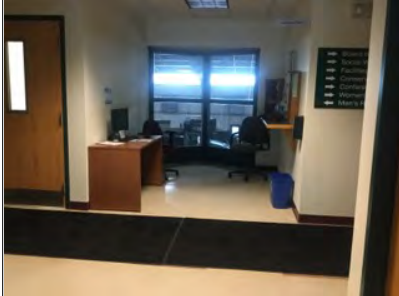
| ID | Location | Floor | Room | Element | Type | Photo | Issues | Current Measure | Recommendations | Quantity | Price | Cost Estimation |
|---|---|---|---|---|---|--|--|---|--|---|---|---|
| 10 | Near Main Entrance | 1 | | Interior Access Route | N/A | | Surface not stable, firm, and slip-resistant | - | Secure mats. | 2 | Labor | \$0 |

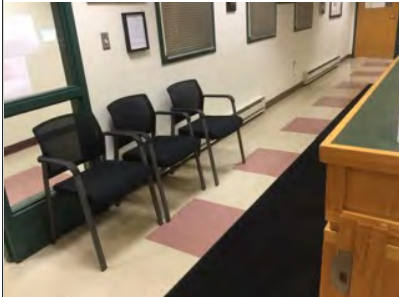
| ID | Location | Floor | Room | Element | Type | Photo | Issues | Current Measure | Recommendations | Quantity | Price | Cost Estimation |
|---|---|---|---|---|---|--|--|---|--|---|---|---|
| 11 | Transfer Station Cemetery Department | 1 | | Interior Access Route | N/A | | Surface not stable, firm, and slip-resistant | - | Secure mat. | 1 | Labor | \$0 |

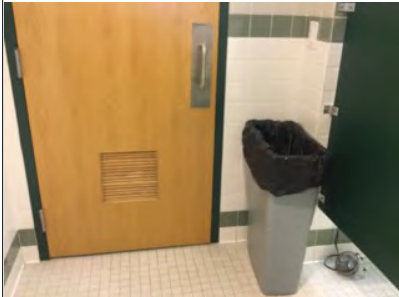
| ID | Location | Floor | Room | Element | Type | Photo | Issues | Current Measure | Recommendations | Quantity | Price | Cost Estimation |
|---|---|---|---|---|---|--|--|---|--|---|---|---|
| 12 | Women's Toilet Room | 1 | | Doors, Doorways, & Gates | Toilet Room | | Maneuvering clearance(s) not provided | - | Relocate trash container so that there is 18" min. on the pull side of the door. | 1 | Labor | \$0 |

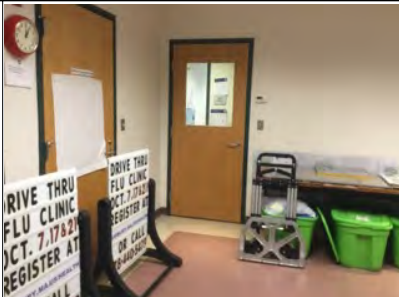
| ID | Location | Floor | Room | Element | Type | Photo | Issues | Current Measure | Recommendations | Quantity | Price | Cost Estimation |
|---|---|---|---|---|---|--|--|---|--|---|---|---|
| 13 | Conference Room | 1 | | Doors, Doorways, & Gates | Meeting Room | | Maneuvering clearance(s) not provided | - | Relocate table so that there is 18" min. on the latch side of the door. | 1 | Labor | \$0 |

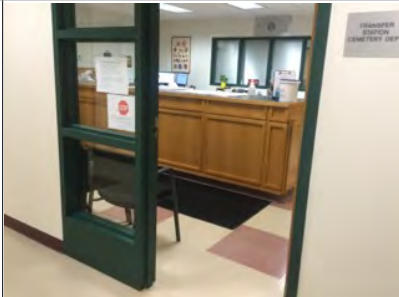
| ID | Location | Floor | Room | Element | Type | Photo | Issues | Current Measure | Recommendations | Quantity | Price | Cost Estimation |
|---|---|---|---|---|---|--|--|---|--|---|---|---|
| 14 | Transfer Station Cemetery Department | 1 | | Signage | Designation | | Sign not located on the latch side of the door | - | Locate sign at permanent rooms alongside the door on the latch side. | 1 | Labor | \$0 |

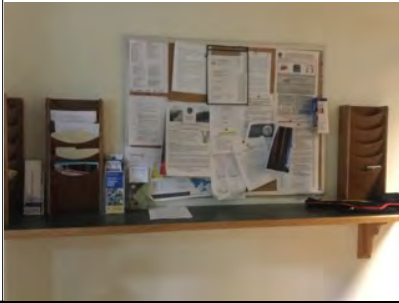
| ID | Location | Floor | Room | Element | Type | Photo | Issues | Current Measure | Recommendations | Quantity | Price | Cost Estimation |
|---|---|---|---|---|---|--|---|---|--|---|---|---|
| 17 | Application Forms Area/Overlook | 1 | | Operable Parts | Other | | Reach < 15" or > 48"(forward/side approach) | 63" | Relocate one of each form to be located between 15"- 48" above the finished floor. | 1 | Labor | \$0 |

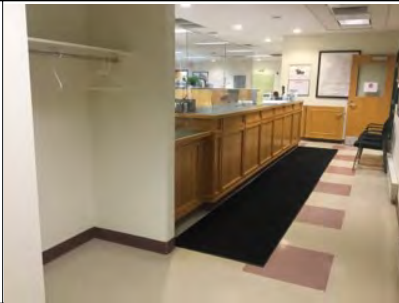
| ID | Location | Floor | Room | Element | Type | Photo | Issues | Current Measure | Recommendations | Quantity | Price | Cost Estimation |
|---|---|---|---|---|---|--|---|---|--|---|---|---|
| 18 | Transfer Station Cemetery Department | 1 | | Operable Parts | Clothes Rod/Hooks | | Reach < 15" or > 48"(forward/side approach) | 62.5" | Relocate clothes rod to be no higher than 48" above the finished floor. | 1 | 256 | \$256 |

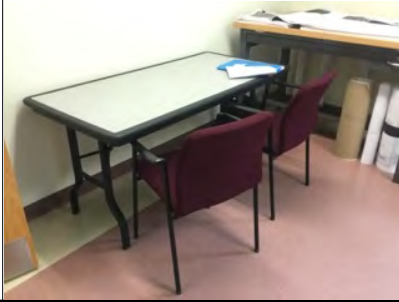
| ID | Location | Floor | Room | Element | Type | Photo | Issues | Current Measure | Recommendations | Quantity | Price | Cost Estimation |
|---|---|---|---|---|---|--|--|---|--|---|---|---|
| 22 | Conservation | 1 | | Dining or Work Surfaces | Work Surface | | Knee or toe clearance not provided | 26.5" | Provide at least 1 dining or work surface with 27" min. knee and toe clearance. | 1 | 700 | \$700 |

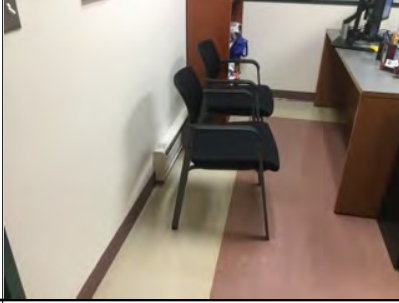
| ID | Location | Floor | Room | Element | Type | Photo | Issues | Current Measure | Recommendations | Quantity | Price | Cost Estimation |
|---|---|---|---|---|---|--|--|---|--|---|---|---|
| 23 | Director of Operations | 1 | | Dining or Work Surfaces | Work Surface | | Clear floor space not provided at work surface | 44" | Relocate desk so that there is 48" clear min. | 1 | Labor | \$0 |

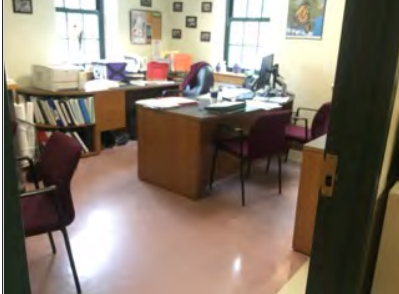
| ID | Location | Floor | Room | Element | Type | Photo | Issues | Current Measure | Recommendations | Quantity | Price | Cost Estimation |
|---|---|---|---|---|---|--|--|---|--|---|---|---|
| 24 | Conservation | 1 | | Dining or Work Surfaces | Work Surface | | Clear floor space not provided at work surface | 37" | Relocate desk so that there is 48" clear min. | 1 | Labor | \$0 |

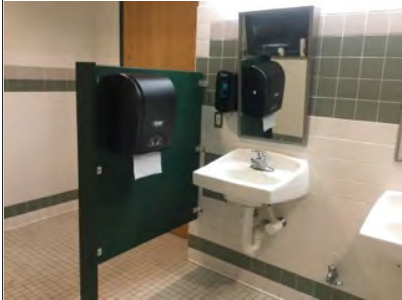
| ID | Location | Floor | Room | Element | Type | Photo | Issues | Current Measure | Recommendations | Quantity | Price | Cost Estimation |
|---|---|---|---|---|---|--|---|---|--|---|---|---|
| 26 | Men's Toilet Room | 1 | | Lavatory | N/A | | Dispensers not within reach range | 47" | Lower the soap dispenser to 42" max. above the floor. | 1 | 353 | \$353 |

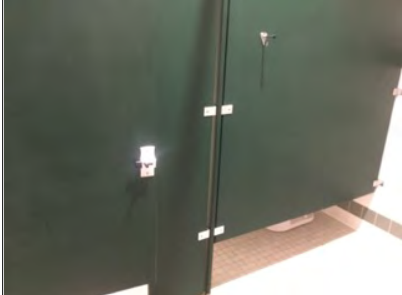
| ID | Location | Floor | Room | Element | Type | Photo | Issues | Current Measure | Recommendations | Quantity | Price | Cost Estimation |
|---|---|---|---|---|---|--|---|---|--|---|---|---|
| 28 | Men's Toilet Room | 1 | | Toilet Compartment | Accessible Compartment | | Door has non-compliant hardware<br>Door has malfunctioning self-closing hinge | -<br>- | Provide hardware that can be operable with one hand and not require tight grasping, pinching, or twisting of the wrist.<br>Repair hinge. | 1 | 70<br>Labor | \$70 |

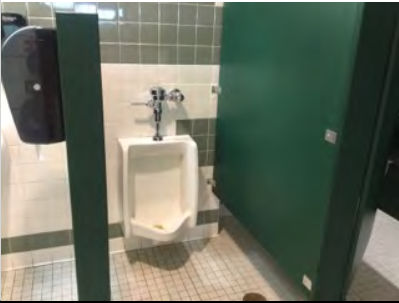
| ID | Location | Floor | Room | Element | Type | Photo | Issues | Current Measure | Recommendations | Quantity | Price | Cost Estimation |
|---|---|---|---|---|---|--|---|---|--|---|---|---|
| 31 | Men's Toilet Room | 1 | | Urinal | N/A | | Urinal recessed > 24" has > 36" clear width | 32" | If urinal is recessed greater than 24" ensure there is a clear width of 36". Relocate the partition. | 1 | 353 | \$353 |

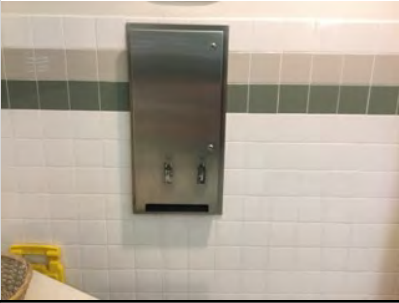
| ID | Location | Floor | Room | Element | Type | Photo | Issues | Current Measure | Recommendations | Quantity | Price | Cost Estimation |
|---|---|---|---|---|---|--|---|---|--|---|---|---|
| 32 | Women's Toilet Room | 1 | | Dispensers | Tampon Dispenser | | Not operable with a closed fist | - | Provide a dispenser that can be operable with one hand and not require tight grasping, pinching, or twisting of the wrist. | 1 | 1000 | \$1000 |

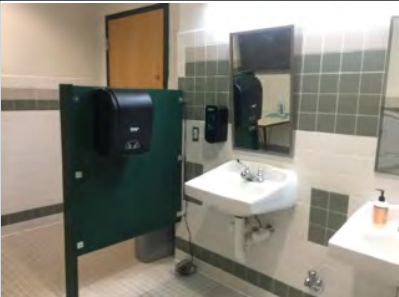
| ID | Location | Floor | Room | Element | Type | Photo | Issues | Current Measure | Recommendations | Quantity | Price | Cost Estimation |
|---|---|---|---|---|---|--|---|---|--|---|---|---|
| 33 | Women's Toilet Room | 1 | | Dispensers | Paper Towel Dispenser | | Dispenser acts as a protruding object | 9" | Relocate paper towel dispensers out of the circulation path. | 2 | 256 | \$512 |

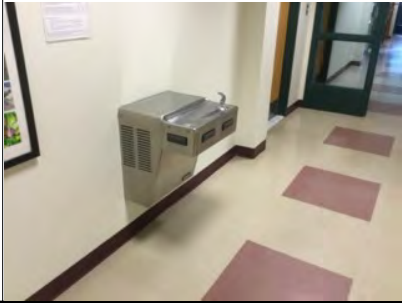
| ID | Location | Floor | Room | Element | Type | Photo | Issues | Current Measure | Recommendations | Quantity | Price | Cost Estimation |
|---|--|---|---|---|---|--|--|---|--|---|---|---|
| 35 | Drinking Fountain Near Women's Toilet Room | 1 | | Drinking Fountains | Low | | No drinking fountain provided for standing users<br>Knee or toe clearance not provided | -<br>26" | Install a Hi-Lo drinking fountain.<br>Provide knee and toe clearance, 27" min. high at drinking fountain for seated users. | 1 | 4216 | \$4216 |

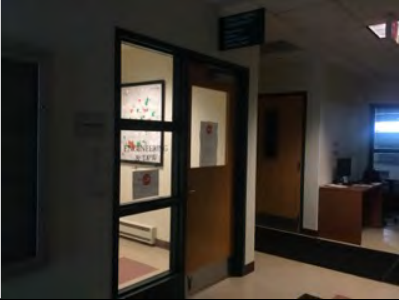
| ID | Location | Floor | Room | Element | Type | Photo | Issues | Current Measure | Recommendations | Quantity | Price | Cost Estimation |
|---|---|---|---|---|---|--|---|---|--|---|---|---|
| 38 | Engineering Near Main Entrance | 1 | | | | | | | Recommend increasing lighting in this area so that signage is more legible. | 1 | - | \$0 |

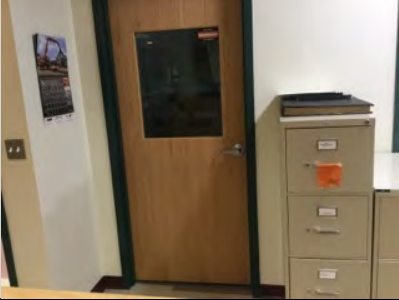
| ID | Location | Floor | Room | Element | Type | Photo | Issues | Current Measure | Recommendations | Quantity | Price | Cost Estimation |
|---|---|---|---|---|---|--|---|---|--|---|---|---|
| 39 | Engineering Conference Room | 1 | | | | | | | Recommend providing designation sign with raised character and braille even though a sign is not provided. | 1 | - | \$0 |

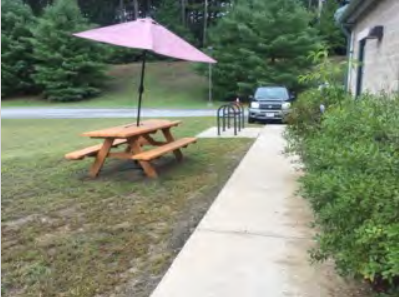
| ID | Location | Floor | Room | Element | Type | Photo | Issues | Current Measure | Recommendations | Quantity | Price | Cost Estimation |
|---|---|---|---|---|---|--|---|---|--|---|---|---|
| 41 | Picnic Table by North Exit | Ext. | | | | | | | Recommend providing an accessible 48-inch wide route around the picnic table with concrete, asphalt or stone dust. | 1 | - | \$0 |

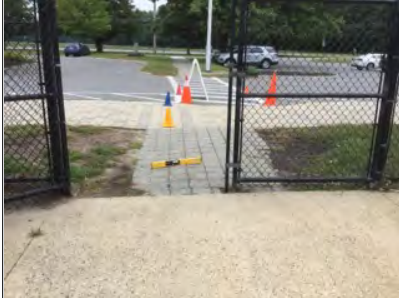
| ID | Location | Floor | Room | Element | Type | Photo | Issues | Current Measure | Recommendations | Quantity | Price | Cost Estimation |
|---|---|---|---|---|---|--|---|---|---|---|---|---|
| 1 | Kids Summer Camp Entrance | Ext. | | Exterior Access Route | Walkway | | Cross slope > 1:50 (2.00%)<br>Does not prevent accumulation of water | 10.7%<br>- | Reduce cross slope to be no steeper than 1:50 (2.00%) and ensure that running slope is no greater than 1:50 (2.00%) at the gate. Repair surface so that it does not accumulate water.<br>(Cost estimate for a 10' long by 4' wide asphalt route.) | 1 | 400 | \$400 |

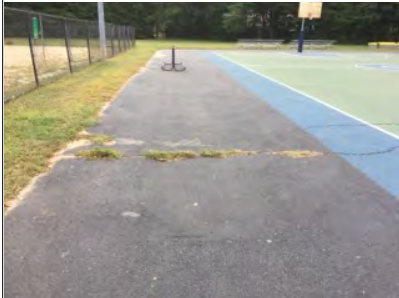
| ID | Location | Floor | Room | Element | Type | Photo | Issues | Current Measure | Recommendations | Quantity | Price | Cost Estimation |
|---|---|---|---|---|---|--|---|---|---|---|---|---|
| 2 | Basketball Court Northeast Walkway | Ext. | | Exterior Access Route | Walkway | | Surface is not stable, firm, and slip-resistant | - | Patch and repair asphalt surface. | 1 | 160 | \$160 |

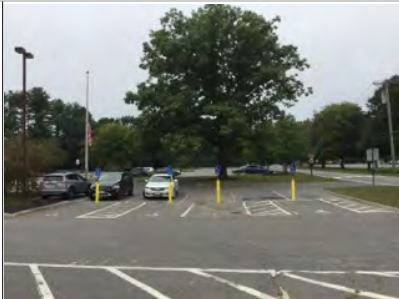
| ID | Location | Floor | Room | Element | Type | Photo | Issues | Current Measure | Recommendations | Quantity | Price | Cost Estimation |
|---|---|---|---|---|---|--|---|---|---|---|---|---|
| 3 | West Parking Lot | Ext. | | Off-Street Parking Lot or Garage | Visitor | | Total # of parking<br>Total # of designated accessible parking spaces<br>Total # of designated van accessible spaces<br>Running or cross slope at space > 1:50 (2.00%) | 107<br>4<br>1<br>6.4% | Reduce running or cross slope at north accessible parking space to be no steeper than 1:50 (2.00%). | 1 | 1440 | \$1440 |

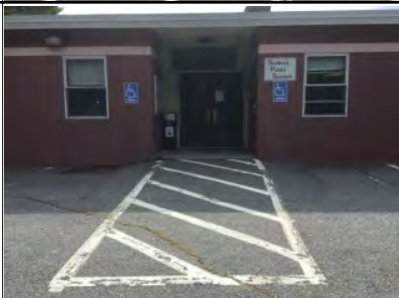
| ID | Location | Floor | Room | Element | Type | Photo | Issues | Current Measure | Recommendations | Quantity | Price | Cost Estimation |
|---|---|---|---|---|---|--|---|---|---|---|---|---|
| 4 | Parking Lot on Northeast Side | Ext. | | Off-Street Parking Lot or Garage | Visitor | | Total # of parking<br>Total # of designated accessible parking spaces<br>Total # of designated van accessible spaces<br>Running or cross slope at space > 1:50 (2.00%)<br>Sign does not have the designation "Van Accessible"<br>Sign bottom < 60" above finished grade | 92<br>5<br>0<br>6.5%<br>-<br>56" | Provide one van accessible space. Add the designation "Van Accessible" to the sign at the larger van accessible parking space. Reduce running or cross slope to be no steeper than 1:50 (2.00%).<br>Locate signs with the bottom of the sign 60" min. above the ground. | 1 | 1940 Labor | \$1940 |

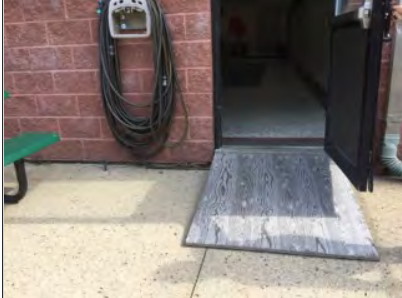
| ID | Location | Floor | Room | Element | Type | Photo | Issues | Current Measure | Recommendations | Quantity | Price | Cost Estimation |
|---|--|---|---|---|---|--|--|---|---|---|---|---|
| 5 | Route Between Pool and Picnic Table Area | 1 | | Exterior Ramp | N/A | | Running slope > 1:12 (8.3%)<br>Handrails not provided at both sides if rise is > 6"<br>Surface is not stable, firm, and slip-resistant | 13.5%<br>7"<br>- | Install a temporary metal ramp to provide an accessible route.<br>(Cost is for a 7' perforated metal ramp with a 5' x 5' platform courtesy of Amramp.) | 1 | 2800 | \$2800 |

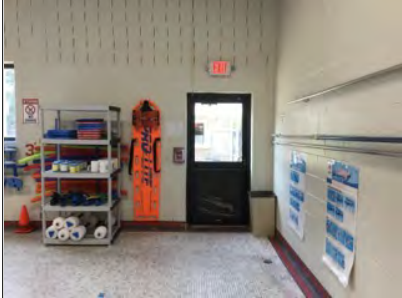
| ID | Location | Floor | Room | Element | Type | Photo | Issues | Current Measure | Recommendations | Quantity | Price | Cost Estimation |
|---|--|---|---|---|---|--|--|---|---|---|---|---|
| 6 | Pool Egress With Step by the Gate | 1 | | Emergency Exit | N/A | | Tactile sign not provided at exit<br>Directional sign to accessible emergency exit not provided | -<br>-<br>- | Provide tactile exit signs with raised characters and braille at exit doors. Mount signs between 48"- 60" above the finished floor located on the latch side of the door.<br>Provide a directional sign indicating the location of the nearest accessible emergency exit. | 1 | 464 | \$464 |

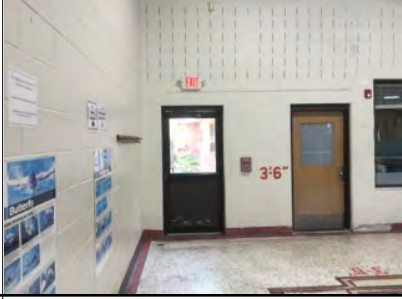
| ID | Location | Floor | Room | Element | Type | Photo | Issues | Current Measure | Recommendations | Quantity | Price | Cost Estimation |
|---|--|---|---|---|---|--|--|---|---|---|---|---|
| 7 | Pool Egress to Stepping Stone Path | 1 | | Emergency Exit | N/A | | Tactile sign not provided at exit<br>Directional sign to accessible emergency exit not provided | -<br>- | Provide tactile exit signs with raised characters and braille at exit doors. Mount signs between 48"- 60" above the finished floor located on the latch side of the door.<br>Provide a directional sign indicating the location of the nearest accessible emergency exit. | 1 | 464 | \$464 |

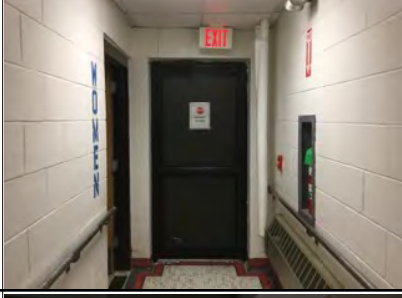
| ID | Location | Floor | Room | Element | Type | Photo | Issues | Current Measure | Recommendations | Quantity | Price | Cost Estimation |
|---|--|---|---|---|---|--|--|---|---|---|---|---|
| 8 | Egress by Pool Locker Rooms to Senior Center Parking Lot | 1 | | Emergency Exit | N/A | | Tactile sign not provided at exit<br>Directional sign to accessible emergency exit not provided | -<br>- | Provide tactile exit signs with raised characters and braille at exit doors. Mount signs between 48"- 60" above the finished floor located on the latch side of the door.<br>Provide a directional sign indicating the location of the nearest accessible emergency exit. | 1 | 464 | \$464 |

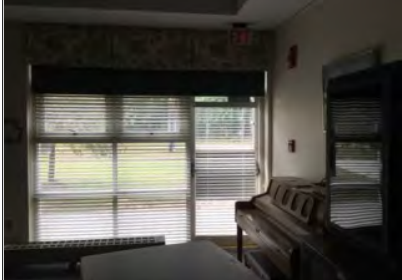
| ID | Location | Floor | Room | Element | Type | Photo | Issues | Current Measure | Recommendations | Quantity | Price | Cost Estimation |
|---|--|---|---|---|---|--|--|---|---|---|---|---|
| 9 | Egress Through Sudbury Pines Room | 1 | | Emergency Exit | N/A | | Tactile sign not provided at exit<br>Directional sign to accessible emergency exit not provided | -<br>- | Provide tactile exit signs with raised characters and braille at exit doors. Mount signs between 48"- 60" above the finished floor located on the latch side of the door.<br>Provide a directional sign indicating the location of the nearest accessible emergency exit. | 1 | 464 | \$464 |

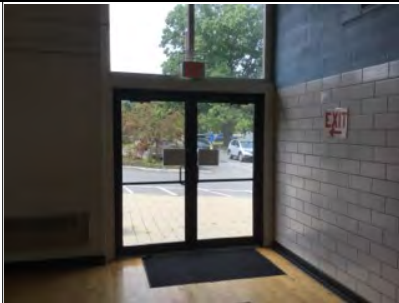
| ID | Location | Floor | Room | Element | Type | Photo | Issues | Current Measure | Recommendations | Quantity | Price | Cost Estimation |
|---|--|---|---|---|---|--|--|---|--|---|---|---|
| 12 | Gym/Stage Egress | 1 | | Emergency Exit | N/A | | Tactile sign not provided at exit<br>Illuminated Int. Symbol of Acc. not provided (MAAB) | -<br>- | Provide tactile exit signs with raised characters and braille at exit doors. Mount signs between 48"- 60" above the finished floor located on the latch side of the door.<br>Provide an illuminated sign with the International Symbol of Accessibility. | 1 | 432 | \$432 |

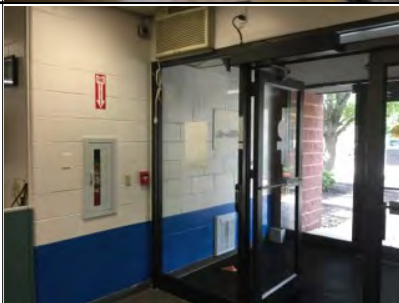
| ID | Location | Floor | Room | Element | Type | Photo | Issues | Current Measure | Recommendations | Quantity | Price | Cost Estimation |
|---|--|---|---|---|---|--|--|---|--|---|---|---|
| 13 | Main Entrance to Pool | 1 | | Emergency Exit | N/A | | Tactile sign not provided at exit<br>Illuminated Int. Symbol of Acc. not provided (MAAB) | -<br>- | Provide tactile exit signs with raised characters and braille at exit doors. Mount signs between 48"- 60" above the finished floor located on the latch side of the door.<br>Provide an illuminated sign with the International Symbol of Accessibility. | 1 | 432 | \$432 |

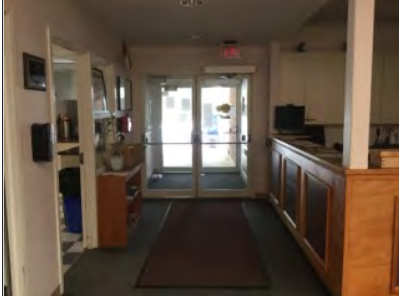
| ID | Location | Floor | Room | Element | Type | Photo | Issues | Current Measure | Recommendations | Quantity | Price | Cost Estimation |
|---|---|---|---|---|---|--|---|---|---|---|---|---|
| 15 | Senior Center Main Exit and School Department Main Exit | 1 | | Emergency Exit | N/A | | Tactile sign not provided at exit<br>Illuminated Int. Symbol of Acc. not provided (MAAB) | -<br>- | Provide tactile exit signs with raised characters and braille at exit doors. Mount signs between 48"- 60" above the finished floor located on the latch side of the door.<br>Provide an illuminated sign with the International Symbol of Accessibility. | 2 | 432 | \$864 |

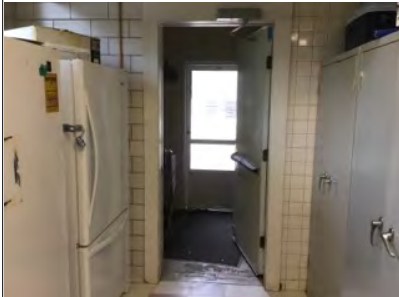
| ID | Location | Floor | Room | Element | Type | Photo | Issues | Current Measure | Recommendations | Quantity | Price | Cost Estimation |
|---|---|---|---|---|---|--|---|---|---|---|---|---|
| 16 | Egress Through Kitchen | 1 | | Emergency Exit | N/A | | Tactile sign not provided at exit<br>Illuminated Int. Symbol of Acc. not provided (MAAB)<br>Maneuvering clearance(s) not provided | -<br>-<br>- | Provide tactile exit signs with raised characters and braille at exit doors. Mount signs between 48"- 60" above the finished floor located on the latch side of the door.<br>Provide an illuminated sign with the International Symbol of Accessibility.<br>Relocate refrigerator to provide 12 inches clear on the latch side of the door, | 1 | 1116 Labor | \$1116 |

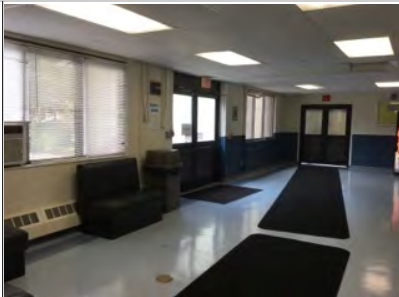
| ID | Location | Floor | Room | Element | Type | Photo | Issues | Current Measure | Recommendations | Quantity | Price | Cost Estimation |
|---|---|---|---|---|---|--|---|---|---|---|---|---|
| 17 | Route to Gym/Stage | 1 | | Interior Access Route | N/A | | Surface not stable, firm, and slip-resistant | 2 | Secure mats. | 1 | Labor | \$0 |

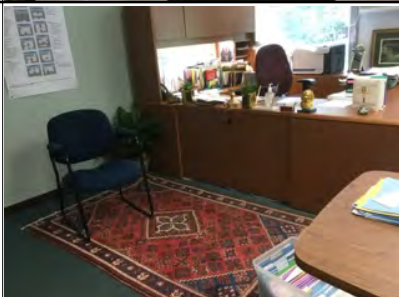
| ID | Location | Floor | Room | Element | Type | Photo | Issues | Current Measure | Recommendations | Quantity | Price | Cost Estimation |
|---|---|---|---|---|---|--|---|---|---|---|---|---|
| 18 | Director of Student Services | 1 | | Interior Access Route | N/A | | Surface not stable, firm, and slip-resistant | - | Secure carpet. | 1 | Labor | \$0 |

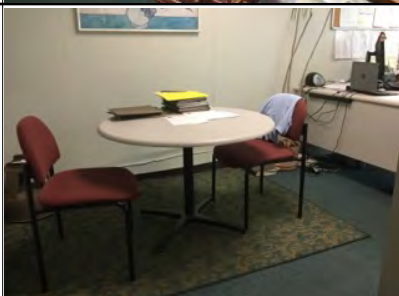
| ID | Location | Floor | Room | Element | Type | Photo | Issues | Current Measure | Recommendations | Quantity | Price | Cost Estimation |
|---|---|---|---|---|---|--|---|---|---|---|---|---|
| 19 | Human Resources | 1 | | Interior Access Route | N/A | | Surface not stable, firm, and slip-resistant | - | Secure carpet. | 1 | Labor | \$0 |

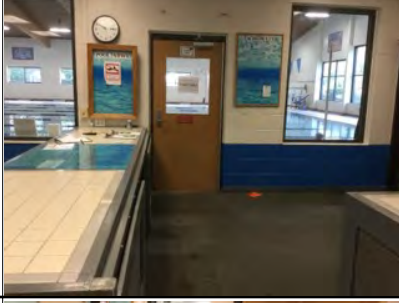
| ID | Location | Floor | Room | Element | Type | Photo | Issues | Current Measure | Recommendations | Quantity | Price | Cost Estimation |
|---|---|---|---|---|---|--|--|---|---|---|---|---|
| 21 | Secondary Entrance to Pool | 1 | | Doors, Doorways, & Gates | Circulation | | Maneuvering clearance(s) not provided | - | Provide an automatic door opener. | 1 | 3060 | \$3060 |

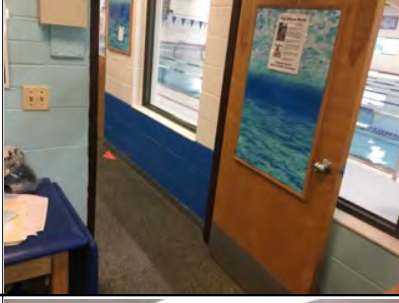
| ID | Location | Floor | Room | Element | Type | Photo | Issues | Current Measure | Recommendations | Quantity | Price | Cost Estimation |
|---|---|---|---|---|---|--|--|---|---|---|---|---|
| 22 | Director's and First Aid Office by Pool | 1 | | Doors, Doorways, & Gates | Office | | Hardware not operable with a closed fist | - | Provide hardware that can be operable with one hand and not require tight grasping, pinching, or twisting of the wrist. | 1 | 484 | \$484 |

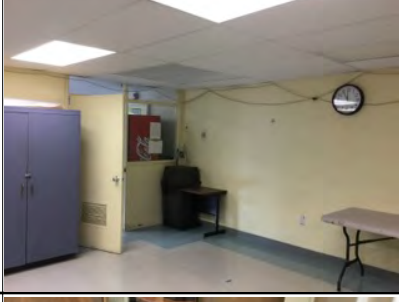
| ID | Location | Floor | Room | Element | Type | Photo | Issues | Current Measure | Recommendations | Quantity | Price | Cost Estimation |
|---|---|---|---|---|---|--|--|---|---|---|---|---|
| 23 | Teen Room | 1 | | Doors, Doorways, & Gates | Meeting Room | | Hardware not operable with a closed fist | - | Provide hardware that can be operable with one hand and not require tight grasping, pinching, or twisting of the wrist. | 1 | 484 | \$484 |

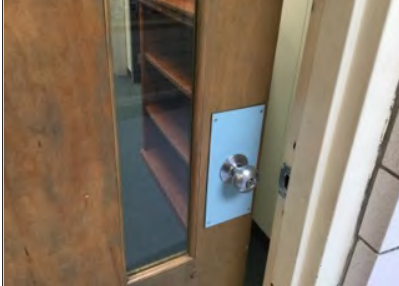
| ID | Location | Floor | Room | Element | Type | Photo | Issues | Current Measure | Recommendations | Quantity | Price | Cost Estimation |
|---|---|---|---|---|---|--|--|---|---|---|---|---|
| 24 | Business Office | 1 | | Doors, Doorways, & Gates | Office | | Hardware not operable with a closed fist | - | Provide hardware that can be operable with one hand and not require tight grasping, pinching, or twisting of the wrist. | 1 | 484 | \$484 |

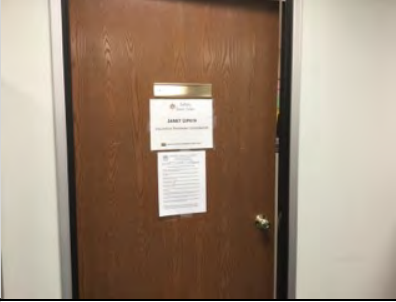
| ID | Location | Floor | Room | Element | Type | Photo | Issues | Current Measure | Recommendations | Quantity | Price | Cost Estimation |
|---|---|---|---|---|---|--|--|---|---|---|---|---|
| 25 | Senior Center Volunteer Program Coordinator | 1 | | Doors, Doorways, & Gates | Office | | Hardware not operable with a closed fist | - | Provide hardware that can be operable with one hand and not require tight grasping, pinching, or twisting of the wrist. | 1 | 484 | \$484 |

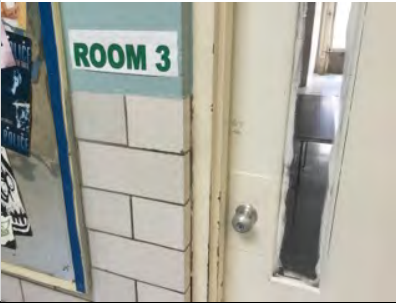
| ID | Location | Floor | Room | Element | Type | Photo | Issues | Current Measure | Recommendations | Quantity | Price | Cost Estimation |
|---|---|---|---|---|---|--|--|---|---|---|---|---|
| 26 | Room 3 Game Room by Parks and Recreation | 1 | | Doors, Doorways, & Gates | Meeting Room | | Hardware not operable with a closed fist | - | Provide hardware that can be operable with one hand and not require tight grasping, pinching, or twisting of the wrist. | 1 | 484 | \$484 |

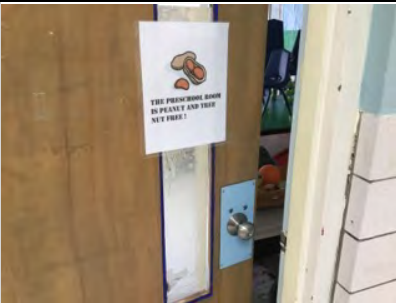
| ID | Location | Floor | Room | Element | Type | Photo | Issues | Current Measure | Recommendations | Quantity | Price | Cost Estimation |
|---|---|---|---|---|---|--|--|---|---|---|---|---|
| 27 | Pre-school Room by Parks and Recreation | 1 | | Doors, Doorways, & Gates | Classroom | | Hardware not operable with a closed fist | - | Provide hardware that can be operable with one hand and not require tight grasping, pinching, or twisting of the wrist. | 1 | 484 | \$484 |

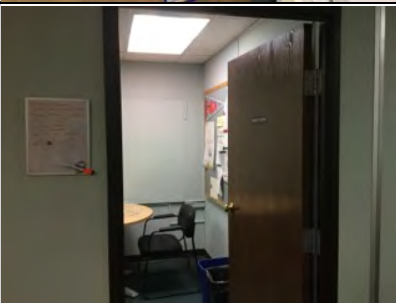
| ID | Location | Floor | Room | Element | Type | Photo | Issues | Current Measure | Recommendations | Quantity | Price | Cost Estimation |
|---|---|---|---|---|---|--|--|---|---|---|---|---|
| 28 | Social Worker for District | 1 | | Doors, Doorways, & Gates | Office | | Hardware not operable with a closed fist | - | Provide hardware that can be operable with one hand and not require tight grasping, pinching, or twisting of the wrist. | 1 | 484 | \$484 |

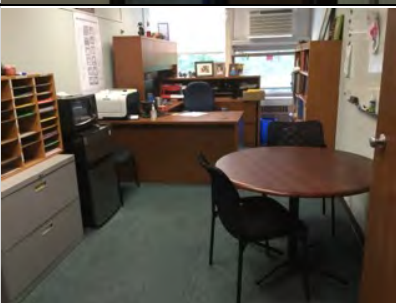
| ID | Location | Floor | Room | Element | Type | Photo | Issues | Current Measure | Recommendations | Quantity | Price | Cost Estimation |
|---|---|---|---|---|---|--|--|---|---|---|---|---|
| 29 | Assistant Director of Student Services | 1 | | Doors, Doorways, & Gates | Office | | Hardware not operable with a closed fist | - | Provide hardware that can be operable with one hand and not require tight grasping, pinching, or twisting of the wrist. | 1 | 484 | \$484 |

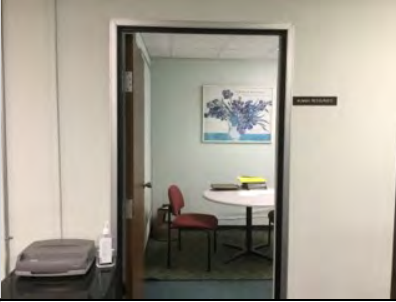
| ID | Location | Floor | Room | Element | Type | Photo | Issues | Current Measure | Recommendations | Quantity | Price | Cost Estimation |
|---|--|---|---|---|---|--|---|---|--|---|---|---|
| 30 | Human Resources | 1 | | Doors, Doorways, & Gates | Office | | Hardware not operable with a closed fist | - | Provide hardware that can be operable with one hand and not require tight grasping, pinching, or twisting of the wrist. | 1 | 484 | \$484 |

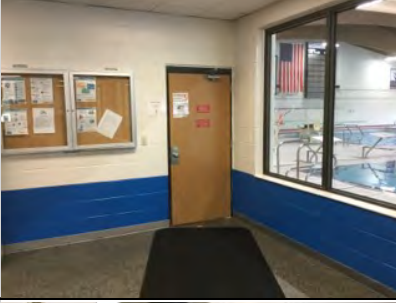
| ID | Location | Floor | Room | Element | Type | Photo | Issues | Current Measure | Recommendations | Quantity | Price | Cost Estimation |
|---|--|---|---|---|---|--|---|---|--|---|---|---|
| 31 | Pool Entrance | 1 | | Doors, Doorways, & Gates | Circulation | | Hardware not operable with a closed fist<br>Door requires > 5 lbs. of force to open | -<br>17 lbs | Provide hardware that can be operable with one hand and not require tight grasping, pinching, or twisting of the wrist.<br>Adjust closers so doors do not require more than 5 pounds of force to open. | 1 | 484<br>Labor | \$484 |

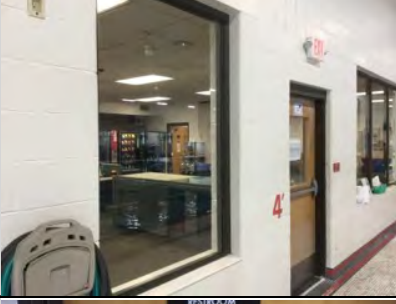
| ID | Location | Floor | Room | Element | Type | Photo | Issues | Current Measure | Recommendations | Quantity | Price | Cost Estimation |
|---|--|---|---|---|---|--|---|---|--|---|---|---|
| 32 | Secondary Entrance to Pool | 1 | | Doors, Doorways, & Gates | Circulation | | Door requires > 5 lbs. of force to open | 16 lbs | Adjust closers so doors do not require more than 5 pounds of force to open. | 1 | Labor | \$0 |

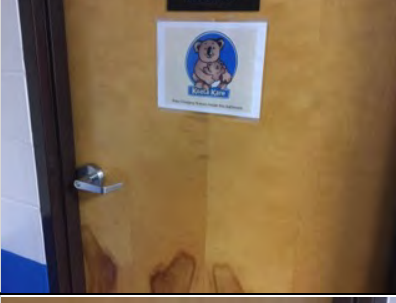
| ID | Location | Floor | Room | Element | Type | Photo | Issues | Current Measure | Recommendations | Quantity | Price | Cost Estimation |
|---|--|---|---|---|---|--|---|---|--|---|---|---|
| 33 | All Gender Toilet Room by Locker Rooms (West Side) | 1 | | Doors, Doorways, & Gates | Toilet Room | | Door requires > 5 lbs. of force to open | 16 lbs | Adjust closers so doors do not require more than 5 pounds of force to open. | 1 | Labor | \$0 |

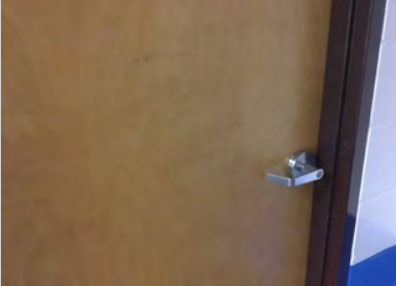
| ID | Location | Floor | Room | Element | Type | Photo | Issues | Current Measure | Recommendations | Quantity | Price | Cost Estimation |
|---|--|---|---|---|---|--|---|---|--|---|---|---|
| 34 | All Gender Toilet Room by Locker Rooms (East Side) | 1 | | Doors, Doorways, & Gates | Toilet Room | | Door requires > 5 lbs. of force to open | 12 lbs | Adjust closers so doors do not require more than 5 pounds of force to open. | 1 | Labor | \$0 |

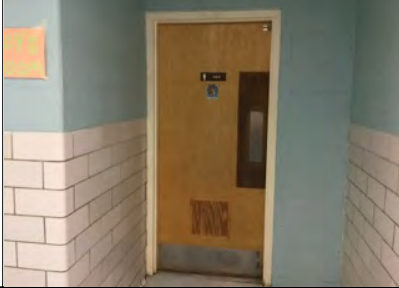
| ID | Location | Floor | Room | Element | Type | Photo | Issues | Current Measure | Recommendations | Quantity | Price | Cost Estimation |
|---|--|---|---|---|---|--|--|---|---|---|---|---|
| 36 | Men's/Boys' Toilet Room by Human Resources | 1 | | Doors, Doorways, & Gates | Toilet Room | | Door requires > 5 lbs. of force to open | 17 lbs | Adjust closers so doors do not require more than 5 pounds of force to open. | 1 | Labor | \$0 |

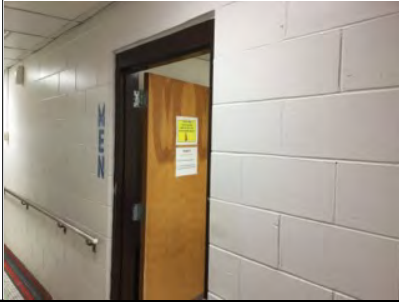
| ID | Location | Floor | Room | Element | Type | Photo | Issues | Current Measure | Recommendations | Quantity | Price | Cost Estimation |
|---|--|---|---|---|---|--|--|---|---|---|---|---|
| 37 | Pool - Men's Locker Room | 1 | | Signage | Designation | | Raised characters not provided on sign<br>Braille not provided on sign | -<br>- | Provide text with raised characters duplicated in braille on sign. | 1 | 232 | \$232 |

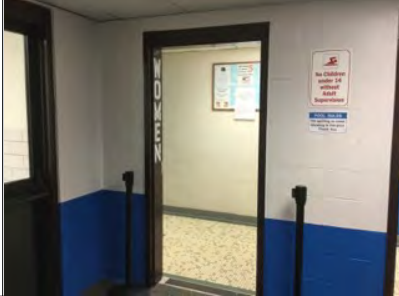
| ID | Location | Floor | Room | Element | Type | Photo | Issues | Current Measure | Recommendations | Quantity | Price | Cost Estimation |
|---|--|---|---|---|---|--|--|---|---|---|---|---|
| 38 | Pool - Women's Locker Room Access From the Reception | 1 | | Signage | Designation | | Raised characters not provided on sign<br>Braille not provided on sign | -<br>- | Provide text with raised characters duplicated in braille on sign. | 1 | 232 | \$232 |

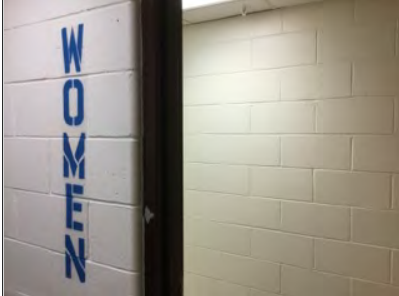
| ID | Location | Floor | Room | Element | Type | Photo | Issues | Current Measure | Recommendations | Quantity | Price | Cost Estimation |
|---|--|---|---|---|---|--|--|---|---|---|---|---|
| 39 | Women's Locker Room Entrance From Pool Side | 1 | | Signage | Designation | | Raised characters not provided on sign<br>Braille not provided on sign | -<br>- | Provide text with raised characters duplicated in braille on sign. | 1 | 232 | \$232 |

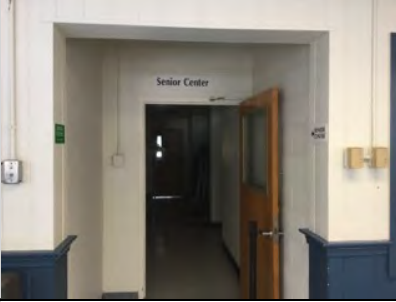
| ID | Location | Floor | Room | Element | Type | Photo | Issues | Current Measure | Recommendations | Quantity | Price | Cost Estimation |
|---|--|---|---|---|---|--|--|---|--|---|---|---|
| 40 | Senior Center Secondary Entrance Next to Gym/Stage | 1 | | Signage | Designation | | Raised characters not provided on sign<br>Braille not provided on sign | -<br>- | Provide text with raised characters duplicated in braille on sign. | 1 | 232 | \$232 |

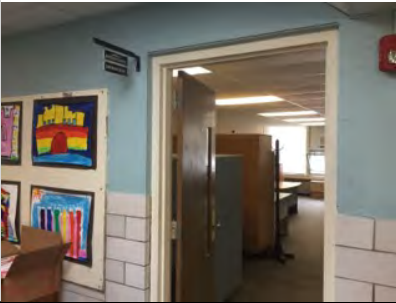
| ID | Location | Floor | Room | Element | Type | Photo | Issues | Current Measure | Recommendations | Quantity | Price | Cost Estimation |
|---|--|---|---|---|---|--|--|---|--|---|---|---|
| 41 | Assistant Superintendent and Superintendent | 1 | | Signage | Designation | | Raised characters not provided on sign<br>Braille not provided on sign | -<br>- | Provide text with raised characters duplicated in braille on sign. | 2 | 232 | \$464 |

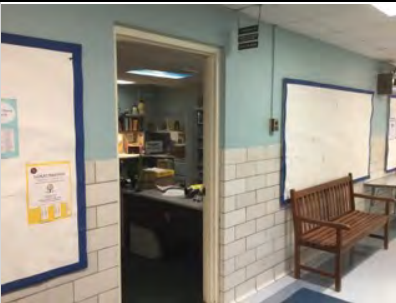
| ID | Location | Floor | Room | Element | Type | Photo | Issues | Current Measure | Recommendations | Quantity | Price | Cost Estimation |
|---|--|---|---|---|---|--|--|---|--|---|---|---|
| 42 | Student Services | 1 | | Signage | Designation | | Raised characters not provided on sign<br>Braille not provided on sign | -<br>- | Provide text with raised characters duplicated in braille on sign. | 1 | 232 | \$232 |

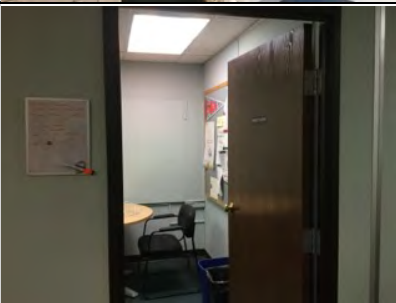
| ID | Location | Floor | Room | Element | Type | Photo | Issues | Current Measure | Recommendations | Quantity | Price | Cost Estimation |
|---|--|---|---|---|---|--|--|---|--|---|---|---|
| 43 | Social Worker for District | 1 | | Signage | Designation | | Raised characters not provided on sign<br>Braille not provided on sign | -<br>- | Provide text with raised characters duplicated in braille on sign. | 1 | 232 | \$232 |

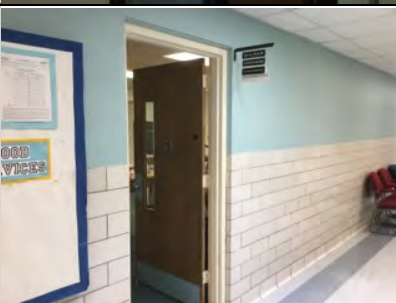
| ID | Location | Floor | Room | Element | Type | Photo | Issues | Current Measure | Recommendations | Quantity | Price | Cost Estimation |
|---|--|---|---|---|---|--|--|---|--|---|---|---|
| 44 | Business Office Clerk and Accounting | 1 | | Signage | Designation | | Raised characters not provided on sign<br>Braille not provided on sign | -<br>- | Provide text with raised characters duplicated in braille on sign. | 1 | 232 | \$232 |

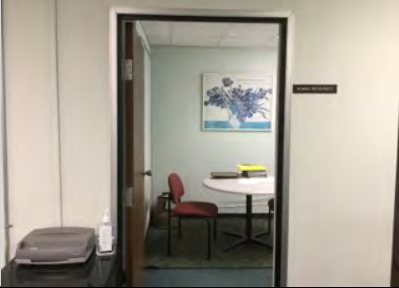
| ID | Location | Floor | Room | Element | Type | Photo | Issues | Current Measure | Recommendations | Quantity | Price | Cost Estimation |
|---|--|---|---|---|---|--|--|---|--|---|---|---|
| 46 | Human Resources | 1 | | Signage | Designation | | Raised characters not provided on sign<br>Braille not provided on sign | -<br>- | Provide text with raised characters duplicated in braille on sign. | 1 | 232 | \$232 |

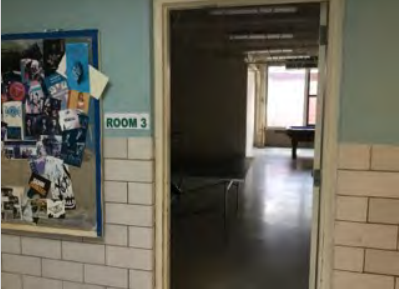
| ID | Location | Floor | Room | Element | Type | Photo | Issues | Current Measure | Recommendations | Quantity | Price | Cost Estimation |
|---|--|---|---|---|---|--|--|---|--|---|---|---|
| 47 | Room 3 Game Room by Parks and Recreation | 1 | | Signage | Designation | | Raised characters not provided on sign<br>Braille not provided on sign | -<br>- | Provide text with raised characters duplicated in braille on sign. | 1 | 232 | \$232 |

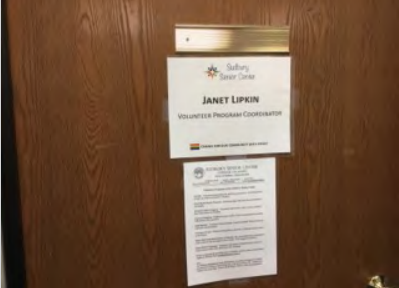
| ID | Location | Floor | Room | Element | Type | Photo | Issues | Current Measure | Recommendations | Quantity | Price | Cost Estimation |
|---|--|---|---|---|---|--|--|---|--|---|---|---|
| 48 | Senior Center Volunteer Program Coordinator | 1 | | Signage | Designation | | Raised characters not provided on sign<br>Braille not provided on sign<br>Sign not located on the latch side of the door | -<br>-<br>- | Provide text with raised characters duplicated in braille on sign.<br>Locate sign at permanent rooms alongside the door on the latch side. | 1 | 232 | \$232 |

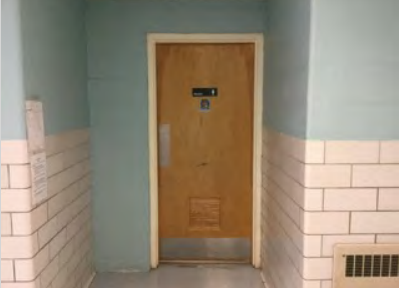
| ID | Location | Floor | Room | Element | Type | Photo | Issues | Current Measure | Recommendations | Quantity | Price | Cost Estimation |
|---|--|---|---|---|---|--|--|---|--|---|---|---|
| 49 | Women's/ Girls' Toilet Room by Human Resources | 1 | 30 | Signage | Designation | | Raised characters not provided on sign<br>Braille not provided on sign<br>Sign not located on the latch side of the door | -<br>-<br>- | Provide text with raised characters duplicated in braille on sign.<br>Locate sign at permanent rooms alongside the door on the latch side. | 1 | 232 | \$232 |

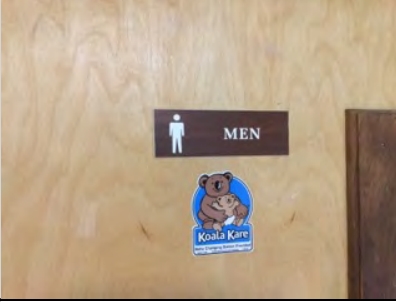
| ID | Location | Floor | Room | Element | Type | Photo | Issues | Current Measure | Recommendations | Quantity | Price | Cost Estimation |
|---|--|---|---|---|---|--|--|---|--|---|---|---|
| 50 | Men's/Boys' Toilet Room by Human Resources | 1 | | Signage | Designation | | Raised characters not provided on sign<br>Braille not provided on sign<br>Sign not located on the latch side of the door | -<br>-<br>- | Provide text with raised characters duplicated in braille on sign.<br>Locate sign at permanent rooms alongside the door on the latch side. | 1 | 232 | \$232 |

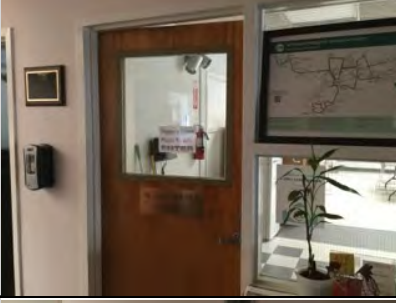
| ID | Location | Floor | Room | Element | Type | Photo | Issues | Current Measure | Recommendations | Quantity | Price | Cost Estimation |
|---|--|---|---|---|---|--|--|---|--|---|---|---|
| 51 | Senior Center, M. Van Houten Room | 1 | | Signage | Designation | | Raised characters not provided on sign<br>Braille not provided on sign<br>Sign not located on the latch side of the door | -<br>-<br>- | Provide text with raised characters duplicated in braille on sign.<br>Locate sign at permanent rooms alongside the door on the latch side. | 1 | 232 | \$232 |

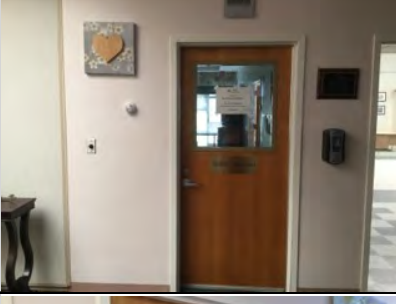
| ID | Location | Floor | Room | Element | Type | Photo | Issues | Current Measure | Recommendations | Quantity | Price | Cost Estimation |
|---|--|---|---|---|---|--|--|---|--|---|---|---|
| 52 | Senior Center, Sudbury Pines Room | 1 | | Signage | Designation | | Raised characters not provided on sign<br>Braille not provided on sign<br>Sign not located on the latch side of the door | -<br>-<br>- | Provide text with raised characters duplicated in braille on sign.<br>Locate sign at permanent rooms alongside the door on the latch side. | 1 | 232 | \$232 |

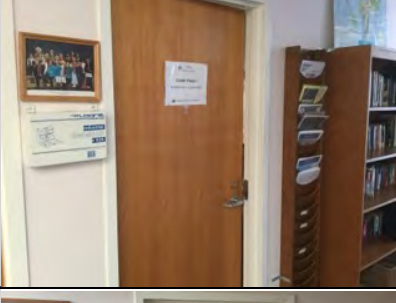
| ID | Location | Floor | Room | Element | Type | Photo | Issues | Current Measure | Recommendations | Quantity | Price | Cost Estimation |
|---|--|---|---|---|---|--|--|---|--|---|---|---|
| 53 | Senior Center, Administrative Coordinator | 1 | | Signage | Designation | | Raised characters not provided on sign<br>Braille not provided on sign<br>Sign not located on the latch side of the door | -<br>-<br>- | Provide text with raised characters duplicated in braille on sign.<br>Locate sign at permanent rooms alongside the door on the latch side. | 1 | 232 | \$232 |

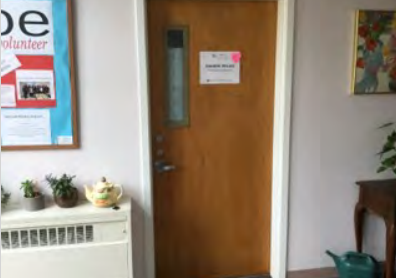
| ID | Location | Floor | Room | Element | Type | Photo | Issues | Current Measure | Recommendations | Quantity | Price | Cost Estimation |
|---|--|---|---|---|---|--|--|---|--|---|---|---|
| 54 | Senior Center, Program Coordinator | 1 | | Signage | Designation | | Raised characters not provided on sign<br>Braille not provided on sign<br>Sign not located on the latch side of the door | -<br>-<br>- | Provide text with raised characters duplicated in braille on sign.<br>Locate sign at permanent rooms alongside the door on the latch side. | 1 | 232 | \$232 |

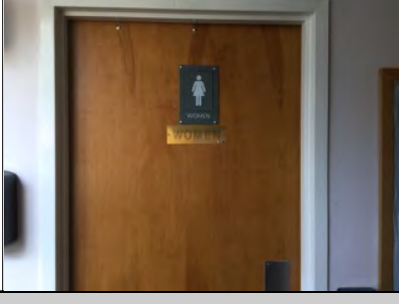
| ID | Location | Floor | Room | Element | Type | Photo | Issues | Current Measure | Recommendations | Quantity | Price | Cost Estimation |
|---|--|---|---|---|---|--|--|---|--|---|---|---|
| 57 | Senior Center, Women's and Men's Toilet Rooms | 1 | | Signage | Designation | | Sign not located on the latch side of the door | - | Locate sign at permanent rooms alongside the door on the latch side. | 2 | Labor | \$0 |

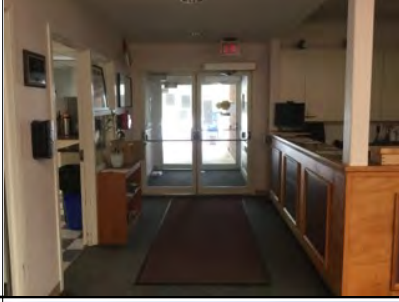
| ID | Location | Floor | Room | Element | Type | Photo | Issues | Current Measure | Recommendations | Quantity | Price | Cost Estimation |
|---|--|---|---|---|---|--|--|---|--|---|---|---|
| 58 | Senior Center Main Reception | 1 | | Service Counter | N/A | | Counter > 36" high | 42.5" | Provide a counter that is 36" max. above the ground or finished floor. | 1 | 880 | \$880 |

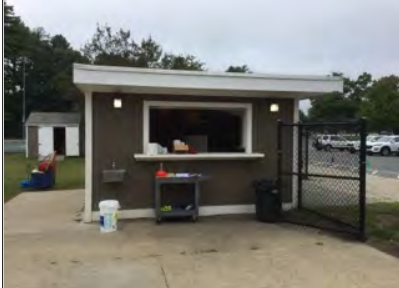
| ID | Location | Floor | Room | Element | Type | Photo | Issues | Current Measure | Recommendations | Quantity | Price | Cost Estimation |
|---|--|---|---|---|---|--|--|---|--|---|---|---|
| 59 | Concession Stand at Kids Summer Camp (Interior of Fence) | Ext. | | Service Counter | N/A | | Counter > 36" high | 47" | Provide a counter that is 36" max. above the ground or finished floor. | 1 | 880 | \$880 |

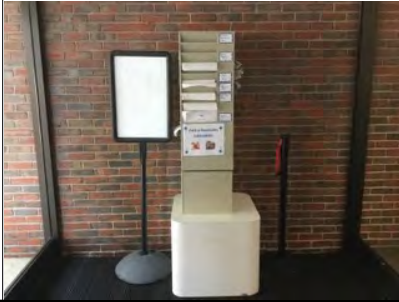
| ID | Location | Floor | Room | Element | Type | Photo | Issues | Current Measure | Recommendations | Quantity | Price | Cost Estimation |
|---|---|---|---|---|---|--|---|---|--|---|---|---|
| 61 | Pool - Main Entrance | 1 | | Operable Parts | Other | | Reach < 15" or > 48"(forward/side approach) | 66" | Ensure that one of each type of form is located no higher than 48" above the finished floor. | 1 | Labor | \$0 |

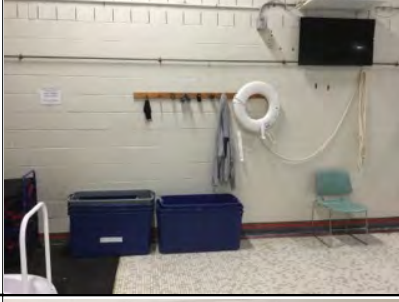
| ID | Location | Floor | Room | Element | Type | Photo | Issues | Current Measure | Recommendations | Quantity | Price | Cost Estimation |
|---|---|---|---|---|---|--|---|---|--|---|---|---|
| 62 | Diving Pool Coat Hooks | 1 | | Operable Parts | Clothes Rod/Hooks | | Side reach > 54" | 69" | Provide one hook at 48" max. above the finished floor. | 1 | 150 | \$150 |

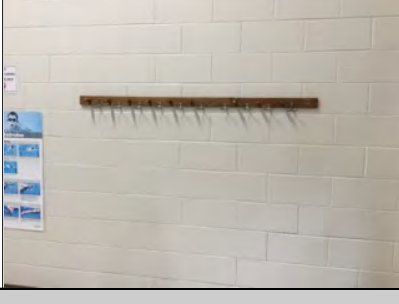
| ID | Location | Floor | Room | Element | Type | Photo | Issues | Current Measure | Recommendations | Quantity | Price | Cost Estimation |
|---|---|---|---|---|---|--|---|---|--|---|---|---|
| 63 | Swimming Pool Coat Hooks | 1 | | Operable Parts | Clothes Rod/Hooks | | Side reach > 54" | 62.5" | Provide one hook at 48" max. above the finished floor. | 1 | 150 | \$150 |

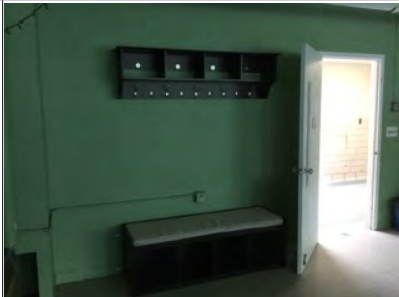
| ID | Location | Floor | Room | Element | Type | Photo | Issues | Current Measure | Recommendations | Quantity | Price | Cost Estimation |
|---|---|---|---|---|---|--|---|---|--|---|---|---|
| 64 | Pre-school Multipurpose Room | 1 | | Children's Reach Ranges | N/A | | Reach < 20" or > 36" (Ages 3 - 4) | 66.25" | Provide one storage hook and shelf that is between 20" and 36" above the finished floor. | 1 | Labor | \$0 |

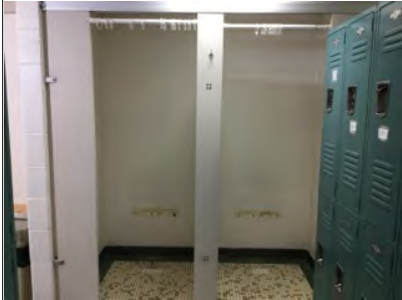
| ID | Location | Floor | Room | Element | Type | Photo | Issues | Current Measure | Recommendations | Quantity | Price | Cost Estimation |
|---|---|---|---|---|---|--|---|---|---|---|---|---|
| 66 | Pool - Women's Locker Room Changing Rooms | 1 | | Locker Room | Women's | | Room is < 78" x 72"<br>Bench < 24" deep<br>Bench < 48" long | 46" 38.5"<br>-<br>- | Provide an accessible changing room that is 78" by 72" minimum.<br>Provide a bench that is 24" deep and 48" long with room on the side to transfer. | 1 | 5866 | \$5866 |

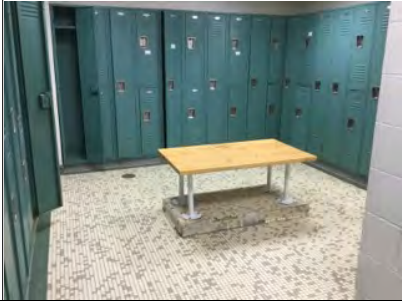
| ID | Location | Floor | Room | Element | Type | Photo | Issues | Current Measure | Recommendations | Quantity | Price | Cost Estimation |
|---|---|---|---|---|---|--|---|---|---|---|---|---|
| 67 | Pool - Women's Locker Room | 1 | | Locker Room | Women's | | Back support not provided at bench<br>Bench is not 17"-19" high<br>Bench < 24" deep<br>Bench < 48" long | -<br>22.5"<br>27"<br>- | Provide at least one bench with back support or that is affixed to a wall with room on the side to transfer.<br>Install a bench with the top of the seat between 17"- 19" above the finished floor.<br>Provide a bench that is 24" deep and 48" long. | 1 | 200 | \$200 |

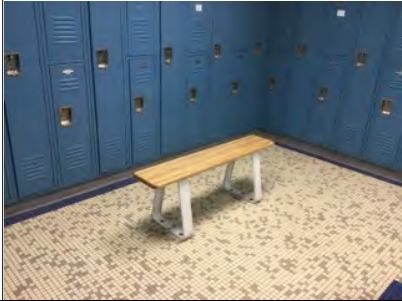
| ID | Location | Floor | Room | Element | Type | Photo | Issues | Current Measure | Recommendations | Quantity | Price | Cost Estimation |
|---|---|---|---|---|---|--|---|---|---|---|---|---|
| 68 | Pool - Men's Locker Room | 1 | | Locker Room | Men's | | Back support not provided at bench<br>Bench < 24" deep<br>Bench < 48" long | -<br>9"<br>- | Provide at least one bench with back support or that is affixed to a wall with room on the side to transfer.<br>Provide a bench that is 24" deep and 48" long. | 1 | 200 | \$200 |

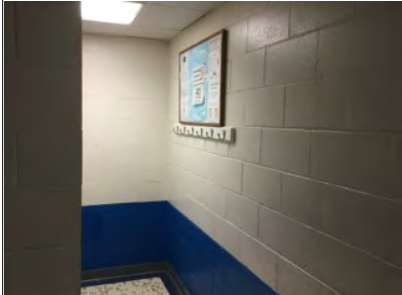
| ID | Location | Floor | Room | Element | Type | Photo | Issues | Current Measure | Recommendations | Quantity | Price | Cost Estimation |
|---|---|---|---|---|---|--|---|---|---|---|---|---|
| 69 | Pool - Men's Locker Room | 1 | | Locker Room | Men's | | Hook > 48" high | 58" | Locate one hook no higher than 48" above the finished floor. | 1 | 150 | \$150 |
