## DPW Offices and Garage

## Town of Sudbury ADA Transition Plan

October 2020

Institute for Human Centered Design

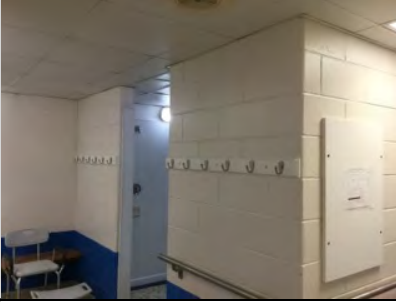
| ID | Location | Floor | Room | Element | Type | Photo | Issues | Current Measure | Recommendations | Quantity | Price | Cost Estimation |
|---|---|---|---|---|---|--|---|---|--|---|---|---|
| 70 | Pool - Men's Showers and Women's Showers | 1 | | Locker Room | Men's | | Hook > 48" high | 62.5" | Locate one hook no higher than 48" above the finished floor. | 2 | 150 | \$300 |

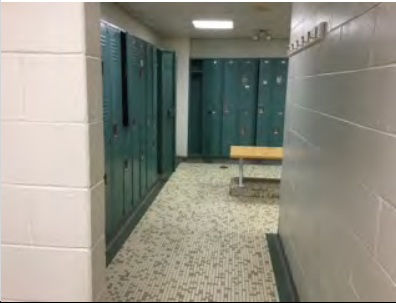
| ID | Location | Floor | Room | Element | Type | Photo | Issues | Current Measure | Recommendations | Quantity | Price | Cost Estimation |
|---|---|---|---|---|---|--|---|---|--|---|---|---|
| 71 | Pool - Women's Locker Room | 1 | | Locker Room | Women's | | Hook > 48" high | 68" | Locate one hook no higher than 48" above the finished floor. | 1 | 150 | \$150 |

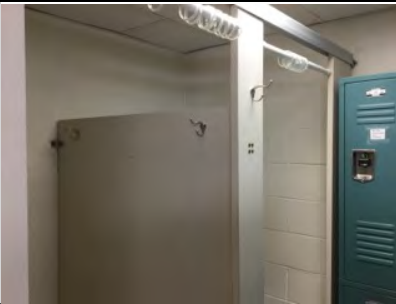
| ID | Location | Floor | Room | Element | Type | Photo | Issues | Current Measure | Recommendations | Quantity | Price | Cost Estimation |
|---|---|---|---|---|---|--|---|---|--|---|---|---|
| 72 | Pool - Women's Locker Room Changing Rooms | 1 | | Locker Room | Women's | | Hook > 48" high | 66.25" | Locate one hook no higher than 48" above the finished floor. | 1 | 150 | \$150 |

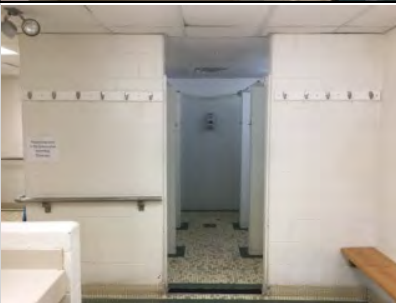
| ID | Location | Floor | Room | Element | Type | Photo | Issues | Current Measure | Recommendations | Quantity | Price | Cost Estimation |
|---|---|---|---|---|---|--|---|---|--|---|---|---|
| 73 | Pool - Women's Locker Room | 1 | | Locker Room | Women's | | Hook > 48" high | 66.25" | Locate one hook no higher than 48" above the finished floor. | 1 | 150 | \$150 |

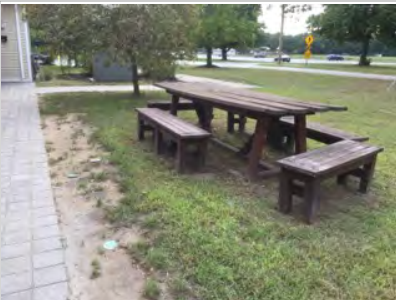
| ID | Location | Floor | Room | Element | Type | Photo | Issues | Current Measure | Recommendations | Quantity | Price | Cost Estimation |
|---|---|---|---|---|---|--|---|---|--|---|---|---|
| 74 | Picnic Table Next to Northeast Parking Lot Accessible Parking by Street | Ext. | | Picnic Tables | N/A | | Toe or knee clearance at tables not provided<br>Picnic table not on an accessible route | -<br>- | Provide at least 1 picnic table in this area with toe and knee clearance.<br>Ensure that the picnic table is connected to an accessible route. | 1 | 1400 | \$1400 |

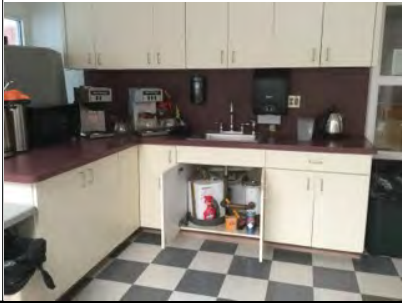
| ID | Location | Floor | Room | Element | Type | Photo | Issues | Current Measure | Recommendations | Quantity | Price | Cost Estimation |
|---|---|---|---|---|---|--|--|---|--|---|---|---|
| 76 | Senior Center, M. Van Houten Room | 1 | | Kitchens and Kitchenettes | Other | | Knee/toe clearance not provided at sink<br>Sink > 34" high | -<br>36.5" | Provide a sink with knee and toe clearance positioned for a forward approach.<br>Ensure the sink is no higher than 34" above the finished floor. | 1 | 4780 | \$4780 |

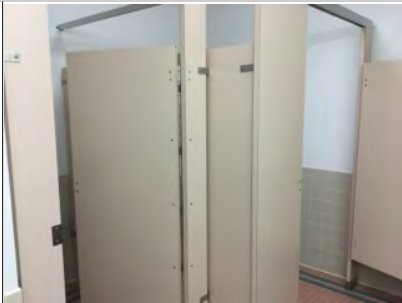
| ID | Location | Floor | Room | Element | Type | Photo | Issues | Current Measure | Recommendations | Quantity | Price | Cost Estimation |
|---|---|---|---|---|---|--|--|---|--|---|---|---|
| 77 | Senior Center, Women's and Men's Toilet Rooms | 1 | | Overall Access | Toilet Room | | Audible and visible alarms not provided | - | When fire system is updated, ensure that a visible and audible fire alarm is installed. | 2 | - | \$0 |

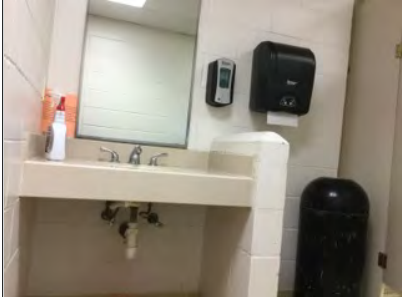
| ID | Location | Floor | Room | Element | Type | Photo | Issues | Current Measure | Recommendations | Quantity | Price | Cost Estimation |
|---|---|---|---|---|---|--|--|---|--|---|---|---|
| 78 | All Gender Toilet Room (West Side) | 1 | | Overall Access | Toilet Room | | Audible and visible alarms not provided | - | When fire system is updated, ensure that a visible and audible fire alarm is installed. | 1 | - | \$0 |

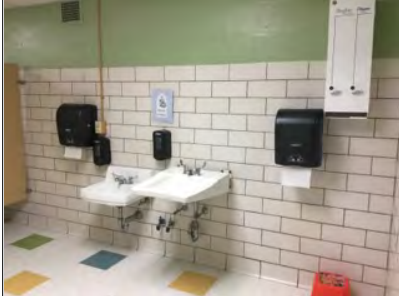
| ID | Location | Floor | Room | Element | Type | Photo | Issues | Current Measure | Recommendations | Quantity | Price | Cost Estimation |
|---|--|---|---|---|---|--|---|---|--|---|---|---|
| 79 | Women's/<br>Girls' Toilet<br>Room by<br>Human<br>Resources | 1 | 30 | Lavatory | N/A | | Plumbing underneath is exposed | - | Insulate or otherwise configure pipes to prevent contact at lavatory with knee and toe clearance. | 1 | 92 | \$92 |

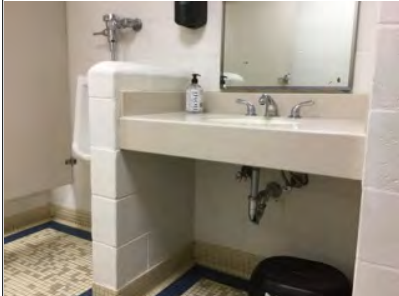
| ID | Location | Floor | Room | Element | Type | Photo | Issues | Current Measure | Recommendations | Quantity | Price | Cost Estimation |
|---|--|---|---|---|---|--|---|---|--|---|---|---|
| 80 | All Gender<br>Toilet Room<br>by Locker<br>Rooms (East<br>Side) | 1 | | Lavatory | N/A | | Plumbing underneath is exposed | - | Insulate or otherwise configure pipes to prevent contact at lavatory. | 1 | 92 | \$92 |

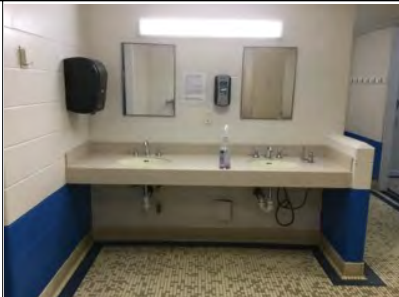
| ID | Location | Floor | Room | Element | Type | Photo | Issues | Current Measure | Recommendations | Quantity | Price | Cost Estimation |
|---|--|---|---|---|---|--|---|---|--|---|---|---|
| 81 | Pool - Men's<br>Locker Room | 1 | | Lavatory | N/A | | Plumbing underneath is exposed<br>Mirror above lavatory w/reflective surface > 40"<br>Dispensers not within reach range | -<br>46.25"<br>50", 52.5" | Insulate or otherwise configure pipes to prevent contact for at least one lavatory.<br>Lower mirror so that the bottom surface is at 40" max. above the finished floor.<br>Lower soap and paper towel dispensers to 42" max. above the floor. | 1 | 860 | \$860 |

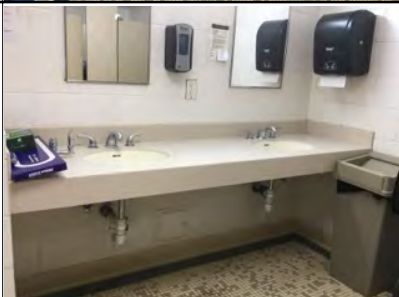
| ID | Location | Floor | Room | Element | Type | Photo | Issues | Current Measure | Recommendations | Quantity | Price | Cost Estimation |
|---|--|---|---|---|---|--|---|---|--|---|---|---|
| 82 | Pool -<br>Women's<br>Locker Room | 1 | | Lavatory | N/A | | Plumbing underneath is exposed<br>Mirror above lavatory w/reflective surface > 40"<br>Dispensers not within reach range | -<br>46"<br>50", 52" | Insulate or otherwise configure pipes to prevent contact for at least one lavatory.<br>Lower mirror so that the bottom surface is at 40" max. above the finished floor.<br>Lower soap and paper towel dispensers to 42" max. above the floor. | 1 | 860 | \$860 |

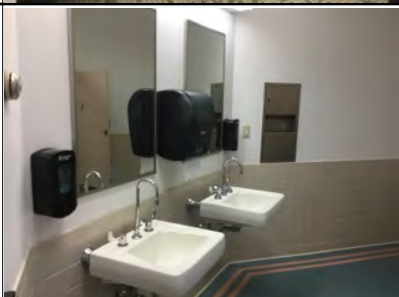
| ID | Location | Floor | Room | Element | Type | Photo | Issues | Current Measure | Recommendations | Quantity | Price | Cost Estimation |
|---|--|---|---|---|---|--|---|---|--|---|---|---|
| 83 | Senior<br>Center,<br>Men's Toilet<br>Room | 1 | | Lavatory | N/A | | Plumbing underneath is exposed<br>Mirror above lavatory w/reflective surface > 40"<br>Dispensers not within reach range | -<br>44.25"<br>49.25", 54.5" | Insulate or otherwise configure pipes to prevent contact for at least one lavatory.<br>Lower mirror so that the bottom surface is at 40" max. above the finished floor.<br>Lower sanitary napkin disposal bag dispenser and paper towel dispenser to 42" max. above the floor. | 1 | 860 | \$860 |

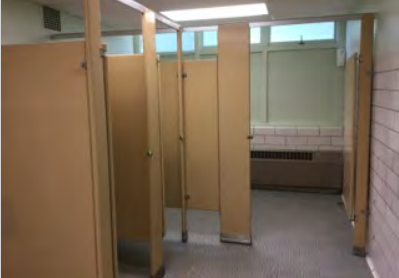
| ID | Location | Floor | Room | Element | Type | Photo | Issues | Current Measure | Recommendations | Quantity | Price | Cost Estimation |
|---|--|---|---|---|---|--|--|---|---|---|---|---|
| 93 | Men's/Boys' Toilet Room by Human Resources | 1 | | Toilet Compartment | Accessible Compartment | | Door has malfunctioning self-closing hinge | - | Repair hinge. | 1 | Labor | \$0 |

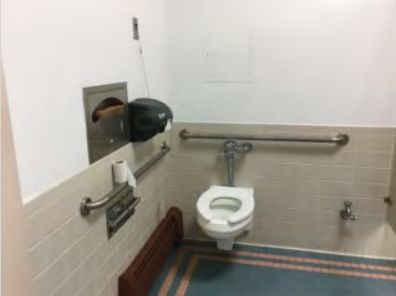
| ID | Location | Floor | Room | Element | Type | Photo | Issues | Current Measure | Recommendations | Quantity | Price | Cost Estimation |
|---|--|---|---|---|---|--|--|---|--|---|---|---|
| 94 | Senior Center, Men's Toilet Room | 1 | | Toilet Compartment | Accessible Compartment | | Side or rear grab bar < 33" or >36" high<br>Flush control not on open side<br>Non-compliant toilet paper dispenser | 30.5"<br>-<br>- | Locate side grab bar between 33"- 36" above the finished floor.<br>Provide the flush control on the open side of the toilet (transfer side).<br>Relocate toilet paper so that it is 24" min. high, located under the grab bar, and between 7" and 9" from the front of the toilet. | 1 | 1123 | \$1123 |

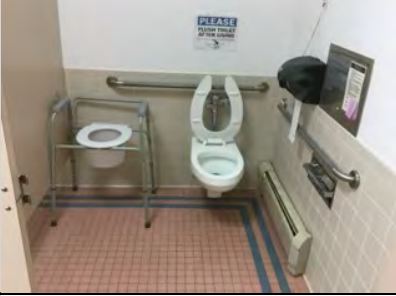
| ID | Location | Floor | Room | Element | Type | Photo | Issues | Current Measure | Recommendations | Quantity | Price | Cost Estimation |
|---|--|---|---|---|---|--|--|---|--|---|---|---|
| 95 | Senior Center, Women's Toilet Room | 1 | | Toilet Compartment | Accessible Compartment | | Side or rear grab bar < 33" or >36" high<br>Non-compliant toilet paper dispenser | 30.5"<br>- | Locate side grab bar between 33"- 36" above the finished floor.<br>Relocate toilet paper so that it is 24" min. high, located under the grab bar, and between 7" and 9" from the front of the toilet. | 1 | 749 | \$749 |

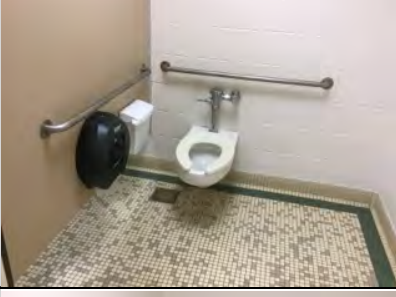
| ID | Location | Floor | Room | Element | Type | Photo | Issues | Current Measure | Recommendations | Quantity | Price | Cost Estimation |
|---|--|---|---|---|---|--|--|---|--|---|---|---|
| 96 | Pool - Women's Locker Room | 1 | | Toilet Compartment | Accessible Compartment | | Flush control not on open side | - | Provide the flush control on the open side of the toilet (transfer side). | 1 | 374 | \$374 |

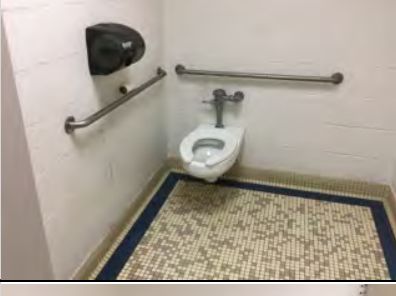
| ID | Location | Floor | Room | Element | Type | Photo | Issues | Current Measure | Recommendations | Quantity | Price | Cost Estimation |
|---|--|---|---|---|---|--|--|---|--|---|---|---|
| 97 | All Gender Toilet Room by Locker Rooms (East Side) | 1 | | Toilet Compartment | Accessible Compartment | | Flush control not on open side<br>Non-compliant toilet paper dispenser | -<br>- | Provide the flush control on the open side of the toilet (transfer side).<br>Relocate toilet paper so that it is 24" min. high, located under the grab bar, and between 7" and 9" from the front of the toilet. | 1 | 630 | \$630 |

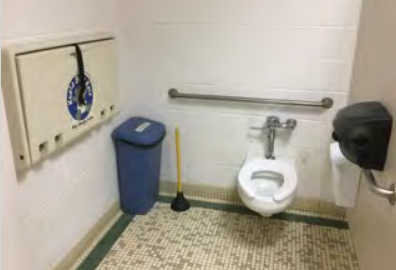
| ID | Location | Floor | Room | Element | Type | Photo | Issues | Current Measure | Recommendations | Quantity | Price | Cost Estimation |
|---|--|---|---|---|---|--|--|---|--|---|---|---|
| 98 | All Gender Toilet Room by Locker Rooms (West Side) | 1 | | Toilet Compartment | Accessible Compartment | | Non-compliant toilet paper dispenser | - | Relocate toilet paper so that it is 24" min. high, located under the grab bar, and between 7" and 9" from the front of the toilet. | 1 | 256 | \$256 |

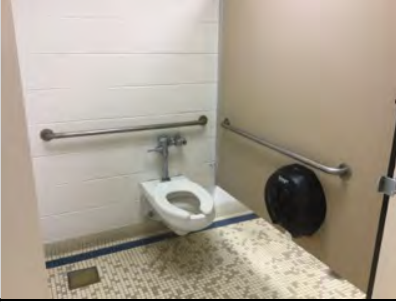
| ID | Location | Floor | Room | Element | Type | Photo | Issues | Current Measure | Recommendations | Quantity | Price | Cost Estimation |
|---|--|---|---|---|---|--|--|---|--|---|---|---|
| 99 | Pool - Men's Locker Room | 1 | | Toilet Compartment | Accessible Compartment | | Clearance at toilet < 72" clear depth (MAAB) | 68" | Provide a wheelchair accessible compartment that is 60" wide and 72" deep. | 1 | 6182 | \$6182 |

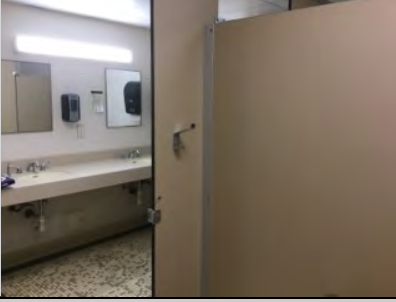
| ID | Location | Floor | Room | Element | Type | Photo | Issues | Current Measure | Recommendations | Quantity | Price | Cost Estimation |
|---|--|---|---|---|---|--|--|---|--|---|---|---|
| 100 | Pool - Women's Locker Room | 1 | | Toilet Compartment | Accessible Compartment | | Coat hook > 48" | 56" | Lower coat hook so that it is no higher than 48". | 1 | 150 | \$150 |

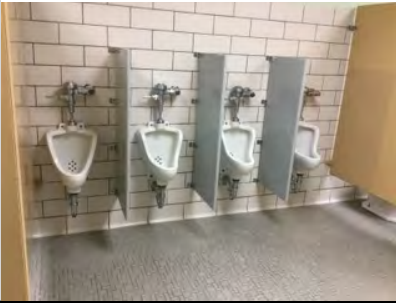
| ID | Location | Floor | Room | Element | Type | Photo | Issues | Current Measure | Recommendations | Quantity | Price | Cost Estimation |
|---|--|---|---|---|---|--|--|---|--|---|---|---|
| 101 | Men's/Boys' Toilet Room by Human Resources | 1 | | Urinal | N/A | | Rim > 17" high<br>Clear floor space not provided at urinal | 24.5"<br>29" | Provide at least one urinal with the rim no higher than 17" above the finished floor.<br>Remove partition to provide a 30" min. by 48" min. clear floor space positioned for a forward approach. | 1 | 3601 | \$3601 |

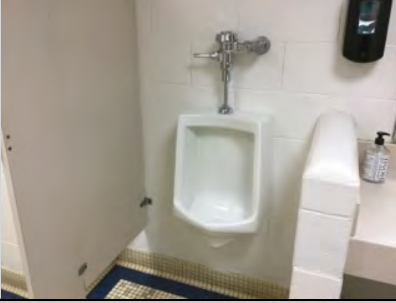
| ID | Location | Floor | Room | Element | Type | Photo | Issues | Current Measure | Recommendations | Quantity | Price | Cost Estimation |
|---|--|---|---|---|---|--|--|---|--|---|---|---|
| 102 | All Gender Toilet Room by Locker Rooms (East Side) | 1 | | Urinal | N/A | | Rim > 17" high<br>Flush control too high or not properly located | 25"<br>51" | Provide at least one urinal with the rim no higher than 17" above the finished floor.<br>Mount flush control at 44" max. above the finished floor. | 1 | 3622 | \$3622 |

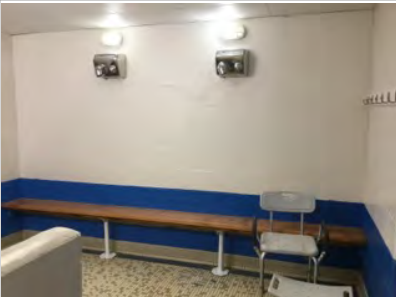
| ID | Location | Floor | Room | Element | Type | Photo | Issues | Current Measure | Recommendations | Quantity | Price | Cost Estimation |
|---|--|---|---|---|---|--|--|---|--|---|---|---|
| 103 | Pool - Men's Locker Room | 1 | | Dispensers | Hand Dryer | | Controls > 42" high<br>Clear floor space not provided at accessory | 70"<br>- | Relocate one hand dryer so the operable part is 42" max. above the finished floor and there is a 30" min. by 48" min. clear floor space. | 1 | 256 | \$256 |

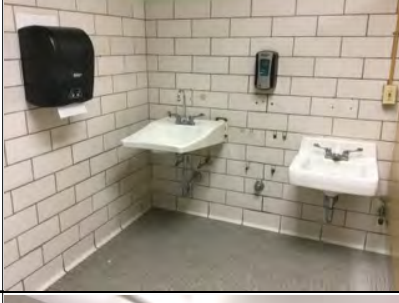
| ID | Location | Floor | Room | Element | Type | Photo | Issues | Current Measure | Recommendations | Quantity | Price | Cost Estimation |
|---|--|---|---|---|---|--|--|---|--|---|---|---|
| 106 | Men's/Boys' Toilet Room by Human Resources | 1 | | Dispensers | Paper Towel Dispenser | | Controls > 42" high<br>Dispenser acts as a protruding object | 43.75"<br>- | Relocate paper towel dispenser so the operable part is 42" max. above the finished floor, and out of the circulation path. | 1 | 353 | \$353 |

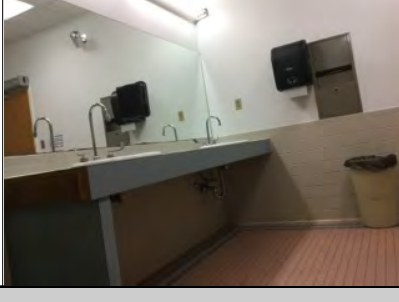
| ID | Location | Floor | Room | Element | Type | Photo | Issues | Current Measure | Recommendations | Quantity | Price | Cost Estimation |
|---|--|---|---|---|---|--|--|---|--|---|---|---|
| 107 | Senior Center, Women's Toilet Room | 1 | | Dispensers | Paper Towel Dispenser | | Controls > 42" high<br>Dispenser acts as a protruding object | 49"<br>- | Relocate paper towel dispenser so the operable part is 42" max. above the finished floor, and out of the circulation path. | 1 | 256 | \$256 |

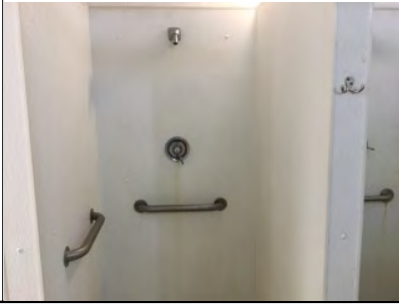
| ID | Location | Floor | Room | Element | Type | Photo | Issues | Current Measure | Recommendations | Quantity | Price | Cost Estimation |
|---|--|---|---|---|---|--|--|---|--|---|---|---|
| 108 | Pool - Women's Showers | 1 | | Shower Compartment | Transfer Type | | Accessible shower not provided | | Provide at least one accessible transfer shower with compliant grab bars and a padded seat. | 1 | 6072 | \$6072 |

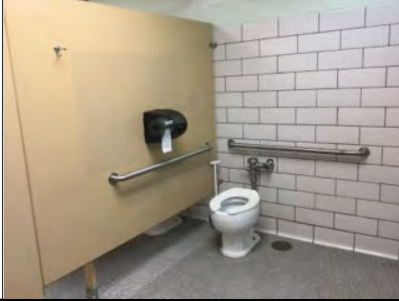
| ID | Location | Floor | Room | Element | Type | Photo | Issues | Current Measure | Recommendations | Quantity | Price | Cost Estimation |
|---|--|---|---|---|---|--|--|---|---|---|---|---|
| 109 | Men's/Boys' Toilet Room by Human Resources | 1 | | Toilet Compartment (Children) | Accessible Compartment | | Flush control not on open side<br>Non-compliant toilet paper dispenser | -<br>- | Provide the flush control on the open side of the toilet (transfer side), no higher than 44".<br>Relocate toilet paper dispenser so that it is between 14"- 19" above the floor and between 7"- 9" in front of the toilet. Ensure dispensers and other devices are not mounted above grab bars. | 1 | 630 | \$630 |

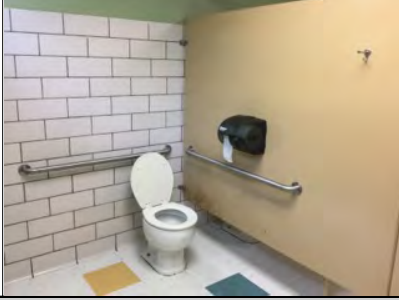
| ID | Location | Floor | Room | Element | Type | Photo | Issues | Current Measure | Recommendations | Quantity | Price | Cost Estimation |
|---|--|---|---|---|---|--|--|---|---|---|---|---|
| 110 | Women's/ Girls' Toilet Room by Human Resources | 1 | 30 | Toilet Compartment (Children) | Accessible Compartment | | Non-compliant toilet paper dispenser<br>Coat hook not within reach range | -<br>59.25" | Relocate toilet paper dispenser so that it is between 14"- 19" above the floor and between 7"- 9" in front of the toilet. Ensure dispensers and other devices are not mounted above grab bars.<br>Lower hook so that it is no higher than 36" high for children ages 3-4. | 1 | 406 | \$406 |

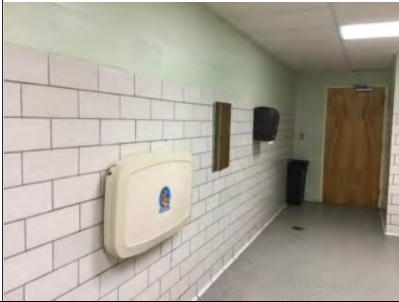
| ID | Location | Floor | Room | Element | Type | Photo | Issues | Current Measure | Recommendations | Quantity | Price | Cost Estimation |
|---|--|---|---|---|---|--|--|---|---|---|---|---|
| 111 | Men's/Boys' Toilet Room by Human Resources | 1 | | Dispensers (Children) | Paper Towel Dispenser | | Dispenser controls > 42" high<br>Dispenser is a protruding object | 49.5"<br>9.5" | Relocate paper towel dispenser so the operable part is 42" max. above the finished floor, and out of the circulation path. | 1 | 353 | \$353 |

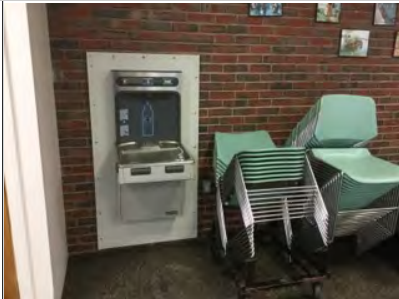
| ID | Location | Floor | Room | Element | Type | Photo | Issues | Current Measure | Recommendations | Quantity | Price | Cost Estimation |
|---|--|---|---|---|---|--|--|---|---|---|---|---|
| 112 | Meeting Room by Pool | 1 | | Drinking Fountains | Low | | No drinking fountain provided for standing users | - | Provide an additional drinking fountain for standing users. | 1 | 4028 | \$4028 |

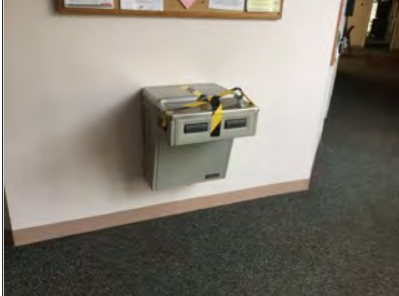
| ID | Location | Floor | Room | Element | Type | Photo | Issues | Current Measure | Recommendations | Quantity | Price | Cost Estimation |
|---|---|---|---|---|---|--|--|---|---|---|---|---|
| 113 | Senior Center, Drinking Fountain Next to Toilet Rooms | 1 | | Drinking Fountains | Low | | No drinking fountain provided for standing users | - | Install a Hi-Lo drinking fountain. | 1 | 4216 | \$4216 |

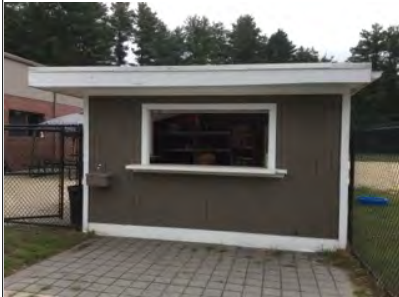
| ID | Location | Floor | Room | Element | Type | Photo | Issues | Current Measure | Recommendations | Quantity | Price | Cost Estimation |
|---|---|---|---|---|---|--|--|---|---|---|---|---|
| 114 | Concession Stand | Ext. | | Drinking Fountains | High | | No drinking fountain provided for seated users | - | Provide an additional drinking fountain for seated users. | 1 | 4028 | \$4028 |

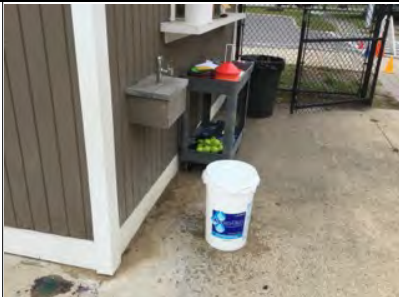
| ID | Location | Floor | Room | Element | Type | Photo | Issues | Current Measure | Recommendations | Quantity | Price | Cost Estimation |
|---|---|---|---|---|---|--|--|---|---|---|---|---|
| 115 | Drinking Fountain at Concession Stand (Interior of Fence) | Ext. | | Drinking Fountains | High | | No drinking fountain provided for seated users<br>Standing height fountain does not have cane protection | -<br>- | Provide an additional drinking fountain for seated users.<br>Provide a cane-detectable barrier skirt under the high unit. | 1 | 4918 | \$4918 |

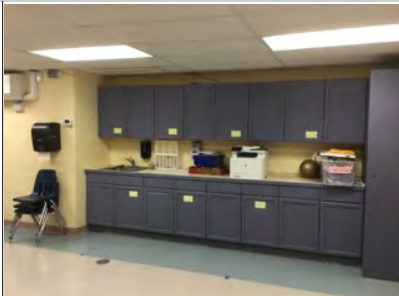
| ID | Location | Floor | Room | Element | Type | Photo | Issues | Current Measure | Recommendations | Quantity | Price | Cost Estimation |
|---|---|---|---|---|---|--|--|---|---|---|---|---|
| 116 | Teen Room | 1 | | Sink | Kitchenette | | Toe and knee clearances not provided<br>Rim or counter > 34" | -<br>36.5" | Ensure there is a 27" knee clearance positioned for a forward approach.<br>Relocate sink with the front of the rim or counter no higher than 34". | 1 | 4780 | \$4780 |

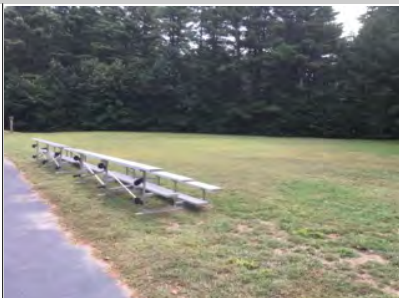
| ID | Location | Floor | Room | Element | Type | Photo | Issues | Current Measure | Recommendations | Quantity | Price | Cost Estimation |
|---|---|---|---|---|---|--|--|---|---|---|---|---|
| 117 | Open Field | Ext. | | Field | Soccer | | Accessible spaces not provided at sidelines seating | - | Provide a 36" x 48" clear floor space at sidelines seating on each side of the bleachers.<br>(Cost estimate for two 3' x 4' asphalt areas.) | 2 | 120 | \$240 |

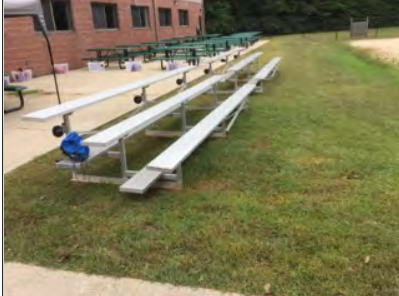
| ID | Location | Floor | Room | Element | Type | Photo | Issues | Current Measure | Recommendations | Quantity | Price | Cost Estimation |
|---|---|---|---|---|---|--|---|---|---|---|---|---|
| 118 | Volleyball Court | Ext. | | Court | Volleyball | | Accessible spaces are not provided at sidelines seating | - | Provide a 36" x 48" clear floor space at sidelines seating on each side of the bleachers. (Cost estimate for two 3' x 4' concrete areas.) | 2 | 192 | \$384 |

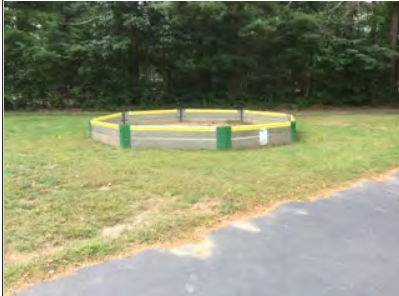
| ID | Location | Floor | Room | Element | Type | Photo | Issues | Current Measure | Recommendations | Quantity | Price | Cost Estimation |
|---|---|---|---|---|---|--|---|---|---|---|---|---|
| 119 | Gaga Ball Court | Ext. | | Court | | | Court is not connected to an accessible route | - | Provide an accessible route to the court and an ADA compliant doorway to the court. (Cost estimate for a hinged doorway at court and 10' long 4' wide asphalt route to the court.) | 1 | 750 | \$750 |

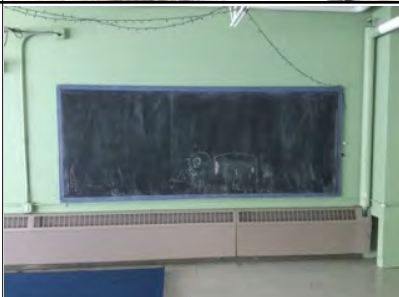
| ID | Location | Floor | Room | Element | Type | Photo | Issues | Current Measure | Recommendations | Quantity | Price | Cost Estimation |
|---|---|---|---|---|---|--|---|---|---|---|---|---|
| 121 | Pre-school Multipurpose Room | 1 | | | | | | | For children aged 3-4 under the ADA the recommendations for reach ranges are between 20" and 36" high, and this blackboard is located near the top of that reach range at 33" above the finished floor. Recommend providing a lower blackboard. | 1 | - | \$0 |

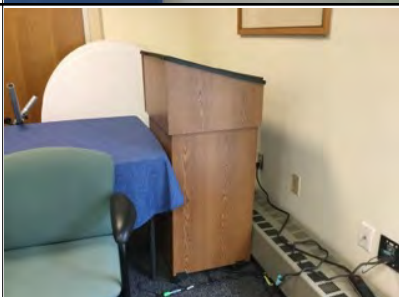
| ID | Location | Floor | Room | Element | Type | Photo | Issues | Current Measure | Recommendations | Quantity | Price | Cost Estimation |
|---|---|---|---|---|---|--|---|---|---|---|---|---|
| 122 | Senior Center, Podium | 1 | | | | | | | Recommend providing an adjustable height podium. | 1 | - | \$0 |

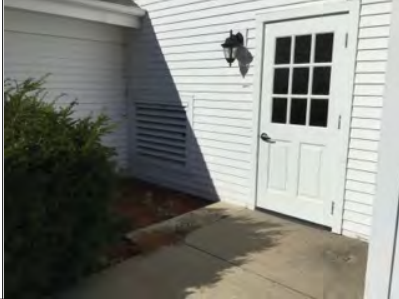
| ID | Location | Floor | Room | Element | Type | Photo | Issues | Current Measure | Recommendations | Quantity | Price | Cost Estimation |
|---|---|---|---|---|---|--|--|---|--|---|---|---|
| 1 | Secondary Entrance on South | Ext. | | Entrance | Secondary Entrance | | Surface not stable, firm, and slip-resistant at entrance | - | Remove the weeds from the door maneuvering clearance area. | 1 | Labor | \$0 |

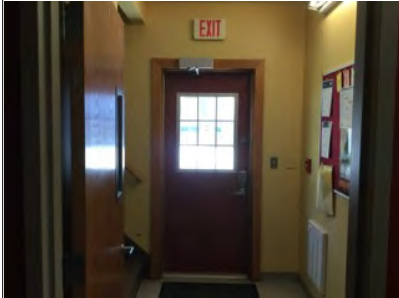
| ID | Location | Floor | Room | Element | Type | Photo | Issues | Current Measure | Recommendations | Quantity | Price | Cost Estimation |
|---|---|---|---|---|---|--|--|---|--|---|---|---|
| 2 | Main Entrance | 1 | | Emergency Exit | N/A | | Tactile sign not provided at exit<br>Illuminated Int. Symbol of Acc. not provided (MAAB) | -<br>- | Provide tactile exit signs with raised characters and braille at exit doors. Mount signs between 48"- 60" above the finished floor located on the latch side of the door.<br>Provide an illuminated sign with the International Symbol of Accessibility. | 1 | 432 | \$432 |

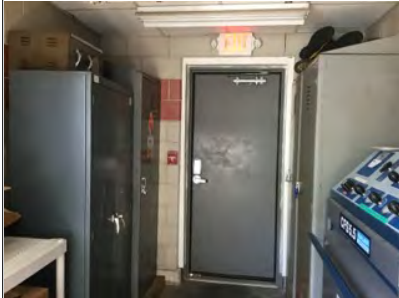
| ID | Location | Floor | Room | Element | Type | Photo | Issues | Current Measure | Recommendations | Quantity | Price | Cost Estimation |
|---|---|---|---|---|---|--|--|---|--|---|---|---|
| 3 | Apparatus Room, South Side Exit | LL | | Emergency Exit | N/A | | Tactile sign not provided at exit<br>Illuminated Int. Symbol of Acc. not provided (MAAB) | -<br>- | Provide tactile exit signs with raised characters and braille at exit doors. Mount signs between 48"- 60" above the finished floor located on the latch side of the door.<br>Provide an illuminated sign with the International Symbol of Accessibility. | 1 | 432 | \$432 |

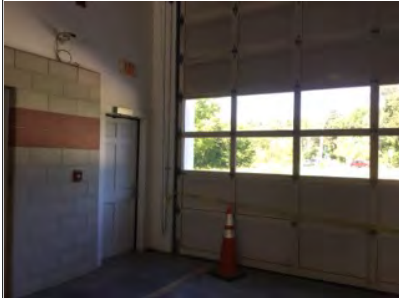
| ID | Location | Floor | Room | Element | Type | Photo | Issues | Current Measure | Recommendations | Quantity | Price | Cost Estimation |
|---|---|---|---|---|---|--|--|---|--|---|---|---|
| 4 | Apparatus Room, North Side Exit (Front) | LL | | Emergency Exit | N/A | | Tactile sign not provided at exit<br>Illuminated Int. Symbol of Acc. not provided (MAAB) | -<br>- | Provide tactile exit signs with raised characters and braille at exit doors. Mount signs between 48"- 60" above the finished floor located on the latch side of the door.<br>Provide an illuminated sign with the International Symbol of Accessibility. | 1 | 432 | \$432 |

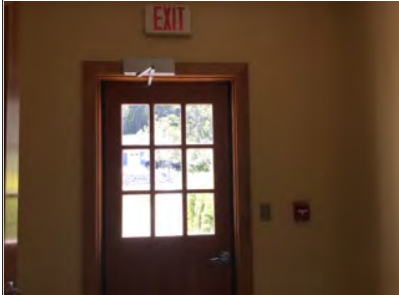
| ID | Location | Floor | Room | Element | Type | Photo | Issues | Current Measure | Recommendations | Quantity | Price | Cost Estimation |
|---|---|---|---|---|---|--|--|---|--|---|---|---|
| 5 | Secondary Entrance on South | 1 | | Emergency Exit | N/A | | Tactile sign not provided at exit<br>Illuminated Int. Symbol of Acc. not provided (MAAB)<br>Door requires > 15 lbs. of force to open | -<br>-<br>17 lbs | Provide tactile exit signs with raised characters and braille at exit doors. Mount signs between 48"- 60" above the finished floor located on the latch side of the door.<br>Provide an illuminated sign with the International Symbol of Accessibility.<br>Adjust closers of exterior doors so doors do not require more than 15 pounds of force. | 1 | 432<br>Labor | \$432 |

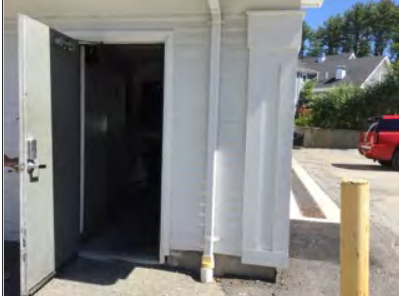
| ID | Location | Floor | Room | Element | Type | Photo | Issues | Current Measure | Recommendations | Quantity | Price | Cost Estimation |
|---|---|---|---|---|---|--|---|---|--|---|---|---|
| 6 | Apparatus Room, South Side Exit | Ext. | | Emergency Exit | N/A | | Threshold > 1/2" high | 2.5" | Alter the threshold to be 1/2" high max. | 1 | 150 | \$150 |

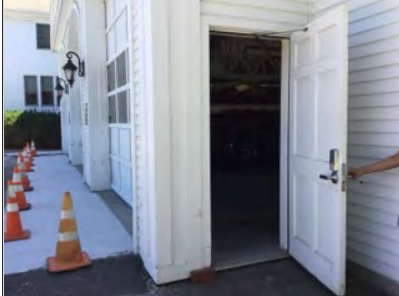
| ID | Location | Floor | Room | Element | Type | Photo | Issues | Current Measure | Recommendations | Quantity | Price | Cost Estimation |
|---|---|---|---|---|---|--|---|---|--|---|---|---|
| 7 | Apparatus Room, North Side Exit (Front) | Ext. | | Emergency Exit | N/A | | Threshold > 1/2" high | 2.5" | Alter the threshold to be 1/2" high max. | 1 | 150 | \$150 |

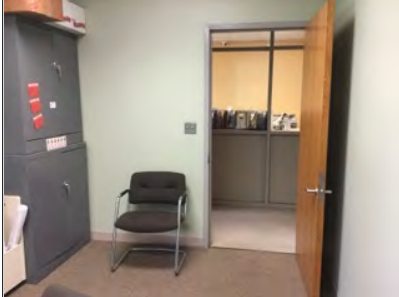
| ID | Location | Floor | Room | Element | Type | Photo | Issues | Current Measure | Recommendations | Quantity | Price | Cost Estimation |
|---|---|---|---|---|---|--|---|---|--|---|---|---|
| 8 | Conference Room | 1 | | Doors, Doorways, & Gates | Meeting Room | | Maneuvering clearance(s) not provided | - | Relocate the chair to ensure that there is 18" clear on the latch side of the door. | 1 | Labor | \$0 |

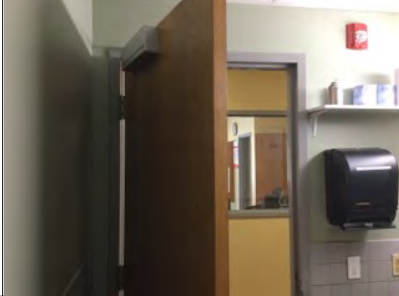
| ID | Location | Floor | Room | Element | Type | Photo | Issues | Current Measure | Recommendations | Quantity | Price | Cost Estimation |
|---|---|---|---|---|---|--|---|---|--|---|---|---|
| 9 | Men's Toilet Room | 1 | | Doors, Doorways, & Gates | Toilet Room | | Maneuvering clearance(s) not provided | - | Provide an automatic door opener. | 1 | 3060 | \$3060 |

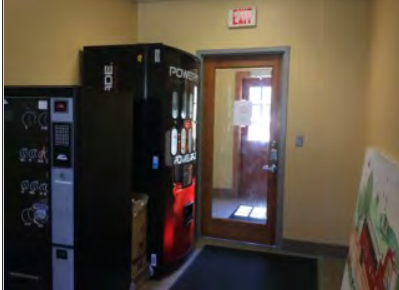
| ID | Location | Floor | Room | Element | Type | Photo | Issues | Current Measure | Recommendations | Quantity | Price | Cost Estimation |
|---|---|---|---|---|---|--|---|---|--|---|---|---|
| 10 | Secondary Entrance/ Egress | 1 | | Doors, Doorways, & Gates | Circulation | | Maneuvering clearance(s) not provided | - | Ensure that vending machine is placed so that it does not affect clear width or maneuvering clearance at the door. | 1 | Labor | \$0 |

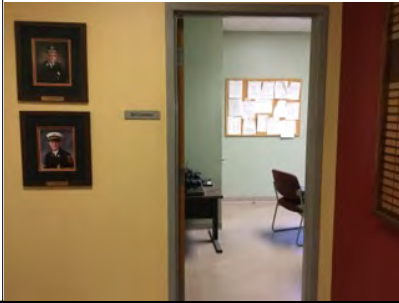
| ID | Location | Floor | Room | Element | Type | Photo | Issues | Current Measure | Recommendations | Quantity | Price | Cost Estimation |
|---|---|---|---|---|---|--|--|---|---|---|---|---|
| 12 | Shift Commander's Office | 1 | | Signage | | | Raised characters not provided on sign<br>Braille not provided on sign<br>Sign not located on the latch side of the door | -<br>-<br>- | Provide text with raised characters duplicated in braille on sign.<br>Locate sign at permanent rooms alongside the door on the latch side. | 1 | 232 | \$232 |

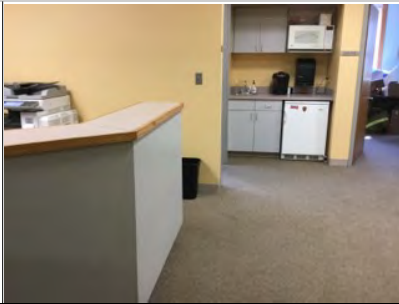
| ID | Location | Floor | Room | Element | Type | Photo | Issues | Current Measure | Recommendations | Quantity | Price | Cost Estimation |
|---|---|---|---|---|---|--|--|---|---|---|---|---|
| 13 | Reception/Chief's Secretary | 1 | | Service Counter | N/A | | Counter > 36" high | 42.25" | Provide a counter that is 36" max. above the ground or finished floor. | 1 | 880 | \$880 |

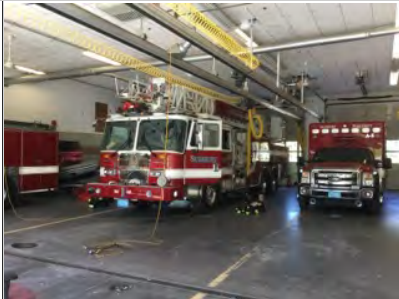
| ID | Location | Floor | Room | Element | Type | Photo | Issues | Current Measure | Recommendations | Quantity | Price | Cost Estimation |
|---|---|---|---|---|---|--|--|---|---|---|---|---|
| 14 | Apparatus Room | LL | | Overall Access | Toilet Room | | Not on an accessible route | - | There is no accessible route (only stairs) between the apparatus room and the toilet rooms. It may be technically infeasible to create an accessible route. | 1 | - | \$0 |

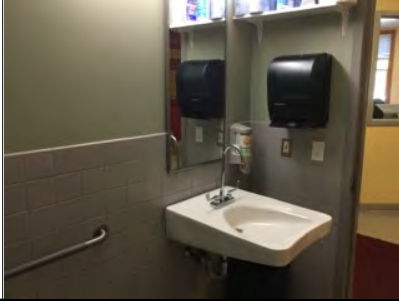
| ID | Location | Floor | Room | Element | Type | Photo | Issues | Current Measure | Recommendations | Quantity | Price | Cost Estimation |
|---|---|---|---|---|---|--|--|---|---|---|---|---|
| 15 | Women's Toilet Room | 1 | | Lavatory | | | Toe or knee clearances not provided<br>Plumbing underneath is exposed<br>Dispensers not within reach range | 25.75"<br>-<br>48" | Provide at least one lavatory with knee and toe clearance positioned for a forward approach.<br>Insulate or otherwise configure pipes to prevent contact at the lavatory.<br>Lower the paper towel dispenser to 42" max. above the floor. | 1 | 2131 | \$2131 |

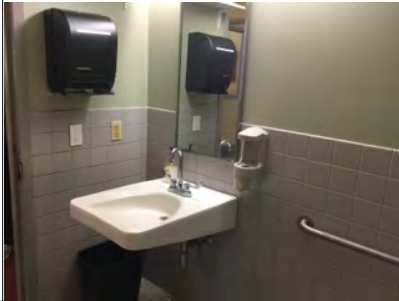
| ID | Location | Floor | Room | Element | Type | Photo | Issues | Current Measure | Recommendations | Quantity | Price | Cost Estimation |
|---|---|---|---|---|---|--|--|---|---|---|---|---|
| 16 | Men's Toilet Room | 1 | | Lavatory | N/A | | Toe or knee clearances not provided<br>Plumbing underneath is exposed<br>Dispensers not within reach range | 25.75"<br>-<br>51.25" | Provide at least one lavatory with knee and toe clearance positioned for a forward approach.<br>Insulate or otherwise configure pipes to prevent contact at the lavatory.<br>Lower the paper towel dispenser to 42" max. above the floor. | 1 | 2131 | \$2131 |

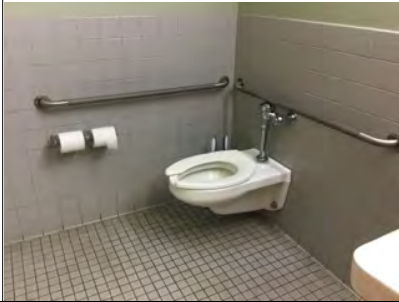
| ID | Location | Floor | Room | Element | Type | Photo | Issues | Current Measure | Recommendations | Quantity | Price | Cost Estimation |
|---|---|---|---|---|---|--|--|---|---|---|---|---|
| 17 | Women's Toilet Room | 1 | | Single-User Toilet | N/A | | Flush control not on open side | - | Relocate the flush control to the open side. | 1 | 374 | \$374 |

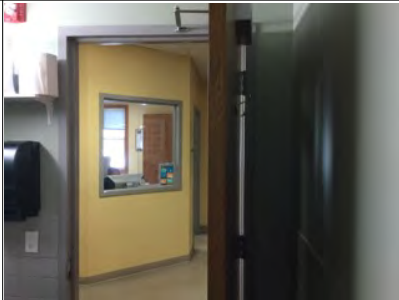
| ID | Location | Floor | Room | Element | Type | Photo | Issues | Current Measure | Recommendations | Quantity | Price | Cost Estimation |
|---|---|---|---|---|---|--|--|---|---|---|---|---|
| 18 | Women's Toilet Room | 1 | | Single-User Toilet | | | Hook located > 48" high | 68" | Locate hook no higher than 48" above the finished floor. | 1 | 150 | \$150 |

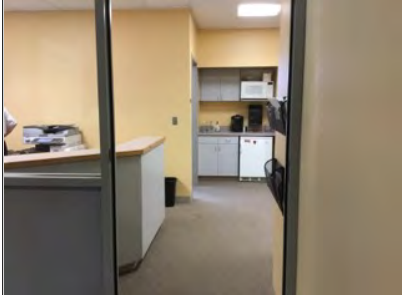
| ID | Location | Floor | Room | Element | Type | Photo | Issues | Current Measure | Recommendations | Quantity | Price | Cost Estimation |
|---|---|---|---|---|---|--|--|---|--|---|---|---|
| 21 | Reception/ Chief's Secretary | 1 | | | | | Signage is not provided | | Recommend providing designation signage with raised characters and braille at all permanent rooms where signage is not provided. | 1 | - | \$0 |

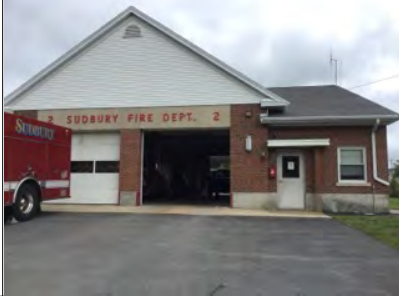
| ID | Location | Floor | Room | Element | Type | Photo | Issues | Current Measure | Recommendations | Quantity | Price | Cost Estimation |
|---|---|---|---|---|---|--|---|---|--|---|---|---|
| 1 | Main Entrance | Ext. | | | | | | | Recommend providing signage with contact information regarding the fire department and the location of services that is open to the public on a sign that is located on an accessible route. | 1 | - | \$0 |

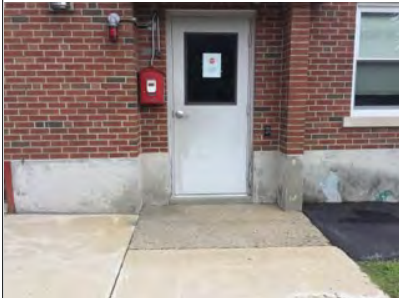
| ID | Location | Floor | Room | Element | Type | Photo | Issues | Current Measure | Recommendations | Quantity | Price | Cost Estimation |
|---|---|---|---|---|---|--|---|---|--|---|---|---|
| 2 | Main Entrance | Ext. | | | | | | | If the Town of Sudbury is planning to open this facility to the public in the future, the 3-inch change in level at the entrance will need to be renovated. | 1 | - | \$0 |

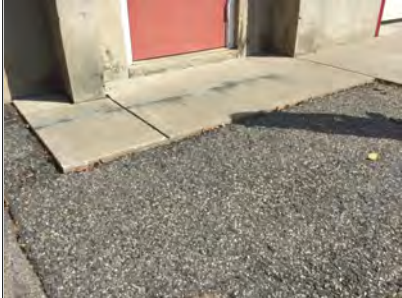
| ID | Location | Floor | Room | Element | Type | Photo | Issues | Current Measure | Recommendations | Quantity | Price | Cost Estimation |
|---|---|---|---|---|---|--|--|---|--|---|---|---|
| 1 | Main Entrance Walkway | Ext. | | Exterior Access Route | Exterior | | Level changes > 1/4" | 1" | Alter change in level to be 1/4" high max. (See ID #2 for cost.) | 1 | - | \$0 |

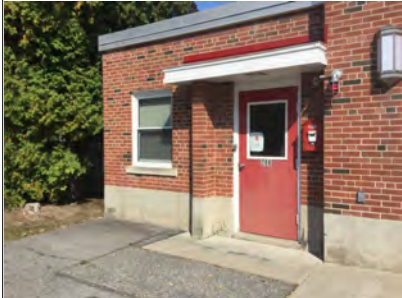
| ID | Location | Floor | Room | Element | Type | Photo | Issues | Current Measure | Recommendations | Quantity | Price | Cost Estimation |
|---|---|---|---|---|---|--|--|---|--|---|---|---|
| 2 | Main Entrance | Ext. | | Entrance | Main Entrance | | Threshold > 1/2" high<br>Hardware not operable with a closed fist | 3"<br>- | Alter threshold to be 1/2" high max.<br>Provide hardware that can be operable with one hand and not require tight grasping, pinching, or twisting of the wrist.<br>(Cost estimate is for compliant hardware and providing a level (2% slope max.) concrete 60" wide by 60" deep area at the door and a sloped walkway (max. slope of 8.33%) to the landing.) | 1 | 1204 | \$1204 |

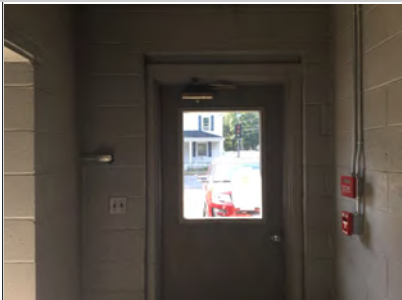
| ID | Location | Floor | Room | Element | Type | Photo | Issues | Current Measure | Recommendations | Quantity | Price | Cost Estimation |
|---|---|---|---|---|---|--|--|---|--|---|---|---|
| 3 | Main Entrance | 1 | | Emergency Exit | N/A | | Tactile sign not provided at exit<br>Illuminated Int. Symbol of Acc. not provided (MAAB) | -<br>- | Provide tactile exit signs with raised characters and braille at exit doors. Mount signs between 48"- 60" above the finished floor located on the latch side of the door.<br>Provide an illuminated sign with the International Symbol of Accessibility. | 1 | 1116 | \$1116 |

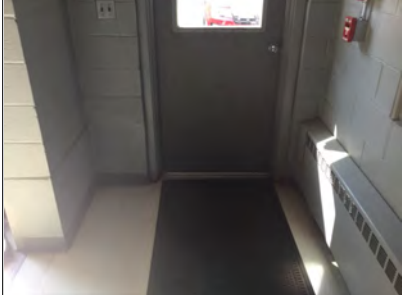
| ID | Location | Floor | Room | Element | Type | Photo | Issues | Current Measure | Recommendations | Quantity | Price | Cost Estimation |
|---|---|---|---|---|---|--|--|---|--|---|---|---|
| 4 | Main Entrance | 1 | | Emergency Exit | N/A | | Maneuvering clearance(s) not provided<br>Mat not securely attached | 7"<br>- | Provide an automatic door opener.<br>Secure the mat. | 1 | 3060 Labor | \$3060 |

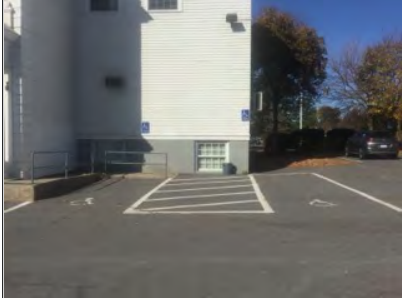
| ID | Location | Floor | Room | Element | Type | Photo | Issues | Current Measure | Recommendations | Quantity | Price | Cost Estimation |
|---|---|---|---|---|---|--|---|---|--|---|---|---|
| 1 | Accessible Parking Spots | Ext. | | Off-Street Parking Lot or Garage | Visitor | | Sign does not have the designation "Van Accessible" | - | Add the designation "Van Accessible" to one of the two accessible parking spaces by the building entrance. | 1 | 500 | \$500 |

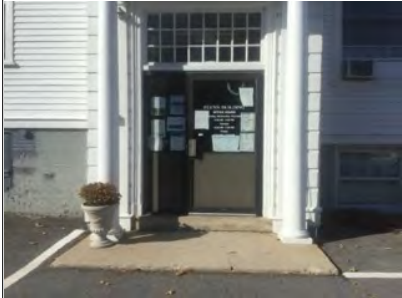
| ID | Location | Floor | Room | Element | Type | Photo | Issues | Current Measure | Recommendations | Quantity | Price | Cost Estimation |
|---|---|---|---|---|---|--|---|---|--|---|---|---|
| 2 | Inaccessible Entrance at South Stair | G | | Entrance | Secondary Entrance | | Entrance not on an accessible route<br>Directional sign to accessible entrance not provided | -<br>- | Provide a directional sign indicating the location of the nearest accessible entrance. | 1 | 346 | \$346 |

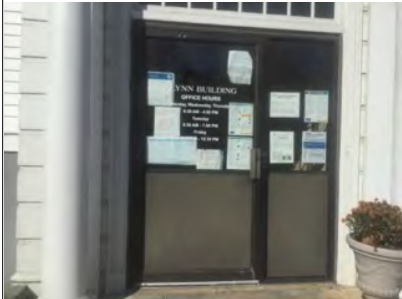
| ID | Location | Floor | Room | Element | Type | Photo | Issues | Current Measure | Recommendations | Quantity | Price | Cost Estimation |
|---|---|---|---|---|---|--|---|---|--|---|---|---|
| 3 | Accessible Entrance at North Stair | G | | Entrance | Main Entrance | | International Symbol of Accessibility not provided | - | Provide a sign with the International Symbol of Accessibility (ISA). | 1 | 346 | \$346 |

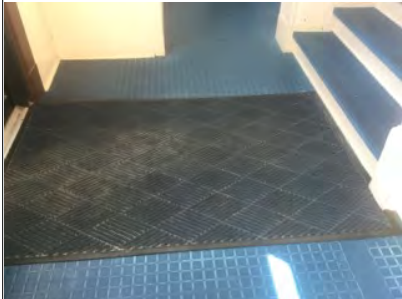
| ID | Location | Floor | Room | Element | Type | Photo | Issues | Current Measure | Recommendations | Quantity | Price | Cost Estimation |
|---|---|---|---|---|---|--|---|---|--|---|---|---|
| 4 | Accessible Entrance at North Stair | G | | Entrance | Main Entrance | | Mat not securely attached | - | Secure the mat. | 1 | Labor | \$0 |

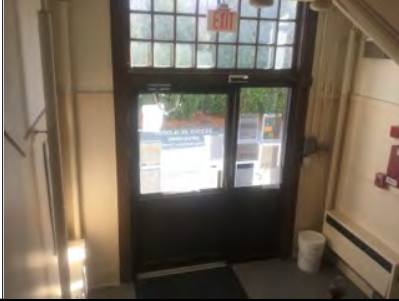
| ID | Location | Floor | Room | Element | Type | Photo | Issues | Current Measure | Recommendations | Quantity | Price | Cost Estimation |
|---|---|---|---|---|---|--|--|---|--|---|---|---|
| 5 | South Stair Exit | G | | Emergency Exit | N/A | | Tactile sign not provided at exit | - | Provide tactile exit signs with raised characters and braille at exit doors. Mount signs between 48"- 60" above the finished floor located on the latch side of the door. | 1 | 232 | \$232 |

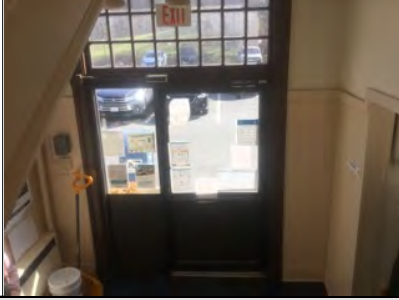
| ID | Location | Floor | Room | Element | Type | Photo | Issues | Current Measure | Recommendations | Quantity | Price | Cost Estimation |
|---|---|---|---|---|---|--|--|---|--|---|---|---|
| 6 | North Stair (Accessible) Exit | G | | Emergency Exit | | | Tactile sign not provided at exit<br>Illuminated Int. Symbol of Acc. not provided (MAAB) | | Provide tactile exit signs with raised characters and braille at exit doors. Mount signs between 48"- 60" above the finished floor located on the latch side of the door.<br>Provide an illuminated sign with the International Symbol of Accessibility. | 1 | 432 | \$432 |

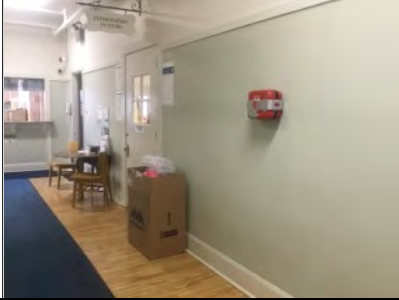
| ID | Location | Floor | Room | Element | Type | Photo | Issues | Current Measure | Recommendations | Quantity | Price | Cost Estimation |
|---|---|---|---|---|---|--|--|---|--|---|---|---|
| 7 | Corridor | 1 | | Interior Access Route | N/A | | Obstructed by protruding objects | 5.5" | Relocate red box out of the circulation path. | 1 | Labor | \$0 |

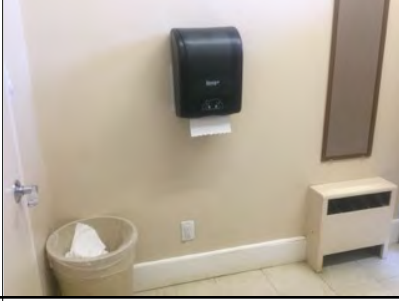
| ID | Location | Floor | Room | Element | Type | Photo | Issues | Current Measure | Recommendations | Quantity | Price | Cost Estimation |
|---|---|---|---|---|---|--|--|---|--|---|---|---|
| 8 | Men's Toilet Room | 1 | | Interior Access Route | N/A | | Obstructed by protruding objects | 9" | Relocate paper towel dispenser out of the circulation route and the door maneuvering clearance. | 1 | 256 | \$256 |

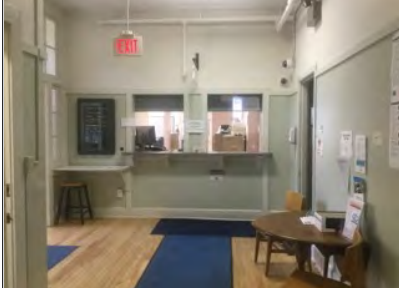
| ID | Location | Floor | Room | Element | Type | Photo | Issues | Current Measure | Recommendations | Quantity | Price | Cost Estimation |
|---|---|---|---|---|---|--|--|---|--|---|---|---|
| 9 | Treasurer/ Tax Collector and Accounting | 1 | | Interior Access Route | N/A | | Surface not stable, firm, and slip-resistant | - | Secure mat. | 1 | Labor | \$0 |

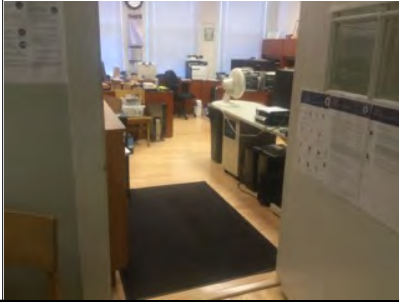
| ID | Location | Floor | Room | Element | Type | Photo | Issues | Current Measure | Recommendations | Quantity | Price | Cost Estimation |
|---|--|---|---|---|---|--|---|---|--|---|---|---|
| 11 | Information<br>Systems | 1 | | Doors,<br>Doorways,<br>& Gates | Office | | Clear width at door < 32" | 30.5" | Install offset hinges to ensure that the door has a clear width of 32 inches. | 1 | 2232 | \$2232 |

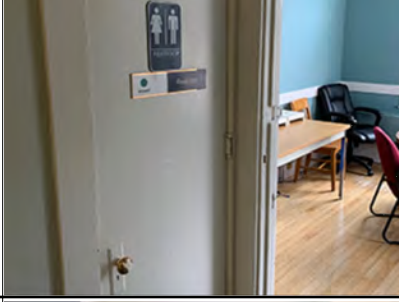
| ID | Location | Floor | Room | Element | Type | Photo | Issues | Current Measure | Recommendations | Quantity | Price | Cost Estimation |
|---|--|---|---|---|---|--|---|---|--|---|---|---|
| 12 | Single-User<br>Toilet Room | 2 | | Doors,<br>Doorways,<br>& Gates | Toilet Room | | Clear width at door < 32"<br>Hardware not operable with a closed fist | 25.75"<br>- | Widen the door so that there is 32" min. clear width.<br>Provide hardware that can be operable with one hand and not require tight grasping, pinching, or twisting of the wrist.<br>(Cost is included in Toilet Room record, ID # 55.) | 1 | - | \$0 |

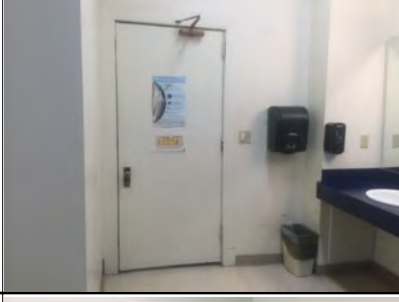
| ID | Location | Floor | Room | Element | Type | Photo | Issues | Current Measure | Recommendations | Quantity | Price | Cost Estimation |
|---|--|---|---|---|---|--|---|---|--|---|---|---|
| 13 | Women's<br>Toilet Room | 1 | | Doors,<br>Doorways,<br>& Gates | Toilet Room | | Maneuvering clearance(s) not provided | 5" | Provide an automatic door opener. | 1 | 3060 | \$3060 |

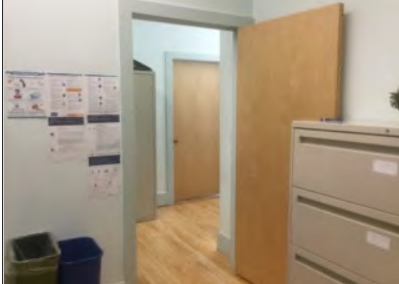
| ID | Location | Floor | Room | Element | Type | Photo | Issues | Current Measure | Recommendations | Quantity | Price | Cost Estimation |
|---|--|---|---|---|---|--|---|---|--|---|---|---|
| 14 | Human<br>Resources<br>(West Office)<br>Path to<br>Human<br>Resources &<br>Assistant<br>Town<br>Manager | 2 | | Doors,<br>Doorways,<br>& Gates | Office | | Maneuvering clearance(s) not provided | 43.75" | Relocate file cabinet to provide 60" deep of maneuvering clearance at door. | 1 | Labor | \$0 |

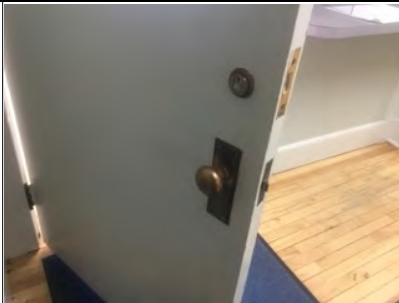
| ID | Location | Floor | Room | Element | Type | Photo | Issues | Current Measure | Recommendations | Quantity | Price | Cost Estimation |
|---|---|---|---|---|---|--|--|---|---|---|---|---|
| 17 | Assessors Office | 1 | | Doors, Doorways, & Gates | Office | | Hardware not operable with a closed fist | - | Provide hardware that can be operable with one hand and not require tight grasping, pinching, or twisting of the wrist. | 1 | 484 | \$484 |

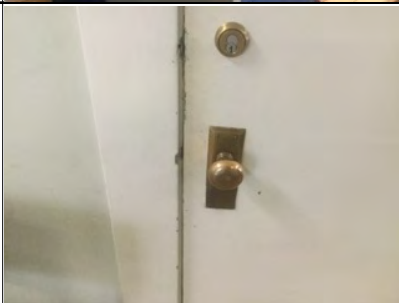
| ID | Location | Floor | Room | Element | Type | Photo | Issues | Current Measure | Recommendations | Quantity | Price | Cost Estimation |
|---|---|---|---|---|---|--|--|---|---|---|---|---|
| 18 | Information Systems | 1 | | Doors, Doorways, & Gates | Office | | Hardware not operable with a closed fist | - | Provide hardware that can be operable with one hand and not require tight grasping, pinching, or twisting of the wrist. | 1 | 484 | \$484 |

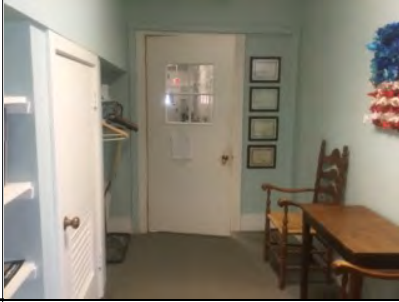
| ID | Location | Floor | Room | Element | Type | Photo | Issues | Current Measure | Recommendations | Quantity | Price | Cost Estimation |
|---|---|---|---|---|---|--|--|---|---|---|---|---|
| 20 | Selectmen, Town Manager, Town Counsel and Notary Office | 2 | | Doors, Doorways, & Gates | Office | | Hardware not operable with a closed fist | - | Provide hardware that can be operable with one hand and not require tight grasping, pinching, or twisting of the wrist. | 1 | 484 | \$484 |

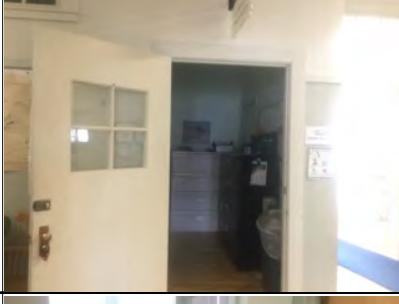
| ID | Location | Floor | Room | Element | Type | Photo | Issues | Current Measure | Recommendations | Quantity | Price | Cost Estimation |
|---|---|---|---|---|---|--|--|---|---|---|---|---|
| 22 | Human Resources and Assistant Town Manager Entrance | 2 | | Doors, Doorways, & Gates | Office | | Hardware not operable with a closed fist | - | Provide hardware that can be operable with one hand and not require tight grasping, pinching, or twisting of the wrist. | 1 | 484 | \$484 |

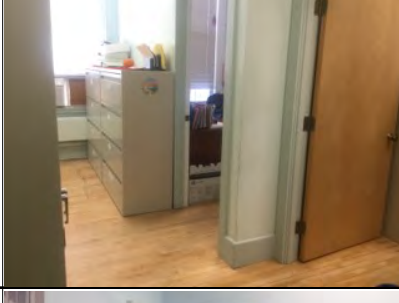
| ID | Location | Floor | Room | Element | Type | Photo | Issues | Current Measure | Recommendations | Quantity | Price | Cost Estimation |
|---|---|---|---|---|---|--|--|---|---|---|---|---|
| 23 | Human Resources (West Office) | 2 | | Doors, Doorways, & Gates | Office | | Hardware not operable with a closed fist | - | Provide hardware that can be operable with one hand and not require tight grasping, pinching, or twisting of the wrist. | 1 | 484 | \$484 |

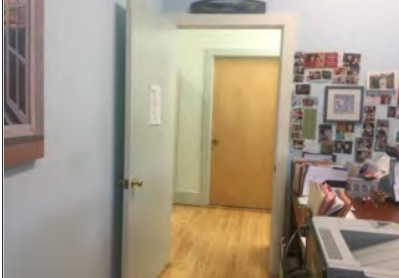
| ID | Location | Floor | Room | Element | Type | Photo | Issues | Current Measure | Recommendations | Quantity | Price | Cost Estimation |
|---|---|---|---|---|---|--|--|---|---|---|---|---|
| 24 | Human Resources (East Office) | 2 | | Doors, Doorways, & Gates | Office | | Hardware not operable with a closed fist | - | Provide hardware that can be operable with one hand and not require tight grasping, pinching, or twisting of the wrist. | 1 | 484 | \$484 |

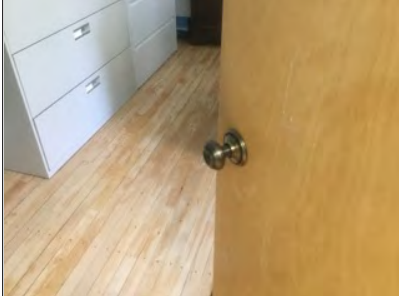
| ID | Location | Floor | Room | Element | Type | Photo | Issues | Current Measure | Recommendations | Quantity | Price | Cost Estimation |
|---|---|---|---|---|---|--|---|---|--|---|---|---|
| 25 | Assistant Town Manager | 2 | | Doors, Doorways, & Gates | Office | | Hardware not operable with a closed fist | - | Provide hardware that can be operable with one hand and not require tight grasping, pinching, or twisting of the wrist. | 1 | 484 | \$484 |

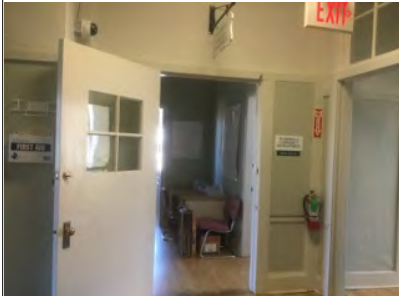
| ID | Location | Floor | Room | Element | Type | Photo | Issues | Current Measure | Recommendations | Quantity | Price | Cost Estimation |
|---|---|---|---|---|---|--|---|---|--|---|---|---|
| 26 | Planning & Community Development | 2 | | Doors, Doorways, & Gates | Classroom | | Hardware not operable with a closed fist | - | Provide hardware that can be operable with one hand and not require tight grasping, pinching, or twisting of the wrist. | 1 | 484 | \$484 |

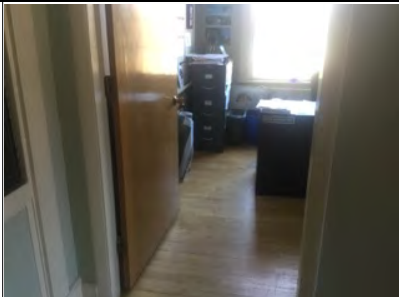
| ID | Location | Floor | Room | Element | Type | Photo | Issues | Current Measure | Recommendations | Quantity | Price | Cost Estimation |
|---|---|---|---|---|---|--|---|---|--|---|---|---|
| 27 | Community Housing Coordinator | 2 | | Doors, Doorways, & Gates | Office | | Hardware not operable with a closed fist | - | Provide hardware that can be operable with one hand and not require tight grasping, pinching, or twisting of the wrist. | 1 | 484 | \$484 |
