## DPW Offices and Garage

## Town of Sudbury ADA Transition Plan

October 2020

Institute for Human Centered Design

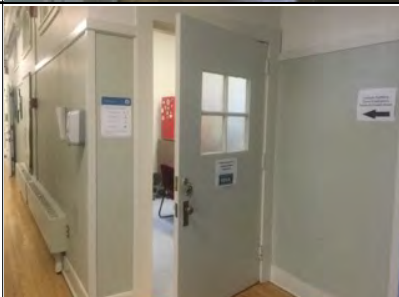
| ID | Location | Floor | Room | Element | Type | Photo | Issues | Current Measure | Recommendations | Quantity | Price | Cost Estimation |
|---|---|---|---|---|---|--|---|---|--|---|---|---|
| 28 | Credit Union | 2 | | Doors, Doorways, & Gates | Office | | Hardware not operable with a closed fist | - | Provide hardware that can be operable with one hand and not require tight grasping, pinching, or twisting of the wrist. | 1 | 484 | \$484 |

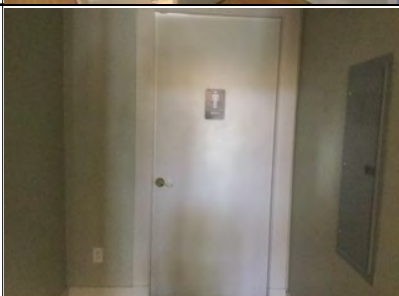
| ID | Location | Floor | Room | Element | Type | Photo | Issues | Current Measure | Recommendations | Quantity | Price | Cost Estimation |
|---|---|---|---|---|---|--|---|---|--|---|---|---|
| 29 | Men's Toilet Room | 1 | | Doors, Doorways, & Gates | Toilet Room | | Hardware not operable with a closed fist<br>Door requires > 5 lbs. of force to open | -<br>11 lbs. | Provide hardware that can be operable with one hand and not require tight grasping, pinching, or twisting of the wrist.<br>Adjust closers so doors do not require more than 5 pounds of force to open. | 1 | 484<br>Labor | \$484 |

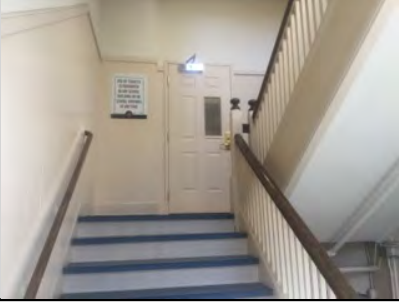
| ID | Location | Floor | Room | Element | Type | Photo | Issues | Current Measure | Recommendations | Quantity | Price | Cost Estimation |
|---|---|---|---|---|---|--|---|---|--|---|---|---|
| 30 | First Floor Entrance on North Side | 1 | | Doors, Doorways, & Gates | Circulation | | Door requires > 5 lbs. of force to open | 14 lbs. | Adjust closers so doors do not require more than 5 pounds of force to open. | 1 | Labor | \$0 |

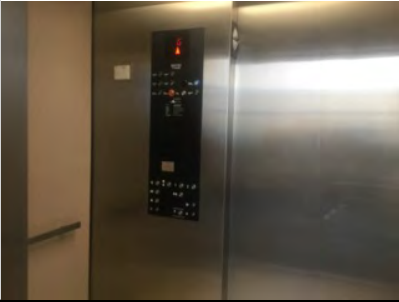
| ID | Location | Floor | Room | Element | Type | Photo | Issues | Current Measure | Recommendations | Quantity | Price | Cost Estimation |
|---|---|---|---|---|---|--|---|---|--|---|---|---|
| 31 | Elevator | | | Elevator | Interior | | Audible car position indicators not provided | - | Install audible car position indicators. | 1 | 1700 | \$1700 |

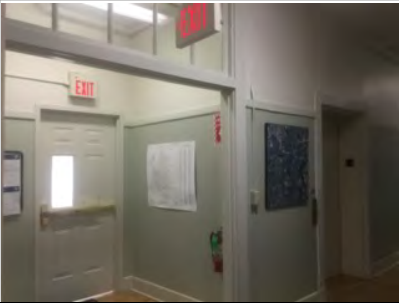
| ID | Location | Floor | Room | Element | Type | Photo | Issues | Current Measure | Recommendations | Quantity | Price | Cost Estimation |
|---|---|---|---|---|---|--|---|---|--|---|---|---|
| 32 | North Stair by Assessors Office | 1 | | Signage | Egress | | Signage is not provided<br>Raised characters not provided on sign<br>Braille not provided on sign | -<br>-<br>- | Locate compliant signage alongside the door on the latch side.<br>Provide text with raised characters duplicated in braille on sign. | 1 | 232 | \$232 |

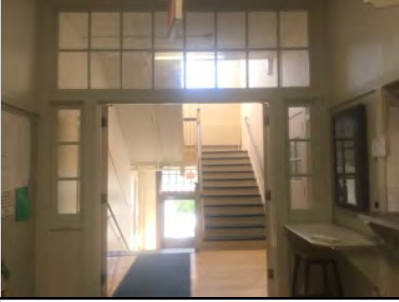
| ID | Location | Floor | Room | Element | Type | Photo | Issues | Current Measure | Recommendations | Quantity | Price | Cost Estimation |
|---|---|---|---|---|---|--|---|---|--|---|---|---|
| 33 | South Stair Exit | 1 | | Signage | Egress | | Signage is not provided<br>Raised characters not provided on sign<br>Braille not provided on sign | -<br>-<br>- | Locate compliant signage alongside the door on the latch side.<br>Provide text with raised characters duplicated in braille on sign. | 1 | 232 | \$232 |

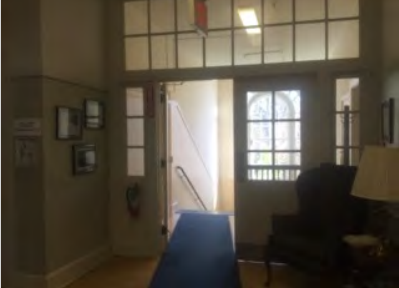
| ID | Location | Floor | Room | Element | Type | Photo | Issues | Current Measure | Recommendations | Quantity | Price | Cost Estimation |
|---|---|---|---|---|---|--|---|---|--|---|---|---|
| 34 | South Stair | 2 | | Signage | Egress | | Signage is not provided<br>Raised characters not provided on sign<br>Braille not provided on sign | -<br>-<br>- | Locate compliant signage alongside the door on the latch side.<br>Provide text with raised characters duplicated in braille on sign. | 1 | 232 | \$232 |

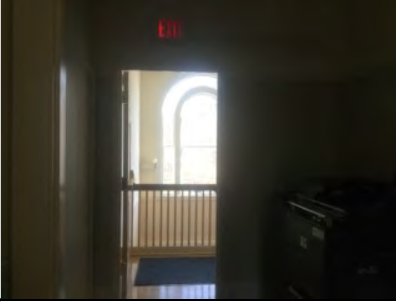
| ID | Location | Floor | Room | Element | Type | Photo | Issues | Current Measure | Recommendations | Quantity | Price | Cost Estimation |
|---|---|---|---|---|---|--|---|---|--|---|---|---|
| 35 | North Stair | 2 | | Signage | Egress | | Signage is not provided<br>Raised characters not provided on sign<br>Braille not provided on sign | -<br>-<br>- | Locate compliant signage alongside the door on the latch side.<br>Provide text with raised characters duplicated in braille on sign. | 1 | 232 | \$232 |

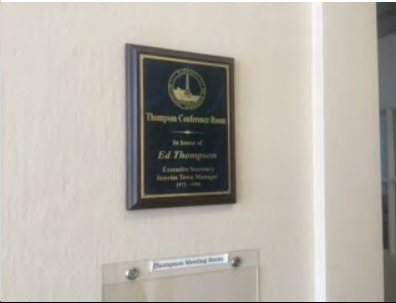
| ID | Location | Floor | Room | Element | Type | Photo | Issues | Current Measure | Recommendations | Quantity | Price | Cost Estimation |
|---|---|---|---|---|---|--|---|---|--|---|---|---|
| 36 | Small Meeting Room/<br>Thompson Conference Room | 2 | | Signage | Designation | | Raised characters not provided on sign<br>Braille not provided on sign | -<br>- | Provide text with raised characters duplicated in braille on sign. | 1 | 232 | \$232 |

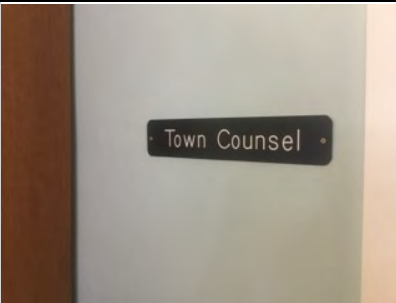
| ID | Location | Floor | Room | Element | Type | Photo | Issues | Current Measure | Recommendations | Quantity | Price | Cost Estimation |
|---|---|---|---|---|---|--|---|---|--|---|---|---|
| 37 | Town Counsel | 2 | | Signage | Designation | | Raised characters not provided on sign<br>Braille not provided on sign | -<br>- | Provide text with raised characters duplicated in braille on sign. | 1 | 232 | \$232 |

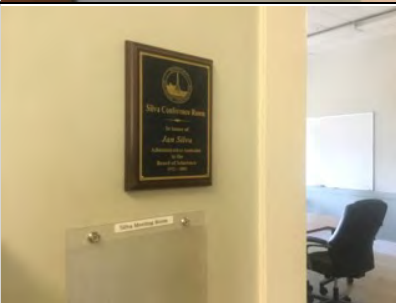
| ID | Location | Floor | Room | Element | Type | Photo | Issues | Current Measure | Recommendations | Quantity | Price | Cost Estimation |
|---|---|---|---|---|---|--|---|---|--|---|---|---|
| 38 | Large Meeting Room | 2 | | Signage | Designation | | Raised characters not provided on sign<br>Braille not provided on sign | -<br>- | Provide text with raised characters duplicated in braille on sign. | 1 | 232 | \$232 |

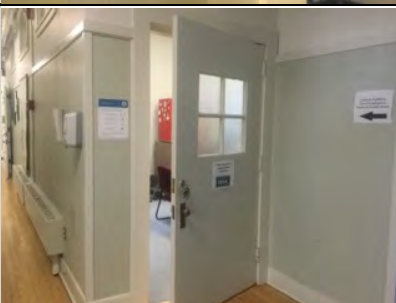
| ID | Location | Floor | Room | Element | Type | Photo | Issues | Current Measure | Recommendations | Quantity | Price | Cost Estimation |
|---|---|---|---|---|---|--|---|---|--|---|---|---|
| 39 | Credit Union | 2 | | Signage | Designation | | Raised characters not provided on sign<br>Braille not provided on sign | -<br>- | Provide text with raised characters duplicated in braille on sign. | 1 | 232 | \$232 |

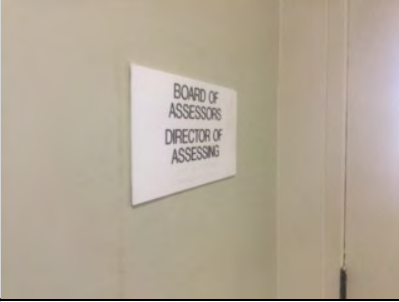
| ID | Location | Floor | Room | Element | Type | Photo | Issues | Current Measure | Recommendations | Quantity | Price | Cost Estimation |
|---|---|---|---|---|---|--|--|---|---|---|---|---|
| 40 | Entrance to Assessors | 1 | | Signage | Designation | | Sign not located on the latch side of the door | - | Locate sign at permanent rooms alongside the door on the latch side. | 1 | Labor | \$0 |

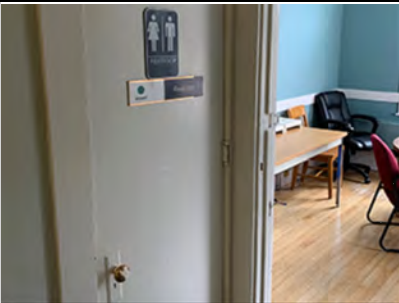
| ID | Location | Floor | Room | Element | Type | Photo | Issues | Current Measure | Recommendations | Quantity | Price | Cost Estimation |
|---|---|---|---|---|---|--|--|---|---|---|---|---|
| 42 | Single-User Toilet Room | 2 | | Signage | Designation | | Sign not located on the latch side of the door | - | Locate sign at permanent rooms alongside the door on the latch side. | 1 | Labor | \$0 |

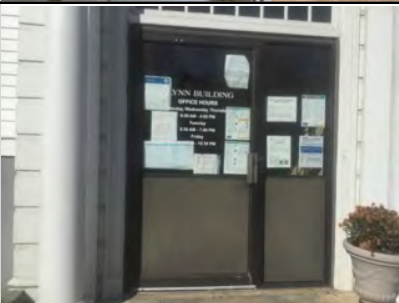
| ID | Location | Floor | Room | Element | Type | Photo | Issues | Current Measure | Recommendations | Quantity | Price | Cost Estimation |
|---|---|---|---|---|---|--|--|---|---|---|---|---|
| 43 | North and South Entrances | Ext. | | Signage | Informational | | Non glare finish and contrast not provided on sign | - | Install a sign with a non-glare finish with characters that have a high contrast to the background. | 2 | 232 | \$464 |

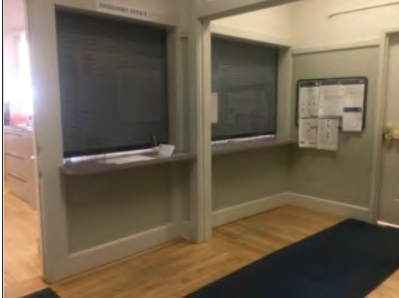
| ID | Location | Floor | Room | Element | Type | Photo | Issues | Current Measure | Recommendations | Quantity | Price | Cost Estimation |
|---|--|---|---|---|---|--|---|---|---|---|---|---|
| 45 | Assessors Office | 1 | | Service Counter | N/A | | Counter > 36" high | 36.75" | Provide a counter that is 36" max. above the ground or finished floor. | 1 | 880 | \$880 |

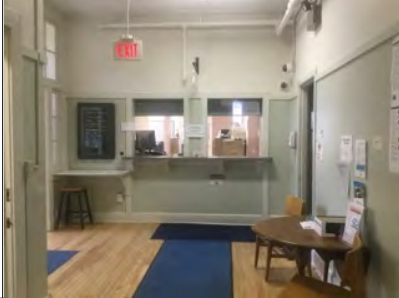
| ID | Location | Floor | Room | Element | Type | Photo | Issues | Current Measure | Recommendations | Quantity | Price | Cost Estimation |
|---|--|---|---|---|---|--|---|---|---|---|---|---|
| 46 | Treasurer/<br>Tax Collector<br>and<br>Accounting | 1 | | Service Counter | N/A | | Counter > 36" high | 41.25"<br>- | Provide a counter that is 36" max. above the ground or finished floor. | 1 | 880 | \$880 |

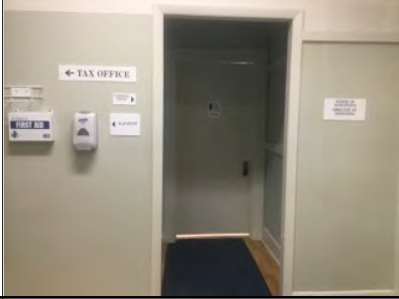
| ID | Location | Floor | Room | Element | Type | Photo | Issues | Current Measure | Recommendations | Quantity | Price | Cost Estimation |
|---|--|---|---|---|---|--|---|---|---|---|---|---|
| 47 | First Aid Kit<br>by Women's<br>Toilet Room | 1 | | Operable Parts | Other | | Reach < 15" or > 48"(forward/side approach) | 58.25" | Relocate first aid kit so that controls are between no higher than 48" max. above the finished floor. | 1 | Labor | \$0 |

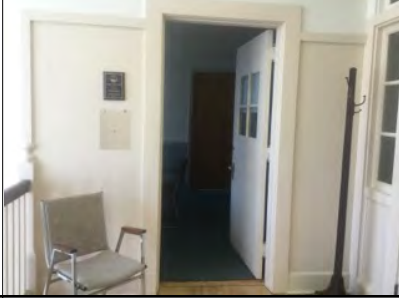
| ID | Location | Floor | Room | Element | Type | Photo | Issues | Current Measure | Recommendations | Quantity | Price | Cost Estimation |
|---|--|---|---|---|---|--|---|---|---|---|---|---|
| 48 | Small Meeting Room/<br>Thompson Conference Room | 2 | | Operable Parts | Clothes Rod/Hooks | | Reach < 15" or > 48"(forward/side approach) | 68" | Provide a a coat hook at 48" max. above the finished floor. | 1 | 150 | \$150 |

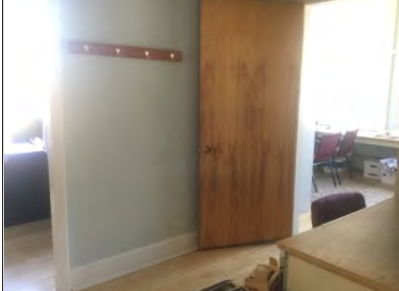
| ID | Location | Floor | Room | Element | Type | Photo | Issues | Current Measure | Recommendations | Quantity | Price | Cost Estimation |
|---|--|---|---|---|---|--|---|---|---|---|---|---|
| 49 | Planning &<br>Community Development | 2 | | Operable Parts | Clothes Rod/Hooks | | Reach < 15" or > 48"(forward/side approach) | 66" | Provide one coat hook no higher than 48" max. above the finished floor. | 1 | 150 | \$150 |

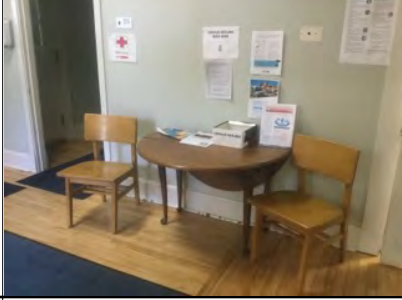
| ID | Location | Floor | Room | Element | Type | Photo | Issues | Current Measure | Recommendations | Quantity | Price | Cost Estimation |
|---|---|---|---|---|---|--|--|---|--|---|---|---|
| 51 | Corridor by Treasurer/ Tax Collector and Accounting | 1 | | Dining or Work Surfaces | Work Surface | | Knee or toe clearance not provided | 26.5" | Provide at least 1 work surface with 27" min. knee and toe clearance. | 1 | 700 | \$700 |

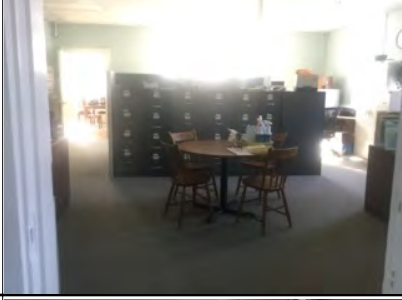
| ID | Location | Floor | Room | Element | Type | Photo | Issues | Current Measure | Recommendations | Quantity | Price | Cost Estimation |
|---|---|---|---|---|---|--|--|---|--|---|---|---|
| 52 | Selectmen's Office | 2 | | Dining or Work Surfaces | Work Surface | | Knee or toe clearance not provided | - | Provide at least 1 work surface with toe clearance. | 1 | 700 | \$700 |

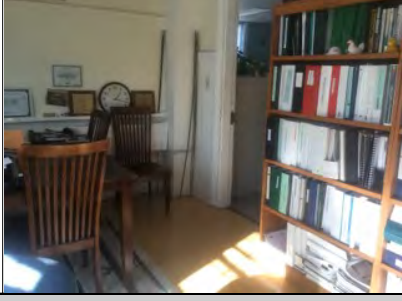
| ID | Location | Floor | Room | Element | Type | Photo | Issues | Current Measure | Recommendations | Quantity | Price | Cost Estimation |
|---|---|---|---|---|---|--|--|---|--|---|---|---|
| 53 | Town Manager's Office | 2 | | Dining or Work Surfaces | Work Surface | | Knee or toe clearance not provided | 25.75" | Provide at least 1 work surface with 27" min. knee and toe clearance. | 1 | 700 | \$700 |

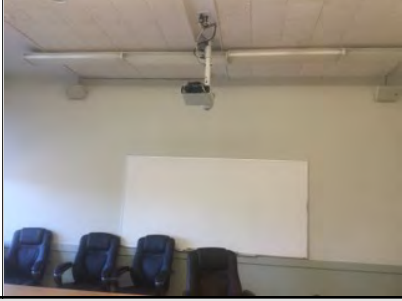
| ID | Location | Floor | Room | Element | Type | Photo | Issues | Current Measure | Recommendations | Quantity | Price | Cost Estimation |
|---|---|---|---|---|---|--|--|---|--|---|---|---|
| 54 | Large Meeting Room | 2 | | Assembly Area | N/A | | Assistive listening devices not provided | - | If audible communication is integral to the use of the space, provide an assistive listening system. | 1 | 1214 | \$1214 |

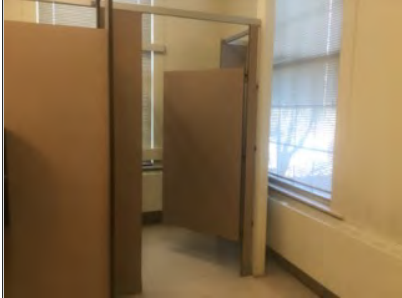
| ID | Location | Floor | Room | Element | Type | Photo | Issues | Current Measure | Recommendations | Quantity | Price | Cost Estimation |
|---|---|---|---|---|---|--|---|---|---|---|---|---|
| 56 | Women's Toilet Room | 1 | | Toilet Compartment | Accessible Compartment | | Door has malfunctioning self-closing hinge | - | Repair hinge. | 1 | Labor | \$0 |

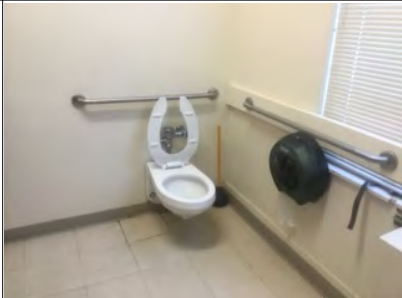
| ID | Location | Floor | Room | Element | Type | Photo | Issues | Current Measure | Recommendations | Quantity | Price | Cost Estimation |
|---|---|---|---|---|---|--|---|---|---|---|---|---|
| 58 | Women's Toilet Room | 1 | | Toilet Compartment | Accessible Compartment | | Centerline < or > 18" (MAAB) | 21.25" | Relocate toilet so the centerline is 18" from the side wall. | 1 | 2828 | \$2828 |

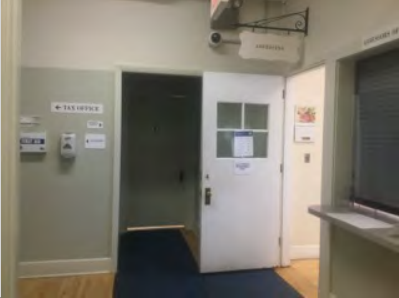
| ID | Location | Floor | Room | Element | Type | Photo | Issues | Current Measure | Recommendations | Quantity | Price | Cost Estimation |
|---|---|---|---|---|---|--|---|---|--|---|---|---|
| 60 | Entrance to Women's Toilet Room | 1 | | | | | | | Recommend providing additional lighting in the men's and women's toilet room vestibules. | 1 | - | \$0 |

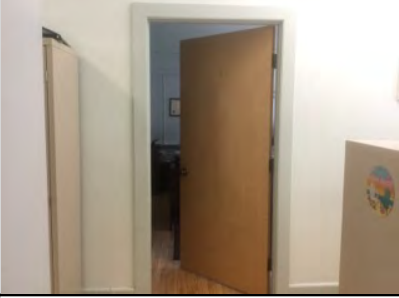
| ID | Location | Floor | Room | Element | Type | Photo | Issues | Current Measure | Recommendations | Quantity | Price | Cost Estimation |
|---|---|---|---|---|---|--|---|---|--|---|---|---|
| 61 | Assistant Town Manager | 2 | | | | | | | Recommend providing signage with raised characters and braille at rooms where signage is not provided. | 1 | - | \$0 |

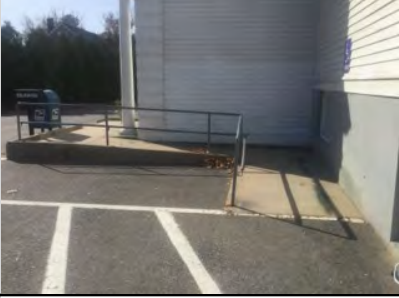
| ID | Location | Floor | Room | Element | Type | Photo | Issues | Current Measure | Recommendations | Quantity | Price | Cost Estimation |
|---|---|---|---|---|---|--|---|---|--|---|---|---|
| 62 | Accessible Entrance Walkway | Ext. | | | | | | | Recommend providing edge protection on the side of the sloped walkway. | 1 | - | \$0 |

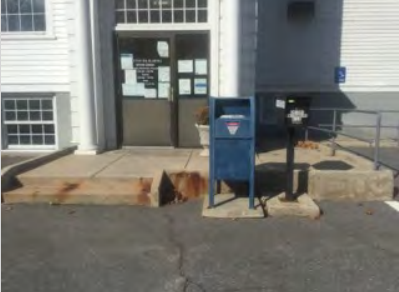
| ID | Location | Floor | Room | Element | Type | Photo | Issues | Current Measure | Recommendations | Quantity | Price | Cost Estimation |
|---|---|---|---|---|---|--|---|---|--|---|---|---|
| 63 | Accessible Entrance Stairs | Ext. | | | | | | | Recommend providing handrails at exterior stairs. | 1 | - | \$0 |

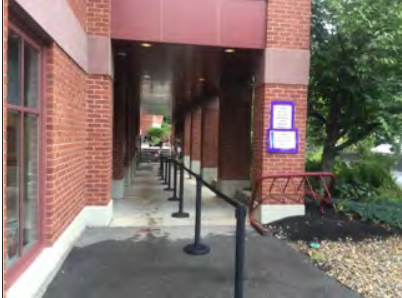
| ID | Location | Floor | Room | Element | Type | Photo | Issues | Current Measure | Recommendations | Quantity | Price | Cost Estimation |
|---|---|---|---|---|---|--|---|---|---|---|---|---|
| 1 | Main Entrance Walkway | Ext. | | Exterior Access Route | Walkway | | Obstructed by protruding objects | - | Provide cane-detectable stanchions with a lower stanchion belt that is cane-detectable, located lower than 27" above the ground. (Cost estimate for 10 stanchions.) | 1 | 870 | \$870 |

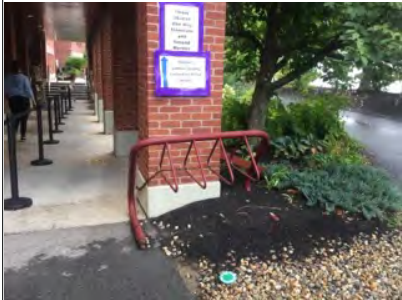
| ID | Location | Floor | Room | Element | Type | Photo | Issues | Current Measure | Recommendations | Quantity | Price | Cost Estimation |
|---|---|---|---|---|---|--|---|---|---|---|---|---|
| 2 | Main Entrance Bike Rack | Ext. | | Exterior Access Route | Exterior | | Accessible route not provided | - | Ensure an accessible route is provided. (Cost estimate for a 6' long, 4' wide asphalt route.) | 1 | 240 | \$240 |

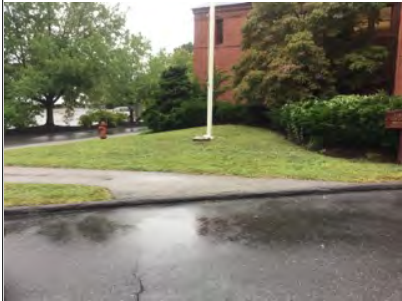
| ID | Location | Floor | Room | Element | Type | Photo | Issues | Current Measure | Recommendations | Quantity | Price | Cost Estimation |
|---|---|---|---|---|---|--|---|---|---|---|---|---|
| 3 | Front of Building | Ext. | | Curb Ramp | N/A | | Curb ramp not provided | - | Provide a curb ramp at intersection. (Cost estimate for a concrete curb ramp.) | 1 | 2800 | \$2800 |

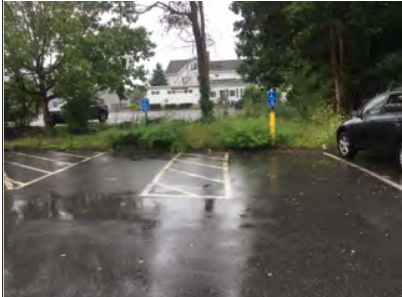
| ID | Location | Floor | Room | Element | Type | Photo | Issues | Current Measure | Recommendations | Quantity | Price | Cost Estimation |
|---|---|---|---|---|---|--|---|---|---|---|---|---|
| 4 | Parking - Side Aisle | Ext. | | Off-Street Parking Lot or Garage | Visitor | | Van space < 132" or <96" wide | 117" | Space with van accessible signage is not large enough to be a van accessible parking space. Relocate sign to accessible parking space in center aisle with the 81" wide access aisle. | 1 | Labor | \$0 |

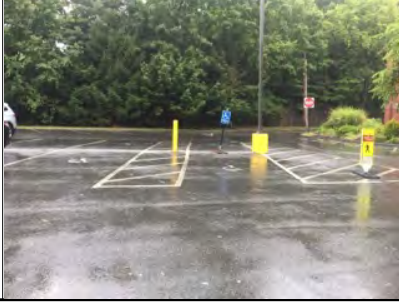
| ID | Location | Floor | Room | Element | Type | Photo | Issues | Current Measure | Recommendations | Quantity | Price | Cost Estimation |
|---|---|---|---|---|---|--|---|---|---|---|---|---|
| 5 | Parking - Center Aisle | Ext. | | Off-Street Parking Lot or Garage | Visitor | | Sign not provided<br>Sign bottom < 60" above finished grade | 2<br>46.5" | Provide two additional accessible parking signs with the bottom of the sign 60" min. above the ground and the top 96" max. above the ground. Relocate existing two signs so that the bottom of the sign is 60" min. above the ground. | 2 | 500<br>Labor | \$1000 |

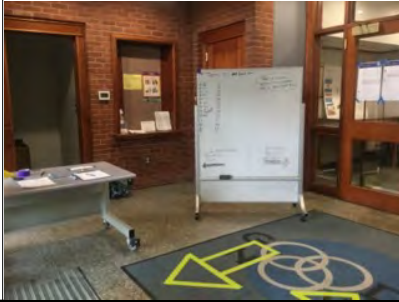
| ID | Location | Floor | Room | Element | Type | Photo | Issues | Current Measure | Recommendations | Quantity | Price | Cost Estimation |
|---|---|---|---|---|---|--|---|---|---|---|---|---|
| 6 | Main Entrance | 1 | | Entrance | Main Entrance | | Mat not securely attached | - | Secure the mat. | 1 | Labor | \$0 |

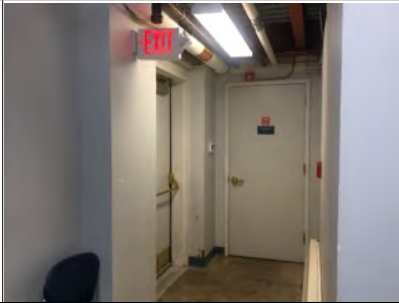
| ID | Location | Floor | Room | Element | Type | Photo | Issues | Current Measure | Recommendations | Quantity | Price | Cost Estimation |
|---|---|---|---|---|---|--|---|---|---|---|---|---|
| 7 | Egress Door 2 on Northeast Side | 1 | | Emergency Exit | N/A | | Tactile sign not provided at exit<br>Directional sign to accessible emergency exit not provided | -<br>- | Provide tactile exit signs with raised characters and braille at exit doors. Mount signs between 48"- 60" above the finished floor located on the latch side of the door.<br>Provide a directional sign indicating the location of the nearest accessible emergency exit. | 1 | 464 | \$464 |

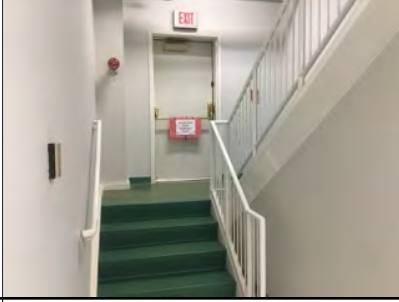
| ID | Location | Floor | Room | Element | Type | Photo | Issues | Current Measure | Recommendations | Quantity | Price | Cost Estimation |
|---|---|---|---|---|---|--|---|---|---|---|---|---|
| 8 | Stairs by Children's Reading Room | 1 | | Emergency Exit | N/A | | Tactile sign not provided at exit<br>Directional sign to accessible emergency exit not provided | -<br>- | Provide tactile exit signs with raised characters and braille at exit doors. Mount signs between 48"- 60" above the finished floor located on the latch side of the door.<br>Provide a directional sign indicating the location of the nearest accessible emergency exit. | 1 | 464 | \$464 |

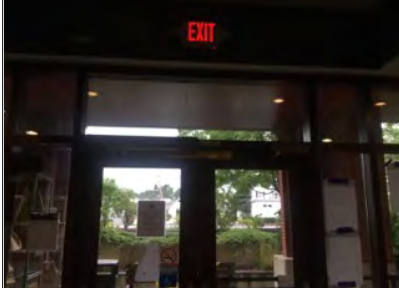
| ID | Location | Floor | Room | Element | Type | Photo | Issues | Current Measure | Recommendations | Quantity | Price | Cost Estimation |
|---|---|---|---|---|---|--|---|---|---|---|---|---|
| 9 | Main Entrance | 1 | | Emergency Exit | N/A | | Tactile sign not provided at exit<br>Illuminated Int. Symbol of Acc. not provided (MAAB) | | Provide tactile exit signs with raised characters and braille at exit doors. Mount signs between 48"- 60" above the finished floor located on the latch side of the door.<br>Provide an illuminated sign with the International Symbol of Accessibility. | 1 | 432 | \$432 |

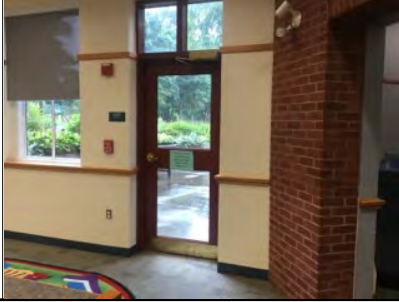
| ID | Location | Floor | Room | Element | Type | Photo | Issues | Current Measure | Recommendations | Quantity | Price | Cost Estimation |
|---|---|---|---|---|---|--|---|---|---|---|---|---|
| 10 | Reading Court | 1 | | Emergency Exit | N/A | | Mat not securely attached | - | Secure the mat. | 1 | Labor | \$0 |

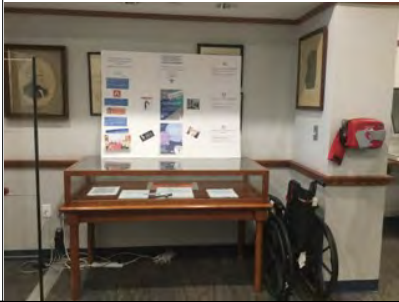
| ID | Location | Floor | Room | Element | Type | Photo | Issues | Current Measure | Recommendations | Quantity | Price | Cost Estimation |
|---|---|---|---|---|---|--|---|---|---|---|---|---|
| 11 | Main Library Entrance Gallery | 1 | | Interior Access Route | N/A | | Obstructed by protruding objects | 5" | Relocate the defibrillator out of the circulation path. | 1 | 256 | \$256 |

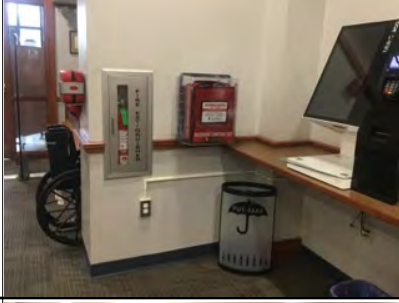
| ID | Location | Floor | Room | Element | Type | Photo | Issues | Current Measure | Recommendations | Quantity | Price | Cost Estimation |
|---|---|---|---|---|---|--|---|---|---|---|---|---|
| 12 | Main Library Entrance Gallery | 1 | | Interior Access Route | N/A | | Obstructed by protruding objects | 10" | Relocate the defibrillator out of the circulation path. | 1 | 256 | \$256 |

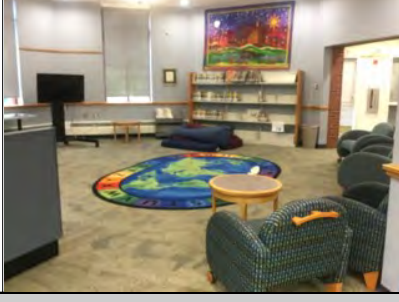
| ID | Location | Floor | Room | Element | Type | Photo | Issues | Current Measure | Recommendations | Quantity | Price | Cost Estimation |
|---|---|---|---|---|---|--|---|---|---|---|---|---|
| 13 | Children's Reading Room | 1 | | Interior Access Route | N/A | | Surface not stable, firm, and slip-resistant | - | Secure the mat. | 1 | Labor | \$0 |

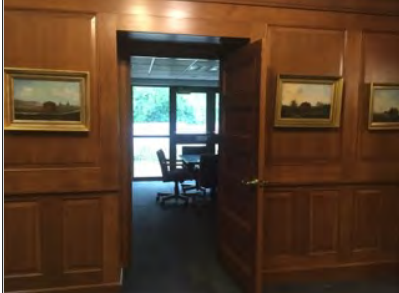
| ID | Location | Floor | Room | Element | Type | Photo | Issues | Current Measure | Recommendations | Quantity | Price | Cost Estimation |
|---|---|---|---|---|---|--|---|---|---|---|---|---|
| 14 | Conference Room | 2 | | Doors, Doorways, & Gates | | | Maneuvering clearance not provided at recess > 6" | - | Install an automatic door opener. | 1 | 3060 | \$3060 |

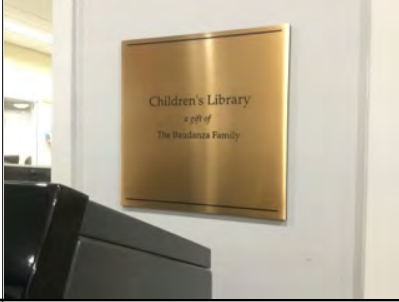
| ID | Location | Floor | Room | Element | Type | Photo | Issues | Current Measure | Recommendations | Quantity | Price | Cost Estimation |
|---|---|---|---|---|---|--|--|---|---|---|---|---|
| 15 | Children's Library Entrance | 1 | | Signage | Designation | | Raised characters not provided on sign<br>Braille not provided on sign | -<br>- | Provide text with raised characters duplicated in braille on sign. Ensure that a clear floor space of 18" by 18" is centered on the tactile characters. | 1 | 232 | \$232 |

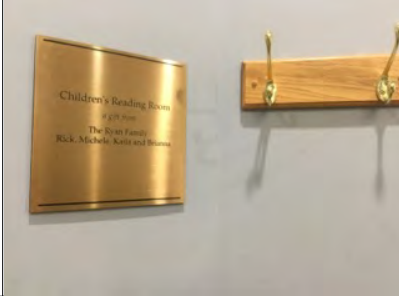
| ID | Location | Floor | Room | Element | Type | Photo | Issues | Current Measure | Recommendations | Quantity | Price | Cost Estimation |
|---|---|---|---|---|---|--|--|---|---|---|---|---|
| 16 | Children's Reading Room | 1 | | Signage | Designation | | Raised characters not provided on sign<br>Braille not provided on sign | -<br>- | Provide text with raised characters duplicated in braille on sign. | 1 | 232 | \$232 |

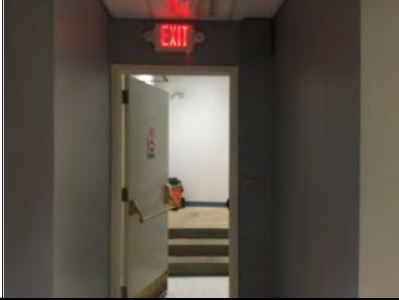
| ID | Location | Floor | Room | Element | Type | Photo | Issues | Current Measure | Recommendations | Quantity | Price | Cost Estimation |
|---|---|---|---|---|---|--|--|---|---|---|---|---|
| 17 | Egress to Stairs Near Restrooms | 1 | | Signage | Egress | | Sign not located on the latch side of the door | - | Locate sign at permanent rooms alongside the door on the latch side. | 1 | Labor | \$0 |

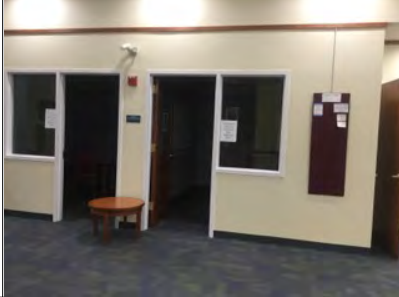
| ID | Location | Floor | Room | Element | Type | Photo | Issues | Current Measure | Recommendations | Quantity | Price | Cost Estimation |
|---|---|---|---|---|---|--|--|---|---|---|---|---|
| 18 | Quiet Study Rooms | 2 | | Signage | Designation | | Signage lacks clear floor space | | Relocate the table to ensure that a clear floor space of 18" by 18" is centered on the tactile characters. | 1 | Labor | \$0 |

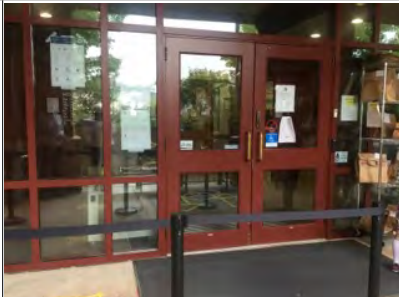
| ID | Location | Floor | Room | Element | Type | Photo | Issues | Current Measure | Recommendations | Quantity | Price | Cost Estimation |
|---|---|---|---|---|---|--|--|---|---|---|---|---|
| 19 | Main Entrance Door Bell | 1 | | Operable Parts | Other | | Reach < 15" or > 48"(forward/side approach) | 57" | Relocate door bell at 48" max. above the ground. | 1 | 138 | \$138 |

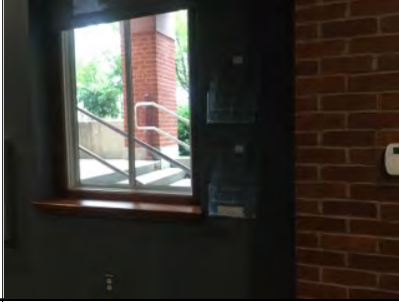
| ID | Location | Floor | Room | Element | Type | Photo | Issues | Current Measure | Recommendations | Quantity | Price | Cost Estimation |
|---|---|---|---|---|---|--|---|---|---|---|---|---|
| 20 | Main Entrance to Community Meeting Room | 1 | | Operable Parts | Other | | Reach < 15" or > 48"(forward/side approach) | 65" | Ensure that one of each type of form is available no higher than 48" above the finished floor. | 1 | Labor | \$0 |

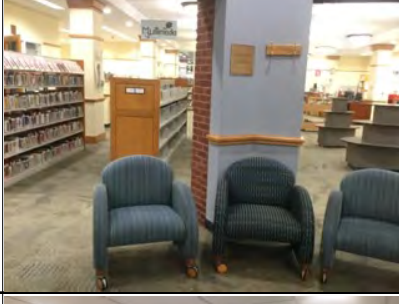
| ID | Location | Floor | Room | Element | Type | Photo | Issues | Current Measure | Recommendations | Quantity | Price | Cost Estimation |
|---|---|---|---|---|---|--|---|---|---|---|---|---|
| 22 | Children's Reading Room | 1 | | Operable Parts | Clothes Rod/Hooks | | Reach < 15" or > 48"(forward/side approach) | 69" | Relocate one hook to be 48" max. above the finished floor. | 1 | 256 | \$256 |

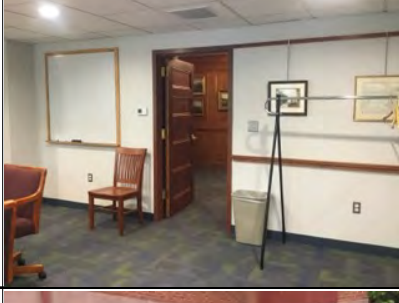
| ID | Location | Floor | Room | Element | Type | Photo | Issues | Current Measure | Recommendations | Quantity | Price | Cost Estimation |
|---|---|---|---|---|---|--|---|---|---|---|---|---|
| 23 | Conference Room | 2 | | Operable Parts | Clothes Rod/Hooks | | Reach < 15" or > 48"(forward/side approach) | 60" | Provide a clothing rack that is located no higher than 48" above the finished floor. | 1 | 92 | \$92 |

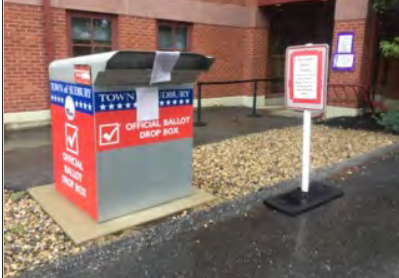
| ID | Location | Floor | Room | Element | Type | Photo | Issues | Current Measure | Recommendations | Quantity | Price | Cost Estimation |
|---|---|---|---|---|---|--|---|---|---|---|---|---|
| 24 | Main Entrance Ballot Box | Ext. | | Operable Parts | Other | | Reach < 15" or > 48"(forward/side approach) | 53.25" | As the ballot box is out of reach range, ensure there are policies in place to assist voters with disabilities. | 1 | Policy | \$0 |

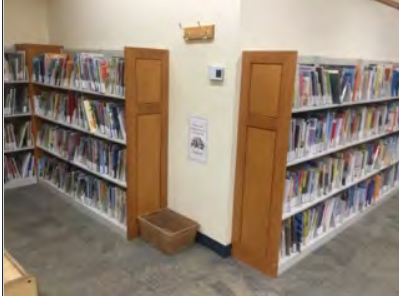
| ID | Location | Floor | Room | Element | Type | Photo | Issues | Current Measure | Recommendations | Quantity | Price | Cost Estimation |
|---|---|---|---|---|---|--|--|---|--|---|---|---|
| 25 | Children's Library Seating Area | 1 | | Children's Reach Ranges | N/A | | 30" x 48" clear space not provided<br>Reach < 20" or > 36" (Ages 3 - 4)<br>Reach < 18" or > 40" (Ages 5 - 8)<br>Reach < 16" or > 44" (Ages 9 - 12) | -<br>66" | Provide a 30" min. by 48" min. clear floor space at coat hook. Relocate bin.<br>If used by children 3-4 years old, locate one hook 36" max. above the finished floor.<br>If used by children 5-8 years old, locate one hook 40" max. above the finished floor.<br>If used by children 9-12 years old, locate one hook 44" max. above the finished floor. | 1 | 70<br>Labor | \$70 |

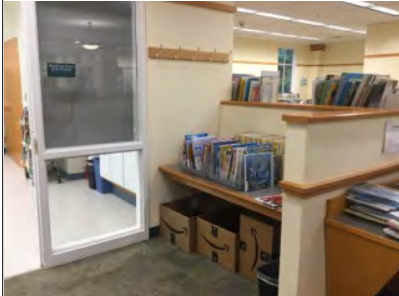
| ID | Location | Floor | Room | Element | Type | Photo | Issues | Current Measure | Recommendations | Quantity | Price | Cost Estimation |
|---|---|---|---|---|---|--|--|---|--|---|---|---|
| 26 | Children's Library Near Program Room Storytelling | 1 | | Children's Reach Ranges | N/A | | 30" x 48" clear space not provided<br>Reach < 20" or > 36" (Ages 3 - 4)<br>Reach < 18" or > 40" (Ages 5 - 8)<br>Reach < 16" or > 44" (Ages 9 - 12) | -<br>66" | Locate one hook with a 30" by 48" clear floor space.<br>If used by children 3-4 years old, locate one hook 36" max. above the finished floor.<br>If used by children 5-8 years old, locate one hook 40" max. above the finished floor.<br>If used by children 9-12 years old, locate one hook 44" max. above the finished floor. | 1 | 70 | \$70 |

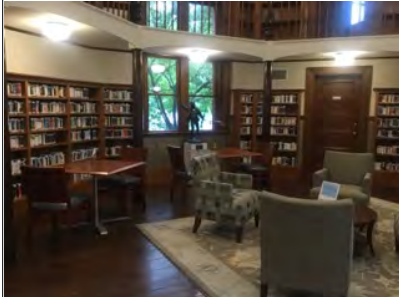
| ID | Location | Floor | Room | Element | Type | Photo | Issues | Current Measure | Recommendations | Quantity | Price | Cost Estimation |
|---|---|---|---|---|---|--|--|---|--|---|---|---|
| 27 | Reading Area - Front of Building | 2 | | Dining or Work Surfaces | Work Surface | | At least one or 5% accessible tables not provided<br>Knee or toe clearance not provided | -<br>- | Provide at least 1 work surface with 27" min. knee and toe clearance. | 1 | 700 | \$700 |

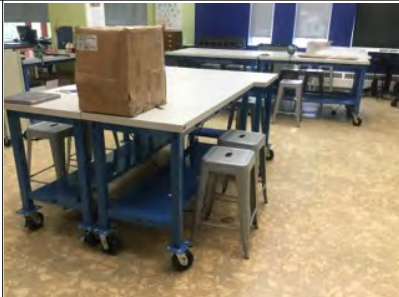
| ID | Location | Floor | Room | Element | Type | Photo | Issues | Current Measure | Recommendations | Quantity | Price | Cost Estimation |
|---|---|---|---|---|---|--|--|---|--|---|---|---|
| 28 | Sara Sherman Now Lab | 2 | | Dining or Work Surfaces | Work Surface | | At least one or 5% accessible tables not provided<br>Knee or toe clearance not provided<br>Top of dining/work surface < 28" or > 34" | -<br>-<br>36.3" | Provide at least one work surface with top between 28"- 34" above the floor and 27" clear height underneath. | 1 | 700 | \$700 |

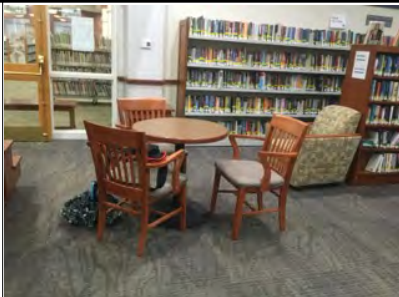
| ID | Location | Floor | Room | Element | Type | Photo | Issues | Current Measure | Recommendations | Quantity | Price | Cost Estimation |
|---|---|---|---|---|---|--|--|---|--|---|---|---|
| 29 | Main Library Near Children's Library Entrance (New Books) | 1 | | Dining or Work Surfaces | Work Surface | | Knee or toe clearance not provided | - | Table lacks toe clearance. Provide at least work surface with toe clearance in this area. | 1 | 700 | \$700 |

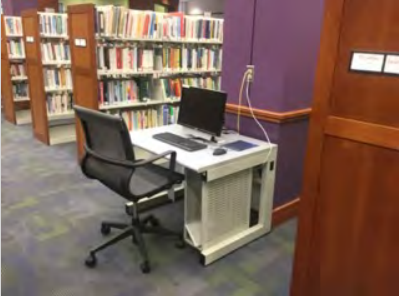
| ID | Location | Floor | Room | Element | Type | Photo | Issues | Current Measure | Recommendations | Quantity | Price | Cost Estimation |
|---|--|---|---|---|---|--|--|---|---|---|---|---|
| 30 | Desktop Near Shelves | 2 | | Dining or Work Surfaces | Work Surface | | Knee or toe clearance not provided | 26" | Provide at least 1 work surface with 27" min. knee and toe clearance. | 1 | 700 | \$700 |

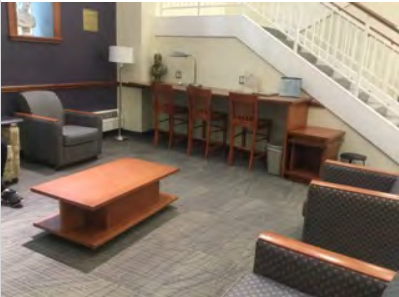
| ID | Location | Floor | Room | Element | Type | Photo | Issues | Current Measure | Recommendations | Quantity | Price | Cost Estimation |
|---|--|---|---|---|---|--|--|---|---|---|---|---|
| 31 | Main Library New Book Area Near Open Stair | | | Dining or Work Surfaces | Work Surface | | Top of dining/work surface < 28" or > 34" | 36.5" | Provide at least one work surface in this area with the top between 28"- 34" above the floor and 27" clear height underneath. | 1 | 700 | \$700 |

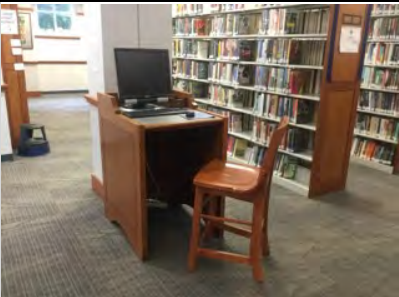
| ID | Location | Floor | Room | Element | Type | Photo | Issues | Current Measure | Recommendations | Quantity | Price | Cost Estimation |
|---|--|---|---|---|---|--|--|---|---|---|---|---|
| 32 | Computer Near Large Print Books - Main Library | 1 | | Dining or Work Surfaces | Work Surface | | Top of dining/work surface < 28" or > 34" | 36.5" | Provide at least work surface with top between 28"- 34" above the floor and 27" clear height underneath. | 1 | 700 | \$700 |

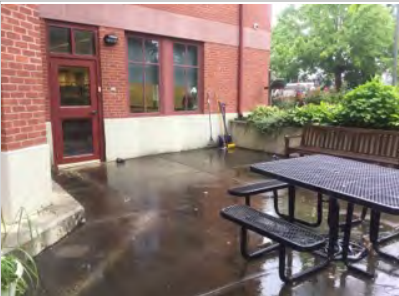
| ID | Location | Floor | Room | Element | Type | Photo | Issues | Current Measure | Recommendations | Quantity | Price | Cost Estimation |
|---|--|---|---|---|---|--|--|---|---|---|---|---|
| 33 | Reading Court | Ext. | | Picnic Tables | N/A | | At least 5% accessible spaces not provided<br>30" clear width not provided<br>Toe or knee clearance at tables not provided | -<br>15.5"<br>- | Provide at least 1 accessible dining surface with a 30" wide by 48" deep clear floor space. Ensure the surface has the required toe and knee clearance. | 1 | 1400 | \$1400 |

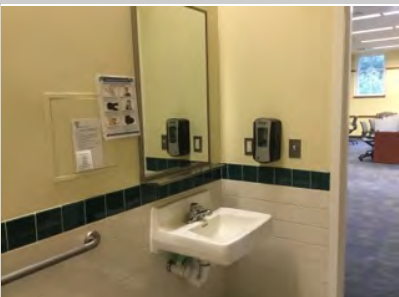
| ID | Location | Floor | Room | Element | Type | Photo | Issues | Current Measure | Recommendations | Quantity | Price | Cost Estimation |
|---|--|---|---|---|---|--|--|---|---|---|---|---|
| 34 | All-Gender Toilet Room East of Drinking Fountain | 2 | | Lavatory | N/A | | Mirror above lavatory w/reflective surface > 40" | 44" | Lower mirror so that the bottom surface is at 40" max. above the finished floor. | 1 | 256 | \$256 |

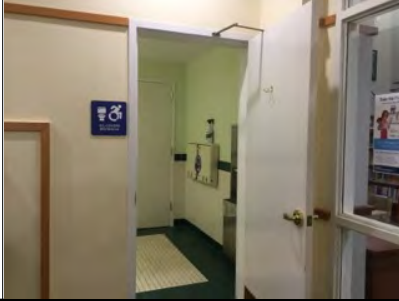
| ID | Location | Floor | Room | Element | Type | Photo | Issues | Current Measure | Recommendations | Quantity | Price | Cost Estimation |
|---|--|---|---|---|---|--|---|---|--|---|---|---|
| 35 | All-Gender Toilet Room - Children's Library | 1 | | Single-User Toilet | N/A | | Hook located > 48" high | 67" | Locate hook no higher than 48" above the finished floor. | 1 | 150 | \$150 |

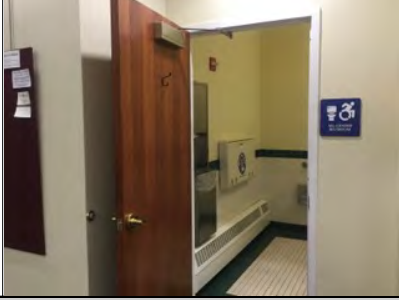
| ID | Location | Floor | Room | Element | Type | Photo | Issues | Current Measure | Recommendations | Quantity | Price | Cost Estimation |
|---|--|---|---|---|---|--|---|---|--|---|---|---|
| 36 | All-Gender Toilet Room East of Drinking Fountain | 2 | | Single-User Toilet | N/A | | Hook located > 48" high | 69" | Locate hook no higher than 48" above the finished floor. | 1 | 150 | \$150 |

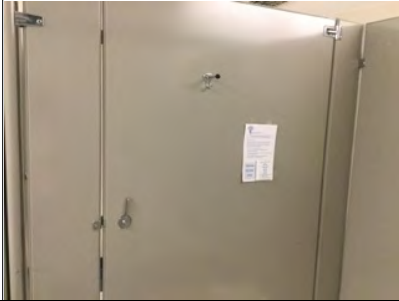
| ID | Location | Floor | Room | Element | Type | Photo | Issues | Current Measure | Recommendations | Quantity | Price | Cost Estimation |
|---|--|---|---|---|---|--|---|---|--|---|---|---|
| 37 | Women's Toilet Room | 1 | | Toilet Compartment | Accessible Compartment | | Door has malfunctioning self-closing hinge<br>Coat hook > 48" | -<br>60" | Repair hinge.<br>Lower coat hook so that it is no higher than 48". | 1 | Labor<br>150 | \$150 |

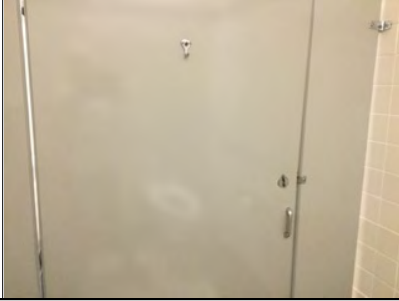
| ID | Location | Floor | Room | Element | Type | Photo | Issues | Current Measure | Recommendations | Quantity | Price | Cost Estimation |
|---|--|---|---|---|---|--|---|---|--|---|---|---|
| 38 | Men's Toilet Room | 1 | | Toilet Compartment | Accessible Compartment | | Door has malfunctioning self-closing hinge<br>Coat hook > 48" | -<br>58" | Repair hinge.<br>Lower coat hook so that it is no higher than 48". | 1 | Labor<br>150 | \$150 |

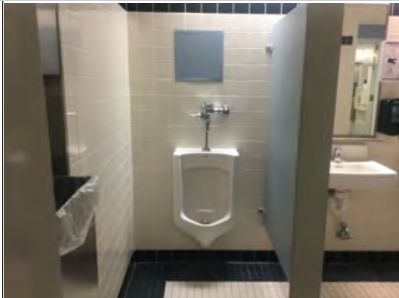
| ID | Location | Floor | Room | Element | Type | Photo | Issues | Current Measure | Recommendations | Quantity | Price | Cost Estimation |
|---|--|---|---|---|---|--|---|---|--|---|---|---|
| 39 | Men's Toilet Room | 1 | | Urinal | N/A | | Flush control too high or not properly located | 46" | Mount flush control at 44" max. above the finished floor. | 1 | 374 | \$374 |

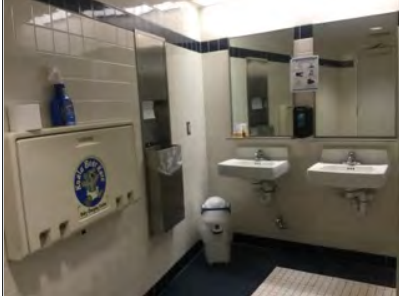
| ID | Location | Floor | Room | Element | Type | Photo | Issues | Current Measure | Recommendations | Quantity | Price | Cost Estimation |
|---|--|---|---|---|---|--|---|---|---|---|---|---|
| 40 | Women's Toilet Room | 1 | | Dispensers | Paper Towel Dispenser | | Controls > 42" high | 56" | Relocate the paper towel dispenser so the operable part is 42" max. above the finished floor. | 1 | 353 | \$353 |

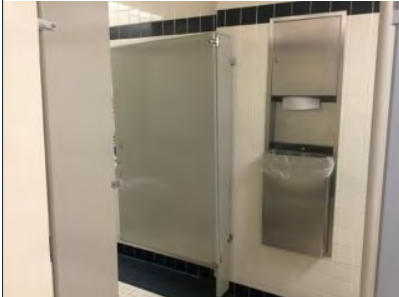
| ID | Location | Floor | Room | Element | Type | Photo | Issues | Current Measure | Recommendations | Quantity | Price | Cost Estimation |
|---|--|---|---|---|---|--|---|---|---|---|---|---|
| 41 | Men's Toilet Room | 1 | | Dispensers | Paper Towel Dispenser | | Controls > 42" high | 55" | Relocate the paper towel dispenser so the operable part is 42" max. above the finished floor. | 1 | 353 | \$353 |

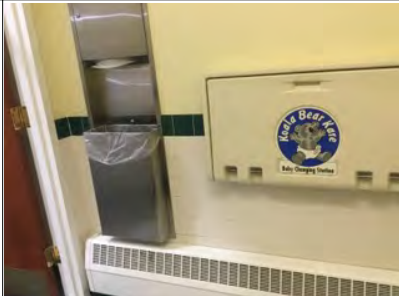
| ID | Location | Floor | Room | Element | Type | Photo | Issues | Current Measure | Recommendations | Quantity | Price | Cost Estimation |
|---|--|---|---|---|---|--|---|---|---|---|---|---|
| 42 | All-Gender Toilet Room East of Drinking Fountain | 2 | | Dispensers | Paper Towel Dispenser | | Controls > 42" high | 54.5" | Relocate paper towel dispenser so the operable part is 42" max. above the finished floor. | 1 | 353 | \$353 |

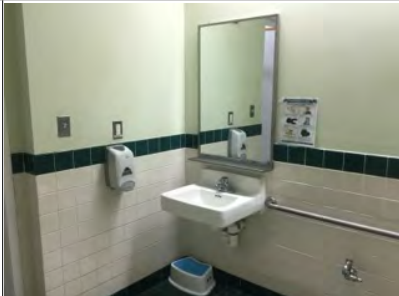
| ID | Location | Floor | Room | Element | Type | Photo | Issues | Current Measure | Recommendations | Quantity | Price | Cost Estimation |
|---|--|---|---|---|---|--|---|---|---|---|---|---|
| 43 | All-Gender Toilet Room - Children's Library | 1 | | Lavatory (Children) | | | Toe or knee clearances not provided<br>Mirror above lavatory w/reflective surface > 31" | 23.75"<br>37.25 | Provide at least one lavatory with 25" min. knee clearance positioned for a forward approach. Ensure toe clearance is also provided.<br><br>Lower mirror so that the bottom surface is at 31" above finished floor. | 1 | 1942 | \$1942 |

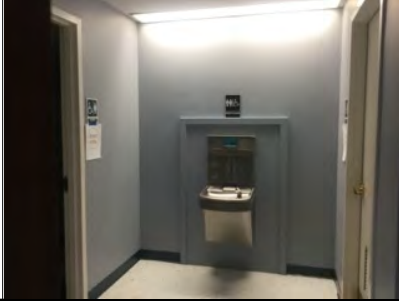
| ID | Location | Floor | Room | Element | Type | Photo | Issues | Current Measure | Recommendations | Quantity | Price | Cost Estimation |
|---|---|---|---|---|---|--|--|---|--|---|---|---|
| 44 | Fountain Near Toilet Rooms | 1 | | Drinking Fountains | Low | | No drinking fountain provided for standing users | - | Provide an additional drinking fountain for standing users. | 1 | 4028 | \$4028 |

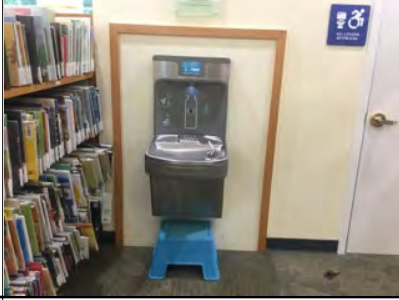
| ID | Location | Floor | Room | Element | Type | Photo | Issues | Current Measure | Recommendations | Quantity | Price | Cost Estimation |
|---|---|---|---|---|---|--|--|---|--|---|---|---|
| 45 | Fountain Near Toilet Room in Children's Library | 1 | | Drinking Fountains | Low | | No drinking fountain provided for standing users | - | Provide an additional drinking fountain for standing users. | 1 | 4028 | \$4028 |

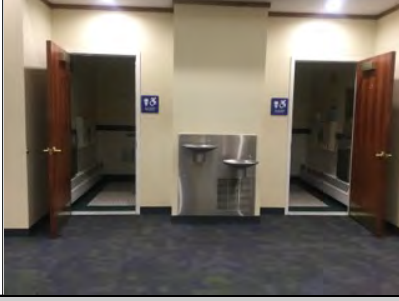
| ID | Location | Floor | Room | Element | Type | Photo | Issues | Current Measure | Recommendations | Quantity | Price | Cost Estimation |
|---|---|---|---|---|---|--|--|---|--|---|---|---|
| 46 | Fountain Near All-Gender Toilet Rooms | 2 | | Drinking Fountains | Hi-Lo | | Standing height fountain does not have cane protection | 13" | Provide a cane-detectable barrier skirt under the high unit. | 1 | 890 | \$890 |

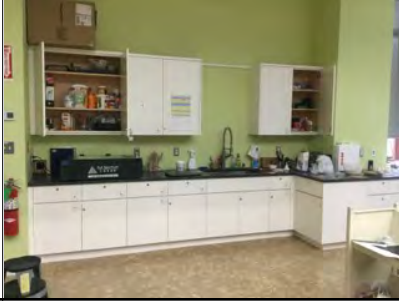
| ID | Location | Floor | Room | Element | Type | Photo | Issues | Current Measure | Recommendations | Quantity | Price | Cost Estimation |
|---|---|---|---|---|---|--|--|---|--|---|---|---|
| 47 | Sara Sherman Now Lab | 2 | | Sink | Lab | | Toe and knee clearances not provided | - | Ensure there is a 27" knee clearance positioned for a forward approach. Brace sink and remove cabinet. | 1 | 1686 | \$1686 |

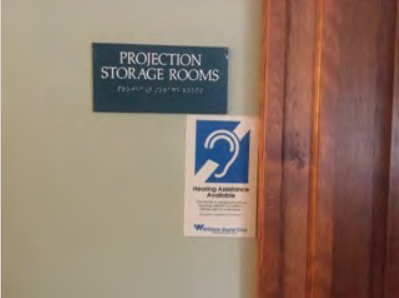
| ID | Location | Floor | Room | Element | Type | Photo | Issues | Current Measure | Recommendations | Quantity | Price | Cost Estimation |
|---|---|---|---|---|---|--|---|---|--|---|---|---|
| 48 | Community Meeting Room | 1 | | | | | | | This is a good example of signage for an assistive listening system. | 1 | - | \$0 |

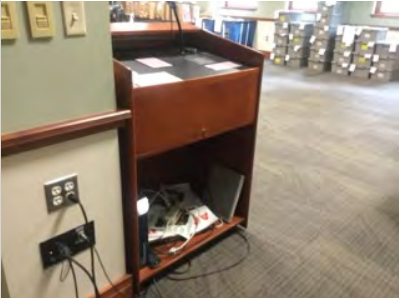
| ID | Location | Floor | Room | Element | Type | Photo | Issues | Current Measure | Recommendations | Quantity | Price | Cost Estimation |
|---|---|---|---|---|---|--|---|---|--|---|---|---|
| 49 | Community Meeting Room | 1 | | | | | | | Recommend providing an adjustable height podium. | 1 | - | \$0 |

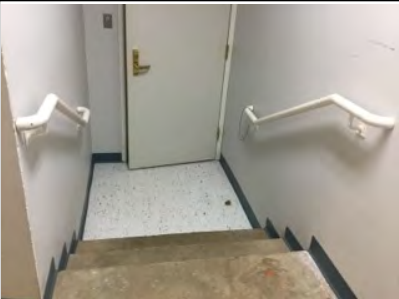
| ID | Location | Floor | Room | Element | Type | Photo | Issues | Current Measure | Recommendations | Quantity | Price | Cost Estimation |
|---|---|---|---|---|---|--|---|---|--|---|---|---|
| 50 | Egress to Stairs Near Restrooms | 1 | | | | | | | Recommend providing contrast strips on stair treads. | 1 | - | \$0 |

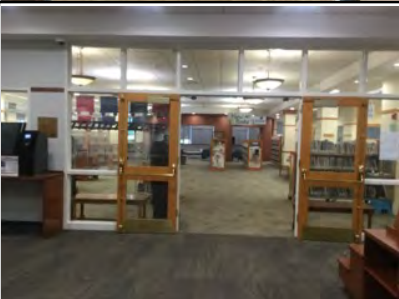
| ID | Location | Floor | Room | Element | Type | Photo | Issues | Current Measure | Recommendations | Quantity | Price | Cost Estimation |
|---|---|---|---|---|---|--|---|---|--|---|---|---|
| 51 | Children's Library Entrance | 1 | | | | | | | Recommend providing a large visual sign at the entrance to the children's library. | 1 | - | \$0 |

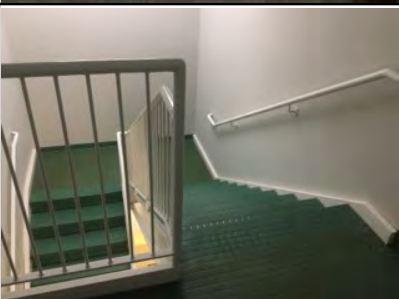
| ID | Location | Floor | Room | Element | Type | Photo | Issues | Current Measure | Recommendations | Quantity | Price | Cost Estimation |
|---|---|---|---|---|---|--|---|---|--|---|---|---|
| 52 | Stairs by Children's Reading Room | 2 | | | | | | | Recommend providing contrast strips on stair treads. | 1 | - | \$0 |

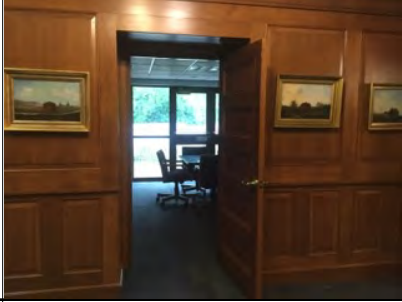
| ID | Location | Floor | Room | Element | Type | Photo | Issues | Current Measure | Recommendations | Quantity | Price | Cost Estimation |
|---|---|---|---|---|---|--|---|---|---|---|---|---|
| 53 | Conference Room | 2 | | | | | | | Recommend providing a designation sign with raised characters and braille at the engineering conference room. | 1 | - | \$0 |

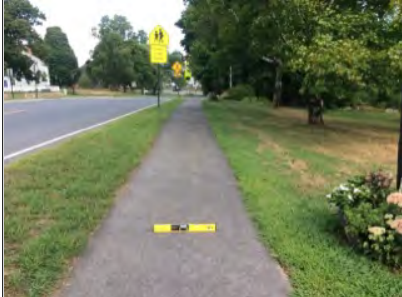
| ID | Location | Floor | Room | Element | Type | Photo | Issues | Current Measure | Recommendations | Quantity | Price | Cost Estimation |
|---|---|---|---|---|---|--|--|---|---|---|---|---|
| 1 | Sidewalk East of House | Ext. | | Exterior Access Route | Sidewalk | | Cross slope > 1:50 (2.00%) | 5.8% - 10% | Reduce cross slope to be no steeper than 1:50 (2.00%).<br>(Cost estimate for 30' long 4' wide asphalt route.) | 1 | 1200 | \$1200 |

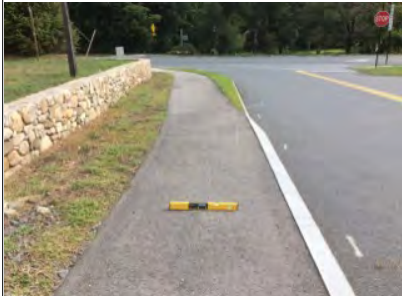
| ID | Location | Floor | Room | Element | Type | Photo | Issues | Current Measure | Recommendations | Quantity | Price | Cost Estimation |
|---|---|---|---|---|---|--|--|---|---|---|---|---|
| 2 | Sidewalk West of Town Hall (Toward Parking Lot) | Ext. | | Exterior Access Route | Sidewalk | | Cross slope > 1:50 (2.00%) | 5.2% | Reduce cross slope to be no steeper than 1:50 (2.00%).<br>(Cost estimate for 10' long 4' wide asphalt route.) | 1 | 400 | \$400 |

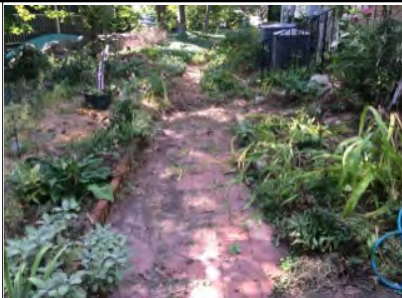
| ID | Location | Floor | Room | Element | Type | Photo | Issues | Current Measure | Recommendations | Quantity | Price | Cost Estimation |
|---|---|---|---|---|---|--|--|---|---|---|---|---|
| 3 | Garden Path Behind House | Ext. | | Exterior Access Route | Walkway | | Cross slope > 1:50 (2.00%)<br>Route not maintained in operable working condition | 5.6%<br>- | Reduce cross slope to be no steeper than 1:50 (2.00%).<br>Ensure the accessible route is maintained in operable working condition.<br>(Cost estimate for 60' long by 4' wide brick paver walkway.) | 1 | 3440 | \$3440 |

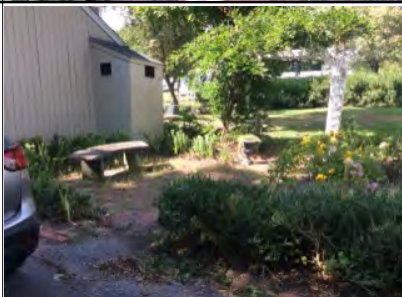
| ID | Location | Floor | Room | Element | Type | Photo | Issues | Current Measure | Recommendations | Quantity | Price | Cost Estimation |
|---|---|---|---|---|---|--|--|---|---|---|---|---|
| 4 | Garden East of Garage | Ext. | | Exterior Access Route | Walkway | | Accessible route not provided | - | Ensure an accessible route is provided to the garden east of the garage and to one bench in this area.<br>(Cost estimate for 6' long 4' wide brick paver walkway.) | 1 | 688 | \$688 |

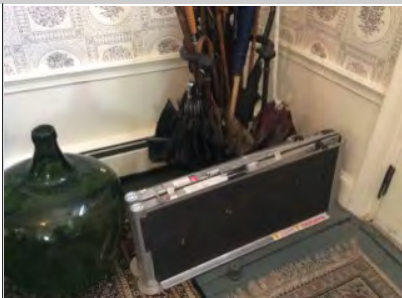
The temporary ramp to the main entrance is not compliant for a level change that is greater than 8.5 inches. (On occasions when the house is open to the public, IHCD recommends renting an accessible metal portable ramp with compliant handrails and landings and a running slope no greater than 8.33 percent.)

| ID | Location | Floor | Room | Element | Type | Photo | Issues | Current Measure | Recommendations | Quantity | Price | Cost Estimation |
|---|---|---|---|---|---|--|--|---|---|---|---|---|
| 5 | Main Entrance Hallway | 1 | | Entrance | Main Entrance | | Entrance not on an accessible route | - | The temporary ramp to the main entrance is not compliant for a level change that is greater than 8.5 inches. On occasions when the house is open to the public, IHCD recommends renting an accessible metal portable ramp with compliant handrails and landings and a running slope no greater than 8.33 percent. | 1 | - | \$0 |

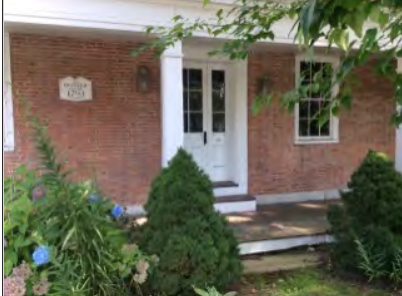
| ID | Location | Floor | Room | Element | Type | Photo | Issues | Current Measure | Recommendations | Quantity | Price | Cost Estimation |
|---|---|---|---|---|---|--|---|---|--|---|---|---|
| 6 | General Store Entrance | Ext. | | Entrance | Secondary Entrance | | Entrance not on an accessible route<br>Directional sign to accessible entrance not provided<br>Clear width at door is < 32" | -<br>-<br>27.25" | Provide a directional sign indicating the location of the nearest accessible entrance. Alteration of the door width may not be feasible. Compliance with the requirements may threaten or destroy the historic significance of the building. | 1 | 346 | \$346 |

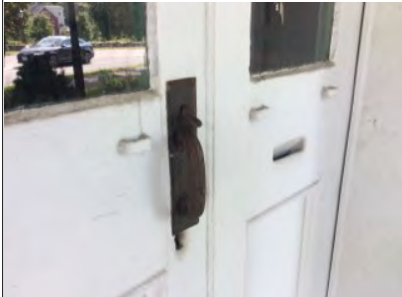
| ID | Location | Floor | Room | Element | Type | Photo | Issues | Current Measure | Recommendations | Quantity | Price | Cost Estimation |
|---|---|---|---|---|---|--|---|---|--|---|---|---|
| 7 | General Store Entrance | 1 | | Entrance | Secondary Entrance | | Hardware not operable with a closed fist | - | Provide hardware that can be operable with one hand and not require tight grasping, pinching, or twisting of the wrist. | 1 | 484 | \$484 |

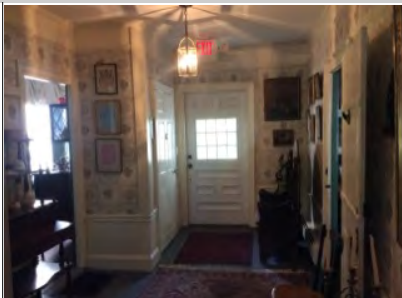
| ID | Location | Floor | Room | Element | Type | Photo | Issues | Current Measure | Recommendations | Quantity | Price | Cost Estimation |
|---|---|---|---|---|---|--|---|---|--|---|---|---|
| 8 | Back Hallway Exit | 1 | | Means of Egress | N/A | | Tactile exit sign not provided | - | Ensure tactile exit signs with raised characters and braille are provided at exit doors. Mount signs between 48"- 60" above the finished floor located on the latch side of the door. | 1 | 232 | \$232 |
