## DPW Offices and Garage

## Town of Sudbury ADA Transition Plan

October 2020

Institute for Human Centered Design

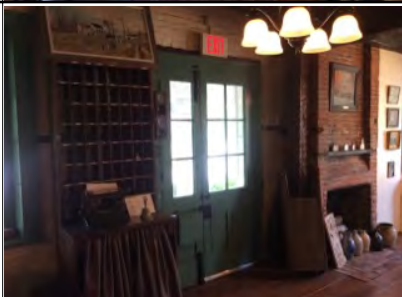
| ID | Location | Floor | Room | Element | Type | Photo | Issues | Current Measure | Recommendations | Quantity | Price | Cost Estimation |
|---|---|---|---|---|---|--|---|---|--|---|---|---|
| 9 | General Store Exit to Concord Road | 1 | | Means of Egress | N/A | | Tactile exit sign not provided | - | Ensure tactile exit signs with raised characters and braille are provided at exit doors. Mount signs between 48"- 60" above the finished floor located on the latch side of the door. | 1 | 232 | \$232 |

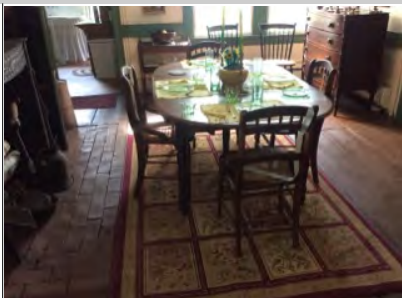
| ID | Location | Floor | Room | Element | Type | Photo | Issues | Current Measure | Recommendations | Quantity | Price | Cost Estimation |
|---|---|---|---|---|---|--|---|---|--|---|---|---|
| 10 | Dining Room | 1 | | Interior Access Route | N/A | | Route < 36" wide | 30.5" | Ensure that a clear width of 36" min. is maintained at the accessible route. Route is allowed to narrow to 32" wide min. for 24" of depth. | 1 | Labor | \$0 |

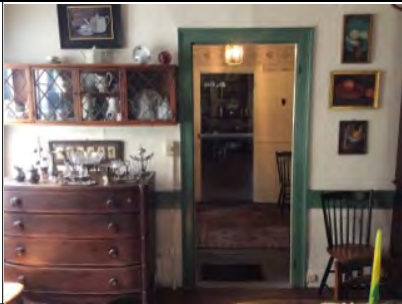
| ID | Location | Floor | Room | Element | Type | Photo | Issues | Current Measure | Recommendations | Quantity | Price | Cost Estimation |
|---|---|---|---|---|---|--|--|---|--|---|---|---|
| 13 | Doorway From Dining Room to Hallway | 1 | | Interior Access Route | N/A | | Obstructed by protruding objects | 10.75" | Provide a cane-detectable barrier underneath the overhead cabinet. | 1 | 306 | \$306 |

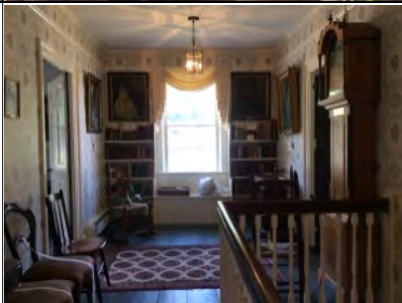
| ID | Location | Floor | Room | Element | Type | Photo | Issues | Current Measure | Recommendations | Quantity | Price | Cost Estimation |
|---|---|---|---|---|---|--|--|---|--|---|---|---|
| 14 | Second Floor | 2 | | Interior Access Route | N/A | | Accessible route not provided | - | Provide a video of the rooms on the second floor or photographs to provide program accessibility. | 1 | - | \$0 |

There is no accessible route to the second floor. It is recommended that Hosmer House provide a video or photographs of the rooms on the second floor to provide program accessibility for visitors who are unable to visit the second floor themselves.

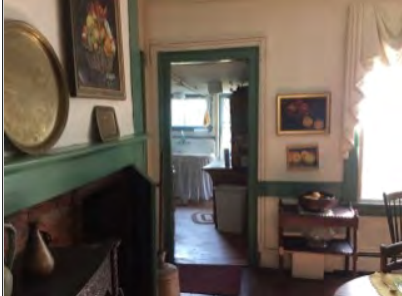
| ID | Location | Floor | Room | Element | Type | Photo | Issues | Current Measure | Recommendations | Quantity | Price | Cost Estimation |
|---|---|---|---|---|---|--|---|---|---|---|---|---|
| 16 | Doorway From Dining Room to Kitchen | 1 | | Doors, Doorways, & Gates | Circulation | | Mat not securely attached | - | Secure the mat. | 1 | Labor | \$0 |

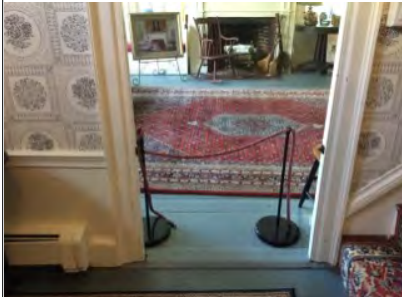
| ID | Location | Floor | Room | Element | Type | Photo | Issues | Current Measure | Recommendations | Quantity | Price | Cost Estimation |
|---|---|---|---|---|---|--|---|---|---|---|---|---|
| 17 | Living Room | 1 | | Doors, Doorways, & Gates | Circulation | | Threshold > 1/2" high | 1" | Alteration may not be feasible. Compliance with the requirements may threaten or destroy the historic significance of the building. Provide a video of the rooms or photographs to provide program accessibility. | 1 | - | \$0 |

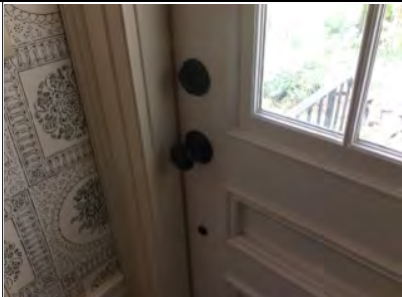
| ID | Location | Floor | Room | Element | Type | Photo | Issues | Current Measure | Recommendations | Quantity | Price | Cost Estimation |
|---|---|---|---|---|---|--|---|---|---|---|---|---|
| 18 | Emergency Egress From Back Hallway | 1 | | Doors, Doorways, & Gates | Emergency Egress | | Hardware not operable with a closed fist | - | Provide hardware that can be operable with one hand and not require tight grasping, pinching, or twisting of the wrist. | 1 | 484 | \$484 |

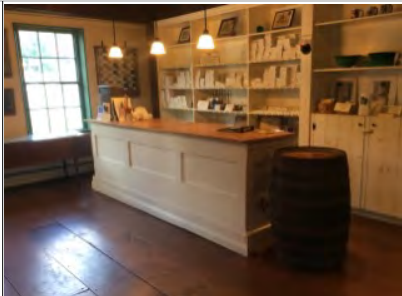
| ID | Location | Floor | Room | Element | Type | Photo | Issues | Current Measure | Recommendations | Quantity | Price | Cost Estimation |
|---|---|---|---|---|---|--|---|---|---|---|---|---|
| 19 | General Store | 1 | | Service Counter | N/A | | Counter > 36" high | 39.25" | Provide another table that is 36" max. above the ground or finished floor. | 1 | 500 | \$500 |

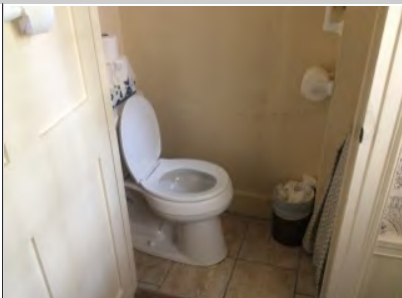
| ID | Location | Floor | Room | Element | Type | Photo | Issues | Current Measure | Recommendations | Quantity | Price | Cost Estimation |
|---|---|---|---|---|---|--|---|---|---|---|---|---|
| 20 | Toilet Room | 1 | | Overall Access | Toilet Room | | Turning space not provided<br>Accessible plumbing fixtures or stalls not provided | -<br>- | As toilet room was renovated in 1983, an accessible toilet room would have been required at the time as part of 521 CMR unless a variance was sought at the time. Recommend providing an accessible toilet room on this level if a toilet room is provided to the public. | 1 | - | \$0 |

As the first floor toilet room was renovated in 1983, an accessible toilet room would have been required at the time under 521 CMR, unless a variance was sought. IHCD recommends providing an accessible toilet room on this level if the toilet room is available for use by the public.

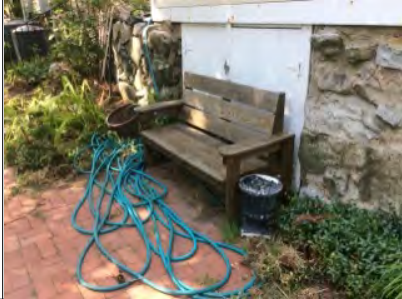
| ID | Location | Floor | Room | Element | Type | Photo | Issues | Current Measure | Recommendations | Quantity | Price | Cost Estimation |
|---|---|---|---|---|---|--|---|---|--|---|---|---|
| 21 | Garden Path Behind House and East of the Garage | 1 | | | | | | - | Recommend providing a level clear floor space of 36" wide min. by 48" deep min. alongside one bench in each garden so that a wheelchair user can sit alongside a person seated on the bench. | 2 | - | \$0 |

- Recommend providing a level clear floor space of 36" wide min. by 48" deep min. alongside one bench in each garden so that a wheelchair user can sit alongside a person seated on the bench.

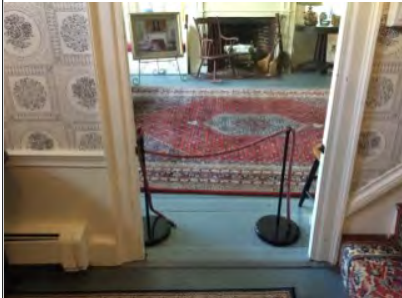
| ID | Location | Floor | Room | Element | Type | Photo | Issues | Current Measure | Recommendations | Quantity | Price | Cost Estimation |
|---|---|---|---|---|---|--|---|---|--|---|---|---|
| 22 | Living Room | 1 | | | | | | - | Recommend providing stanchions that stand out more from the background and are easier to see. | 1 | - | \$0 |

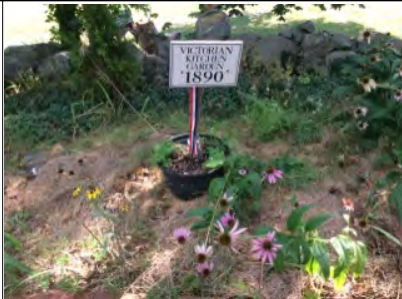
| ID | Location | Floor | Room | Element | Type | Photo | Issues | Current Measure | Recommendations | Quantity | Price | Cost Estimation |
|---|---|---|---|---|---|--|---|---|--|---|---|---|
| 23 | Garden Path Behind House | Ext. | | | | | | - | Recommend locating sign regarding the Victorian kitchen garden on an accessible route. | 1 | - | \$0 |

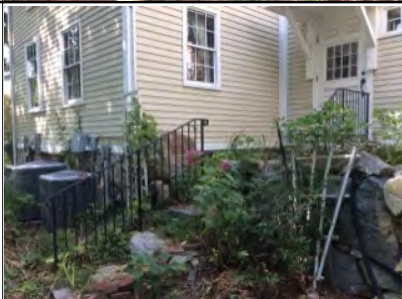
| ID | Location | Floor | Room | Element | Type | Photo | Issues | Current Measure | Recommendations | Quantity | Price | Cost Estimation |
|---|---|---|---|---|---|--|---|---|--|---|---|---|
| 24 | Stairs Outside of Back Hallway Exit | Ext. | | | | | | - | Stairs may be hazardous for users. Recommend renovating stairs. | 1 | - | \$0 |

- The stairs outside the exit from the back hallway exit door may be hazardous for users. Recommend renovating stairs.
- Recommend providing handrails on the stairs to the porch.

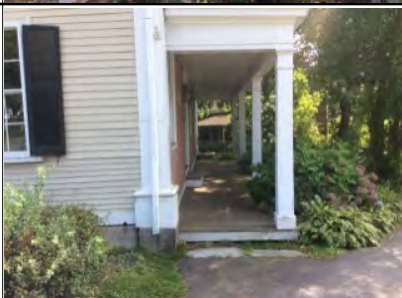
| ID | Location | Floor | Room | Element | Type | Photo | Issues | Current Measure | Recommendations | Quantity | Price | Cost Estimation |
|---|---|---|---|---|---|--|---|---|--|---|---|---|
| 25 | General Store Entrance | Ext. | | | | | | - | Recommend providing handrails on the stairs to the porch. | 1 | - | \$0 |

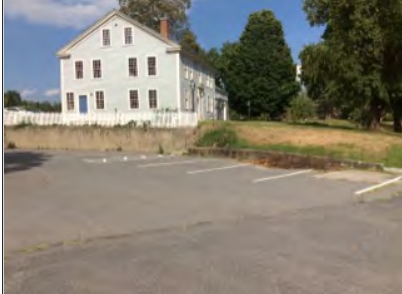
| ID | Location | Floor | Room | Element | Type | Photo | Issues | Current Measure | Recommendations | Quantity | Price | Cost Estimation |
|---|---|---|---|---|---|---|---|---|--|---|---|---|
| 28 | Lower Town Hall Parking Lot | Ext. | | | | | | - | Recommend providing a van accessible parking space in this lot as it is closer to the Hosmer House than the lot behind Town Hall. | 1 | - | \$0 |

- Recommend providing a van accessible parking space in the lower Town Hall parking lot as it is closer to the Hosmer House than the lot behind Town Hall.

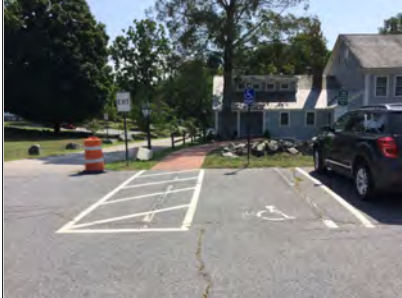
| ID | Location | Floor | Room | Element | Type | Photo | Issues | Current Measure | Recommendations | Quantity | Price | Cost Estimation |
|---|---|---|---|---|---|--|--|---|---|---|---|---|
| 1 | Parking Lot | Ext | | Off-Street Parking Lot or Garage | N/A | | Total # of parking<br>Total # of designated accessible parking spaces<br>Total # of designated van accessible spaces<br>Sign does not have the designation "Van Accessible"<br>Van space < 132" or <96" wide<br>Access aisle not compliant | 6<br>1<br>0<br>-<br>-<br>- | Provide at least one van accessible parking space for the facility.<br>(Cost estimate includes "Van Accessible" sign and restriping.) | 1 | 800 | \$800 |

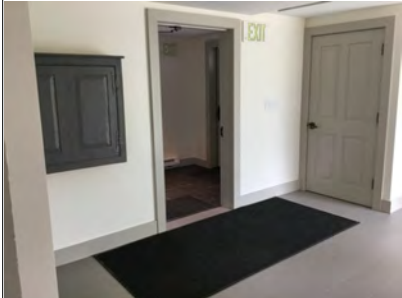
| ID | Location | Floor | Room | Element | Type | Photo | Issues | Current Measure | Recommendations | Quantity | Price | Cost Estimation |
|---|---|---|---|---|---|--|--|---|---|---|---|---|
| 2 | Lobby - Northeast Accessible Entrance | 1 | | Entrance | Main Entrance | | Mat not securely attached | - | Secure the mat. | 1 | Labor | \$0 |

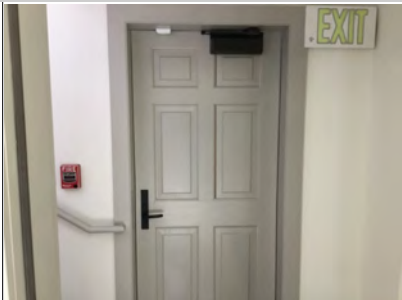
| ID | Location | Floor | Room | Element | Type | Photo | Issues | Current Measure | Recommendations | Quantity | Price | Cost Estimation |
|---|---|---|---|---|---|--|--|---|---|---|---|---|
| 3 | Stairwell - Exit to East Side of Building | 1 | | Emergency Exit | N/A | | Tactile sign not provided at exit<br>Directional sign to accessible emergency exit not provided | -<br>- | Provide tactile exit signs with raised characters and braille at exit doors. Mount signs between 48"- 60" above the finished floor located on the latch side of the door.<br>Provide a directional sign indicating the location of the nearest accessible emergency exit. | 2 | 232 | \$464 |

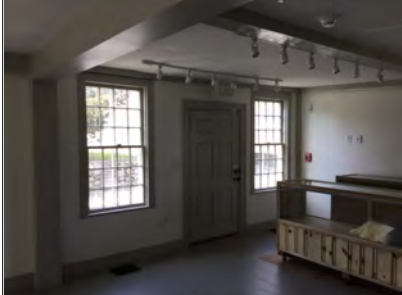
| ID | Location | Floor | Room | Element | Type | Photo | Issues | Current Measure | Recommendations | Quantity | Price | Cost Estimation |
|---|---|---|---|---|---|--|--|---|---|---|---|---|
| 4 | Exhibit Space - Exit to West Side of Building | 1 | 106 | Emergency Exit | N/A | | Tactile sign not provided at exit<br>Directional sign to accessible emergency exit not provided | -<br>- | Provide tactile exit signs with raised characters and braille at exit doors. Mount signs between 48"- 60" above the finished floor located on the latch side of the door.<br>Provide a directional sign indicating the location of the nearest accessible emergency exit. | 2 | 232 | \$464 |

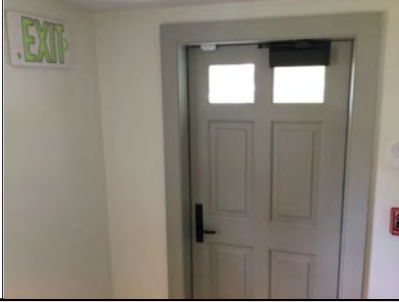
| ID | Location | Floor | Room | Element | Type | Photo | Issues | Current Measure | Recommendations | Quantity | Price | Cost Estimation |
|---|--|---|---|---|---|--|--|---|---|---|---|---|
| 5 | Vestibule - Northeast Accessible Entrance | 1 | | Emergency Exit | N/A | | Tactile sign not provided at exit<br>Illuminated Int. Symbol of Acc. not provided (MAAB) | -<br>- | Provide tactile exit signs with raised characters and braille at exit doors. Mount signs between 48"- 60" above the finished floor located on the latch side of the door.<br>Provide an illuminated sign with the International Symbol of Accessibility. | 1 | 432 | \$432 |

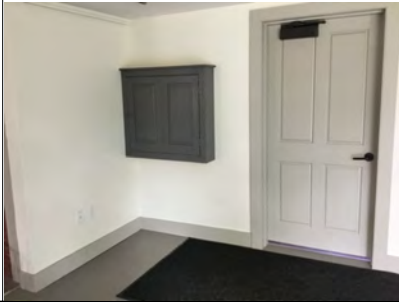
| ID | Location | Floor | Room | Element | Type | Photo | Issues | Current Measure | Recommendations | Quantity | Price | Cost Estimation |
|---|--|---|---|---|---|--|--|---|---|---|---|---|
| 6 | Lobby - Northeast Door to Parking Lot | 1 | | Interior Access Route | N/A | | Obstructed by protruding objects | 7.75" | Provide a cane-detectable barrier under the cabinet. | 1 | 306 | \$306 |

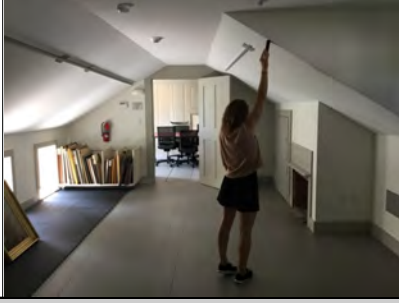
| ID | Location | Floor | Room | Element | Type | Photo | Issues | Current Measure | Recommendations | Quantity | Price | Cost Estimation |
|---|--|---|---|---|---|--|--|---|---|---|---|---|
| 7 | File Room - East Side of Building | 2 | | Interior Access Route | N/A | | Vertical clearance < 80" above finished floor | - | Provide ADA compliant double belt stanchions on each side of the route where the ceiling is less than 80" above the finished floor. Ensure that the lower horizontal belt of the stanchion is 27 inches maximum above the floor.<br>(Cost estimate for 4 stanchions.) | 4 | 93 | \$372 |

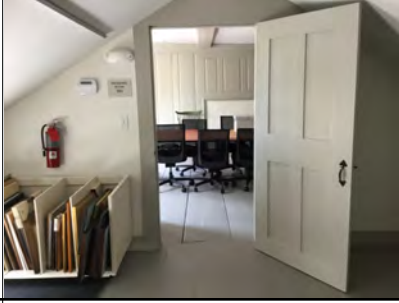
| ID | Location | Floor | Room | Element | Type | Photo | Issues | Current Measure | Recommendations | Quantity | Price | Cost Estimation |
|---|--|---|---|---|---|--|--|---|---|---|---|---|
| 8 | File Room to Research Room | 2 | | Doors, Doorways, & Gates | Circulation | | Maneuvering clearance(s) not provided | - | Relocate storage to provide 18" clear on the latch side of the door and at sign. | 1 | Labor | \$0 |

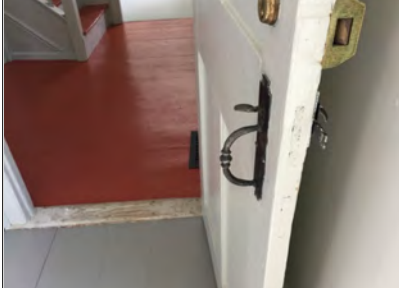
| ID | Location | Floor | Room | Element | Type | Photo | Issues | Current Measure | Recommendations | Quantity | Price | Cost Estimation |
|---|--|---|---|---|---|--|--|---|---|---|---|---|
| 9 | Exhibit Space - Southwest Side of Building | 1 | 106 | Doors, Doorways, & Gates | Circulation | | Threshold > 1/2" high<br>Hardware not operable with a closed fist | 1.25"<br>- | Alter the threshold to be 1/2" high max.<br>Provide hardware that can be operable with one hand and not require tight grasping, pinching, or twisting of the wrist. | 1 | 634 | \$634 |

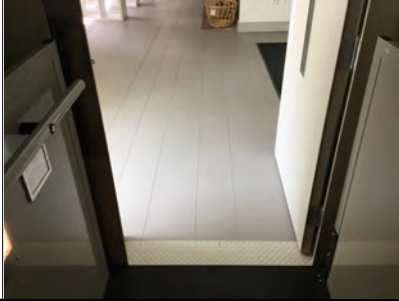
| ID | Location | Floor | Room | Element | Type | Photo | Issues | Current Measure | Recommendations | Quantity | Price | Cost Estimation |
|---|---|---|---|---|---|--|---|---|---|---|---|---|
| 10 | Platform Lift, East Side of Building | 1 | | Platform Lift or LULA Elevator | Interior | | Doors remain open < 20 seconds | 13 sec. | Adjust door opening speed. | 1 | Labor | \$0 |

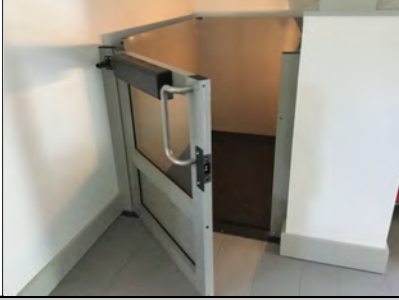
| ID | Location | Floor | Room | Element | Type | Photo | Issues | Current Measure | Recommendations | Quantity | Price | Cost Estimation |
|---|---|---|---|---|---|--|---|---|---|---|---|---|
| 11 | Platform Lift, East Side of Building | 2 | | Platform Lift or LULA Elevator | Interior | | Doors remain open < 20 seconds | 13 sec. | Adjust door opening speed. | 1 | Labor | \$0 |

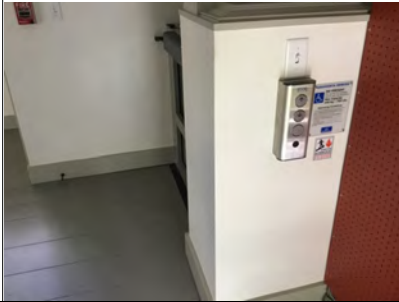
| ID | Location | Floor | Room | Element | Type | Photo | Issues | Current Measure | Recommendations | Quantity | Price | Cost Estimation |
|---|---|---|---|---|---|--|---|---|---|---|---|---|
| 12 | Platform Lift, East Side of Building | 2 | | Signage | Informational | | Visual characters < 40" above ground | - | Mount visual sign regarding fire precautions so that the baseline of the lowest character is 40" min. above the finished floor. | 1 | Labor | \$0 |

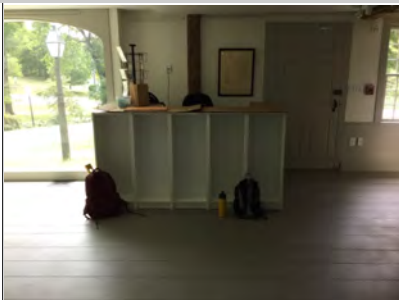
| ID | Location | Floor | Room | Element | Type | Photo | Issues | Current Measure | Recommendations | Quantity | Price | Cost Estimation |
|---|---|---|---|---|---|--|---|---|---|---|---|---|
| 13 | Lobby - East Side of Building | 1 | | Service Counter | N/A | | Counter > 36" high | 42" | Provide a counter that is 36" max. above the ground or finished floor. | 1 | 880 | \$880 |

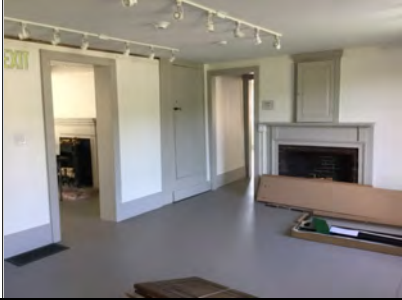
| ID | Location | Floor | Room | Element | Type | Photo | Issues | Current Measure | Recommendations | Quantity | Price | Cost Estimation |
|---|--|---|---|---|---|--|---|---|---|---|---|---|
| 16 | Exhibit Space - North Side of Building | 1 | 104 | | | | | - | Recommend providing signage with raised characters and braille at all permanent rooms including the door between Rooms 104 and 105. | 1 | - | \$0 |

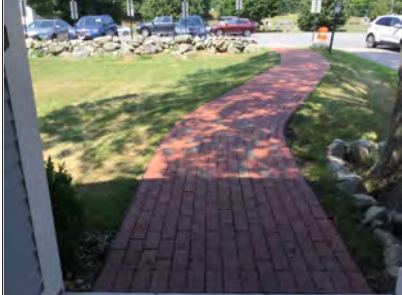
| ID | Location | Floor | Room | Element | Type | Photo | Issues | Current Measure | Recommendations | Quantity | Price | Cost Estimation |
|---|--|---|---|---|---|--|---|---|---|---|---|---|
| 17 | Main Entrance - Route to Parking Lot | Ext | | | | | | * | Recommend providing edge protection along open sides of walkway. | 1 | - | \$0 |

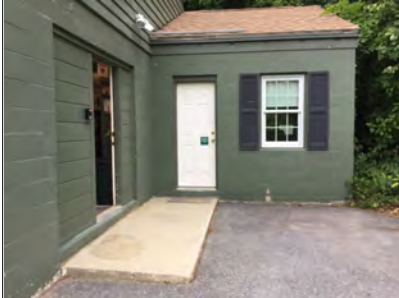
| ID | Location | Floor | Room | Element | Type | Photo | Issues | Current Measure | Recommendations | Quantity | Price | Cost Estimation |
|---|---|---|---|---|---|--|---|---|---|---|---|---|
| 1 | Entrance to Office on East | Ext. | | Entrance | Secondary Entrance | | Entrance not on an accessible route<br>Clear width at door is < 32"<br>Mat not securely attached<br>Threshold > 1/2" high<br>Hardware not operable with a closed fist | -<br>29"<br>-<br>1.25"<br>- | Provide a directional sign indicating the location of the nearest accessible entrance.<br>Secure the mat.<br>Provide hardware that can be operable with one hand and not require tight grasping, pinching, or twisting of the wrist. | 1 | 830<br>Labor | \$830 |

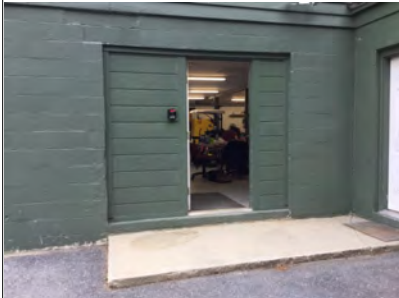
| ID | Location | Floor | Room | Element | Type | Photo | Issues | Current Measure | Recommendations | Quantity | Price | Cost Estimation |
|---|---|---|---|---|---|--|---|---|---|---|---|---|
| 2 | East Garage - Building Exit | Ext. | | Entrance | Main Entrance | | International Symbol of Accessibility not provided<br>Threshold > 1/2" high | -<br>7" | Install a metal ramp to provide an accessible entry route to the building. After the entrance is made accessible, provide a sign with the International Symbol of Accessibility (ISA).<br>(Cost is for a 7' perforated metal ramp with a 5' x 5' platform courtesy of Amramp and an exterior sign.) | 1 | 3146 | \$3146 |

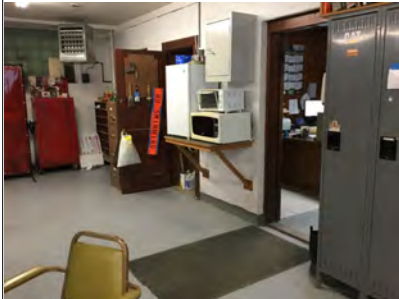
| ID | Location | Floor | Room | Element | Type | Photo | Issues | Current Measure | Recommendations | Quantity | Price | Cost Estimation |
|---|---|---|---|---|---|--|---|---|---|---|---|---|
| 3 | Office Entrance From East Garage | 1 | | Emergency Exit | N/A | | Tactile sign not provided at exit<br>Directional sign to accessible emergency exit not provided | -<br>-<br>- | Provide tactile exit signs with raised characters and braille at exit doors. Mount signs between 48"- 60" above the finished floor located on the latch side of the door.<br>Provide a directional sign indicating the location of the nearest accessible emergency exit. | 1 | 464 | \$464 |

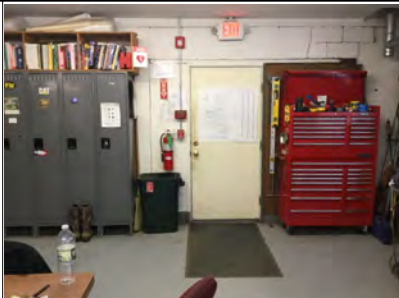
| ID | Location | Floor | Room | Element | Type | Photo | Issues | Current Measure | Recommendations | Quantity | Price | Cost Estimation |
|---|---|---|---|---|---|--|---|---|---|---|---|---|
| 4 | East Garage - Building Exit | 1 | | Emergency Exit | N/A | | Tactile sign not provided at exit<br>Illuminated Int. Symbol of Acc. not provided (MAAB) | -<br>- | Provide tactile exit signs with raised characters and braille at exit doors. Mount signs between 48"- 60" above the finished floor located on the latch side of the door.<br>After the entrance/exit door is brought into compliance, provide an illuminated sign with the International Symbol of Accessibility. | 1 | 432 | \$432 |

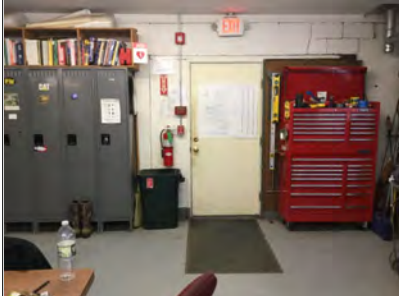
| ID | Location | Floor | Room | Element | Type | Photo | Issues | Current Measure | Recommendations | Quantity | Price | Cost Estimation |
|---|---|---|---|---|---|--|--|---|---|---|---|---|
| 5 | East Garage - Building Exit | 1 | | Doors, Doorways, & Gates | Circulation | | Maneuvering clearance(s) not provided<br>Mat not securely attached<br>Hardware not operable with a closed fist | -<br>-<br>- | Relocate the trash bin.<br>Secure the mat.<br>Provide hardware that can be operable with one hand and not require tight grasping, pinching, or twisting of the wrist. | 1 | Labor<br>484 | \$484 |

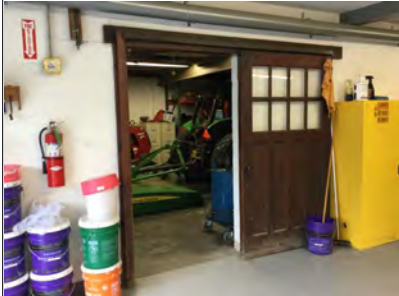
| ID | Location | Floor | Room | Element | Type | Photo | Issues | Current Measure | Recommendations | Quantity | Price | Cost Estimation |
|---|---|---|---|---|---|--|--|---|---|---|---|---|
| 6 | Route to Center Garage From East Garage | 1 | | Doors, Doorways, & Gates | Circulation | | Hardware not operable with a closed fist | - | Provide hardware that can be operable with one hand and not require tight grasping, pinching, or twisting of the wrist. | 1 | 484 | \$484 |

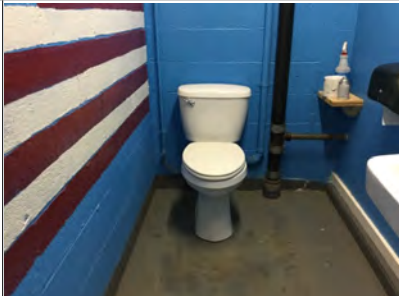
| ID | Location | Floor | Room | Element | Type | Photo | Issues | Current Measure | Recommendations | Quantity | Price | Cost Estimation |
|---|---|---|---|---|---|--|--|---|---|---|---|---|
| 7 | Center Garage Toilet Room | 1 | | Lavatory | N/A | | Not on an accessible route<br>Flush control not on open side<br>Toe or knee clearances not provided<br>Turning space not provided<br>Faucet is not operable with a closed fist<br>Grab bar not provided<br>Plumbing underneath is exposed<br>Mirror above lavatory w/reflective surface > 40"<br>Dispensers not within reach range | 7.75"<br>-<br>26.5"<br>51"<br>-<br>-<br>-<br>50.5"<br>58" | Add an accessible single-user toilet room located on an accessible route. | 1 | 24604 | \$24604 |

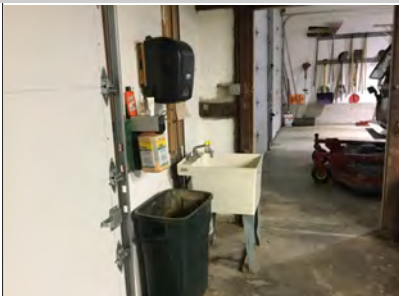
| ID | Location | Floor | Room | Element | Type | Photo | Issues | Current Measure | Recommendations | Quantity | Price | Cost Estimation |
|---|---|---|---|---|---|--|--|---|---|---|---|---|
| 8 | Center Garage | 1 | | Sink | Other | | Toe and knee clearances not provided<br>Non-compliant faucets<br>Dispenser not within reach range | -<br>-<br>55" | Ensure there is a 27" knee clearance positioned for a forward approach.<br>Install faucets that do not require tight grasping, pinching, or twisting of the wrist.<br>Relocate dispenser 48" max. above the finished floor or ground. | 1 | 2928 | \$2928 |

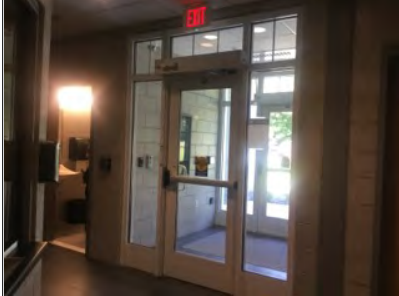
| ID | Location | Floor | Room | Element | Type | Photo | Issues | Current Measure | Recommendations | Quantity | Price | Cost Estimation |
|---|---|---|---|---|---|--|--|---|--|---|---|---|
| 1 | Lobby Exit | 1 | 104 | Emergency Exit | N/A | | Tactile sign not provided at exit<br>Illuminated Int. Symbol of Acc. not provided (MAAB) | -<br>- | Provide tactile exit signs with raised characters and braille at exit doors. Mount signs between 48"- 60" above the finished floor located on the latch side of the door.<br>Provide an illuminated sign with the International Symbol of Accessibility. | 1 | 432 | \$432 |

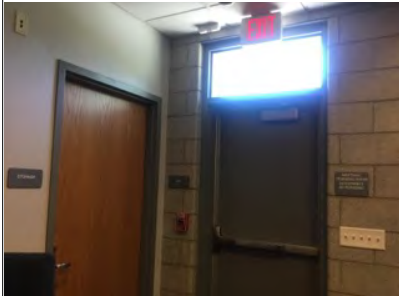
| ID | Location | Floor | Room | Element | Type | Photo | Issues | Current Measure | Recommendations | Quantity | Price | Cost Estimation |
|---|---|---|---|---|---|--|--|---|--|---|---|---|
| 2 | Meeting Room | 1 | 144 | Emergency Exit | | | Directional sign to accessible emergency exit not provided | - | Provide a directional sign indicating the location of the nearest accessible emergency exit. | 1 | 232 | \$232 |

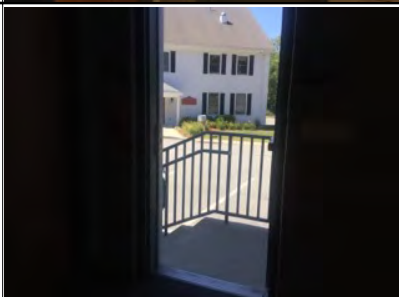
| ID | Location | Floor | Room | Element | Type | Photo | Issues | Current Measure | Recommendations | Quantity | Price | Cost Estimation |
|---|---|---|---|---|---|--|--|---|--|---|---|---|
| 3 | Meeting Room to Parking | 1 | 144 | Emergency Exit | N/A | | Door requires > 15 lbs. of force to open | 18 lbs. | Adjust closers of exterior doors so doors do not require more than 15 pounds of force.<br>Note: Fire doors shall have a minimum opening force allowable by the appropriate administrative authority. | 1 | Labor | \$0 |

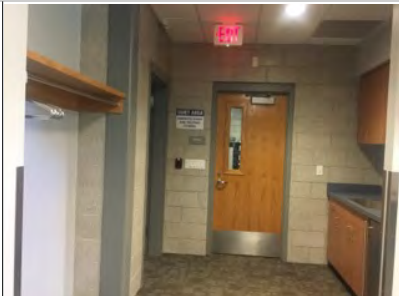
| ID | Location | Floor | Room | Element | Type | Photo | Issues | Current Measure | Recommendations | Quantity | Price | Cost Estimation |
|---|---|---|---|---|---|--|--|---|--|---|---|---|
| 4 | Meeting Room | 1 | 144 | Operable Parts | Clothes Rod/Hooks | | Reach < 15" or > 48"(forward/side approach) | 68" | Relocate clothes rod to be 48" max. above the finished floor. | 2 | 256 | \$512 |

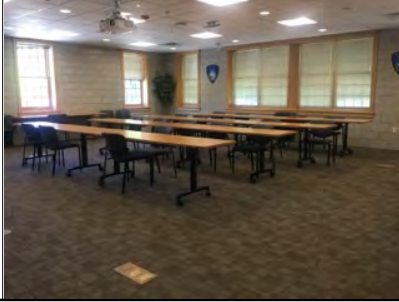
Speakers are provided in the meeting room, however there is no evidence of an assistive listening system. If audible communication is integral to the use of the space, an assistive listening system and a sign indicating the system is available must be provided. Assistive listening equipment must be kept charged and otherwise maintained in operable working condition so it is available when needed.

| ID | Location | Floor | Room | Element | Type | Photo | Issues | Current Measure | Recommendations | Quantity | Price | Cost Estimation |
|---|---|---|---|---|---|--|---|---|--|---|---|---|
| 5 | Meeting Room | 1 | 144 | Assembly Area | N/A | | Assistive listening devices not provided | - | If audible communication is integral to the use of the space, provide an assistive listening system. | 1 | 1214 | \$1214 |

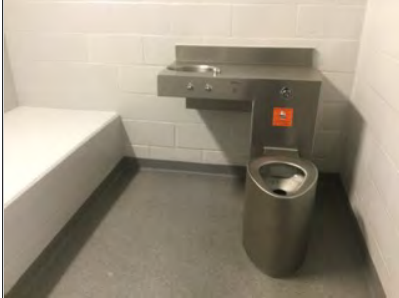
| ID | Location | Floor | Room | Element | Type | Photo | Issues | Current Measure | Recommendations | Quantity | Price | Cost Estimation |
|---|---|---|---|---|---|--|---|---|--|---|---|---|
| 6 | Accessible Cell 4 | 1 | 136 | Detention Facilities | Other | | Side or rear grab bar not provided | | Provide one ligature-resistant grab bar on the side wall of the water closet and one on the rear wall. | 2 | 898 | \$1796 |

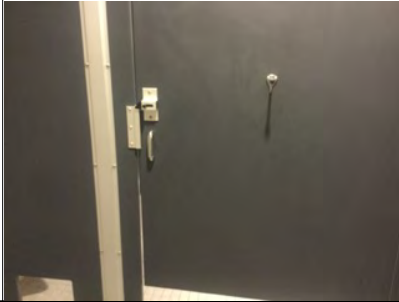
| ID | Location | Floor | Room | Element | Type | Photo | Issues | Current Measure | Recommendations | Quantity | Price | Cost Estimation |
|---|---|---|---|---|---|--|---|---|--|---|---|---|
| 7 | Men's Toilet Room by Lobby | 1 | 103 | Toilet Compartment | Accessible Compartment | | Door has malfunctioning self-closing hinge | - | Repair hinge. | 1 | Labor | \$0 |

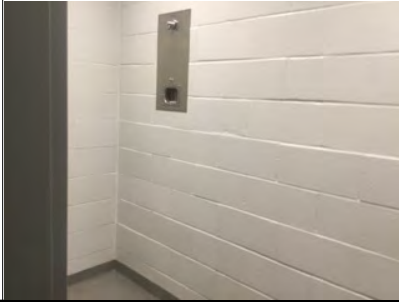
| ID | Location | Floor | Room | Element | Type | Photo | Issues | Current Measure | Recommendations | Quantity | Price | Cost Estimation |
|---|---|---|---|---|---|--|---|---|--|---|---|---|
| 8 | Shower by Booking | 1 | | Shower Compartment | Other | | Grab bars not provided<br>Control height < 38" or > 48" | -<br>60" | Provide a ligature resistant grab bar on the control wall and one on the adjacent wall to comply with a roll-in type shower. Relocate controls at 48" max. above the finished floor. | 1 | 2374 | \$2374 |

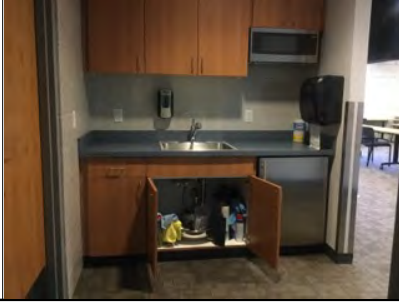
| ID | Location | Floor | Room | Element | Type | Photo | Issues | Current Measure | Recommendations | Quantity | Price | Cost Estimation |
|---|---|---|---|---|---|---|--|---|--|---|---|---|
| 9 | Meeting Room | 1 | 144 | Sink | Kitchenette | | Toe and knee clearances not provided<br>Rim or counter > 34" | -<br>36.5" | Relocate sink with the front of the rim or counter no higher than 34". Provide 27" high of knee clearance positioned for a forward approach. | 1 | 4780 | \$4780 |

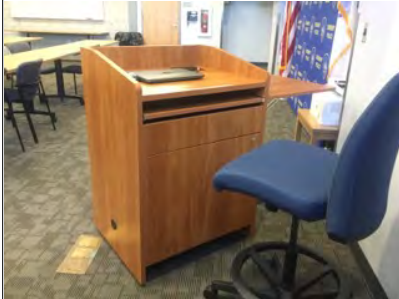
| ID | Location | Floor | Room | Element | Type | Photo | Issues | Current Measure | Recommendations | Quantity | Price | Cost Estimation |
|---|---|---|---|---|---|---|--|---|--|---|---|---|
| 10 | Meeting Room | 1 | 144 | | | | | | Recommend providing an adjustable height podium. | 1 | - | \$0 |

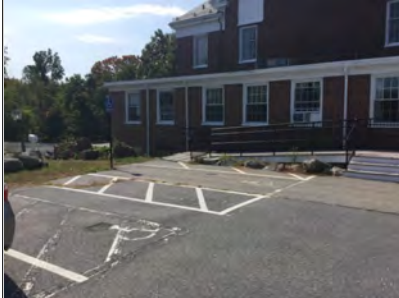
| ID | Location | Floor | Room | Element | Type | Photo | Issues | Current Measure | Recommendations | Quantity | Price | Cost Estimation |
|---|---|---|---|---|---|--|---|---|--|---|---|---|
| 1 | Parking Lot | Ext | | Off-Street Parking Lot or Garage | Visitor | | Van space < 132" or <96" wide<br>Sign does not have the designation "Van Accessible" | 111"<br>- | Provide one van accessible space that is at least 132" wide. Ensure the access aisle is 60" min. for this space. Add the designation "Van Accessible" to the sign located at the van accessible space. (Cost estimate for repainting two spaces, and striping the landing to the ramp to be 60" min, and providing signage with the designation "Van Accessible" at the van accessible parking space.) | 1 | 1100 | \$1100 |

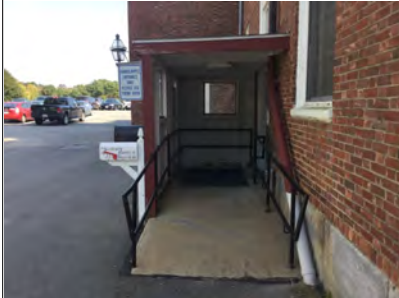
| ID | Location | Floor | Room | Element | Type | Photo | Issues | Current Measure | Recommendations | Quantity | Price | Cost Estimation |
|---|---|---|---|---|---|--|---|---|--|---|---|---|
| 2 | Accessible Entrance to Meeting Hall | 1 | | Exterior Ramp | N/A | | Running slope > 1:12 (8.3%)<br>Edge protection < 4" high | 11.2%<br>- | Reduce running slope to be no steeper than 1:12 (8.3%). Provide edge protection that prevents the passage of a 4" diameter sphere, where any portion of the sphere is within 4" of the finished floor or ground surface. (Cost for repaving a concrete ramp to a shallower slope, including 1-1/2" pipe handrails - per 15 linear feet and providing edge protection at the bottom exterior rail.) | 1 | 6587 | \$6587 |

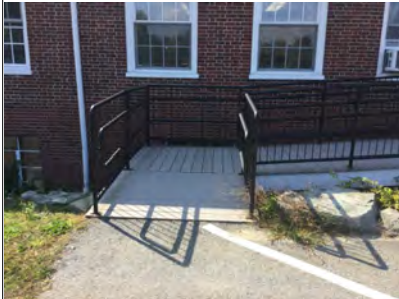
| ID | Location | Floor | Room | Element | Type | Photo | Issues | Current Measure | Recommendations | Quantity | Price | Cost Estimation |
|---|---|---|---|---|---|--|---|---|--|---|---|---|
| 3 | East Entrance Ramp | 1 | | Exterior Ramp | N/A | | Landing < 60" min. long | 49" | Redo striping in the parking lot to ensure that 60" min. deep is provided at the base of the ramp. (Cost listed under ID #1.) | 1 | - | \$0 |

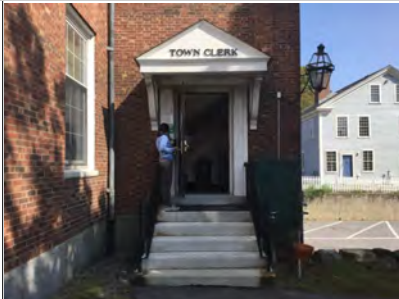
| ID | Location | Floor | Room | Element | Type | Photo | Issues | Current Measure | Recommendations | Quantity | Price | Cost Estimation |
|---|---|---|---|---|---|--|---|---|--|---|---|---|
| 4 | Entrance to South Stairwell | 1 | | Entrance | Secondary Entrance | | Entrance not on an accessible route<br>Directional sign to accessible entrance not provided | -<br>- | Provide a directional sign indicating the location of the nearest accessible entrance. | 1 | 346 | \$346 |

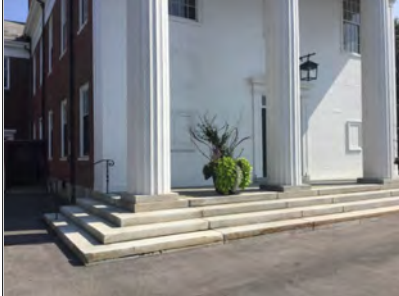
| ID | Location | Floor | Room | Element | Type | Photo | Issues | Current Measure | Recommendations | Quantity | Price | Cost Estimation |
|---|--|---|---|---|---|--|---|---|---|---|---|---|
| 5 | West Side of Building | Ext | | Entrance | Main Entrance | | Entrance not on an accessible route<br>Directional sign to accessible entrance not provided | -<br>- | Provide a directional sign indicating the location of the nearest accessible entrance.<br>(Note: Where a directional sign is required, it should be located to minimize backtracking. In some cases, this could mean locating a sign at the beginning of a route, not just at the inaccessible entrance to the building.) | 2 | 346 | \$692 |

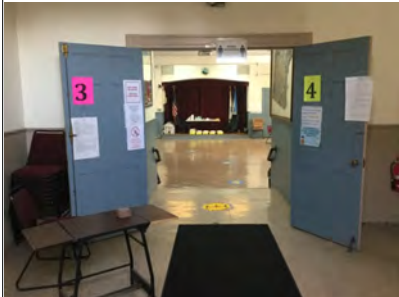
| ID | Location | Floor | Room | Element | Type | Photo | Issues | Current Measure | Recommendations | Quantity | Price | Cost Estimation |
|---|--|---|---|---|---|--|---|---|---|---|---|---|
| 6 | Lobby From Main Entrance to Meeting Hall | 1 | | Entrance | Main Entrance | | Mat not securely attached | - | Secure the mat. | 1 | Labor | \$0 |

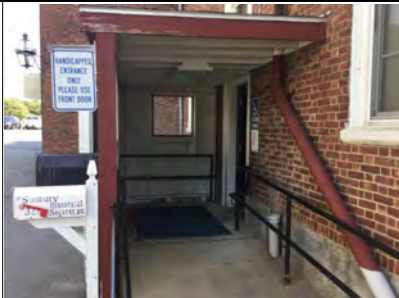
| ID | Location | Floor | Room | Element | Type | Photo | Issues | Current Measure | Recommendations | Quantity | Price | Cost Estimation |
|---|--|---|---|---|---|--|---|---|---|---|---|---|
| 7 | Accessible Entrance to Meeting Hall | 1 | | Entrance | Secondary Entrance | | Mat not securely attached | - | Secure the mat. | 1 | Labor | \$0 |

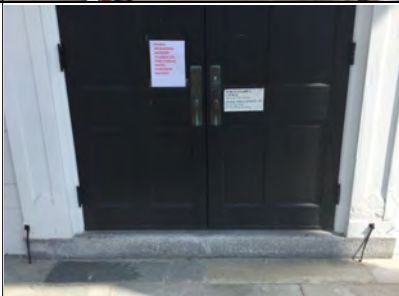
| ID | Location | Floor | Room | Element | Type | Photo | Issues | Current Measure | Recommendations | Quantity | Price | Cost Estimation |
|---|--|---|---|---|---|--|---|---|---|---|---|---|
| 8 | Main Entrance - West Side of Building | Ext | | Entrance | Main Entrance | | Hardware not operable with a closed fist | -<br>- | Provide hardware that can be operable with one hand and not require tight grasping, pinching, or twisting of the wrist. | 1 | 484 | \$484 |

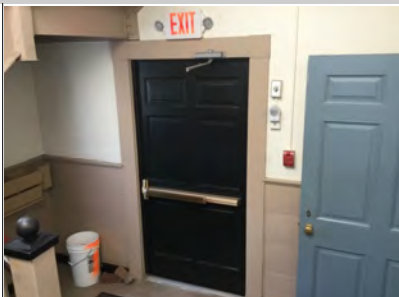
| ID | Location | Floor | Room | Element | Type | Photo | Issues | Current Measure | Recommendations | Quantity | Price | Cost Estimation |
|---|--|---|---|---|---|--|---|---|---|---|---|---|
| 9 | Exit From South and North Stairwells | 1 | | Emergency Exit | N/A | | Tactile sign not provided at exit<br>Directional sign to accessible emergency exit not provided | -<br>- | Provide tactile exit signs with raised characters and braille at exit doors. Mount signs between 48"- 60" above the finished floor located on the latch side of the door.<br>Provide a directional sign indicating the location of the nearest accessible emergency exit. | 4 | 232 | \$928 |

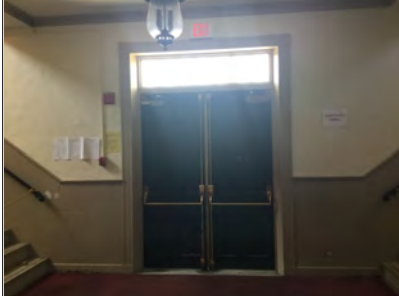
| ID | Location | Floor | Room | Element | Type | Photo | Issues | Current Measure | Recommendations | Quantity | Price | Cost Estimation |
|---|---|---|---|---|---|--|--|---|--|---|---|---|
| 10 | Main Entrance - West Side of Building | 1 | | Emergency Exit | N/A | | Tactile sign not provided at exit<br>Directional sign to accessible emergency exit not provided<br>Door requires > 15 lbs. of force to open | -<br>-<br>23 lbs. | Provide tactile exit signs with raised characters and braille at exit doors. Mount signs between 48"- 60" above the finished floor located on the latch side of the door.<br>Provide a directional sign indicating the location of the nearest accessible emergency exit. Adjust closers of exterior doors so doors do not require more than 15 pounds of force. | 2 | 232<br>Labor | \$464 |

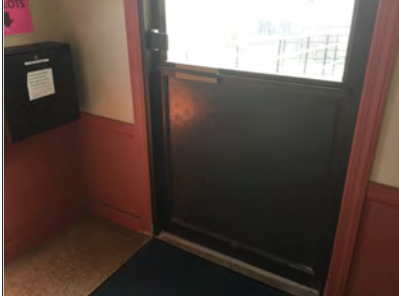
| ID | Location | Floor | Room | Element | Type | Photo | Issues | Current Measure | Recommendations | Quantity | Price | Cost Estimation |
|---|---|---|---|---|---|--|--|---|--|---|---|---|
| 11 | Exit to East Side of Building | 1 | | Emergency Exit | N/A | | Tactile sign not provided at exit<br>Illuminated Int. Symbol of Acc. not provided (MAAB) | -<br>- | Provide tactile exit signs with raised characters and braille at exit doors. Mount signs between 48"- 60" above the finished floor located on the latch side of the door.<br>Provide an illuminated sign with the International Symbol of Accessibility. | 1 | 432 | \$432 |

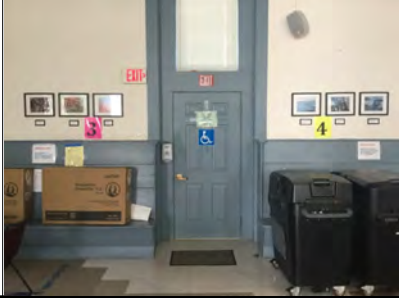
| ID | Location | Floor | Room | Element | Type | Photo | Issues | Current Measure | Recommendations | Quantity | Price | Cost Estimation |
|---|---|---|---|---|---|--|--|---|--|---|---|---|
| 12 | Accessible Exit From Meeting Hall | 1 | | Emergency Exit | N/A | | Tactile sign not provided at exit<br>Illuminated Int. Symbol of Acc. not provided (MAAB)<br>Maneuvering clearance(s) not provided<br>Mat not securely attached | -<br>-<br>6.5"<br>- | Provide tactile exit signs with raised characters and braille at exit doors. Mount signs between 48"- 60" above the finished floor located on the latch side of the door.<br>Provide an illuminated sign with the International Symbol of Accessibility. Provide an automatic door opener.<br>Secure the mat. | 1 | 3492<br>Labor | \$3492 |

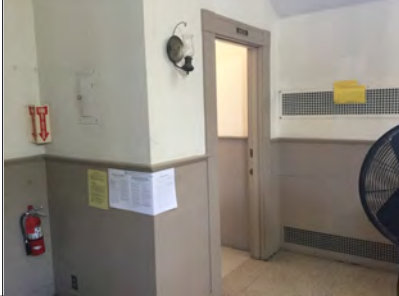
| ID | Location | Floor | Room | Element | Type | Photo | Issues | Current Measure | Recommendations | Quantity | Price | Cost Estimation |
|---|---|---|---|---|---|--|--|---|--|---|---|---|
| 13 | Men's Toilet Room by Lobby at Main Entrance | 1 | | Interior Access Route | N/A | | Obstructed by protruding objects | 5.25" | Provide a cane-detectable barrier at the light fixture. | 1 | 306 | \$306 |

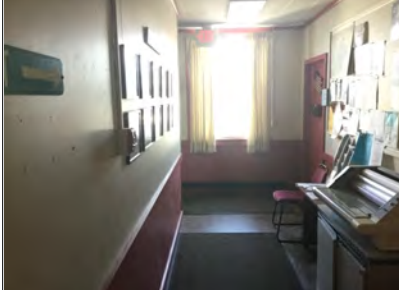
| ID | Location | Floor | Room | Element | Type | Photo | Issues | Current Measure | Recommendations | Quantity | Price | Cost Estimation |
|---|---|---|---|---|---|--|--|---|--|---|---|---|
| 14 | Hallway Between Town Clerk Office and East Side of Building | 1 | | Interior Access Route | N/A | | Surface not stable, firm, and slip-resistant | - | Secure mat. | 1 | Labor | \$0 |

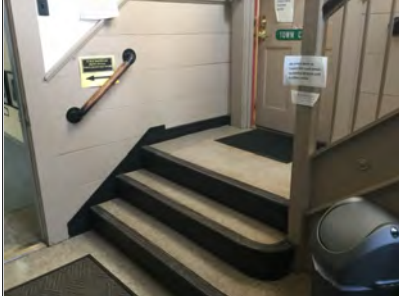
| ID | Location | Floor | Room | Element | Type | Photo | Issues | Current Measure | Recommendations | Quantity | Price | Cost Estimation |
|---|---|---|---|---|---|--|---|---|--|---|---|---|
| 15 | South Stairwell - Entrance to Town Clerk Office | 1 | | Interior Access Route | N/A | | Accessible route not provided | - | There is no interior accessible route to the Town Clerk office. Look into the feasibility of installing a platform lift between the Meeting Hall and this office. | 1 | 21660 | \$21660 |

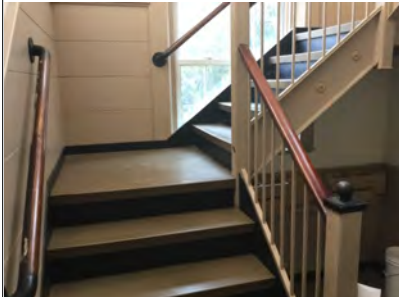
| ID | Location | Floor | Room | Element | Type | Photo | Issues | Current Measure | Recommendations | Quantity | Price | Cost Estimation |
|---|---|---|---|---|---|--|---|---|--|---|---|---|
| 16 | South Stairwell | 2 | | Interior Access Route | | | Accessible route not provided | - | At the time of survey, no public programs were provided on the second floor and mezzanine. If public programs will be provided on these levels, consider providing a Limited Use Limited Access (LULA) elevator. | 1 | - | \$0 |

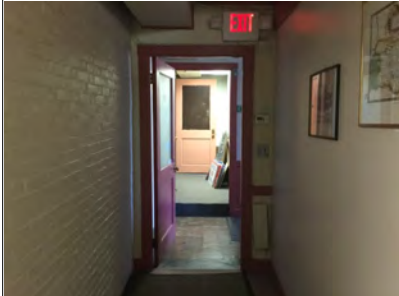
| ID | Location | Floor | Room | Element | Type | Photo | Issues | Current Measure | Recommendations | Quantity | Price | Cost Estimation |
|---|---|---|---|---|---|--|---|---|--|---|---|---|
| 17 | Hallway Between Town Clerk Office and East Exit | 1 | | Doors, Doorways, & Gates | Circulation | | Mat not securely attached<br>Hardware not operable with a closed fist | -<br>- | Secure the mat.<br>Provide hardware that can be operable with one hand and not require tight grasping, pinching, or twisting of the wrist. | 1 | Labor<br>484 | \$484 |

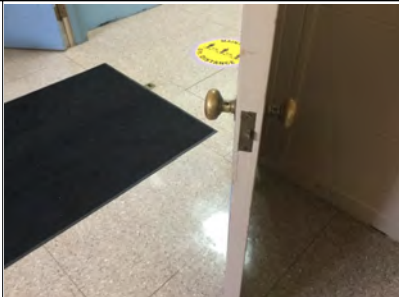
| ID | Location | Floor | Room | Element | Type | Photo | Issues | Current Measure | Recommendations | Quantity | Price | Cost Estimation |
|---|---|---|---|---|---|--|---|---|--|---|---|---|
| 18 | Meeting Hall Door | 1 | | Doors, Doorways, & Gates | Other | | Hardware not operable with a closed fist | - | Provide hardware that can be operable with one hand and not require tight grasping, pinching, or twisting of the wrist. | 1 | 484 | \$484 |

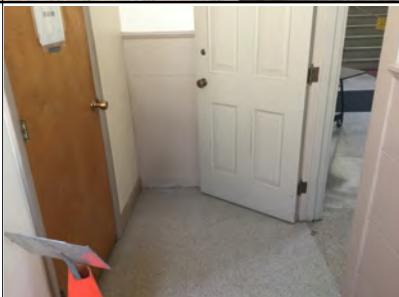
| ID | Location | Floor | Room | Element | Type | Photo | Issues | Current Measure | Recommendations | Quantity | Price | Cost Estimation |
|---|---|---|---|---|---|--|---|---|--|---|---|---|
| 19 | Women's Toilet Room by Lobby at Main Entrance | 1 | | Doors, Doorways, & Gates | Toilet Room | | Hardware not operable with a closed fist | - | Provide hardware that can be operable with one hand and not require tight grasping, pinching, or twisting of the wrist. | 1 | 484 | \$484 |

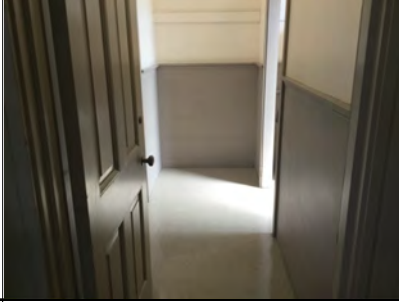
| ID | Location | Floor | Room | Element | Type | Photo | Issues | Current Measure | Recommendations | Quantity | Price | Cost Estimation |
|---|--|---|---|---|---|--|---|---|--|---|---|---|
| 20 | Men's Toilet Room by Lobby at Main Entrance | 1 | | Doors, Doorways, & Gates | Toilet Room | | Hardware not operable with a closed fist | - | Provide hardware that can be operable with one hand and not require tight grasping, pinching, or twisting of the wrist. | 1 | 484 | \$484 |

addition, IHCD recommends addressing protruding objects and inaccessible door hardware at the men's and women's multi-user toilet rooms by the front lobby.

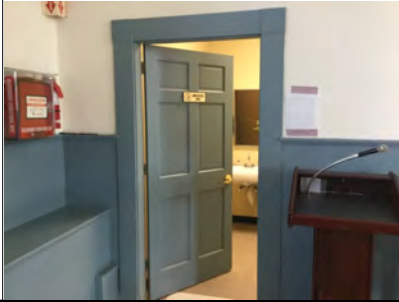
| ID | Location | Floor | Room | Element | Type | Photo | Issues | Current Measure | Recommendations | Quantity | Price | Cost Estimation |
|---|--|---|---|---|---|--|---|---|--|---|---|---|
| 22 | Employee Only Toilet Room - Meeting Hall | 1 | | Signage | Designation | | Raised characters not provided on sign<br>Braille not provided on sign<br>International Symbol of Acc. not provided<br>Sign not located on the latch side of the door | -<br>-<br>-<br>- | Provide text with raised characters duplicated in braille on sign.<br>Provide a sign with the International Symbol of Accessibility.<br>Locate sign at permanent rooms alongside the door on the latch side. | 1 | 232 Labor | \$232 |

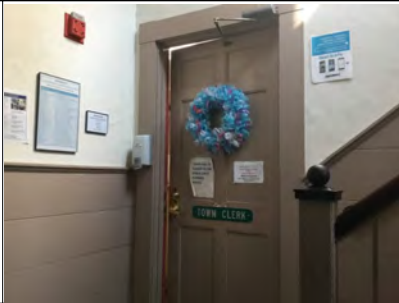
| ID | Location | Floor | Room | Element | Type | Photo | Issues | Current Measure | Recommendations | Quantity | Price | Cost Estimation |
|---|--|---|---|---|---|--|---|---|--|---|---|---|
| 23 | South Stairwell - Entrance to Town Clerk Office | 1 | | Signage | Designation | | Raised characters not provided on sign<br>Braille not provided on sign<br>Sign not located on the latch side of the door | -<br>-<br>- | Provide text with raised characters duplicated in braille on sign.<br>Locate sign at permanent rooms alongside the door on the latch side. | 1 | 232 Labor | \$232 |

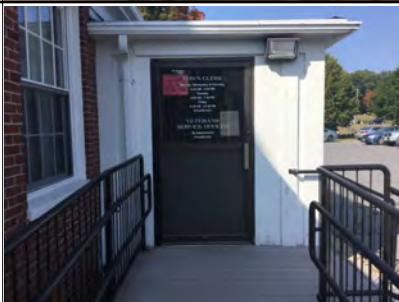
| ID | Location | Floor | Room | Element | Type | Photo | Issues | Current Measure | Recommendations | Quantity | Price | Cost Estimation |
|---|--|---|---|---|---|--|---|---|--|---|---|---|
| 24 | Ramp at East Entrance to Town Clerk and Veteran's Services | Ext | | Signage | Informational | | Non glare finish and contrast not provided on sign | - | Install a sign with a non-glare finish with characters that have a high contrast to the background. | 1 | 232 | \$232 |

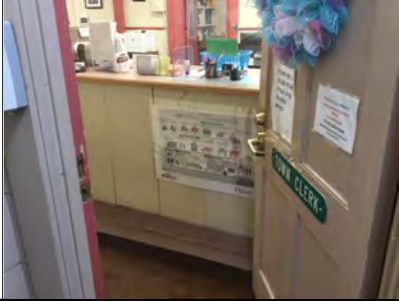
| ID | Location | Floor | Room | Element | Type | Photo | Issues | Current Measure | Recommendations | Quantity | Price | Cost Estimation |
|---|---|---|---|---|---|--|---|---|--|---|---|---|
| 25 | Town Clerk Office | 1 | | Service Counter | N/A | | Counter > 36" high | 42.25" | Provide a counter that is 36" max. above the ground or finished floor. | 1 | 880 | \$880 |

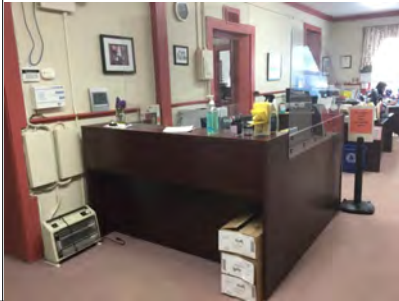
| ID | Location | Floor | Room | Element | Type | Photo | Issues | Current Measure | Recommendations | Quantity | Price | Cost Estimation |
|---|---|---|---|---|---|--|---|---|--|---|---|---|
| 26 | Town Clerk Office | 1 | | Service Counter | N/A | | Counter > 36" high<br>Knee clearance not compliant | 44.25"<br>10.75" | Provide a counter that is 36" max. above the ground or finished floor.<br>Ensure that knee clearance is 17" min. for a forward approach. | 1 | 880 | \$880 |

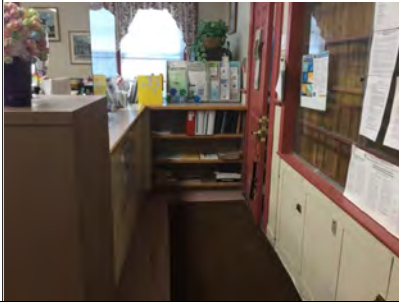
| ID | Location | Floor | Room | Element | Type | Photo | Issues | Current Measure | Recommendations | Quantity | Price | Cost Estimation |
|---|---|---|---|---|---|--|---|---|--|---|---|---|
| 27 | Town Clerk Office Brochures | 1 | | Operable Parts | Other | | Reach < 15" or > 48"(forward/side approach) | 60" | Relocate one of each type of form to be no higher than 48" above the finished floor. | 1 | Labor | \$0 |

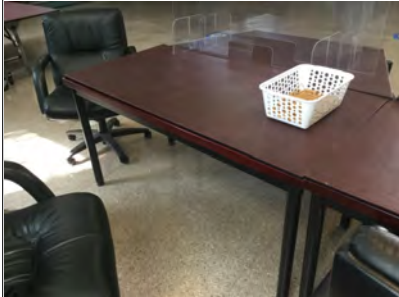
| ID | Location | Floor | Room | Element | Type | Photo | Issues | Current Measure | Recommendations | Quantity | Price | Cost Estimation |
|---|---|---|---|---|---|--|---|---|--|---|---|---|
| 28 | Meeting Hall | 1 | | Dining or Work Surfaces | Work Surface | | At least one or 5% accessible tables not provided<br>Knee or toe clearance not provided | -<br>26" | Provide at least 1 work surface with 27" min. knee and toe clearance. | 1 | 700 | \$700 |

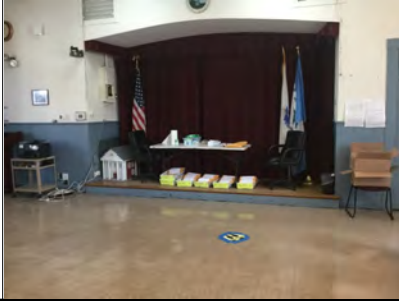
| ID | Location | Floor | Room | Element | Type | Photo | Issues | Current Measure | Recommendations | Quantity | Price | Cost Estimation |
|---|--|---|---|---|---|--|---|---|---|---|---|---|
| 29 | Meeting Hall - Stage | 1 | | Assembly Area | N/A | | Accessible route to stage not provided | 8" | Provide a portable ramp to the stage. | 1 | 500 | \$500 |

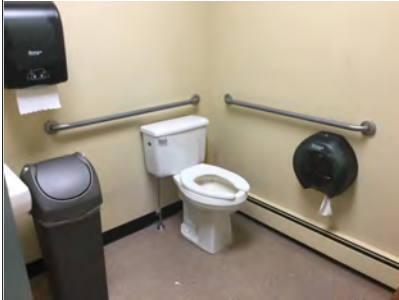
| ID | Location | Floor | Room | Element | Type | Photo | Issues | Current Measure | Recommendations | Quantity | Price | Cost Estimation |
|---|--|---|---|---|---|--|---|---|---|---|---|---|
| 30 | Employee Only Toilet Room - Meeting Hall | 1 | | Overall Access | Toilet Room | | Audible and visible alarms not provided | - | When fire system is updated, ensure that a visible and audible fire alarm is installed. | 1 | - | \$0 |

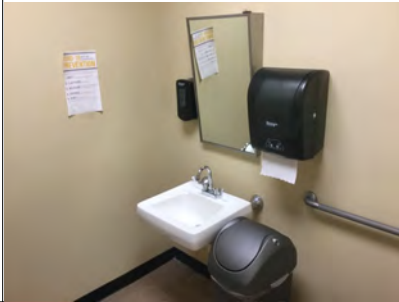
| ID | Location | Floor | Room | Element | Type | Photo | Issues | Current Measure | Recommendations | Quantity | Price | Cost Estimation |
|---|--|---|---|---|---|--|---|---|---|---|---|---|
| 31 | Employee Only Toilet Room - Meeting Hall | 1 | | Lavatory | N/A | | Toe or knee clearances not provided<br>Dispensers not within reach range<br>Paper towel dispenser mounted over grab bar | 24.5"<br>50", 46" | Provide at least one lavatory with knee and toe clearance positioned for a forward approach. Lower soap and paper towel dispensers to 42" max. above the floor. Relocate paper towel dispenser so that it is not mounted above the rear grab bar. | 1 | 2198 | \$2198 |

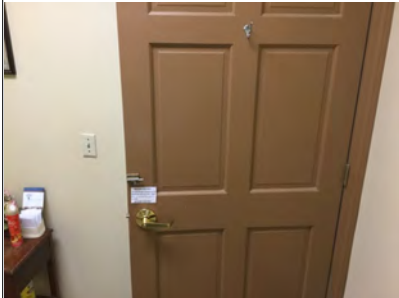
| ID | Location | Floor | Room | Element | Type | Photo | Issues | Current Measure | Recommendations | Quantity | Price | Cost Estimation |
|---|--|---|---|---|---|--|---|---|---|---|---|---|
| 32 | Employee Only Toilet Room - Meeting Hall | 1 | | Single-User Toilet | N/A | | Hook located > 48" high | 65.75" | Locate hook no higher than 48" above the finished floor. | 1 | 150 | \$150 |

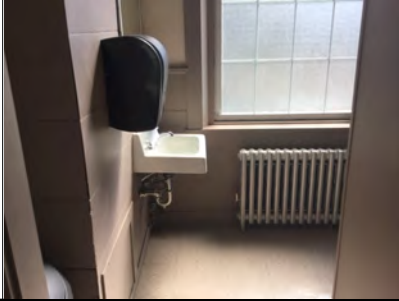
| ID | Location | Floor | Room | Element | Type | Photo | Issues | Current Measure | Recommendations | Quantity | Price | Cost Estimation |
|---|--|---|---|---|---|--|---|---|--|---|---|---|
| 33 | Men's Toilet Room - Lobby at Main Entrance | 1 | | Dispensers | Paper Towel Dispenser | | Dispenser acts as a protruding object | - | Relocate paper towel dispenser out of the circulation path. | 1 | 256 | \$256 |

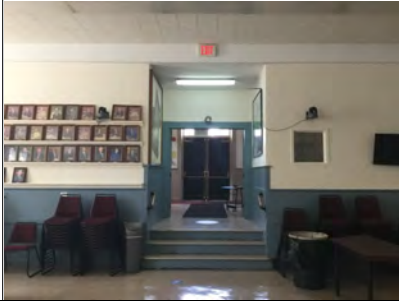
| ID | Location | Floor | Room | Element | Type | Photo | Issues | Current Measure | Recommendations | Quantity | Price | Cost Estimation |
|---|--|---|---|---|---|--|---|---|--|---|---|---|
| 34 | Meeting Hall Entrance | 1 | | | | | | | Recommend providing color contrast strips on the stair treads to increase visibility. | 1 | - | \$0 |

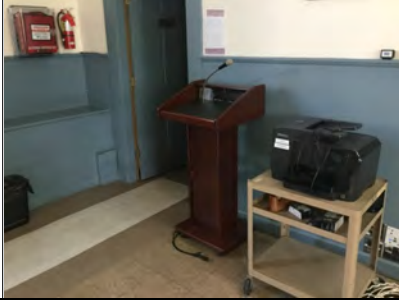
| ID | Location | Floor | Room | Element | Type | Photo | Issues | Current Measure | Recommendations | Quantity | Price | Cost Estimation |
|---|--|---|---|---|---|--|---|---|--|---|---|---|
| 35 | Meeting Hall | 1 | | | | | | | Recommend providing an adjustable-height podium. | 1 | - | \$0 |

- Recommend providing an adjustable-height podium in the meeting hall.

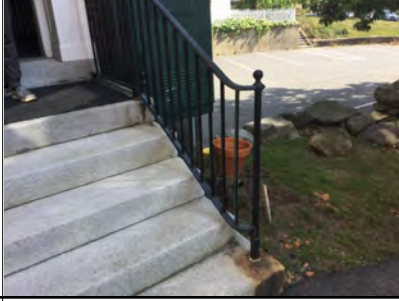
| ID | Location | Floor | Room | Element | Type | Photo | Issues | Current Measure | Recommendations | Quantity | Price | Cost Estimation |
|---|--|---|---|---|---|--|---|---|--|---|---|---|
| 36 | Entrance to South Stairwell | 1 | | | | | | | Recommend providing color contrast strips on the stair treads to increase visibility.<br>Recommend providing handrails with a 1-1/4" to 1-1/2" circular cross section, and ensuring that the sloped bottom extension extends one tread depth minimum beyond last riser nosing in same direction as stair flight. | 1 | - | \$0 |
