## DPW Offices and Garage

## Town of Sudbury ADA Transition Plan

October 2020

Institute for Human Centered Design

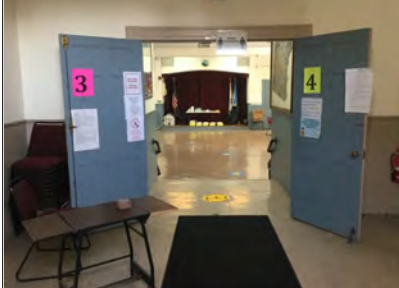
| ID | Location | Floor | Room | Element | Type | Photo | Issues | Current Measure | Recommendations | Quantity | Price | Cost Estimation |
|---|--|---|---|---|---|--|---|---|--|---|---|---|
| 37 | Lobby From Main Entrance to Meeting Hall | 1 | | | | | | - | Recommend providing designation signage with raised characters and braille where no signage is present. | 1 | - | \$0 |

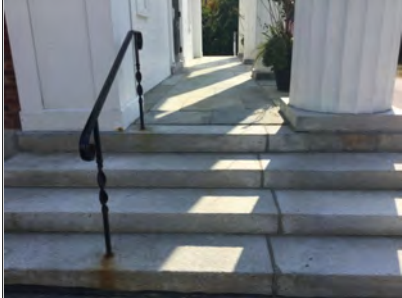
| ID | Location | Floor | Room | Element | Type | Photo | Issues | Current Measure | Recommendations | Quantity | Price | Cost Estimation |
|---|---|---|---|---|---|---|---|---|--|---|---|---|
| 38 | West Side of Building | Ext | | | | | | | Recommend providing color contrast strips on the stair treads to increase visibility.<br>Recommend providing handrails with a 1-1/4" to 1-1/2" circular cross section, and ensuring that the sloped bottom extension extends one tread depth minimum beyond last riser nosing in same direction as stair flight.<br>Recommend providing a second handrail. | 1 | - | \$0 |

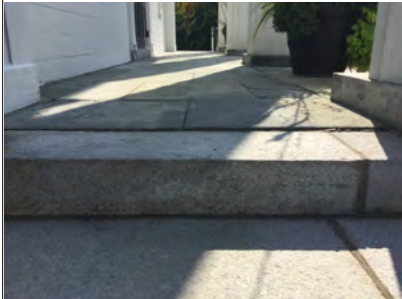
| ID | Location | Floor | Room | Element | Type | Photo | Issues | Current Measure | Recommendations | Quantity | Price | Cost Estimation |
|---|---|---|---|---|---|---|---|---|--|---|---|---|
| 39 | West Side of Building | Ext | | | | | | | Recommend repairing uneven surface at the top of the stairs to prevent tripping, although it is not part of the accessible route. | 1 | - | \$0 |

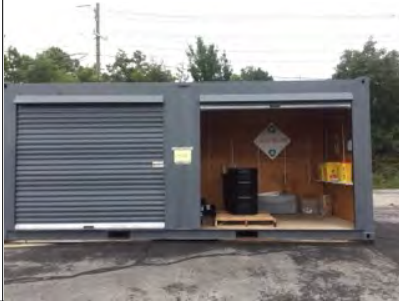
| ID | Location | Floor | Room | Element | Type | Photo | Issues | Current Measure | Recommendations | Quantity | Price | Cost Estimation |
|---|---|---|---|---|---|--|---|---|---|---|---|---|
| 1 | Battery Disposal Drop-Off | Ext. | | Exterior Access Route | Exterior | | Not provided from all site arrival points | 8" | Have staff provide assistance accessing the battery drop-off receptacles as needed. | 1 | Labor | \$0 |

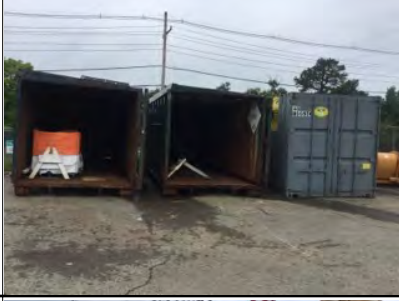
| ID | Location | Floor | Room | Element | Type | Photo | Issues | Current Measure | Recommendations | Quantity | Price | Cost Estimation |
|---|---|---|---|---|---|--|---|---|---|---|---|---|
| 2 | Tires/CRT Monitors | Ext. | | Exterior Access Route | Exterior | | Not provided from all site arrival points | 11.5" | Ensure an accessible route is provided from all points of arrival.<br><br>Have staff provide assistance accessing the Tire/CRT drop-off receptacles as needed. | 1 | Labor | \$0 |

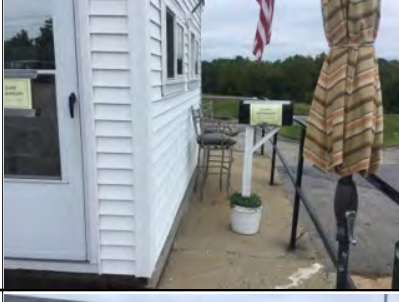
| ID | Location | Floor | Room | Element | Type | Photo | Issues | Current Measure | Recommendations | Quantity | Price | Cost Estimation |
|---|---|---|---|---|---|--|---|---|---|---|---|---|
| 3 | Service Window at Office | Ext. | | Exterior Access Route | Exterior | | Not provided from all site arrival points | - | Relocate mailbox so it does not block 36" min. wide accessible route to service counter. | 1 | Labor | \$0 |

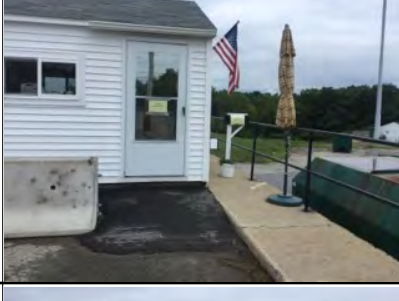
| ID | Location | Floor | Room | Element | Type | Photo | Issues | Current Measure | Recommendations | Quantity | Price | Cost Estimation |
|---|---|---|---|---|---|--|---|---|---|---|---|---|
| 4 | Path to Service Window at Office | Ext. | | Exterior Access Route | N/A | | Not provided from all site arrival points | - | Ensure an accessible route is provided from all points of arrival.<br><br>(Cost based on a straight pressure treated wood ramp that provides access to the door and the walkway leading to the service window. Ensure ramp includes a 5'x5' level landing where it meets the door and walkway.) | 1 | 1176 | \$1176 |

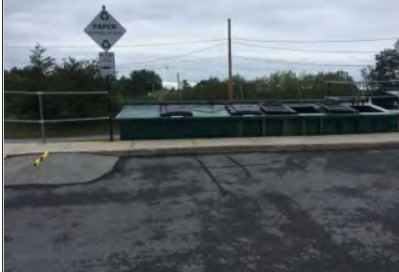
| ID | Location | Floor | Room | Element | Type | Photo | Issues | Current Measure | Recommendations | Quantity | Price | Cost Estimation |
|---|---|---|---|---|---|--|---|---|---|---|---|---|
| 5 | Paper/ Newspaper & Mixed Drop-off | Ext. | | Exterior Access Route | Exterior | | Cross slope > 1:50 (2.00%)<br>Running slope > 1:20 (5%)<br>Level changes > 1/4" | 2.1%<br>14.4%<br>1.5" | Have staff provide assistance accessing the paper drop-off receptacles as needed. | 1 | Labor | \$0 |

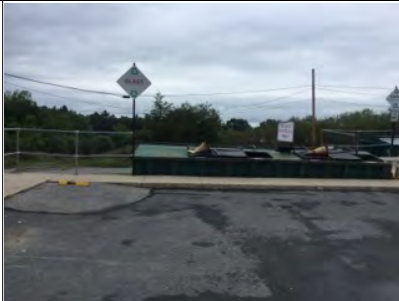
| ID | Location | Floor | Room | Element | Type | Photo | Issues | Current Measure | Recommendations | Quantity | Price | Cost Estimation |
|---|---|---|---|---|---|--|---|---|--|---|---|---|
| 6 | Glass Recycling Drop-off | Ext. | | Exterior Access Route | Exterior | | Cross slope > 1:50 (2.00%)<br>Running slope > 1:20 (5%)<br>Level changes > 1/4" | 4.5%<br>12.3%<br>1" | Have staff provide assistance accessing the glass drop-off receptacles as needed. | 1 | Labor | \$0 |

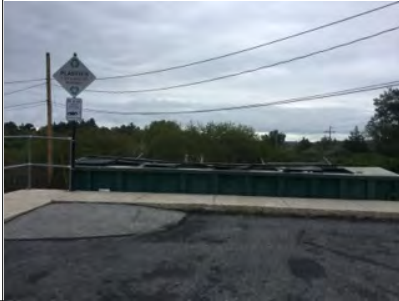
| ID | Location | Floor | Room | Element | Type | Photo | Issues | Current Measure | Recommendations | Quantity | Price | Cost Estimation |
|---|---|---|---|---|---|--|---|---|--|---|---|---|
| 7 | Plastics 3 to 6 & No Number Drop-Off | Ext. | | Exterior Access Route | Exterior | | Cross slope > 1:50 (2.00%)<br>Running slope > 1:20 (5%)<br>Level changes > 1/4" | 3.1%<br>7.9%<br>2" | Have staff provide assistance accessing the plastics drop-off receptacles as needed. | 1 | Labor | \$0 |

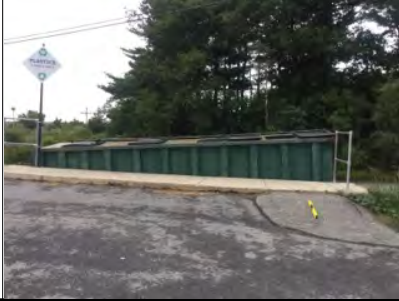
| ID | Location | Floor | Room | Element | Type | Photo | Issues | Current Measure | Recommendations | Quantity | Price | Cost Estimation |
|---|---|---|---|---|---|--|---|---|--|---|---|---|
| 8 | Plastics 1 & 2 Only Drop-Off | Ext. | | Exterior Access Route | Exterior | | Running slope > 1:20 (5%)<br>Level changes > 1/4" | 18.7%<br>2" | Have staff provide assistance accessing the plastics drop-off receptacles as needed. | 1 | Labor | \$0 |

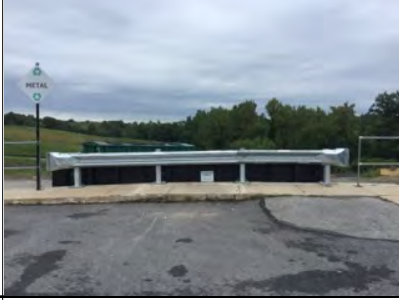
| ID | Location | Floor | Room | Element | Type | Photo | Issues | Current Measure | Recommendations | Quantity | Price | Cost Estimation |
|---|---|---|---|---|---|--|---|---|--|---|---|---|
| 9 | Metal Drop-off | Ext. | | Exterior Access Route | Exterior | | Running slope > 1:20 (5%)<br>Level changes > 1/4" | 12.3%<br>2" | Have staff provide assistance accessing the metal drop-off receptacles as needed. | 1 | Labor | \$0 |

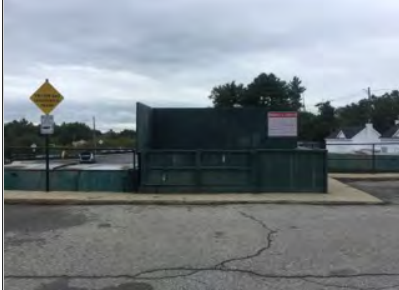
| ID | Location | Floor | Room | Element | Type | Photo | Issues | Current Measure | Recommendations | Quantity | Price | Cost Estimation |
|---|---|---|---|---|---|--|---|---|--|---|---|---|
| 10 | Compactor/ Yellow Bag Household Trash | Ext. | | Exterior Access Route | Exterior | | Level changes > 1/4" | 3.5" | Have staff provide assistance accessing the yellow bag household waste drop-off receptacles as needed. | 1 | Labor | \$0 |

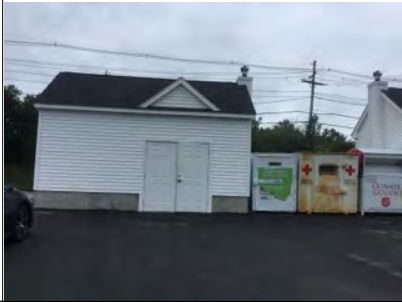
| ID | Location | Floor | Room | Element | Type | Photo | Issues | Current Measure | Recommendations | Quantity | Price | Cost Estimation |
|---|---|---|---|---|---|--|---|---|---|---|---|---|
| 12 | Book Shed | Ext. | | Doors, Doorways, & Gates | N/A | | Maneuvering clearance at door > 1:50 (2.00%) (MAAB) | 7.4% | Alter so that the slope in all directions is no greater than 1:50 (2.00%) yielding a 5'x5' level landing at the door.<br><br>Cost to be determined based on specific remedy selected. | 1 | - | \$0 |

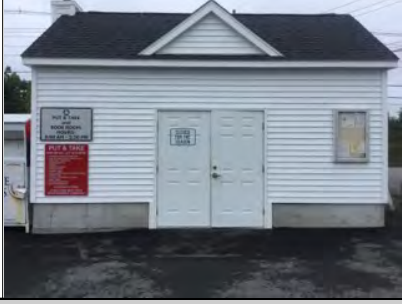
| ID | Location | Floor | Room | Element | Type | Photo | Issues | Current Measure | Recommendations | Quantity | Price | Cost Estimation |
|---|---|---|---|---|---|--|---|---|---|---|---|---|
| 13 | Put-N-Take | Ext. | | Doors, Doorways, & Gates | N/A | | Maneuvering clearance at door > 1:50 (2.00%) (MAAB) | 7.1% | Alter so that the slope in all directions is no greater than 1:50 (2.00%) yielding a 5'x5' level landing at the door.<br><br>Cost to be determined based on specific remedy selected. | 1 | - | \$0 |

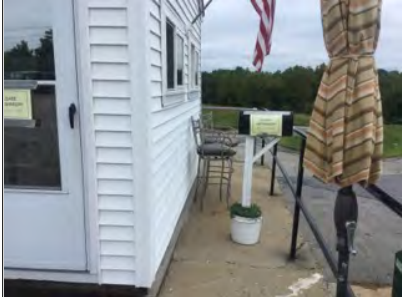
| ID | Location | Floor | Room | Element | Type | Photo | Issues | Current Measure | Recommendations | Quantity | Price | Cost Estimation |
|---|---|---|---|---|---|--|---|---|---|---|---|---|
| 14 | Service Window - Personal Shelter/ Office | Ext. | | Service Counter | N/A | | Counter > 36" high | 56" | Provide a counter that is 36" max. above the ground. | 1 | 880 | \$880 |

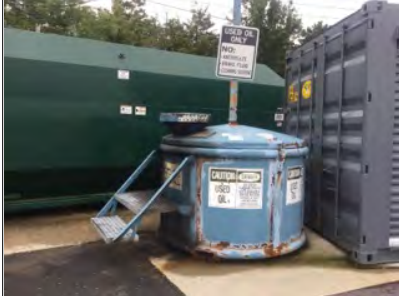
| ID | Location | Floor | Room | Element | Type | Photo | Issues | Current Measure | Recommendations | Quantity | Price | Cost Estimation |
|---|---|---|---|---|---|--|--|---|---|---|---|---|
| 15 | Used Oil Drop-Off | Ext. | | Operable Parts | N/A | | Element not on an accessible route | - | Have staff provide assistance accessing the used oil drop-off receptacle as needed. | 1 | Labor | \$0 |

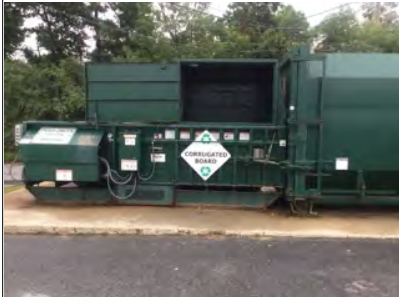
| ID | Location | Floor | Room | Element | Type | Photo | Issues | Current Measure | Recommendations | Quantity | Price | Cost Estimation |
|---|---|---|---|---|---|--|--|---|---|---|---|---|
| 16 | Cardboard Compactor | Ext. | | Operable Parts | N/A | | Element not on an accessible route | 59" | Have staff provide assistance accessing the cardboard drop-off receptacles as needed. | 1 | Labor | \$0 |

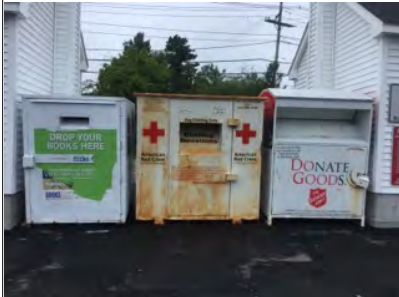
| ID | Location | Floor | Room | Element | Type | Photo | Issues | Current Measure | Recommendations | Quantity | Price | Cost Estimation |
|---|---|---|---|---|---|--|--|---|---|---|---|---|
| 17 | Book and Clothing Drop-off | Ext. | | Trash / Recycling | N/A | | Trash container opening not within reach range | 60" | Have staff provide assistance accessing the book and clothing recycling receptacles as needed. | 1 | Labor | \$0 |

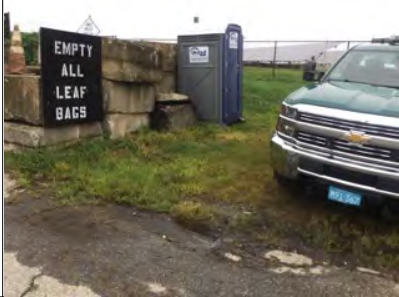
| ID | Location | Floor | Room | Element | Type | Photo | Issues | Current Measure | Recommendations | Quantity | Price | Cost Estimation |
|---|---|---|---|---|---|--|--|---|---|---|---|---|
| 18 | Portable Toilet | Ext. | | Portable Toilet | N/A | | Not located on an accessible route<br>Accessible portable toilets not provided | -<br>- | Locate portable toilet on an accessible route.<br>Ensure that at least 5% of portable toilets are accessible. | 1 | 4600 | \$4600 |

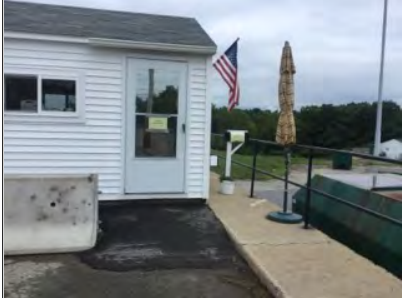
| ID | Location | Floor | Room | Element | Type | Photo | Issues | Current Measure | Recommendations | Quantity | Price | Cost Estimation |
|---|---|---|---|---|---|--|---|---|---|---|---|---|
| 19 | Service Window - Personal Shelter/ Office | Ext. | | Buzzer or Intercom | N/A | | | | Recommend providing a buzzer or intercom on an accessible route at base of recommended ramp proving an accessible route to the service window so visitors can notify staff that they may require assistance. Ensure the controls no higher than 48" above the ground. | 1 | - | \$0 |
