Roof Repair Project Report

**Fairbank Complex
40 Fairbank Road
Sudbury, Massachusetts**

February 14, 2014

RBA Project No. 2014007.00

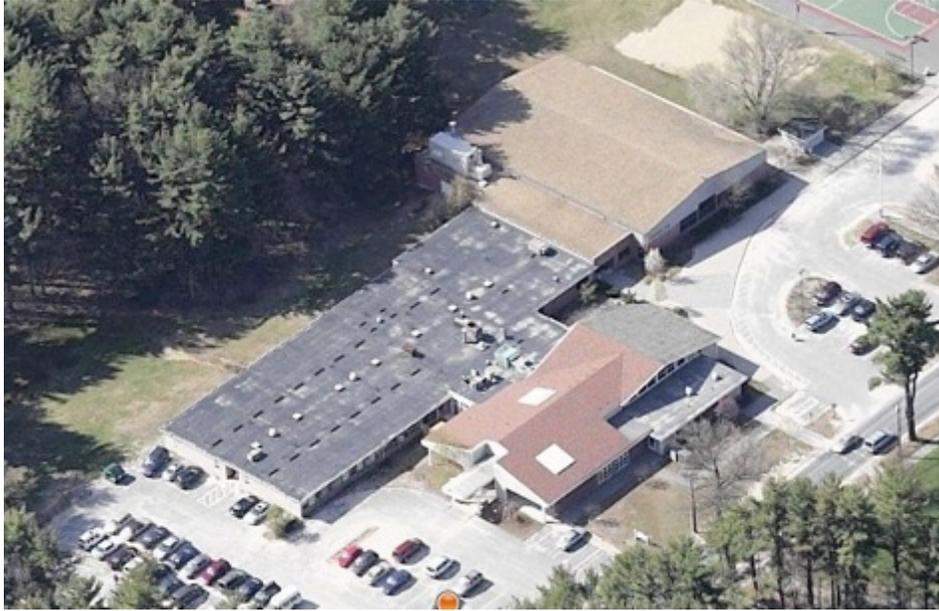
Photo No. 01

Description:
Aerial view of the Fairbank Complex. The subject roofs are the black colored roofs surrounding the reddish brown shingled roofs of the Senior Center.
