ROOF CONDITION SURVEY

**For
Town of Sudbury**

**Fairbank Complex
40 Fairbank Road
Sudbury, Massachusetts**

February 3, 2012

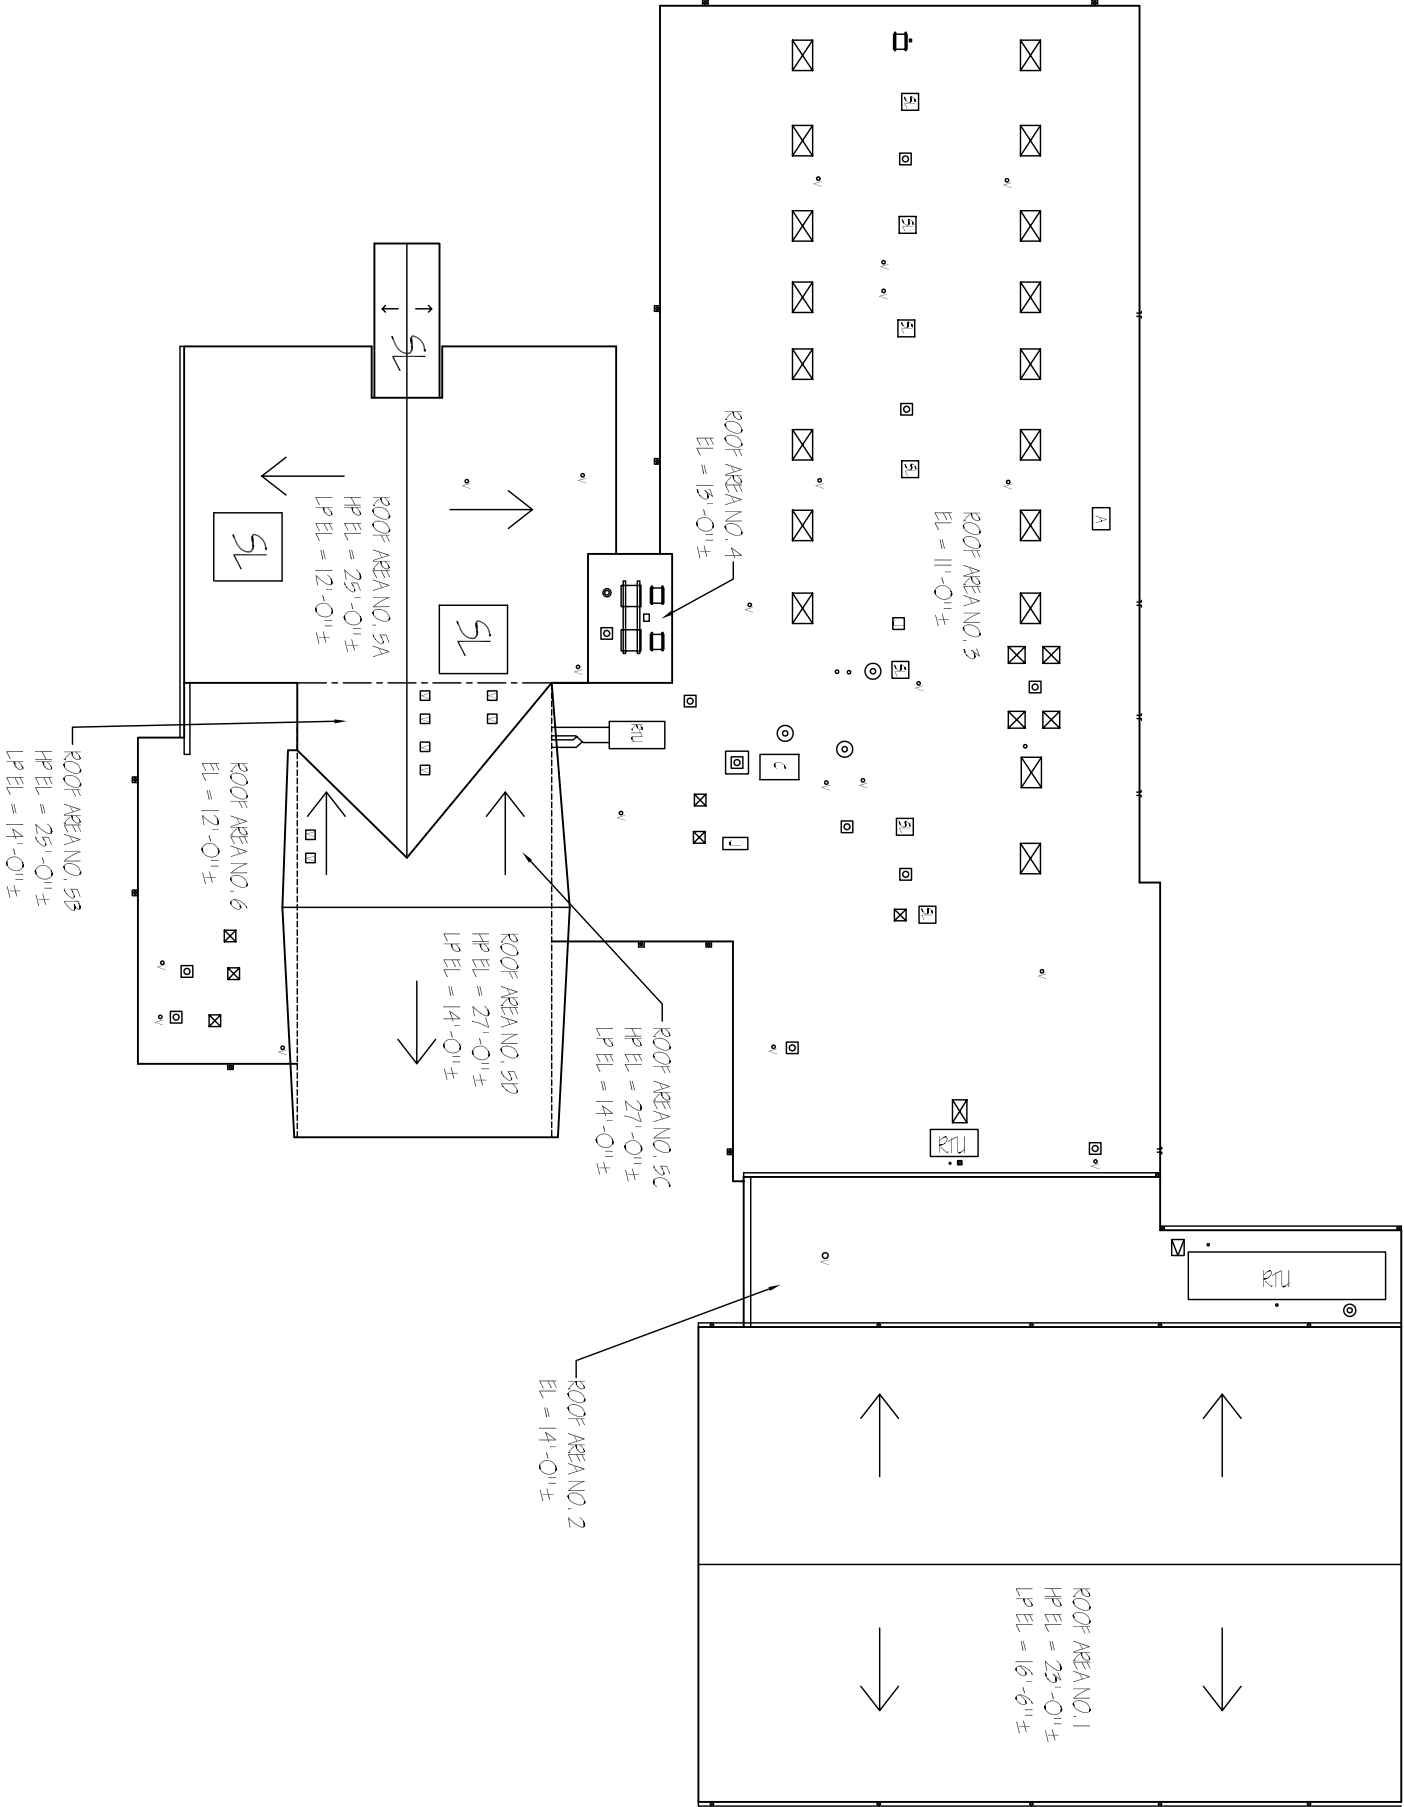
| | <p>Photo No. 16</p> <p>Location: Fairbank Complex</p> <p>Description: Ridge between Roof Area Nos. 5C and 5D (5D has the newer/darker shingle roof covering). The older shingles are cracked throughout. The newer shingles are in good condition.</p> |
