Bruce Freeman Rail Trail Culvert Inventory

TO: Bill O'Rourke, Deputy Director of Public Works
FROM: Janet Moonan, P.E., and Eric Ohanian, P.E., Tighe & Bond
COPY: Dan Nason, Director of Public Works, Dave Loring, P.E., Tighe &
DATE: Bond March 1, 2018, updated April 19, 2018

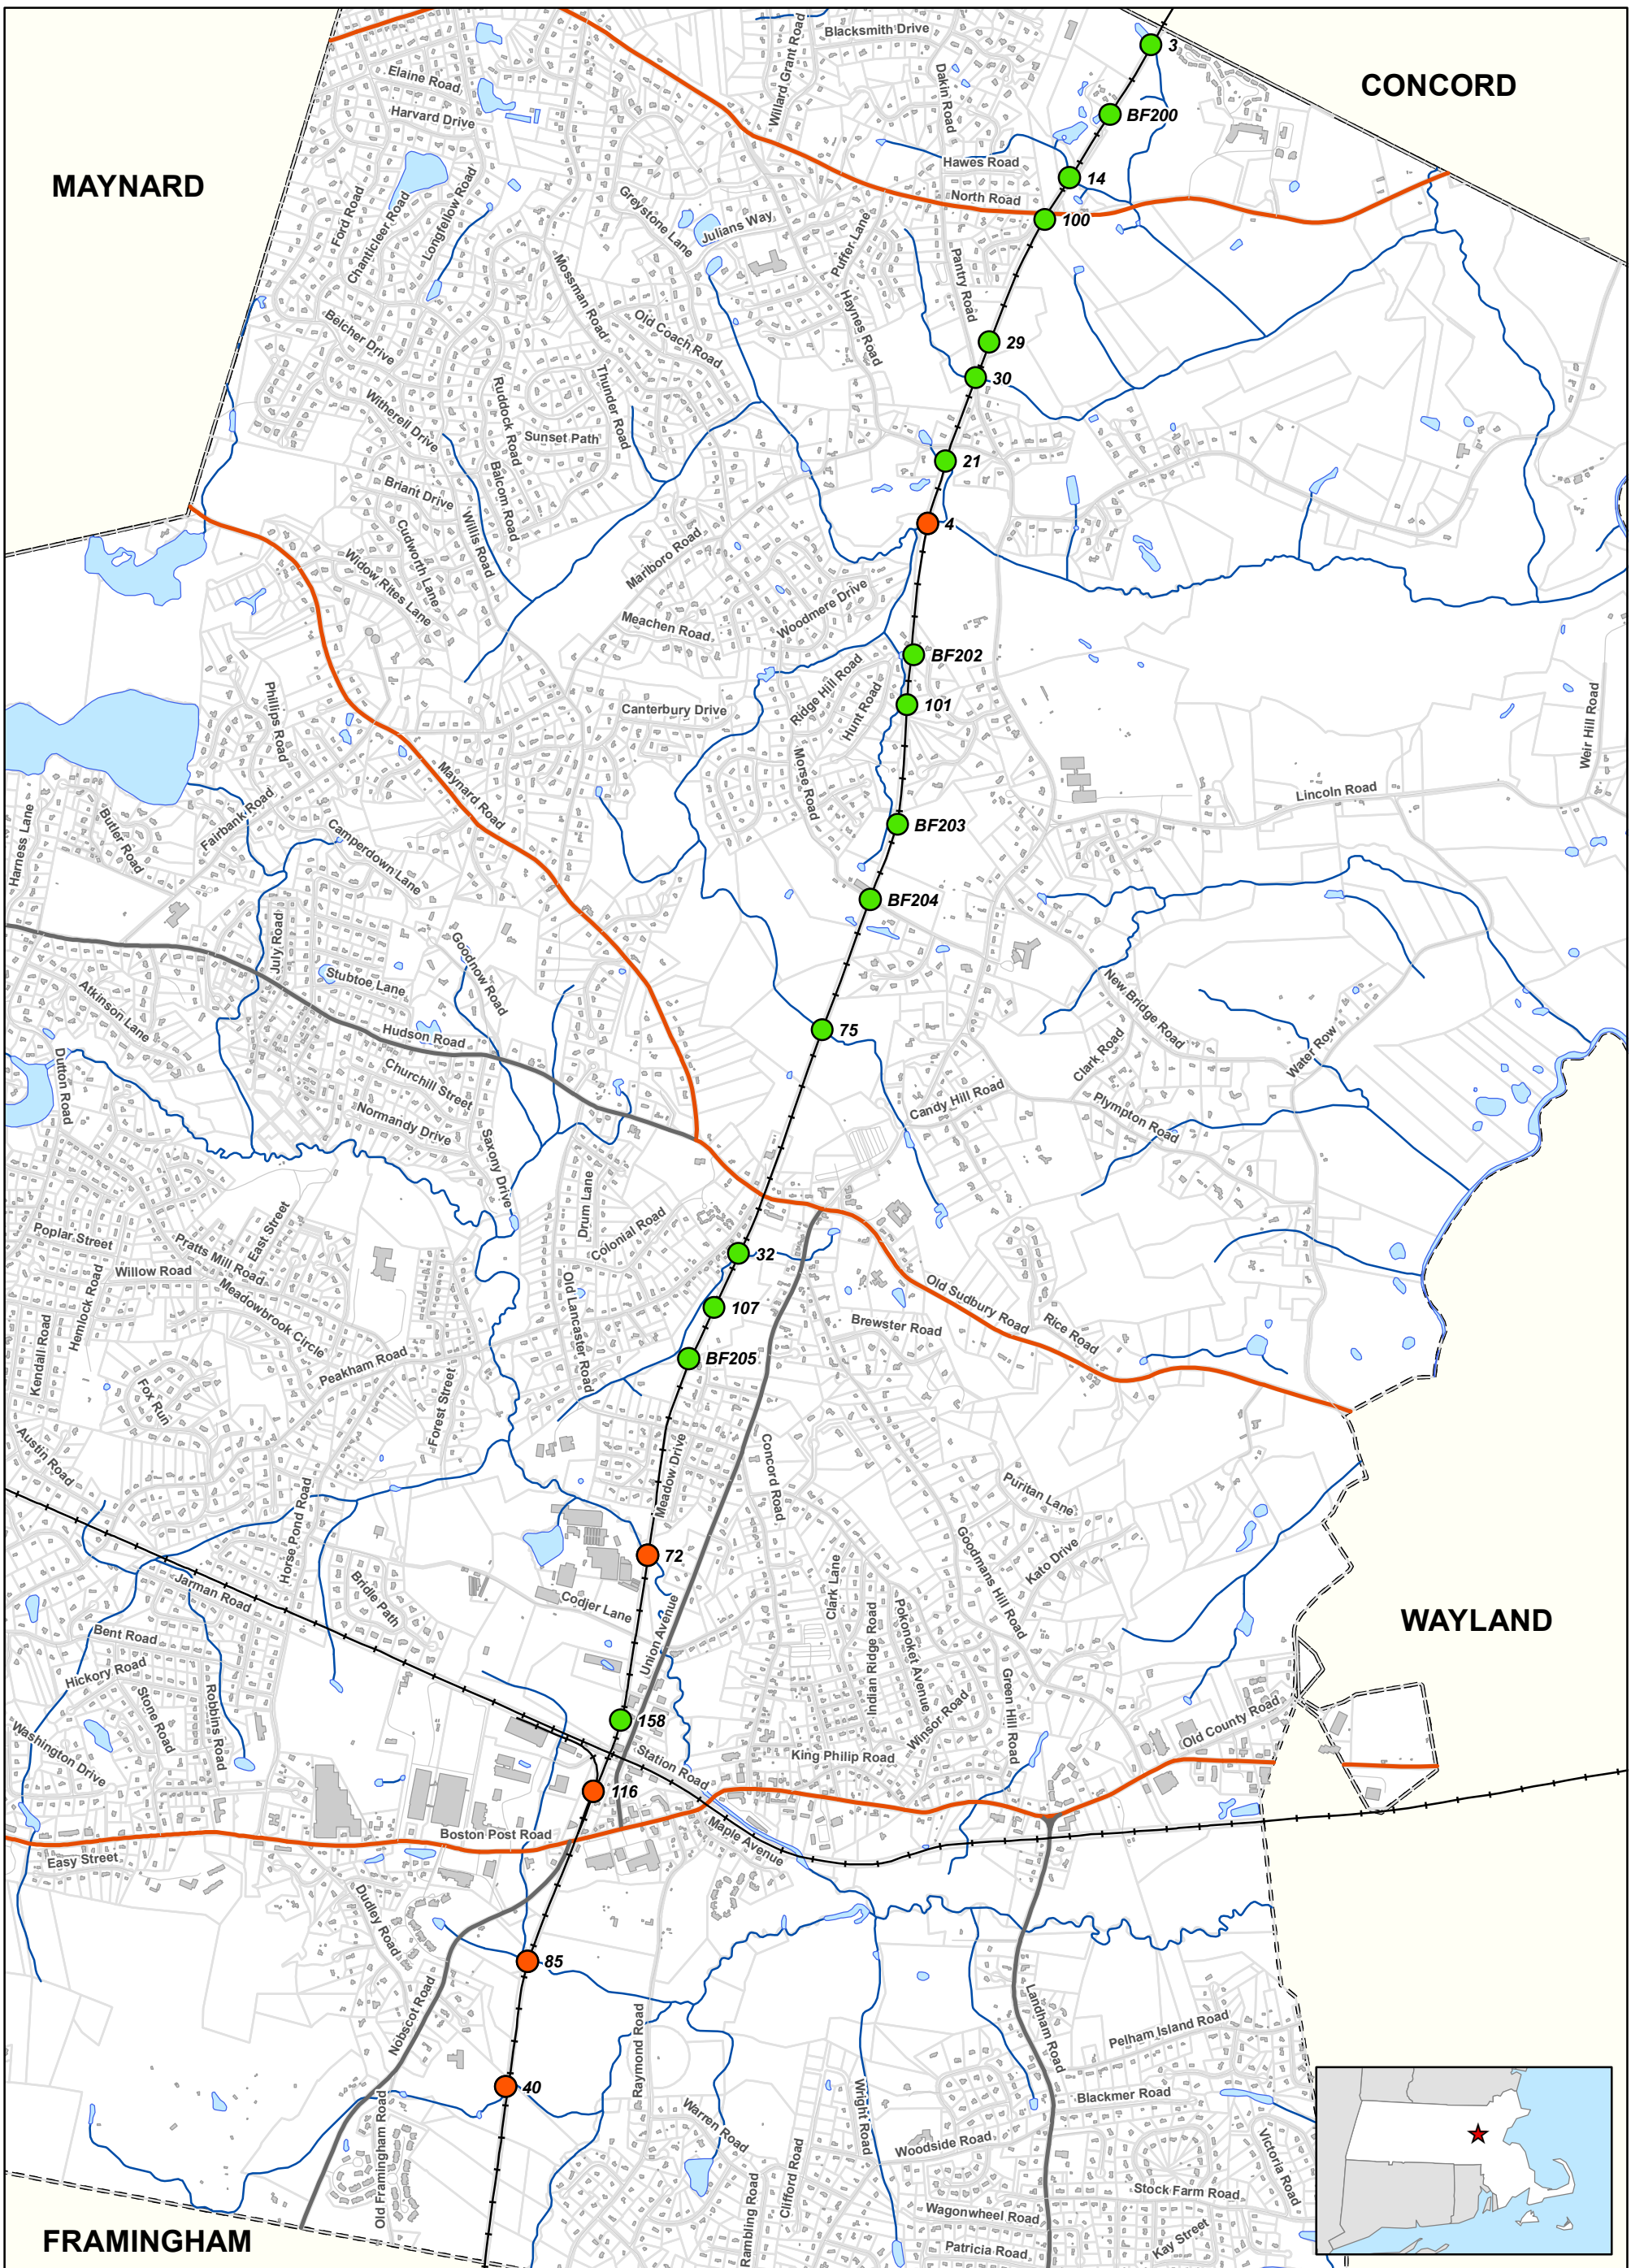
Photo 30: Outlet of Culvert 158

- Culverts 14 and 158 were mostly submerged at the date of visit and therefore an inventory could not be completed. Following sediment and debris removal, further evaluation of condition is necessary to determine replacement or repair needs.

The photographs show a mostly submerged culvert and there is vegetative growth that is blocking the view of the inlet and outlet, therefore the condition cannot be assessed. Additional information is needed (is there a history of flooding at this location?) Debris appear to be reducing hydraulic capacity. Culvert needs to be cleaned to remove sediment and obstructions.
