Flynn Building

Town of Sudbury ADA Transition Plan

December 2020

Institute for Human Centered Design

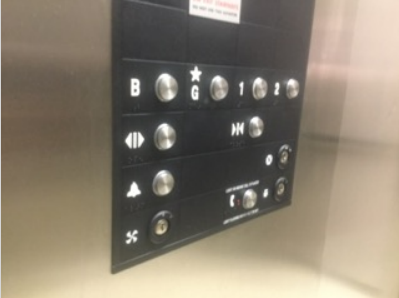
ID	Location	Floor	Room	Element	Type	Photo	Issues	Current Measure	Recommendations	Quantity	Price	Cost Estimation
59	Elevator

Elevator panel signage is clear and well done.	1	-	\$0
60	Entrance to Women's Toilet Room	1

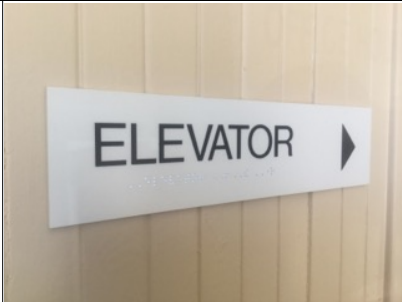
ID	Location	Floor	Room	Element	Type	Photo	Issues	Current Measure	Recommendations	Quantity	Price	Cost Estimation
64	Elevator	G

It is encouraging to see directional signs with raised characters and braille.	1	-	\$0
