Loring Elementary School

Town of Sudbury ADA Transition Plan

January 2021

Town of Sudbury
Loring Elementary School

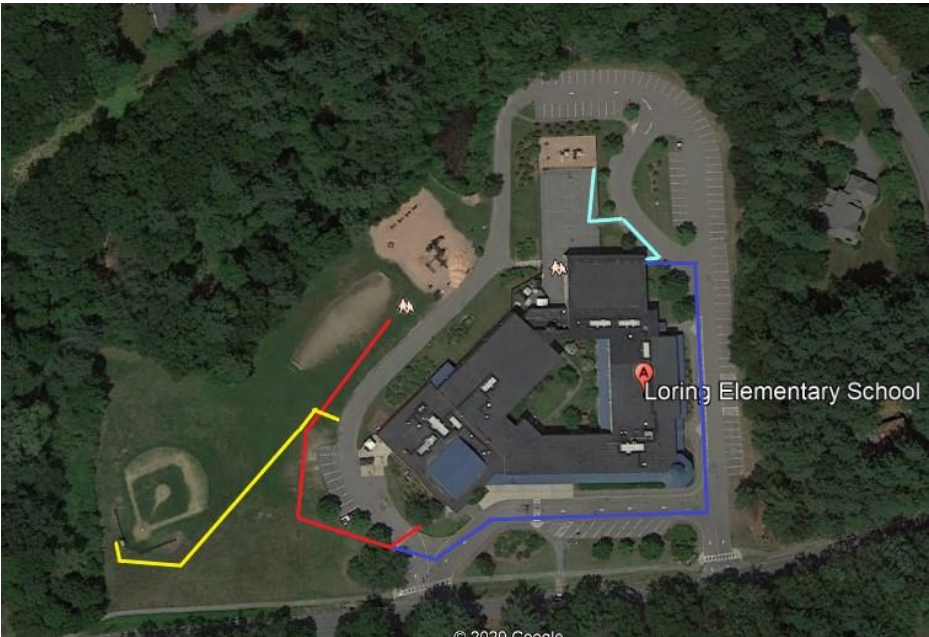
Figure 1: In the following image, the aqua line indicates the approximate route to the upper basketball court and playground. The blue line indicates the approximate route from the upper to

the lower amenities area. The yellow line indicates the approximate location of a new route to the edge of sport activity and team seating at the baseball field. The red line indicates the approximate location of a new route from a cafeteria exit to the future location of the new basketball hoops and the redesigned and rebuilt accessible lower playground. IHCD is including approximate costs to correct issues along the aqua route and for the inclusion of the new yellow route. Sudbury has budgeted for the new red route, the installation of the new basketball hoops, and for the new lower playground. Sudbury also has existing plans to address any excessive slope or other accessibility issues with the blue route and general circulation path between the upper and lower amenities areas.

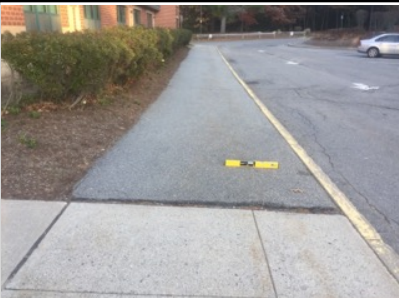
Cross slope > 1:50 (2.00%)	4.7%	Reduce cross slope to be no steeper than 1:50 (2.00%). (Cost for 4'x15' of asphalt to correct slope.)	1	600	\$600
4	From Main Entrance Towards Exit 11	Ext.		Exterior Access Route	Walkway

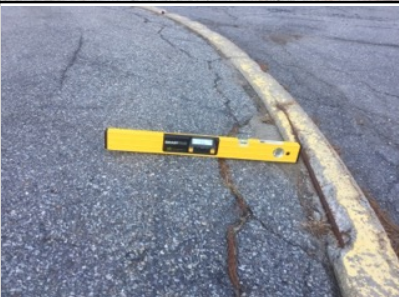
Cross slope > 1:50 (2.00%)	13.6%	Reduce cross slope to be no steeper than 1:50 (2.00%). (Cost for 4'x6' of asphalt to correct slope.)	1	240	\$240

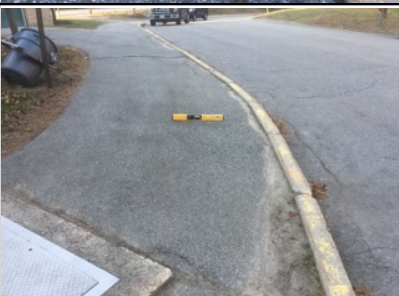
5	From Exit 10 To Exit 8	Ext.		Exterior Access Route	Walkway

Cross slope > 1:50 (2.00%)	8.7%	Reduce cross slope to be no steeper than 1:50 (2.00%). (Cost based on 4'x6' of asphalt to correct slope.)	1	240	\$240

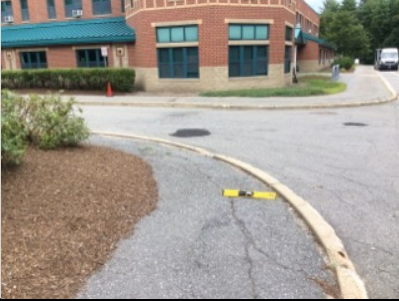
Cross slope > 1:50 (2.00%)	15.8%	Reduce cross slope to be no steeper than 1:50 (2.00%).	1	240	\$240
9	Walkway	Ext.		Exterior Access Route	Walkway	 	Cross slope > 1:50 (2.00%)	10.9%	Reduce cross slope to be no steeper than 1:50 (2.00%).	1	240	\$240
10	Walkway	Ext.		Exterior Access Route	Walkway	 	Cross slope > 1:50 (2.00%)	9.7%	Reduce cross slope to be no steeper than 1:50 (2.00%).	1	240	\$240

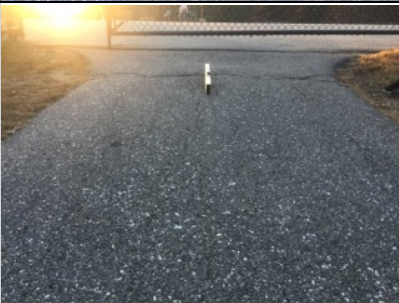
14	Path to Basketball Court/Upper Playground	Ext.		Exterior Access Route	Walkway

Running slope > 1:20 (5%)	7%	Reduce running slope to be no steeper than 1:20 (5%). (Cost based on 4'x6' of asphalt to correct slope.)	1	240	\$240
15	Courtyard to Lobby Entrance	Ext.		Exterior Access Route	Walkway

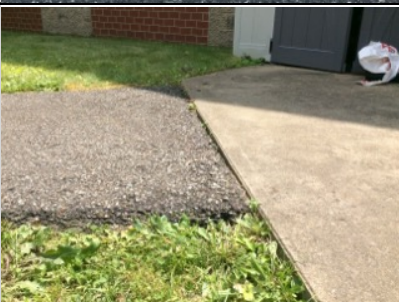
Level changes > 1/4"	-	Alter change in level to be 1/4" high max. (Cost based on a 4'x4' asphalt patch.)	1	160	\$160

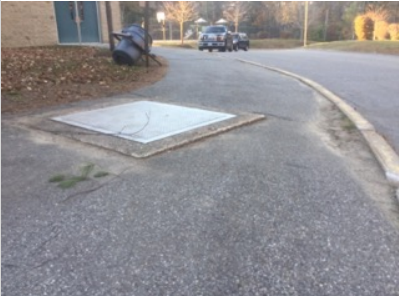
Level changes > 1/4"	1"	Alter change in level to be 1/4" high max. (Cost based on 2'x10 of beveled asphalt to reduce change in level.)	1	200	\$200
18	Exit 8	Ext.		Exterior Access Route	Walkway

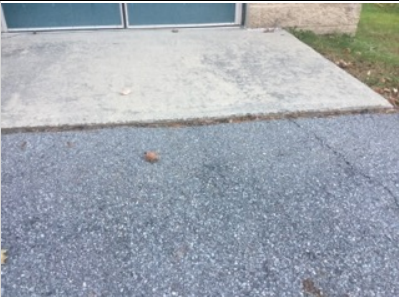
Level changes > 1/4"	1	Alter change in level to be 1/4" high max. (Cost based on an asphalt patch.)	1	160	\$160
19	Curb Ramp at Basketball Court	Ext.		Exterior Access Route	Exterior

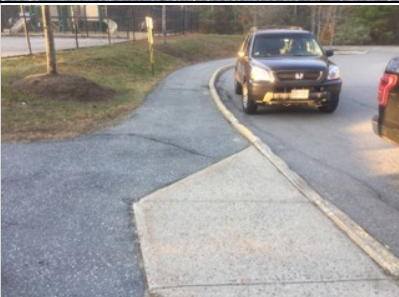
Level changes > 1/4"	2"	Alter change in level to be 1/4" high max. (Cost based on asphalt patch to correct change in level.) (Cost included in ID #37 - Cost for a new compliant curb ramp.)	1	-	\$0

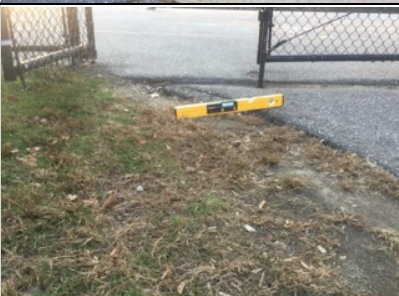
20	Small Gate Entry to Basketball Court/Upper Playground	Ext.		Exterior Access Route	Exterior

Level changes > 1/4"	2"	Alter change in level to be 1/4" high max. (Cost for an asphalt patch.)	1	160	\$160

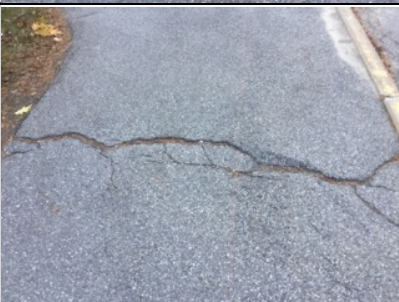
25	From Exit 10 To Exit 8	Ext.		Exterior Access Route	Walkway

Route not maintained in operable working condition	-	Ensure the accessible route is maintained in operable working condition. Repair deteriorated asphalt. (Cost based on an asphalt patch.)	1	160	\$160

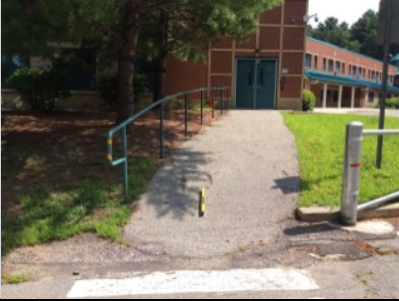
Curb Ramp												
29	Exit From Cafeteria	Ext.		Curb Ramp	N/A

Curb ramp not provided Running slope > 1:12 (8.33%) Handrails not provided at both sides if rise is > 6"	- 25%	Provide a curb ramp at intersection. Provide a handrail on both sides. (Cost estimate for a new concrete curb ramp and 30' of metal handrail.)	1	5020	\$5020
30	Crosswalk Near Woodside Road	Ext.		Curb Ramp	N/A

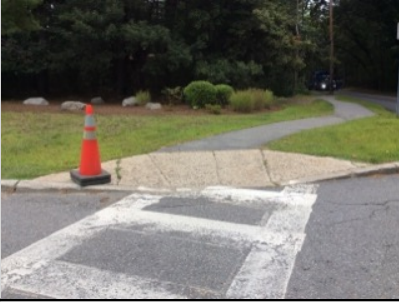
Running slope > 1:12 (8.33%)	10.7%	Reduce running slope to be no steeper than 1:12 (8.33%). (Cost estimate for a new concrete curb ramp.)	1	2800	\$2800

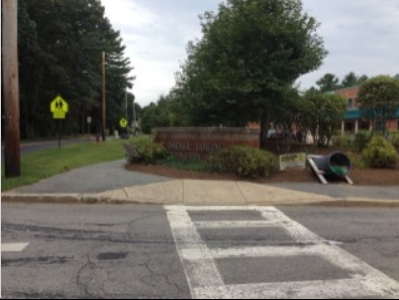
Running slope > 1:12 (8.33%) Landing not provided at top of curb ramp	10.7% -	Reduce running slope to be no steeper than 1:12 (8.33%). Provide landing at top of curb ramp or reconfigure ramp. (Cost estimate for a new concrete curb ramp.)	1	2800	\$2800
33	Curb Ramp at Basketball Court	Ext.		Curb Ramp	N/A

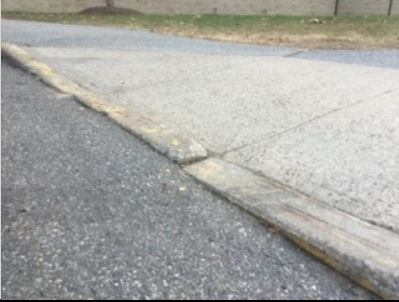
Transition from curb ramp to street not flush	2"	Ensure transition from curb ramp to street is flush or free of changes in level. (Cost included in ID #37 - Cost for a new compliant curb ramp.)	1	-	\$0

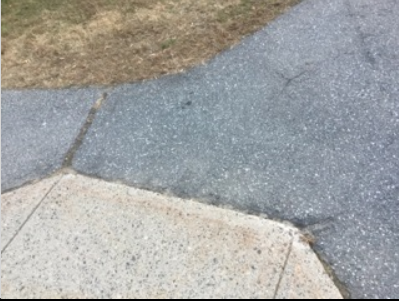
34	Curb Ramp at Basketball Court	Ext.		Curb Ramp	N/A

Transition from curb ramp to street not flush	-	Ensure transition from curb ramp to street is flush or free of changes in level. (Cost included in ID #37 - Cost for a new compliant curb ramp.)	1	-	\$0
35	Curb Ramp at Basketball Court	Ext.		Curb Ramp	N/A

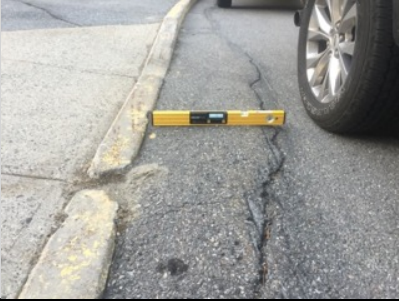
Transition from curb ramp to street not flush	-	Ensure transition from curb ramp to street is flush or free of changes in level. (Cost included in ID #37 - Cost for a new compliant curb ramp.)	1	-	\$0

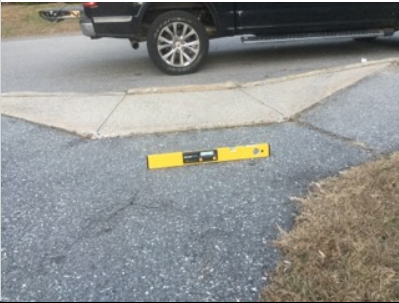
Landing not provided at top of curb ramp Cross slope > 1:50 (2%) (MAAB)	- 3.3%	Provide a 5'x5' landing at top of curb ramp. Reduce cross slope at curb ramp to be no steeper than 1:50 (2%). (Cost for a new compliant concrete curb ramp addressing all shown curb ramp issues.)	1	2800	\$2800
Off-Street Parking Lot or Garage												
38	By Baseball Field	Ext.		Off-Street Parking Lot or Garage	N/A

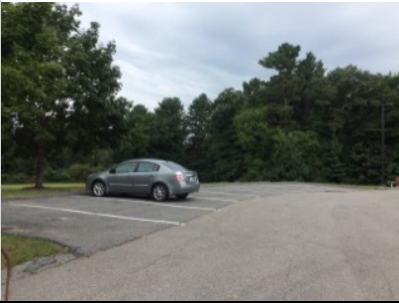
Total # of parking Total # of designated accessible parking spaces Total # of designated van accessible spaces Sign not provided Sign does not have the designation "Van Accessible"	9 - - - -	Provide one compliant van accessible parking space and access aisle each 8' wide min. (re-stripe). Provide a sign with the International Symbol of Accessibility with the bottom of the sign 60" min. above the ground and the top 96" max. above the ground. Add the designation "Van Accessible" to the sign located at the van accessible space.	1	800	\$800

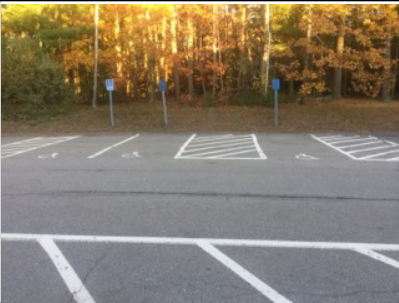
39	Accessible Parking Opposite Exit 11 and 10	Ext.		Off-Street Parking Lot or Garage	N/A

Total # of designated accessible parking spaces Total # of designated van accessible spaces Sign does not have the designation "Van Accessible"	2 1 -	Add the designation "Van Accessible" to the sign located at the van accessible space (the space furthest to the right in this photograph). Ensure there is at least 60" clear height measured to the bottom of the sign.	1	500	\$500
Exterior Stair												
40	Staircase Lower Level	Ext.		Exterior Stair	N/A

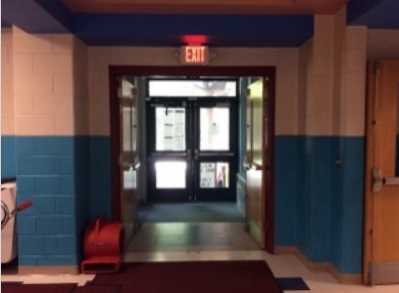
Tactile exit sign not provided	-	Ensure tactile exit signs with raised characters and braille are provided at exit doors. Mount signs between 48"- 60" above the finished floor located on the latch side of the door.	1	232	\$232

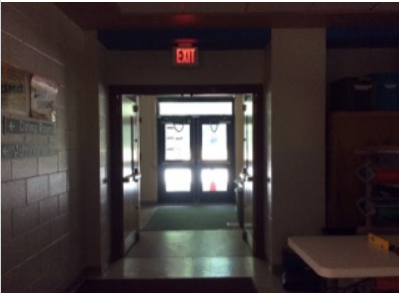
44	Egress Door 11	1		Means of Egress	N/A

Tactile exit sign not provided	-	Ensure tactile exit signs with raised characters and braille are provided at exit doors. Mount signs between 48"- 60" above the finished floor located on the latch side of the door.	1	232	\$232
45	Main Entrance and Egress Door 1	1		Means of Egress	N/A

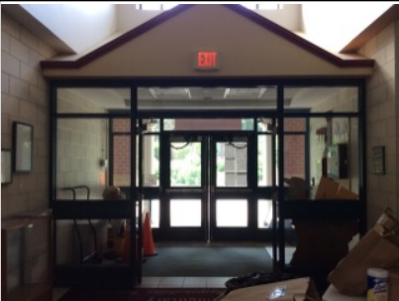
Tactile exit sign not provided Illuminated ISA symbol not provided (MAAB)	- -	Ensure tactile exit signs with raised characters and braille are provided at exit doors. Mount signs between 48"- 60" above the finished floor located on the latch side of the door. Provide an illuminated sign with the International Symbol of Accessibility.	1	432	\$432

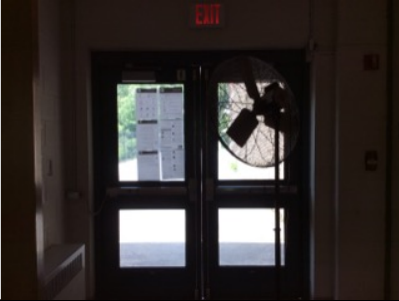
Tactile exit sign not provided Illuminated ISA symbol not provided (MAAB)	- -	Ensure tactile exit signs with raised characters and braille are provided at exit doors. Mount signs between 48"- 60" above the finished floor located on the latch side of the door. Provide an illuminated sign with the International Symbol of Accessibility.	1	432	\$432

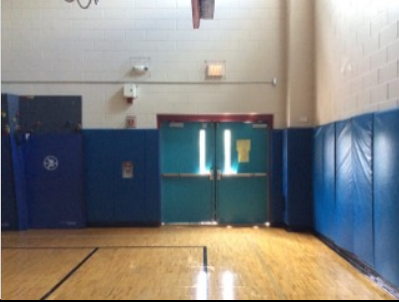
48	Egress Door 7	1	154	Means of Egress	N/A

Tactile exit sign not provided Illuminated ISA symbol not provided (MAAB)	- -	Ensure tactile exit signs with raised characters and braille are provided at exit doors. Mount signs between 48"- 60" above the finished floor located on the latch side of the door. Provide an illuminated sign with the International Symbol of Accessibility.	1	432	\$432
49	Egress Door 8	1	154	Means of Egress	N/A

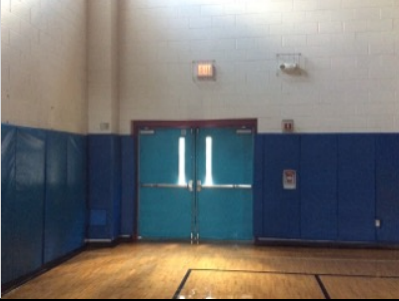
Tactile exit sign not provided Illuminated ISA symbol not provided (MAAB)	- -	Ensure tactile exit signs with raised characters and braille are provided at exit doors. Mount signs between 48"- 60" above the finished floor located on the latch side of the door. Provide an illuminated sign with the International Symbol of Accessibility.	1	432	\$432
Interior Access Route												
50	Assistant Principle	1	102	Interior Access Route	N/A

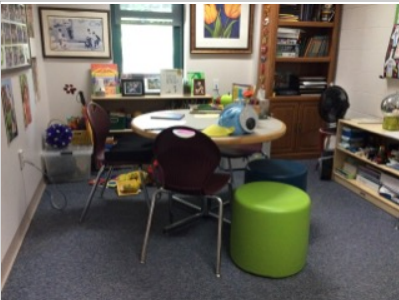
Route < 36" wide	-	Ensure that a clear width of 36" min. is maintained at the accessible route.	1	Labor	\$0

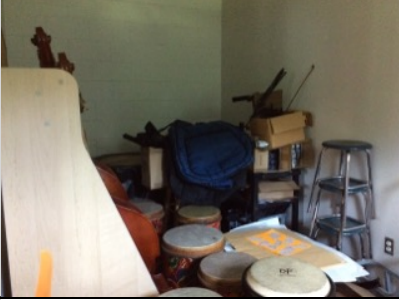
Route < 36" wide	-	Ensure that a clear width of 36" min. is maintained at the accessible route.	1	Labor	\$0
53	Work Room	1		Interior Access Route	N/A

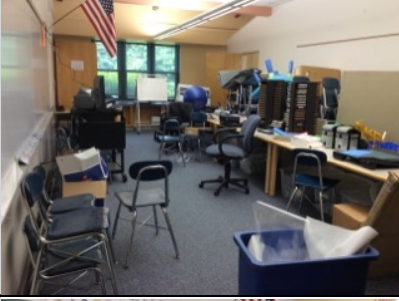
Route < 36" wide	-	Ensure that a clear width of 36" min. is maintained at the accessible route.	1	Labor	\$0
54	Special Education	1	159	Interior Access Route	N/A

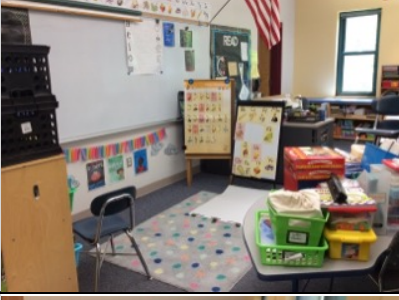
Route < 36" wide	-	Ensure that a clear width of 36" min. is maintained at the accessible route.	1	Labor	\$0
55	Classroom 235	2	235	Interior Access Route	N/A

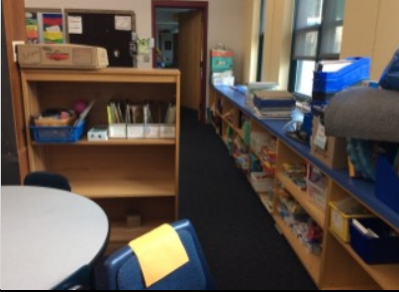
Route < 36" wide	29"	Ensure that a clear width of 36" min. is maintained at the accessible route.	1	Labor	\$0

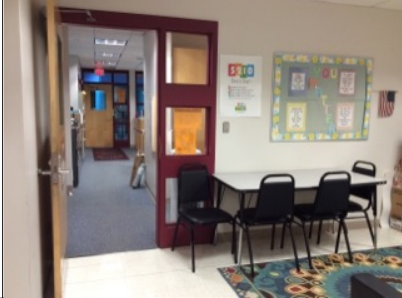
Maneuvering clearance(s) not provided	-	Remove chair to provide 18" min. pull-side maneuvering clearance at door.	1	Labor	\$0
58	Room 110	1	110	Doors, Doorways, & Gates	Office

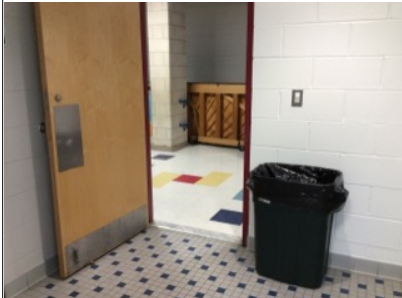
60	Girls' Toilet Room	1	168	Doors, Doorways, & Gates	Toilet Room

Maneuvering clearance(s) not provided	-	Remove the trash can to provide 18" min. pull-side maneuvering clearance at door.	1	Labor	\$0

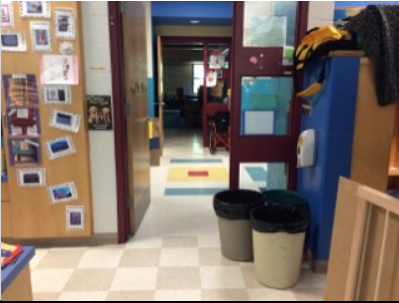
Maneuvering clearance(s) not provided	-	Remove trash cans to provide 18" min. pull-side maneuvering clearance at the door.	1	Labor	\$0
63	Spanish Classroom Single-User Toilet Room	1	133	Doors, Doorways, & Gates	Toilet Room

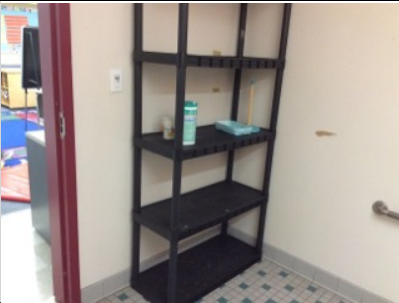
Maneuvering clearance(s) not provided	14"	Remove shelving to provide 18" min. pull-side maneuvering clearance at door.	1	Labor	\$0
64	Men's Toilet Room	1	127	Doors, Doorways, & Gates	Toilet Room

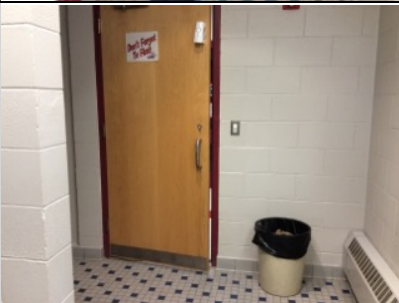
Maneuvering clearance(s) not provided	-	Remove the trash can to provide 18" min. pull-side maneuvering clearance at the door.	1	Labor	\$0

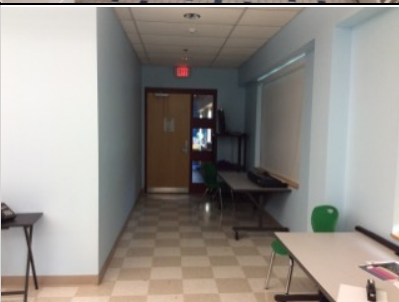
65	Learning Center	1	115	Doors, Doorways, & Gates	Circulation

Maneuvering clearance(s) not provided	-	Remove stored items to provide 18" min. pull-side maneuvering clearance at the door.	1	Labor	\$0

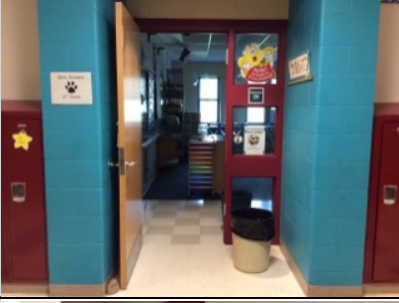
Maneuvering clearance(s) not provided	-	Remove trash cans to provide 18" min. pull-side maneuvering clearance at the door.	1	Labor	\$0
68	Boys' Toilet Room	2	227	Doors, Doorways, & Gates	Toilet Room

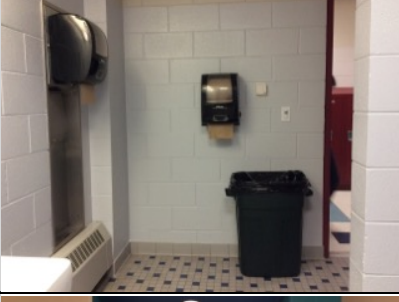
Maneuvering clearance(s) not provided	-	Remove the trash can to provide 18" min. pull-side maneuvering clearance at the door.	1	Labor	\$0

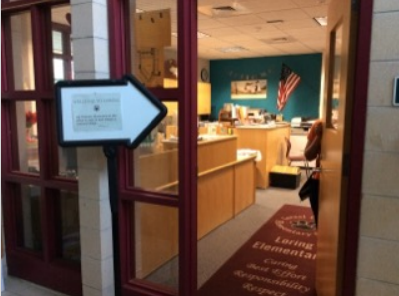
Mat not securely attached	-	Secure the mat.	1	Labor	\$0
73	Cafetorium	1	185	Doors, Doorways, & Gates	Circulation

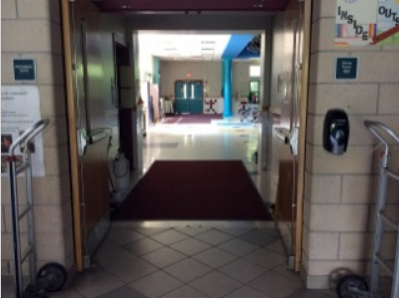
Mat not securely attached	-	Secure the mat.	1	Labor	\$0
74	Hallway	1		Doors, Doorways, & Gates	Circulation

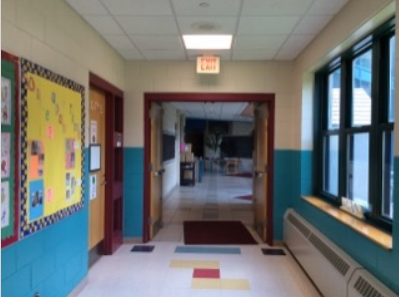
Mat not securely attached	-	Secure the mat.	1	Labor	\$0
75	Cafetorium Egress	1		Doors, Doorways, & Gates	Emergency Egress

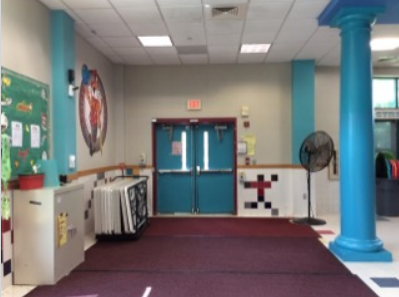
Mat not securely attached	- -	Secure the mat.	1	Labor	\$0

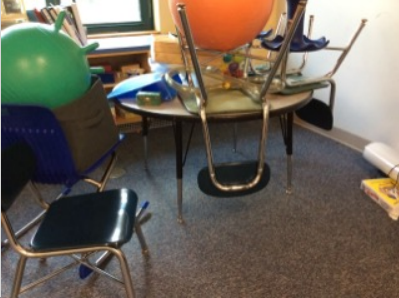
Knee or toe clearance not provided	22"	Provide at least 1 work surface with 24" min. knee and toe clearance.	1	700	\$700
Assembly Area												
83	Cafetorium Stage	1		Assembly Area	N/A

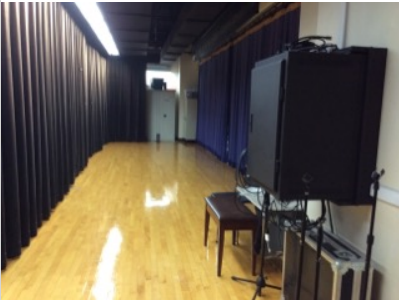
Assistive listening devices not provided	-	If audible communication is integral to the use of the space, provide an assistive listening system.	1	1214	\$1214
Picnic Tables												
84	Lower Playground	Ext.		Picnic Tables	N/A

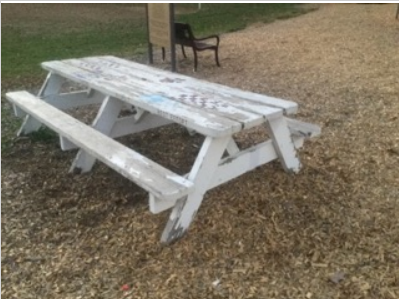
At least 5% accessible spaces not provided	-	Ensure that at least 5% (minimum one) of the picnic tables in this area are accessible. (Cost based on a new accessible picnic table.)	1	1400	\$1400

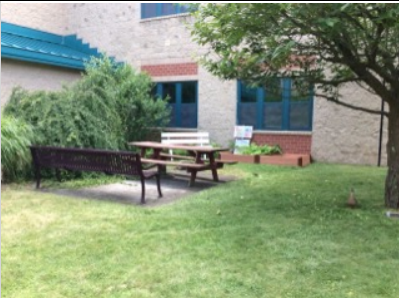
85	Courtyard	Ext.		Picnic Tables	N/A

Toe or knee clearance at tables not provided Picnic table not on an accessible route	- -	Provide at least 1 picnic table in this area with toe and knee clearance. Ensure that the dining surface is connected to an accessible route. (Cost based on an accessible picnic table.)	1	1400	\$1400

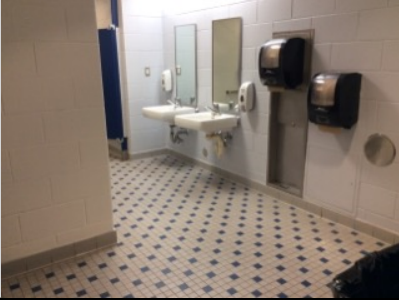
Dispenser acts as a protruding object	-	Relocate dispenser out of the circulation path or place a cane-detectable barrier under the dispenser.	1	306	\$306
92	Women's Toilet Room	1		Dispensers	Paper Towel Dispenser

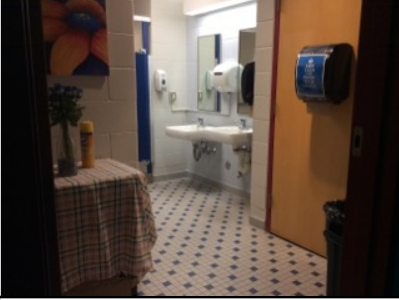
Dispenser acts as a protruding object	-	Relocate dispenser out of the circulation path or place a cane-detectable barrier under the dispenser.	1	306	\$306
93	Girls' Toilet Room	2		Dispensers	Paper Towel Dispenser

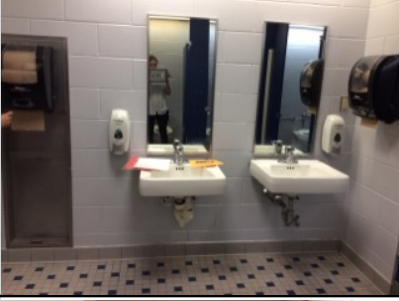
Dispenser acts as a protruding object	-	Relocate dispenser out of the circulation path or place a cane-detectable barrier under the dispenser.	1	306	\$306

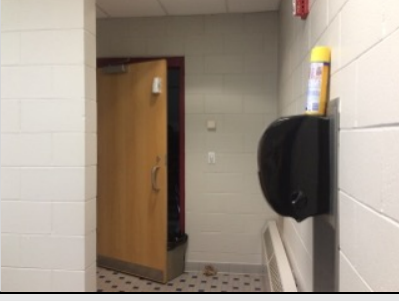
94	Men's Toilet Room	2	213	Dispensers	Paper Towel Dispenser

Dispenser acts as a protruding object	-	Relocate dispenser out of the circulation path or place a cane-detectable barrier under the dispenser.	1	306	\$306
Toilet Rooms for Children

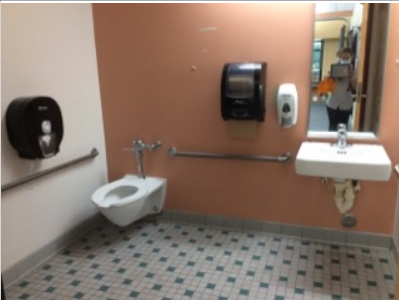
Flush control not on open side Non-compliant toilet paper dispenser	- -	Move the flush control to the open side. Mount flush control between 20" - 30" above the floor. Relocate toilet paper dispenser so that it is between 14"- 19" above the floor and between 7"- 9" in front of the toilet. Ensure dispensers and other devices are not mounted above grab bars. Also relocate the paper towel and soap dispensers from above the grab bar.	1	1433	\$1433
97	Kindergarten Single-User Toilet Room	1	135	Single-User Toilet (Children)	N/A

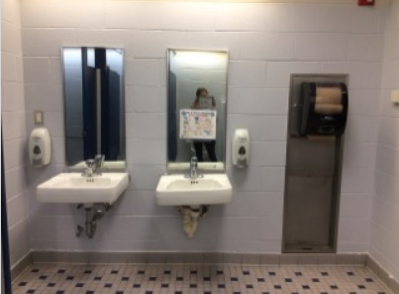
Toe or knee clearances not provided	23"	Provide at least one lavatory with 25" min. knee clearance positioned for a forward approach. Ensure toe clearance is also provided.	1	1686	\$1686

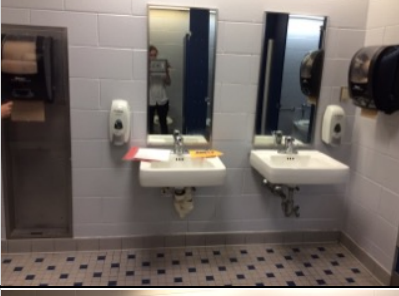
Toe or knee clearances not provided	23"	Provide at least one lavatory with 25" min. knee clearance positioned for a forward approach. Ensure toe clearance is also provided.	1	1686	\$1686
112	Boys Toilet Room	1	147	Lavatory (Children)	N/A

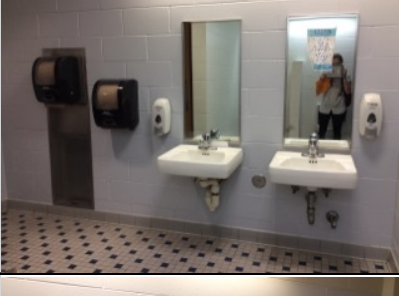
Toe or knee clearances not provided	23.25"	Provide at least one lavatory with 25" min. knee clearance positioned for a forward approach. Ensure toe clearance is also provided.	1	1686	\$1686
113	Girls Toilet Room	1	146	Lavatory (Children)	N/A

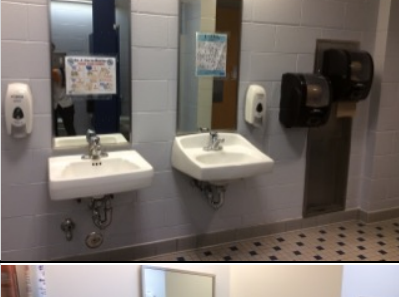
Toe or knee clearances not provided	23.25"	Provide at least one lavatory with 25" min. knee clearance positioned for a forward approach. Ensure toe clearance is also provided.	1	1686	\$1686

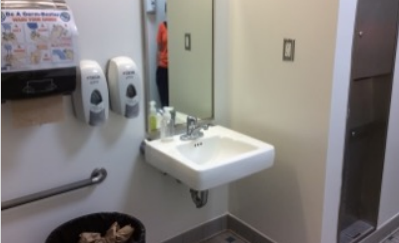
114		1	109	Lavatory (Children)	N/A

Toe or knee clearances not provided Exposed plumbing underneath	22" -	Provide at least one lavatory with 25" min. knee clearance positioned for a forward approach. Ensure toe clearance is also provided. Insulate or otherwise configure pipes to prevent contact, for at least one lavatory.	1	1778	\$1778

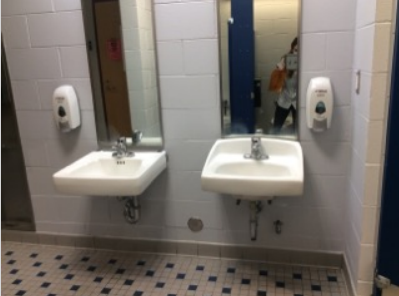
Toe or knee clearances not provided Exposed plumbing underneath	22.5" -	Provide at least one lavatory with 25" min. knee clearance positioned for a forward approach. Ensure toe clearance is also provided. Insulate or otherwise configure pipes to prevent contact, for at least one lavatory.	1	1778	\$1778
116	Kindergarten Single-User Toilet Room	1	135	Lavatory (Children)	N/A

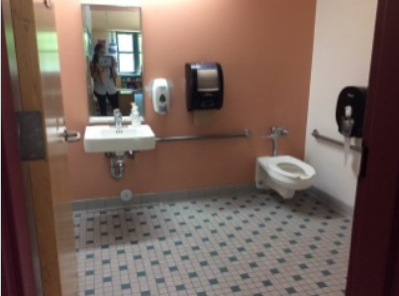
Toe or knee clearances not provided Exposed plumbing underneath	23.5" -	Provide at least one lavatory with 25" min. knee clearance positioned for a forward approach. Ensure toe clearance is also provided. Insulate or otherwise configure pipes to prevent contact, for at least one lavatory.	1	1778	\$1778
117	Girls Toilet Room	1	146	Lavatory (Children)	N/A

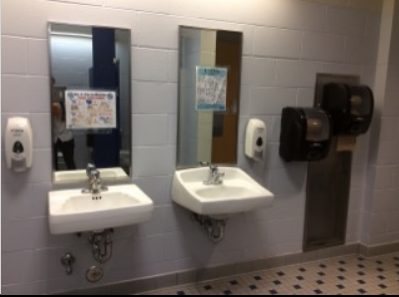
Exposed plumbing underneath	-	Insulate or otherwise configure pipes to prevent contact, for at least one lavatory.	1	92	\$92

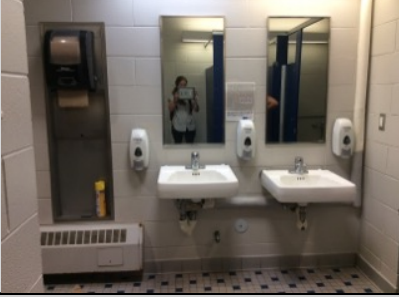
118	Men's Room	1	127	Lavatory (Children)	N/A

Exposed plumbing underneath	-	Insulate or otherwise configure pipes to prevent contact, for at least one lavatory.	1	92	\$92
Dispensers (Children)												
119	Girls Toilet Room	1	168	Dispensers (Children)	Paper Towel Dispenser

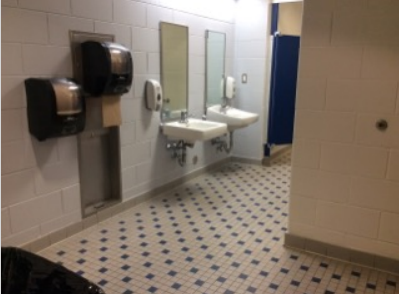
Dispenser is a protruding object	-	Relocate dispenser out of the circulation path or place a cane-detectable barrier under the dispenser.	1	306	\$306

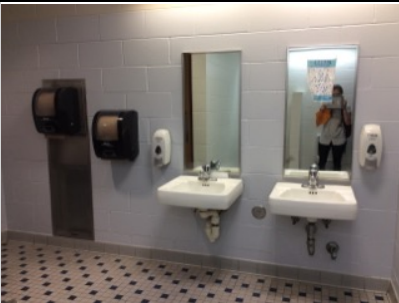
Dispenser is a protruding object	-	Relocate paper towel dispenser out of the circulation path or place a cane-detectable barrier under the dispenser.	1	306	\$306
121	Girls Toilet Room	1	146	Dispensers (Children)	Paper Towel Dispenser

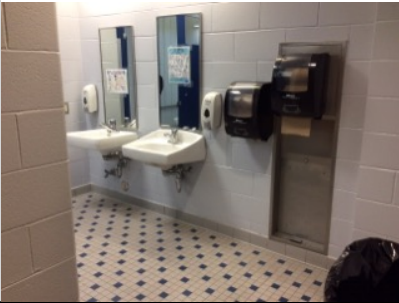
Dispenser is a protruding object	-	Relocate dispenser out of the circulation path or place a cane-detectable barrier under the dispenser.	1	306	\$306
Urinal (Children)												
122	Boys' Toilet Room	2	241	Urinal (Children)

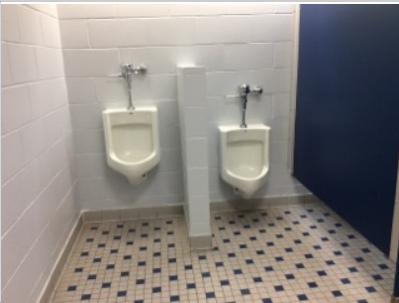
Rim > 15" high (MAAB)	16.5"	Provide at least one urinal with the rim no higher than 15" above the finished floor.	1	3248	\$3248
Additional Access												
Drinking Fountains												
123	Drinking Fountain	1		Drinking Fountains	Low

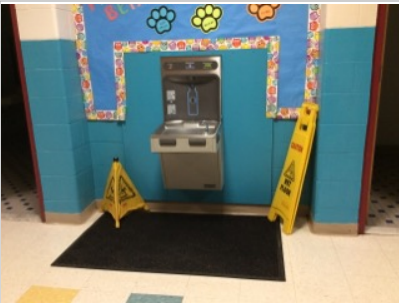
No drinking fountain provided for standing users	-	Provide an additional drinking fountain for standing users or install a Hi-Lo drinking fountain.	1	4028	\$4028

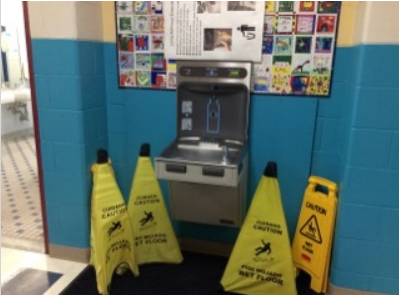
124	Hallway	1	147	Drinking Fountains	Low

No drinking fountain provided for standing users	-	Provide an additional drinking fountain for standing users or install a Hi-Lo drinking fountain.	1	4028	\$4028

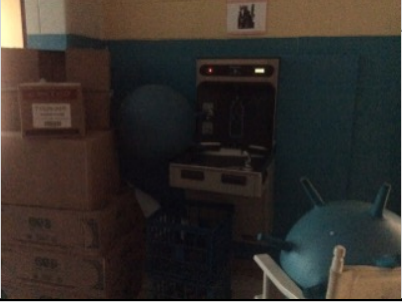
No drinking fountain provided for standing users	-	Provide an additional drinking fountain for standing users or install a Hi-Lo drinking fountain.	1	4028	\$4028
Sink												
126	Health Exam Room	1	108	Sink	Other

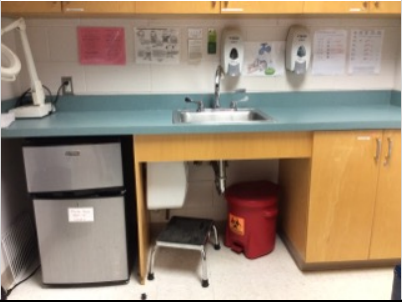
Clear floor space not provided at sink Exposed plumbing underneath sink	- -	Provide a 30" by 48" clear floor space positioned for a forward approach (relocate stored objects). Insulate or otherwise configure pipes at sink.	1	92	\$92
127	Learning Center	1	115	Sink	Other

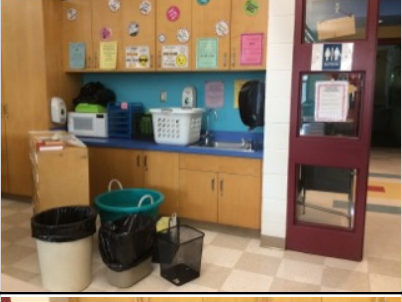
Toe and knee clearances not provided	-	Ensure there is a 25" knee clearance positioned for a forward approach.	1	1686	\$1686

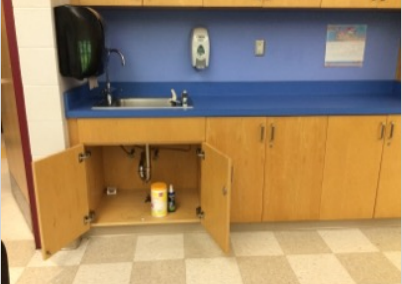
129	Music Room	1	164	Sink	Other

Toe and knee clearances not provided Exposed plumbing underneath sink	- -	Ensure there is a 27" knee clearance positioned for a forward approach. Insulate or otherwise configure pipes at sink.	1	1778	\$1778

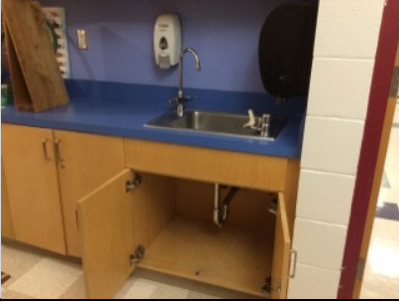
ID	Location	Floor	Room	Element	Type	Photo	Issues	Current Measure	Recommendations	Quantity	Price	Cost Estimation
130	Work Room	1		Sink	Other

Toe and knee clearances not provided Exposed plumbing underneath sink	- -	Ensure there is a 27" knee clearance positioned for a forward approach. Insulate or otherwise configure pipes at sink.	1	1778	\$1778
131	Grade 3 Classroom	2	236	Sink	Classroom

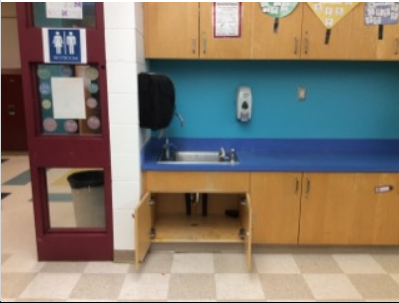
Toe and knee clearances not provided Exposed plumbing underneath sink	21" -	Ensure there is a 27" knee clearance positioned for a forward approach. Insulate or otherwise configure pipes at sink.	1	1778	\$1778
132	Grade 2 Classroom	2	233	Sink	Classroom

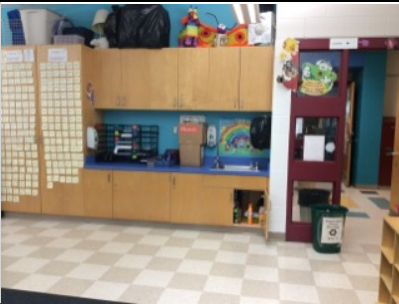
Toe and knee clearances not provided Exposed plumbing underneath sink	- -	Ensure there is a 27" knee clearance positioned for a forward approach. Insulate or otherwise configure pipes at sink.	1	1778	\$1778
133	Cafetorium	1		Sink	Other

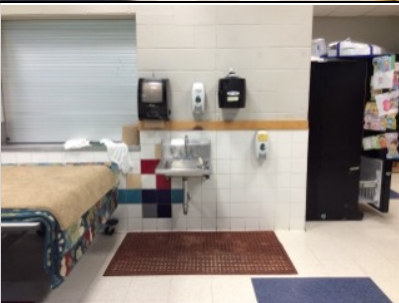
Exposed plumbing underneath sink	-	Insulate or otherwise configure pipes at sink.	1	92	\$92

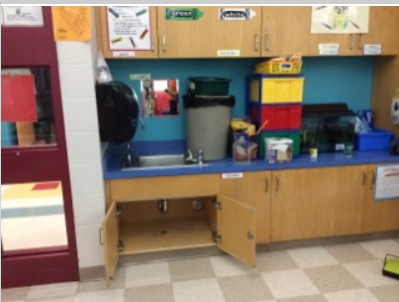
Sinks for Children's Use												
134	Grade 1 Classroom	1	162	Sinks for Children's Use	Classroom

Exposed plumbing underneath Knee or toe clearance not provided	- 20"	Insulate or otherwise configure pipes to prevent contact, for at least one sink. Provide at least one sink with 25" high knee and toe clearance positioned for a forward approach.	1	1778	\$1778

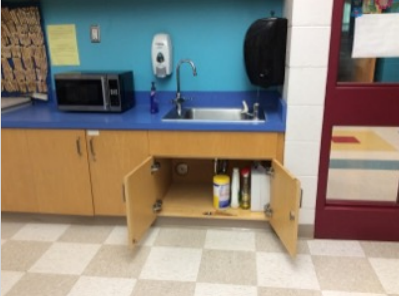
ID	Location	Floor	Room	Element	Type	Photo	Issues	Current Measure	Recommendations	Quantity	Price	Cost Estimation
135	Literacy	1	161	Sinks for Children's Use	Other

Exposed plumbing underneath Knee or toe clearance not provided	- -	Insulate or otherwise configure pipes to prevent contact, for at least one sink. Provide at least one sink with 25" high knee and toe clearance positioned for a forward approach.	1	1778	\$1778
136	Special Education	1	159	Sinks for Children's Use	Classroom

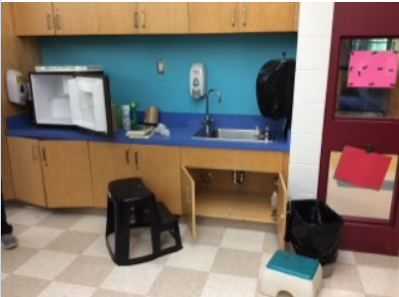
Exposed plumbing underneath Knee or toe clearance not provided	- -	Insulate or otherwise configure pipes to prevent contact, for at least one sink. Provide at least one sink with 25" high knee and toe clearance positioned for a forward approach.	1	1778	\$1778
137	Kindergarten	1	135	Sinks for Children's Use	Classroom

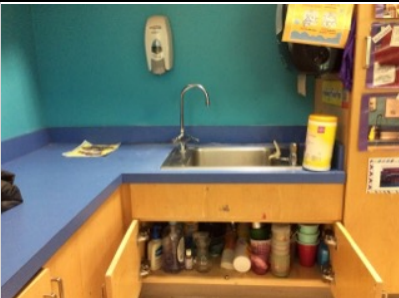
Exposed plumbing underneath Knee or toe clearance not provided	- -	Insulate or otherwise configure pipes to prevent contact, for at least one sink. Provide at least one sink with 25" high knee and toe clearance positioned for a forward approach.	1	1778	\$1778

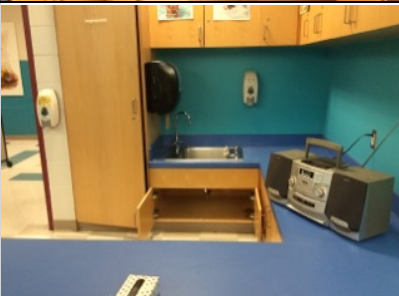
138	Spanish	1	133	Sinks for Children's Use	Classroom

Exposed plumbing underneath Knee or toe clearance not provided	- -	Insulate or otherwise configure pipes to prevent contact, for at least one sink. Provide at least one sink with 25" high knee and toe clearance positioned for a forward approach.	1	1778	\$1778
139	Grade 5 Classroom	2	220	Sinks for Children's Use	Classroom

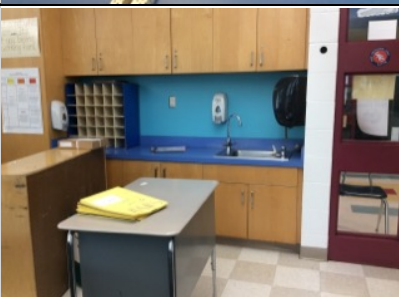
Knee or toe clearance not provided	-	Provide at least one sink with 25" high knee and toe clearance positioned for a forward approach.	1	1686	\$1686
Play and Sport Areas

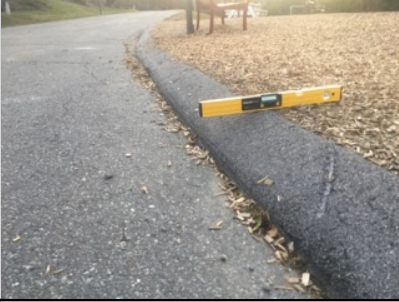
ID	Location	Floor	Room	Element	Type	Photo	Issues	Current Measure	Recommendations	Quantity	Price	Cost Estimation
Play Areas												
140	Entry - Lower Playground Border at Street	Ext.		Play Areas	N/A

Accessible route not provided to playground	-	Install an accessible route to the playground. Reduce change in level at the playground border to 1/2" max. beveled for a width of 4' wide min. Note: Costs are not included in this catalog because IHCD has been told that Sudbury has budgeted for a new compliant lower playground.	1	-	\$0
141	Route Between Upper and Lower Outdoor Amenities	Ext.		Play Areas	N/A

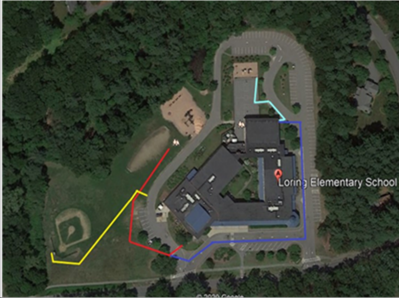
Accessible route not provided to playground	-	Note: An accessible route is not provided from the school basketball court and upper playground to the lower playground area. See Figure 1 in the report narrative for details regarding the provision of an accessible route between outdoor amenities.	1	-	\$0

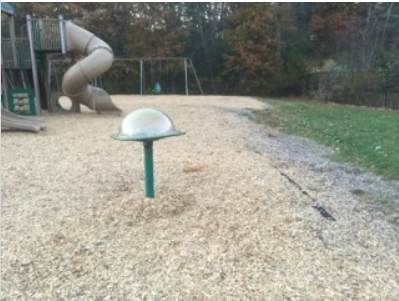
142	Lower Playground	Ext.		Play Areas	N/A

Accessible route not provided around playground	-	Provide an accessible route around the play area. Note: Costs are not included in this catalog for an accessible route around the lower playground because IHCD has been told that Sudbury has budgeted for a new compliant lower playground.	1	-	\$0
143	Upper Playground	Ext.		Play Areas	N/A

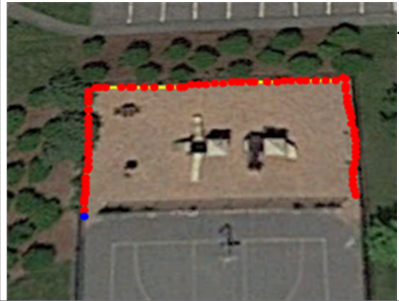
Accessible route not provided around playground	-	Provide an accessible route around the play area. (Cost estimate for a 4' wide min. by 150' stone dust path around the perimeter sides of the playground not bordered by the fence.)	1	4800	\$4800
144	Upper Playground	Ext.		Play Areas	N/A

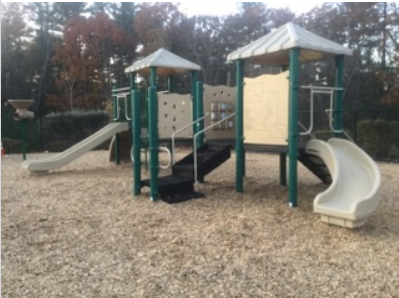
Accessible route not provided to play components	-	Provide a compliant impact-attenuating surface to and around the play components. (Cost estimate for 1,200 sq. ft. of poured-in-place rubber surface.)	1	16800	\$16800

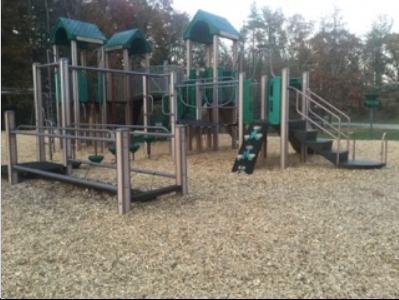
ID	Location	Floor	Room	Element	Type	Photo	Issues	Current Measure	Recommendations	Quantity	Price	Cost Estimation
145	Lower Playground	Ext.		Play Areas	N/A

Accessible route not provided to play components	-	Provide a compliant impact-attenuating surface to and around the play components. (Cost estimate for 1500 sq. ft. of poured-in-place rubber surface.) Note: Costs for this remedy are not included in this catalog because IHCD has been told that Sudbury has budgeted for a new compliant lower playground.	1	-	\$0
Field												
146	Baseball Field	Ext.		Field	Baseball

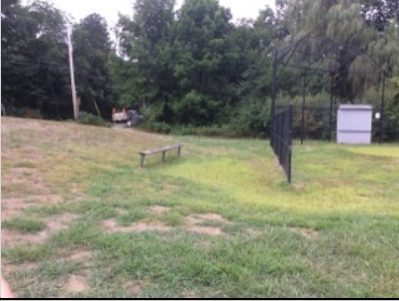
Accessible spaces not provided at team seating Field not connected to an accessible route	- -	Provide a 36" x 48" clear floor space at team seating. Provide an accessible route to the field. (Cost estimate for a 4' wide min. x 240' long stone dust path providing an accessible route to the boundary of sport activity at the baseball field and connecting to the team seating.)	1	7680	\$7680

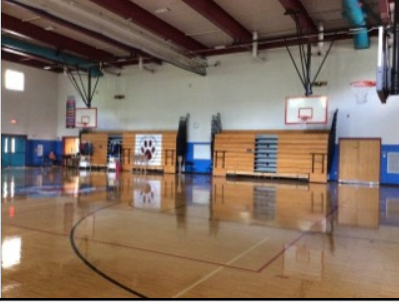
Court												
147	Gymnasium	1	154	Court	Basketball

Accessible spaces are not provided at sidelines seating	-	Provide a 36" x 48" clear floor space at sidelines seating. Number of accessible seats required is based on the total number of bleacher seats. See the 2010 ADA Standards for Accessible Design Table 221.2.1.	1	-	\$0
Best Practice												
Bench												
148	Courtyard	Ext.		Bench	N/A
