# Broadacres Farm

## Town of Sudbury ADA Transition Plan

September 2020

Institute for Human Centered Design

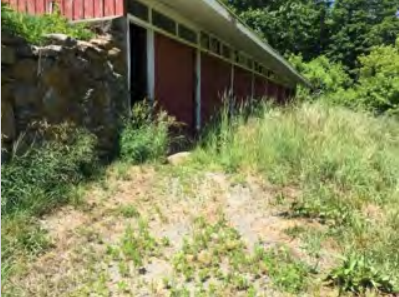
ID	Location	Floor	Room	Element	Type	Photo	Issues	Current Measure	Recommendations	Quantity	Price	Cost Estimation
<b>Approach and Entrance</b>												
<b>Exterior Access Route</b>												
1	Path Between Horse Riding Practice Building and Horse Barn	Ext.		Exterior Access Route	Walkway

Running slope > 1:20 (5%) Surface is not stable, firm, and slip-resistant Accessible route not provided	7.3% - 250'	Ensure an accessible route is provided with a slope no greater than 1:20 (5.00%). (Cost estimate for a 250' long 4' wide stone dust walkway.)	1	8000	\$8000
2	House Entrance	Ext.		Exterior Access Route	Walkway

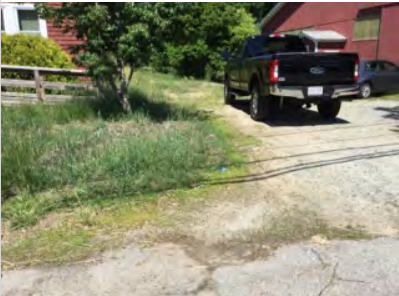
Level changes > 1/4"	2"	Alter change in level to be 1/4" high max. (Cost estimate for a 4' by 4' asphalt area.)	1	160	\$160
3	Horse Riding Practice Building	Ext.		Exterior Access Route	Walkway

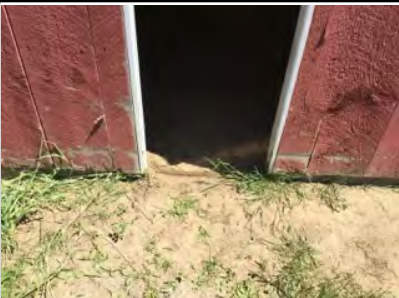
Accessible route not provided	-	Ensure an accessible route is provided to the new main entrance door. (Cost estimate for a 10' long 4' wide stone dust walkway.)	1	320	\$320

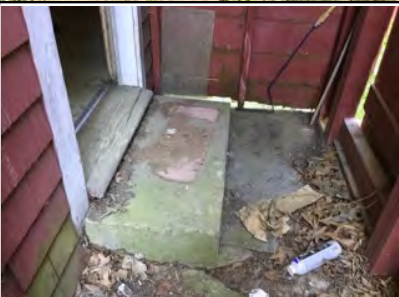
4	Kitchen Egress to Outdoor Office	Ext.		Exterior Access Route	Exterior

Accessible route not provided	-	Due to lack of space an accessible route may not be technically feasible to the outdoor office.	1	-	\$0
<b>Off-Street Parking Lot or Garage</b>												
5	Parking Area	Ext.		Off-Street Parking Lot or Garage	Visitor

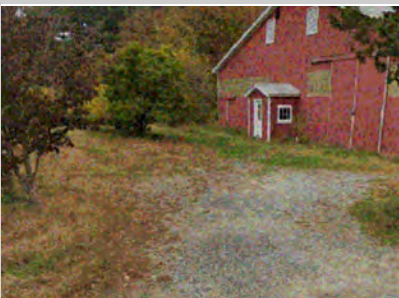
Total # of parking Total # of designated van accessible spaces	3 0	Provide one van accessible parking space.	1	1850	\$1850

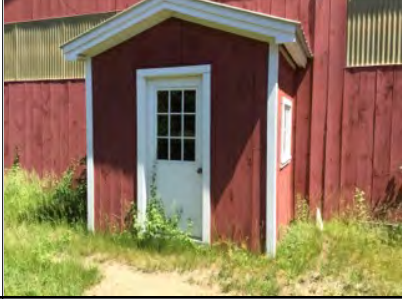
8	Horse Riding Practice Building Observation Area	Ext.		Entrance	Secondary Entrance

Entrance not on an accessible route Threshold > 1/2" high Hardware not operable with a closed fist International Symbol of Accessibility not provided	- 5" -	After the entrance is made accessible, provide a sign with the International Symbol of Accessibility (ISA). Provide hardware that can be operable with one hand and not require tight grasping, pinching, or twisting of the wrist. Provide a sloped walkway with a 5' by 5' level platform at the door. (Cost estimate includes a 15' long concrete route to the door, door hardware and sign.)	1	2030	\$2030
9	Horse Riding Practice Building Main Entrance	Ext.		Entrance	Main Entrance

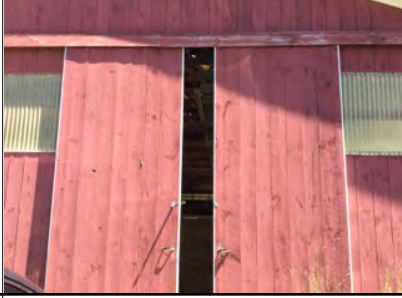
International Symbol of Accessibility not provided	- -	Provide a sign with the International Symbol of Accessibility (ISA) at the new accessible entrance door.	1	346	\$346
10	House - Main Entrance	Ext.		Entrance	Main Entrance

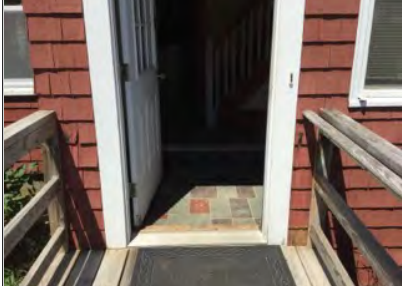
Threshold > 1/2" high Hardware not operable with a closed fist	1" -	Alter threshold to be 1/2" high max. Provide hardware that can be operable with one hand and not require tight grasping, pinching, or twisting of the wrist.	1	634	\$634

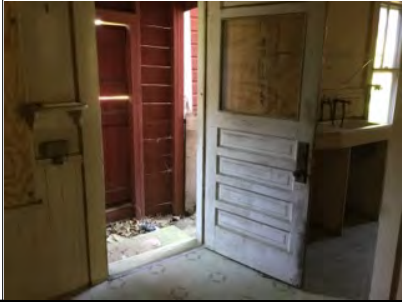
Door requires > 15 lbs. of force to open	-	Provide an accessible door into the facility. (Cost estimate for installing a solid core wood door.)	1	2972	\$2972
<b>Emergency Exit</b>												
12	Kitchen Egress	1		Emergency Exit	N/A

Tactile sign not provided at exit Directional sign to accessible emergency exit not provided	- -	Provide tactile exit signs with raised characters and braille at exit doors. Mount signs between 48"- 60" above the finished floor located on the latch side of the door. Provide a directional sign indicating the location of the nearest accessible emergency exit.	1	464	\$464
13	Horse Riding Practice Building Inaccessible Door	Ext.		Emergency Exit	N/A

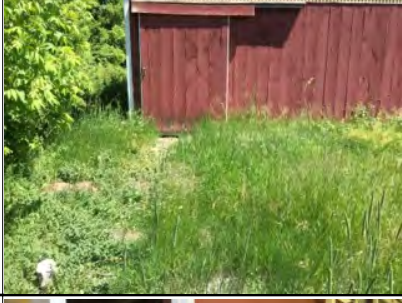
Tactile sign not provided at exit Directional sign to accessible emergency exit not provided	- -	At the interior of the exit door: provide tactile exit signs with raised characters and braille at exit doors. Mount signs between 48"- 60" above the finished floor located on the latch side of the door. Provide a directional sign indicating the location of the nearest accessible emergency exit.	1	464	\$464

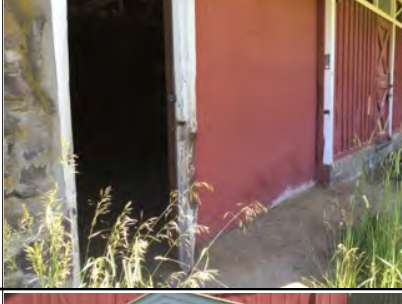
14	Horse Barn Exit	1		Emergency Exit	N/A

Tactile sign not provided at exit Illuminated Int. Symbol of Acc. not provided (MAAB)	- -	Provide tactile exit signs with raised characters and braille at exit doors. Mount signs between 48"- 60" above the finished floor located on the latch side of the door. Provide an illuminated sign with the International Symbol of Accessibility.	1	1116	\$1116
15	Horse Riding Practice Building Observation Area	Ext.		Emergency Exit	N/A

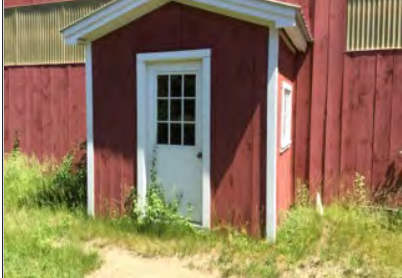
Tactile sign not provided at exit Illuminated Int. Symbol of Acc. not provided (MAAB)	- - -	Provide a tactile exit signs with raised characters and braille at the interior. Mount signs between 48"- 60" above the finished floor located on the latch side of the door. After the door is made accessible, provide an illuminated sign with the International Symbol of Accessibility on the interior of the door.	1	1116	\$1116

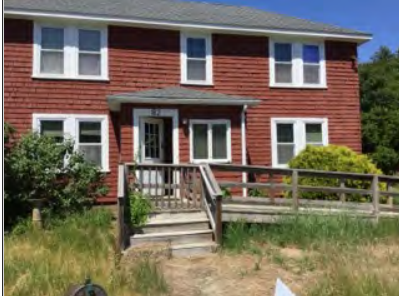
ID	Location	Floor	Room	Element	Type	Photo	Issues	Current Measure	Recommendations	Quantity	Price	Cost Estimation
16	House - Main Entrance	Ext.		Emergency Exit	N/A

Tactile sign not provided at exit Illuminated Int. Symbol of Acc. not provided (MAAB)	- -	Provide a tactile exit sign with raised characters and braille at the interior of the exit door. Mount sign between 48"- 60" above the finished floor located on the latch side of the door. After the exit is made accessible, provide an illuminated sign with the International Symbol of Accessibility.	1	1116	\$1116
17	Horse Riding Practice Building Main Entrance	Ext.		Emergency Exit	N/A

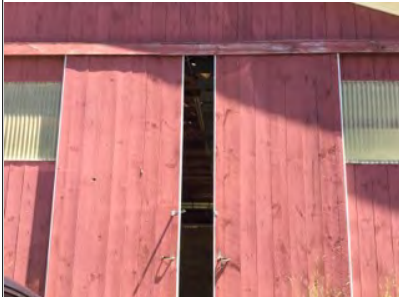
Tactile sign not provided at exit Illuminated Int. Symbol of Acc. not provided (MAAB) Directional sign to accessible emergency exit not provided	- - - -	At the interior of the exit door: provide tactile exit signs with raised characters and braille at the existing main exit door and the new accessible main exit door. Provide a directional sign indicating the location of the nearest accessible emergency exit at the inaccessible exit. Provide an illuminated sign with the International Symbol of Accessibility at the accessible exit door.	1	1580	\$1580

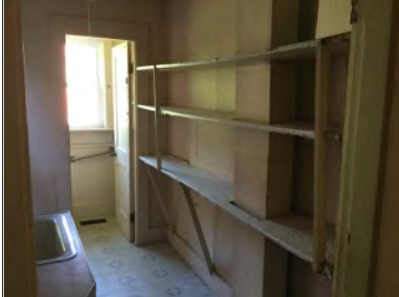
<b>Access to Goods and Services</b>												
<b>Interior Access Route</b>												
18	Kitchen Storage and Bathroom	1		Interior Access Route	N/A

Route < 36" wide	31"	Ensure that a clear width of 36" min. is maintained at the accessible route. Remove shelves. Route is allowed to narrow to 32 inches for a depth of 24 inches.	1	Labor	\$0
19	Horse Barn Entrance	1		Interior Access Route	N/A

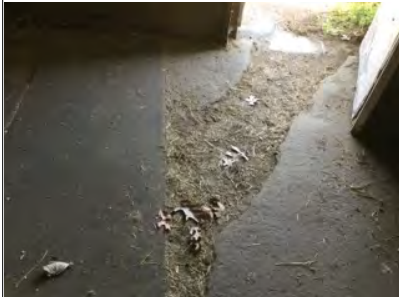
Level changes > 1/4"	2"	Alter change in level to be 1/4" high max.	1	144	\$144
20	House - Main Entrance	1		Interior Access Route	N/A

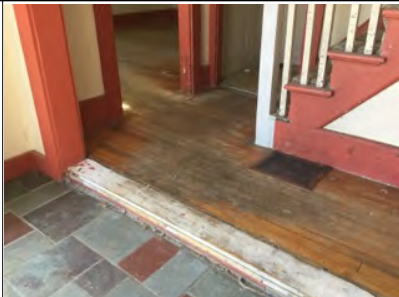
Level changes > 1/4"	3"	Alter change in level to be 1/4" high max.	1	432	\$432

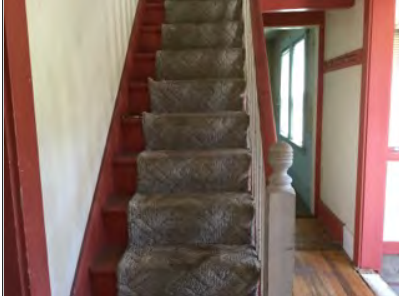
ID	Location	Floor	Room	Element	Type	Photo	Issues	Current Measure	Recommendations	Quantity	Price	Cost Estimation
21	Stair	1		Interior Access Route	N/A

Accessible route not provided	-	Consider locating all public programs on the first floor of the building.	1	-	\$0
22	Basement	B		Interior Access Route	N/A

There is no accessible vertical circulation between the basement, first and second floors of the house. Rather than installing a lift, which may trigger full compliance for the building due to 521 CMR 3.3.2, IHCD recommends not locating public programs in the basement or on the second floor.

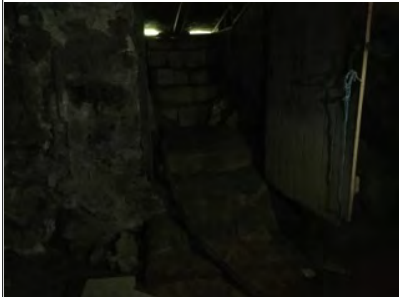
Vertical clearance < 80" above finished floor	62.5"	The basement is unfinished with tripping hazards, no lighting, and has vertical clearance less than 80" above the floor in some areas. IHCD recommends not providing public programs in this area.	1	-	\$0
<b>Doors, Doorways, &amp; Gates</b>												
23	Dining Room	1		Doors, Doorways, & Gates	Other

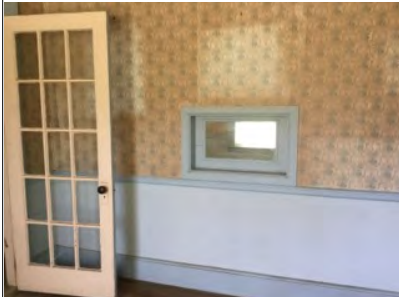
Hardware not operable with a closed fist	-	Provide hardware that can be operable with one hand and not require tight grasping, pinching, or twisting of the wrist.	1	484	\$484
24	Access to Porch From the Living Room	1		Doors, Doorways, & Gates	Other

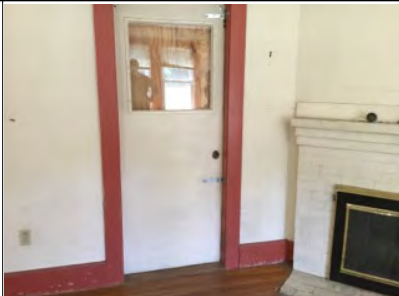
Hardware not operable with a closed fist	-	Provide hardware that can be operable with one hand and not require tight grasping, pinching, or twisting of the wrist.	1	484	\$484

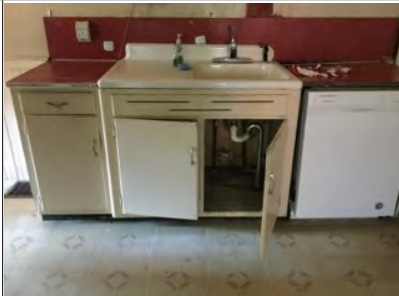
<b>Kitchens and Kitchenettes</b>												
25	Kitchen	1		Kitchens and Kitchenettes	N/A

Knee/toe clearance not provided at sink Sink > 34" high Countertop > 34" high	- - -	Provide a sink with knee and toe clearance positioned for a forward approach. Lower sink to be no higher than 34" positioned for a forward approach. Lower countertop to provide a work surface no higher than 34" positioned for a forward approach.	1	3974	\$3974
<b>Toilet &amp; Bathing Rooms</b>

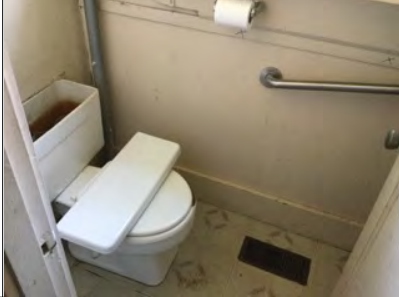
Turning space not provided Accessible plumbing fixtures or stalls not provided	40" -	Add an accessible single-user toilet room.	1	24604	\$24604
27	Kitchen Bathroom in the House	1		Overall Access	Toilet Room

Turning space not provided Accessible plumbing fixtures or stalls not provided	31" -	Provide an accessible single-user toilet room.	1	24604	\$24604
<b>Additional Access</b>												
<b>Sink</b>												
28	Kitchen Storage Area	1		Sink	Other

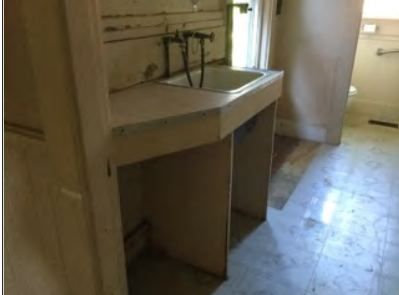
Toe and knee clearances not provided Rim or counter > 34" Non-compliant faucets	24" 37" -	Ensure there is a 27" knee clearance positioned for a forward approach. Relocate sink with the front of the rim or counter no higher than 34". Install faucets that do not require tight grasping, pinching, or twisting of the wrist.	1	4080	\$4080

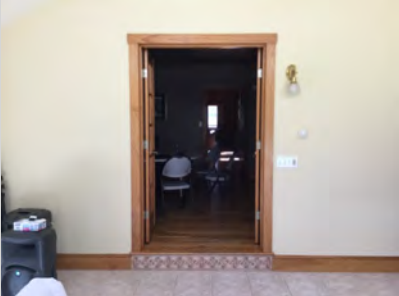
ID	Location	Floor	Room	Element	Type	Photo	Issues	Current Measure	Recommendations	Quantity	Price	Cost Estimation
1	Building 1 - Door Between Rear Office and Sun Room	1

Note: From the sun room entrance, if the public is allowed to access the rest of the house, a lift or 17' ramp will need to be installed in this location.	1	-	\$0
2	Building 1 - Parking	Ext.		Off-Street Parking Lot or Garage	Employee

**Note:** At Building 1, IHCD recommends making the entrance to the sun room the accessible entrance because the front entrance has challenges with door clear width, door maneuvering clearance and complex level changes. A directional sign should be provided at the front entrance directing people to the accessible entrance. The Town should note that from the sun room, if the public is allowed to access the rest of the house, a lift or 17 foot long ramp will need to be installed in this location.

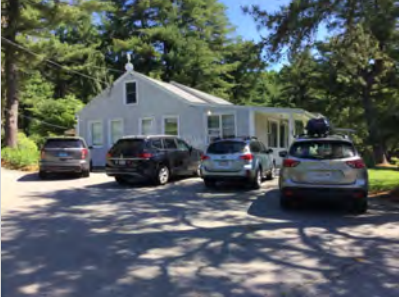
Total # of parking Total # of designated accessible parking spaces Total # of designated van accessible spaces	5 0 0	Provide one van accessible parking space.	1	1850	\$1850
3	Building 1 - Route to Entrance	Ext.		Entrance	Main Entrance

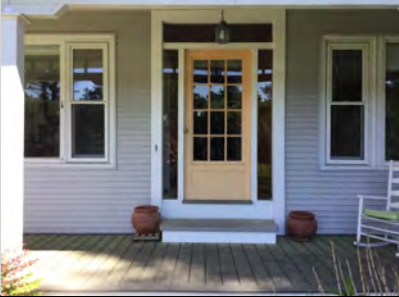
Entrance not on an accessible route Directional sign to accessible entrance not provided	27.25" -	Provide a directional sign indicating the location of the nearest accessible entrance.	1	346	\$346
4	Building 1 - Side Patio	1		Entrance	Secondary Entrance

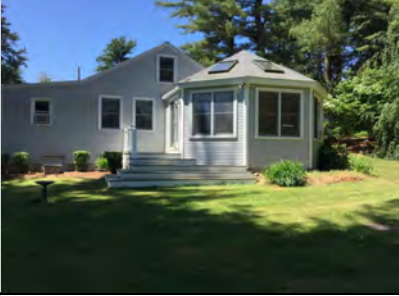
Entrance not on an accessible route	-	Provide a 35' long ramp to this entrance with compliant landings. (Cost estimate for a pressure treated wood dogleg ramp to address a 35" change in level.)	1	8566	\$8566

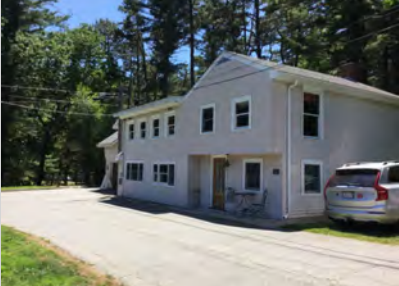
5	Building 2	Ext.		Off-Street Parking Lot or Garage	Visitor

Total # of parking Total # of designated van accessible spaces	5 est. 0	Provide one van accessible space.	1	1850	\$1850

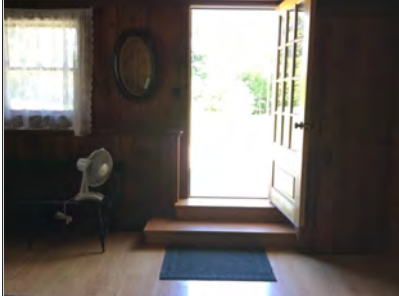
ID	Location	Floor	Room	Element	Type	Photo	Issues	Current Measure	Recommendations	Quantity	Price	Cost Estimation
6	Building 2 - Main Entrance	1		Interior Access Route	N/A

Level changes > 1/4"	12.5"	Provide a compliant wood ramp to address the 12.5" change in level. (Cost estimate for a wood dogleg ramp.)	1	5027	\$5027
7	Building 2 - Main Entrance	Ext.		Entrance	Main Entrance

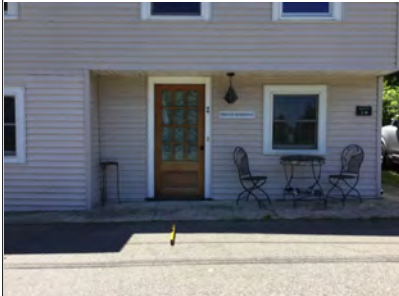
Entrance not on an accessible route Hardware not operable with a closed fist	3.25" -	Provide a compliant sloped walkway to the entrance and a level platform at the entrance that provides door maneuvering clearance. Provide hardware that can be operable with one hand and not require tight grasping, pinching, or twisting of the wrist. (Cost estimate for door hardware and a 15' long by 4' wide concrete route.)	1	1864	\$1864
8	Building 4 - Parking	1		Off-Street Parking Lot or Garage	N/A

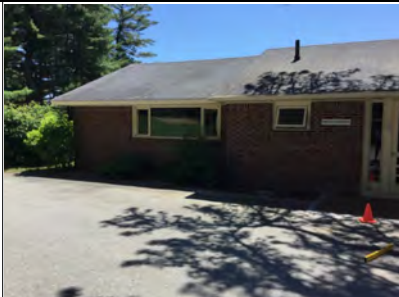
Total # of parking Total # of designated van accessible spaces	5 0	Provide one van accessible space.	1	1850	\$1850

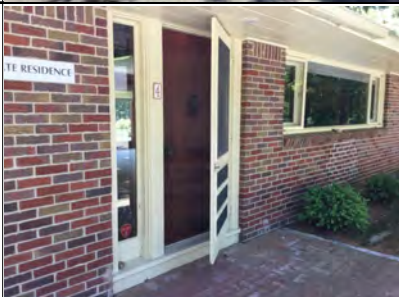
9	Building 4 - Main Entrance	1		Exterior Access Route	Exterior

Accessible route not provided	6.25"	Ensure an accessible route is provided. Provide a 6' long ramp with compliant platforms at the top and bottom. (Cost estimate for a straight concrete ramp with a 6" rise.)	1	7080	\$7080
10	Building 4 - Main Entrance	1		Entrance	Main Entrance

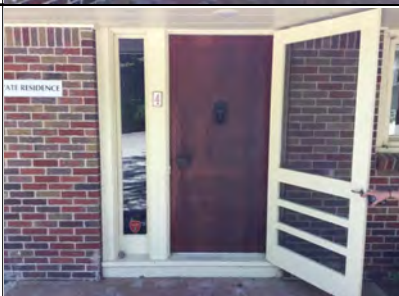
Hardware not operable with a closed fist	-	Provide hardware that can be operable with one hand and not require tight grasping, pinching, or twisting of the wrist.	1	484	\$484

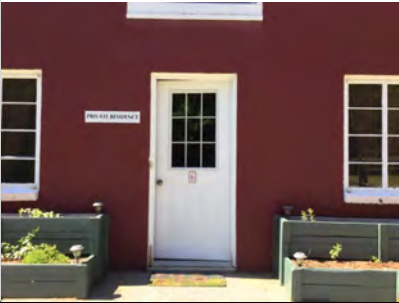
Threshold > 1/2" high Hardware not operable with a closed fist	2", 1" -	Alter threshold to be 1/2" high max. Provide hardware that can be operable with one hand and not require tight grasping, pinching, or twisting of the wrist.	1	534	\$534
13	Building 6 - Route to Horse Stable Barn	Ext.		Off-Street Parking Lot or Garage	Visitor

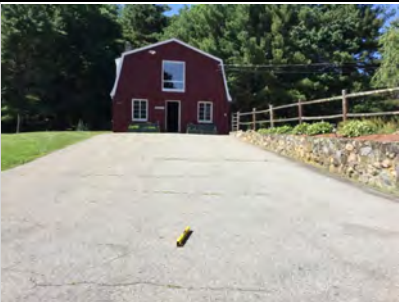
Total # of designated van accessible spaces Total # of parking	5 est. 0	Provide one van accessible space.	1	1850	\$1850

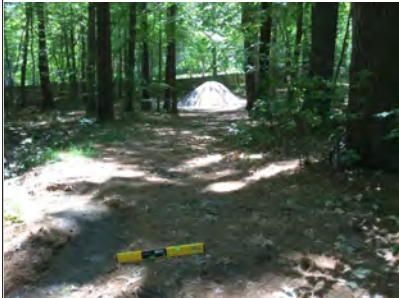
Cross slope > 1:50 (2.00%) Running slope > 1:20 (5%)	11.9% 4.0%	Reduce cross slope to be no steeper than 1:50 (2.00%). Reduce running slope to be no steeper than 1:20 (5%). (Cost does not include an accessible route. Accessible routes will require further study.)	1	-	\$0
3	Picnic Pavilion by Swimming Pond	Ext.		Exterior Access Route	Exterior

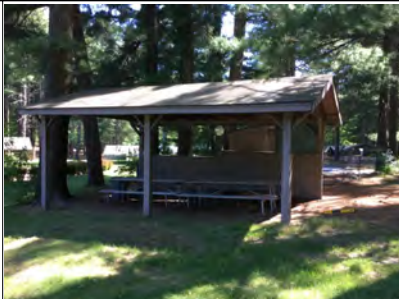
Cross slope > 1:50 (2.00%) Running slope > 1:20 (5%)	8.4% 19.0%	Reduce cross slope to be no steeper than 1:50 (2.00%). Reduce running slope to be no steeper than 1:20 (5%). (Cost does not include an accessible route. Accessible routes will require further study.)	1	-	\$0

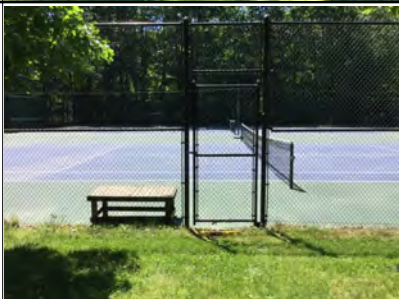
4	Tennis Courts	Ext.		Exterior Access Route	Exterior

Cross slope > 1:50 (2.00%) Running slope > 1:20 (5%) Accessible route not provided	5.0% 10.3% -	Ensure an accessible route is provided to the tennis court from a site arrival point and to other areas of sport activity. Reduce cross slope to be no steeper than 1:50 (2.00%). Reduce running slope to be no steeper than 1:20 (5%). (Cost does not include an accessible route. Accessible routes will require further study.)	1	-	\$0
5	Route to Golf Area	Ext.		Exterior Access Route	Exterior

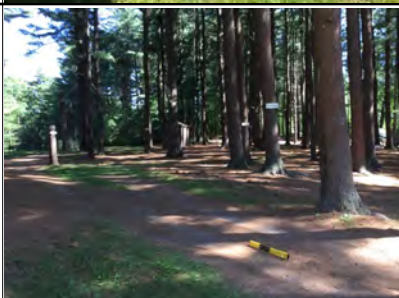
Cross slope > 1:50 (2.00%) Running slope > 1:20 (5%) Accessible route not provided	3.6% 7.1% -	Provide an accessible route from a site arrival point and other areas of sport activity. Reduce cross slope to be no steeper than 1:50 (2.00%). Reduce running slope to be no steeper than 1:20 (5%). (Cost does not include an accessible route. Accessible routes will require further study.)	1	-	\$0

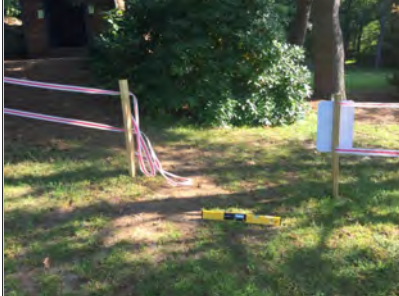
Cross slope > 1:50 (2.00%) Accessible route not provided	10%	Reduce cross slope to be no steeper than 1:50 (2.00%). Provide an accessible route with a surface that is stable, firm and slip resistant. (Cost does not include an accessible route. Accessible routes will require further study.)	1	-	\$0
7	Sandbox 2	Ext.		Exterior Access Route	Exterior

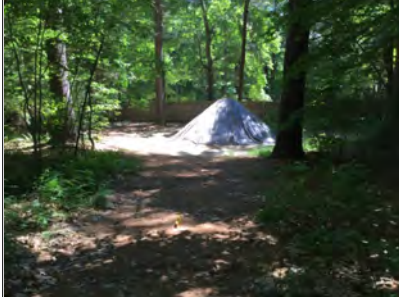
Running slope > 1:20 (5%)	18.2%	Ensure an accessible route is provided between the site arrival point and sand box area. Reduce running slope to be no steeper than 1:20 (5%). (Cost does not include an accessible route. Accessible routes will require further study.)	1	-	\$0
8	Route to Swimming Pool and Toilet Rooms From Liberty Lane	Ext.		Exterior Access Route	Exterior

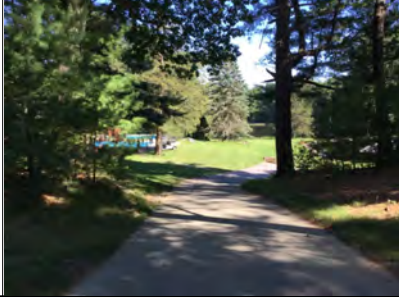
Running slope > 1:20 (5%)	-	Reduce running slope to be no steeper than 1:20 (5%). (Cost does not include an accessible route. Accessible routes will require further study.)	1	-	\$0

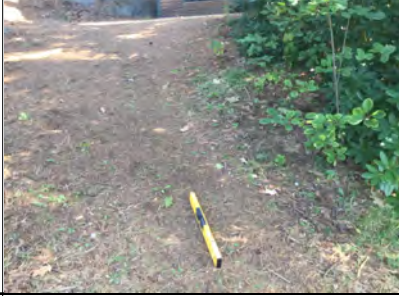
9	Route to Men's and Women's Toilet Rooms by Swimming Pool	Ext.		Exterior Access Route	Exterior

Running slope > 1:20 (5%) Surface is not stable, firm, and slip-resistant Accessible route not provided	16.4% - -	Reduce running slope to be no steeper than 1:20 (5%). Provide an accessible surface that is stable, firm and slip resistant. (Cost does not include an accessible route. Accessible routes will require further study.)	1	-	\$0
10	Picnic Pavilion East of Garden	Ext.		Exterior Access Route	Exterior

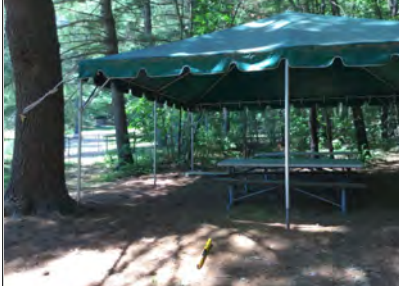
Running slope > 1:20 (5%) Accessible route not provided	17.6%	Reduce running slope to be no steeper than 1:20 (5%). Ensure an accessible route is provided from a site arrival point to the pavilion. (Cost does not include an accessible route. Accessible routes will require further study.)	1	-	\$0

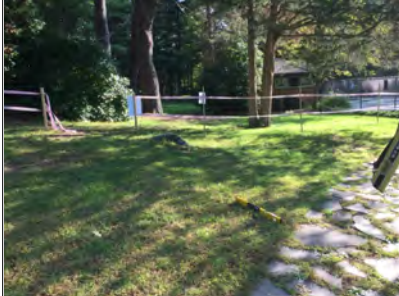
Running slope > 1:20 (5%) Accessible route not provided	17.3% -	Reduce running slope to be no steeper than 1:20 (5%). Provide an accessible route with a surface that is stable, firm and slip resistant. (Cost does not include an accessible route. Accessible routes will require further study.)	1	-	\$0
12	Street Hockey/ Basketball Court by Swimming Area and Camp Craft	Ext.		Exterior Access Route	Exterior

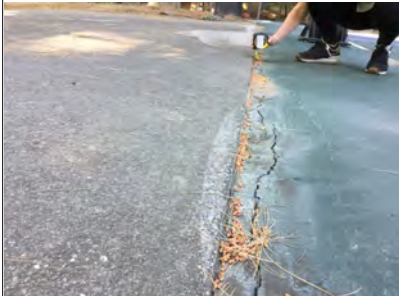
Level changes > 1/4"	1/2"	Alter change in level to be 1/4" high max. (Cost estimate to patch a 4' x 4' asphalt area.)	1	160	\$160
13	Golf Area	Ext.		Exterior Access Route	Exterior

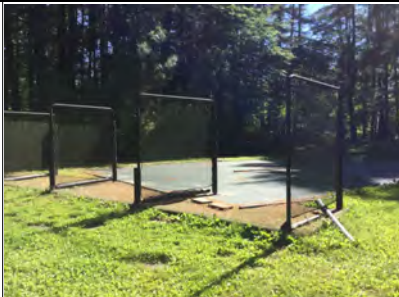
Level changes > 1/4"	5"	Alter change in level to be 1/4" high max. (Cost estimate for 5' by 5' asphalt area.)	1	250	\$250

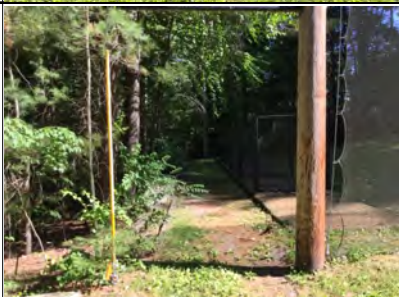
14	Golf Area	Ext.		Exterior Access Route	Exterior

Level changes > 1/4"	5"	Alter change in level to be 1/4" high max. at one driving range min. (Cost estimate for 5' by 5' asphalt area.)	1	250	\$250
15	Camp Craft Pavilion	Ext.		Exterior Access Route	Exterior

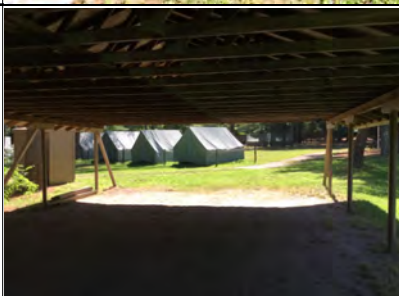
Surface is not stable, firm, and slip-resistant	-	Provide a surface at the pavilion that is stable, firm and slip resistant. Surface is currently sand. (Cost for 20' long 4' wide stone dust route.)	1	640	\$640

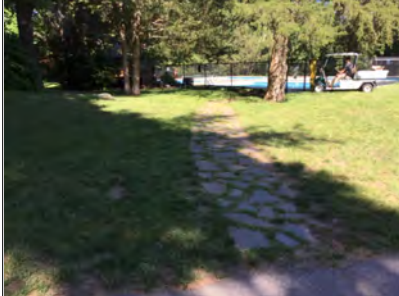
Surface is not stable, firm, and slip-resistant	-	Remove pavers and install a stone dust route with a running slope no greater than 1:20 (5%). (Cost does not include an accessible route. Accessible routes will require further study.)	1	-	\$0
17	Sandbox 1	Ext.		Exterior Access Route	Exterior

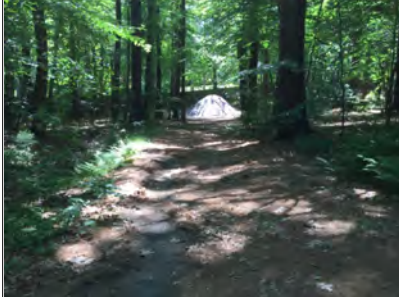
Route not maintained in operable working condition Accessible route not provided	- -	Provide an accessible route between the site arrival point and sand box area. Ensure the accessible route is maintained in operable working condition. (Cost does not include an accessible route. Accessible routes will require further study.)	1	-	\$0
18	West Garden Entrance	Ext.		Exterior Access Route	Exterior

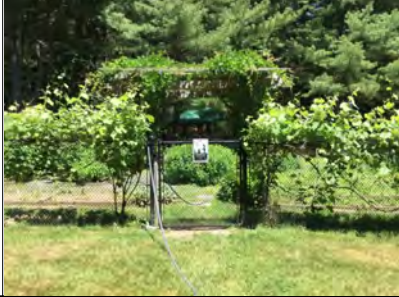
Accessible route not provided	-	Provide an accessible route between the garden and a site arrival point. Ensure it is stable, firm and slip-resistant. (Cost does not include an accessible route. Accessible routes will require further study.)	1	-	\$0

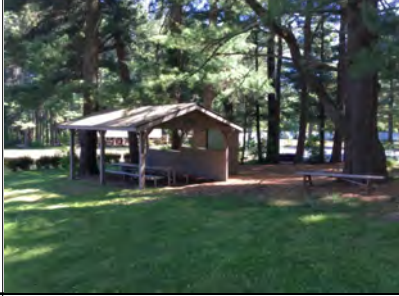
19	Picnic Pavilion by Swimming Pond	Ext.		Exterior Access Route	Exterior

Accessible route not provided	-	Provide an accessible route from a site arrival point and to other program areas. (Cost does not include an accessible route. Accessible routes will require further study.)	1	-	\$0
20	Camp Craft Pavilion	Ext.		Exterior Access Route	Exterior

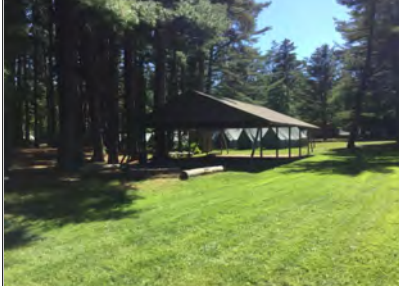
Accessible route not provided	-	Provide an accessible route from a site arrival point and to other program areas. (Cost does not include an accessible route. Accessible routes will require further study.)	1	-	\$0

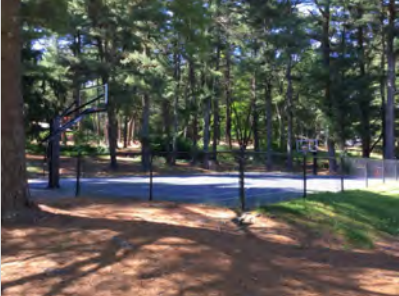
Accessible route not provided	-	Provide an accessible route from a site arrival point and between areas of sport activity. (Cost does not include an accessible route. Accessible routes will require further study.)	1	-	\$0
22	Kayaking, Canoeing, and Fishing Pond	Ext.		Exterior Access Route	Exterior

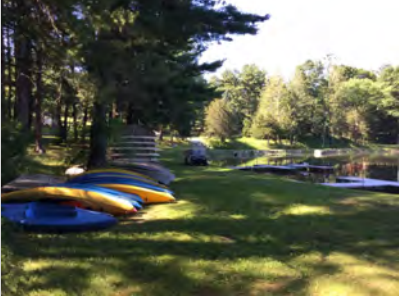
Accessible route not provided	-	Provide an accessible route from a site arrival point to the pond. (Cost does not include an accessible route. Accessible routes will require further study.)	1	-	\$0
23	Gaga Ball Court	Ext.		Exterior Access Route	Exterior

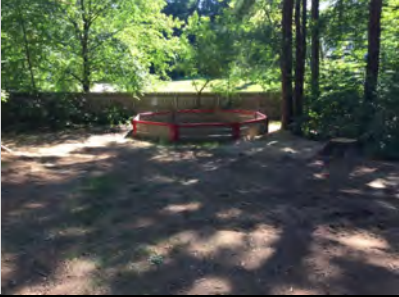
Accessible route not provided	-	Provide an accessible route from a site arrival point and other amenities. (Cost does not include an accessible route. Accessible routes will require further study.)	1	-	\$0

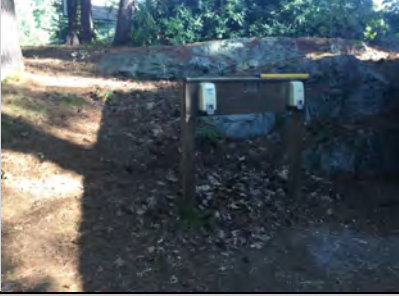
24	Men's and Women's Toilet Rooms by Swimming Pool Hand Sanitizer Area	Ext.		Exterior Access Route	Exterior

Accessible route not provided	-	Locate hand sanitizers on an accessible route.	1	Labor	\$0
<b>Off-Street Parking Lot or Garage</b>												
25	Visitor Parking North of Camp Entrance From Haynes Road	Ext.		Off-Street Parking Lot or Garage	Visitor

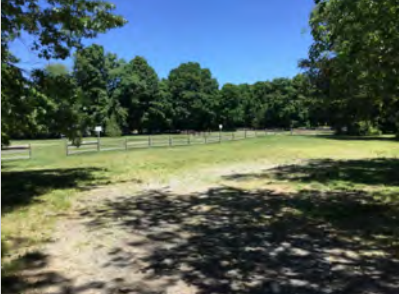
Total # of parking Total # of designated accessible parking spaces Total # of designated van accessible spaces Surface not stable, firm, and slip-resistant	80 0 0 -	Provide four (4) car accessible spaces. Provide one (1) van accessible spaces. Provide a surface that is stable, firm and slip resistant such as stone dust at the accessible parking spaces.	5	1652	\$8260

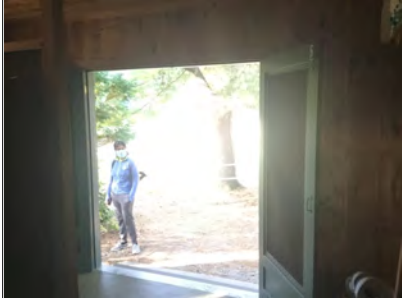
Tactile sign not provided at emergency exit Illuminated International Symbol of Acc. not provided (MAAB)	- -	Provide a sign with raised characters and braille at the emergency exit. After the exit is made accessible provide an illuminated sign with the International Symbol of Accessibility (ISA).	1	1116	\$1116
<b>Access to Goods and Services</b>												
<b>Doors, Doorways, &amp; Gates</b>

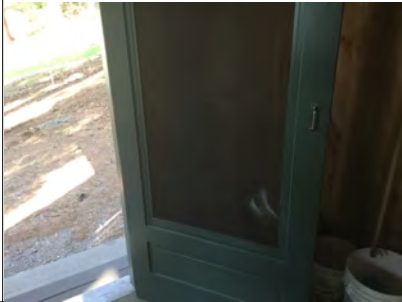
28	Men's and Women's Toilet Rooms by Swimming Pool	Ext.		Doors, Doorways, & Gates	Toilet Room

Hardware not operable with a closed fist	-	Provide hardware that can be operable with one hand and not require tight grasping, pinching, or twisting of the wrist.	1	484	\$484
<b>Signage</b>												
29	Gaga Ball Court	Ext.		Signage	N/A

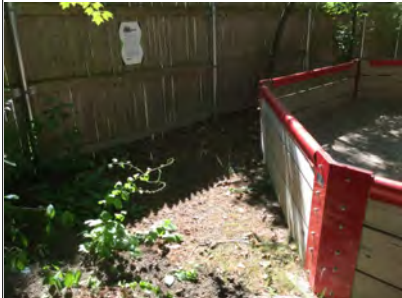
Accessible route not provided Text size non-compliant	- -	Provide an accessible route to the informational signage. Ensure that character size complies with the Character Height Table 703.5.5 in the ADA 2010 Standards. (Cost does not include accessible route.)	1	346	\$346

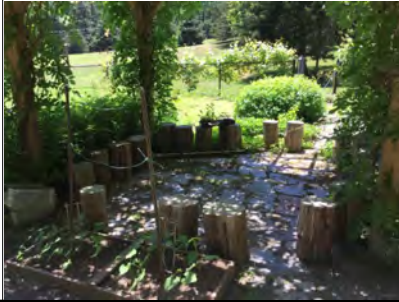
No accessible route to one bench in this area	21	Provide an accessible route to at least one (1) bench in this area. (Cost estimate for 6' long, 4' wide stone dust route from the walkway.)	1	192	\$192
32	Street Hockey/ Basketball Court by Swimming Area and Camp Craft	Ext.		Benches	N/A

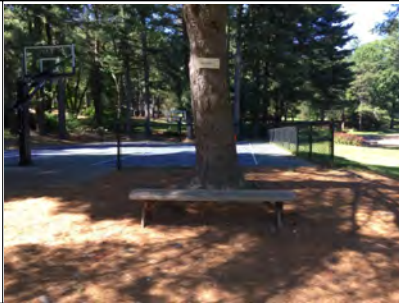
No accessible route to one bench in this area	-	Provide an accessible route to at least one (1) bench in this area. (Cost estimate for 10' long, 4' wide stone dust walkway from the court.)	1	320	\$320

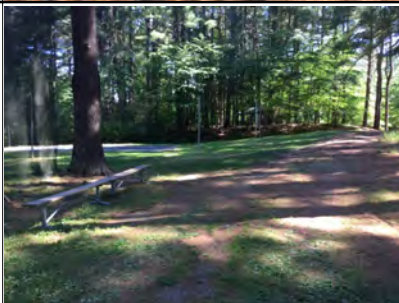
33	Golf Area	Ext.		Benches	N/A

No accessible route to one bench in this area	-	Provide an accessible route to at least one (1) bench in this area. (Cost estimate for 10' long, 4' wide stone dust walkway from the golf area.)	1	320	\$320
34	Golf Area	Ext.		Benches	N/A

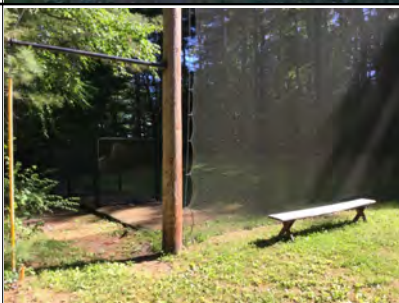
No accessible route to one bench in this area	-	Provide an accessible route to at least one (1) bench in this area. (Cost estimate for 10' long, 4' wide stone dust walkway from the golf area.)	1	320	\$320
<b>Toilet &amp; Bathing Rooms</b>

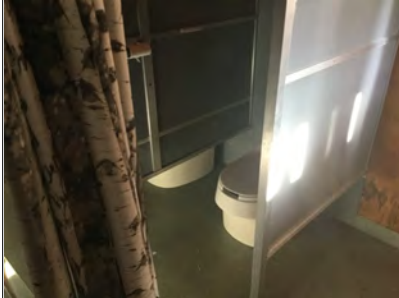
ID	Location	Floor	Room	Element	Type	Photo	Issues	Current Measure	Recommendations	Quantity	Price	Cost Estimation
<b>Overall Access</b>												
35	Men's and Women's Toilet Rooms by Swimming Pool	1		Overall Access	Toilet Room

Turning space not provided Accessible plumbing fixtures or stalls not provided	- -	Provide one accessible wheelchair compartment for women and one for men.	2	6182	\$12364
<b>Additional Access</b>												
<b>Drinking Fountains</b>												
36	Near Lacrosse Field	Ext.		Drinking Fountains	N/A

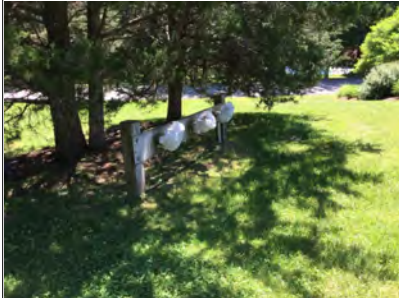
Fountain not on accessible route Operable parts malfunctioning Spout < 38" or > 43" (standing users) No drinking fountain provided for seated users	- - 27.75" 22.75"	Provide an accessible route to drinking fountains. Repair drinking fountains. Provide a drinking fountain for standing users with the spout between 38"- 43" above the finished floor or ground. Provide a drinking fountain for seated users with a 27" high knee clearance or install a Hi-Lo drinking fountain. (Cost does not include an accessible route. Accessible routes will require further study.)	1	4216	\$4216

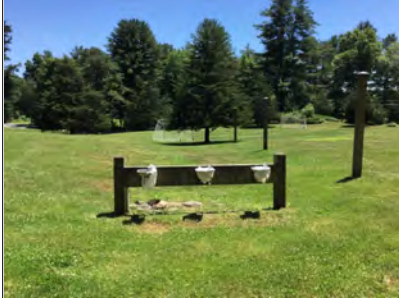
37	Near Garden Entrance	Ext.		Drinking Fountains	N/A

Fountain not on accessible route Operable parts malfunctioning Spout < 38" or > 43" (standing users) No drinking fountain provided for seated users	- - 30.25" -	Provide an accessible route to drinking fountains. Repair drinking fountains. Provide a drinking fountain for standing users with the spout between 38"- 43" above the finished floor or ground. Provide a drinking fountain for seated users with a 27" high knee clearance or install a Hi-Lo drinking fountain. (Cost does not include an accessible route. Accessible routes will require further study.)	1	4216	\$4216
38	Drinking Fountains by Tennis Courts	Ext.		Drinking Fountains	N/A

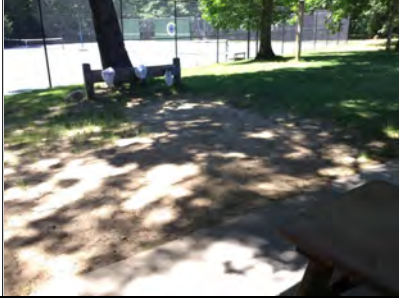
Fountain not on accessible route Operable parts malfunctioning Spout < 38" or > 43" (standing users) No drinking fountain provided for seated users	- - 28.75" -	Provide an accessible route to drinking fountains. Repair drinking fountains. Provide a drinking fountain for standing users with the spout between 38"- 43" above the finished floor or ground. Provide a drinking fountain for seated users with a 27" high knee clearance or install a Hi-Lo drinking fountain. (Cost does not include an accessible route. Accessible routes will require further study.)	1	4216	\$4216

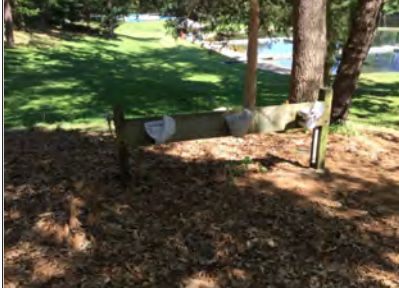
39	Near Swimming Pond	Ext.		Drinking Fountains	N/A

Fountain not on accessible route Operable parts malfunctioning Spout < 38" or > 43" (standing users) No drinking fountain provided for seated users	- - 28.75" -	Provide an accessible route to drinking fountains. Repair drinking fountains. Provide a drinking fountain for standing users with the spout between 38"- 43" above the finished floor or ground. Provide a drinking fountain for seated users with a 27" high knee clearance or install a Hi-Lo drinking fountain. (Cost does not include an accessible route. Accessible routes will require further study.)	1	4216	\$4216

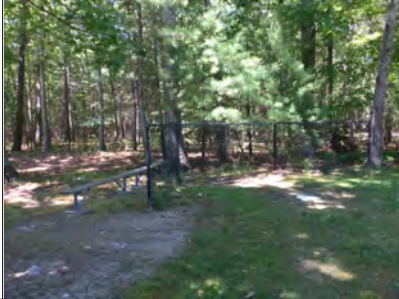
ID	Location	Floor	Room	Element	Type	Photo	Issues	Current Measure	Recommendations	Quantity	Price	Cost Estimation
<b>Play and Sport Areas</b>												
<b>Field</b>												
40	Softball Field	Ext.		Field	Softball

Accessible spaces are not provided at team seating	-	Provide a 36" x 48" clear floor space at team seating. (Cost estimate for 3' x 4' stone dust area.)	1	96	\$96
41	Soccer Fields	Ext.		Field	Soccer

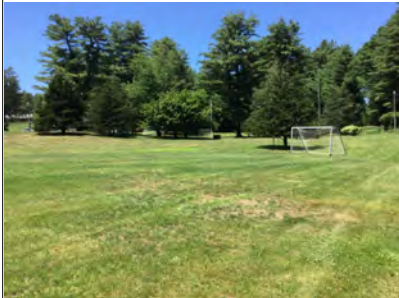
Not connected to an accessible-route	-	Provide an accessible route to the soccer field from a site arrival point. (Cost does not include an accessible route. Accessible routes will require further study.)	1	-	\$0
42	Softball Field	Ext.		Field	Softball

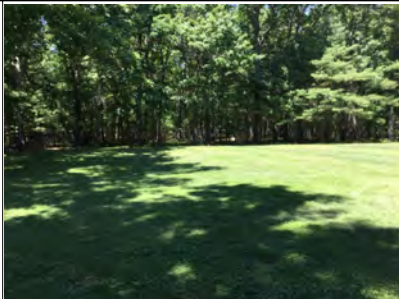
Not connected to an accessible-route	-	Provide an accessible route to the softball field from a site arrival point and other areas of sport activity. (Cost does not include an accessible route. Accessible routes will require further study.)	1	-	\$0

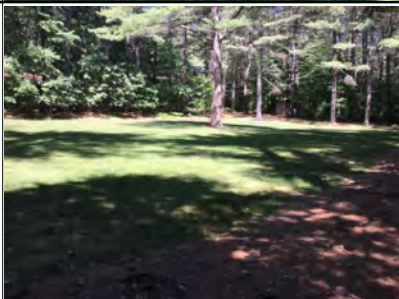
43	Fox Field Sports	Ext.		Field

Not connected to an accessible-route	-	Provide an accessible route to the sports field a site arrival point and other areas of sport activity. (Cost does not include an accessible route. Accessible routes will require further study.)	1	-	\$0
44	Lacrosse Field	Ext.		Field	Lacrosse

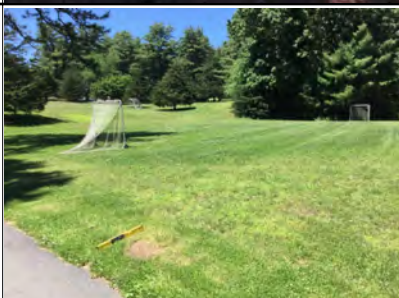
Not connected to an accessible-route Running slope > 1:20 (5%)	- 20%	Reduce running slope to be no steeper than 1:20 (5%). Provide an accessible route to the field from a site arrival point. (Cost does not include an accessible route. Accessible routes will require further study.)	1	-	\$0

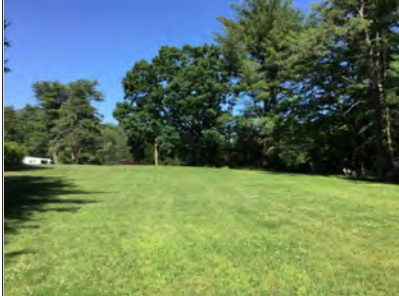
ID	Location	Floor	Room	Element	Type	Photo	Issues	Current Measure	Recommendations	Quantity	Price	Cost Estimation
<b>Court</b>												
45	Volleyball Court	Ext.		Court	Volleyball

Not connected to accessible route	-	Provide an accessible route to the volleyball field from a site arrival point and other areas of sport activity. (Cost does not include an accessible route. Accessible routes will require further study.)	1	-	\$0
46	Gaga Ball Court	Ext.		Court	Gaga Ball

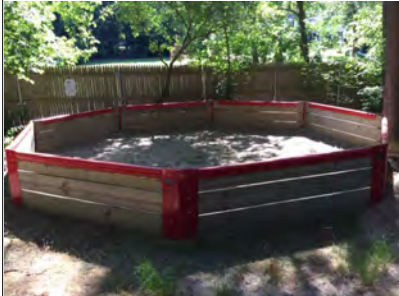
Not connected to accessible route	-	Provide an accessible entrance into the gaga ball court that is 32" wide min. clear and has a change in level no greater than 1/2".	1	Labor	\$0
47	Street Hockey/ Basketball Court by Tennis Court	Ext.		Court	Basketball

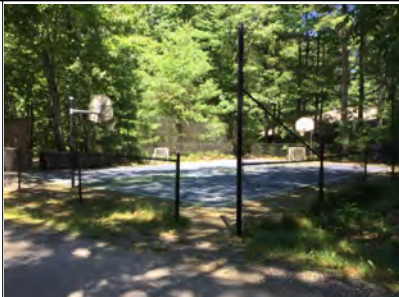
Not connected to accessible route Surface is not stable, firm, and slip-resistant	- -	Provide an accessible route to the street hockey/basketball court from a site arrival point and other areas of sport activity. (Cost does not include an accessible route. Accessible routes will require further study.)	1	-	\$0

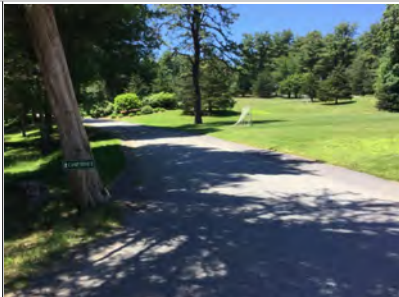
<b>Best Practice</b>												
48	Liberty Lane To Main Area of Camp	Ext.

Recommend providing signage that is visible to visitors while driving through the entrance. Existing signage is difficult to read.	1	-	\$0
49	Golf Area and Other Locations	Ext.

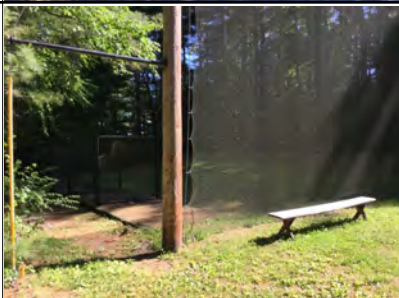
Recommend providing some benches with backs and some with arms. Recommend providing clear floor space alongside benches so that a person using a wheelchair can sit shoulder to shoulder with a person seated on the bench.	1	-	\$0

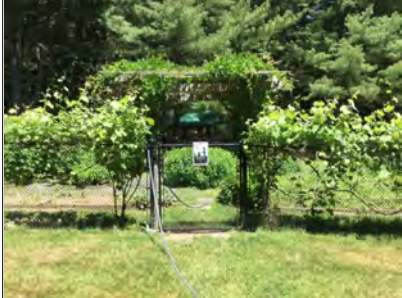
ID	Location	Floor	Room	Element	Type	Photo	Issues	Current Measure	Recommendations	Quantity	Price	Cost Estimation
50	West and East Garden Entrances	Ext.

Recommend providing a 10" high solid surface (kickplate) on the push side of each gate.	1	-	\$0

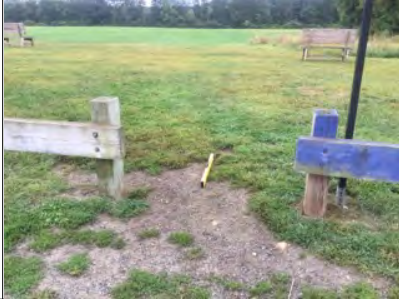
ID	Location	Floor	Room	Element	Type	Photo	Issues	Current Measure	Recommendations	Quantity	Price	Cost Estimation
<b>Approach and Entrance</b>												
<b>Exterior Access Route</b>												
1	Entrance Near Picnic Table on West Side	Ext.		Exterior Access Route	Exterior

Running slope > 1:20 (5%) Accessible route not provided	7.4% -	Reduce running slope to be no steeper than 1:20 (5%). Ensure an accessible route is provided. (Cost estimate for a 6' long, 4' wide stone dust route.)	1	192	\$192
2	Center Entrance to Wayside	Ext.		Exterior Access Route	Exterior

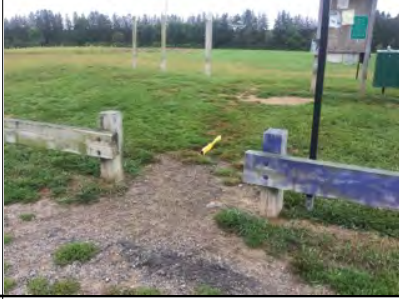
Running slope > 1:20 (5%) Accessible route not provided	9.8% -	Reduce running slope to be no steeper than 1:20 (5%). Ensure an accessible route is provided. (Cost estimate for a 4' wide 14' long stone dust route.)	1	448	\$448
3	Wayside and Trash Container	Ext.		Exterior Access Route	Exterior

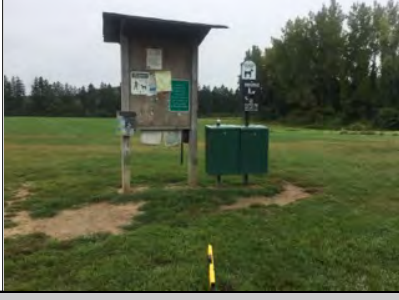
Accessible route not provided	-	Ensure an accessible route is provided. (Cost estimate for a 4' wide 13' long stone dust route.)	1	416	\$416

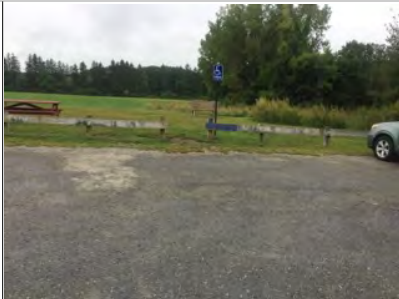
<b>Off-Street Parking Lot or Garage</b>												
4	Parking Lot	Ext.		Off-Street Parking Lot or Garage	Visitor

Total # of parking Total # of designated accessible parking spaces	175 est. 3	Parking lot has 175-200 spaces estimated. Provide three additional accessible spaces.	3	800	\$2400
5	Parking Lot Near Picnic Table on West Side	Ext.		Off-Street Parking Lot or Garage	Visitor

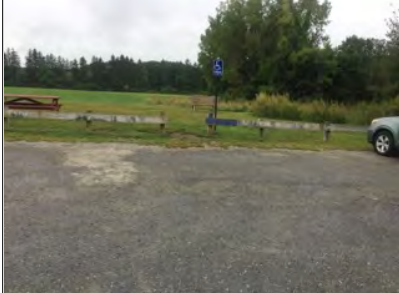
Access aisle not provided	-	Provide a marked access aisle that is at least 60" wide.	1	300	\$300

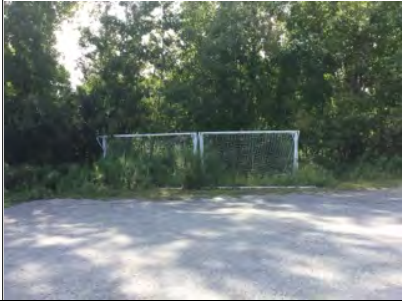
Not connected to an accessible-route	-	Provide an accessible route to the field. (Cost estimate for 10' long, 4' wide stone dust route.)	1	320	\$320
<b>Best Practice</b>												
12	Picnic Table Near Parking Lot	Ext.

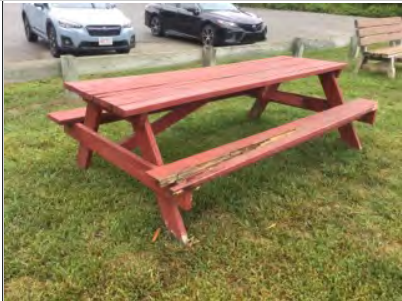
-	Recommend providing a 48" wide min. stable, firm and slip resistant surface under and around an accessible picnic table once it is placed in the picnic area and connected to an accessible route.	1	-	\$0

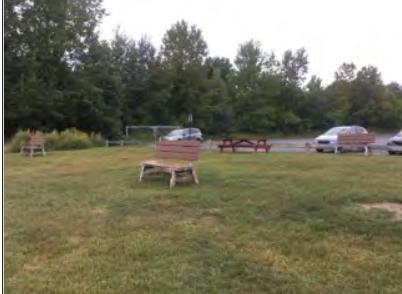
13	Bench Near Parking Lot	Ext.

-	Recommend providing clear floor space of 36" wide minimum by 48" deep alongside one bench so that a wheelchair user can sit alongside someone sitting on the bench.	1	-	\$0

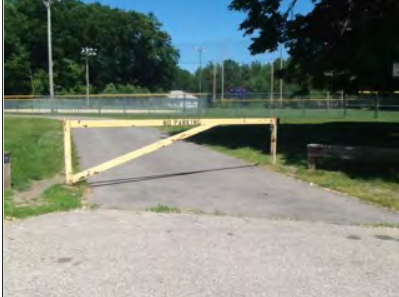
ID	Location	Floor	Room	Element	Type	Photo	Issues	Current Measure	Recommendations	Quantity	Price	Cost Estimation
<b>Approach and Entrance</b>												
<b>Exterior Access Route</b>												
1	Path Between Baseball Field 1 and Softball Field 2 (Gate Closed)	Ext.		Exterior Access Route	Walkway

Exterior route < 48" wide	-	Ensure that gate is opened during operating hours.	1	Labor	\$0
2	Asphalt Path to Entrance to Baseball Field 3	Ext.		Exterior Access Route	Walkway

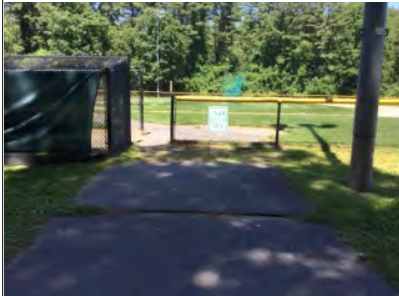
Level changes > 1/4"	1"	Alter change in level to be 1/4" high max.	1	320	\$320
3	Ice Rink Entrance	Ext.		Exterior Access Route	Exterior

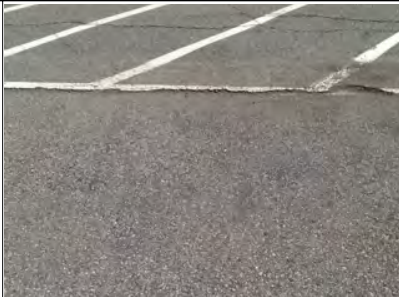
Level changes > 1/4" Route not maintained in operable working condition	1" -	Alter change in level to be 1/4" high max. Ensure the accessible route is maintained in operable working condition.	1	160	\$160
4	Ice Rink Entrance	Ext.		Exterior Access Route	Exterior

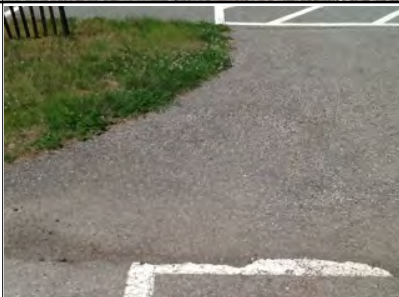
Route not maintained in operable working condition	1"	Ensure the accessible route is maintained in operable working condition.	1	160	\$160

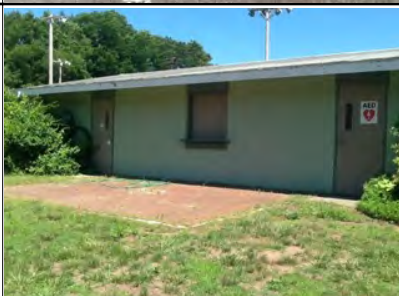
5	South Side of South Concession Between Field 1 and Field 2	Ext.		Exterior Access Route	Walkway

Accessible route not provided	-	Provide an accessible route to the toilet room, concession stand and office on the south side of the concession stand. (Cost estimate for 54' long, 4' wide asphalt route.)	1	2160	\$2160

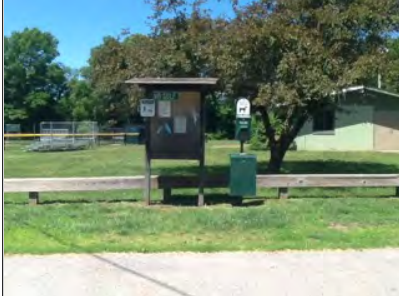
ID	Location	Floor	Room	Element	Type	Photo	Issues	Current Measure	Recommendations	Quantity	Price	Cost Estimation
6	Wayside Signage and Dog Waste Bin Next to Baseball Field 1	Ext.		Exterior Access Route	Walkway

Accessible route not provided	-	Ensure an accessible route is provided. (Cost estimate for a 15' long by 4' wide asphalt route.)	1	600	\$600
<b>Off-Street Parking Lot or Garage</b>												
7	Parking Lot by Tennis Courts and Ice Rink	Ext.		Off-Street Parking Lot or Garage	Visitor

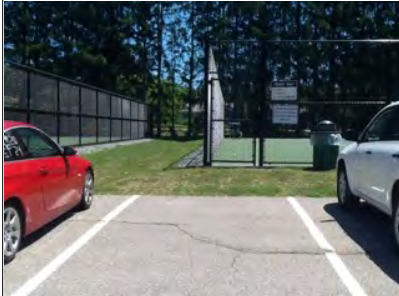
Total # of parking Total # of designated accessible parking spaces	86 0	Provide three car accessible parking spaces and one van accessible parking space in this lot. As best practice, locate at least one of each accessible space by the ice rink, one by the north tennis court and one by the south tennis court.	4	800	\$3200
8	North (Lower Featherland) Parking Lot	Ext.		Off-Street Parking Lot or Garage	Visitor

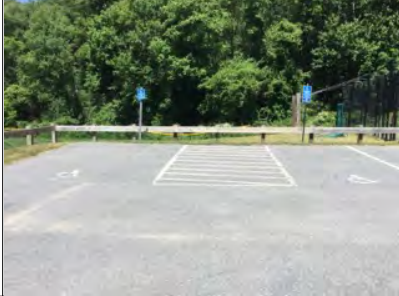
Total # of parking Total # of designated accessible parking spaces Sign does not have the designation "Van Accessible"	44 2 -	Add the designation "Van Accessible" to one of the parking spaces.	1	500	\$500

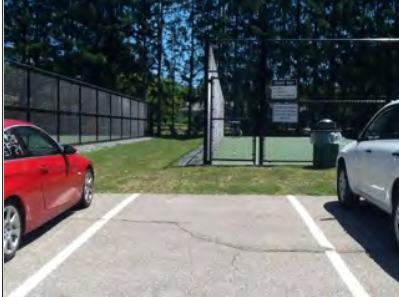
<b>Entrance</b>												
9	South Tennis Court, North Door by Parking Lot, and North and South Doors by Concord Road	Ext.		Entrance	Main Entrance

Entrance not on an accessible route	15%	Provide a directional sign indicating the location of the nearest accessible entrance.	3	346	\$1038
10	North Tennis/ Basketball Court, Door on South by Concord Road	Ext.		Entrance	Secondary Entrance

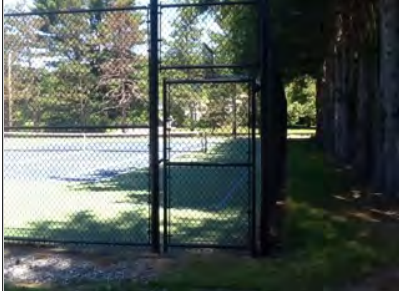
Entrance not on an accessible route	-	Provide a directional sign indicating the location of the nearest accessible entrance.	1	346	\$346

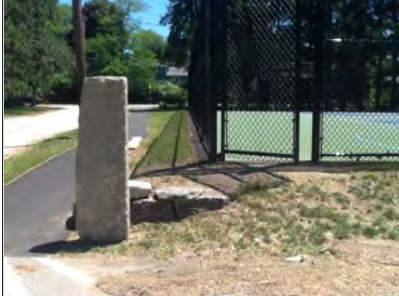
ID	Location	Floor	Room	Element	Type	Photo	Issues	Current Measure	Recommendations	Quantity	Price	Cost Estimation
11	North Tennis/ Basketball Court, Path to the North Entrance by the Parking Lot	Ext.		Entrance	Secondary Entrance

Entrance not on an accessible route	-	Provide a directional sign indicating the location of the nearest accessible entrance.	1	346	\$346
12	North Tennis/ Basketball Court, Path to the South Entrance by the Parking Lot	Ext.		Entrance	Secondary Entrance

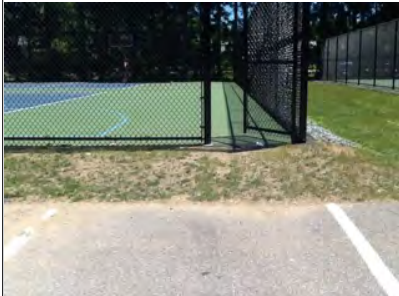
Entrance not on an accessible route	14%	Provide a directional sign indicating the location of the nearest accessible entrance.	1	346	\$346
13	South Tennis Court, South Door by Parking Lot (Accessible)	Ext.		Entrance	Main Entrance

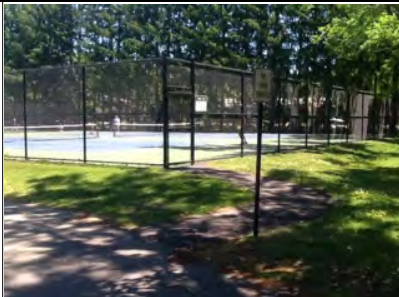
International Symbol of Acc. not provided	-	Provide a sign with the International Symbol of Accessibility (ISA).	1	346	\$346
14	North Tennis/ Basketball Court, Door on North by Concord Road	Ext.		Entrance	Main Entrance

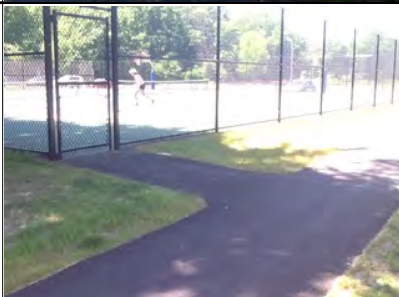
International Symbol of Acc. not provided	-	Provide a sign with the International Symbol of Accessibility (ISA).	1	346	\$346
