# Broadacres Farm

## Town of Sudbury ADA Transition Plan

September 2020

Institute for Human Centered Design

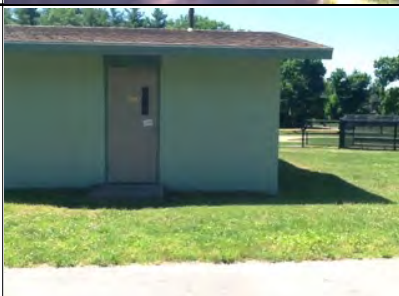
15	Men's Toilet Room in South Concession Between Field 1 and Field 2	Ext.		Entrance	Secondary Entrance

Threshold is > 1/2" high	5"	Provide an asphalt walkway to the step that is sloped no greater than 1:20 (5%). Cost estimate for 10' long by 4' wide asphalt walkway.	1	400	\$400

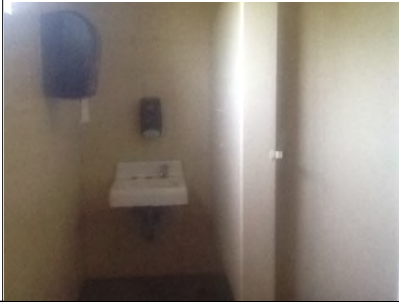
Route < 36" wide	34"	Ensure that a clear width of 36" min. is maintained at the lavatory when the toilet room is under renovation to add an accessible compartment. 36" clear is required when the depth is greater than 24".	1	Labor	\$0
18	South Concession Stand Men's Toilet Room	1		Interior Access Route	Interior

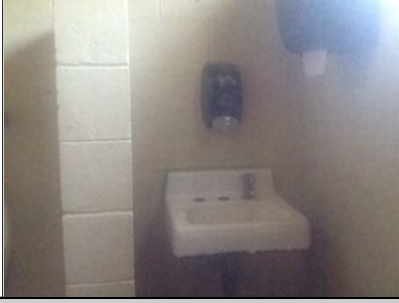
Route < 36" wide	34"	Ensure that a clear width of 36" min. is maintained at the lavatory when the toilet room is under renovation to add an accessible compartment. 36" clear is required when the depth is greater than 24".	1	Labor	\$0

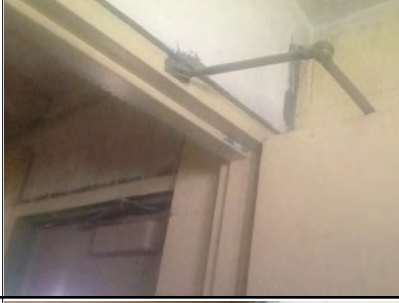
<b>Doors, Doorways, &amp; Gates</b>												
19	South Concession Stand Women's Toilet Room Exit to the Exterior	1		Doors, Doorways, & Gates	Toilet Room

Maneuvering clearance(s) not provided	40"	Provide an automatic door opener.	1	3060	\$3060
20	South Concession Stand Men's Toilet Room Exit to the Exterior	1		Doors, Doorways, & Gates	Toilet Room

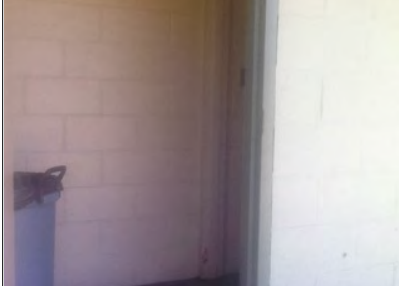
Maneuvering clearance(s) not provided	40"	Provide an automatic door opener.	1	3060	\$3060

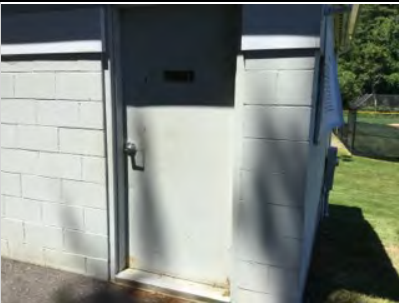
Threshold > 1/2" high	3"	Alter the threshold to be 1/2" high max.	1	150	\$150
24	North (Lower Featherland) Concession Stand AED	Ext.		Doors, Doorways, & Gates	N/A

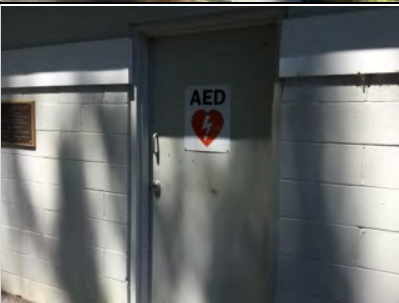
Hardware not operable with a closed fist	-	Provide hardware that can be operable with one hand and not require tight grasping, pinching, or twisting of the wrist.	1	484	\$484

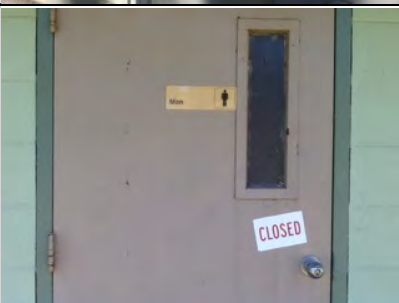
25	Men's Toilet Room in South Concession Between Field 1 and Field 2	Ext.		Doors, Doorways, & Gates	Toilet Room

Hardware not operable with a closed fist	-	Provide hardware that can be operable with one hand and not require tight grasping, pinching, or twisting of the wrist.	1	484	\$484

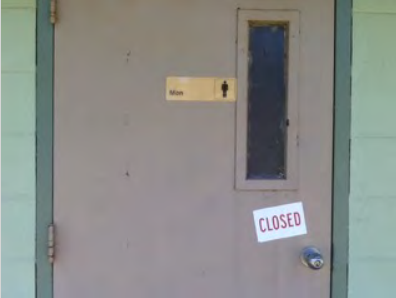
ID	Location	Floor	Room	Element	Type	Photo	Issues	Current Measure	Recommendations	Quantity	Price	Cost Estimation
<b>Signage</b>												
26	Men's Toilet Room in South Concession Between Field 1 and Field 2	Ext.		Signage	Designation

Raised characters not provided Braille not provided Sign not located on the latch side of the door	- - -	Provide text with raised characters duplicated in braille. Locate sign at permanent rooms alongside the door on the latch side.	1	232	\$232
27	Women's Toilet Room in South Concession Between Field 1 and Field 2	Ext.		Signage	Designation

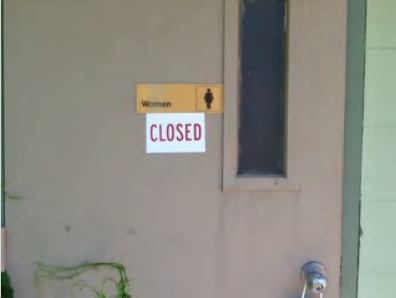
Raised characters not provided Braille not provided Sign not located on the latch side of the door	- - -	Provide text with raised characters duplicated in braille. Locate sign at permanent rooms alongside the door on the latch side.	1	232	\$232
28	North (Lower Featherland) Concession Stand Women's Toilet Room	Ext.		Signage	Designation

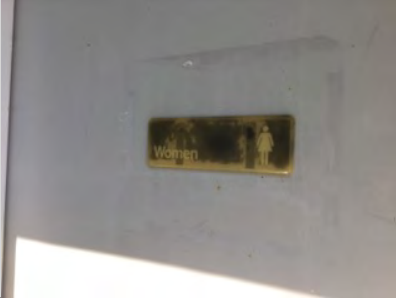
Raised characters not provided Braille not provided Sign not located on the latch side of the door	- - -	Provide text with raised characters duplicated in braille. Locate sign at permanent rooms alongside the door on the latch side.	1	232	\$232

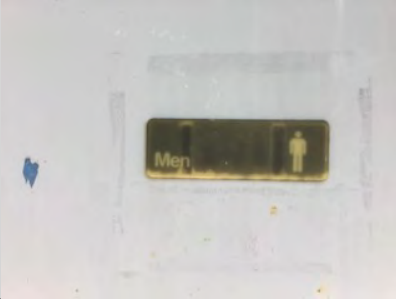
29	North (Lower Featherland) Concession Stand Men's Toilet Room	Ext.		Signage	Designation

Raised characters not provided Braille not provided Sign not located on the latch side of the door	- - -	Provide text with raised characters duplicated in braille. Locate sign at permanent rooms alongside the door on the latch side.	1	232	\$232
<b>Service Counter</b>												
30	South Concession Stand	1		Service Counter	N/A

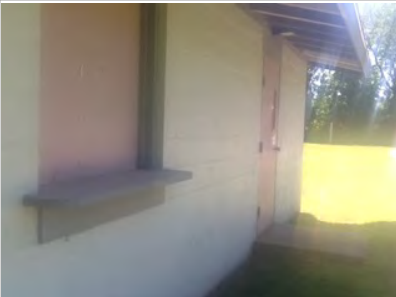
Counter > 36" high	47"	Provide a counter that is 36" max. above the ground.	1	880	\$880

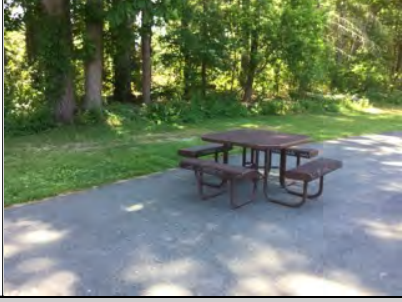
Toe or knee clearance at table not provided	-	Provide at least one picnic table with top between 28"- 34" above the ground and 27" clear height underneath.	1	1400	\$1400
<b>Trash / Recycling</b>												
33	South Tennis Court, North Door by Parking Lot	Ext.		Trash / Recycling	N/A

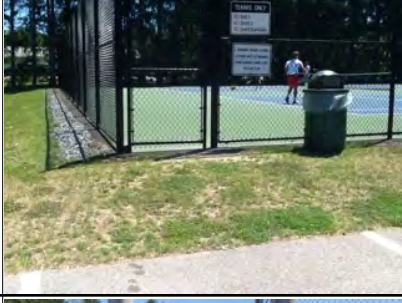
Trash container not connected to an accessible route	-	Ensure trash container is located on an accessible route.	1	Labor	\$0
34	Edge of Softball Field 2	Ext.		Trash / Recycling	N/A

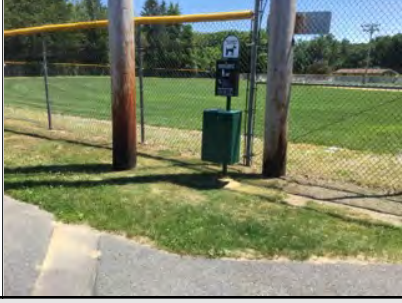
Trash container not connected to an accessible route	-	Provide an accessible route to trash container. (Cost estimate for a 6' long, 4' wide stone dust route.)	1	192	\$192

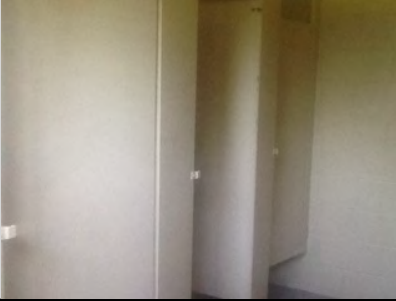
ID	Location	Floor	Room	Element	Type	Photo	Issues	Current Measure	Recommendations	Quantity	Price	Cost Estimation
<b>Overall Access</b>												
35	South Concession Stand Women's Toilet Room	1		Overall Access	Toilet Room

Accessible plumbing fixtures or stalls not provided	-	Provide one accessible wheelchair compartment.	1	6182	\$6182
36	South Concession Stand Men's Toilet Room	1		Overall Access	Toilet Room

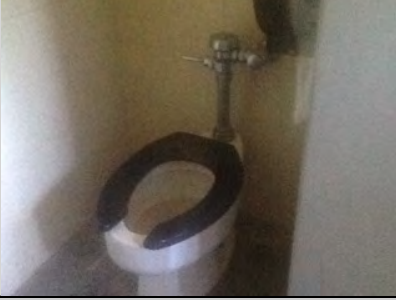
Accessible plumbing fixtures or stalls not provided	-	Provide one accessible wheelchair compartment.	1	6182	\$6182
<b>Lavatory</b>												
37	South Concession Stand Women's Toilet Room	1		Lavatory	N/A

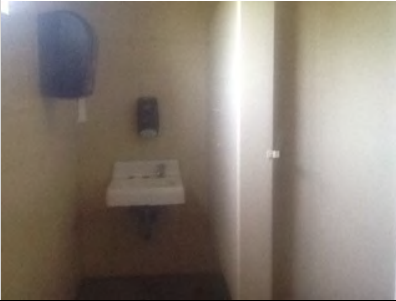
Toe or knee clearances not provided Faucet not operable with a closed fist Exposed plumbing underneath	25" - -	Provide knee and toe clearance positioned for a forward approach. Provide a faucet that can be operable with one hand and not require tight grasping, pinching, or twisting of the wrist at lavatory. Insulate or otherwise configure pipes to prevent contact at lavatory.	1	2764	\$2764

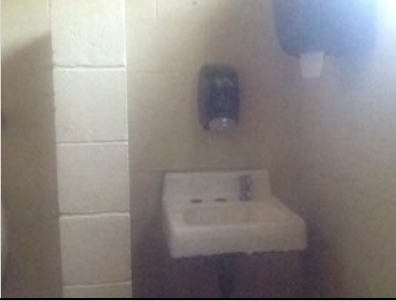
38	South Concession Stand Men's Toilet Room	1		Lavatory	N/A

Toe or knee clearances not provided Faucet not operable with a closed fist Exposed plumbing underneath	24" - -	Provide knee and toe clearance positioned for a forward approach. Provide a faucet that can be operable with one hand and not require tight grasping, pinching, or twisting of the wrist at lavatory. Insulate or otherwise configure pipes to prevent contact at lavatory.	1	2764	\$2764
<b>Urinal</b>												
39	South Concession Stand Men's Toilet Room	1		Urinal	N/A

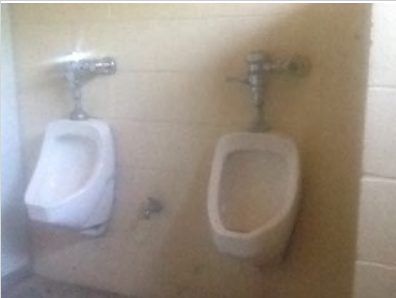
Rim > 17" high	-	Provide at least one urinal with the rim no higher than 17" above the finished floor.	1	3248	\$3248

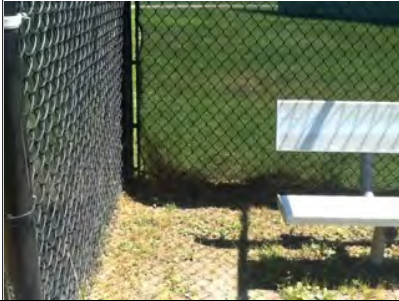
Accessible spaces are not provided at team seating	33.5"	Relocate bench to provide a 36" x 48" clear floor space at team seating. Provide a stone dust surface at accessible team seating space.	1	96 Labor	\$96
42	Baseball Field 1 Entrance Team Seating Area 2	Ext.		Field	Baseball

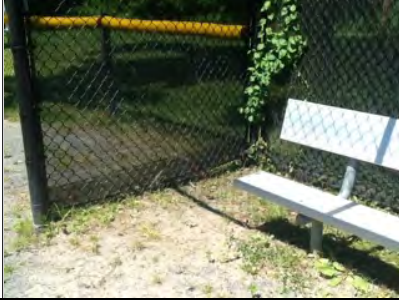
Accessible spaces are not provided at team seating	30"	Relocate bench to provide a 36" x 48" clear floor space at team seating. Provide a stone dust surface at accessible team seating space.	1	96 Labor	\$96

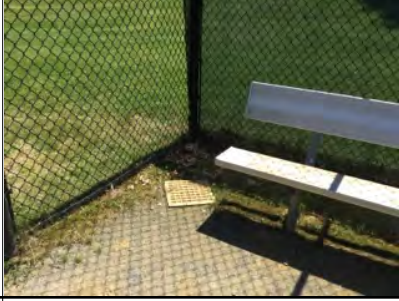
43	Baseball Field 5 Team Seating 1	Ext.		Field	Baseball

Accessible spaces are not provided at team seating	30.5"	Relocate bench to provide a 36" x 48" clear floor space at team seating. Provide a stone dust surface at accessible team seating space.	1	96 Labor	\$96
44	Baseball Field 5 Team Seating 2	Ext.		Field	Baseball

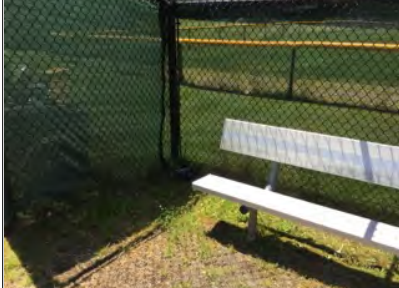
Accessible spaces are not provided at team seating	-	Provide a a 36" x 48" stone dust surface at accessible team seating space.	1	96	\$96

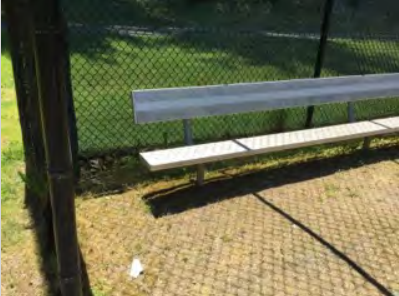
ID	Location	Floor	Room	Element	Type	Photo	Issues	Current Measure	Recommendations	Quantity	Price	Cost Estimation
45	Baseball Field 4 Team Seating 1	Ext.		Field	Baseball

Accessible spaces are not provided at team seating	25"	Relocate bench to provide a 36" x 48" clear floor space at team seating. Provide a stone dust surface at accessible team seating space.	1	96 Labor	\$96
46	Baseball Field 4 Team Seating 2	Ext.		Field	Baseball

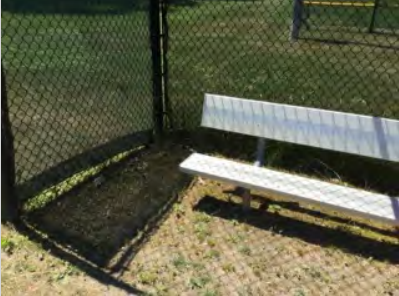
Accessible spaces are not provided at team seating	32"	Relocate bench to provide a 36" x 48" clear floor space at team seating. Provide a stone dust surface at accessible team seating space.	1	96 Labor	\$96
47	Baseball Field 3, Team Seating 1	Ext.		Field	Baseball	 	Accessible spaces are not provided at team seating	-	Provide a a 36" x 48" stone dust surface at accessible team seating space alongside the bench.	1	96	\$96
48	Baseball Field 3, Team Seating 2	Ext.		Field	Baseball	 	Accessible spaces are not provided at team seating	31"	Relocate bench to provide a 36" x 48" clear floor space at team seating. Provide a stone dust surface at accessible team seating space.	1	96 Labor	\$96

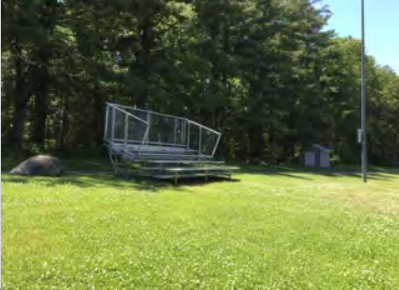
49	Baseball Field 4 Bleacher	Ext.		Field	Baseball

Accessible spaces not provided at sidelines seating	-	Provide a 36" x 48" clear floor space on each side of the bleacher. (Cost estimate for 15' long, 4' wide stone dust route.)	2	480	\$960

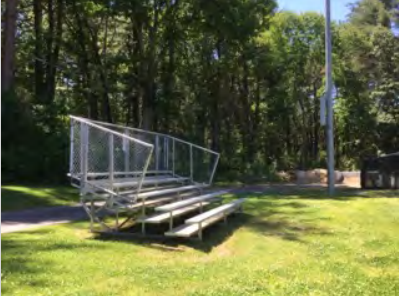
ID	Location	Floor	Room	Element	Type	Photo	Issues	Current Measure	Recommendations	Quantity	Price	Cost Estimation
50	Baseball Field 3 Bleacher	Ext.		Field	Baseball

Accessible spaces not provided at sidelines seating	-	Provide a 36" x 48" clear floor space on each side of the bleacher. (Cost estimate for 15' long, 4' wide stone dust route.)	2	480	\$960
51	Baseball Field 1 Bleachers Near Team Seating Area 1	Ext.		Field	Baseball

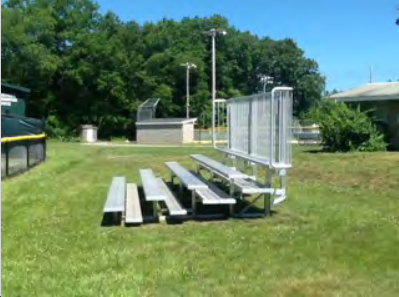
Accessible spaces not provided at sidelines seating Not connected to an accessible-route	- -	Provide a 36" x 48" clear floor space on each side of the bleacher. Provide an accessible route to the bleacher. (Cost estimate for 95' long, 4' wide stone dust route.)	1	3040	\$3040
52	Baseball Field 1 Bleachers near Team Seating 2	Ext.		Field	Baseball

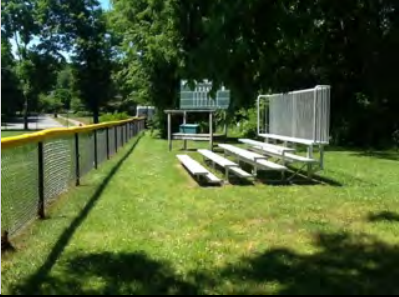
Accessible spaces not provided at sidelines seating Not connected to an accessible-route	- -	Provide a 36" x 48" clear floor space on each side of the bleacher. Provide an accessible route to the bleacher. (Cost estimate for 103' long, 4' wide stone dust route.)	1	3296	\$3296

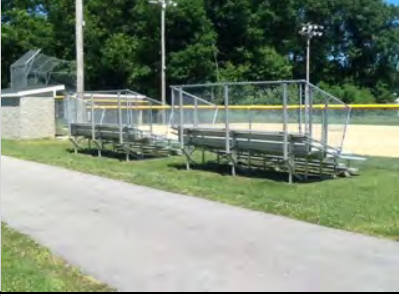
53	Adult Softball Field 2 Bleachers on South	Ext.		Field	Softball

Accessible spaces not provided at sidelines seating Not connected to an accessible-route	- -	Provide a 36" x 48" clear floor space on each side of each bleacher. Provide an accessible route to the accessible seating area. (Cost estimate for 18' long, 4' wide stone dust route.)	4	576	\$2304
54	Baseball Field 5 Bleacher	Ext.		Field	Baseball

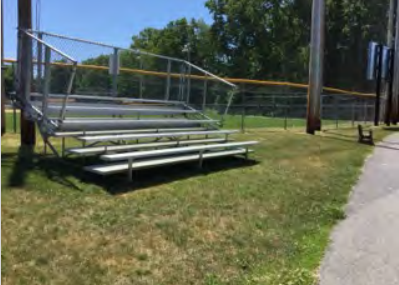
Accessible spaces not provided at sidelines seating Not connected to an accessible-route	- 8.1%	Relocate bleacher to an accessible route closer to the asphalt. Provide a level 36" x 48" clear floor space on each side of the bleacher. Provide an accessible route to the field. (Cost estimate for 4' long, 4' wide stone dust route.)	2	128	\$256

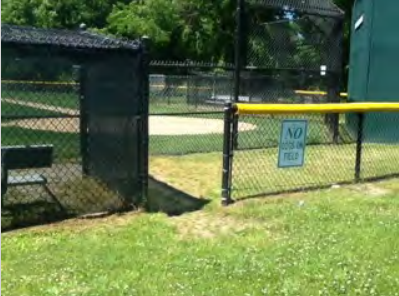
ID	Location	Floor	Room	Element	Type	Photo	Issues	Current Measure	Recommendations	Quantity	Price	Cost Estimation
55	Baseball Field 1 Entrance	Ext.		Field	Baseball

Not connected to an accessible-route	-	Provide an accessible route to the field and to each team seating area. (Cost estimate for 200' long, 4' wide stone dust walkway.)	1	6400	\$6400
56	Path to Baseball Field 5 Team Seating	Ext.		Field	Baseball

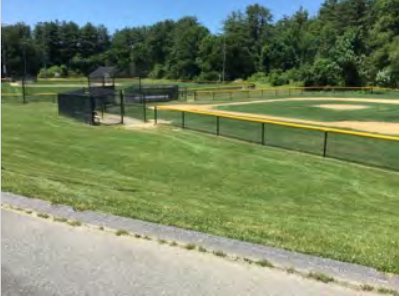
Not connected to an accessible-route	-	Provide an accessible route to the baseball field, including to the team seating areas. (Cost estimate for 210' long, 4' wide stone dust route.)	1	6720	\$6720
57	Entrance to Baseball Field 4	Ext.		Field	Baseball

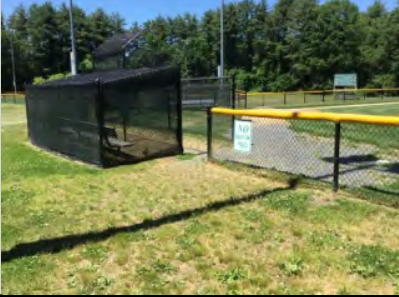
Not connected to an accessible-route	-	Provide an accessible route to the field and team seating areas. (Cost estimate for 120' long, 4' wide stone dust route.)	1	3840	\$3840
58	Adult Softball Field 2 Team Seating Areas	Ext.		Field	Softball

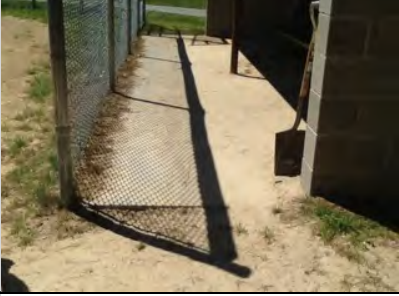
Not connected to an accessible-route Level changes > 1/4"	- 1.75"	Provide an accessible route to each team seating area. Ensure that level changes are no greater than 1/4" high. (Cost estimate for 12' long, 4' wide asphalt route.)	2	480	\$960

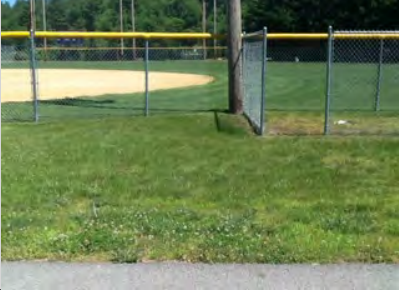
59	Adult Softball Field 2 Pitching Area on South Side	Ext.		Field	Softball

Practice areas are not on an accessible route	-	Provide an accessible route to the pitching area on the south side. (Cost estimate for 20' long by 4' wide stone dust route.)	1	640	\$640

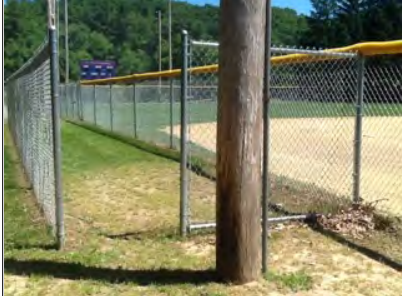
ID	Location	Floor	Room	Element	Type	Photo	Issues	Current Measure	Recommendations	Quantity	Price	Cost Estimation
60	Adult Softball Field 2 Pitching Practice on West Side	Ext.		Field	Softball

Practice areas are not on an accessible route	-	Provide an accessible route to the pitching area on the west side. (Cost estimate for 10' long, 4' wide stone dust route.)	1	320	\$320
61	Batting Cage	Ext.		Field	Baseball

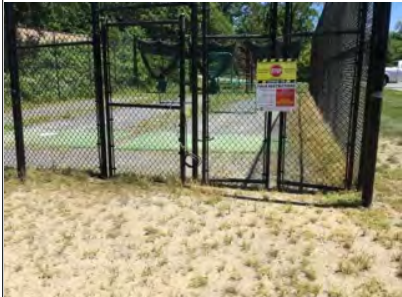
Practice areas are not on an accessible route	-	Provide an accessible route to practice areas. (Cost estimate for 54' long, 4' wide stone dust route.)	1	1728	\$1728
62	Entrance to Baseball Field 3	Ext.		Field	Baseball

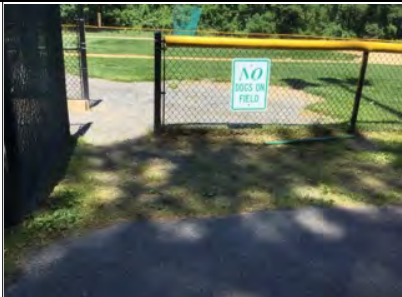
No accessible route to all areas of sport activity	-	Install an accessible route between all areas of sports activity including the team the field, team seating area and batting cage. (Cost estimate for 200' long, 4' wide stone dust route.)	1	6400	\$6400
<b>Best Practice</b>

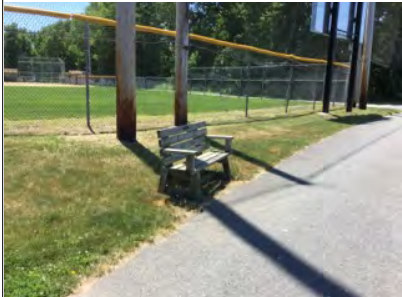
63	Bench Near Baseball Field 5	Ext.

Recommend providing clear floor space of 36" wide minimum by 48" deep alongside one bench so that a wheelchair user can sit alongside someone sitting on the bench.	1	-	\$0

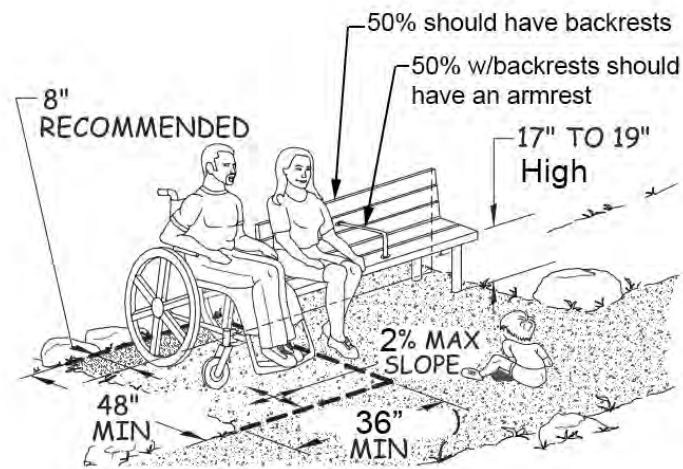
- Recommend providing handrails at the stepped route to spectator seating north of the baseball field.
- Recommend providing clear floor space of 36" wide minimum by 48" deep alongside one bench so that a wheelchair user can sit alongside someone sitting on the bench. See the following diagram:

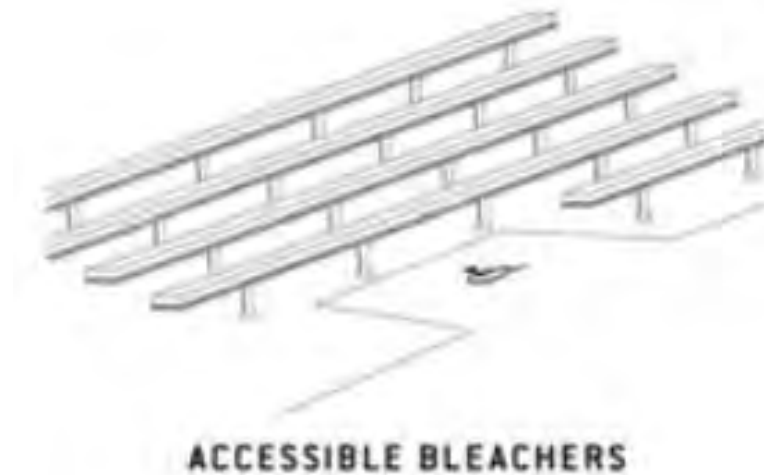
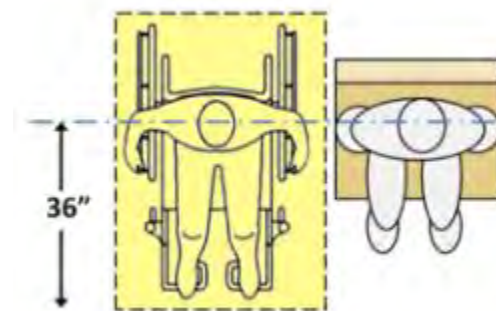
**Note:** The following graphics illustrate placement of accessible spaces alongside bleachers. Space for wheelchair users should be positioned so that a wheelchair user can sit shoulder to shoulder next to a person seated in the bleachers.

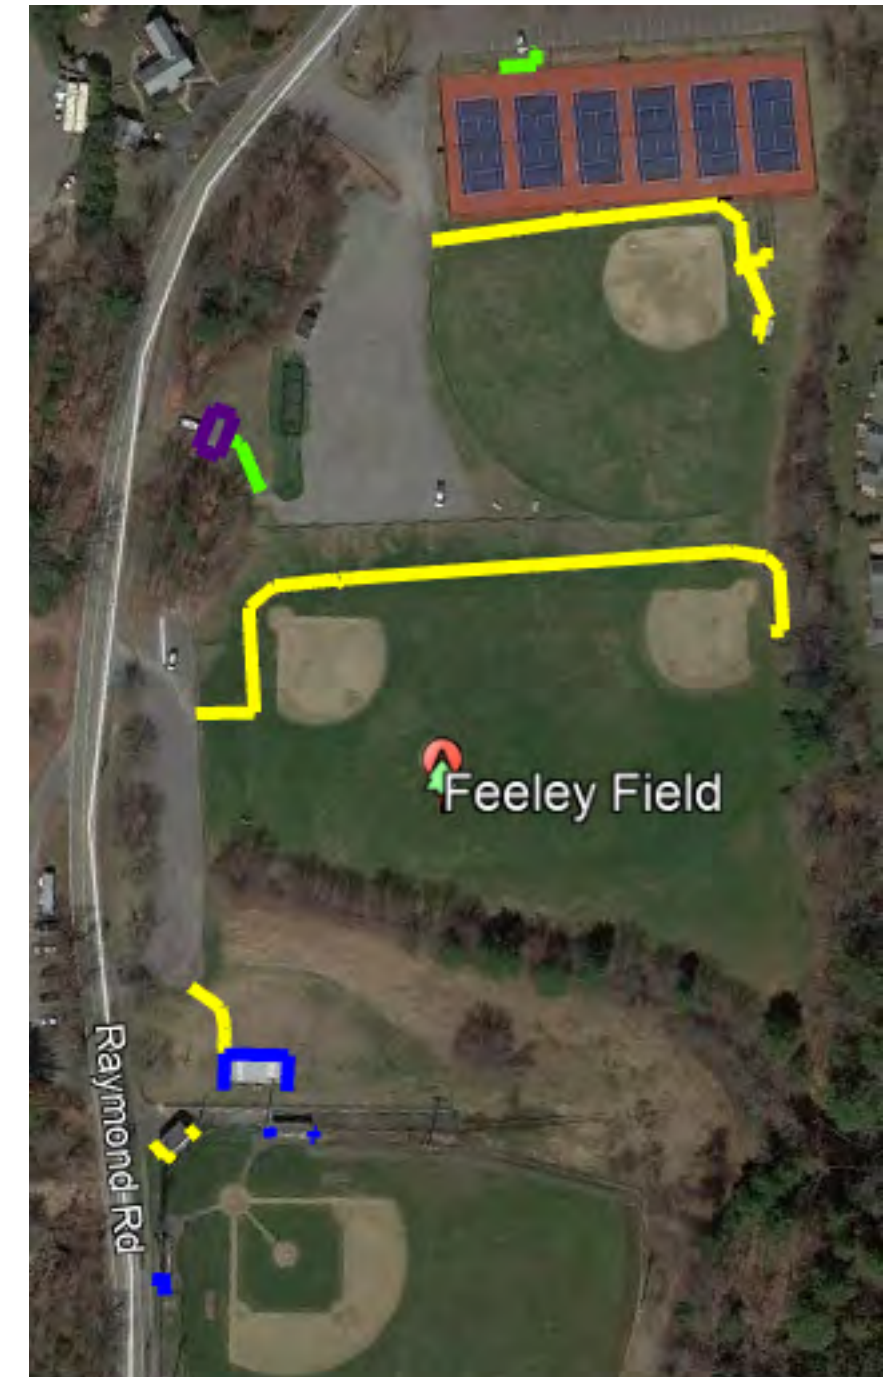
**Note:** The following image uses lines to show the approximate suggested location of accessible routes that need to be provided to amenities in Feeley Field. Yellow lines represent stone dust walkways, blue lines represent asphalt walkways, green lines represent concrete ramps and purple lines represent concrete walkways.

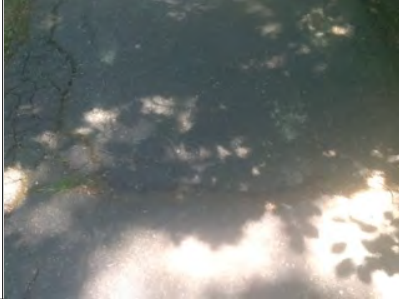
Route not maintained in operable working condition Level changes > 1/4"	2" -	Alter change in level to be 1/4" high max. Ensure the accessible route is maintained in operable working condition.	1	160	\$160
2	North Concession Stand and Toilet Room Building	Ext.		Exterior Access Route	Walkway

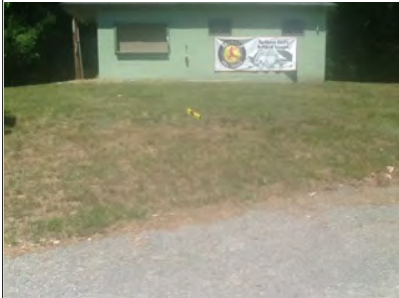
Accessible route not provided	13%	Ensure an accessible route is provided. (Cost estimate for 50' long concrete ramp to the building.)	1	59007	\$59007
3	Signage at Tennis Court	Ext.		Exterior Access Route	Walkway

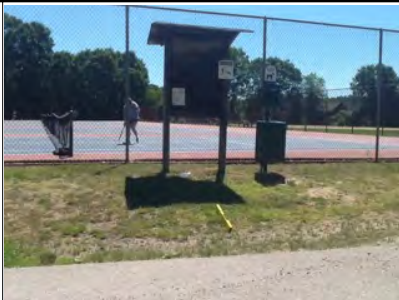
Accessible route not provided	27.8%	Relocate wayside sign to an accessible route.	1	Labor	\$0

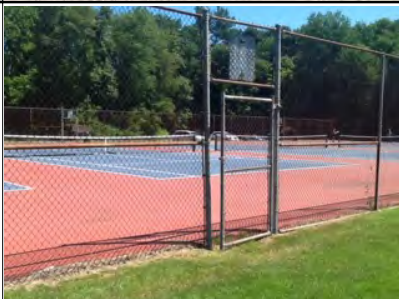
4	Southwest Tennis Entrance From North Softball Field	Ext.		Exterior Access Route	Walkway

Accessible route not provided		Install an accessible route between all areas of sport activity. (Cost estimate for 6' long by 4' wide stone dust route.)	1	192	\$192
<b>Off-Street Parking Lot or Garage</b>												
5	Parking Lot by Tennis Courts	Ext.		Off-Street Parking Lot or Garage	Visitor

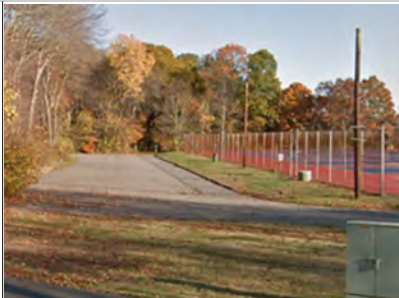
Total # of parking Total # of designated accessible parking spaces Total # of designated van accessible spaces	29 0 0	Provide one van accessible parking space and one car accessible parking space by the northwest entrance. (Cost of one accessible space, access aisle, sign and striping, including leveling space.)	2	1850	\$3700

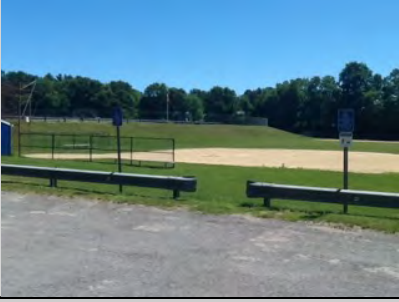
Total # of parking Total # of designated accessible parking spaces Access aisle not provided Sign does not have the designation "Van Accessible"	45 est. 2 - -	Provide a marked access aisle for one car accessible and one van accessible parking space. Add the designation "Van Accessible" to the sign located at the van accessible space.	1	1100	\$1100

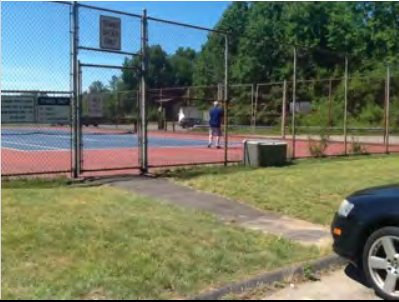
<b>Entrance</b>												
8	Northwest Tennis Entry	Ext.		Entrance	Gate

Entrance not on an accessible route	13.3%	Provide an accessible route into the tennis court from the parking lot. (Cost estimate based on a 30' long concrete ramp with handrails).	1	35404	\$35404
9	North Center Tennis Entrance	Ext.		Entrance	Gate

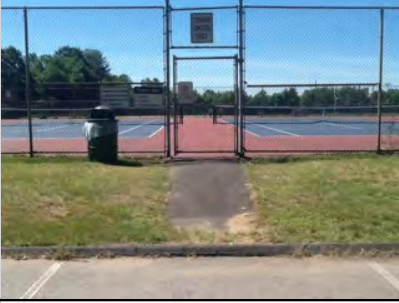
Directional sign to accessible entrance not provided	12%	Provide a directional sign indicating the location of the nearest accessible entrance.	1	346	\$346
10	Northeast Tennis Entry	Ext.		Entrance	Gate

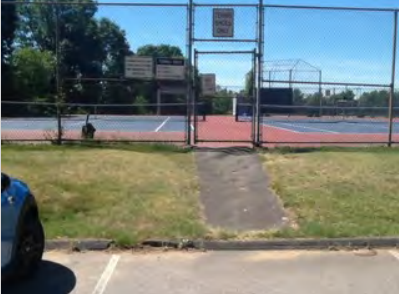
Directional sign to accessible entrance not provided	16.5%	Provide a directional sign indicating the location of the nearest accessible entrance.	1	346	\$346

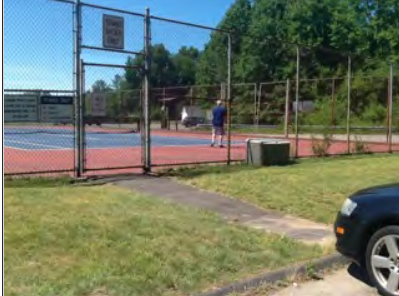
ID	Location	Floor	Room	Element	Type	Photo	Issues	Current Measure	Recommendations	Quantity	Price	Cost Estimation
11	Northwest Tennis Entrance	Ext.		Entrance	Gate

International Symbol of Acc. not provided		After entrance is made accessible provide signage with the International Symbol of Accessibility (ISA).	1	346	\$346
12	Tennis Entrances on South	Ext.		Entrance	Gate

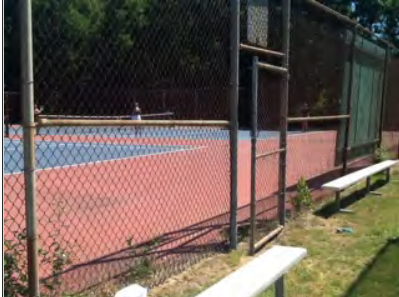
International Symbol of Acc. not provided	-	After an accessible route is made to both south entrances, provide a sign with the International Symbol of Accessibility (ISA) at each gate.	2	346	\$692
<b>Access to Goods and Services</b>												
<b>Doors, Doorways, &amp; Gates</b>												
13	Women's Toilet Room	1		Doors, Doorways, & Gates	Toilet Room

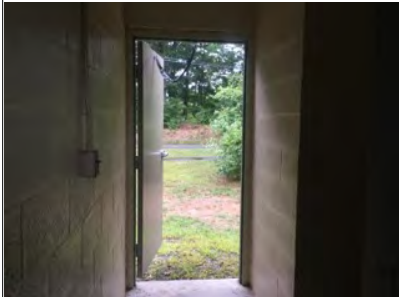
Maneuvering clearance(s) not provided	2"	Provide an automatic door opener.	1	3060	\$3060
14	Women's and Men's Toilet Room Doors	Ext.		Doors, Doorways, & Gates	Toilet Room

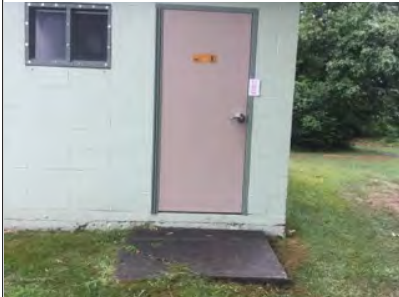
Threshold > 1/2" high	6", 10"	Threshold is 6" to 10" at the men's and women's toilet room. Recommend providing a raised walkway around building to connect concession counters, and toilet rooms. (Cost estimate based on 107' long, 4' wide min. walkway around building so that the maximum door threshold to both toilet rooms is 1/2 inch.	1	6848	\$6848

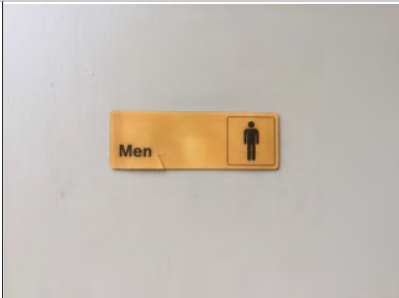
<b>Signage</b>												
15	Men's Toilet Room	Ext.		Signage	Designation

Raised characters not provided Braille not provided Sign not located on the latch side of the door	- - -	Provide text with raised characters duplicated in braille. Locate sign at permanent rooms alongside the door on the latch side.	1	232	\$232

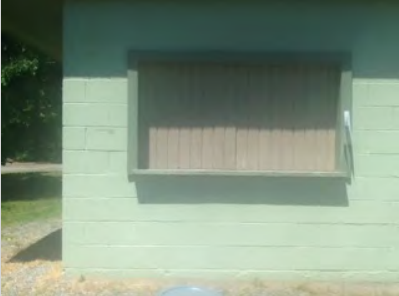
Not connected to a accessible route Counter > 36" high	- 41"	Ensure the counter is connected to an accessible route. Provide a counter that is 36" max. above the ground. (Note: If a raised walkway or plinth is built around the building, concession counter may not need to be lowered.)	1	Labor 880	\$880
18	North Concession Stand	Ext.		Service Counter	N/A

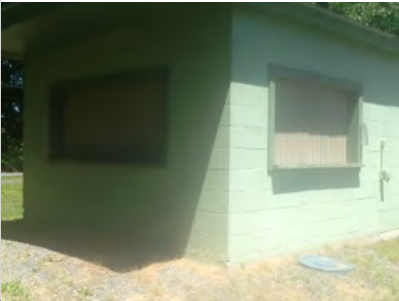
Not connected to a accessible route Counter > 36" high	- 38"	Ensure the counter is connected to an accessible route. Provide a counter that is 36" max. above the ground. (Note: If a raised walkway or plinth is built around the building, concession counter may not need to be lowered.)	1	Labor 880	\$880

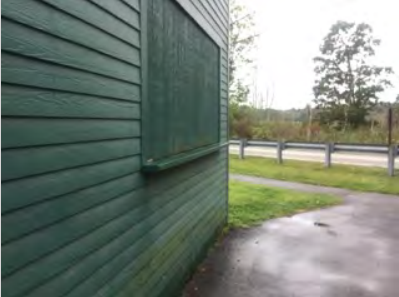
19	Baseball Field Concession Stand	Ext.		Service Counter	N/A

Counter > 36" high	47"	Provide a counter that is 36" max. above the ground.	1	880	\$880
<b>Picnic Tables</b>												
20	North Concession Stand Picnic Area	Ext.		Picnic Tables	N/A

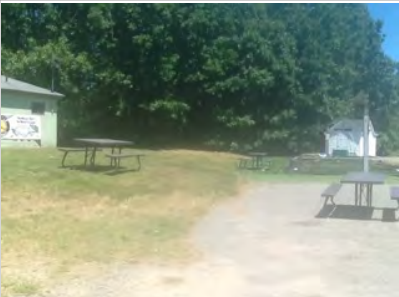
Toe or knee clearance at table not provided	-	Provide at least one picnic table with top between 28"- 34" above the ground and 27" clear height underneath. Ensure it is located on an accessible route.	1	1400	\$1400

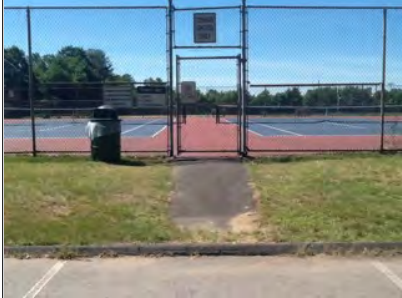
Trash container not connected to an accessible route	12%	Ensure trash container is located on an accessible route.	1	Labor	\$0
<b>Toilet &amp; Bathing Rooms</b>												
<b>Overall Access</b>												
23	Men's Toilet Room	1		Overall Access	Toilet Room

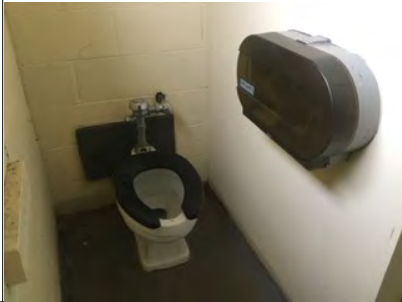
Accessible plumbing fixtures or stalls not provided Toe or knee clearances not provided Faucet not operable with a closed fist Exposed plumbing underneath lavatory Urinal rim > 17" high Clear floor space not provided at urinal Flush control too high or not properly located at urinal	- - - - - -	Renovate toilet room to be an accessible single-user toilet room. Provide a faucet that can be operable with one hand and not require tight grasping, pinching, or twisting of the wrist for at least one lavatory. Insulate or otherwise configure pipes to prevent contact at lavatory. Provide at least one lavatory with knee and toe clearance positioned for a forward approach.	1	24604	\$24604

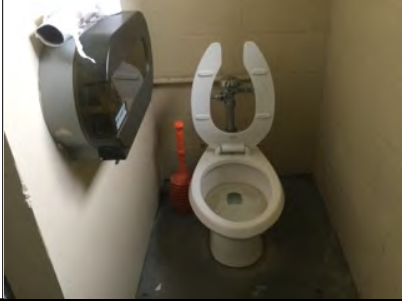
24	Women's Toilet Room	1		Overall Access	Toilet Room

Accessible plumbing fixtures or stalls not provided Faucet not operable with a closed fist Exposed plumbing underneath	-	Renovate toilet room to be an accessible single-user toilet room. Provide a faucet that can be operable with one hand and not require tight grasping, pinching, or twisting of the wrist for at least one lavatory. Insulate or otherwise configure pipes to prevent contact at lavatory.	1	24604	\$24604
<b>Play and Sport Areas</b>

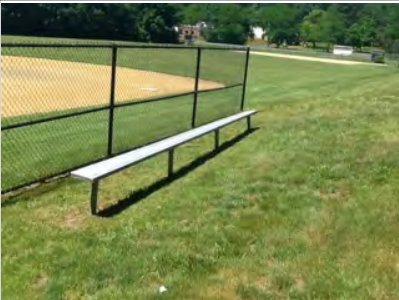
Accessible spaces are not provided at team seating Not connected to an accessible-route	- -	Provide a 36" x 48" clear floor space at team seating. Provide an accessible route to the field. (Cost estimate for 420' 4' wide stone dust route from southwest softball field.)	1	13440	\$13440
27	Southwest Softball Field Team Seating	Ext.		Field	Softball

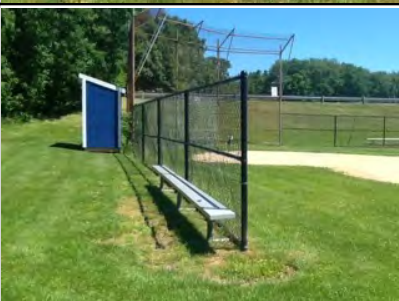
Accessible spaces are not provided at team seating No accessible route to all areas of sport activity	- -	Provide a 36" x 48" clear floor space at each team seating area Install an accessible route to each team seating area. (Cost estimate for 216' long, 4' wide stone dust route from the parking lot.)	1	6912	\$6912

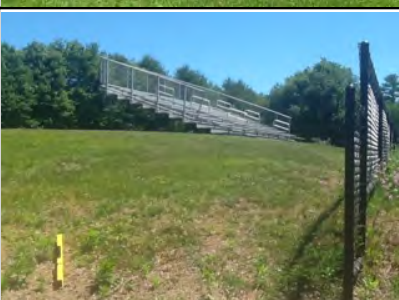
28	Baseball Field, Access to Bleachers	Ext.		Field	Baseball

Accessible spaces not provided at sidelines seating	-	Provide an accessible route to team seating area from the parking lot to the north. Provide a 36" x 48" clear floor space on each side of the bleacher. (Cost estimate for 173' long, 4' wide stone dust route.)	1	5536	\$5536
29	Baseball Field, Bleacher In Front of Press Box	Ext.		Field	Baseball

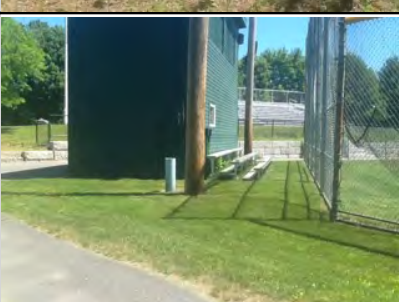
Accessible spaces not provided at sidelines seating	-	Provide an accessible route to sideline seating and a 36" x 48" clear floor space alongside each side of bleacher. (Cost estimate for 34' long, 4' wide stone dust route.)	1	1088	\$1088

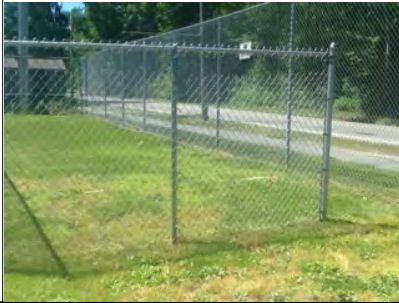
Practice areas are not on an accessible route	-	Provide an accessible route to practice areas. (Cost estimate for 12' long, 4' wide asphalt route.)	1	480	\$480
<b>Court</b>												
37	Tennis Entry on Southeast From North Softball Field	Ext.		Court	Tennis

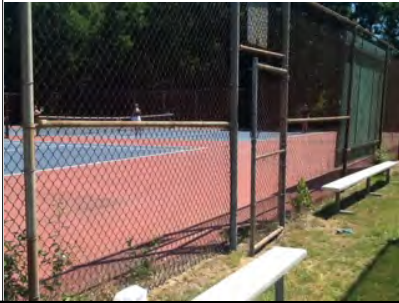
No accessible route between all areas of sport activity	-	Install an accessible route between the tennis court and softball field. (Cost estimate for 4' long by 4' wide stone dust route.)	1	128	\$128

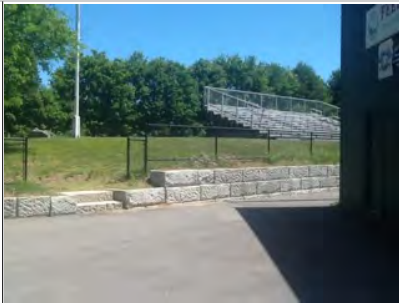
<b>Best Practice</b>												
38	Baseball Field, Path to Upper Level Bleachers	Ext.

Recommend providing handrails at the stepped route to spectator seating.	1	-	\$0
39	North Concession Stand and Toilet Rooms	Ext.

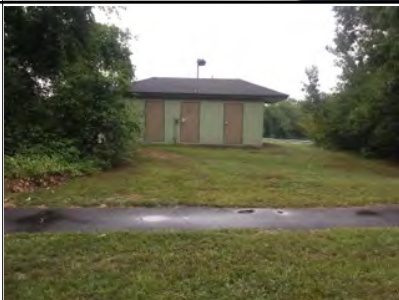
Recommend providing an accessible route from this facility to the sidewalk.	1	-	\$0

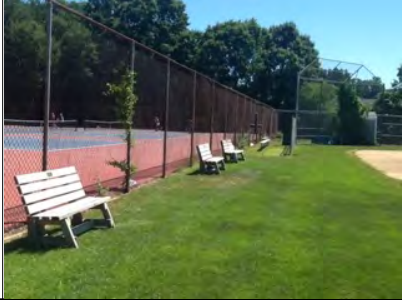
Recommend providing clear floor space of 36" wide minimum by 48" deep alongside one bench so that a wheelchair user can sit alongside someone sitting on the bench.	1	-	\$0

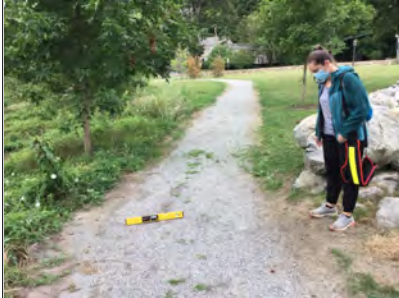
Cross slope > 1:50 (2.00%)	12%	Reduce cross slope to be no steeper than 1:50 (2.00%).  (Cost based on 4'x15' of stone dust to correct slope.)	1	480	\$480
2	Walkway West of World War I Memorial	Ext.		Exterior Access Route	Walkway

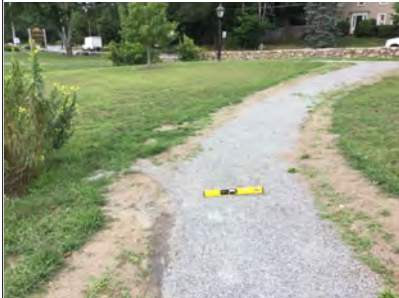
Cross slope > 1:50 (2.00%)	11.5%	Reduce cross slope to be no steeper than 1:50 (2.00%).  (Cost based on 4'x6' of stone dust to correct slope.)	1	192	\$192
3	Walkway Southeast of World War I Memorial	Ext.		Exterior Access Route	Walkway

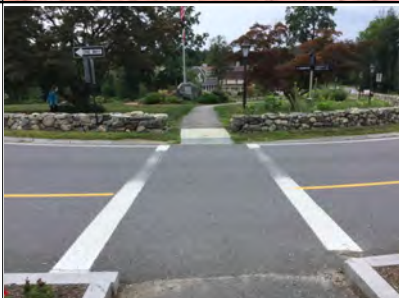
Detectable warning not provided		Provide a detectable warning on the curb ramp.	1	360	\$360

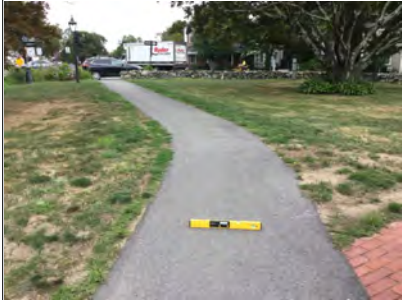
Recommend providing a bench with a 36" min. x 48" min. wide stable, firm and slip resistant surface such as stone dust at one end by the pathway the runs along Hudson Road to provide a location near the memorial for visitors to rest while at the park.	1	-	\$0
<b>Clear Floor Space by Bench</b>												
7	Southeast End of the Park	Ext.		Clear Floor Space by Bench	N/A

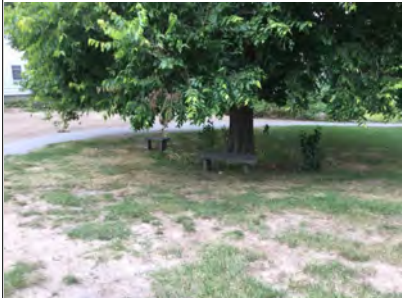
Recommend providing a 36" min. x 48" min. wide stable, firm and slip resistant surface such as stone dust at one end of one of the benches in this area once the bench is connected to an accessible route.	1	-	\$0

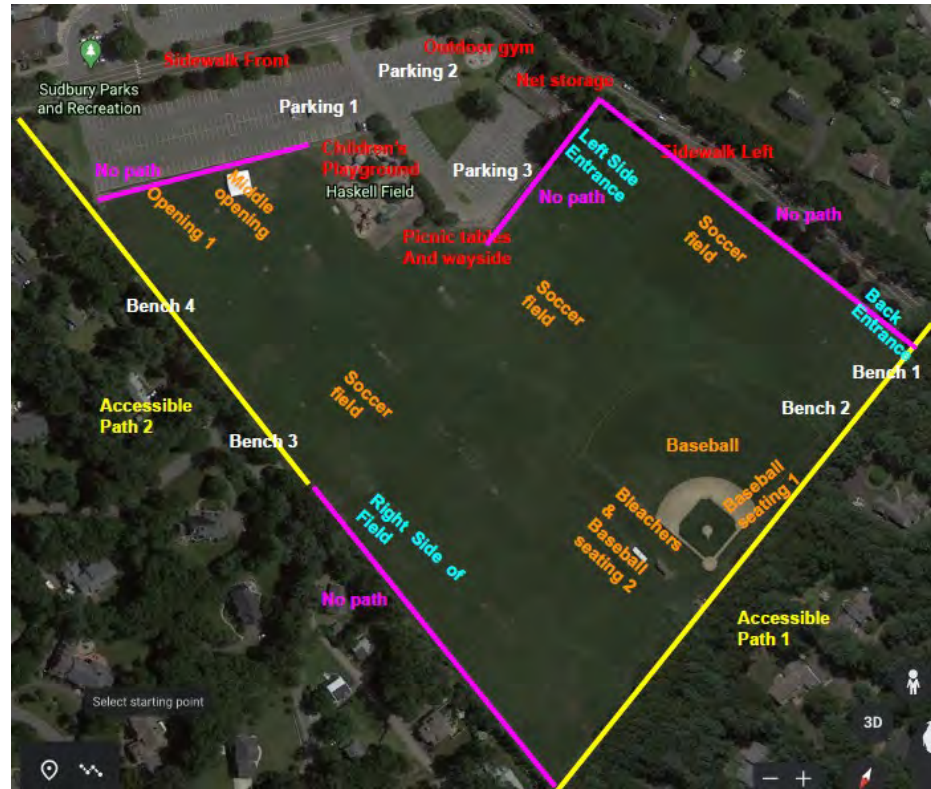
**Figure 1:** View of Haskell Field showing the approximate location of accessible routes (yellow lines) and the approximate suggested location for new accessible routes (purple lines) that connect existing paths to all of the boundaries of sport activity and to park amenities.

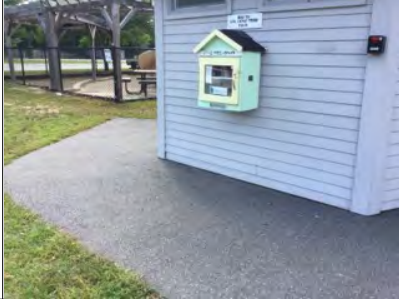
Route obstructed by protruding objects	15"	Provide a cane-detectable barrier below book exchange 27" max. above the ground. (Book exchange protrudes 15.75".)	1	306	\$306
2	Left Side Entrance From Parking 3 to Soccer Fields	Ext.		Exterior Access Route	Walkway

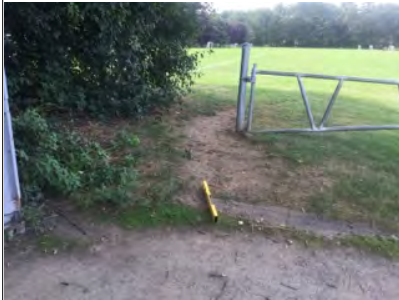
Running slope > 1:20 (5%)	10.2%	Reduce running slope to be no steeper than 1:20 (5%), reduce change in level from parking to soccer field entrance to 1/2" max.	1	Labor	\$0
3	Path to Children's Playground	Ext.		Exterior Access Route	Exterior

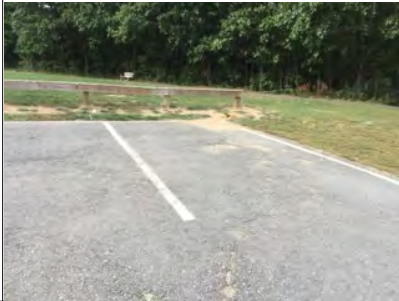
Accessible route not provided	-	Ensure an accessible route is provided between the parking lot and the existing accessible path.  (Cost based on a 4' wide min. x 15' firm, stable and slip resistant accessible path to the existing path.)	1	960	\$960
<b>Access to Goods and Services</b>

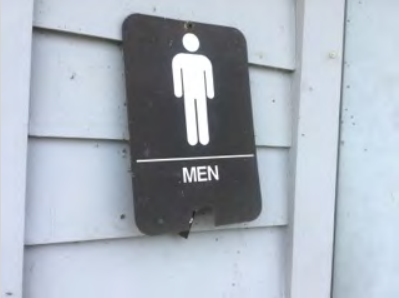
Sign not maintained in operable working condition		Provide new sign with raised characters and braille.	1	232	\$232
<b>Service Counter</b>												
7	Concession Stand - Children's Playground	Ext.		Service Counter	N/A

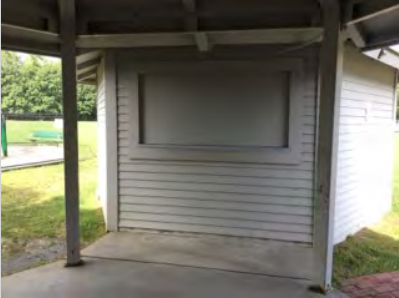
Counter > 36" high	41.5"	Provide a counter that is 36" max. above the ground.	1	880	\$880
<b>Operable Parts</b>												
8	Wayside	Ext.		Operable Parts	N/A

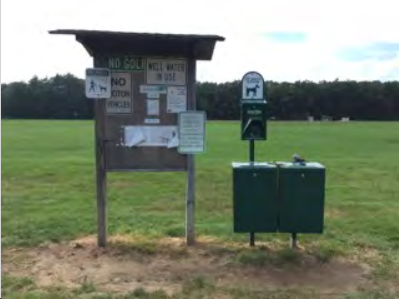
Reach < 15" or > 48"(forward/side approach)	53.5"	Reposition dog waste bag dispenser to between 15"- 48" above the finished floor.	1	Labor	\$0
<b>Picnic Tables</b>												
9	Picnic Table Near Accessible Play Structure 1 - Children's Playground	Ext.		Picnic Tables	N/A

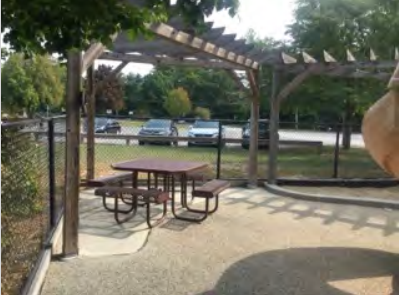
Toe or knee clearance at table not provided	-	Provide at least one picnic table in this area with top between 28"- 34" above the ground and 27" clear height underneath.	1	1400	\$1400

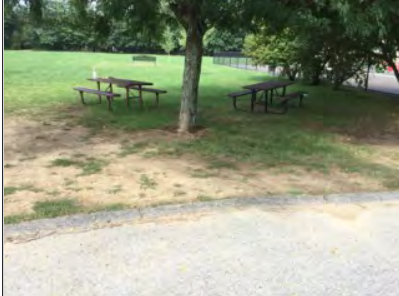
Toe or knee clearance at table not provided Picnic table not on an accessible route	- -	Provide at least one picnic table with top between 28"- 34" above the ground and 27" clear height underneath. Ensure that the dining surface is connected to an accessible route.	1	1400	\$1400
11	Opening 1 Near Accessible Path 2 From Right Side of Parking 1	Ext.		Picnic Tables	N/A

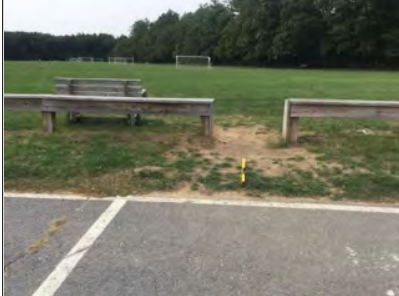
Toe or knee clearance at table not provided Picnic table not on an accessible route	- 17%	Provide at least one picnic table with top between 28"- 34" above the ground and 27" clear height underneath. Ensure that the dining surface is connected to an accessible route.  (Cost based on an accessible picnic table and a 4' wide min. x 15' firm, stable and slip resistant accessible path to the picnic table.)	1	2360	\$2360

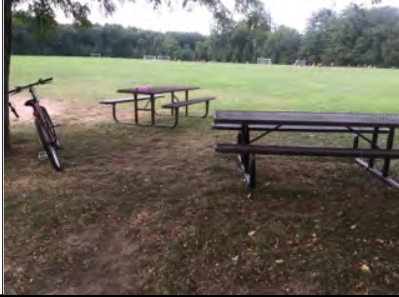
12	Picnic Tables Near Parking 3	Ext.		Picnic Tables	N/A

Toe or knee clearance at table not provided Picnic table not on an accessible route	- -	Provide at least one picnic table with top between 28"- 34" above the ground and 27" clear height underneath. Ensure that the accessible picnic table in this area is connected to an accessible route.	1	1400	\$1400
13	Outdoor Play Gym	Ext.		Picnic Tables	N/A

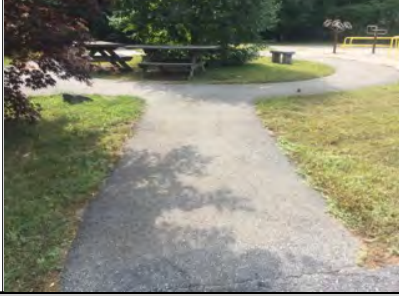
Picnic table not on an accessible route	-	Ensure that the picnic table is connected to an accessible route. (Cost based on a stone dust patch, 3'x4' min., at the accessible end of the accessible picnic table.)	1	240	\$240
<b>Benches</b>												
14	Bench Next to Children's Playground	Ext.		Benches	N/A

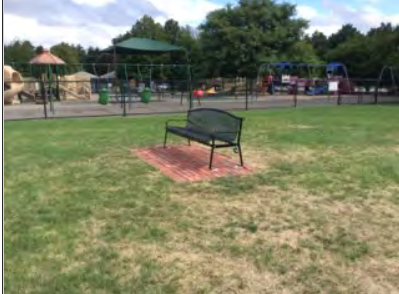
No accessible route to one bench in this area		Provide an accessible route to at least one bench in this area.  (Cost based on a 4' wide min. x 15' long stone dust path to bench.)	1	480	\$480

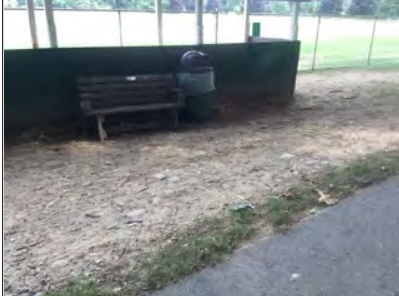
No accessible route to one bench in this area	-	Provide an accessible route to at least one bench in this area and to the trash receptacle or relocate both to an accessible route. (Cost based on a 4' wide min. x 6' firm, stable and slip resistant path to bench and trash receptacle.)	1	240	\$240
16	Right Side Soccer Field	Ext.		Benches	N/A

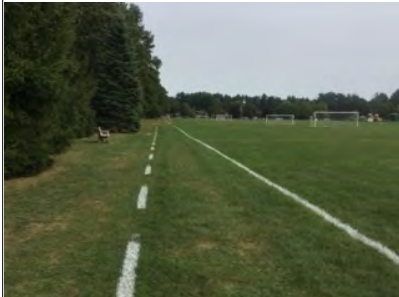
No accessible route to one bench in this area	-	Install an accessible route with a 5.00% max. running and 2.00% max. cross slope between towards benches and the resumed accessible path. (Cost based on a 4' wide min. x 60' long path leading towards benches and the resumed accessible path.)	1	1920	\$1920
17	Accessible Path 2	Ext.		Benches	N/A

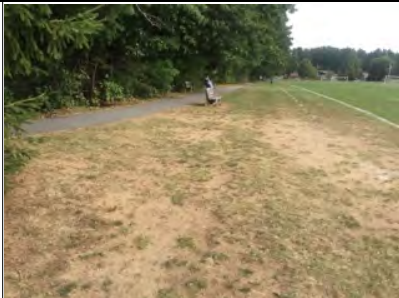
No accessible route to one bench in this area	-	Install an accessible route with a 5.00% max. running and 2.00% max. cross slope between towards benches and the resumed accessible path. (Cost based on a 4' wide min. x 60' long path leading towards benches and the resumed accessible path.)	1	1920	\$1920

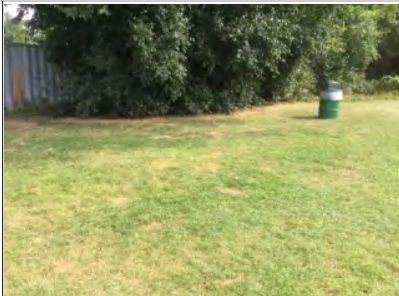
<b>Trash / Recycling</b>												
18	Left Side Entrance From Parking 3 to Soccer Fields	Ext.		Trash / Recycling	N/A

Trash container not connected to an accessible route	-	Ensure trash container is located on an accessible route.	1	Labor	\$0
19	Path 2	Ext.		Trash / Recycling	N/A

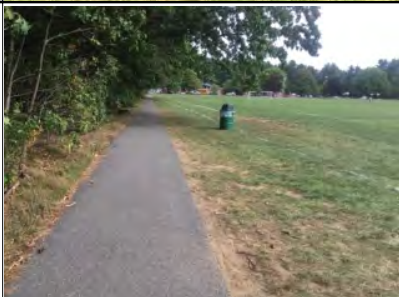
Trash container not connected to an accessible route	-	Ensure trash container is located on an accessible route.	1	Labor	\$0
<b>Toilet &amp; Bathing Rooms</b>

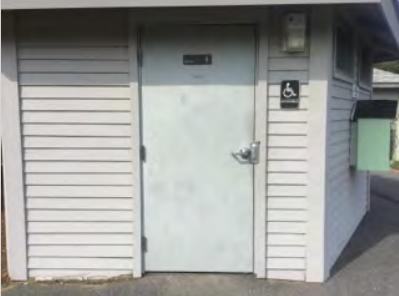
This toilet room was locked on the day that IHCD was at Haskell Field and could not be surveyed.	1	-	\$0
<b>Additional Access</b>												
<b>Drinking Fountains</b>												
22	Fountain - Children's Playground	Ext.		Drinking Fountains	Seated

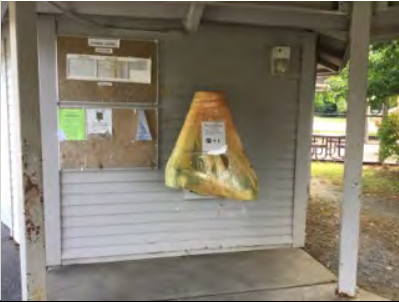
No drinking fountain provided for standing users	-	Provide an additional drinking fountain for standing users or install a Hi-Lo drinking fountain.	1	4028	\$4028
<b>Play and Sport Areas</b>												
<b>Play Areas</b>

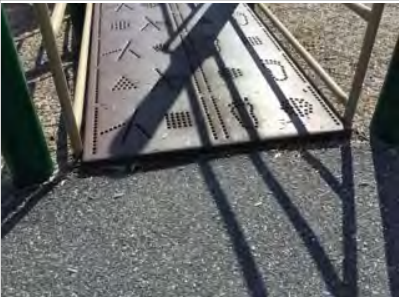
23	Accessible Play Structure 2 - Children's Playground	Ext.		Play Areas	N/A

Accessible route not provided at play components	1"	Reduce change in level to 1/2" max.	1	Labor	\$0
