# Broadacres Farm

## Town of Sudbury ADA Transition Plan

September 2020

Institute for Human Centered Design

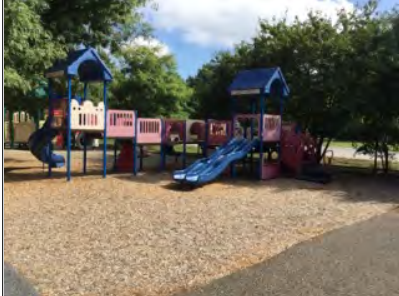
ID	Location	Floor	Room	Element	Type	Photo	Issues	Current Measure	Recommendations	Quantity	Price	Cost Estimation
24	Play Structure 3 - Children's Playground	Ext.		Play Areas	N/A

Accessible route not provided at play components	-	Provide a compliant impact-attenuating surface under and around the play components.  <b>Note:</b> IHCD team has been told that Sudbury has budgeted \$163,000 to address this issue at Haskell Field.	1	-	\$0
25	Near Climber	Ext.		Play Areas	N/A

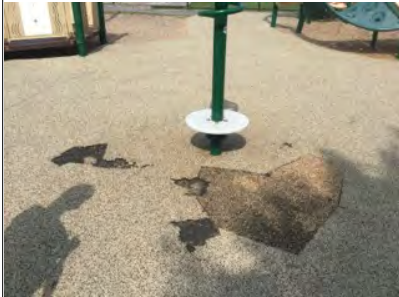
Play areas not maintained in operable working condition	-	Ensure play area is maintained in operable working condition/repair patch as needed.	1	Labor	\$0
26	Accessible Play Structure 2 - Children's Playground	Ext.		Play Areas	N/A

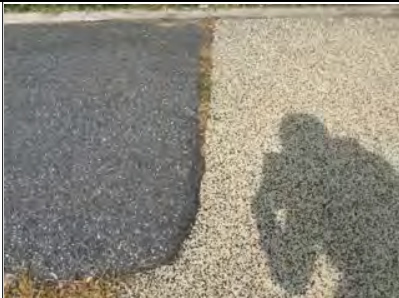
Play areas not maintained in operable working condition	-	Ensure play area is maintained in operable working condition.	1	Labor	\$0
27	Ground Play Components	Ext.		Play Areas	N/A

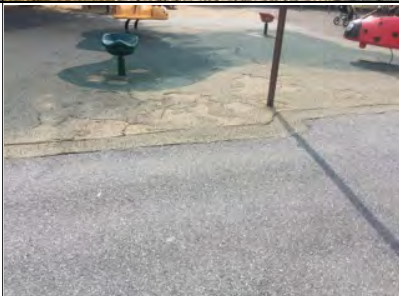
Play areas not maintained in operable working condition	-	Ensure play area is maintained in operable working condition.	1	Labor	\$0

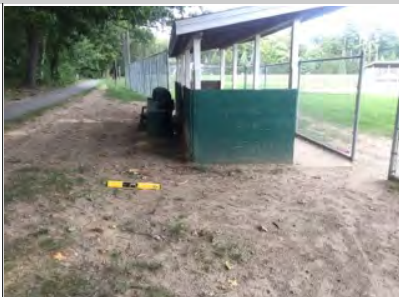
<b>Field</b>												
28	Path 1 Baseball Seating	Ext.		Field	Baseball

Accessible spaces are not provided at team seating	14%	Provide a 48" wide min. firm, stable and slip resistant path to team seating with a 5.00% max. running and 2.00% max. cross slope. (Cost based on a 48" wide x 15' long stone dust path.)	1	480	\$480

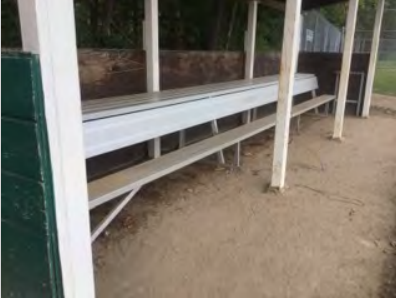
ID	Location	Floor	Room	Element	Type	Photo	Issues	Current Measure	Recommendations	Quantity	Price	Cost Estimation
29	Baseball Seating	Ext.		Field	Baseball

Accessible spaces are not provided at team seating	-	Provide a 36" x 48" clear floor space at team seating.	1	Labor	\$0
30	Baseball Seating 2	Ext.		Field	Baseball

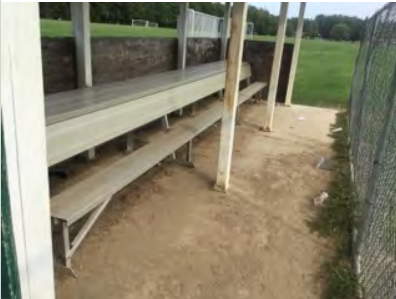
Accessible spaces are not provided at team seating	-	Provide a 36" x 48" clear floor space at team seating.	1	Labor	\$0
31	Bleachers	Ext.		Field	Baseball

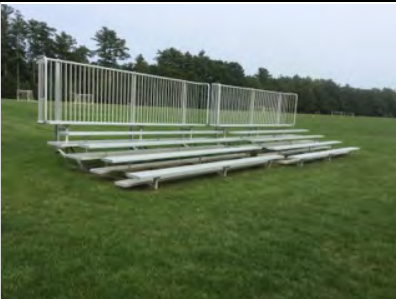
Accessible spaces not provided at sidelines seating	-	Provide a 4' wide min. firm, stable and slip resistant route to the sideline seating bleachers with a 5.00% max. running and 2.00% max. cross slope. Provide a 36" x 48" clear floor space at sidelines seating. (Cost based on a 4' wide min. x 30' path.)	1	960	\$960
32	Baseball Dugout to Field	Ext.		Field	Baseball

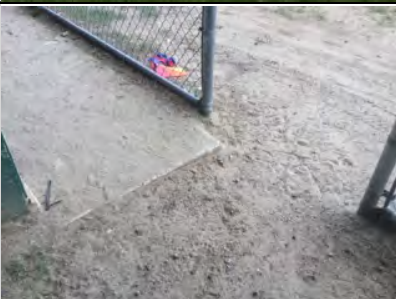
Not connected to an accessible-route	28.5"	Provide an accessible route to the field. Widen gate to 32" min.	1	Labor	\$0

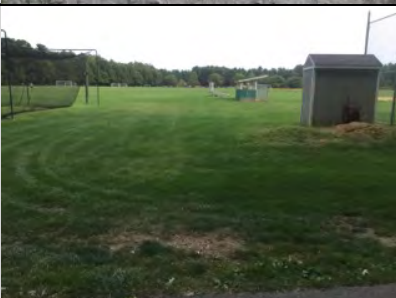
33	Towards Baseball Seating 2	Ext.		Field	Baseball

Not connected to an accessible-route	-	Provide a 4' wide min. firm, stable and slip resistant route to the equipment storage shed, the boundary of sport activity, and to the second team seating dugout with a 5.00% max. running and 2.00% max. cross slope at baseball. (Cost based on a 4' wide min. x 60' path.)	1	1920	\$1920

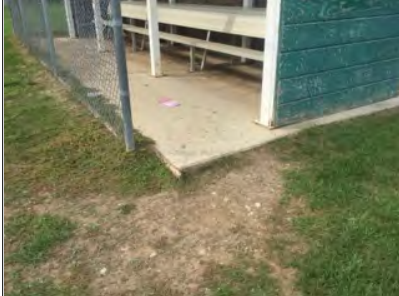
ID	Location	Floor	Room	Element	Type	Photo	Issues	Current Measure	Recommendations	Quantity	Price	Cost Estimation
34	Baseball Seating 2	Ext.		Field	Baseball

Not connected to an accessible-route	3"	Reduce change in level to 1/2" max. (Cost based on a concrete patch.)	1	256	\$256
35	Batting Cage	Ext.		Field	Baseball

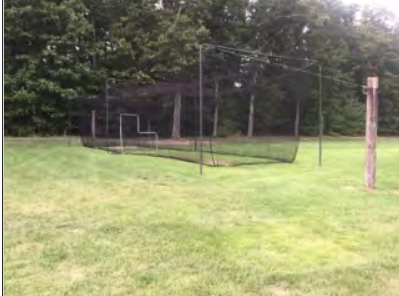
Not connected to an accessible-route	-	Provide a firm, stable and slip resistant accessible route to the batting cage entry with a 5.00% max. running and 2.00% max. cross slope.	1	960	\$960
36	Right Side of Soccer Field	Ext.		Field	Soccer

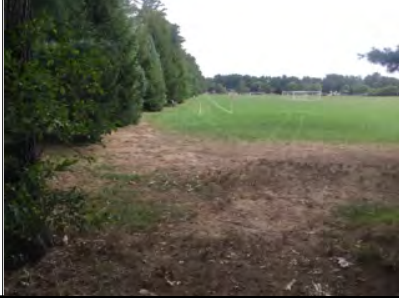
No accessible route to all areas of sport activity	-	Install an accessible route with a 5.00% max. running and 2.00% max. cross slope between the existing path and boundary of sport activity at the soccer field. (Cost based on a 4' wide min. x 60' long path leading towards the benches and the resumed accessible path.)	1	1920	\$1920

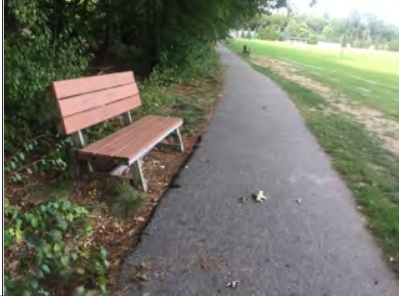
<b>Best Practice</b>												
<b>Bench</b>												
37	Bench 1 on Path 1	Ext.		Bench	N/A

Recommend providing a 3'x4' asphalt patch at one end of bench.	1	-	\$0
38	Bench 2 on Path 1	Ext.		ench	N/A

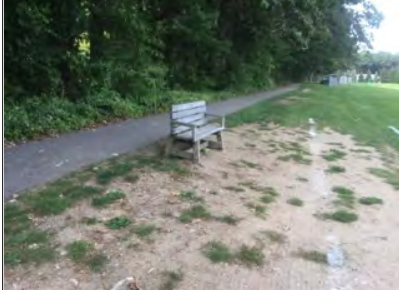
Recommend providing a 3'x4' asphalt patch at one end of bench.	1	-	\$0

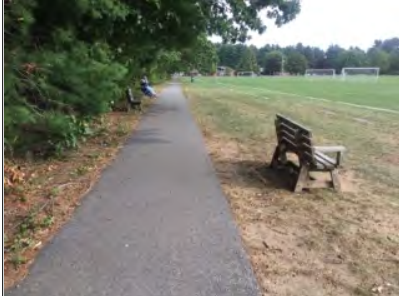
ID	Location	Floor	Room	Element	Type	Photo	Issues	Current Measure	Recommendations	Quantity	Price	Cost Estimation
39	Path 2	Ext.		Bench	N/A

Recommend relocate bench closer to existing accessible route and providing a 3'x4' asphalt patch at one end of bench.	1	-	\$0
40	Bench 3 on Path 2	Ext.		3ench	N/A

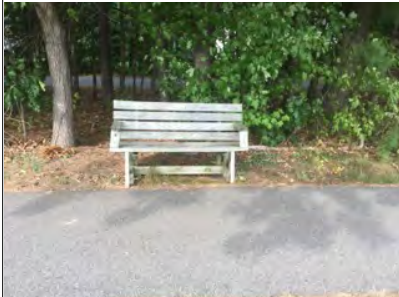
Recommend providing a 3'x4' asphalt patch at one end of bench.	1	-	\$0
<b>Men's Toilet Room</b>												
41	Men's Toilet Room	Ext.		Men's Toilet Room	N/A

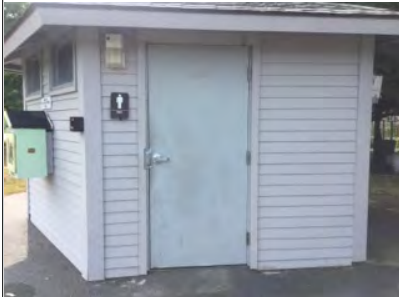
Recommend providing a sign with the International Symbol of Accessibility (ISA) at the men's toilet room.	1	-	\$0
<b>Picnic Table</b>												
42	Picnic Tables Near Parking 3	Ext.		Picnic Table	N/A

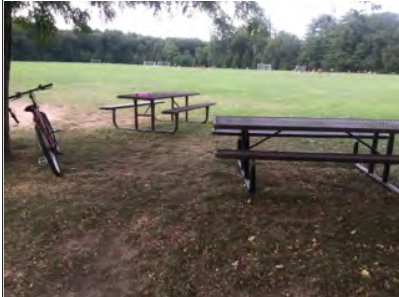
Recommend proving a 48" min. firm, stable and slip resistant surface around the exterior of each accessible picnic table in the park.	1	-	\$0

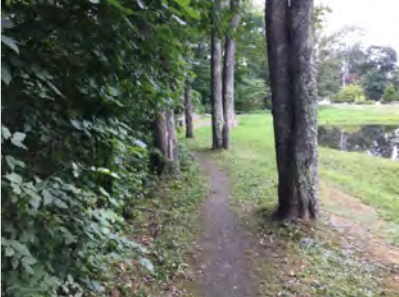
ID	Location	Floor	Room	Element	Type	Photo	Issues	Current Measure	Recommendations	Quantity	Price	Cost Estimation
<b>Approach and Entrance</b>												
<b>Exterior Access Route</b>												
1	Walkway South of Pond	Ext.		Exterior Access Route	Exterior

Exterior route < 48" wide	17"	Ensure that a clear width of 48" min. is maintained at the accessible route. (Cost estimate for labor and 20' long 4' wide stone dust route.)	1	Labor 640	\$640
2	Dogwood Path	Ext.		Exterior Access Route	Exterior

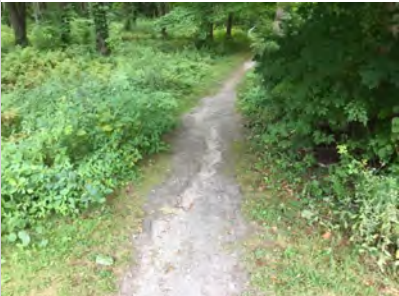
Exterior route < 48" wide Cross slope > 1:50 (2.00%) Running slope > 1:20 (5%)	20"-30" 3.4% 9.1%-17%	Ensure that a clear width of 48" min. is maintained at the accessible route. Reduce cross slope to be no steeper than 1:50 (2.00%). Reduce running slope to be no steeper than 1:20 (5%). (Cost estimate for a 530' long, 4' wide stone dust path.)	1	16960	\$16960
3	9/11 Memorial	Ext.		Exterior Access Route	Walkway

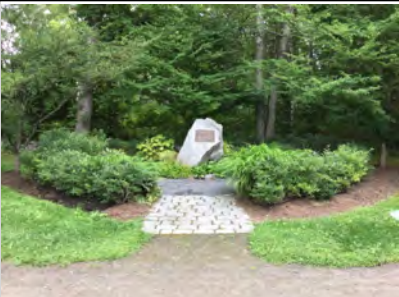
Surface openings > 1/2" Running slope > 1:20 (5%)	1.5" 10.1%	Ensure that surface has openings that are 1/2" max. and the long opening dimension is perpendicular to the dominant direction of travel. Reduce running slope to be no steeper than 1:20 (5%). (Cost estimate for a 14' long 4' wide stone dust route.)	1	560	\$560

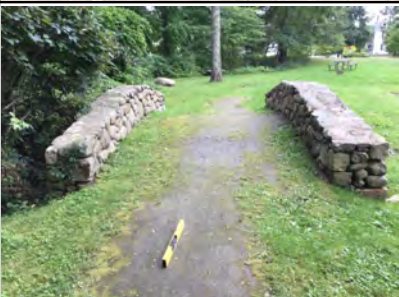
4	Walkway South of Pond	Ext.		Exterior Access Route	Walkway

Running slope > 1:20 (5%)	7.3%	Reduce running slope to be no steeper than 1:20 (5%). (Cost estimate for a 6' long 4' wide stone dust area.)	1	240	\$240
5	Walkway South of Pond	Ext.		Exterior Access Route	Walkway

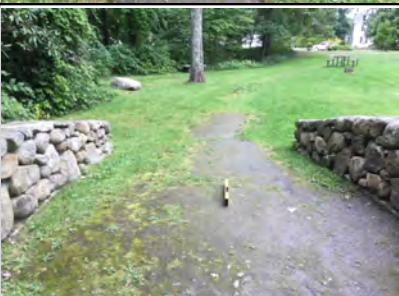
Running slope > 1:20 (5%)	9.7%	Reduce running slope to be no steeper than 1:20 (5%). (Cost estimate for a 12' long 4' wide stone dust area.)	1	480	\$480

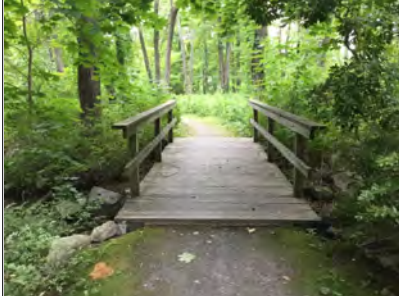
ID	Location	Floor	Room	Element	Type	Photo	Issues	Current Measure	Recommendations	Quantity	Price	Cost Estimation
6	Dogwood Path	Ext.		Exterior Access Route	Walkway

Level changes > 1/4"	3"	Alter change in level to be 1/4" high max. (Cost estimate for providing a 12' by 4' stone dust area.)	1	480	\$480
7	Dogwood Path Bridge	Ext.		Exterior Access Route	Walkway

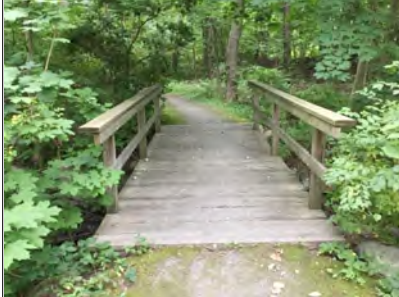
Level changes > 1/4"	1.25"	Alter change in level to be 1/4" high max. (Cost estimate for providing a 4' by 4' stone dust area.)	1	160	\$160
8	Walkway from Pond to Concord Road	Ext.		Exterior Access Route	Walkway

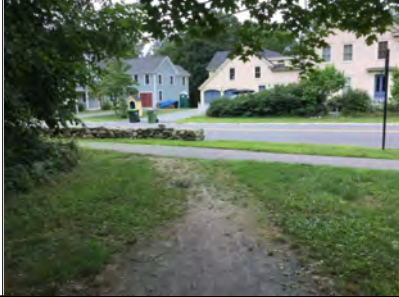
Route not maintained in operable working condition Vertical clearance < 80" above ground	- 74"	Ensure the accessible route is maintained in operable working condition. Trim low hanging tree branches. (Cost estimate for a 20' long 4' wide stone dust route.)	1	840	\$840
9	Cricket Pond	Ext.		Exterior Access Route	Exterior

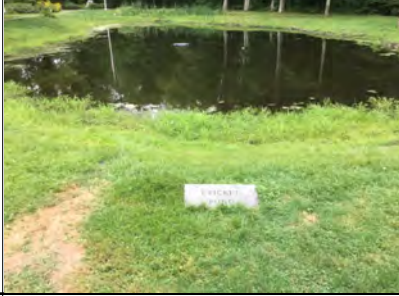
Accessible route not provided	-	Locate sign identifying pond on an accessible route.	1	Labor	\$0

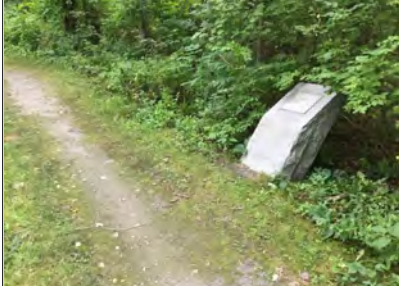
10	Dogwood Path Plaque	Ext.		Exterior Access Route	Exterior

Accessible route not provided	-	Ensure an accessible route is provided to the plaque. (Cost estimate for a 6' long by 4' wide stone dust walkway.)	1	192	\$192

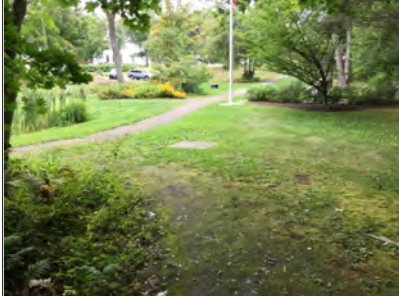
ID	Location	Floor	Room	Element	Type	Photo	Issues	Current Measure	Recommendations	Quantity	Price	Cost Estimation
11	Entrance from Dogwood Path to 9/11 Memorial	Ext.		Exterior Access Route	Exterior

Accessible route not provided		Ensure an accessible route is provided between the dogwood path and the 9/11 Memorial path. (Cost estimate for a 20' long by 4' wide stone dust walkway.)	1	640	\$640
12	Near Stairs to Old Sudbury Road	Ext.		Exterior Access Route	Exterior

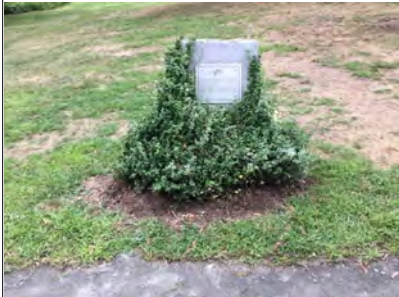
Accessible route not provided	-	Ensure an accessible route is provided. (Cost estimate for a 6' long by 4' wide stone dust walkway.)	1	192	\$192
13	Plaque Along Walkway by Pond and 9/11 Memorial	Ext.		Exterior Access Route	Exterior

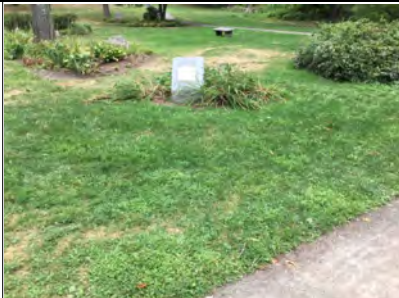
Accessible route not provided	-	Ensure an accessible route is provided. (Cost estimate for a 10' long by 4' wide stone dust walkway.)	1	320	\$320
14	Walkway from Pond to Concord Road	Ext.		Exterior Access Route	Exterior

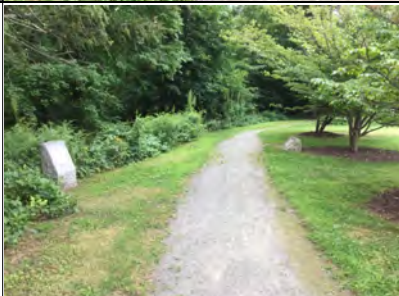
Accessible route not provided	-	Ensure an accessible route is provided to each plaque. (Cost estimate for a 6' long by 4' wide stone dust walkway.)	2	192	\$384

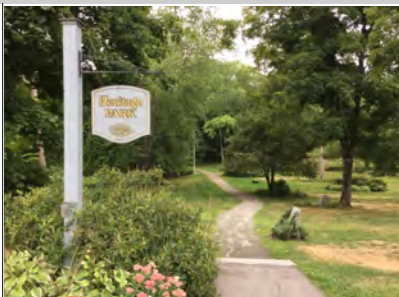
<b>Entrance</b>												
15	Main Entrance from Old Sudbury Road	Ext.		Entrance	Main Entrance

Entrance not on an accessible route		Provide a directional sign indicating the location of the nearest accessible entrance.	1	346	\$346
<b>Access to Goods and Services</b>

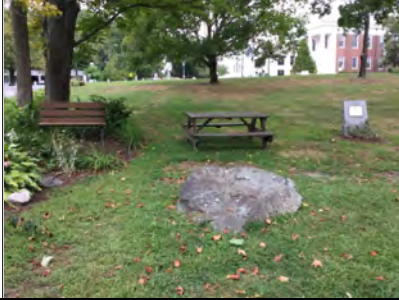
Toe or knee clearance at table not provided Picnic table not on an accessible route	- -	Provide at least one picnic table with top between 28"- 34" above the ground and 27" clear height underneath. Ensure that the dining surface is connected to an accessible route. (Cost for an accessible picnic table.)	1	1400	\$1400
18	Walkway South of Pond	Ext.		Picnic Tables	N/A

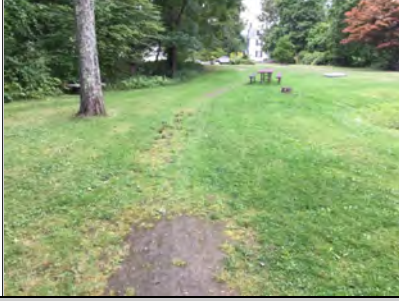
Toe or knee clearance at table not provided Picnic table not on an accessible route	14.75" deep -	Provide at least one picnic table with top between 28"- 34" above the ground and 27" clear height underneath. Ensure that the dining surface is connected to an accessible route. (Cost estimate for 20' long 4' wide stone dust walkway and a new accessible picnic table.)	1	2040	\$2040

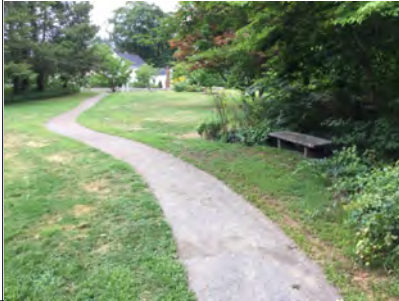
<b>Benches</b>												
19	Along Walkway by Pond	Ext.		Benches	N/A

No accessible route to one bench in this area		Provide an accessible route to at least one bench in this area. (Cost estimate for a 10' long by 4' wide stone dust walkway.)	1	320	\$320
20	Dogwood Path Bench After Bridge by 9/11 Memorial	Ext.		Benches	N/A

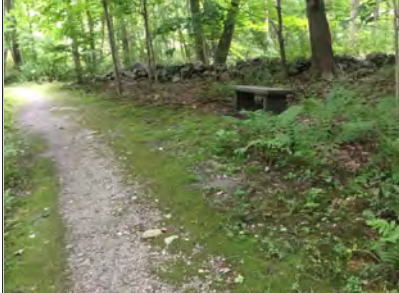
No accessible route to one bench in this area		Provide an accessible route to at least one bench in this area. (Cost estimate for a 10 long by 4' wide stone dust walkway.)	1	320	\$320

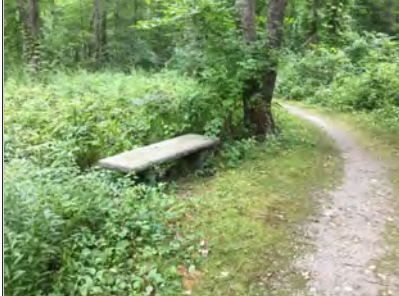
ID	Location	Floor	Room	Element	Type	Photo	Issues	Current Measure	Recommendations	Quantity	Price	Cost Estimation
21	Dogwood Path Bench Before Bridge by Concord Road	Ext.		Benches	N/A

No accessible route to one bench in this area	-	Provide an accessible route to at least one bench in this area. (Cost estimate for a 6' long by 4' wide stone dust walkway.)	1	192	\$192
22	Walkway from 9/11 Memorial to Pond	Ext.		Benches	N/A

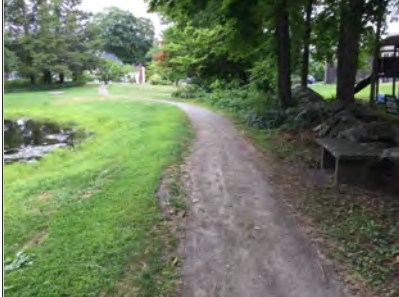
No accessible route to one bench in this area	-	Provide an accessible route to at least one bench in this area. (Cost estimate for a 6' long by 4' wide stone dust walkway.)	1	192	\$192
23	Walkway from Old Sudbury Road to 9/11 Memorial	Ext.		Benches	N/A

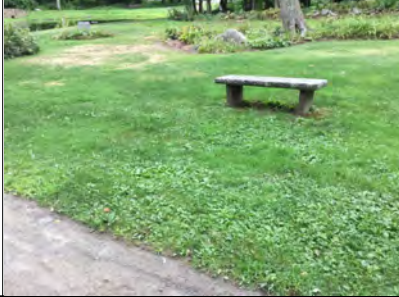
No accessible route to one bench in this area		Provide an accessible route to at least one bench in this area. (Cost estimate for a 10' long by 4' wide stone dust walkway.)	1	320	\$320
24	Walkway South of Pond	Ext.		Benches	N/A

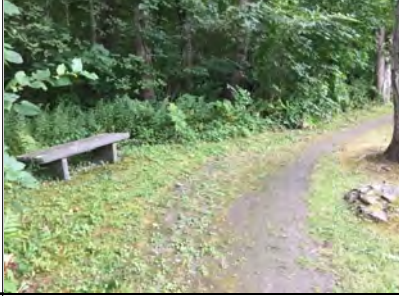
No accessible route to one bench in this area		Provide an accessible route to at least one bench in this area. (Cost estimate for a 6' long by 4' wide stone dust walkway.)	1	192	\$192

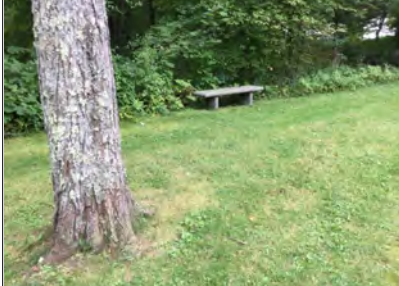
25	Walkway South of Pond	Ext.		Benches	N/A

No accessible route to one bench in this area		Provide an accessible route to at least one bench in this area. (Cost estimate for 10' long 4' wide stone dust walkway.)	1	320	\$320

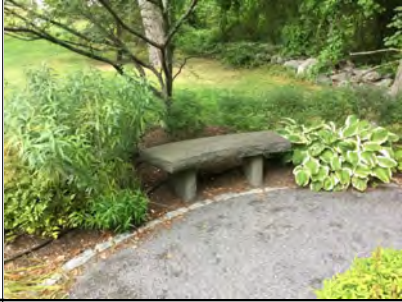
ID	Location	Floor	Room	Element	Type	Photo	Issues	Current Measure	Recommendations	Quantity	Price	Cost Estimation
26	9/11 Memorial	Ext.

Recommend providing space alongside one bench in each area for a wheelchair user to sit shoulder to shoulder with a person seated on the bench.	1	-	\$0
27	Main Entrance from Old Sudbury Road	Ext.

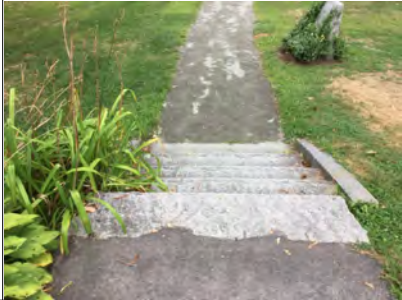
Recommend providing visual contrast strips at stair for safety and increased visibility.	1	-	\$0
28	Main Entrance from Old Sudbury Road	Ext.

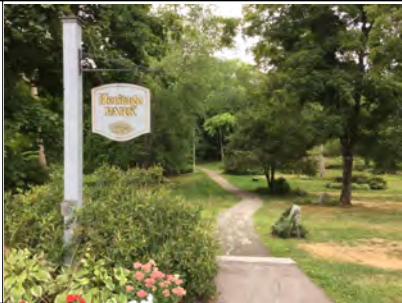
Recommend providing an accessible entrance to the park at this point if possible.	1	-	\$0
29	Near Pond	Ext.

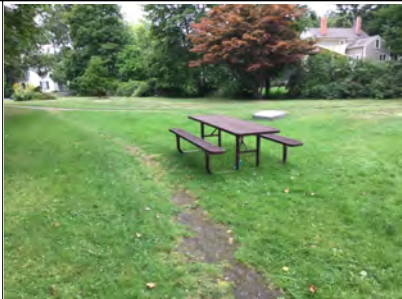
Recommend providing a 48" wide route around all sides of one picnic table in each area.	1	-	\$0

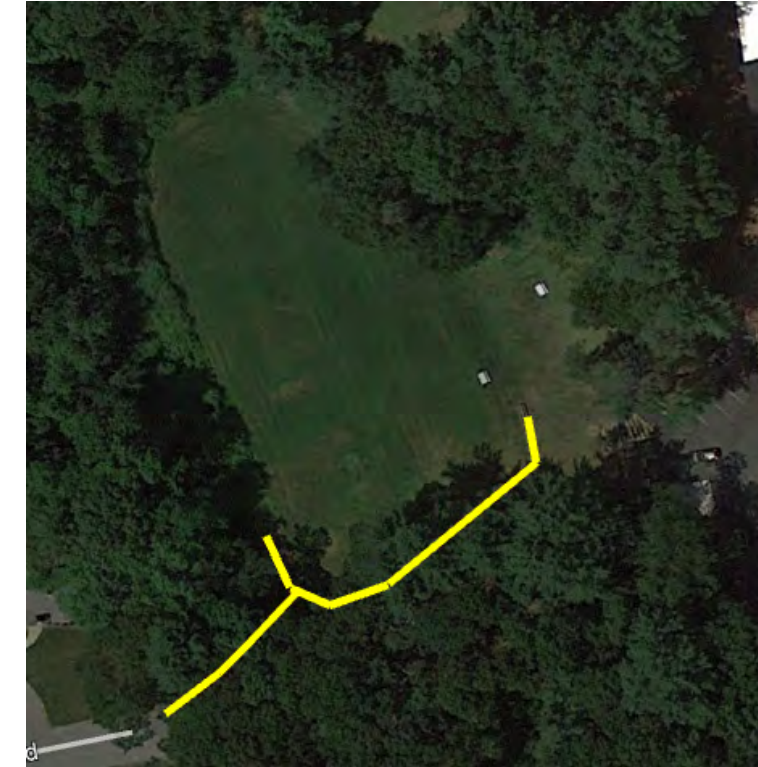
- Team and spectator seating benches lack a 36" by 48" clear floor space alongside them.

The diagram above shows a proposed accessible route to the sports field, team seating areas, spectator seating area and picnic area.

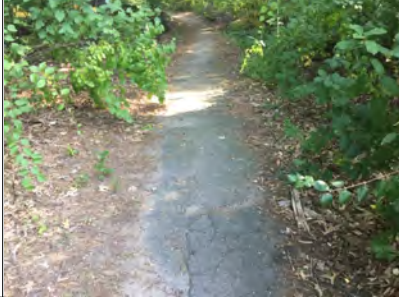
ID	Location	Floor	Room	Element	Type	Photo	Issues	Current Measure	Recommendations	Quantity	Price	Cost Estimation
<b>Approach and Entrance</b>												
<b>Exterior Access Route</b>												
1	Route from East End of Wilshire Road	Ext.		Exterior Access Route	Walkway

Exterior route < 48" wide Cross slope > 1:50 (2.00%) Running slope > 1:20 (5%) Route not maintained in operable working condition	23" 10.4% 10.1% -	Provide an accessible route to the field from Wilshire Road. (Cost estimate for a 100' long, 4' wide accessible stone dust route.)	1	3200	\$3200
<b>Access to Goods and Services</b>												
<b>Picnic Tables</b>												
2	Sunny Picnic Area	Ext.		Picnic Tables	N/A

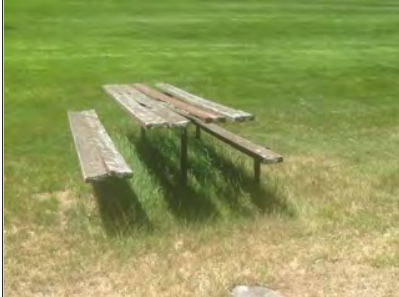
Toe or knee clearance at table not provided Picnic table not on an accessible route	- -	Provide at least one picnic table with top between 28"- 34" above the ground and 27" clear height underneath. Ensure that the picnic table is connected to an accessible route. (Cost estimate for a 130' long, 4' wide stone dust route and an accessible picnic table.)	1	5560	\$5560

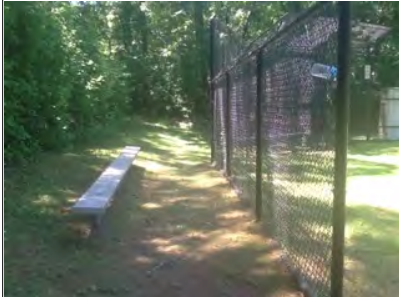
<b>Play and Sport Areas</b>												
<b>Field</b>												
3	East Team Seating Area	Ext.		Field	Baseball

Accessible spaces are not provided at team seating Not connected to an accessible-route	- -	Provide a 36" x 48" clear floor space at team seating alongside the bench. Provide an accessible route to the team seating area. (Cost estimate for a 36" by 48" stone dust clear floor space alongside the bench and a 30' long, 4' wide accessible stone dust route from the edge of the field to the team seating area.)	1	1056	\$1056
4	West Team Seating Area	Ext.		Field	Baseball

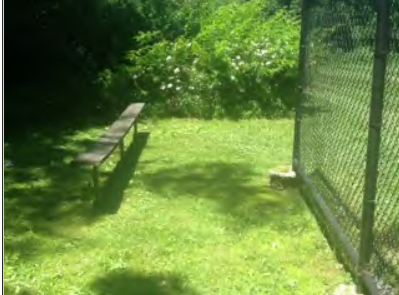
Accessible spaces are not provided at team seating Not connected to an accessible-route	- -	Provide a 36" x 48" clear floor space at team seating. Provide an accessible route to the team seating area. (Cost estimate for a 36" by 48" stone dust clear floor space alongside the bench and a 30' long, 4' wide accessible stone dust route from the spectator seating area to the west team seating area.)	1	1152	\$1152

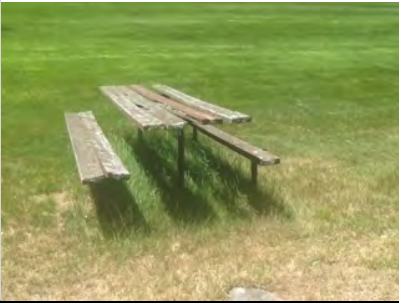
-	Recommend providing a 48" wide min. stable, firm and slip resistant surface under and around an accessible picnic table.	1	-	\$0

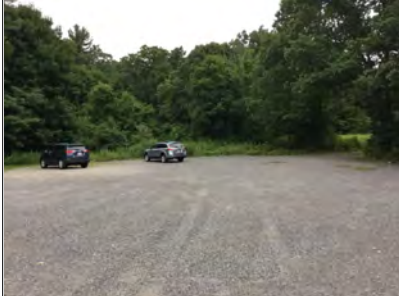
ID	Location	Floor	Room	Element	Type	Photo	Issues	Current Measure	Recommendations	Quantity	Price	Cost Estimation
1	Parking Lot	Ext.		Off-Street Parking Lot or Garage	N/A

Total # of parking Total # of designated accessible parking spaces	112 est. 0	Based on 112 estimated parking spaces, provide four (4) car accessible parking spaces and one (1) van accessible parking space.	5	800	\$4000
2	Route from Parking Lot to Field	Ext.		Exterior Access Route	Exterior

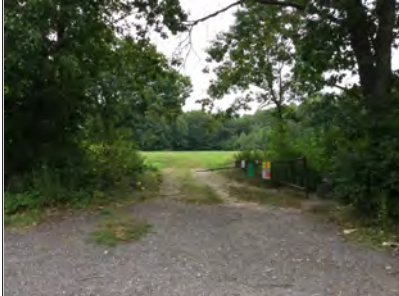
Accessible route not provided	-	Ensure an accessible route is provided. (Cost estimate for a 70' long, 4' wide stone dust route.)	1	2240	\$2240

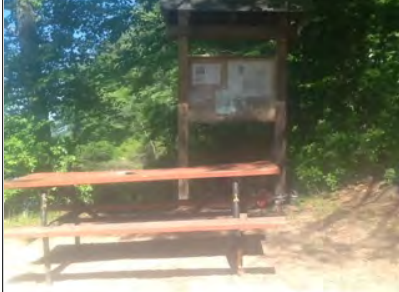
ID	Location	Floor	Room	Element	Type	Photo	Issues	Current Measure	Recommendations	Quantity	Price	Cost Estimation
<b>Approach and Entrance</b>												
<b>Exterior Access Route</b>												
1	Wayside Near Picnic Area and Dock	Ext.		Exterior Access Route	Exterior

Not provided from all site arrival points	-	Ensure an accessible route is provided to the wayside.(Relocate picnic table so it does not obstruct access to the clear floor space at the wayside.)	1	Labor	\$0
2	Path to Memorial	Ext.		Exterior Access Route	Walkway

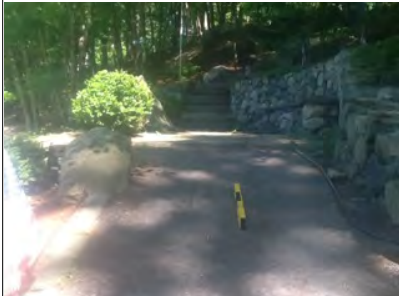
Running slope > 1:20 (5%)	16.4%	Reduce running slope to be no steeper than 1:20 (5%).  (Reducing running slope on path to memorial may be technically infeasible.)	1	-	\$0
3	Near Memorial and Exterior Stairs	Ext.		Exterior Access Route	Sidewalk

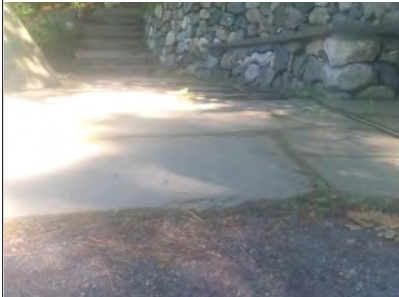
Level changes > 1/4"	1.5"	Alter change in level to be 1/4" high max.  (Cost based on a 4'x4' asphalt patch.)	1	160	\$160

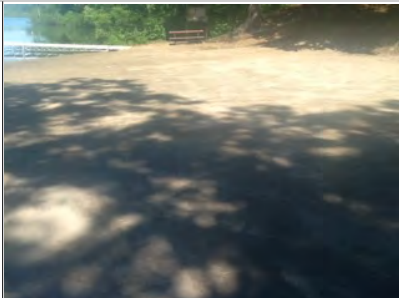
Level changes > 1/4"	1"	Alter change in level to be 1/4" high max.	1	Labor	\$0
<b>Off-Street Parking Lot or Garage</b>												
5	Parking Area Near Dock	Ext.		Off-Street Parking Lot or Garage	N/A

Total # of parking Total # of designated accessible parking spaces Total # of designated van accessible spaces Access aisle not provided Sign not provided Sign does not have the designation "Van Accessible"	5 - - - - -	Provide a compliant van accessible parking space with a marked access aisle 60" wide min. and no steeper than 1:48 (2.08%) in all directions. Provide a sign with the International Symbol of Accessibility (ISA) located 60" min. and 96" max. above the ground. Add the designation "Van Accessible" to the sign located at the van accessible space.	1	1850	\$1850

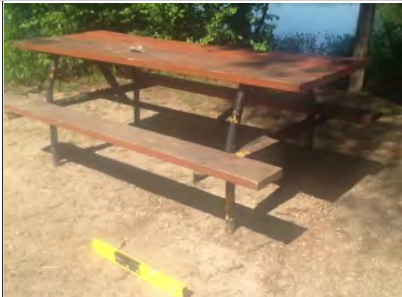
Recommend, since providing an accessible route to the memorial may be technically infeasible, including some photos and descriptions of the memorial at the wayside by the beach so individuals who are unable to access the memorial can see and learn about it.	1	-	\$0
<b>Picnic Table</b>												
8	Picnic Area by Dock	Ext.		icnic Table	N/A

Recommend providing a 48" wide min. stable, firm and slip resistant surface such as stone dust under and around an accessible picnic table once one is placed in the picnic area by the dock.	1	-	\$0

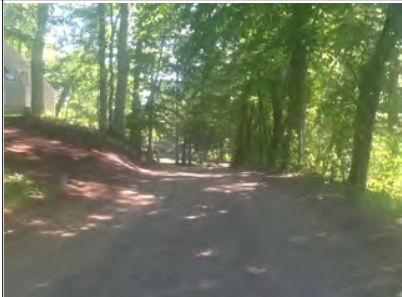
<b>Sign</b>												
9	Lake Shore Drive	Ext.		Sign	N/A

Recommend providing a sign at the intersection of Lake Shore Drive and Elmwood Avenue directing visitors to Willis Lake Park.	1	-	\$0
