UTILITY VEGETATION MANAGEMENT AND BULK ELECTRIC RELIABILITY
REPORT FROM THE FEDERAL ENERGY REGULATORY COMMISSION

SEPTEMBER 7, 2004

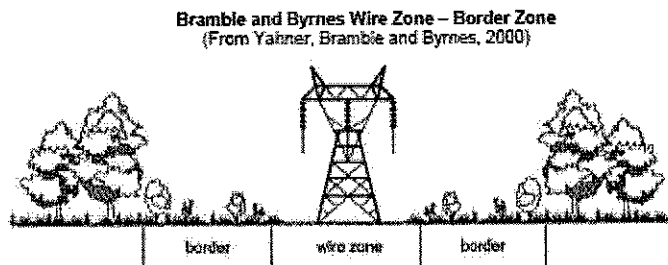
Several transmission owners employ a wire zone – border zone approach which is both environmentally friendly and effective in ensuring reliability. This method involves creating a low-growing vegetation environment directly under transmission lines, which physically prevents dangerous vegetation from encroaching into energized transmission facilities. The CNUC Final Vegetation Report stated that the wire zone-border zone has

“been proven to be effective in reducing and/or eliminating outages related to vegetation on transmission ROW [rights of way].”³⁰ The wire zone-border zone concept is depicted in the graphic below.

- Application of wire zone – border zone concepts (described below)
- Proper consideration of line sag and sway
- Frequent field inspection of vegetation conditions
- Comprehensive public education programs
