Mitigation Area Annual Report Eversource Sudbury to Hudson Transmission Reliability Project Sudbury, Massachusetts

OCTOBER 2023 - OCTOBER 2024

MITIGATION AREA ANNUAL REPORT EVERSOURCE SUDBURY TO HUDSON TRANSMISSION RELIABILITY PROJECT SUDBURY, MASSACHUSETTS

SWCA Project No. 67849

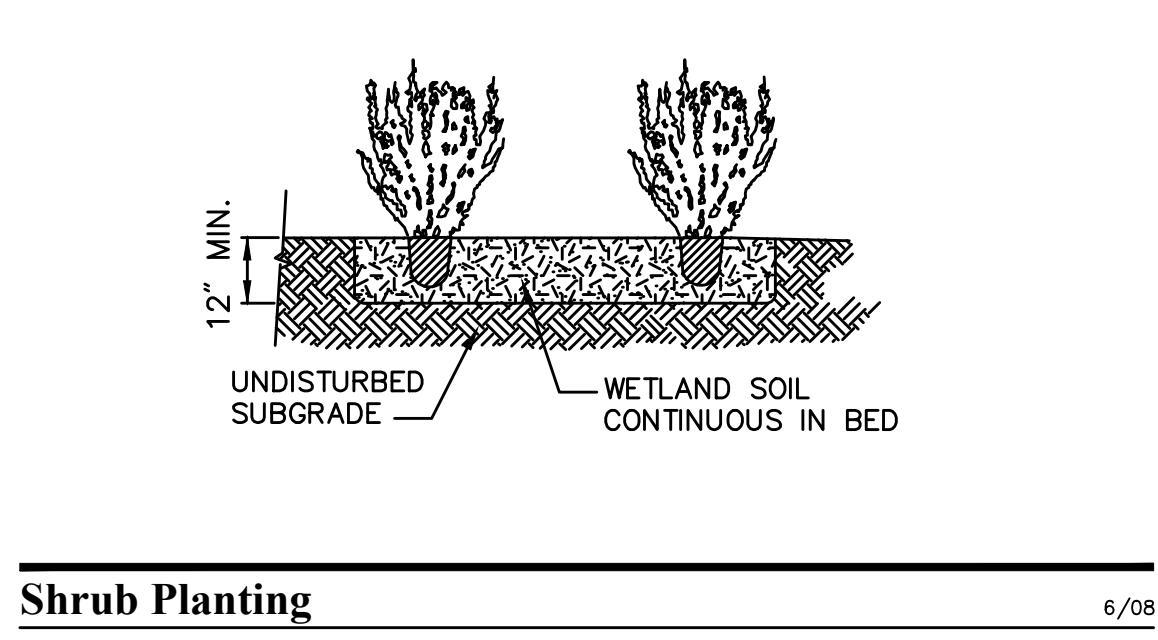
N.T.S. Source: VHB LD_691 WETLAND SEED × **GIANT BUR-REED** BUTTONBUSH MIX SWEET PEPPERBUSH ARROW ARUM REPLICATION AREA/WETLAND SEED MIX SILKY DOGWOOD TREE SNAG

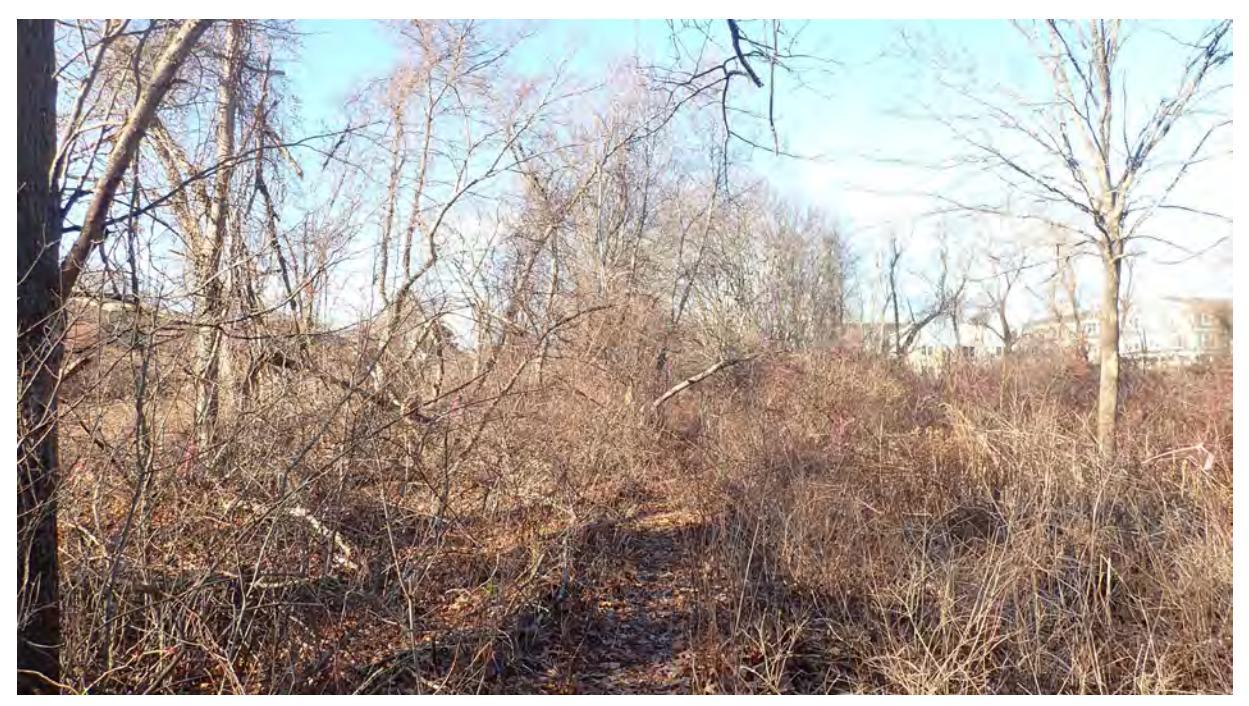
Photo #1: View of area proposed for wetland mitigation prior to construction. Railroad tracks are located in the center of the photo, the area proposed for mitigation is located on the left side of the railroad tracks. Photo taken November 18, 2022. *Facing west.*

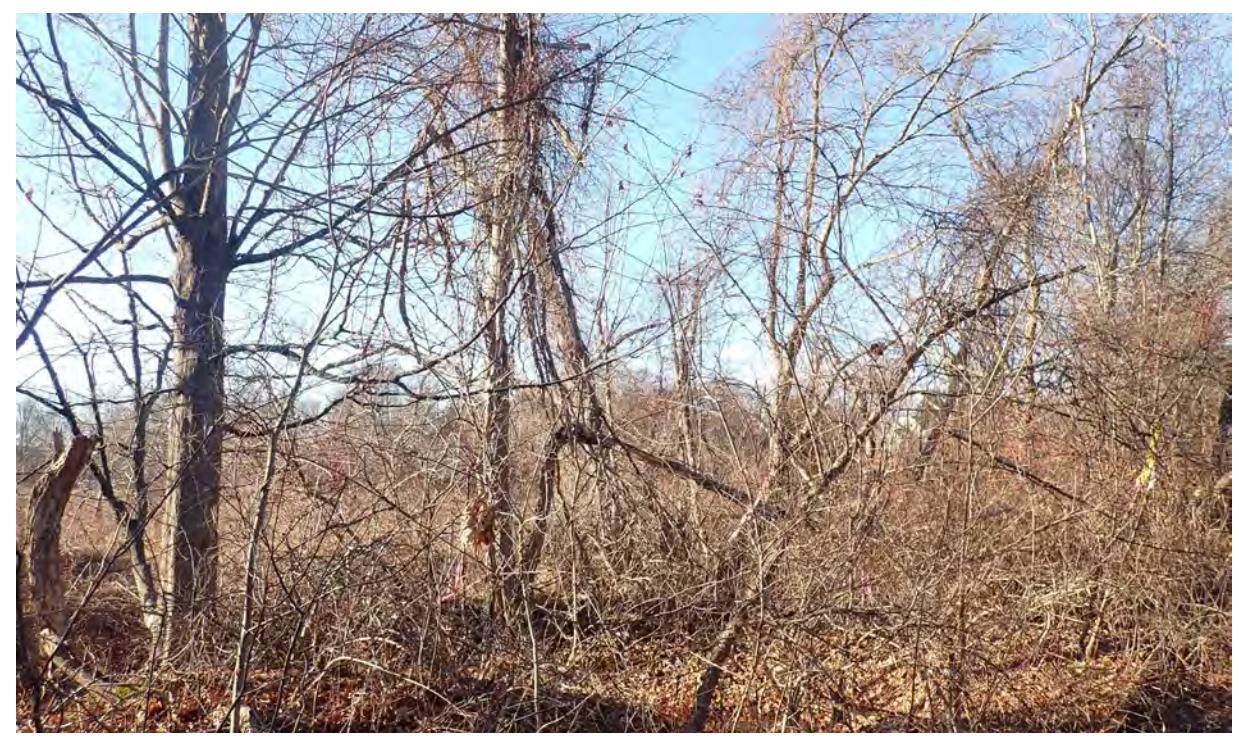
Photo #2: Another view of the area proposed for wetland mitigation prior to construction. Photo taken November 18, 2022. *Facing southwest*.

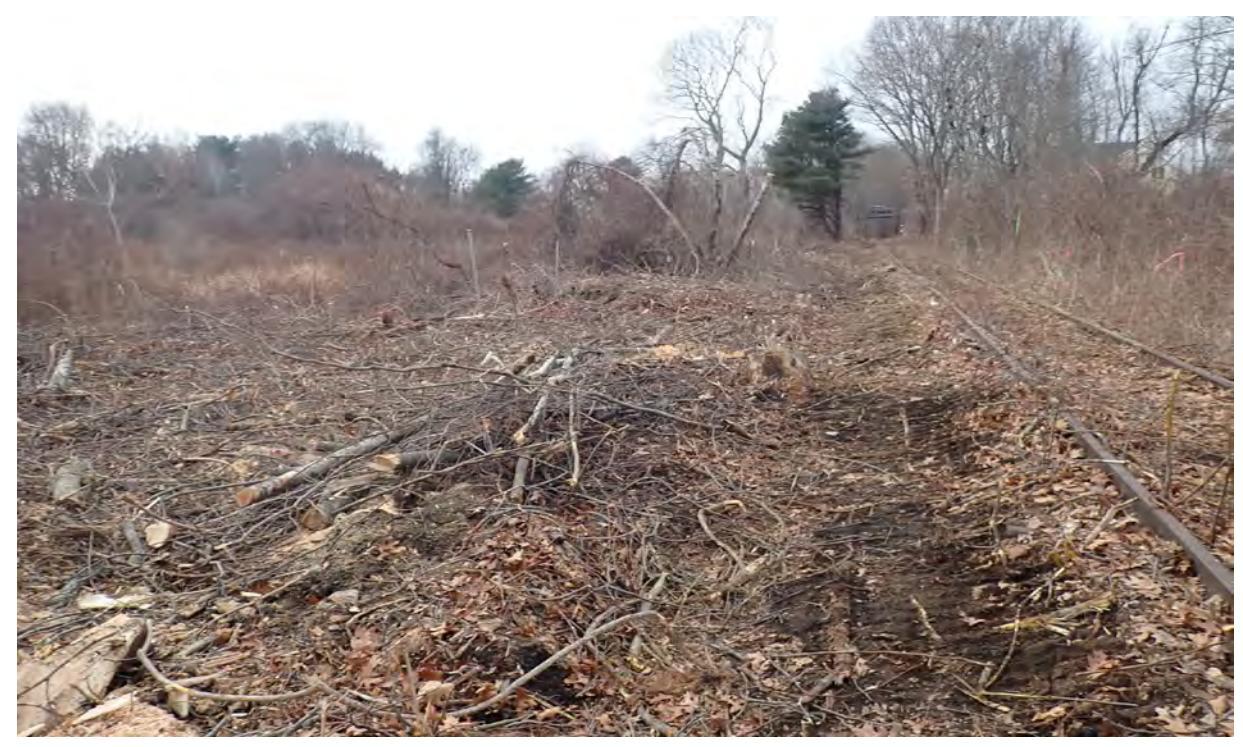
Photo #3: View of wetland mitigation area after tree removal. Photo taken December 22, 2022. *Facing west.*

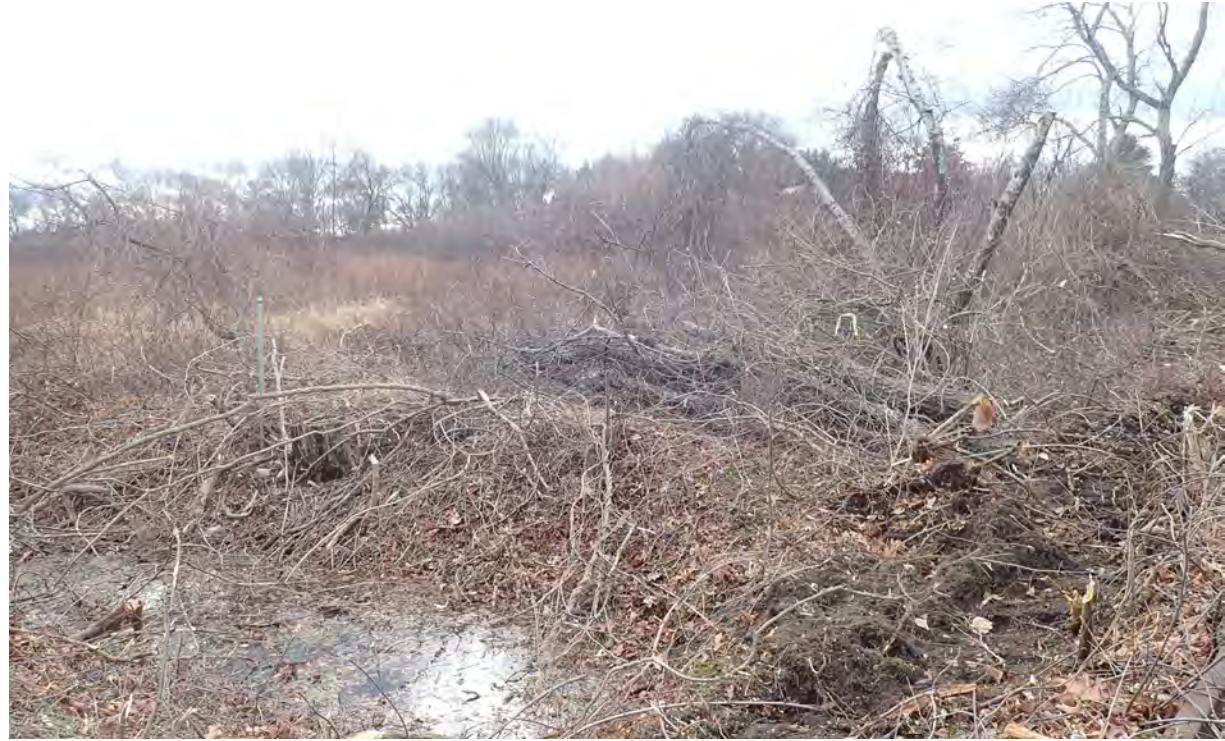
Photo #4: Another view of wetland mitigation area after tree removal. Photo taken December 22, 2022. *Facing southwest*.

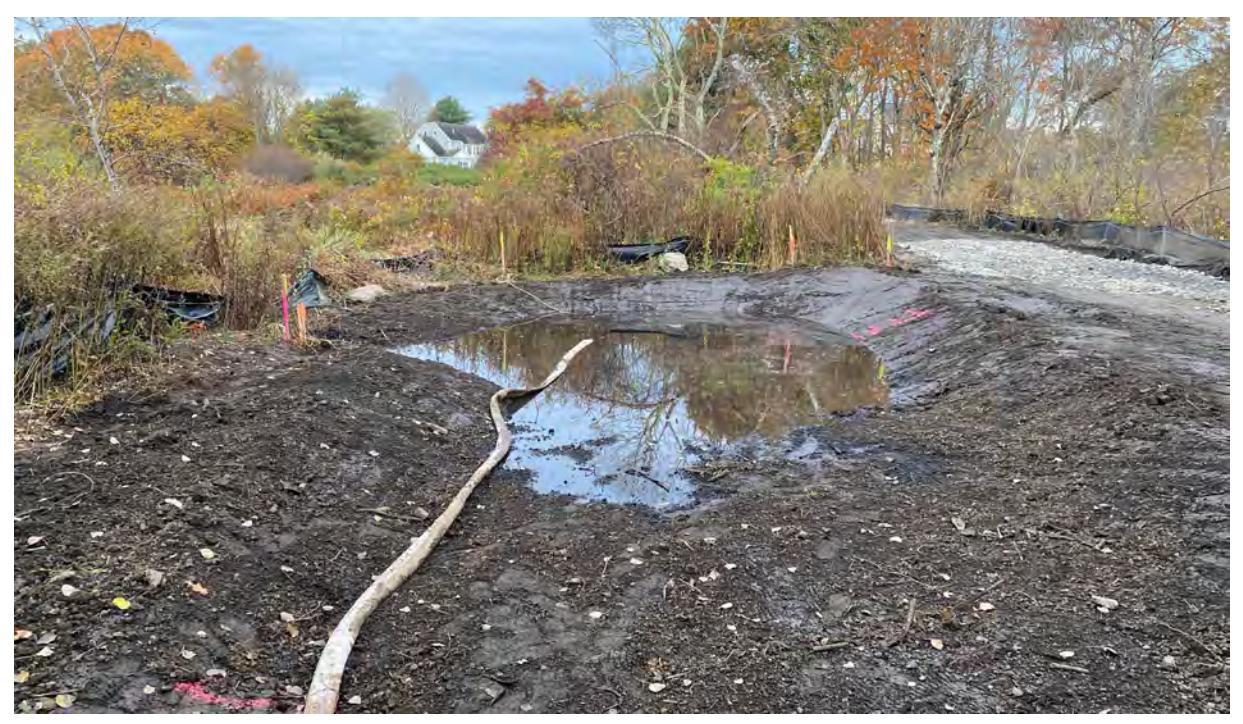
Photo #5: View of the wetland mitigation area after area was graded. Photo taken October 27, 2023. *Facing west*.

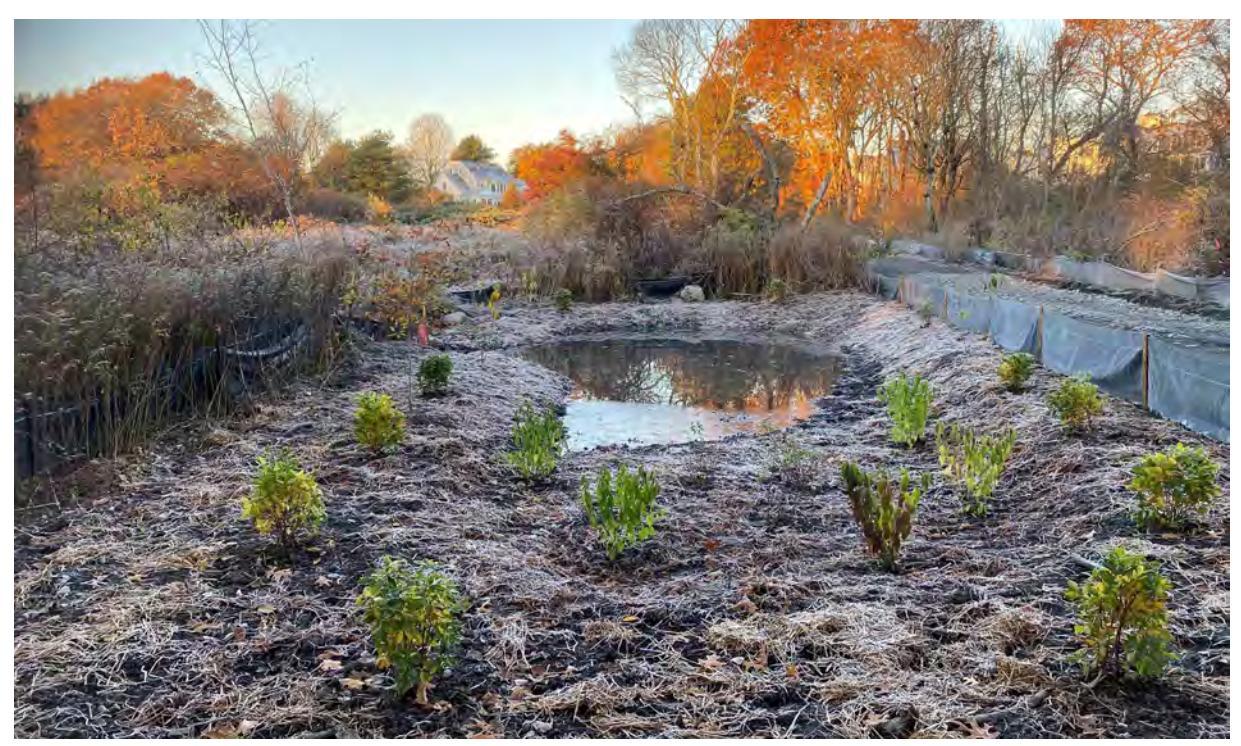
Photo #6: View of installed plantings within the wetland mitigation area. Understory was seeded with a wetland seed mix and stabilized with straw mulch. Photo taken October 27, 2023. *Facing west.*

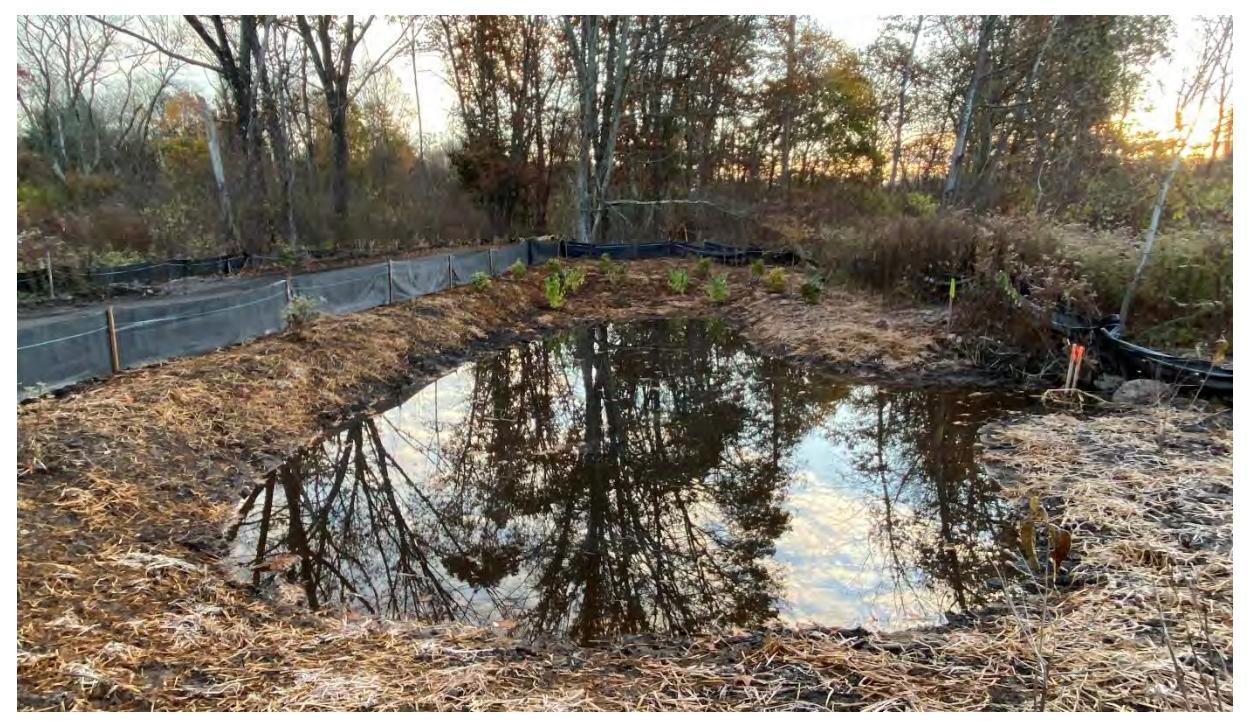
Photo #7: Another view of wetland mitigation area after plant installation. Photo taken October 27, 2023. *Facing east.*

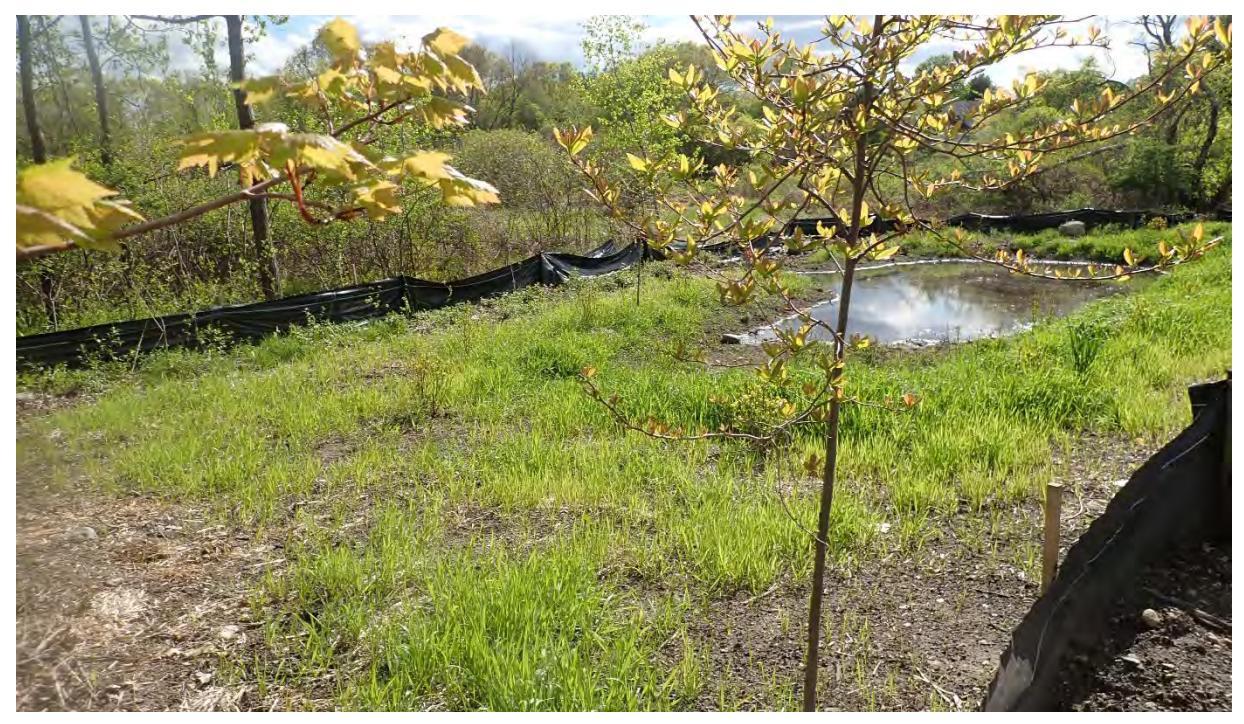
Photo #8: View of wetland mitigation area in May. The applied seed mix has started to germinate. Photo taken May 13, 2024. *Facing southwest*.

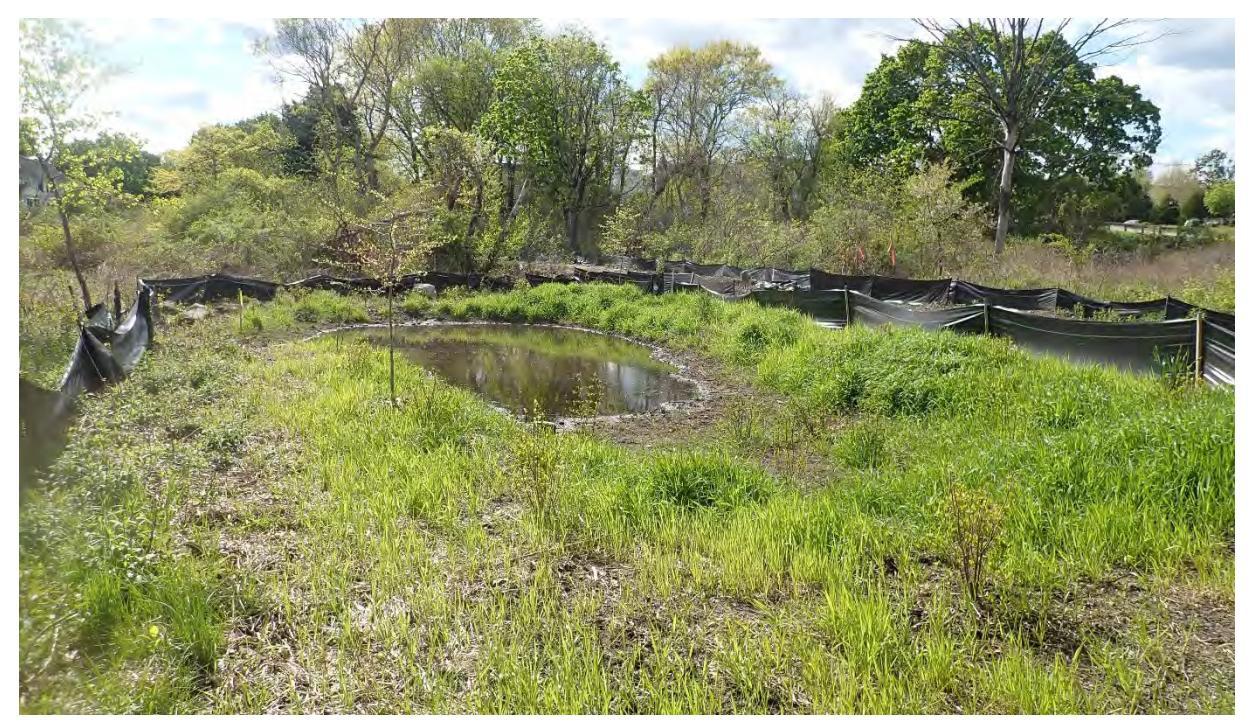
Photo #9: Another view of wetland mitigation area in May. Photo taken May 13, 2024. *Facing west.*

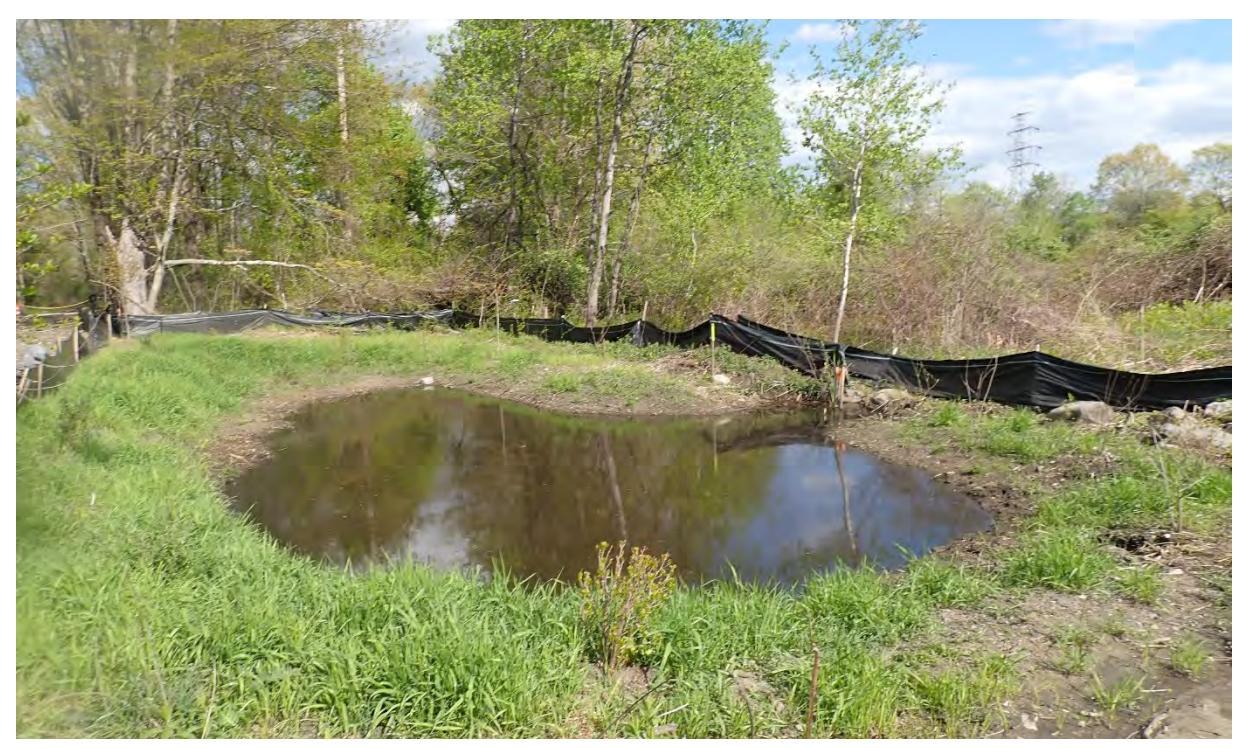
Photo #10: View of wetland mitigation area in May. Photo taken May 13, 2024. Facing east.

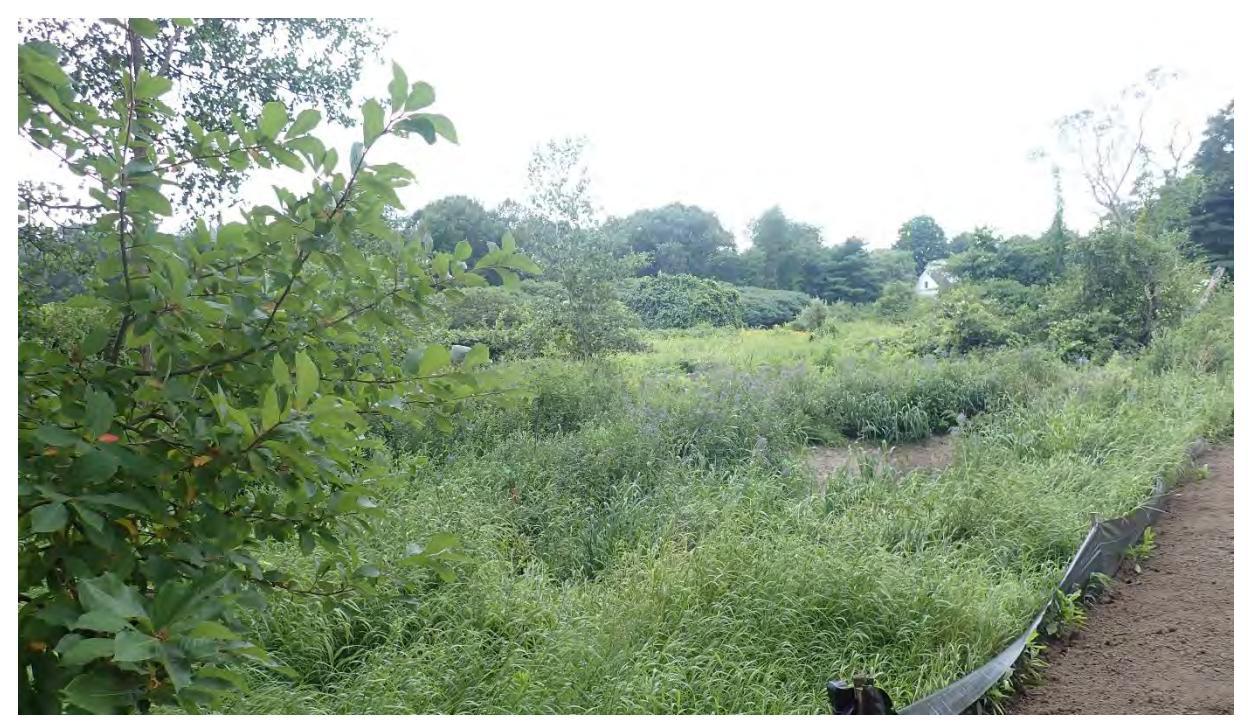
Photo #11: View of wetland mitigation area in July. Installed plantings all appear in good condition. Understory has fully revegetated. Photo taken July 30, 2024. *Facing southwest*.

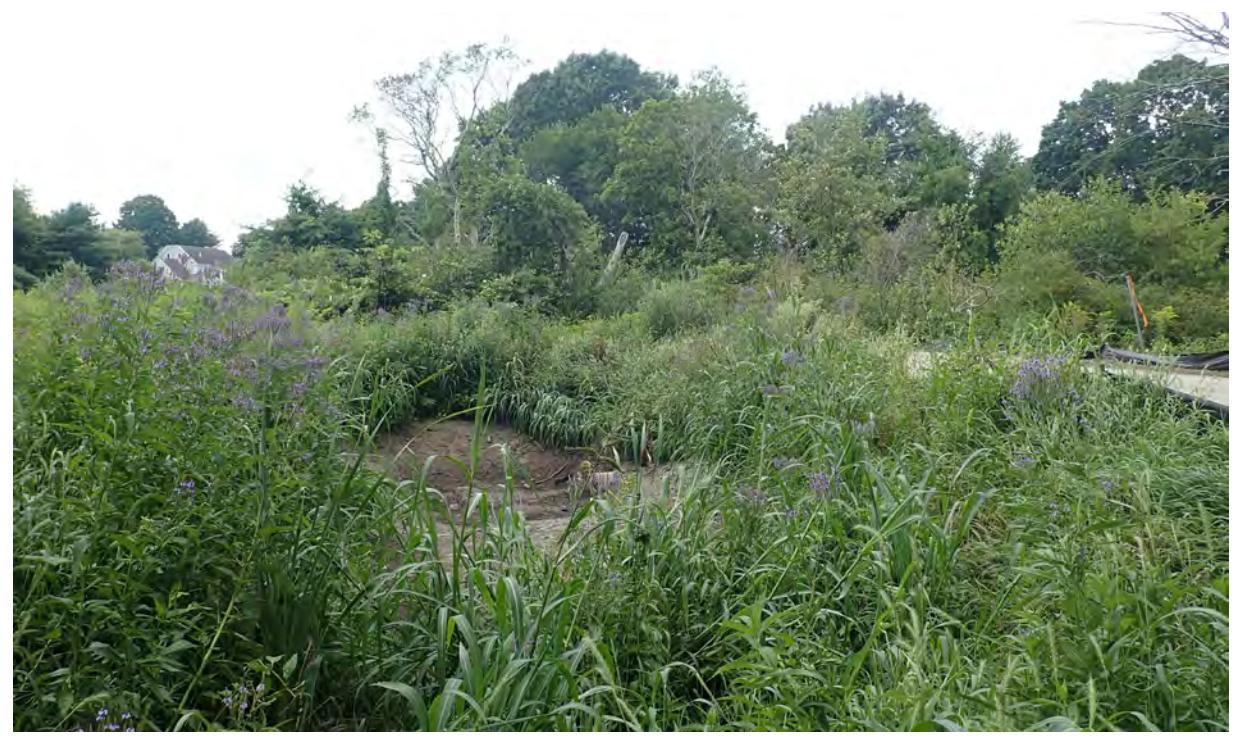
Photo #12: Another view of the wetland mitigation area in July. Photo taken July 30, 2024. *Facing west.*

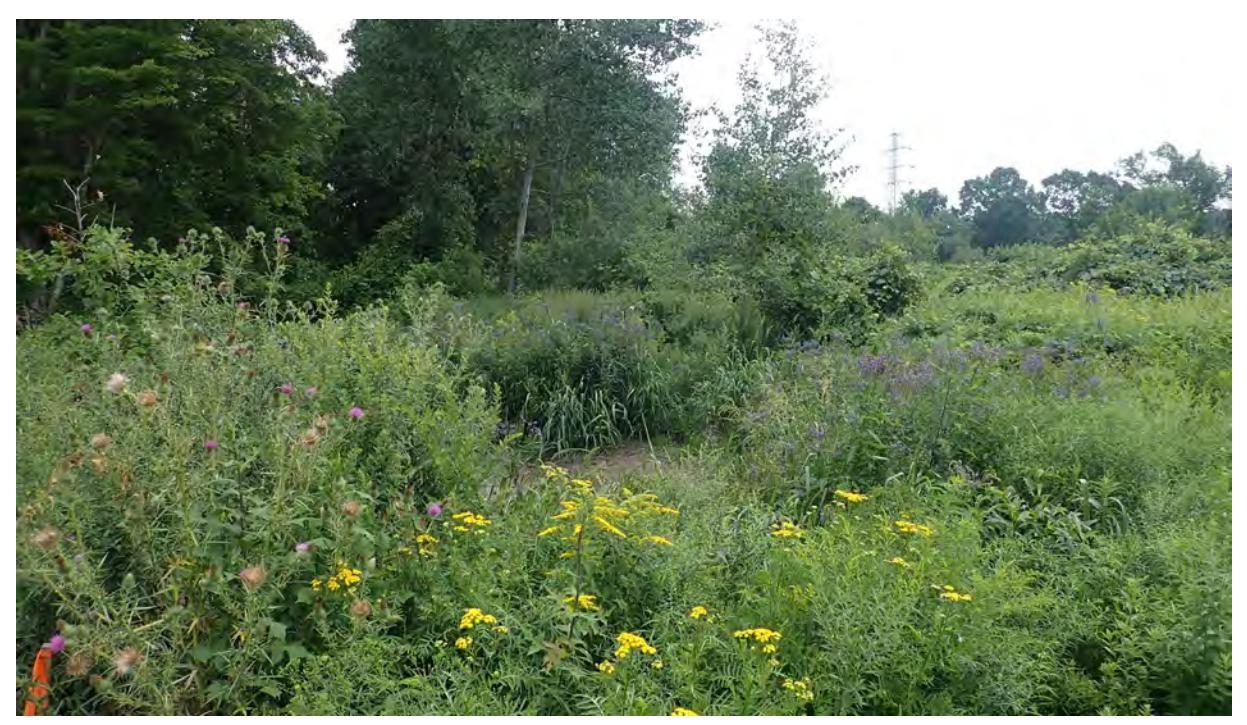
Photo #13: Another view of the wetland mitigation area in July. Photo taken July 30, 2024. *Facing southeast.*

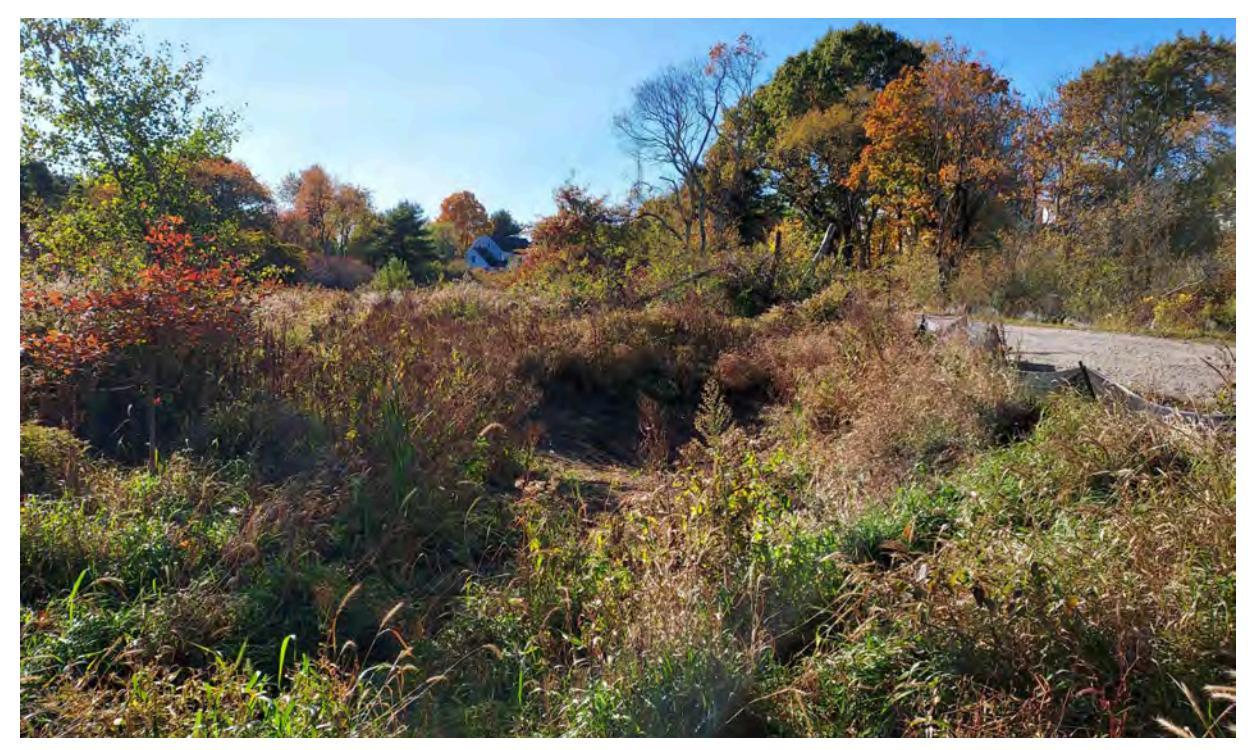
By the end of June 2024, the installed plantings had all survived and showed signs of additional growth. The understory of the mitigation area was densely vegetated with a variety of grasses. A patch of non-native common barnyard grass (*Echinochloa crus-galli*) was observed within the mitigation area. A SWCA restoration team removed the barnyard grass via hand pulling and applied additional a New England Wetland Seed Mix to the area between June 2024 and August 2024. During the annual review of the area in October 2024, there were no signs of barnyard grass within the mitigation area. The patch of mitigation area, where barnyard grass was removed and additional seed mix applied, did not show signs of germination of either the wetland seed mix or the non-native barnyard grass. The installed shrubs and trees were all present and appeared to be in good condition.

Photo #14: View of wetland mitigation area after barnyard grass was removed and additional New England wetland seed mix applied. Photo taken October 18, 2024. *Facing west*.

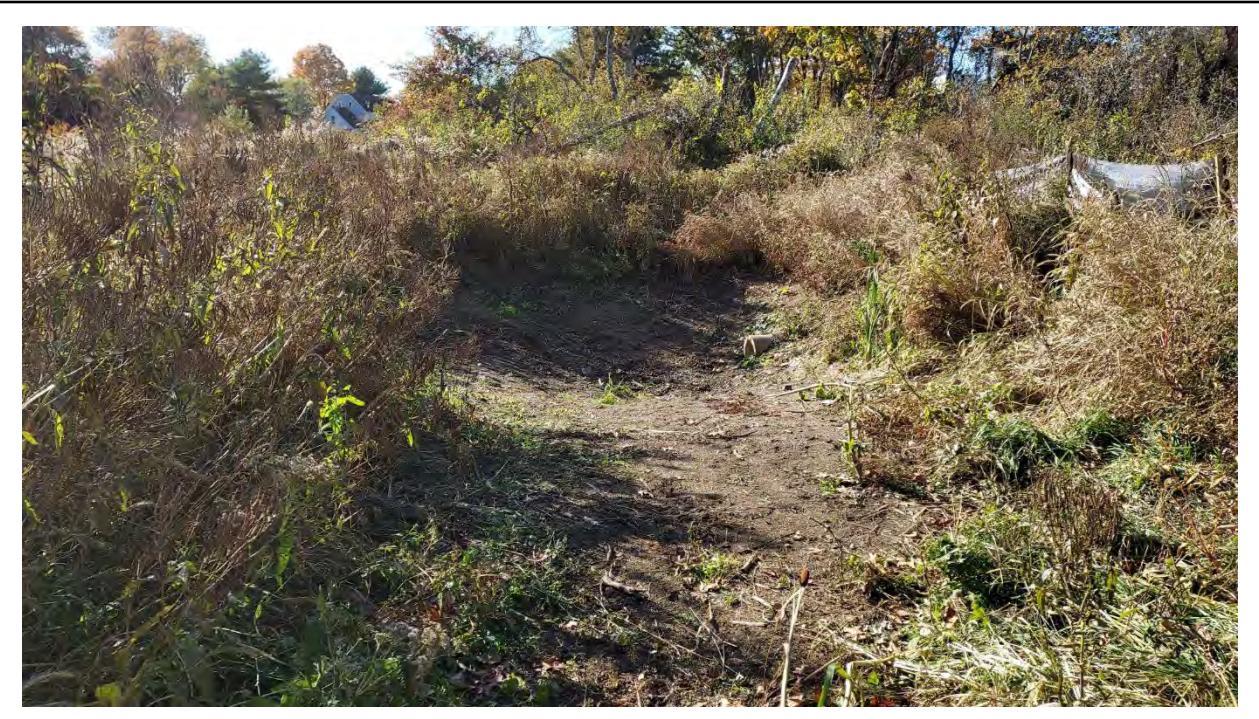
Photo #15: Another view of wetland mitigation area after barnyard grass was removed and additional New England wetland seed mix applied. No water present in the detention basin since July. Photo taken October 18, 2024. *Facing west*.

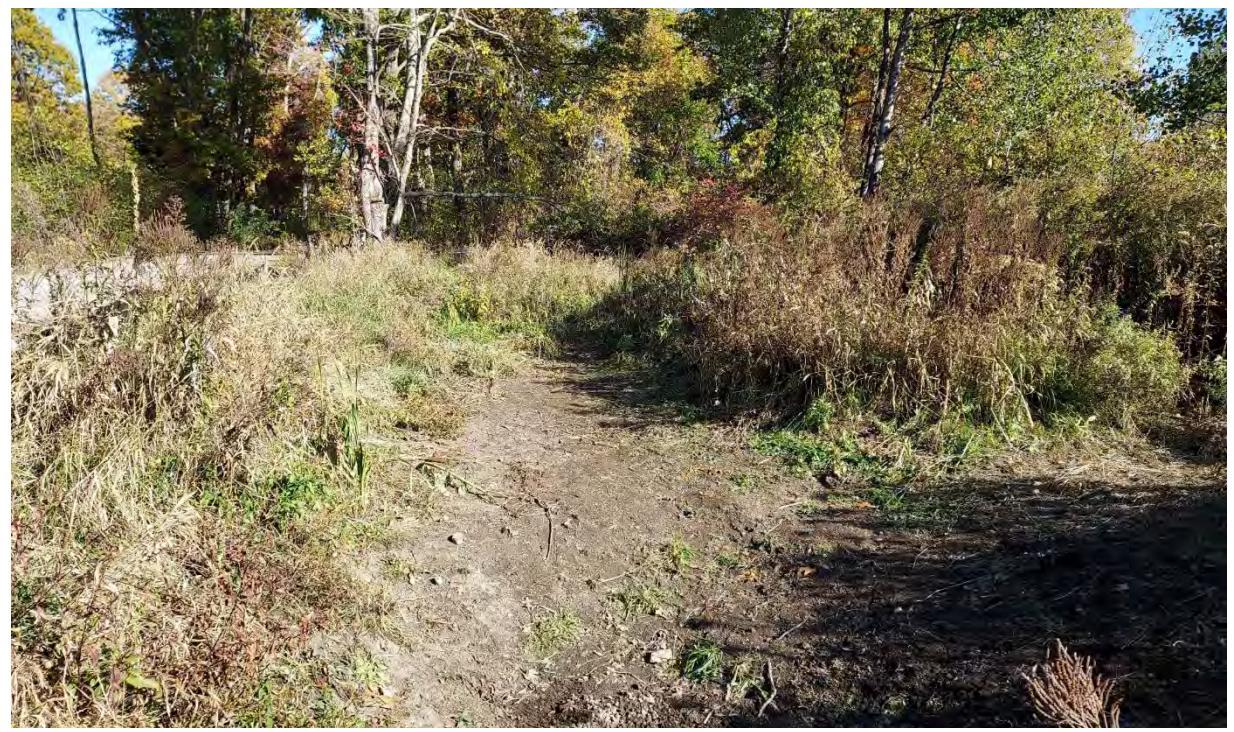
Photo #16: Another view of wetland mitigation area after barnyard grass was removed. The barnyard grass was removed from the slope leading towards the detention basin. Photo taken October 18, 2024. *Facing east.*

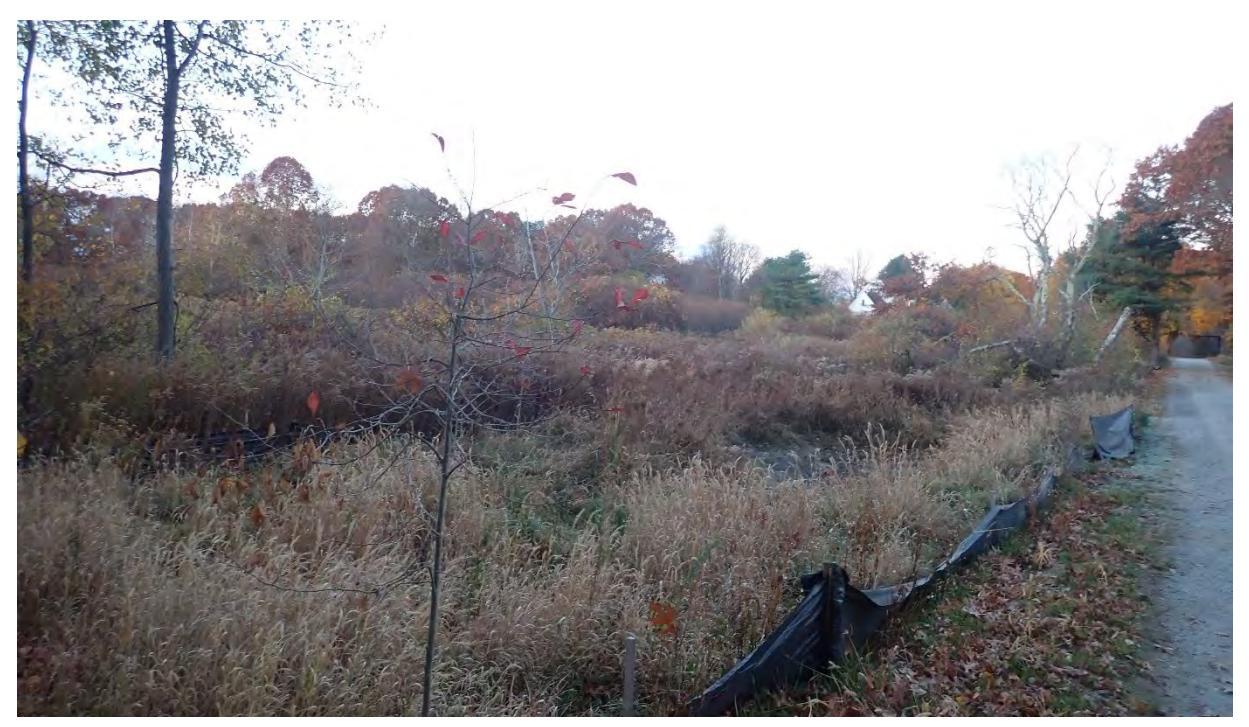
Photo #17: View of the wetland mitigation area in October. All of the installed shrubs and trees remain on site and appear to be in good condition. Photo taken October 28, 2024 *Facing southwest*.

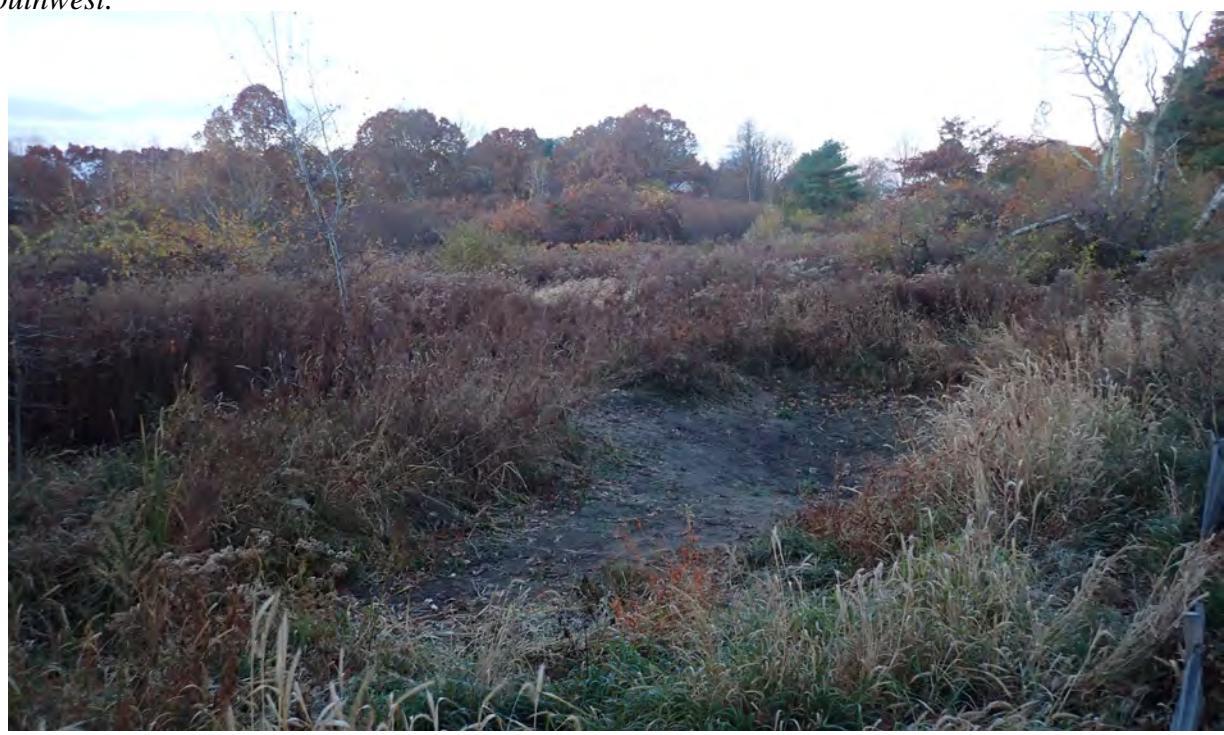
Photo #18: Another view of the wetland mitigation area in October. No water present within the detention basin. Small unvegetated patch on the slope of the detention basin was the location of the removed barnyard grass. Photo taken October 28, 2024 *Facing southwest*.

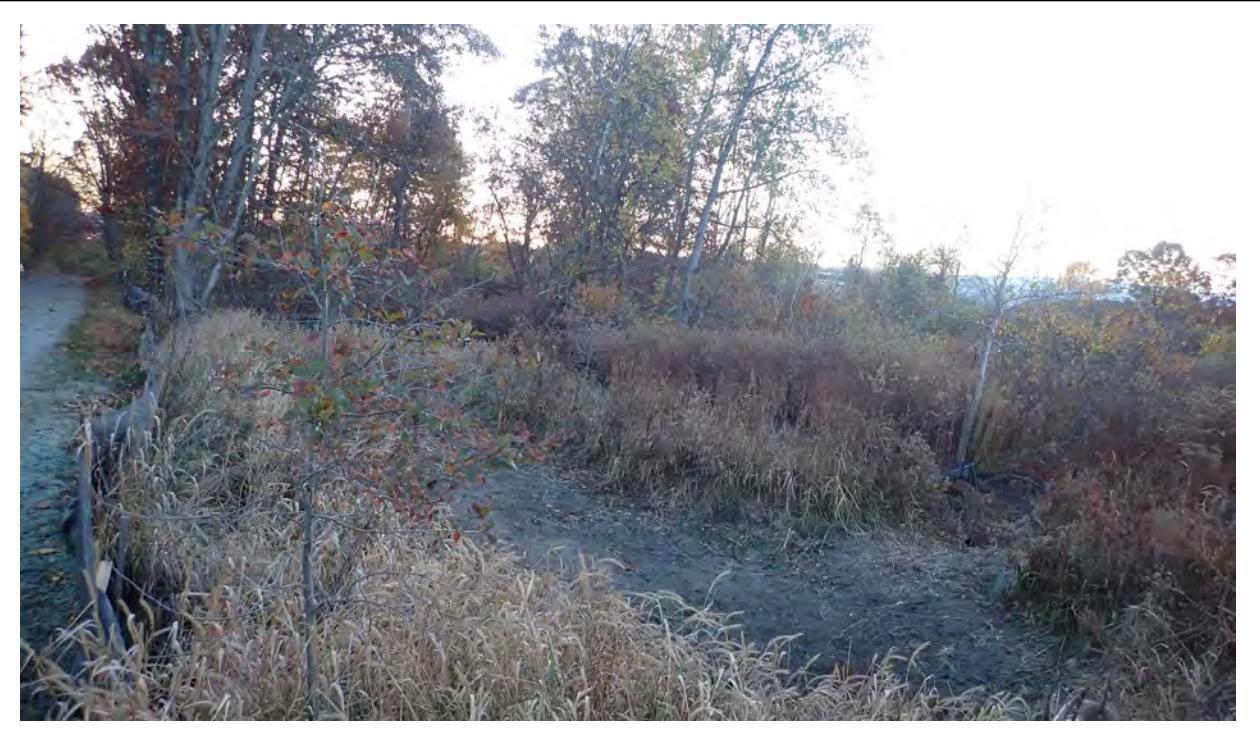
Photo #19: Another view of the wetland mitigation area in October. Photo taken October 28, 2024. *Facing southeast*.
