Rail Trails in Sudbury: Bridging the Past to the Future

BY LORI CAPONE, CONSERVATION COORDINATOR

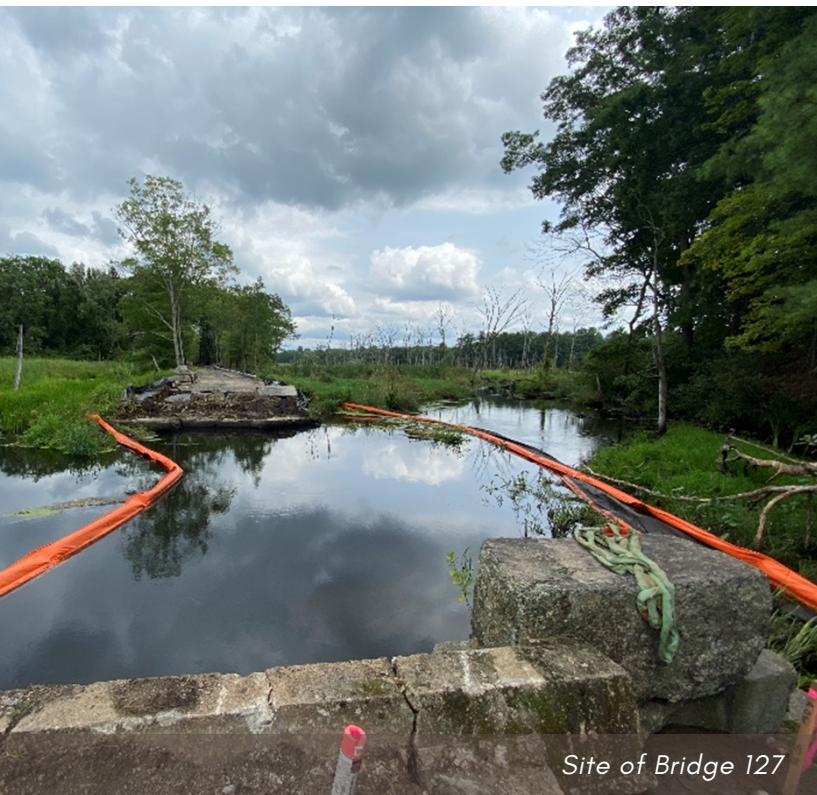
Site of Bridge 127

The footing installation at Bridge 127 was an impressive feat given its location on narrow peninsulas surrounded by water. The existing bridge was half submerged in Hop Brook. Weeks were spent driving interlocking metal sheets into the ground to create a watertight box. Soil was then excavated and concrete footings installed. This required a substantial amount of dewatering, contained within the limit of work. The superstructure has not yet been installed. The decking on Bridge 128 will be installed in the next few weeks.

Since my last article in the Spring, the most significant change within the Mass Central corridor was the bisection of the corridor with the removal of Bridge 127, shortly followed by Bridge 128. These bridges, both over Hop Brook, are two of the most beautiful locations within the corridor. Both removals were very different in scope. Bridge 127 was more degraded of the two bridges and dangerous to traverse. This structure was removed in its entirety in less than

half an hour. Following removal of Bridge 127, divers spent days hand removing underwater pieces. Alternately, Bridge 128, being more structurally sound, was only losing its rails, ties, and wooden footbridge that had been constructed atop. This took three hours to remove, but it was all in one piece.
