Re: Phase 2 of Sudbury–Hudson Transmission Reliability – Mass Central Rail Trail,
NHESP File No.: 15-34327

Corridor Management Plan for Massachusetts Central Rail Trail-Wayside Section and Sudbury-Hudson Transmission Reliability Project

**MassCentral Rail Trail (MCRT) – Wayside Section
Stormwater Management System
Operation and Maintenance Plan (O&M)
and
Long Term Pollution Prevention Plan (LTPPP)**

MASS CENTRAL RAIL TRAIL - WAYSIDE
 MASS CENTRAL RAIL TRAIL
 HUDSON, STOW, MARLBOROUGH & SUDBURY, MA

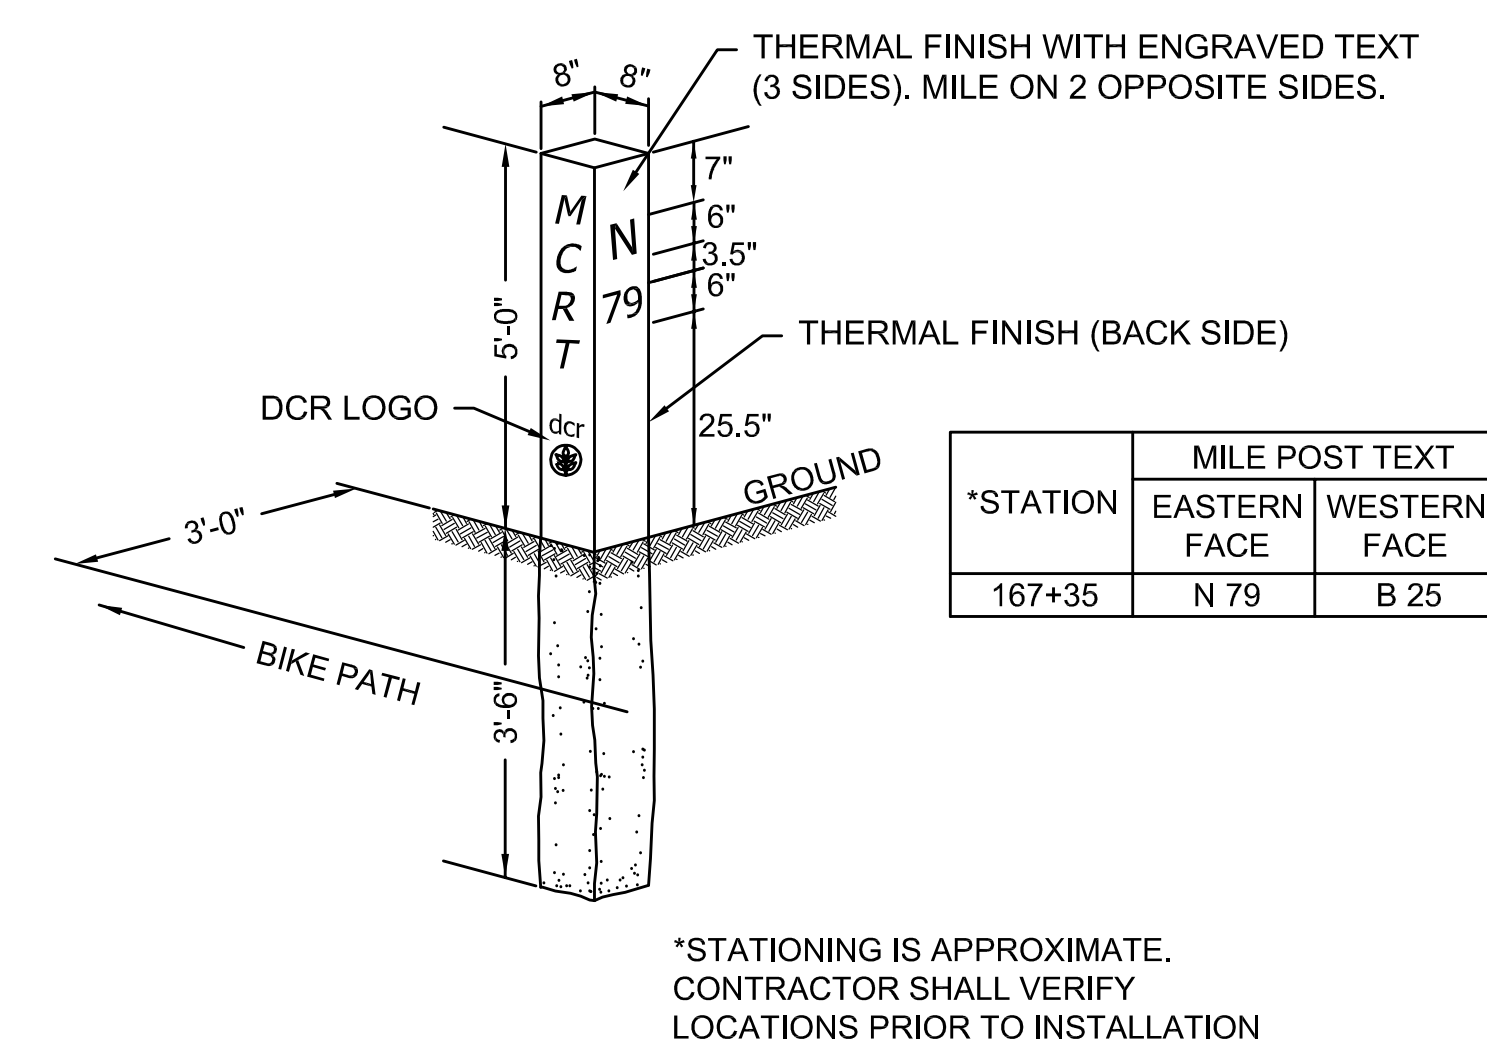
GRANITE MILE POST

NOTE:
 ALL LETTERING TO BE 1/2" "V"
 SUNK LETTER IN TACOMA TEXT

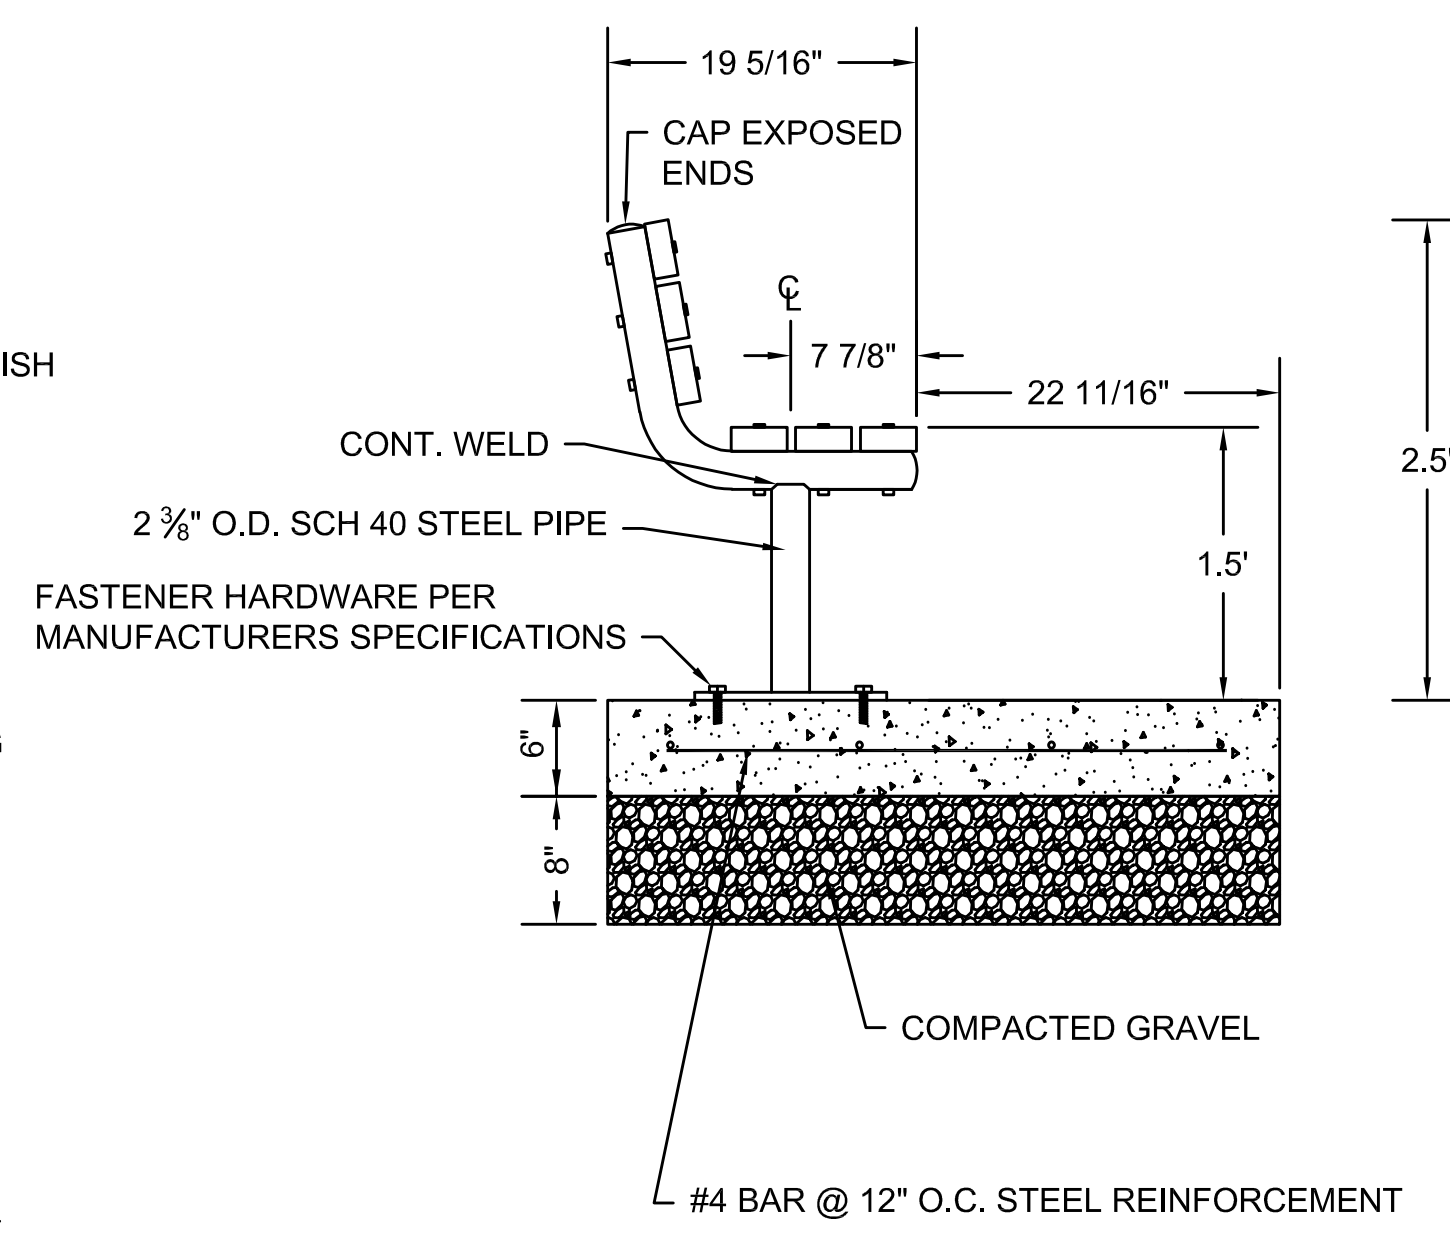
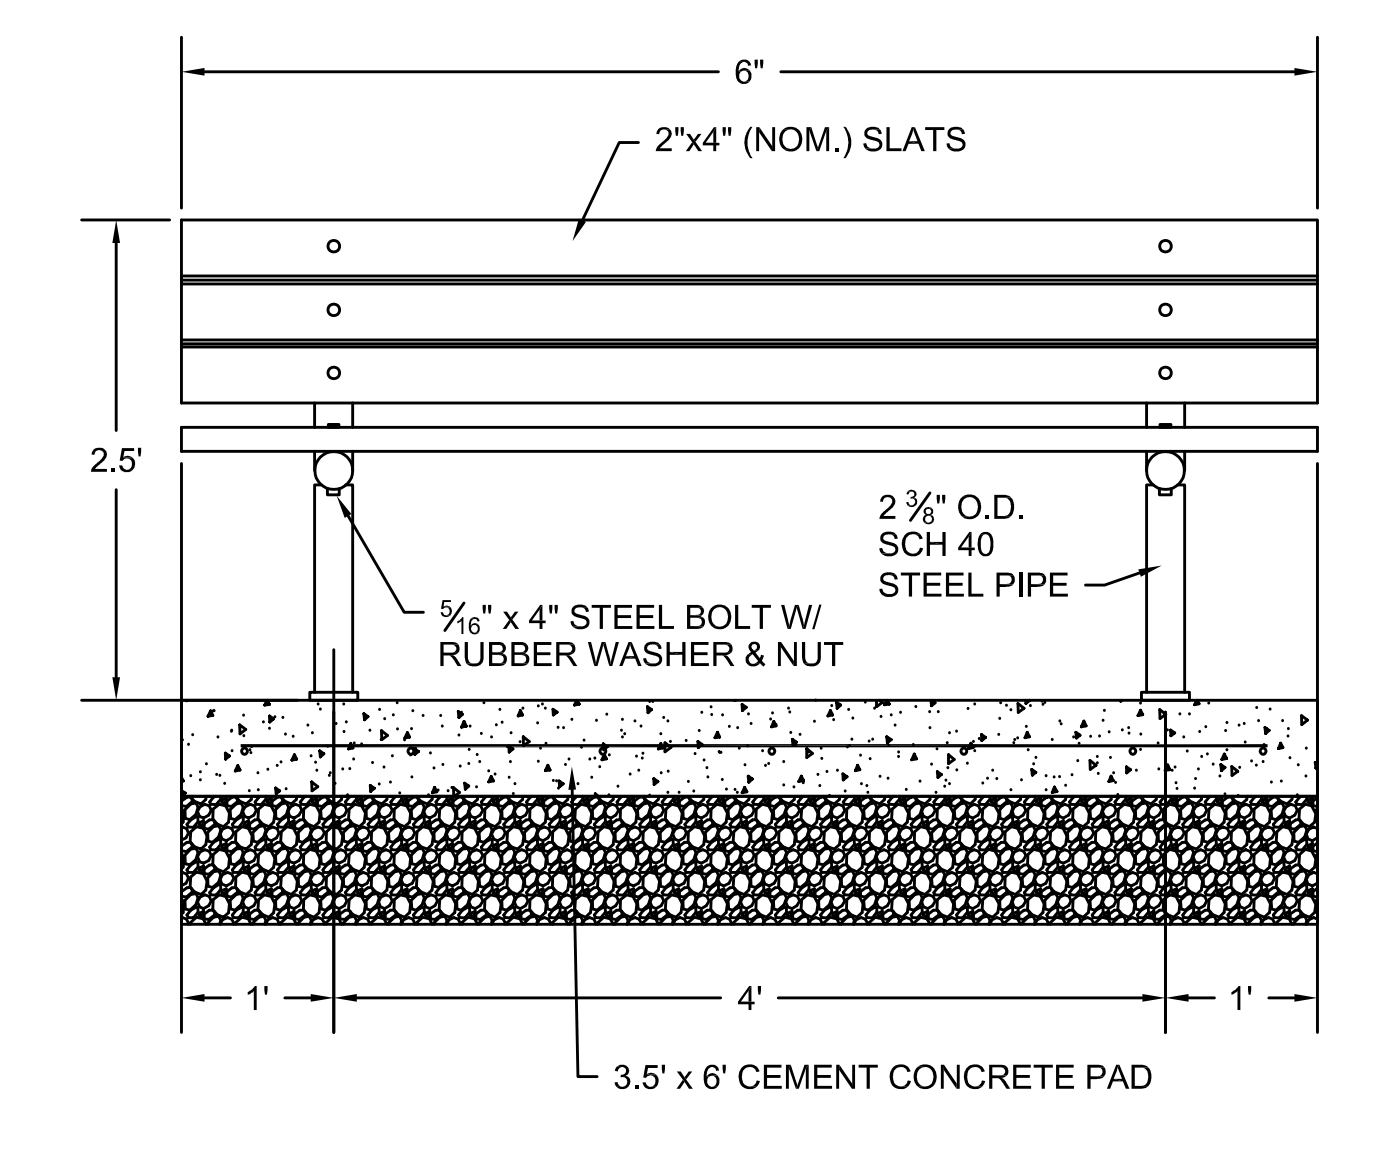
- BENCH NOTES:**
1. STEEL PIPING SHALL BE POWDER COATED BRONZE FINISH
 2. SLATS SHALL BE 2x4 (NOM.). MATERIAL AND FINISH TO BE PER SPECIAL PROVISIONS.
 3. ALL HARDWARE SHALL BE STAINLESS STEEL UNLESS OTHERWISE NOTED.

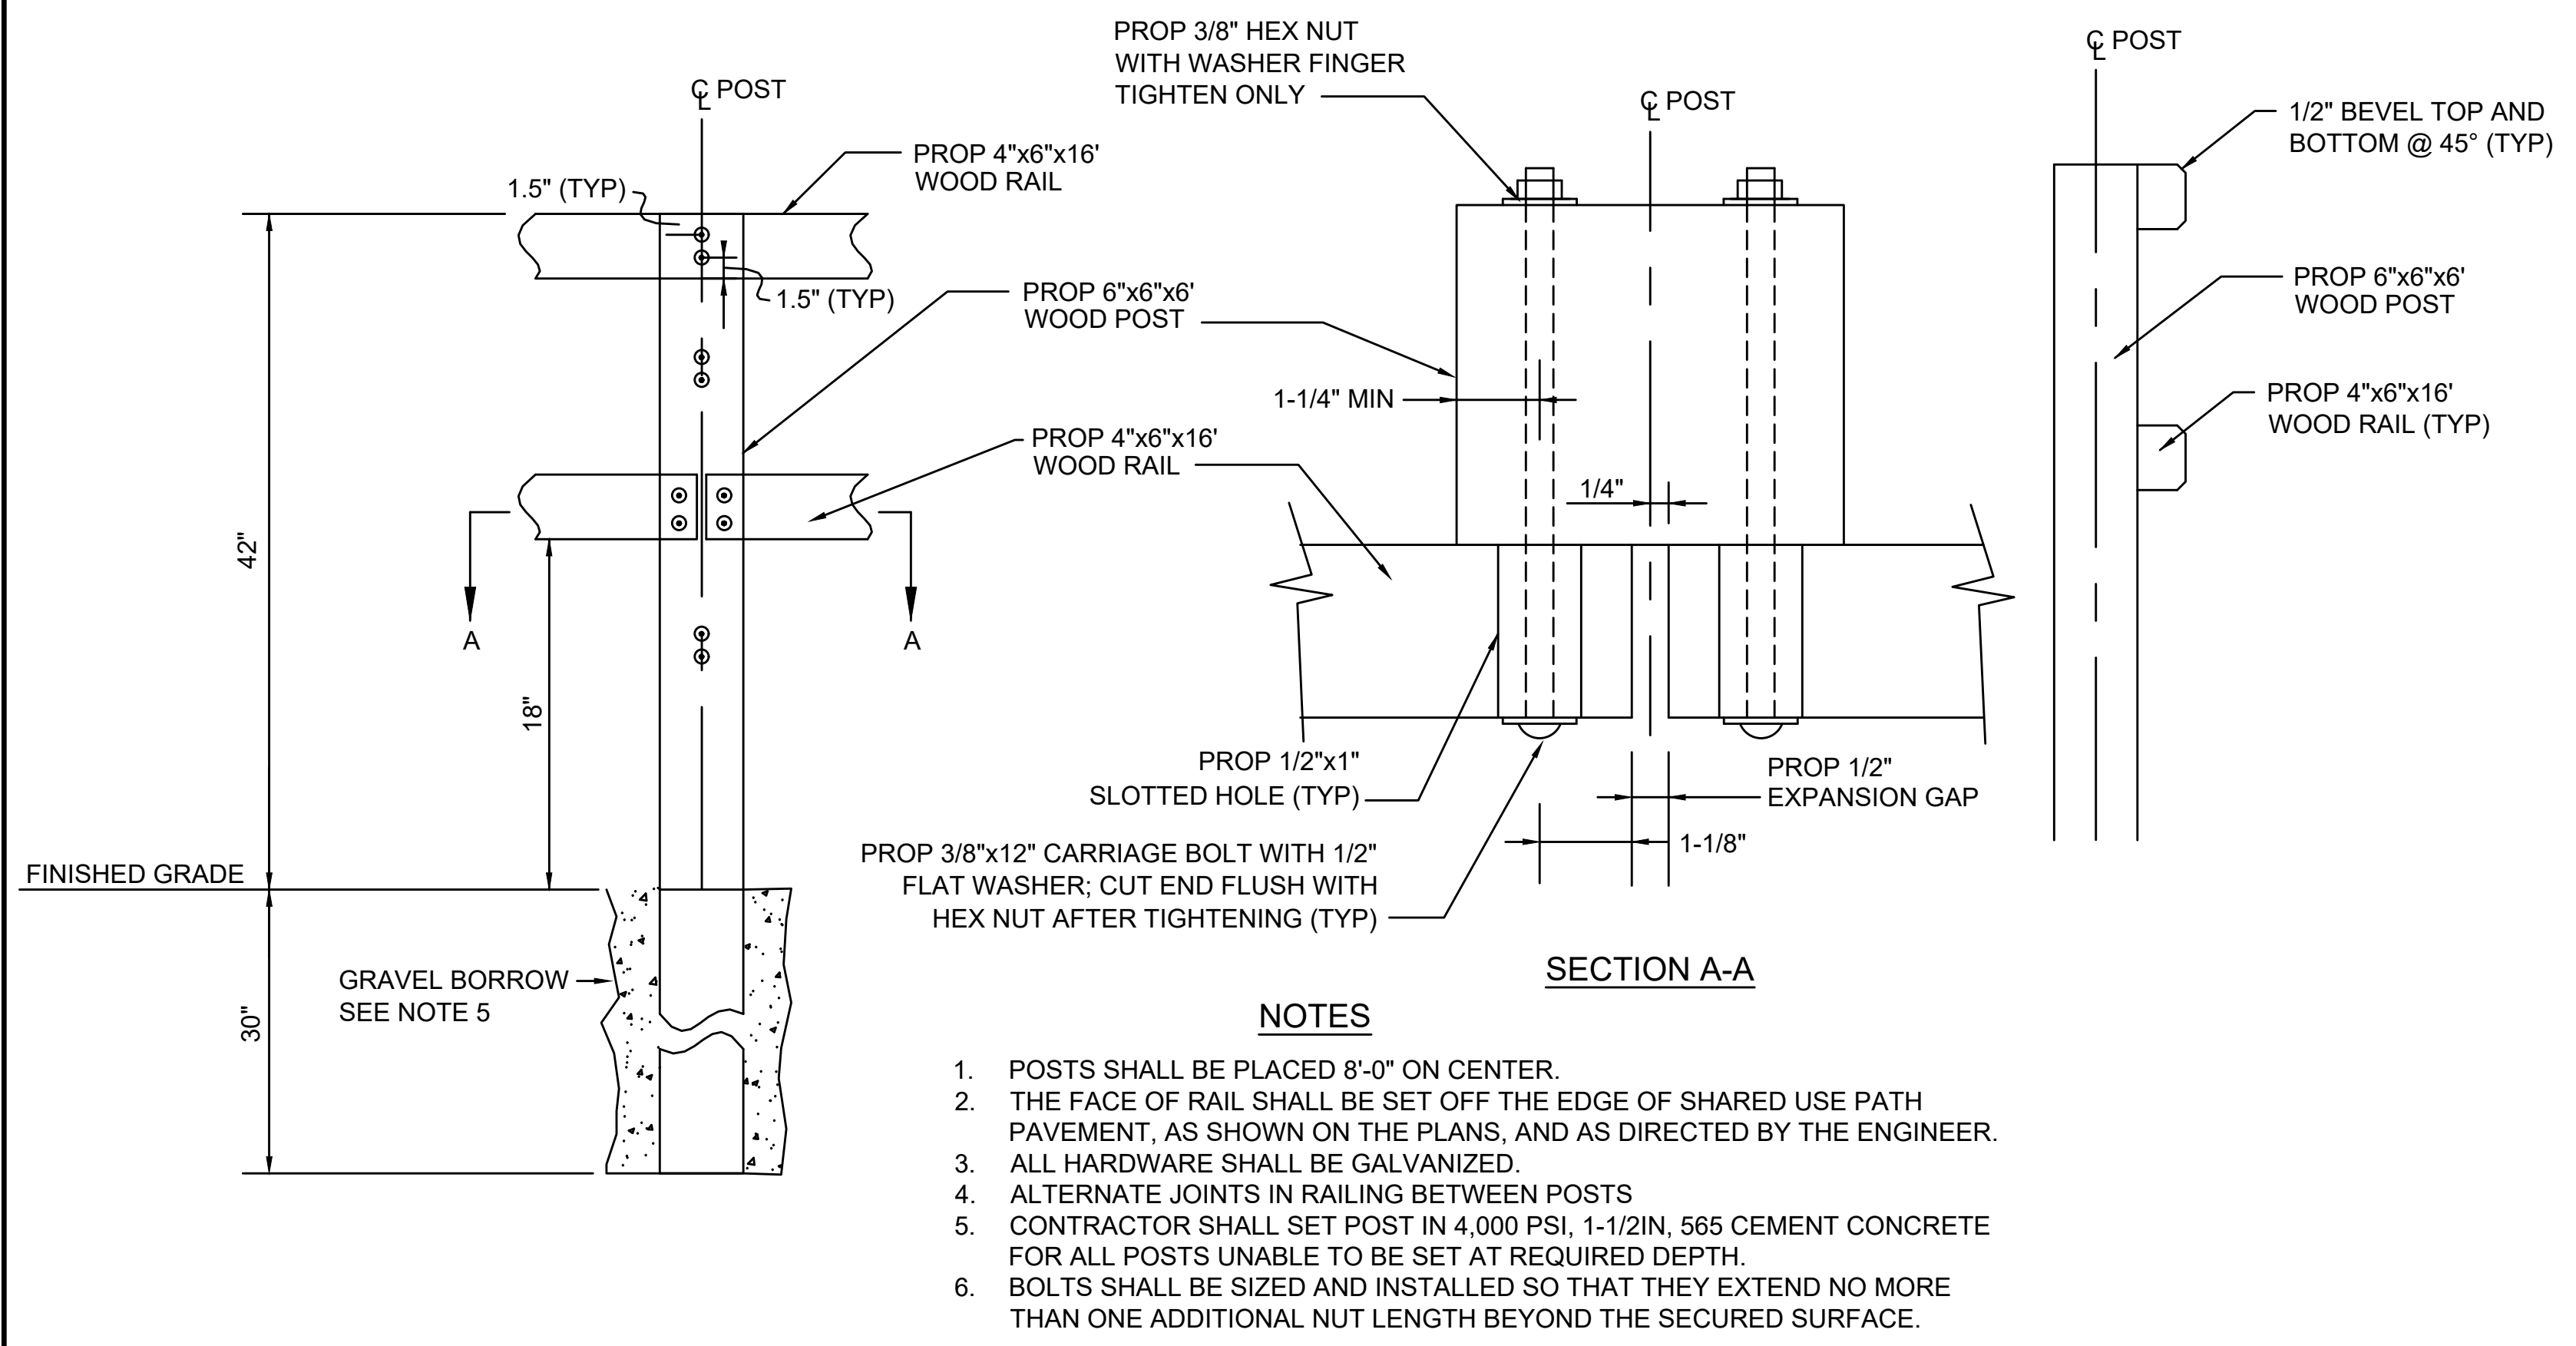
WOOD RAIL - ELEVATION AND SECTION VIEWS

- NOTES**
1. POSTS SHALL BE PLACED 8'-0" ON CENTER.
 2. THE FACE OF RAIL SHALL BE SET OFF THE EDGE OF SHARED USE PATH PAVEMENT, AS SHOWN ON THE PLANS, AND AS DIRECTED BY THE ENGINEER.
 3. ALL HARDWARE SHALL BE GALVANIZED.
 4. ALTERNATE JOINTS IN RAILING BETWEEN POSTS
 5. CONTRACTOR SHALL SET POST IN 4,000 PSI, 1-1/2IN, 565 CEMENT CONCRETE FOR ALL POSTS UNABLE TO BE SET AT REQUIRED DEPTH.
 6. BOLTS SHALL BE SIZED AND INSTALLED SO THAT THEY EXTEND NO MORE THAN ONE ADDITIONAL NUT LENGTH BEYOND THE SECURED SURFACE.

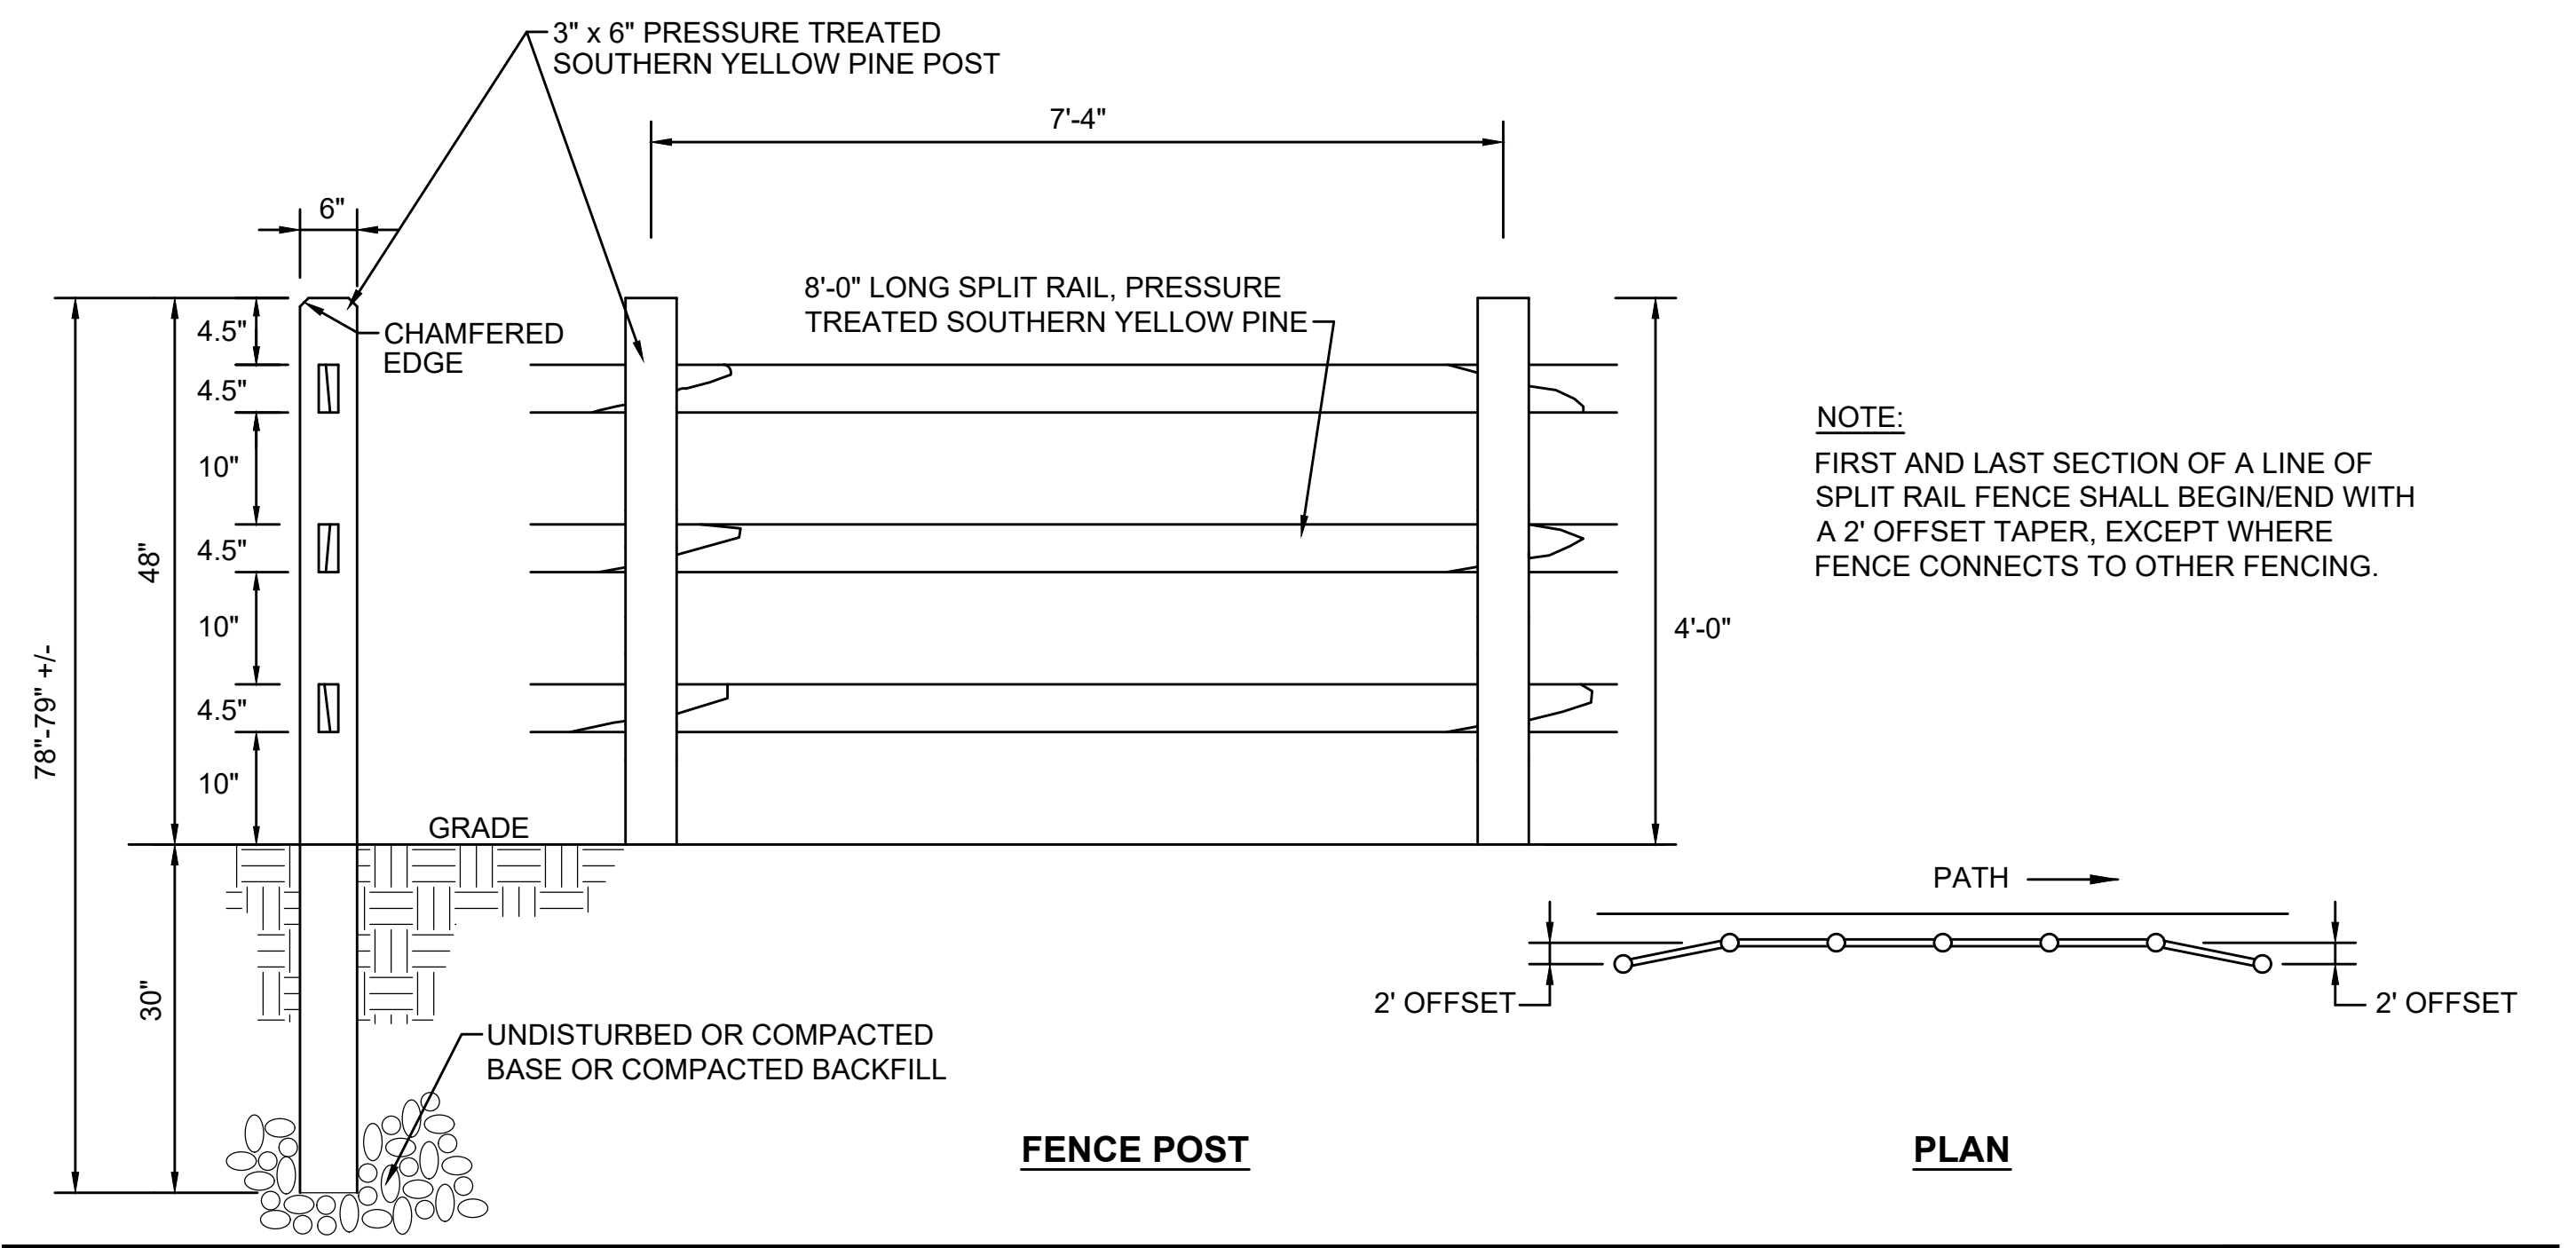
SPLIT RAIL WOOD FENCE

NOTE:
FIRST AND LAST SECTION OF A LINE OF SPLIT RAIL FENCE SHALL BEGIN/END WITH A 2' OFFSET TAPER, EXCEPT WHERE FENCE CONNECTS TO OTHER FENCING.

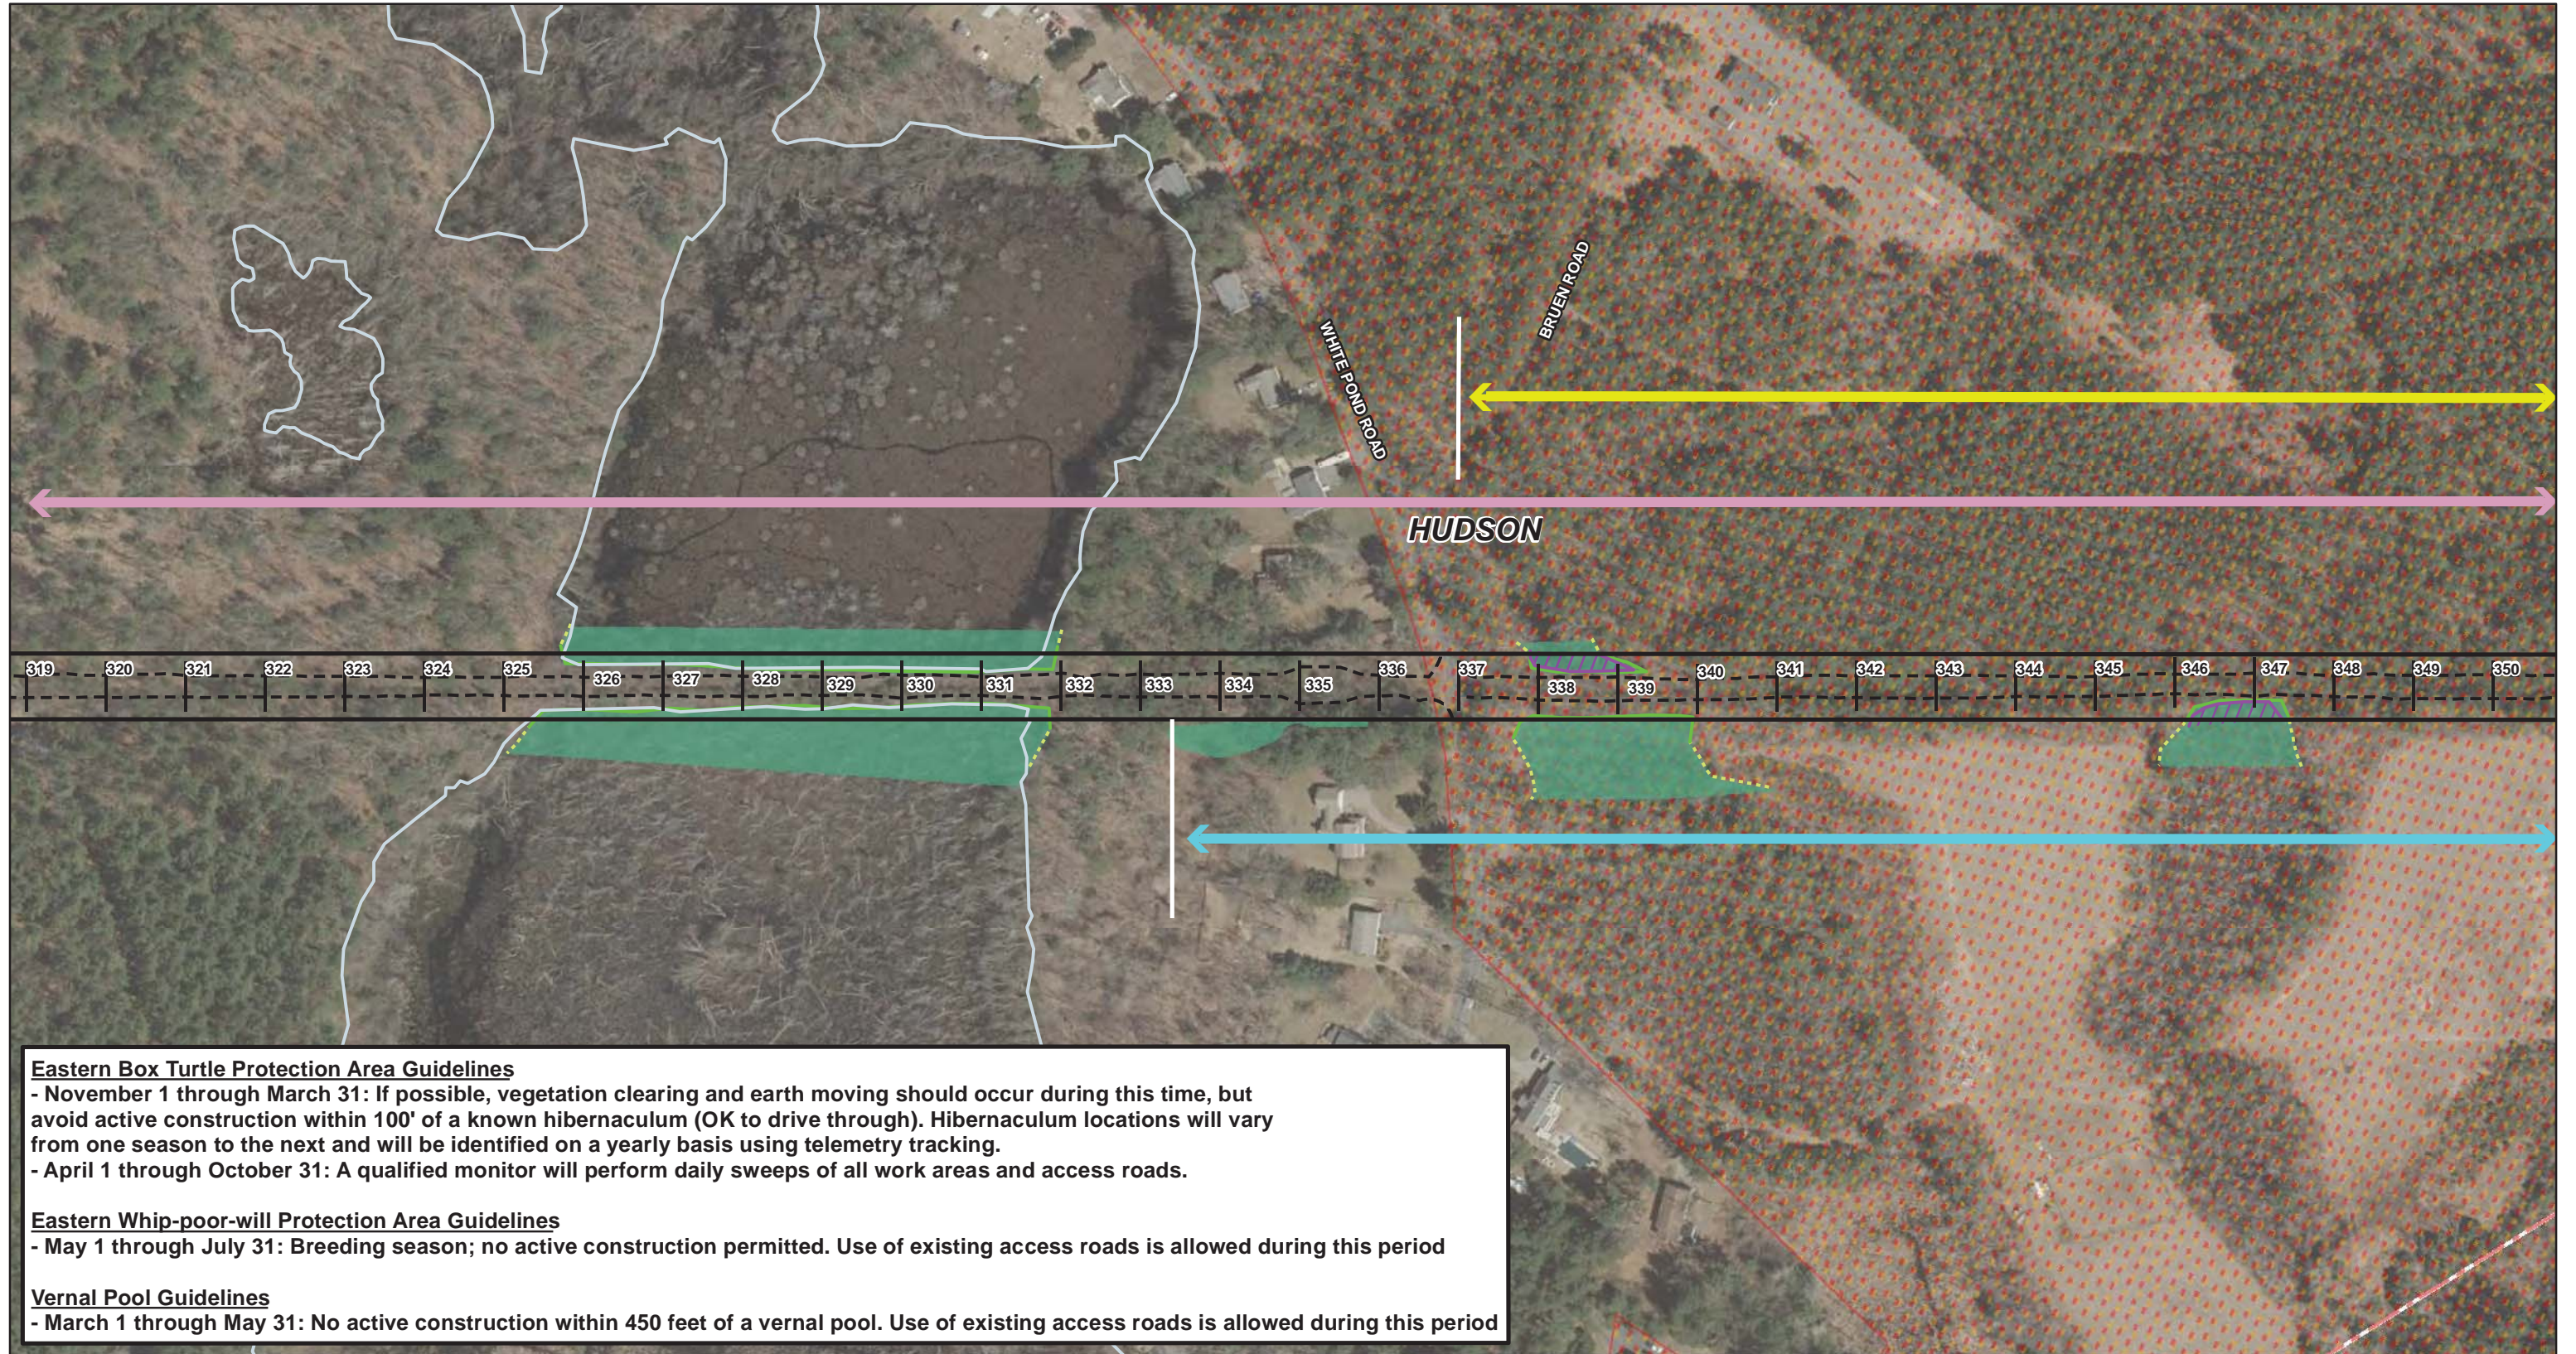
Sheet 2 of 11

Eastern Box Turtle Protection Area Guidelines
 - November 1 through March 31: If possible, vegetation clearing and earth moving should occur during this time, but avoid active construction within 100' of a known hibernaculum (OK to drive through). Hibernaculum locations will vary from one season to the next and will be identified on a yearly basis using telemetry tracking.
 - April 1 through October 31: A qualified monitor will perform daily sweeps of all work areas and access roads.

Eastern Whip-poor-will Protection Area Guidelines
 - May 1 through July 31: Breeding season; no active construction permitted. Use of existing access roads is allowed during this period
