Weekly Environmental Compliance Summary

Sudbury to Hudson Transmission Reliability Project (USEPA Tracking # MAR1003UW)

Week of: May 1 to May 5, 2023

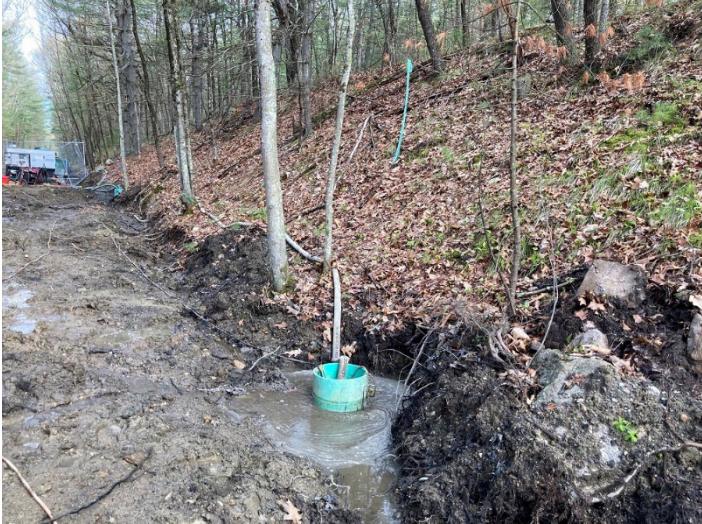
| Description: View of pumping operation in segment 5. See additional dewatering inspection report. Facing west. | | | |

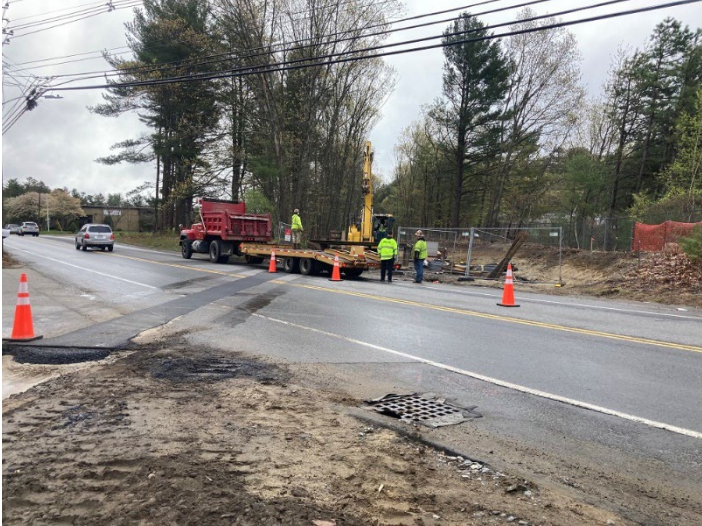
| Description: View of de-mob from Main St. Facing east. | | | |

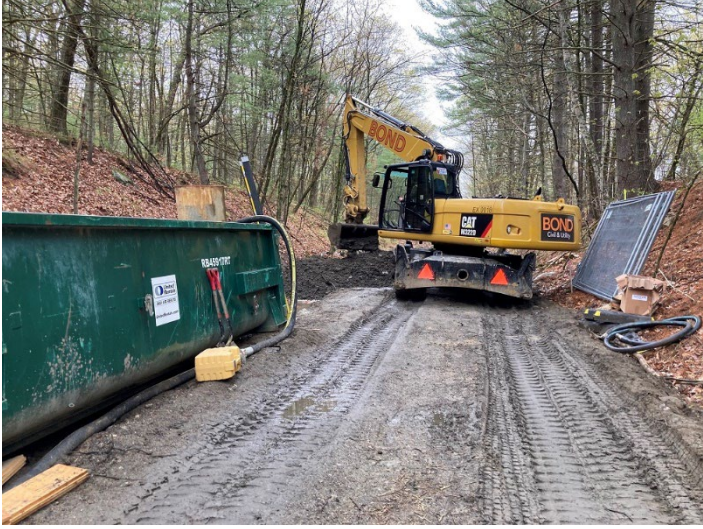
| <p>Description: View of work and pumping operation in segment 5. See additional dewatering inspection report. Facing east.</p> | | | |

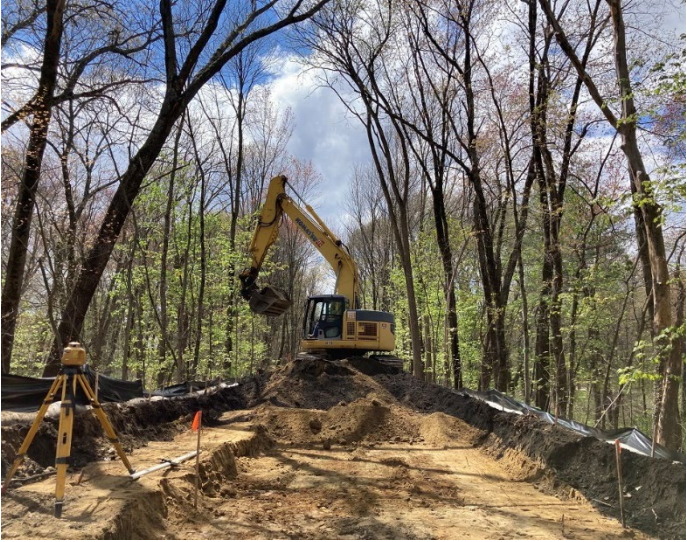
| Description: View of ET&L performing cuts & fills in segment 1. Facing west. | | | |

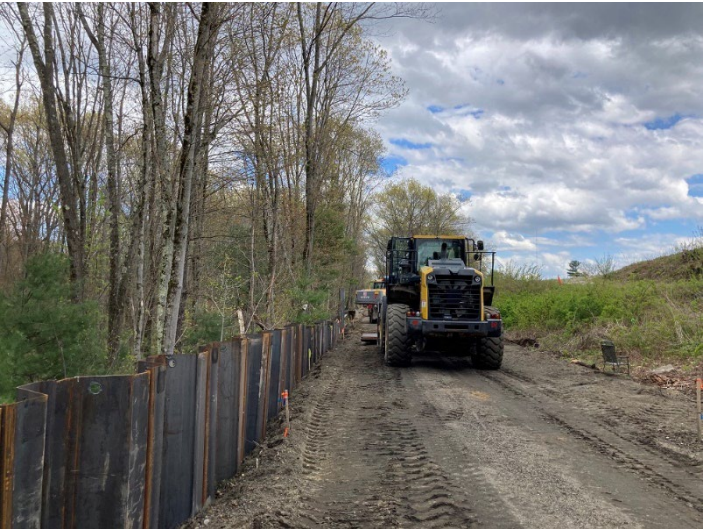
| Description: View of ET&L installing sheet walls in segment 1. Facing east. | | | |

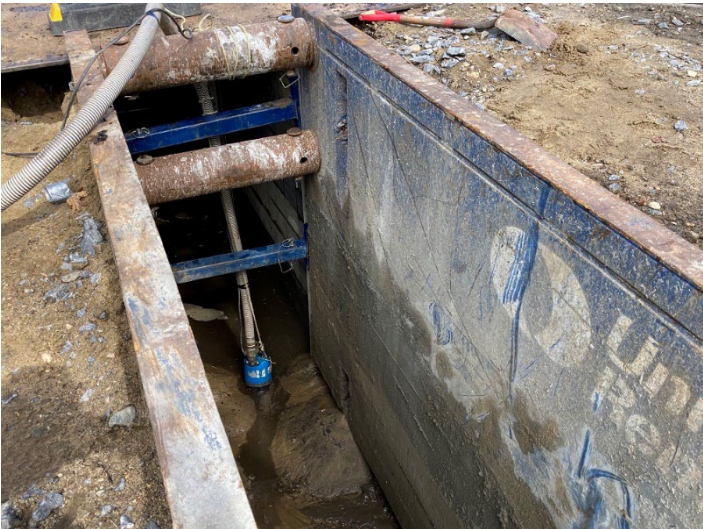
| Description: View of pump in trench/ dewatering water prior to treatment. Water appeared slightly turbid. | | | | |

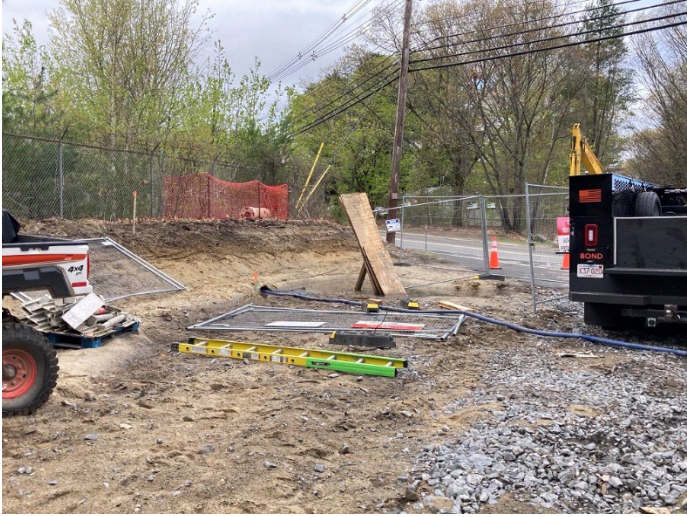
| Description: View of water being pumped from trench to controls. Facing southwest. | | | | |

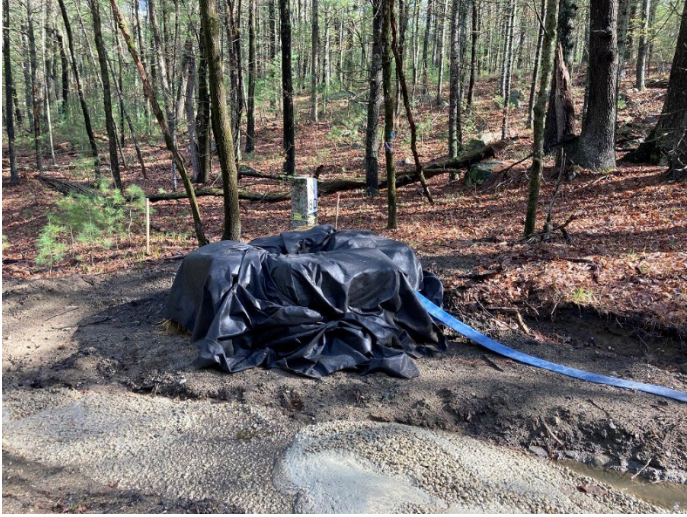
| Description: View of dewatering controls (straw bale corral with filter fabric and silt bag) below frac tank and filtration system. Facing north. | | | | |

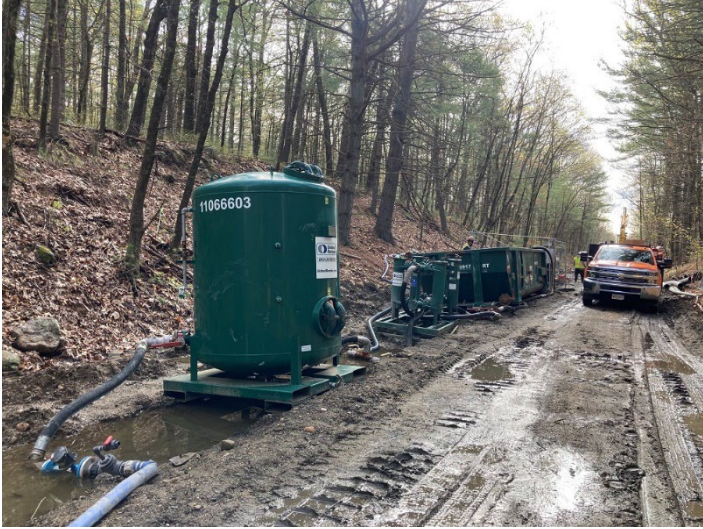
| Description: View of frac tank and filtration system. Facing northeast. | | | | |

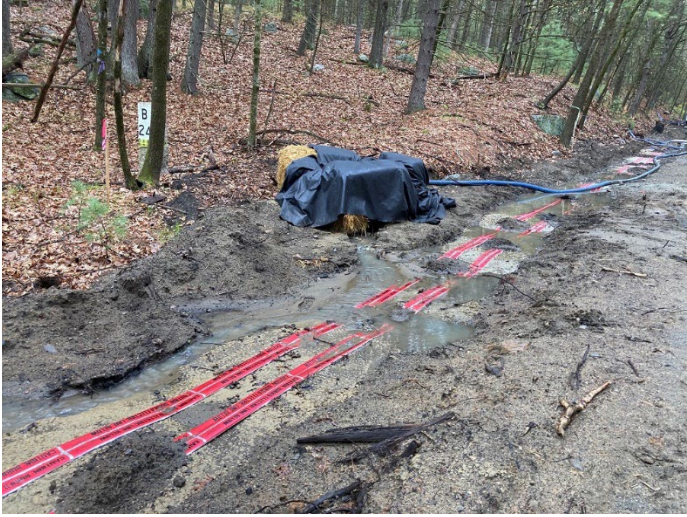
| Description: View of dewatering controls (straw bale corral with filter fabric and silt bag) and discharge below controls. Facing northeast. | | | | |

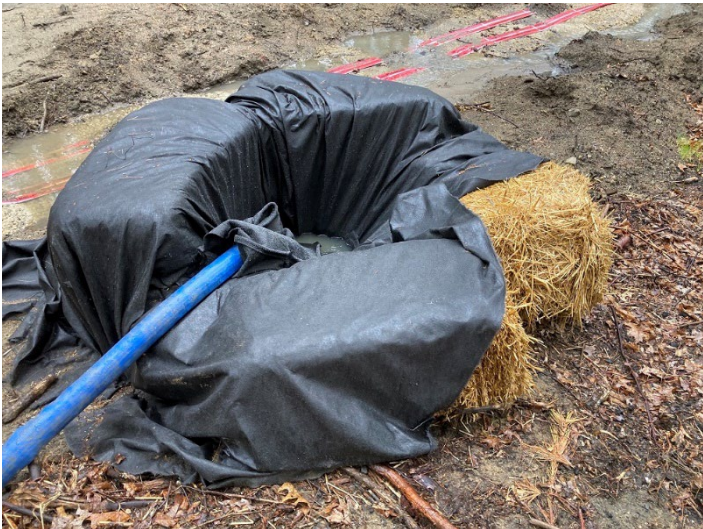
| Description: View of dewatering controls (straw bale corral with filter fabric and silt bag). | | | | |

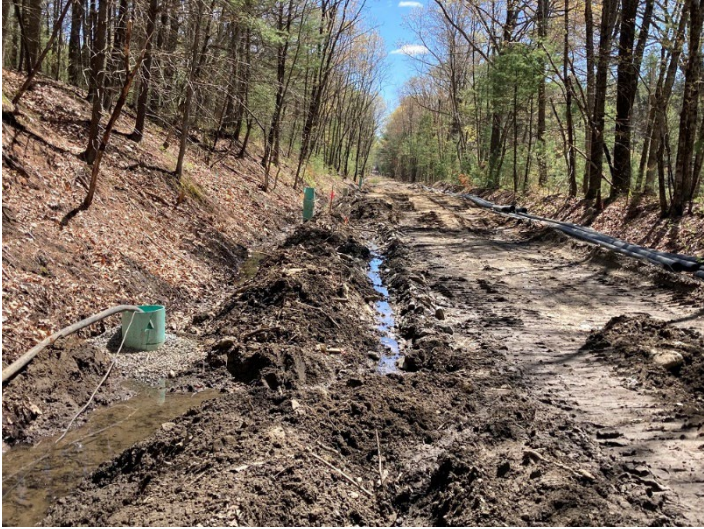
| Description: View of pumping operation /dewatering water prior to treatment in segment 5. Water appeared slightly turbid. Facing east. | | | |

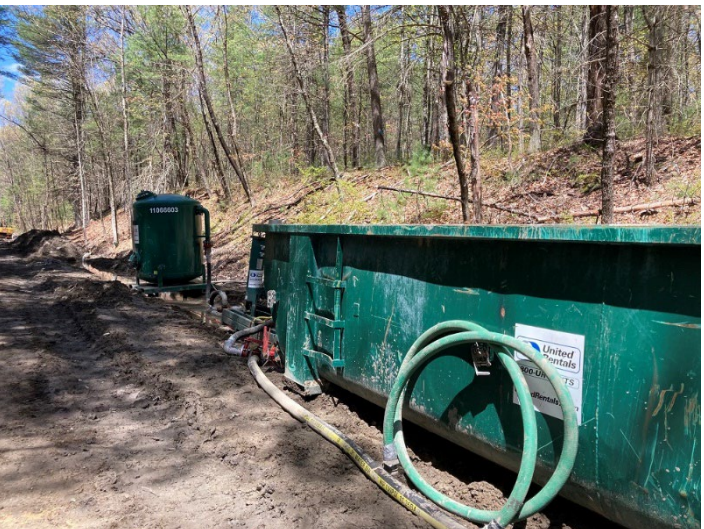
| Description: View of frac tank and filtration system. Facing northwest. | | | |

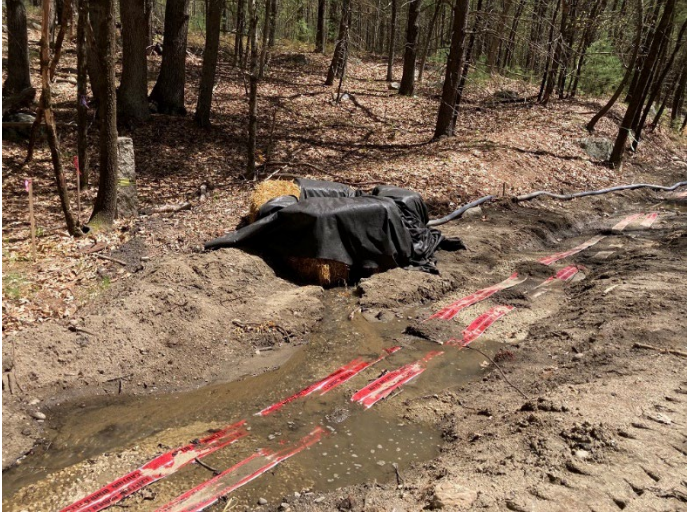
| Description: View of dewatering controls (straw bale corral with filter fabric and silt bag) and discharge below controls. Facing northeast. | | | | |

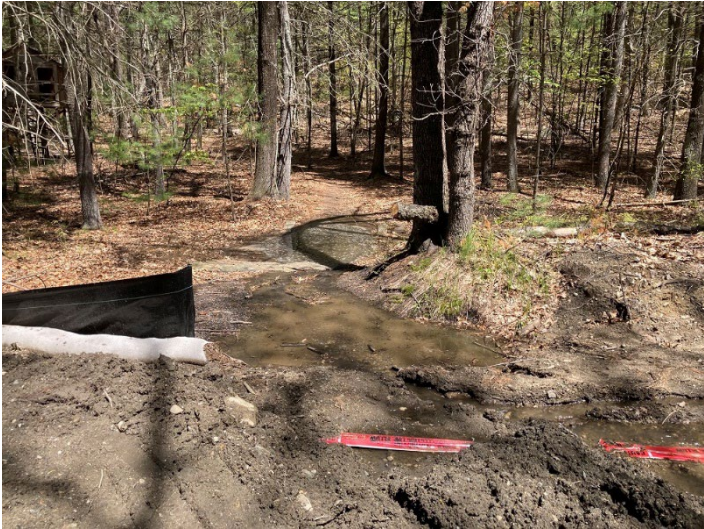
| Description: View of discharge from project ROW. Facing north. | | | | |
