Weekly Environmental Compliance Summary

Sudbury to Hudson Transmission Reliability Project (USEPA Tracking # MAR1003UW)

Week of: July 24 to July 28, 2023

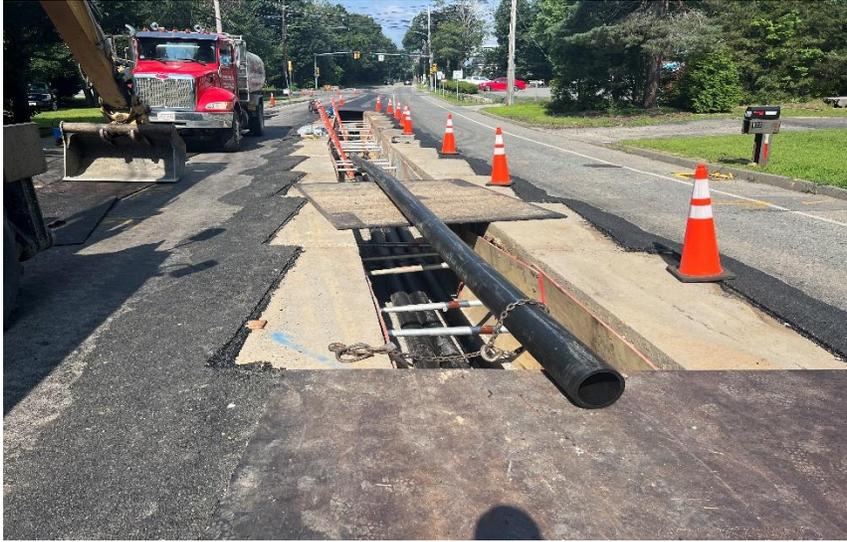
Description: Conduit installation along Forest Avenue. <i>Facing West.</i>

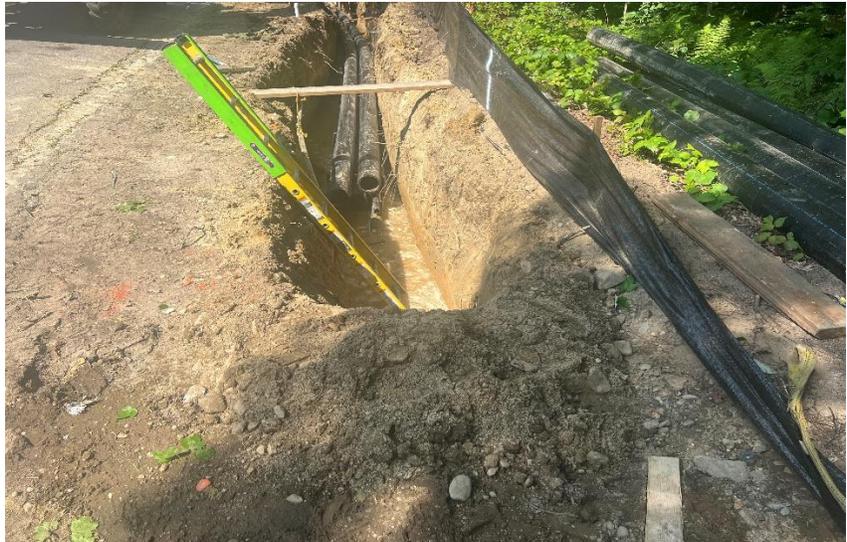
Description: Conduit being installed along Wilkins Street. <i>Facing South.</i>

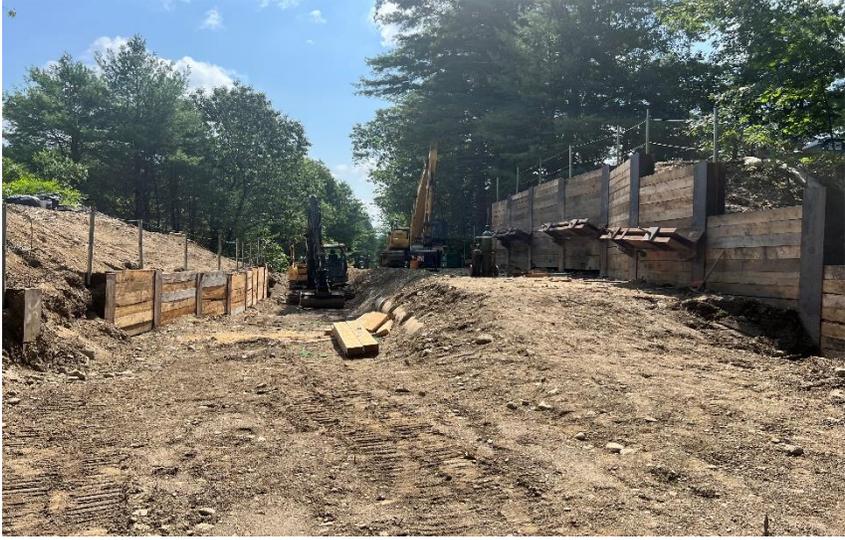
Description: Chestnut Street closure work. <i>Facing east.</i>

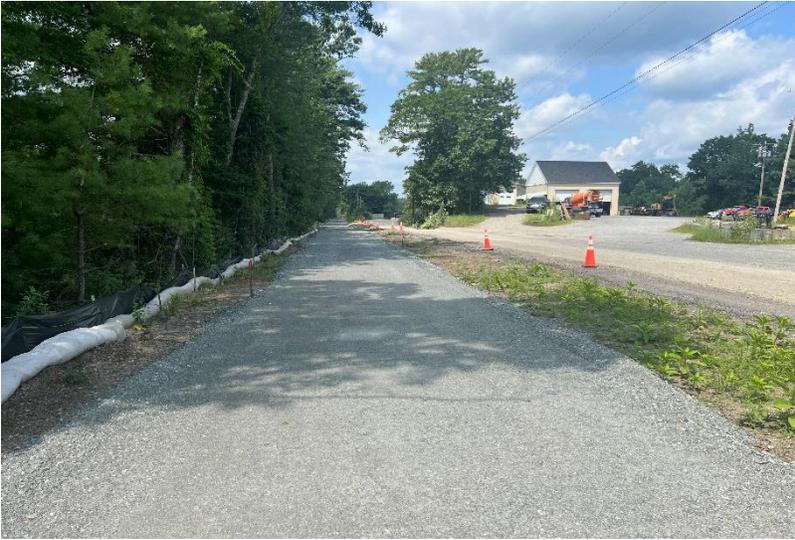
Description: Area where ET&L has spread gravel within segment 3. <i>Facing West.</i>

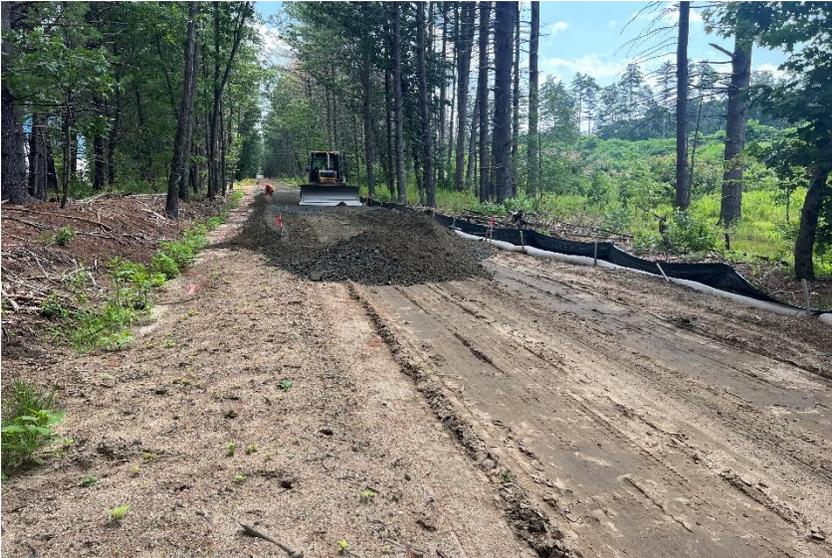
Description: Bond spreading gravel throughout segment 4. <i>Facing East.</i>

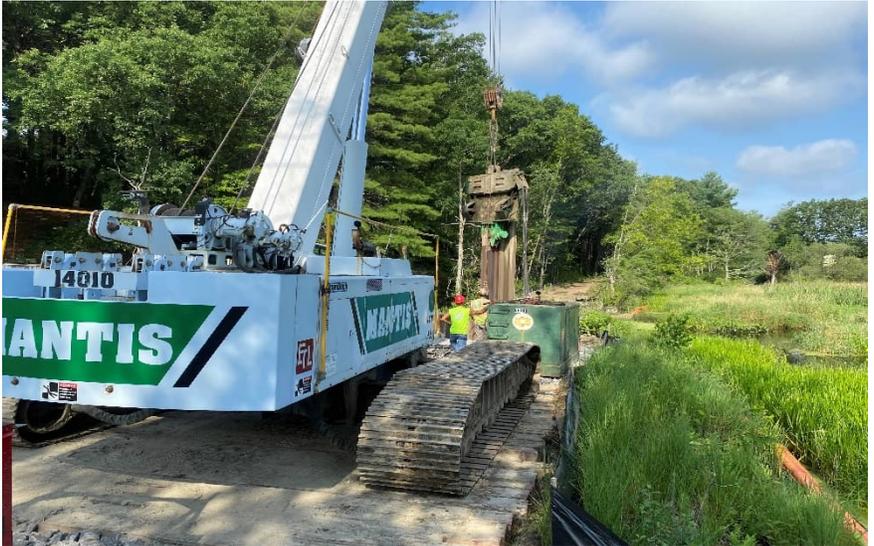
Description: Work area within segment 14, bridge 127, adding sheeting, existing erosion control, looking westward.

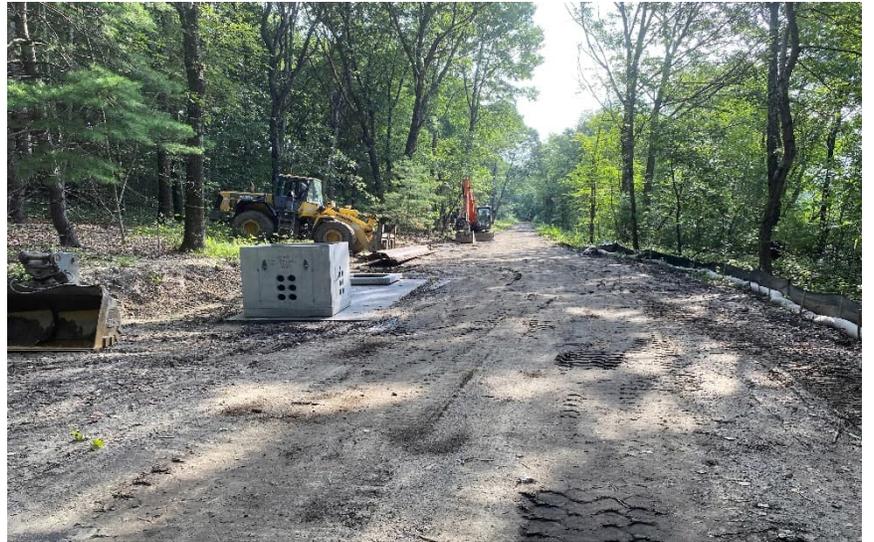
Description: Work area within segment 14, manhole #26, existing erosion control, looking eastward.

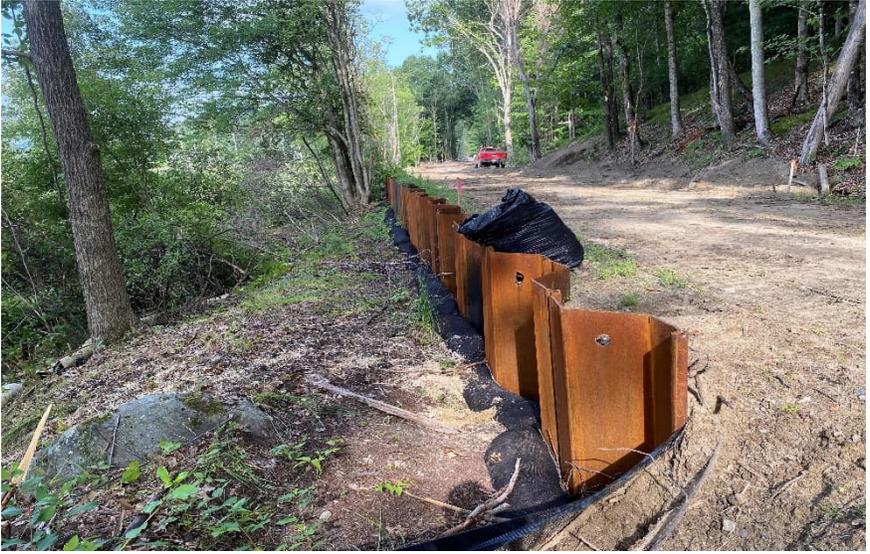
Description: Work area within segment 14, existing erosion control (sheeting), looking westward.

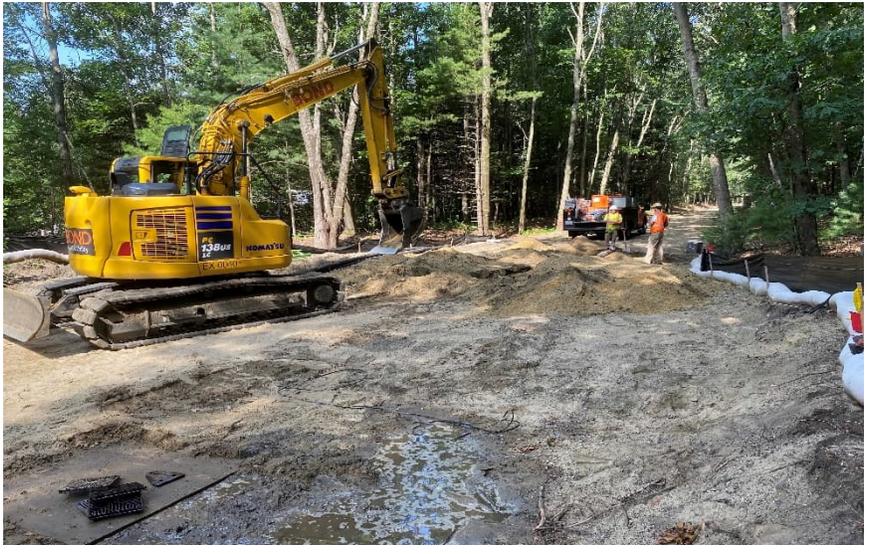
Description: Work area within segment 11, conduit work at manhole 23, existing erosion control, looking westward.

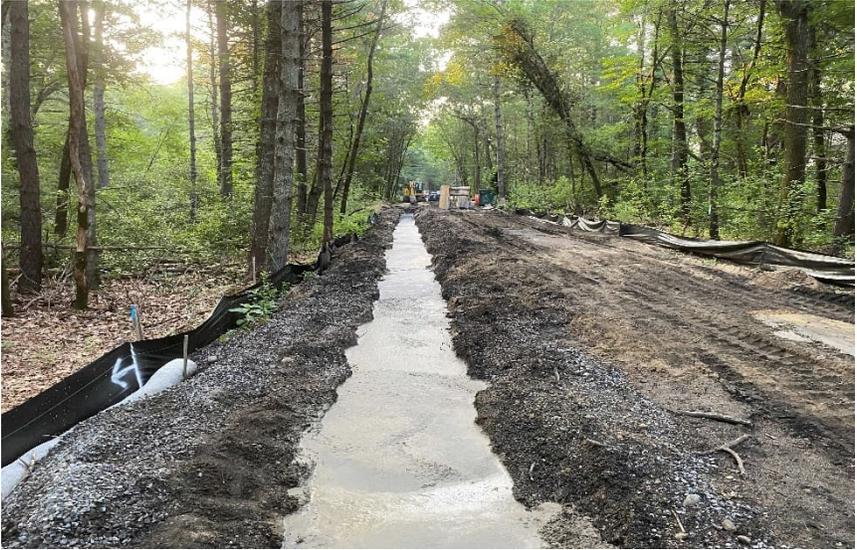
Description: Work area within segment 5 (recently installed conduit), existing erosion control, looking eastward.

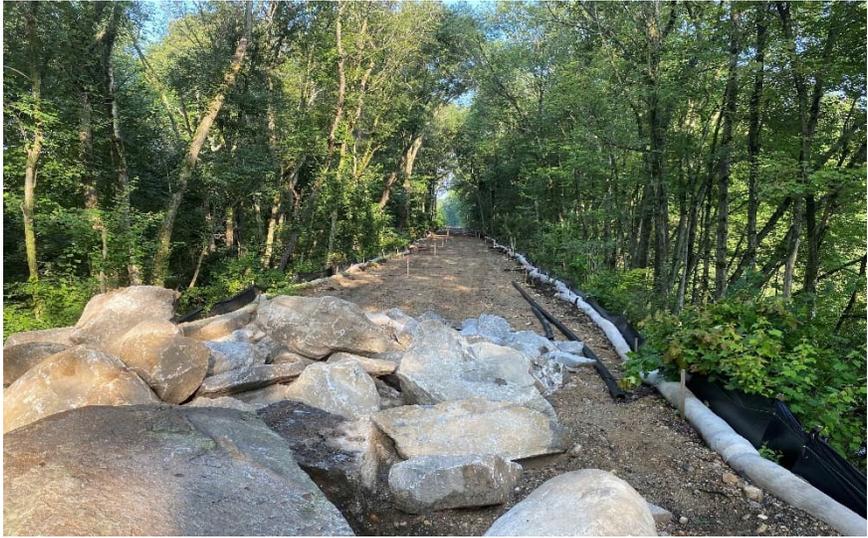
Description: Work area within segment 1, existing erosion control, looking westward.

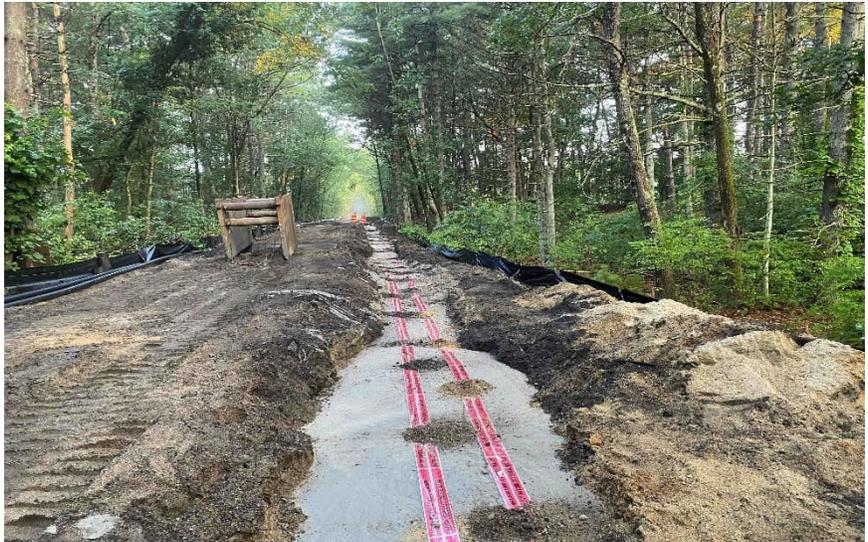
Description: Work area within segment 5, conduit work, existing erosion control, looking westward.

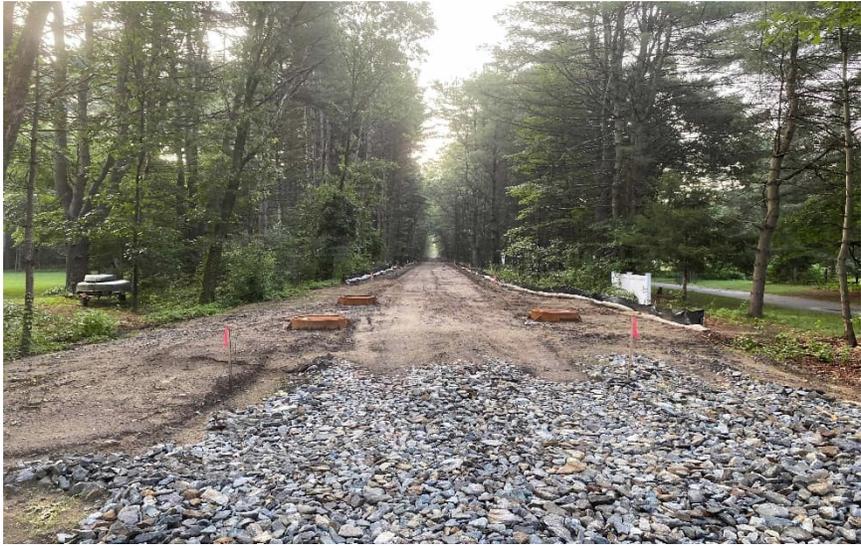
Description: Work area within segment 5, manhole #11, existing erosion control, looking eastward.

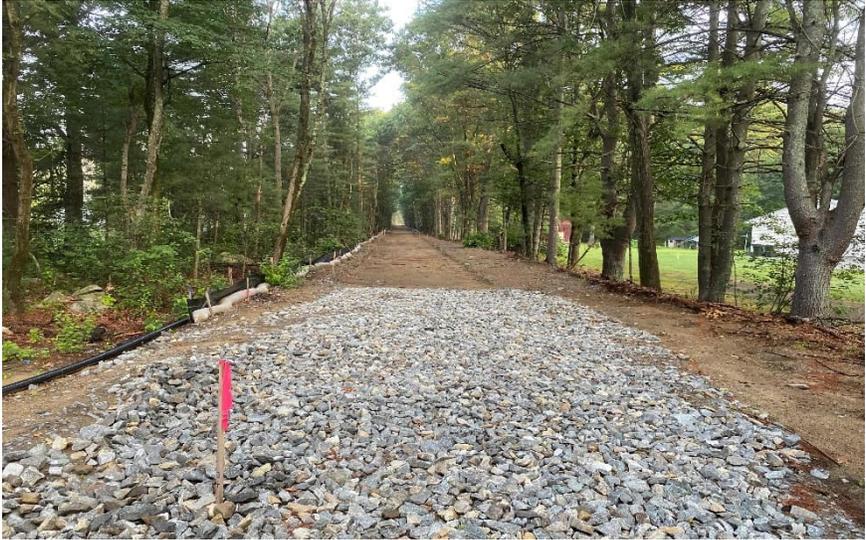
Description: Work area within segment 4, existing erosion control, looking westward.

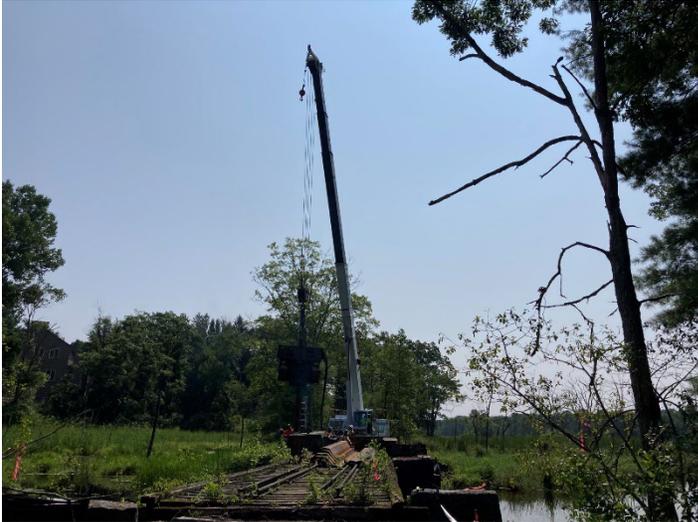
Description: View of ET&L driving sheets at bridge 127 in segment 14. Facing east.

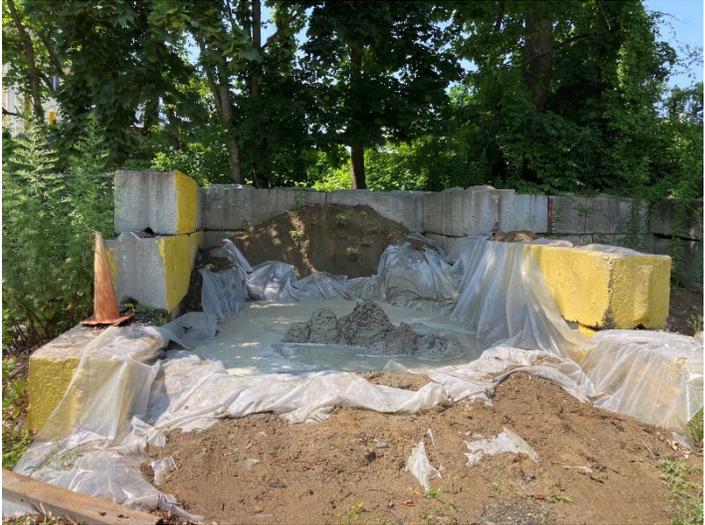
Description: View of concrete washout station that has been installed in parking lot/storage area above Sudbury Substation. Facing west.

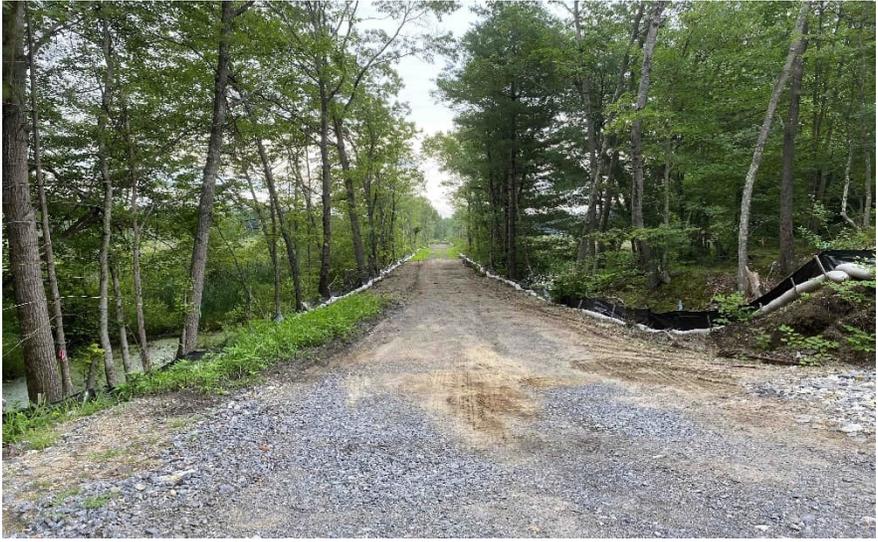
Description: Work area within segment 2, existing erosion control, looking eastward.

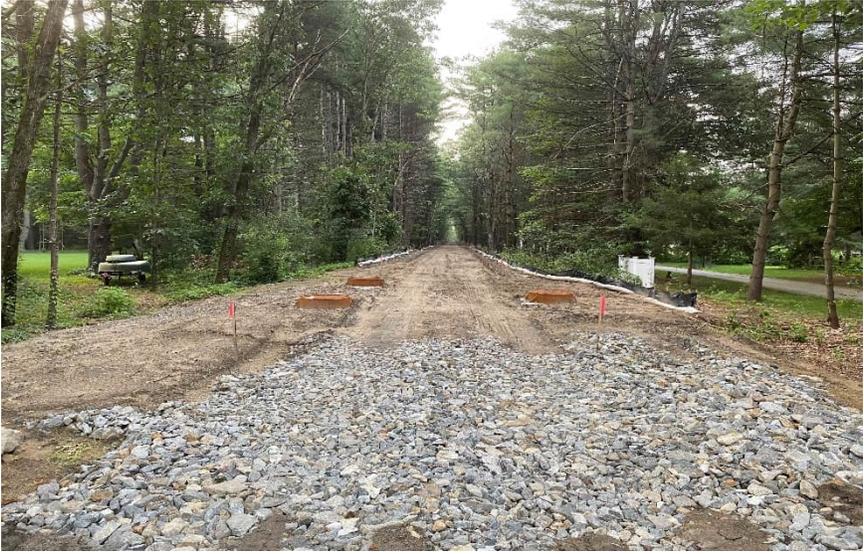
Description: Work area within segment 5, manhole #11, existing erosion control, looking eastward.

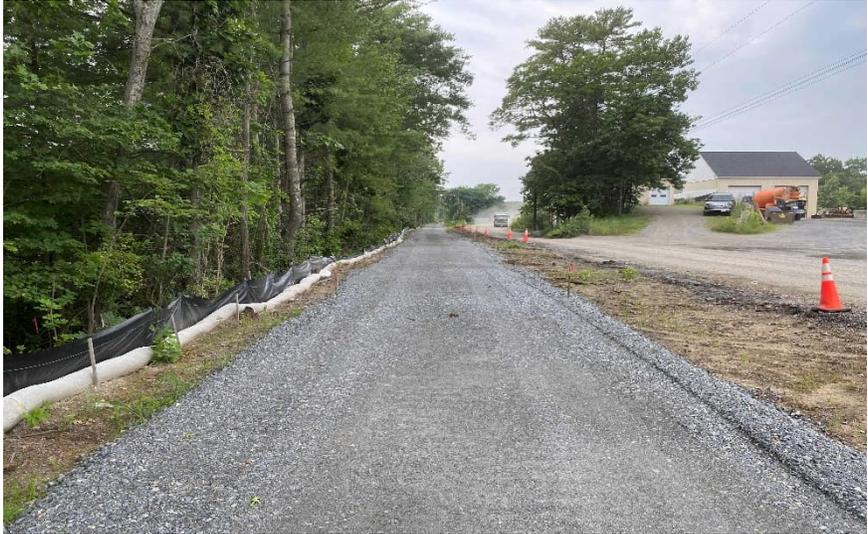
Description: Work area within segment 3, existing erosion control, looking westward.

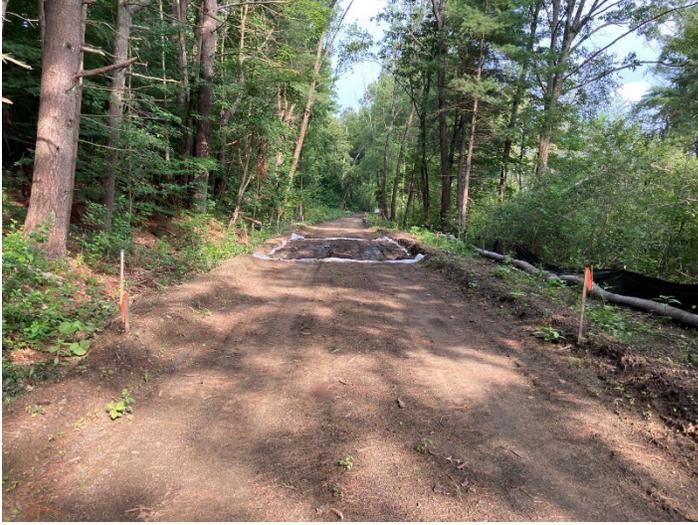
<p>Description: View of lined equipment containment area in segment 13. Facing west.</p>

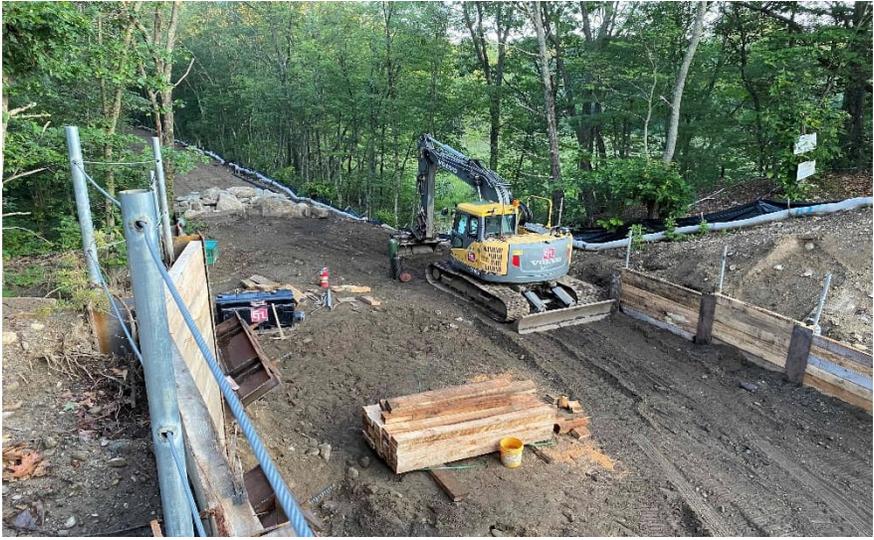
<p>PHOTOGRAPHIC LOG</p>	
<p>Client Name: Eversource</p>		<p>Site Location: Sudbury to Hudson Transmission Reliability Project</p>	<p>Town: Hudson</p>
<p>Photo No.: 3</p>	<p>Date: 7-28-23</p>

<p>Description:</p> <p>Work area within segment 1, Chestnut Street crossing, existing erosion control, looking westward.</p>

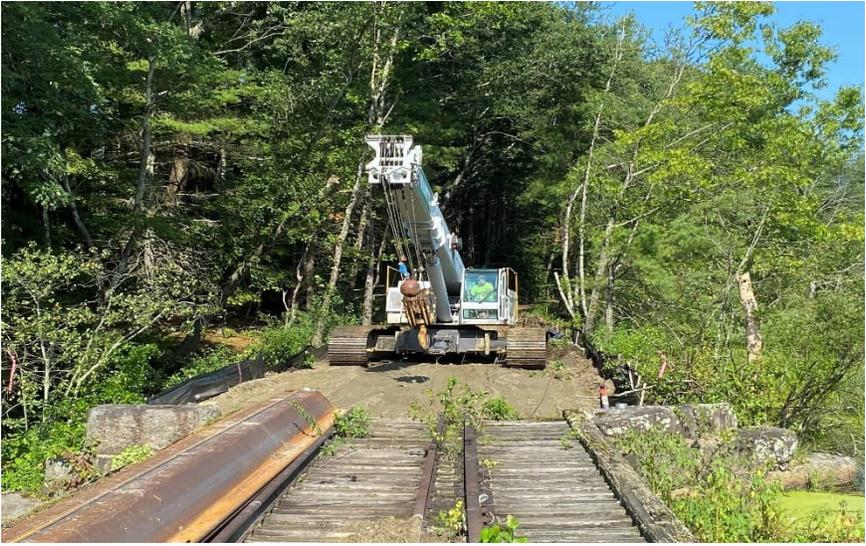
<p>PHOTOGRAPHIC LOG</p>	
<p>Client Name: Eversource</p>		<p>Site Location: Sudbury to Hudson Transmission Reliability Project</p>	<p>Town: Sudbury</p>
<p>Photo No.: 7</p>	<p>Date: 7-28-23</p>

<p>Description:</p> <p>Work area within Segment 13, near Bridge 127, existing erosion control, looking eastward.</p>

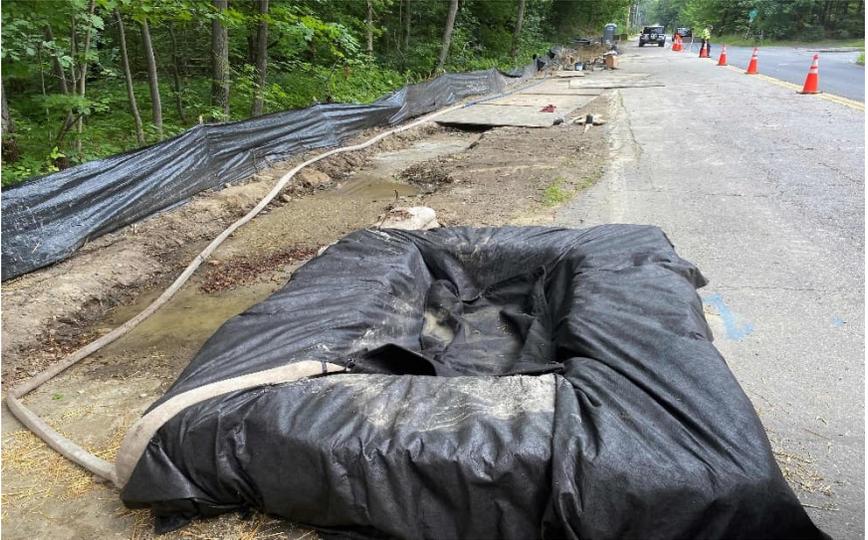
PHOTOGRAPHIC LOG	
Client Name: Eversource		Site Location: Sudbury to Hudson Transmission Reliability Project	Town: Hudson
Photo No.: 4	Date: 7/27/2023

Description: Wilkins Avenue. View of discharge bag/bales, looking eastward.

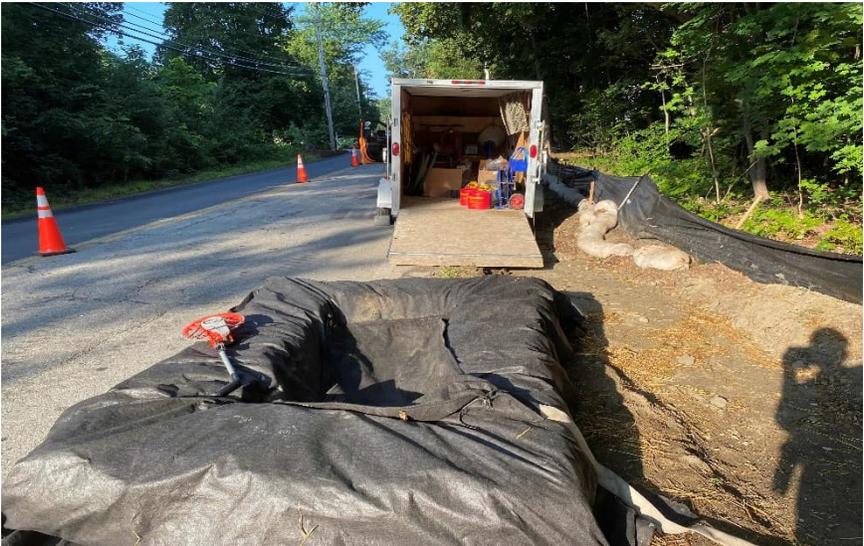
<h2 style="margin: 0;">PHOTOGRAPHIC LOG</h2>	
Client Name: Eversource		Site Location: Sudbury to Hudson Transmission Reliability Project	Town: Hudson
Photo No.: 4	Date: 7/28/2023

Description: Wilkins Avenue. View of discharge bag/bales, looking westward.

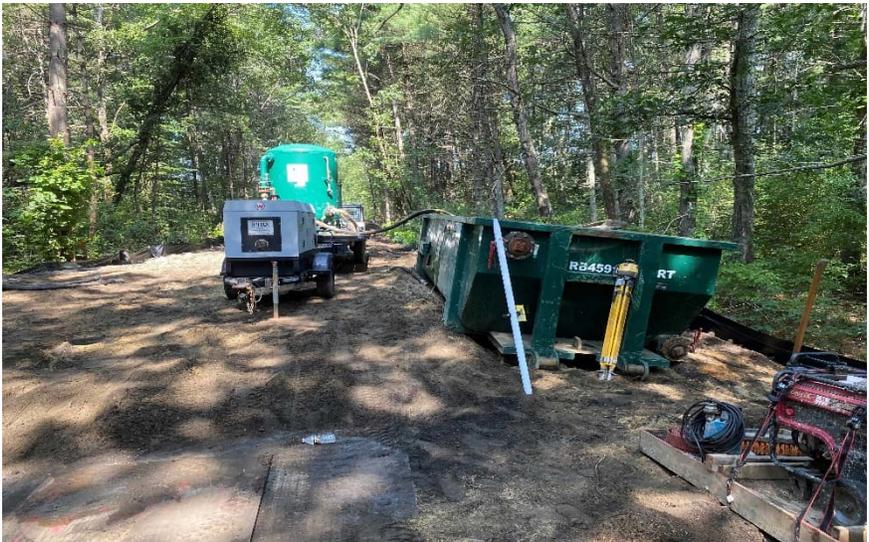
PHOTOGRAPHIC LOG	
Client Name: Eversource		Site Location: Sudbury to Hudson Transmission Reliability Project	Town: Hudson
Photo No.: 2	Date: 7/28/2023

Description: View of dewatering operation from frac tank to filtration system to dewatering bag/corral, looking westward.
