# Wildlife Habitat Features Report Eversource Sudbury to Hudson Transmission Reliability Project Sudbury, Massachusetts

DECEMBER 2022- MAY 2023

SWCA Project No. 67849

July 2023

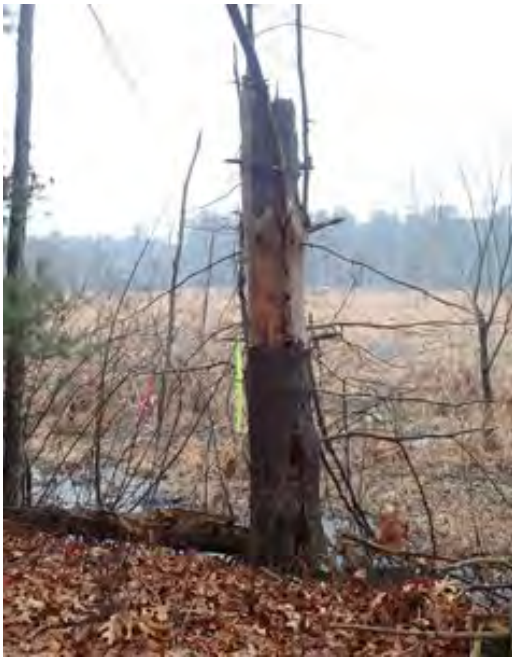
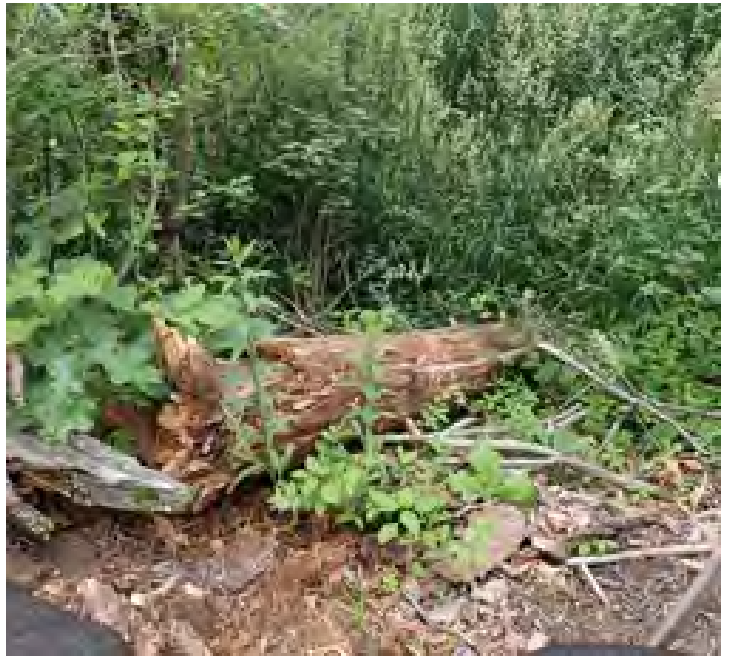
**Photo #33** View of installed fallen log in Impact Area 19. Snag was originally proposed to be saved, however, during the silt fence installation, snag has fallen/ had to be removed and was placed partially within resource area. *Facing south.*
