ROOF CONDITION SURVEY

For
Town of Sudbury
19 Sudbury Public Buildings
Sudbury, Massachusetts

February 3, 2012

RBA Project No. 201056.00

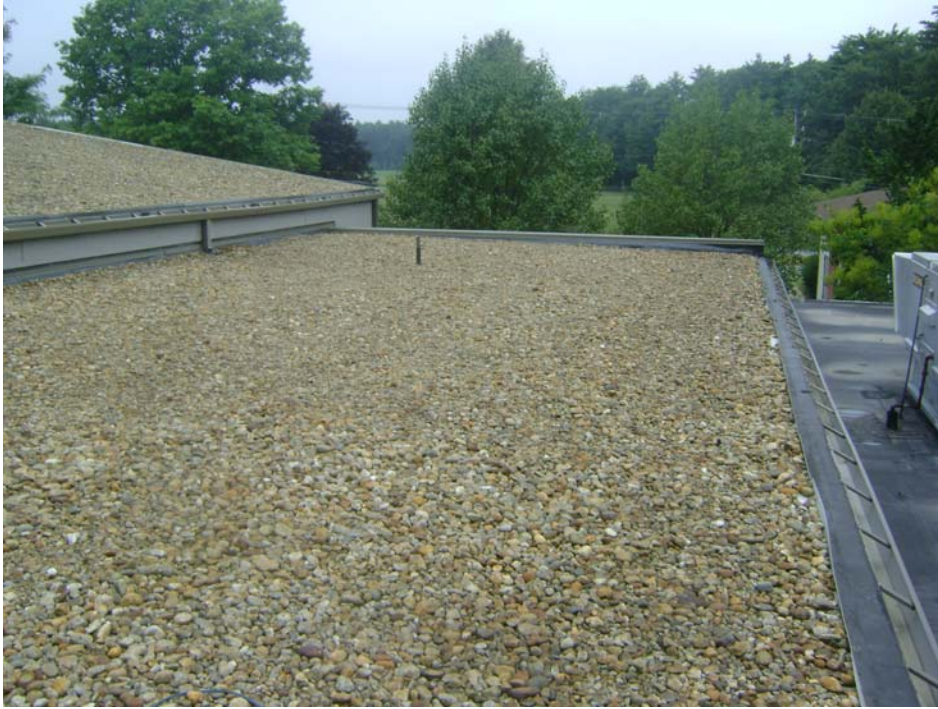
Description: Overview of Roof Area No. 1. Note that stone ballast has migrated away from the roof ridge.

3. Replace the stone ballast EPDM roof (Roof Area No. 1 at 10,650 SF) in **year 2013**. The recommendation is a "go-over" application replacement with an adhered 60-mil reinforced PVC roof membrane system to include new overlay rigid board roof insulation (R-value to meet stretch energy code), flashings, edge metal, roof drainage system, repairs to deteriorated roof decking, and a roofing manufacturer's 20-year full system labor and material warranty.

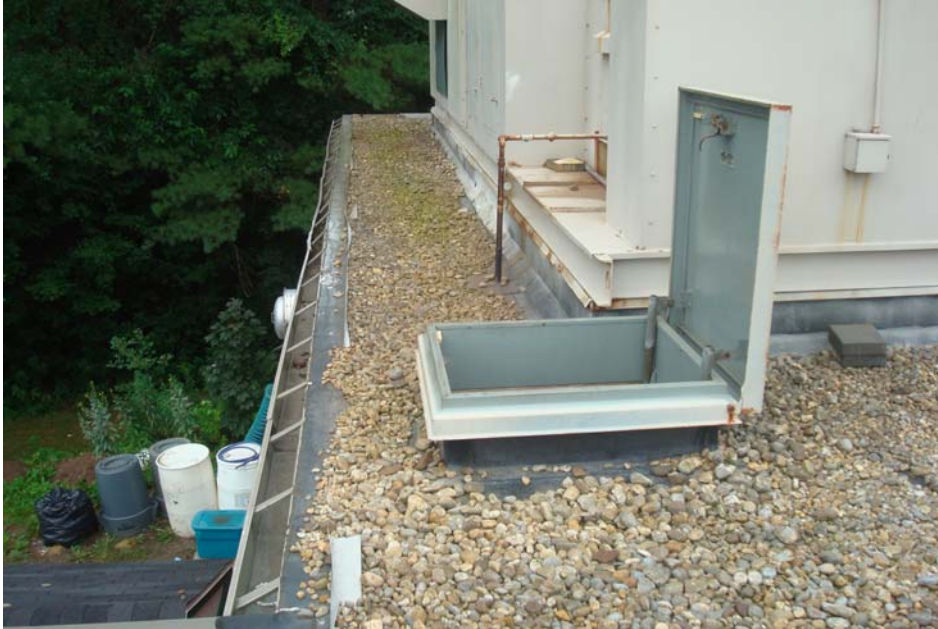
Description:
Ballast retention bar of Roof Area No. 1 is loose.

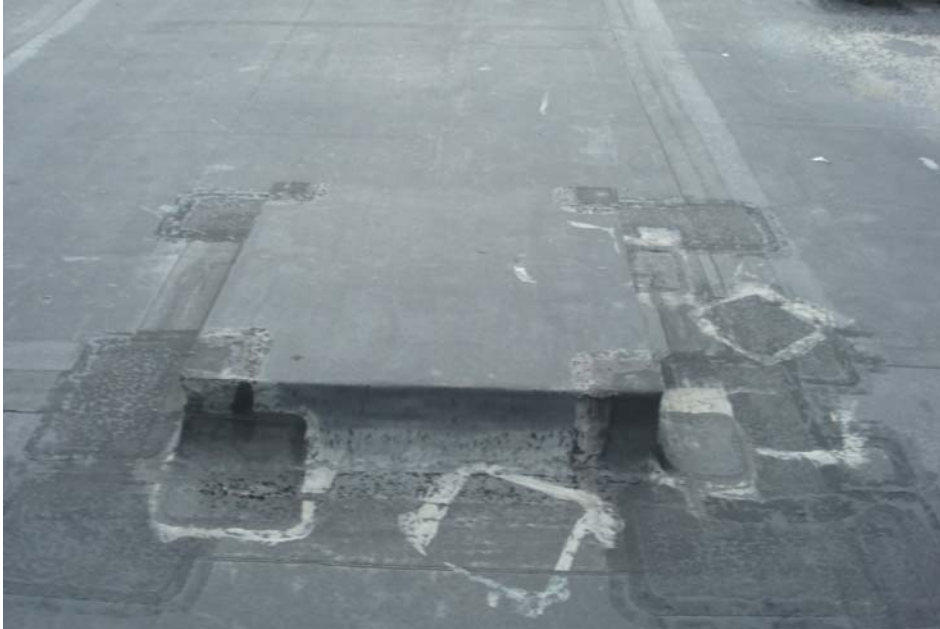
Photo No. 10

Description: EPDM base flashings of Roof Area No. 2 are pulling away from the parapet due to membrane shrinkage.

The low-sloped roof recommendation (Roof Area No. 2) is complete removal ("tear-off" application) and replacement with an adhered 60-mil reinforced PVC roof membrane system to include new rigid board roof insulation (tapered as necessary so as to achieve positive drainage; R-value to meet stretch energy code), flashings, edge metal, roof drainage system, snow guards, repairs to deteriorated roof decking, and a roofing manufacturer's 20-year full system labor and material warranty.

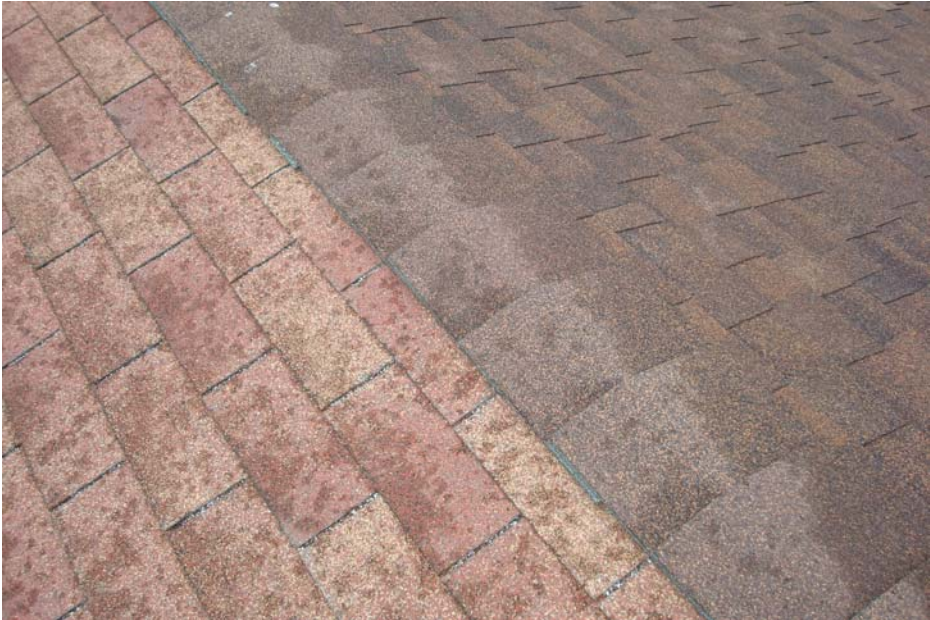
<p>Photo No. 15</p> <p>Location: Fairbank Complex</p> <p>Description: Shingle valley between Roof Areas 5B and 5C is irregular due to loose or poorly applied plywood roof decking.</p>

The steep-sloped recommendation (Roof Area No. 5) is to remove all shingle roofing, including the more recently installed roofing over Roof Area 5D, down to the roof deck (in the case of Roof Area 5A, down to the existing rigid board roof insulation). Roof Area 5D does not require renovation at this time but in order to improve thermal performance and avoid irregular appearance and detailing and to maintain watertightness, replacement is recommended. Roof Area 5A should receive new plywood sheathing (over the existing rigid board roof insulation) and shingle roofing. Roof Area 5B should receive new plywood sheathing and shingle roofing and should have new thermal insulation installed in the confined space below the roof deck. Roof Areas 5C and 5D should receive new nailable rigid board roof insulation and shingle roofing.

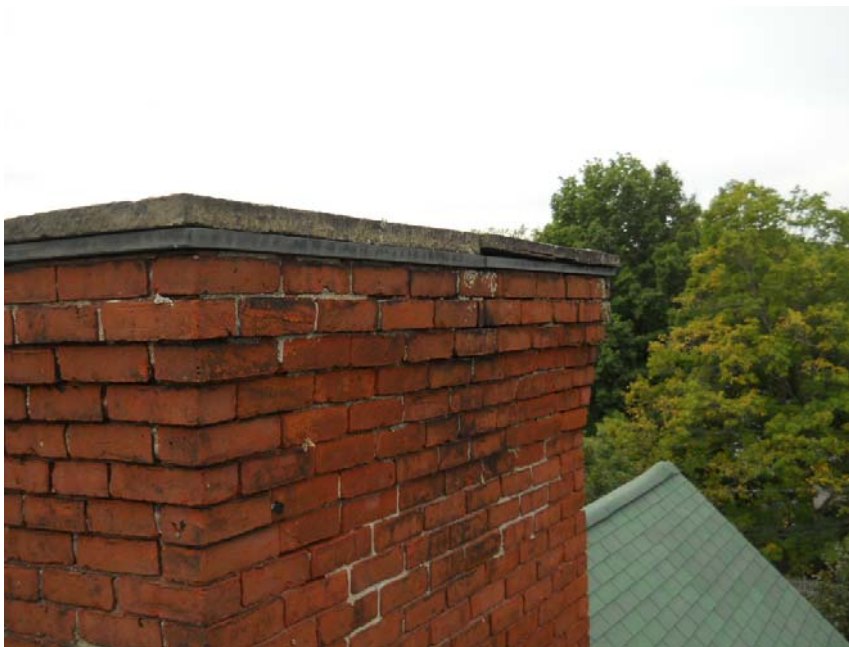
Photo No. 09

Description:
Deteriorated Chimney Cap

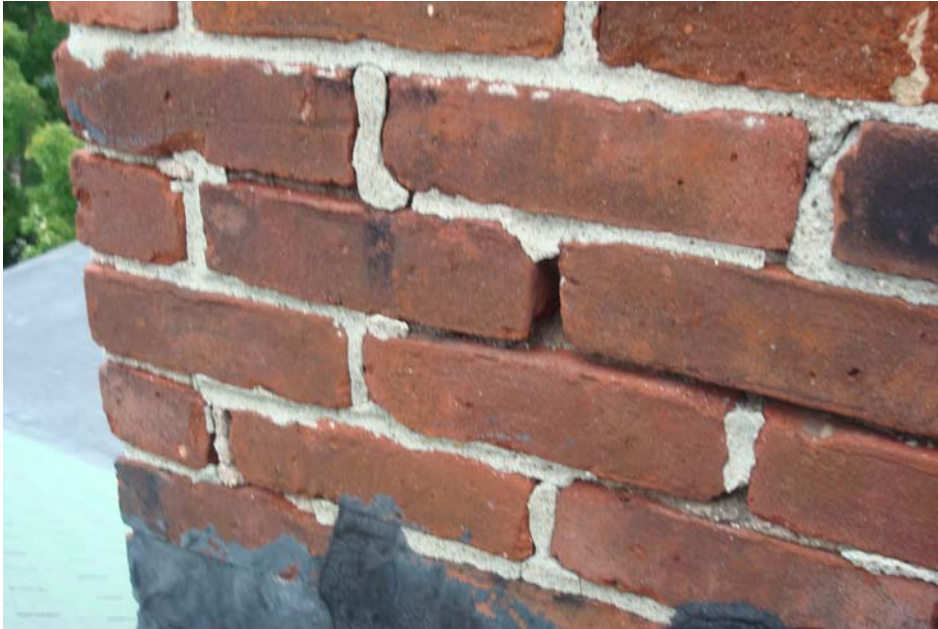
Photo No. 10

Description:
Deteriorated Chimney Cap & Brick Mortar

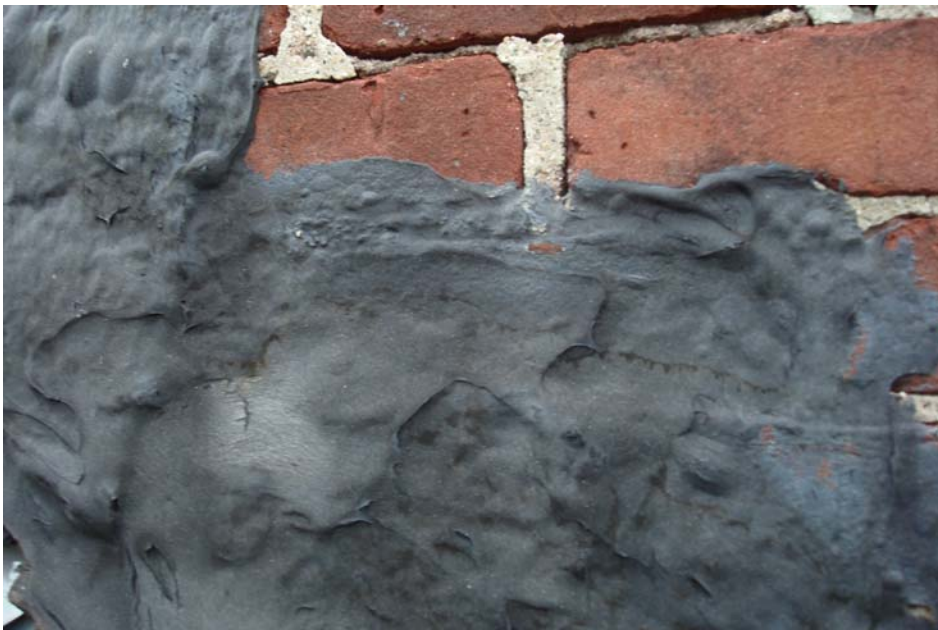
Photo No. 11

Description:
Deteriorated Brick Mortar

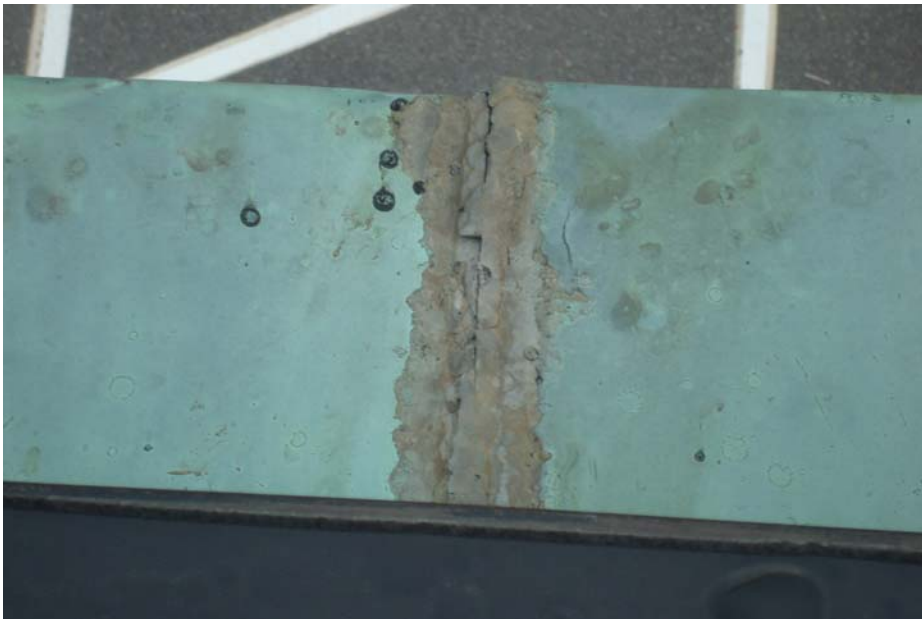
Photo No. 15

Description:
Deteriorated
Copper Shelf

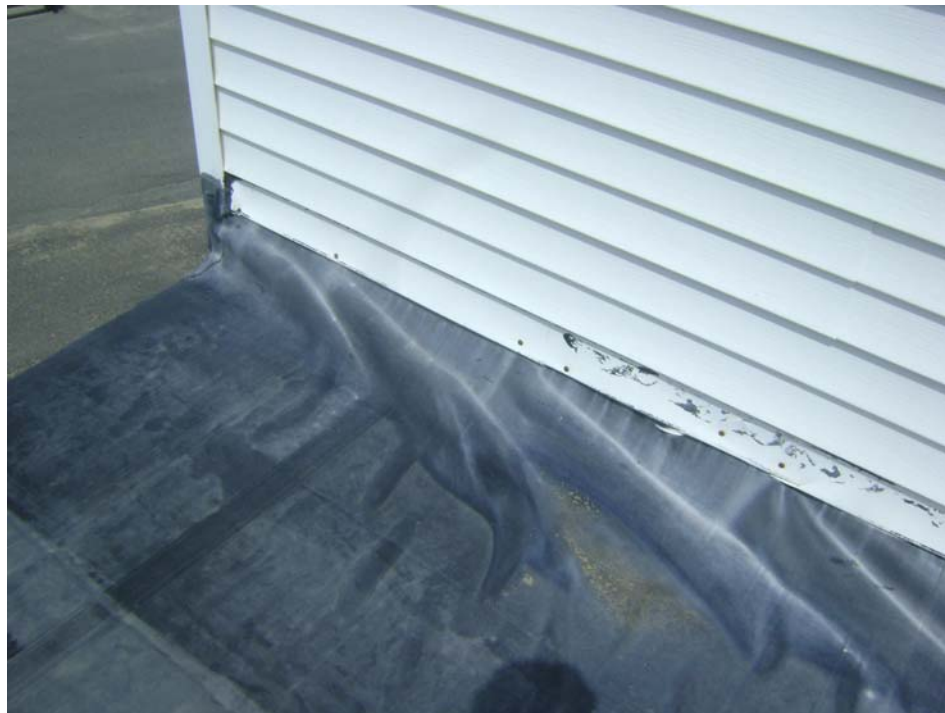
Photo No. 09

Description:
Ponding Water on
Roof Area No. 2

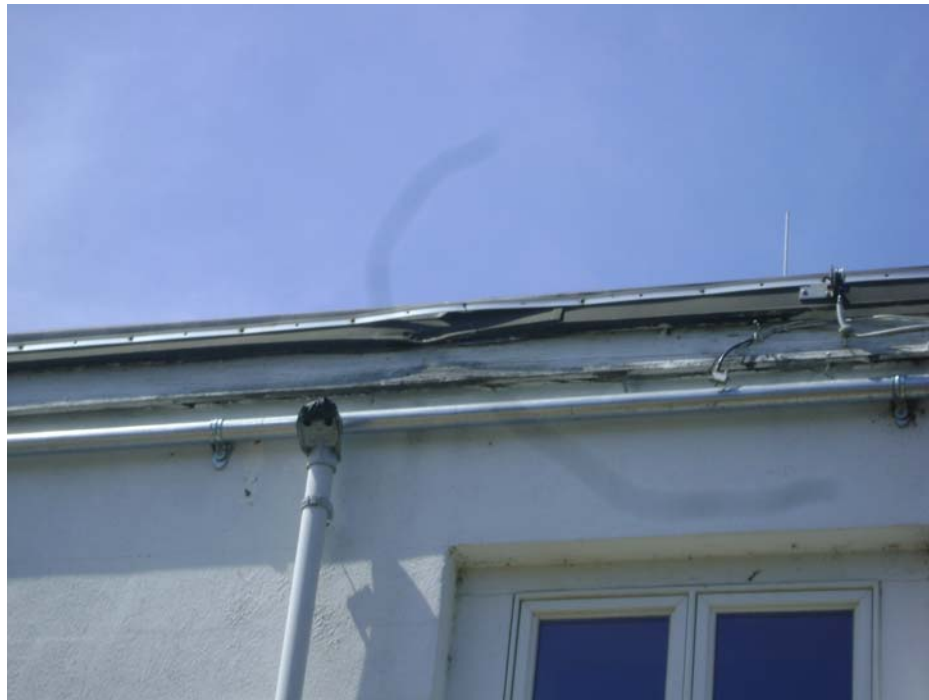
Photo No. 18

Location: Highway Office & Garage Building

Description:
Deteriorated Edge Metal & Wood Fascia

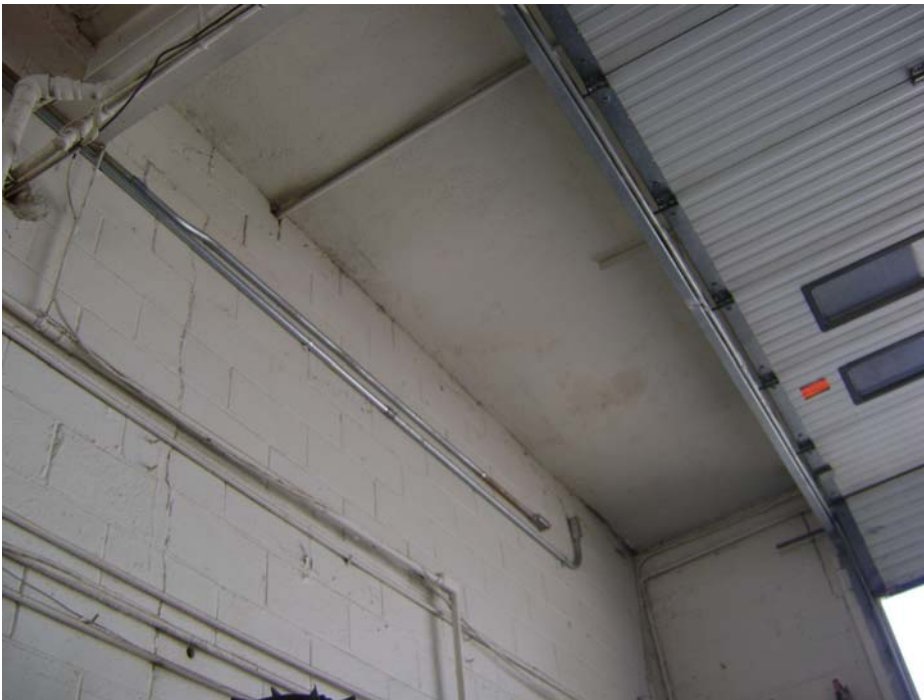
Photo No. 20

Location: Highway Office & Garage Building

Description: Stained Ceiling From Roof Leak

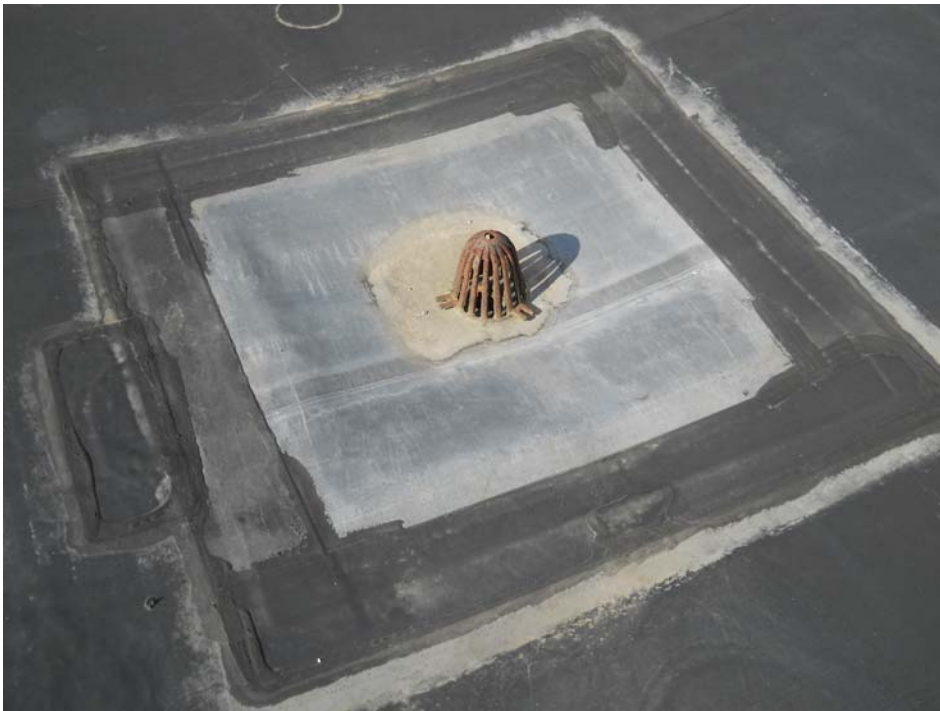
Photo No. 04

Description: Some roof drains include sheet metal sleeves with original cast iron strainers

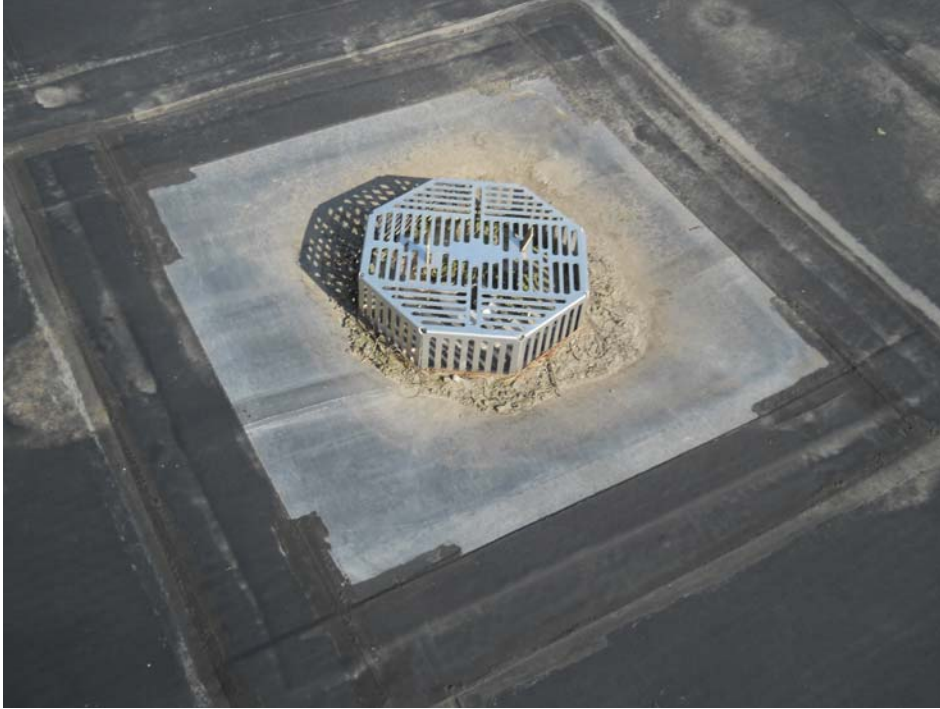
Photo No. 05

Description: Other drains are constructed of heavy wall aluminum with aluminum strainers.

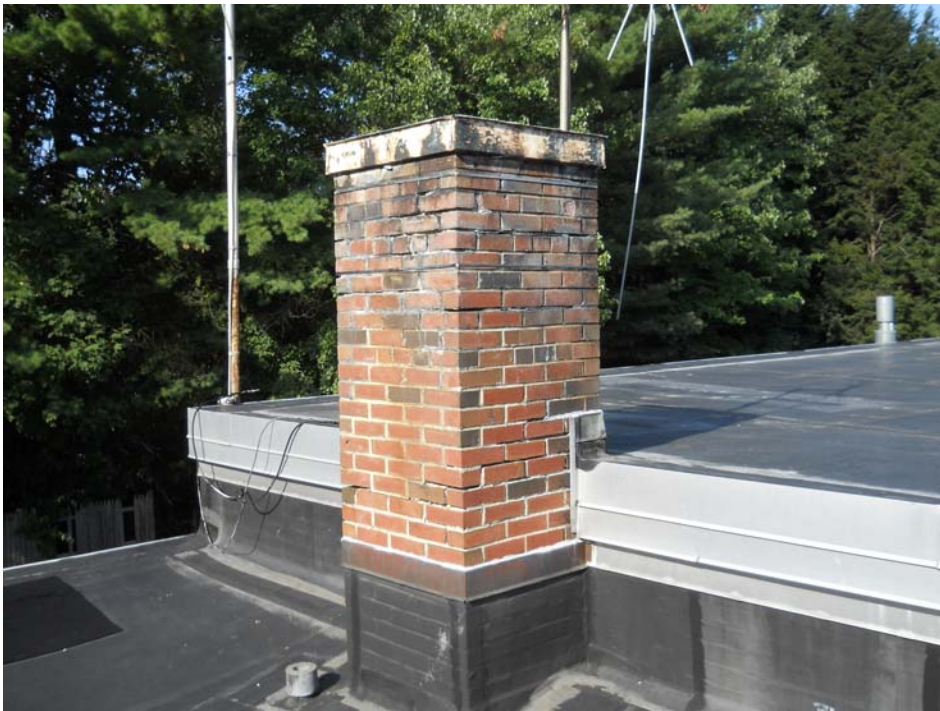
Photo No. 06

Description: Masonry chimney requires repairs.

- Replace 3,045 SF of roof area.
- Repair 500 SF of roof decking.
- Replace 2 cast iron roof drains.
- Repoint masonry chimney.

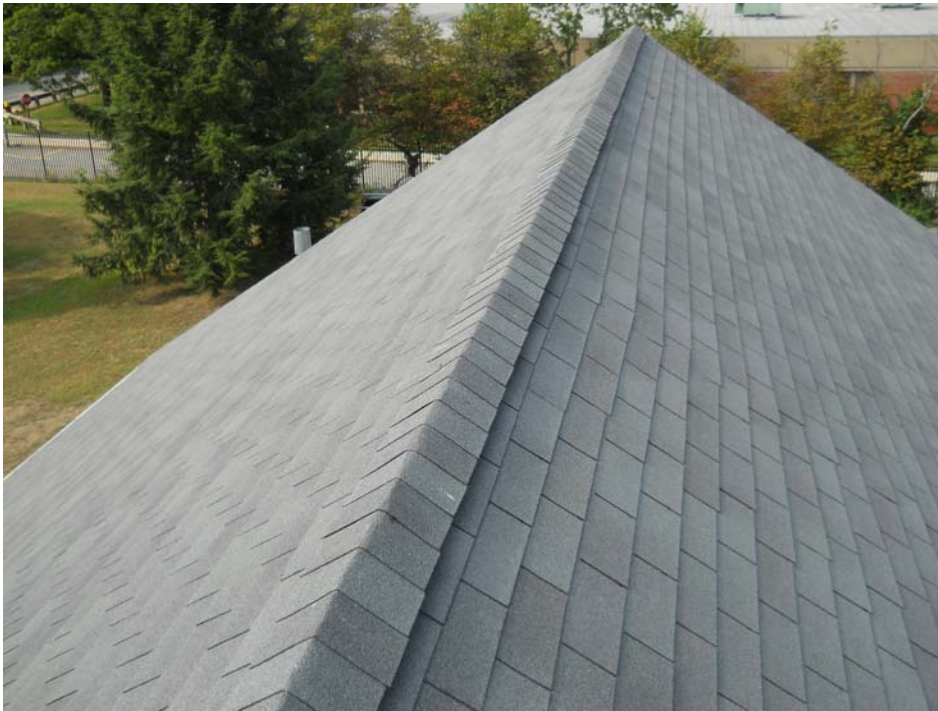
Photo No. 02

Description:
Overview of Roof.
Overall, the shingle
roof material is in
good condition.

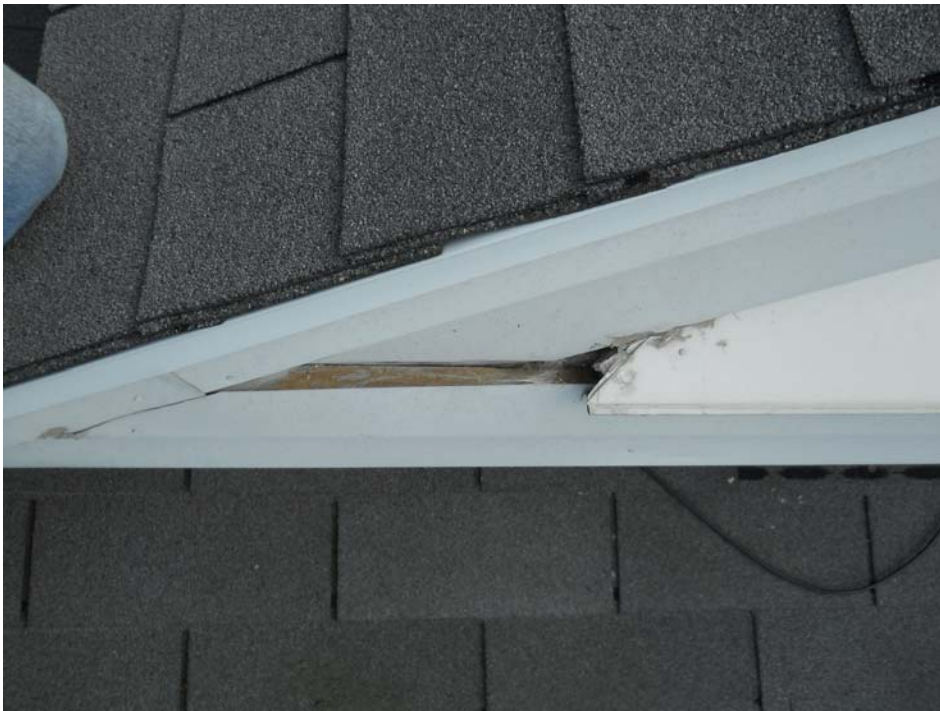
Photo No. 04

Description: Rake edge returns were never fully clad with sheet metal resulting in exposed and weathered wood trim.

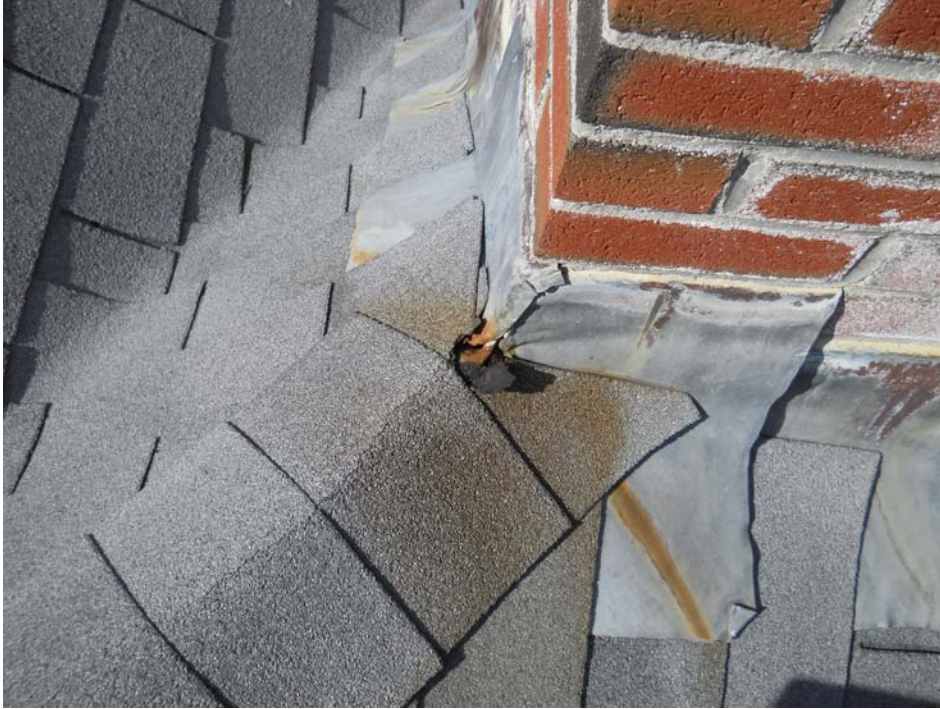
Photo No. 05

Description: Open transition between shingles and lead counterflashing.

1. Implement repairs to the steep-sloped shingle roof (Roof Area Nos. 1 & 2 at 4,135 SF) in year **2010**. Repair work includes replacing deteriorated wood roof decking and missing shingles; seal voids in joints of the copper step flashing.
2. Replace the steep-sloped shingle roof (Roof Area Nos. 1 & 2 at 4,135 SF) in year **2018**. Replacement includes installation of a new heavy duty architectural asphalt shingle system complete with felt underlayment, ice and water barrier membrane, ventilation improvements, gutters and downspouts, and a roofing manufacturer's material warranty (minimum 40-year time frame).

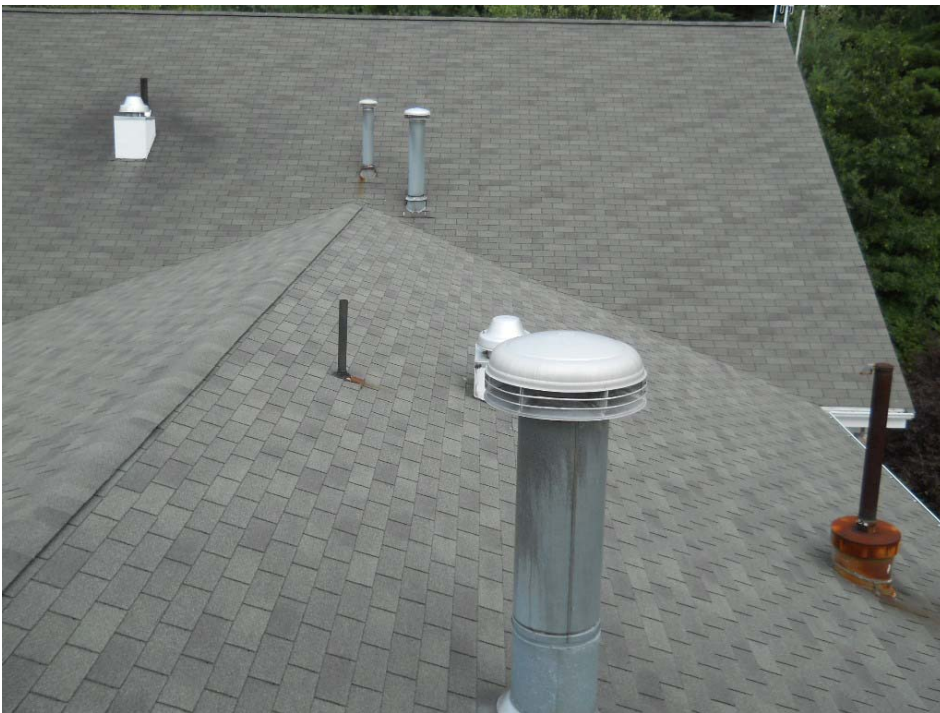
Photo No. 02

Description:
Overview of Roof.
Overall, the roof is in good condition.

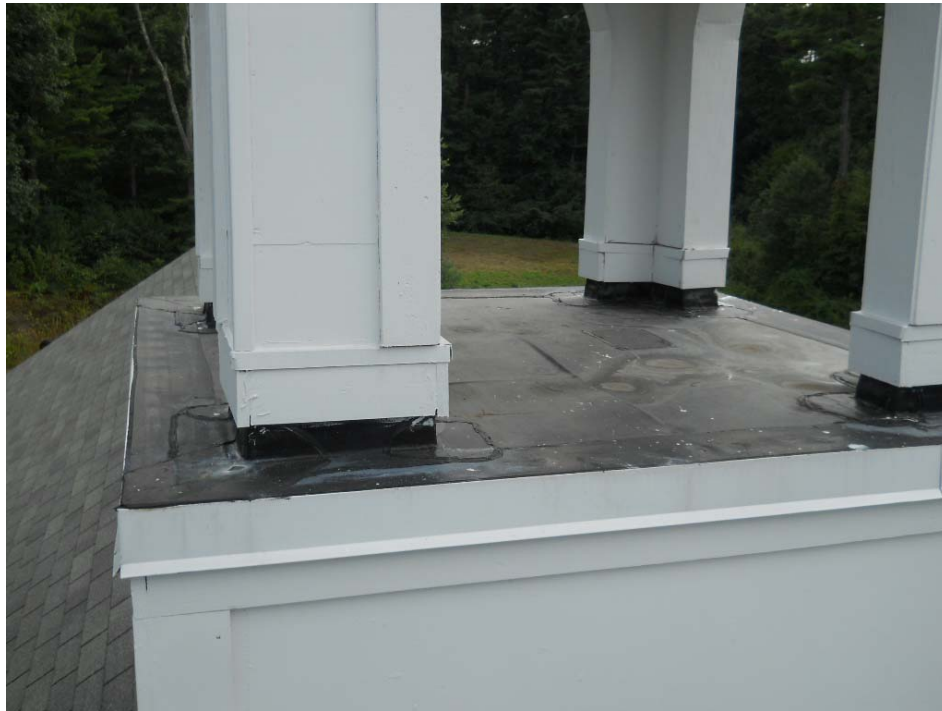
Photo No. 04

Description:
Cupola structure of apparatus bays appears in good condition.

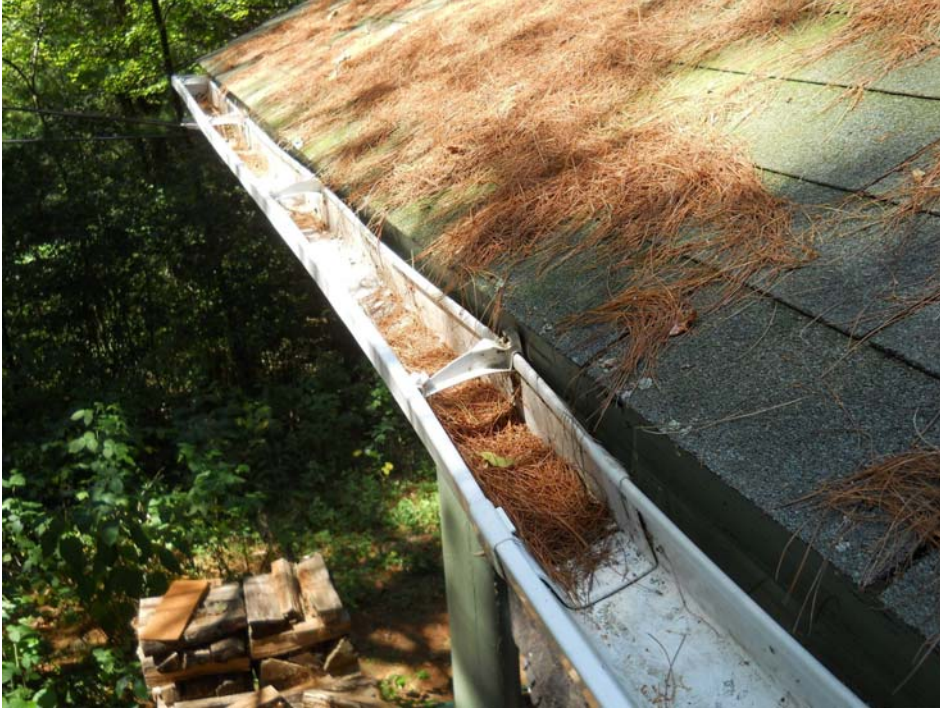
Photo No. 05

Description:
Gutter Backed Up
With Pine Needles

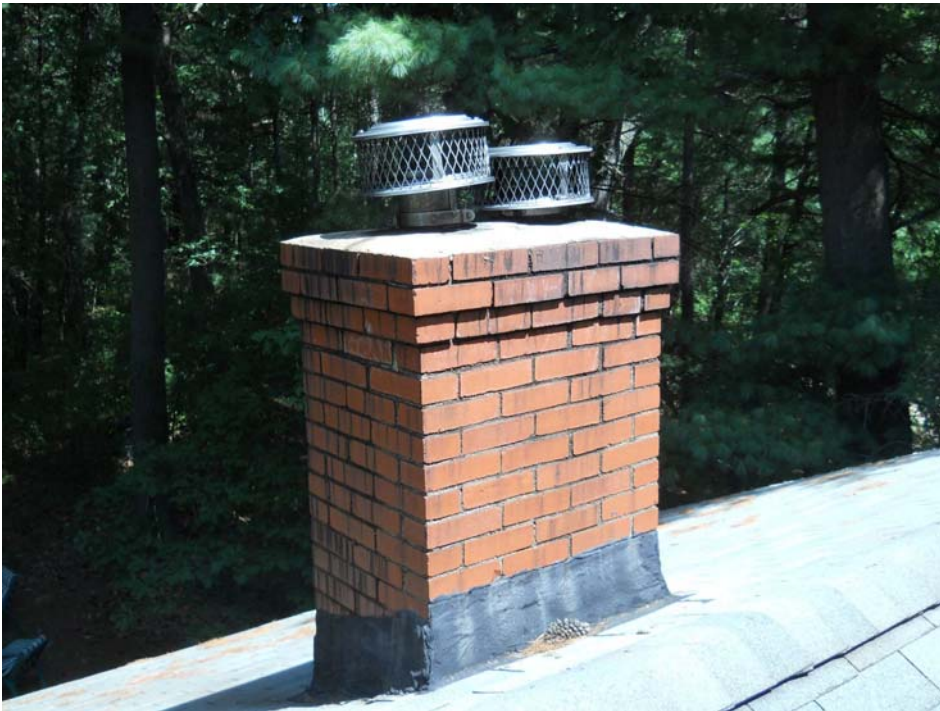
Photo No. 06

Description:
Improperly Flashed
Chimney

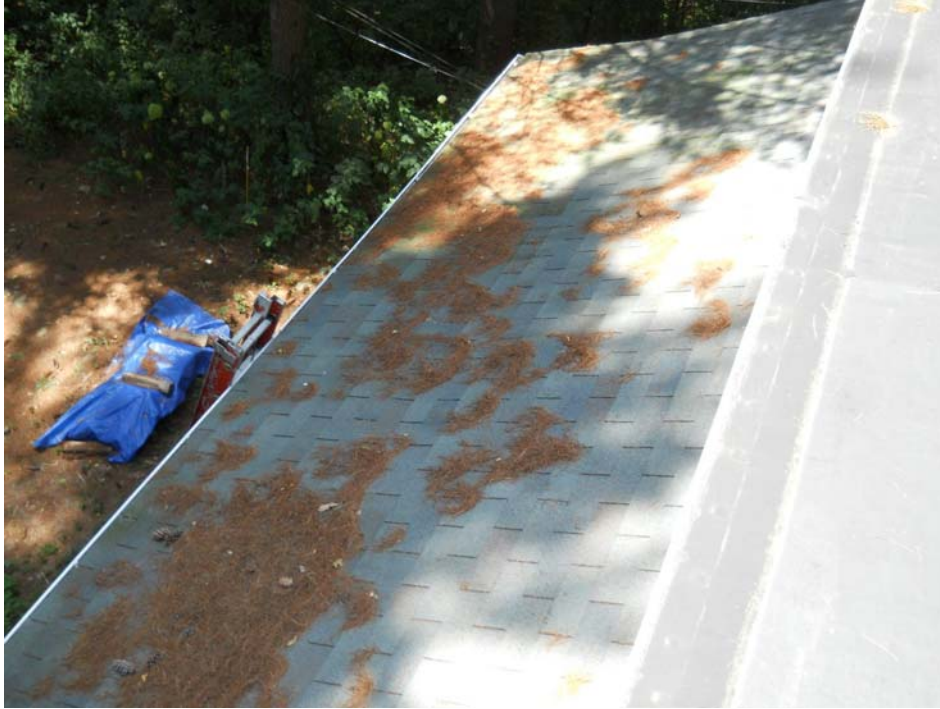
Photo No. 07

Description: Moss & Pine Needle Accumulation

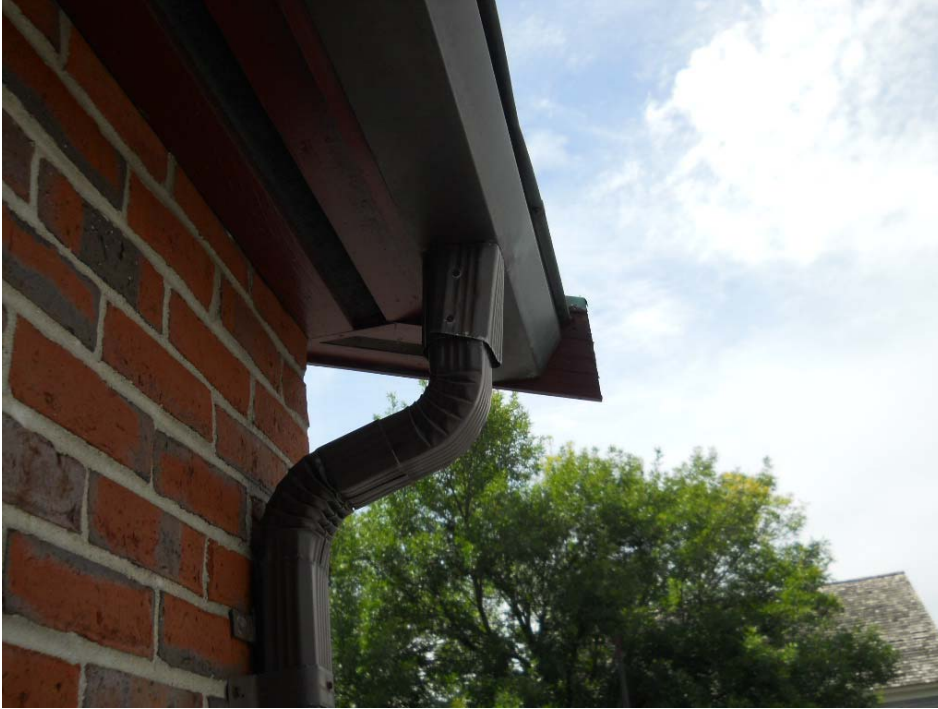
Photo No. 03

Description: All downspouts have been fitted with a downspout collar to allow mechanical attachment.

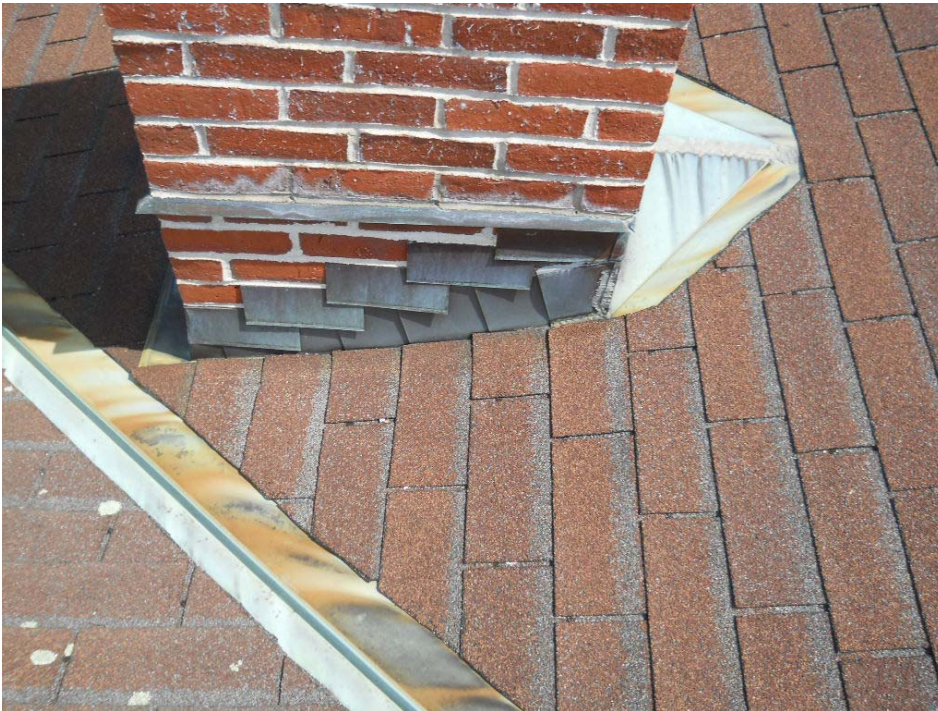
Photo No. 06

Description: Unusual flashing configurations at the brick chimney suggest that the chimney was extended when the addition was built.

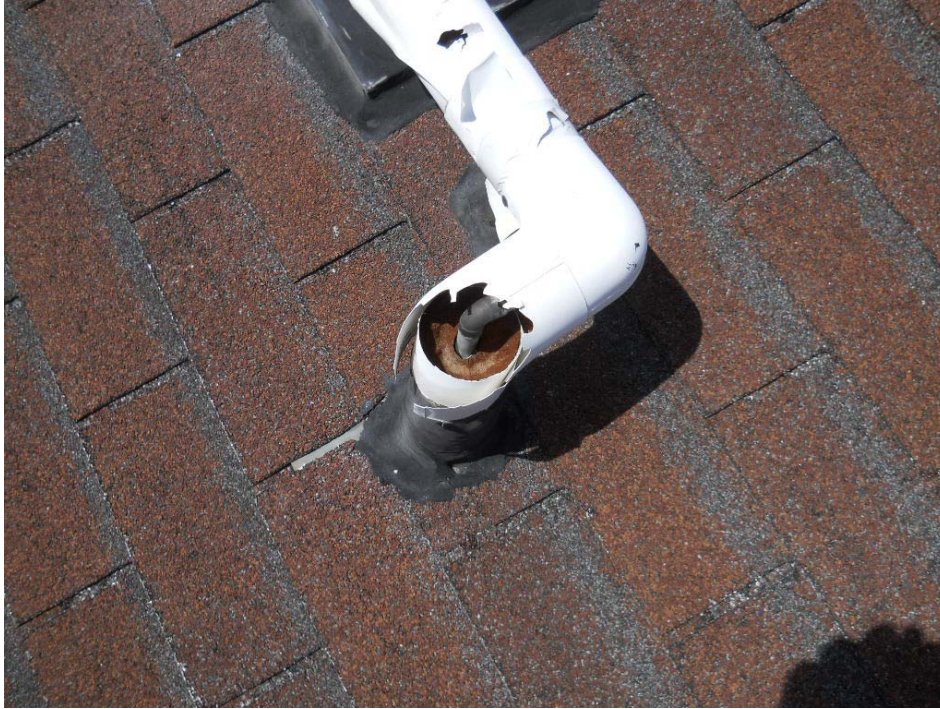
Photo No. 07

Description:
Piping leading from the roof-mounted solar panels is probable source of water entry.

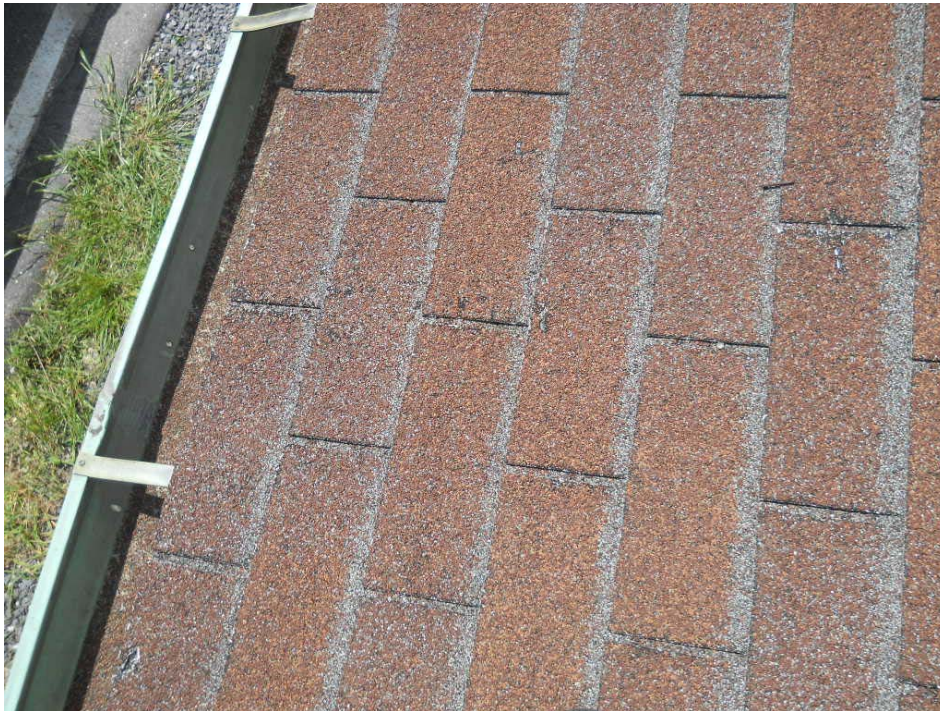
Photo No. 08

Description:
Shingle surfaces are worn.

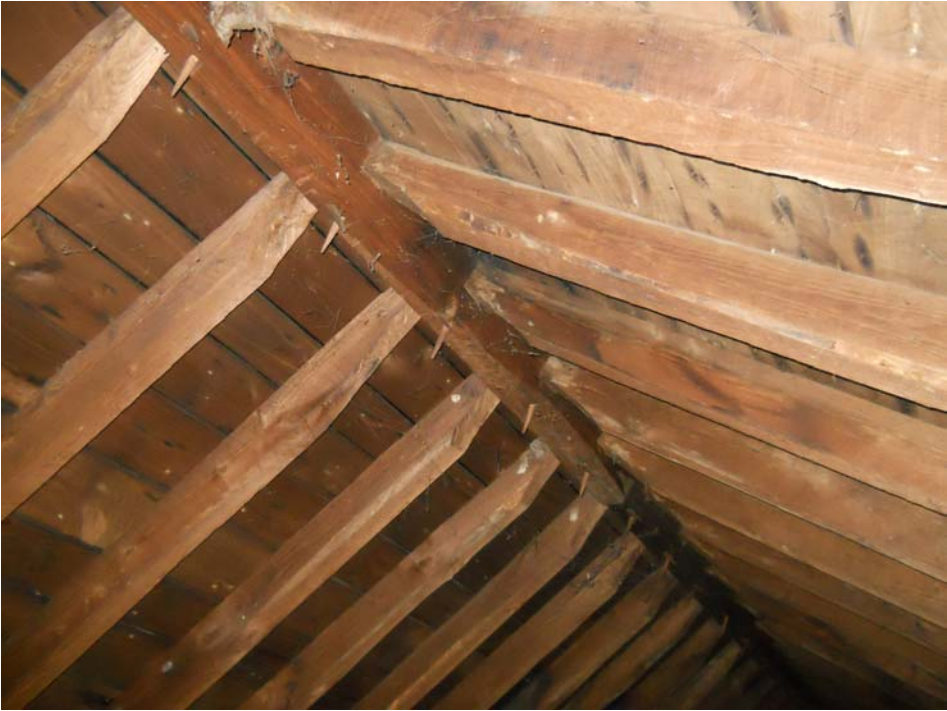
Photo No. 05

Location: Carding Mill House

Description: Water Stained Ridge Beam

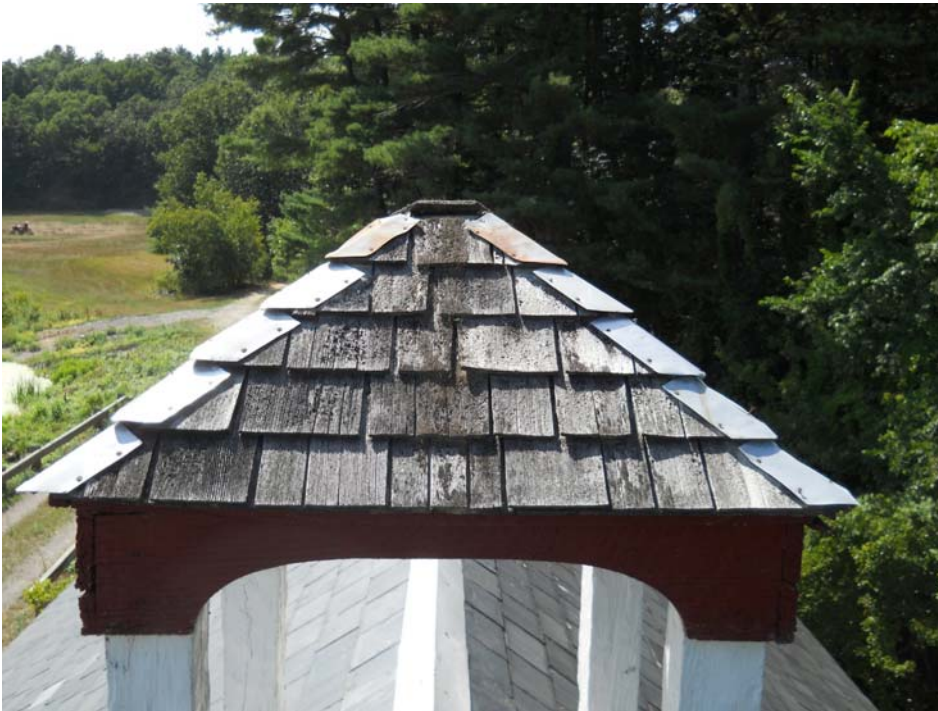
Photo No. 10

Location: Carding Mill House

Description: Cedar Shingles In Poor Condition.

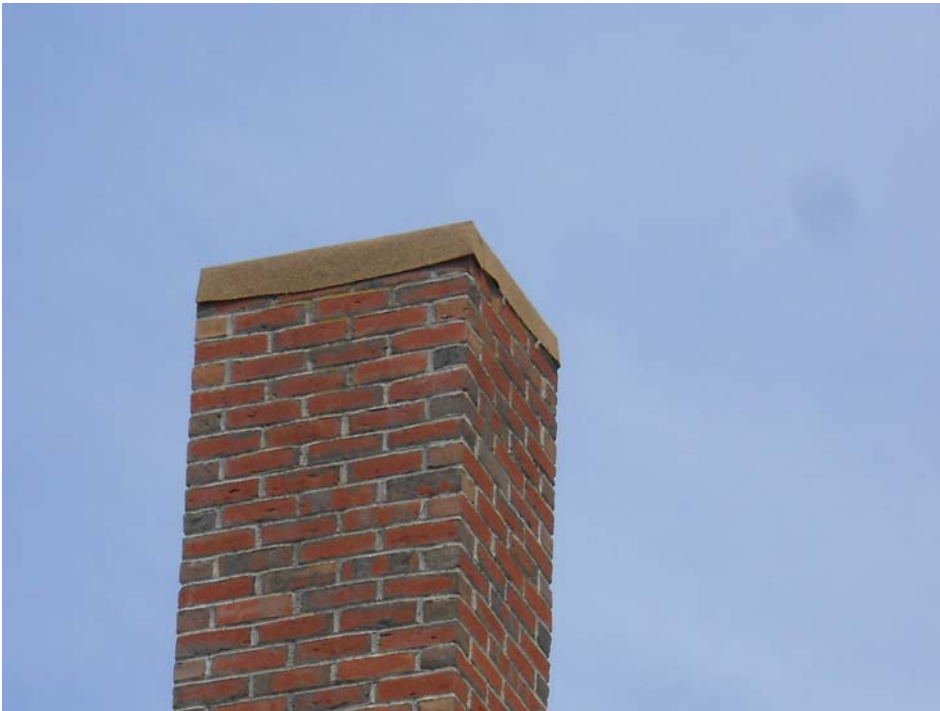
Photo No. 06

The roofing systems that exist at this location are in good condition. No leaks are reported. One of the chimneys is capped off with what appears to be a roll roofing type of product that is nailed to the bricks at the perimeter (loose areas were observed).

Location: Loring Parsonage

Description:
Improper Chimney
Cap Flashing

No corrective repairs are recommended at this time except to replace the chimney cap with a proper sheetmetal cap in year **2011**.

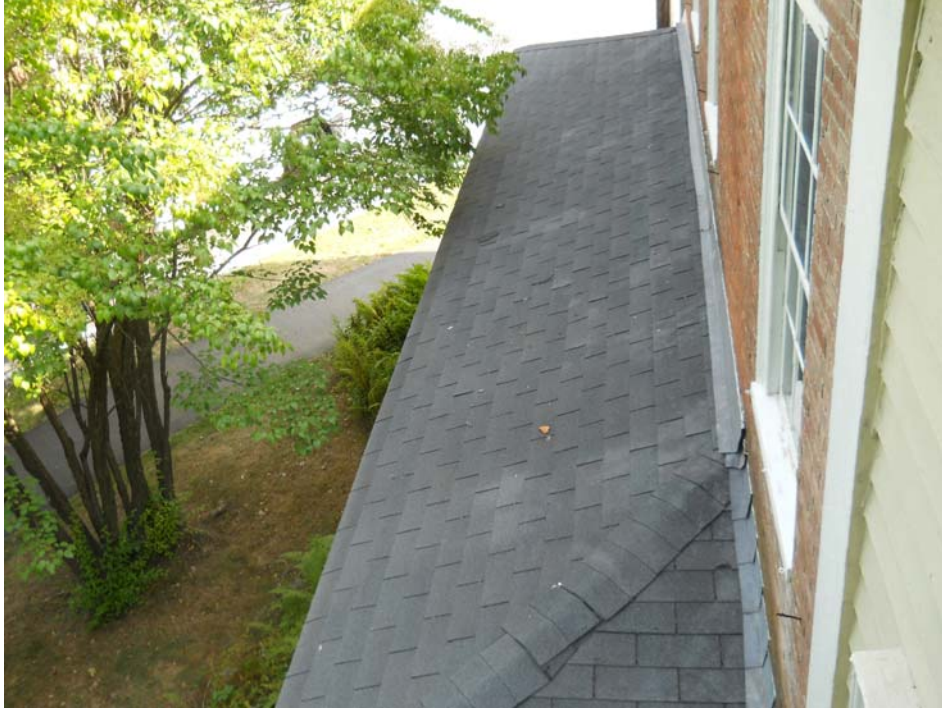
Photo No. 03

Location: Hosmer House

Description:
Partial Overview of Roof Area No. 1.
Note the loose counterflashing and hip shingles.

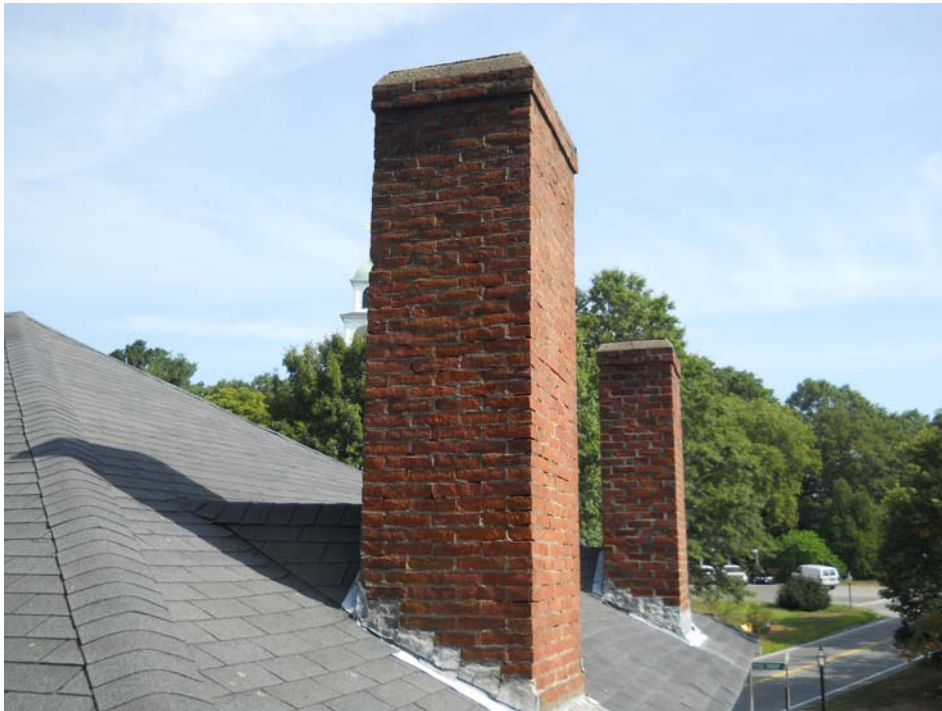
Photo No. 04

Four of the six chimneys are in various stages of deterioration (deteriorated mortar joints, bricks, and chimney caps).

Location: Hosmer House

Description:
Partial overview of Roof Area No. 2.
Brick masonry chimneys require repointing.

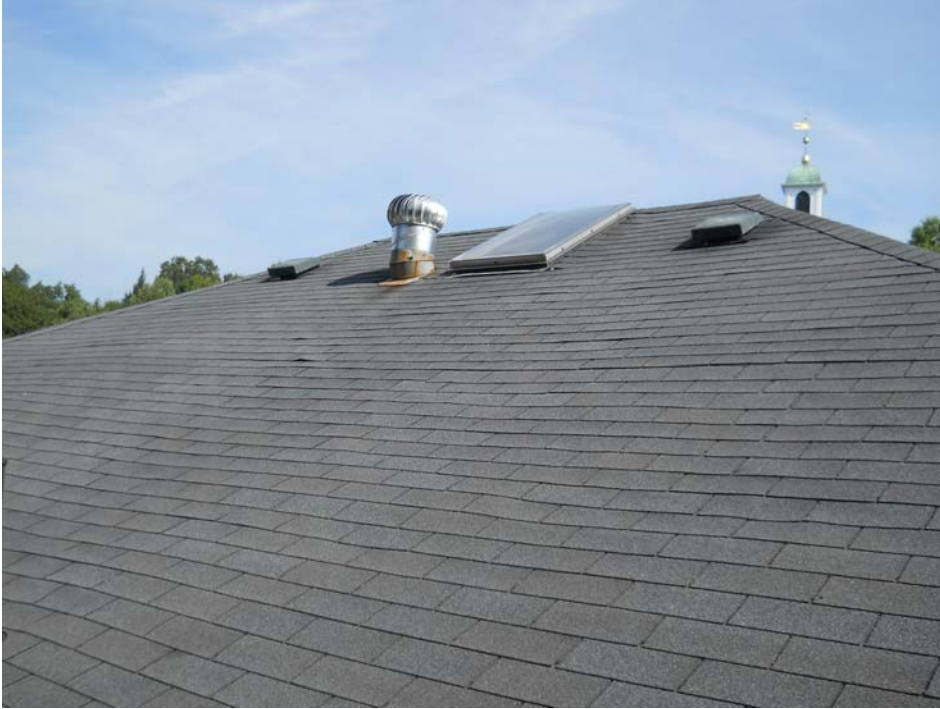
Photo No. 05

The shingle roofing system that exists on Roof Nos. 1 and 2 are 3-tab style, are the oldest shingle system on the building (estimated to be in excess of 20-years old) and are in fair to poor condition (approx. 2,040 SF). Sporadic leakage is reported to occur in various locations.

Location: Hosmer House

Description:
Partial overview of Roof Area No. 2. Shingles are buckling.

1. Replace the steep-sloped shingle roof (Roof Area Nos. 1 & 2 at 2,040 SF) in year **2012**. Replacement includes installation of a new heavy duty architectural asphalt shingle system complete with felt underlayment, ice and water barrier membrane, ventilation improvements, gutters and downspouts, chimney repairs, and a roofing manufacturer's material warranty (minimum 40-year time frame).
