ROOF CONDITION SURVEY

For
Town of Sudbury
19 Sudbury Public Buildings
Sudbury, Massachusetts

February 3, 2012

RBA Project No. 201056.00

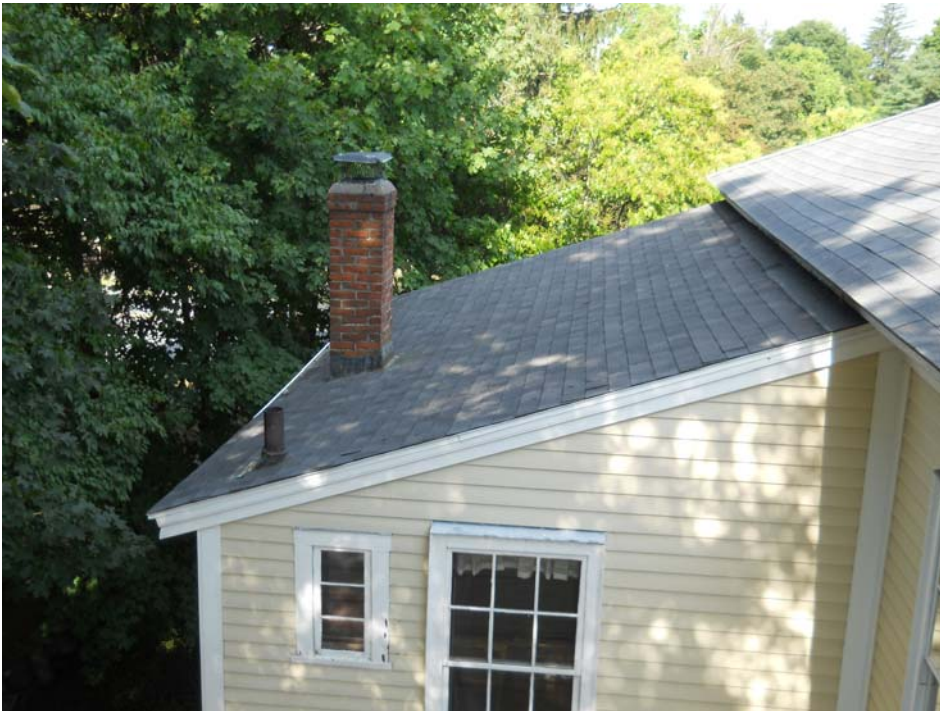
Photo No. 06

Location: Hosmer House

Description:
Partial overview of Roof Area No. 3. Squirrels gain access to the main attic beneath the eave in the foreground.

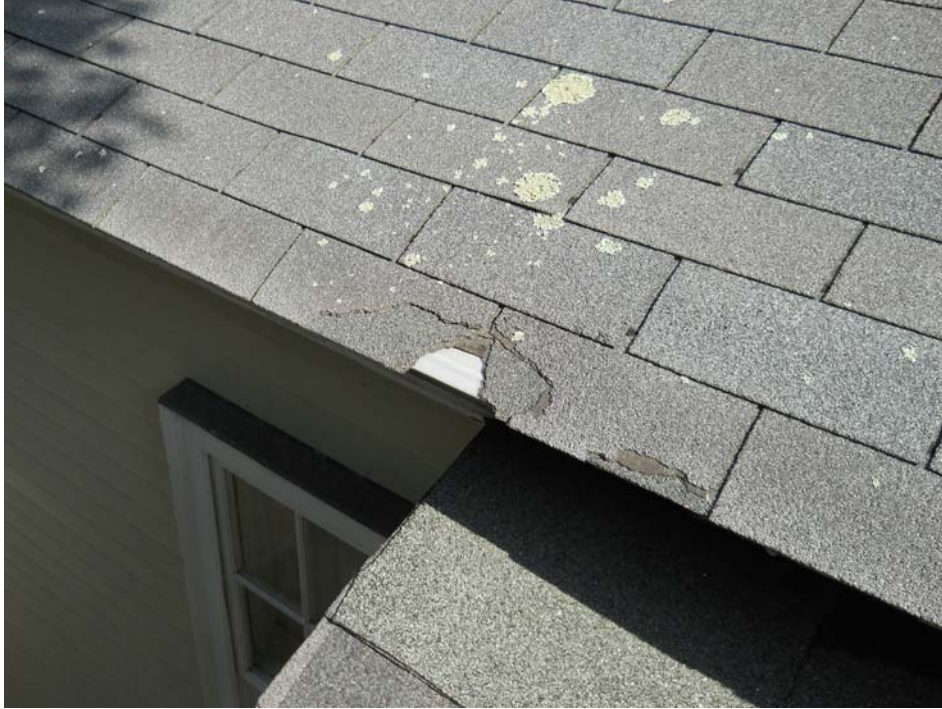
Photo No. 09

The shingle roofing system that exists on Roof Nos. 1 and 2 are 3-tab style, are the oldest shingle system on the building (estimated to be in excess of 20-years old) and are in fair to poor condition (approx. 2,040 SF). Sporadic leakage is reported to occur in various locations.

Location: Hosmer House

Description:
Deteriorated
Shingles on Roof
Area No. 2

1. Replace the steep-sloped shingle roof (Roof Area Nos. 1 & 2 at 2,040 SF) in year **2012**. Replacement includes installation of a new heavy duty architectural asphalt shingle system complete with felt underlayment, ice and water barrier membrane, ventilation improvements, gutters and downspouts, chimney repairs, and a roofing manufacturer's material warranty (minimum 40-year time frame).

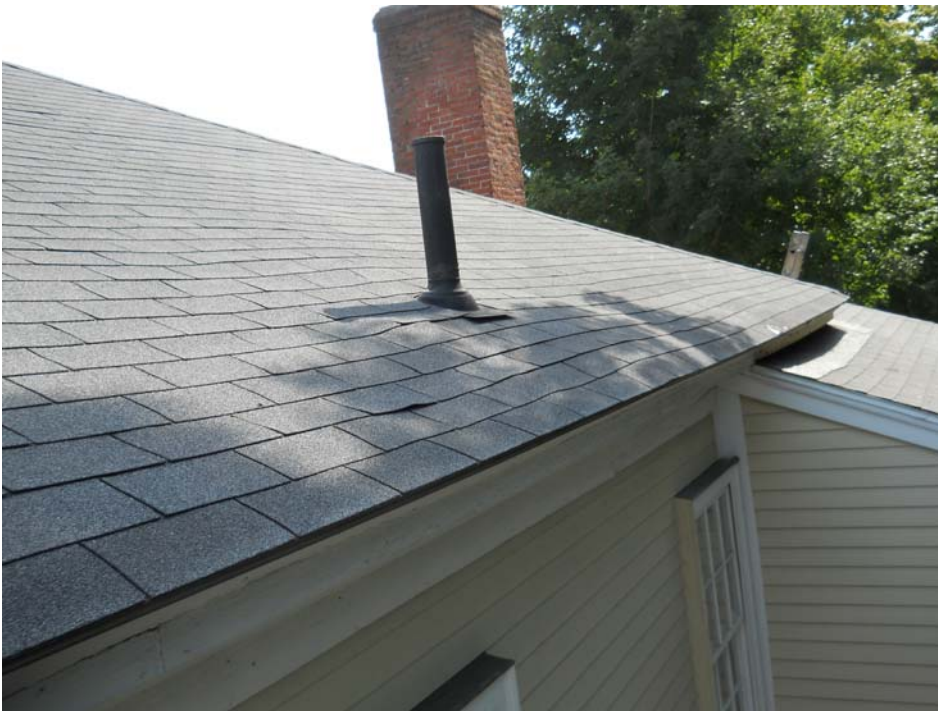
Photo No. 12

Location: Hosmer House

Description: Roof
Decking Curling

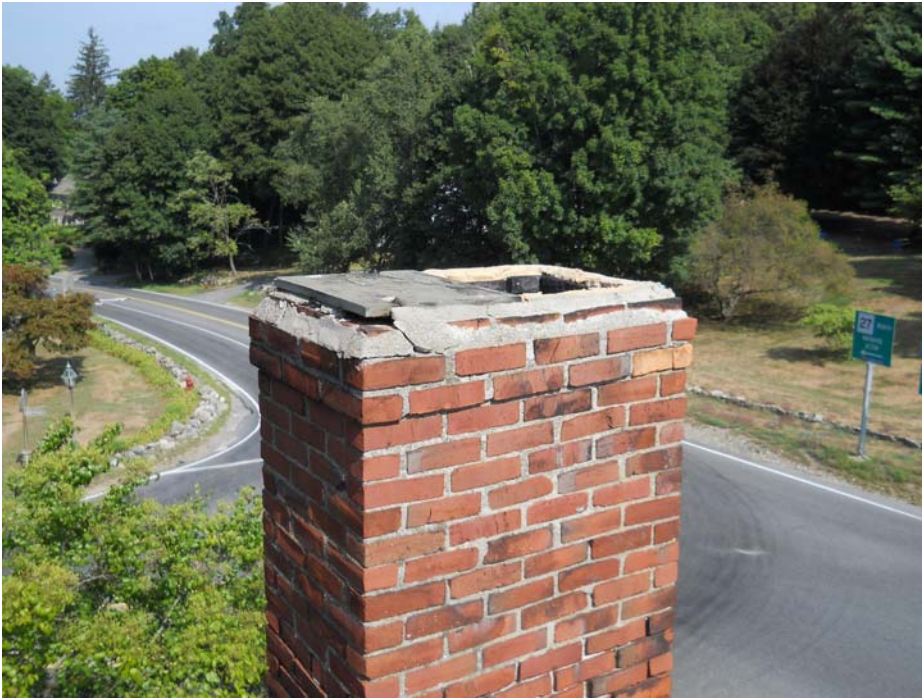
Photo No. 13

Four of the six chimneys are in various stages of deterioration (deteriorated mortar joints, bricks, and chimney caps).

Location: Hosmer House

Description:
Deteriorated
Chimney Cap

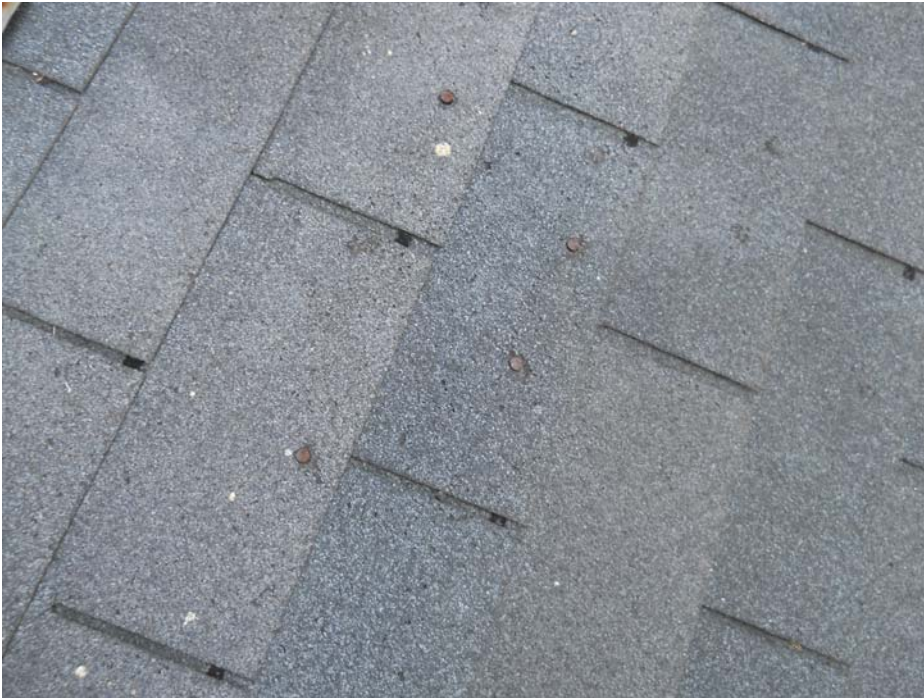
Photo No. 17

Location: Hosmer House

Description: Nail Back-out on Roof Area No. 1

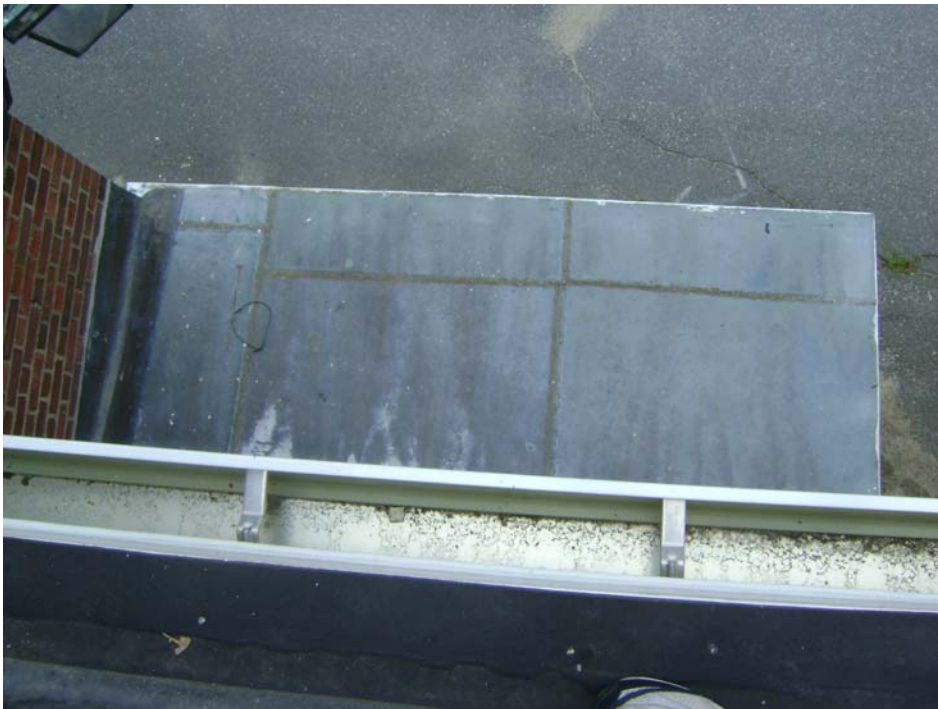
Photo No. 10

Location: DPW
Highway Office &
Garage

Description:
Soldered flat seam
copper roofing is in
fair condition.

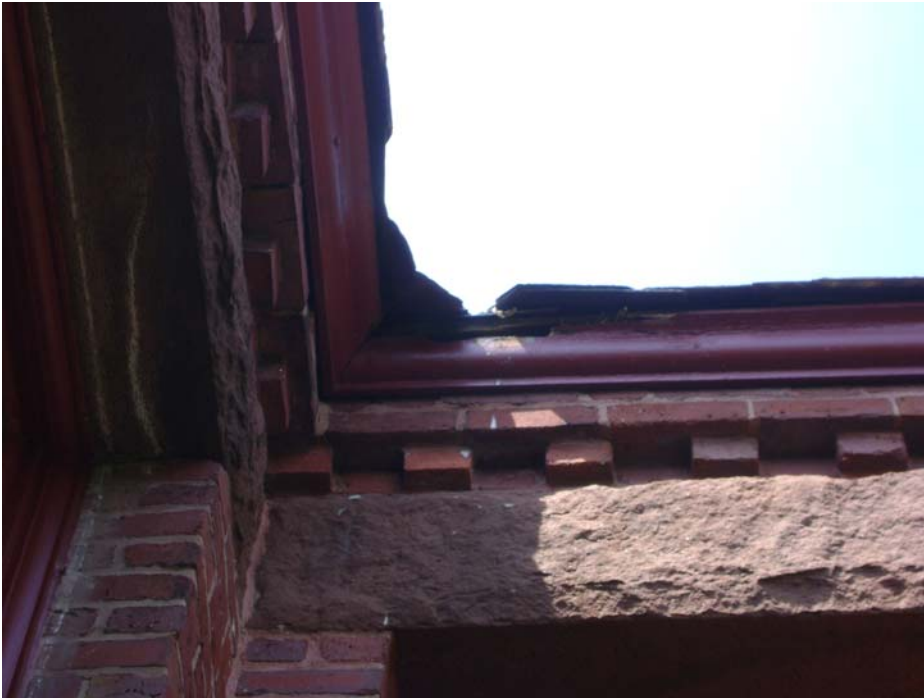
Photo No. 16

Description:
Delaminated
EPDM Membrane
on Roof Area No. 3

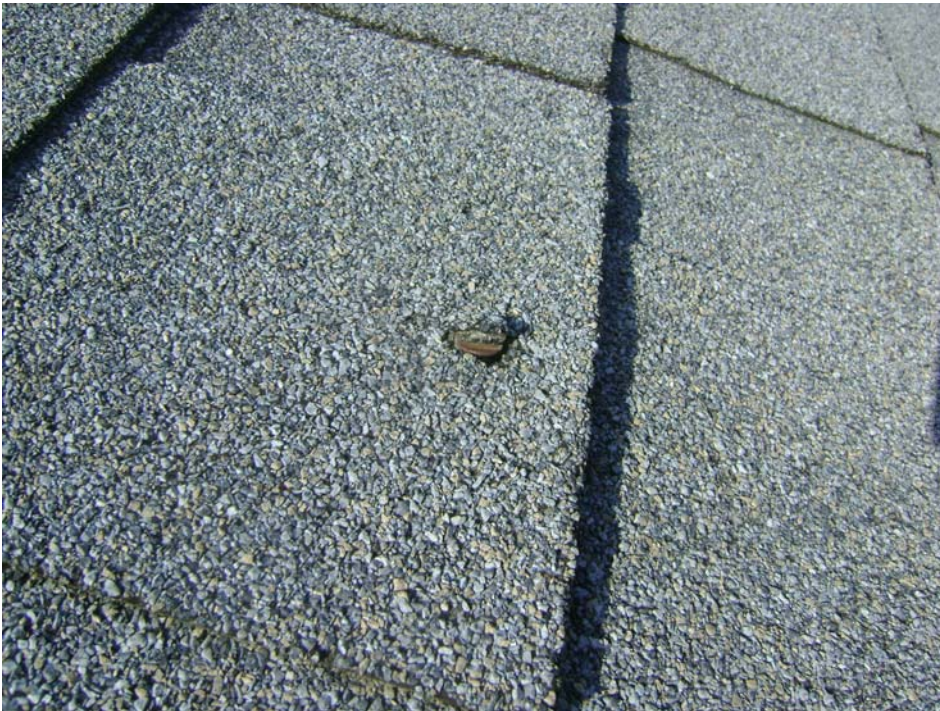
Photo No. 10

The shingle roofing system (Roof Area No. 1) appears to be in good condition. However nails securing the shingles at several locations are backing out and creating holes in the shingles.

Description: Nail
Backing Out (1 of
70 Count) on Roof
Area No. 1

1. Implement repairs to the steep-sloped metal roof (Roof Area No. 3 at 17,525 SF) in year **2011**. Repair work includes reflashing rooftop penetrations and associated crickets, re-securing panel fasteners and installing new panel fasteners as needed.
2. Implement repairs to the steep-sloped shingle roof (Roof Area No. 1 at 10,500 SF) in year **2011**. Repair work includes resealing shingle nails and repairing holes as needed.

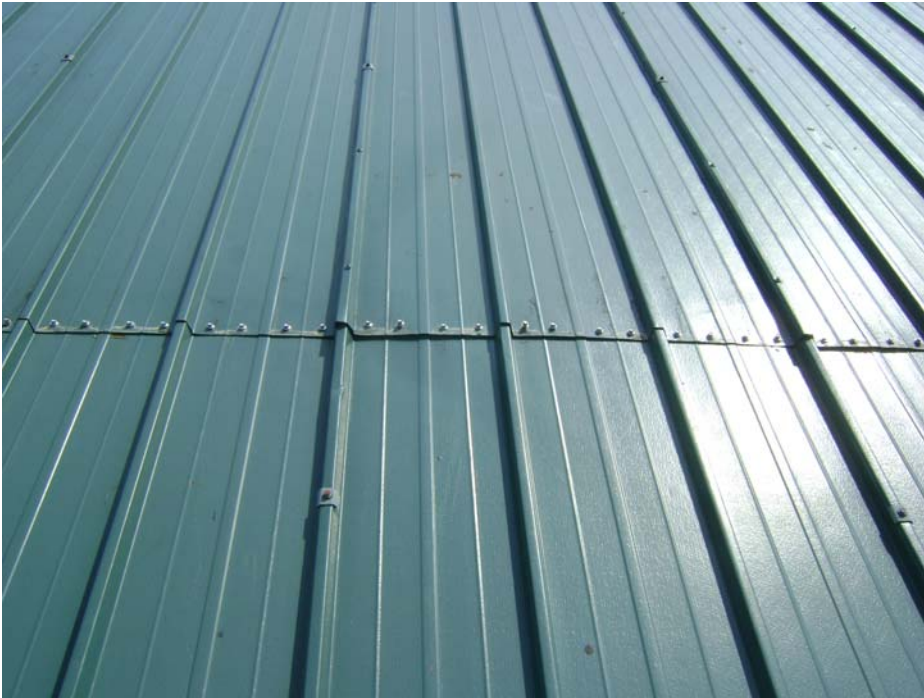
Photo No. 13

The sloped metal roofing system (Roof Area No. 3) appears to be in good to fair condition. Rusting was observed on some of the panels; otherwise, on the whole, the panels appear to be in good condition. Rooftop units and associated crickets are flashed with EPDM membrane and some deterioration was observed (unadhered and deteriorated seams). A significant number of panel fasteners have backed out and in some cases a gap exists at the end panels.

Description: Roof
Seam Opening &
Screws Popping
Out on Roof Area
No. 3

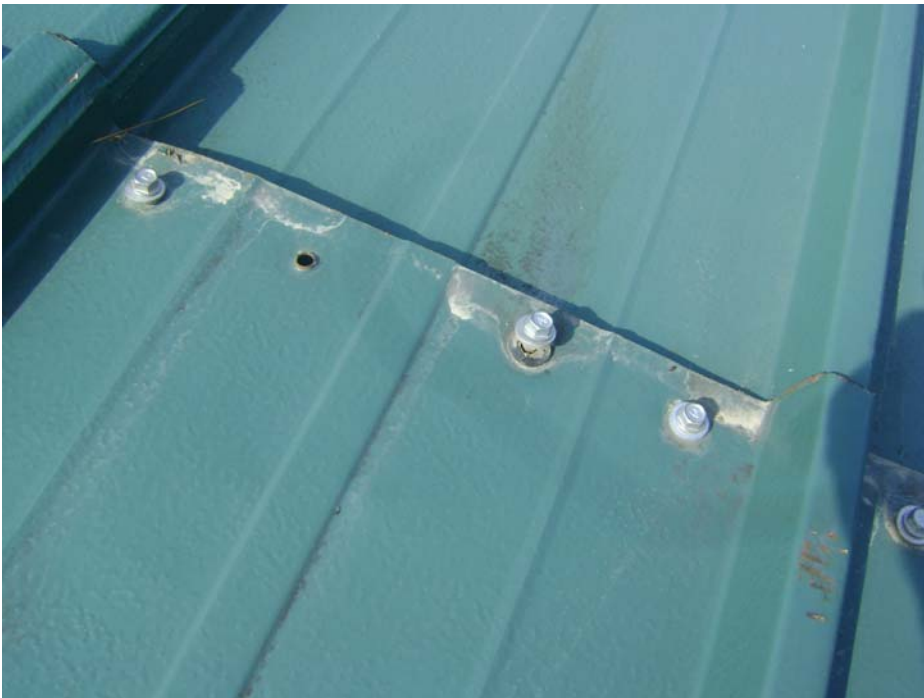
Photo No. 14

Description:
Screws Missing &
Popping Out on
Roof Area No. 3

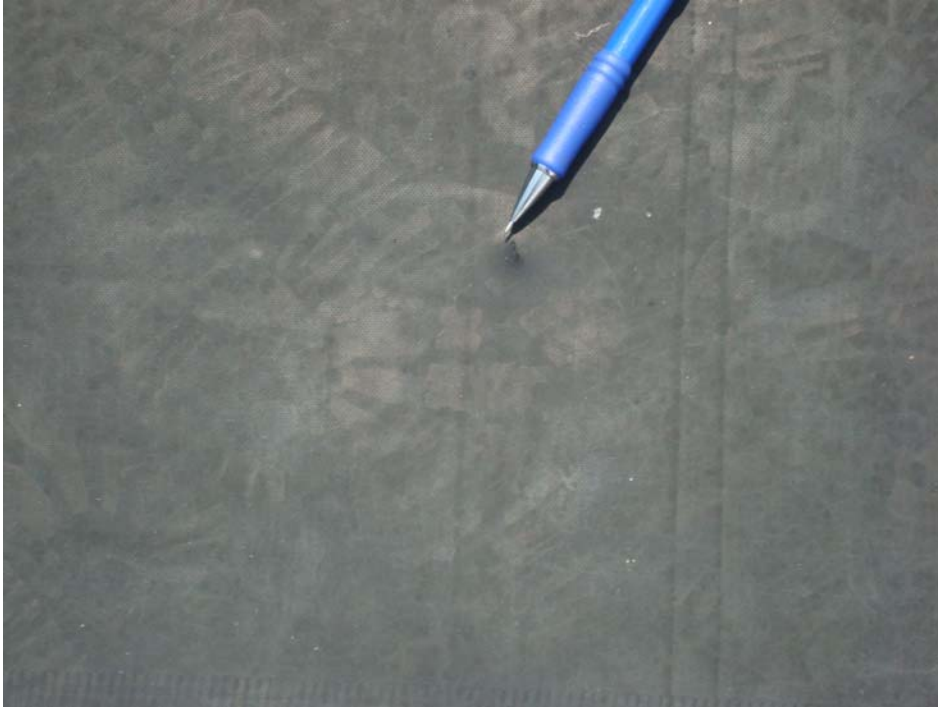
Photo No. 07

Description:
Puncture in roof membrane.

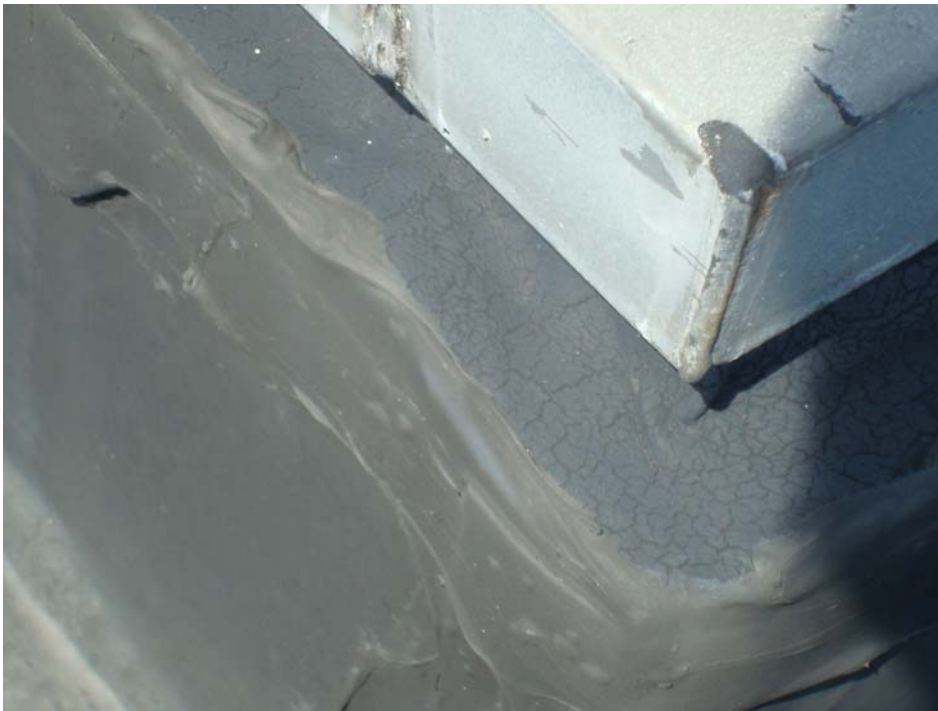
Photo No. 08

Description:
Neoprene base flashings are aged and cracked.

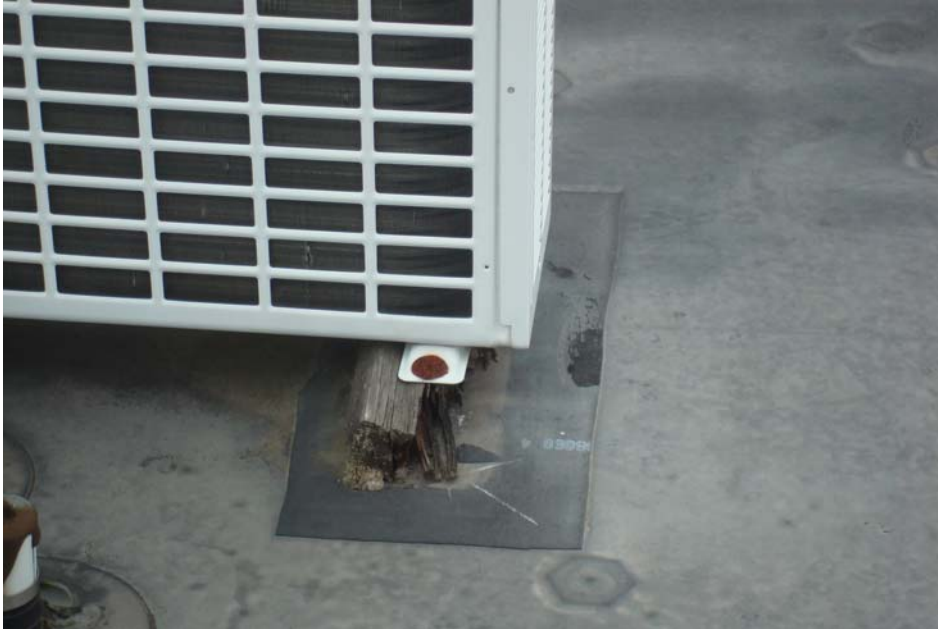
Photo No. 05

Description:
Typical deteriorated wood sleeper support.

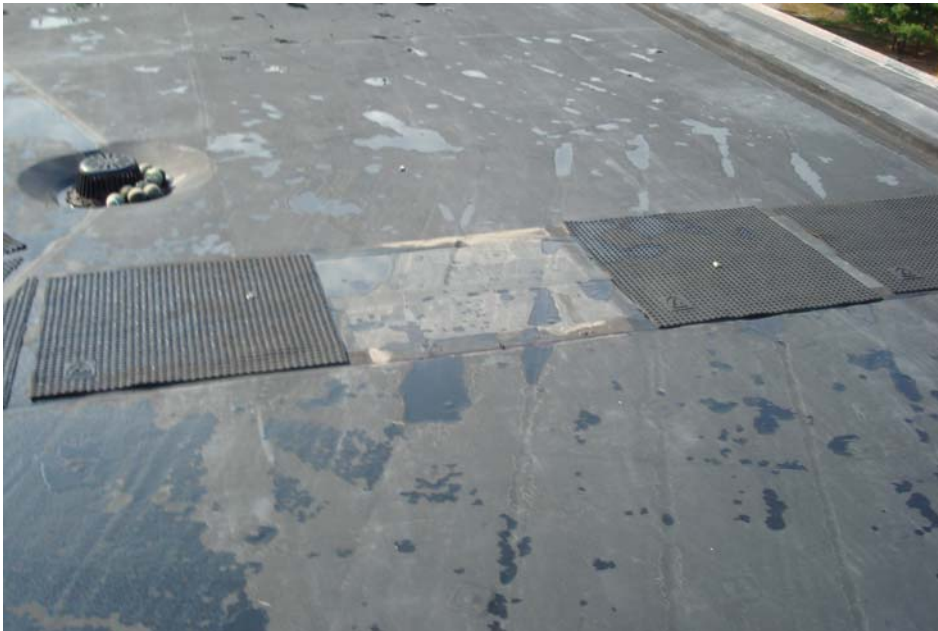
Photo No. 06

Description:
Walkway pads are loose.

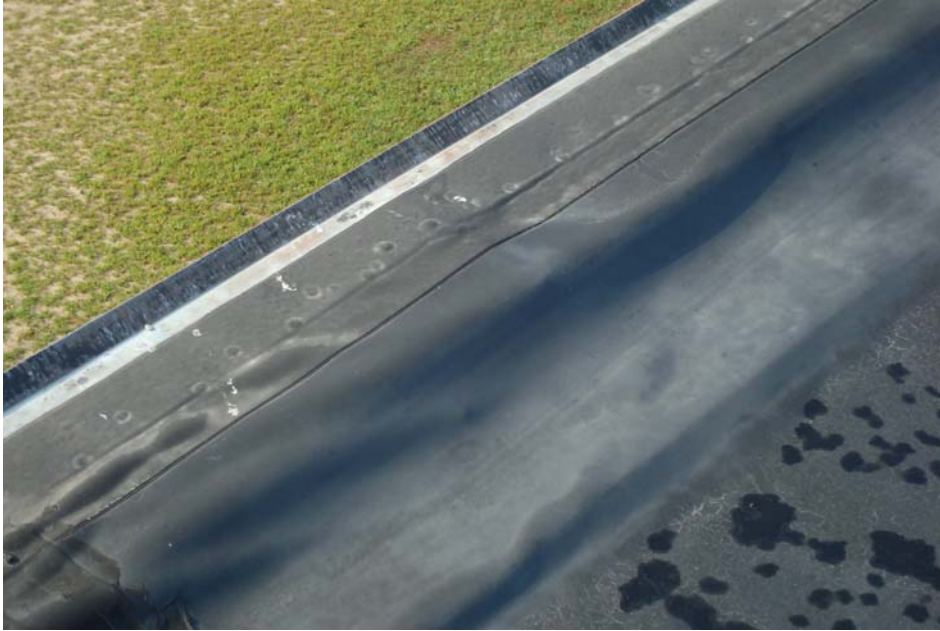
Photo No. 07

Description:
EPDM flashing is loose.

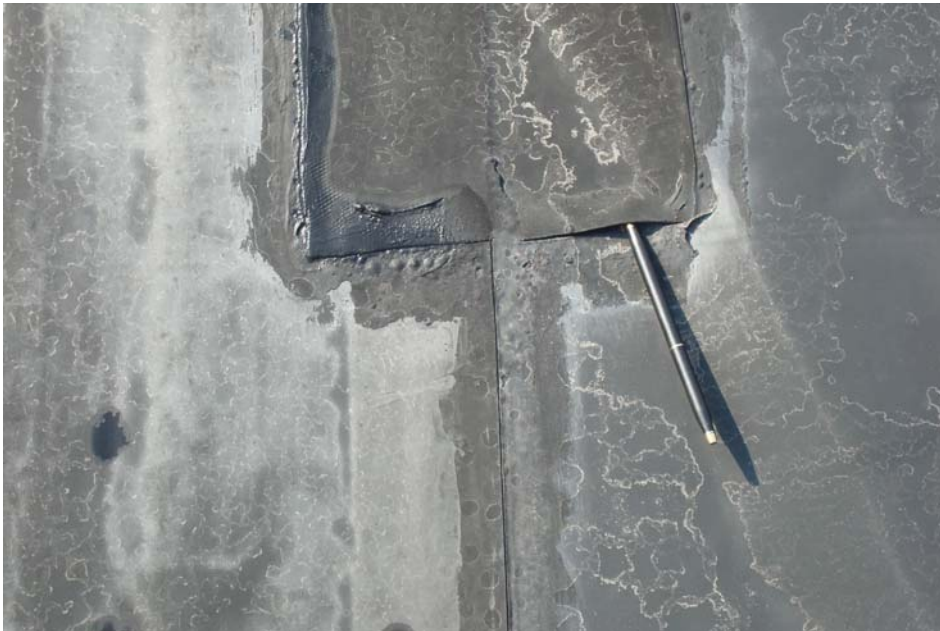
Photo No. 08

Description:
Typical failed seam.

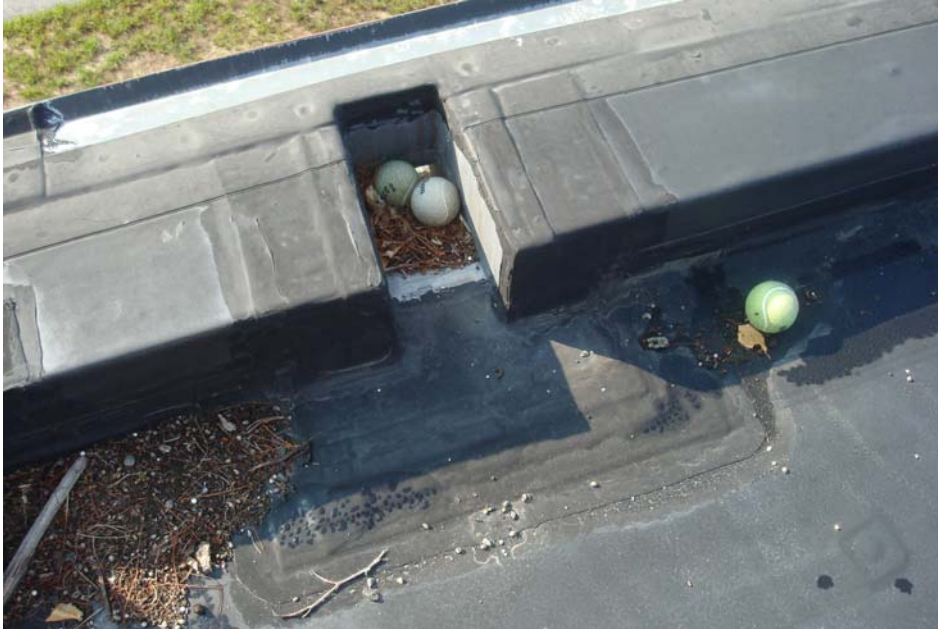
Photo No. 09

Description:
Scuppers are blocked.

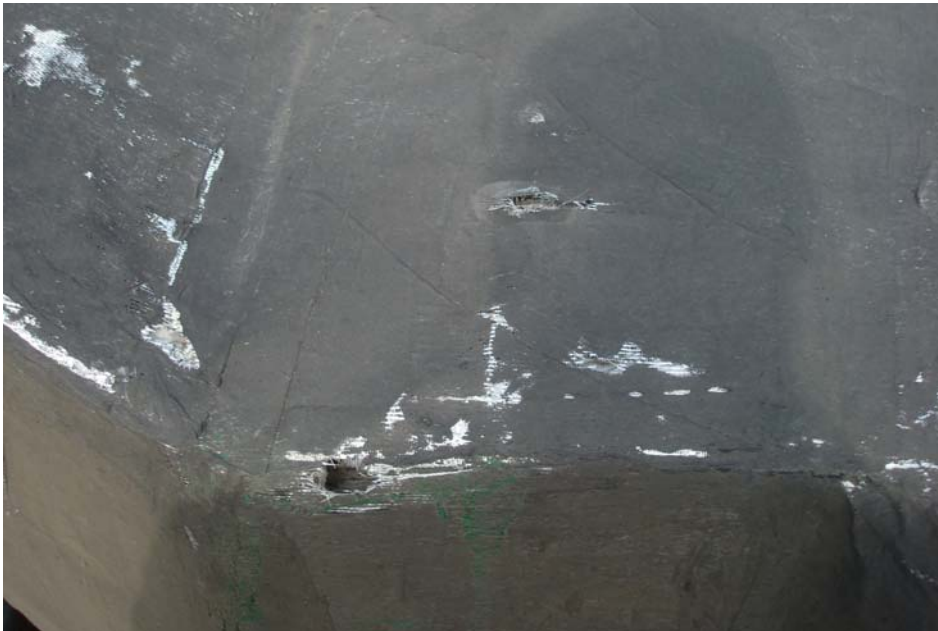
Photo No. 10

Description:
Weatherproof duct coverings are damaged.

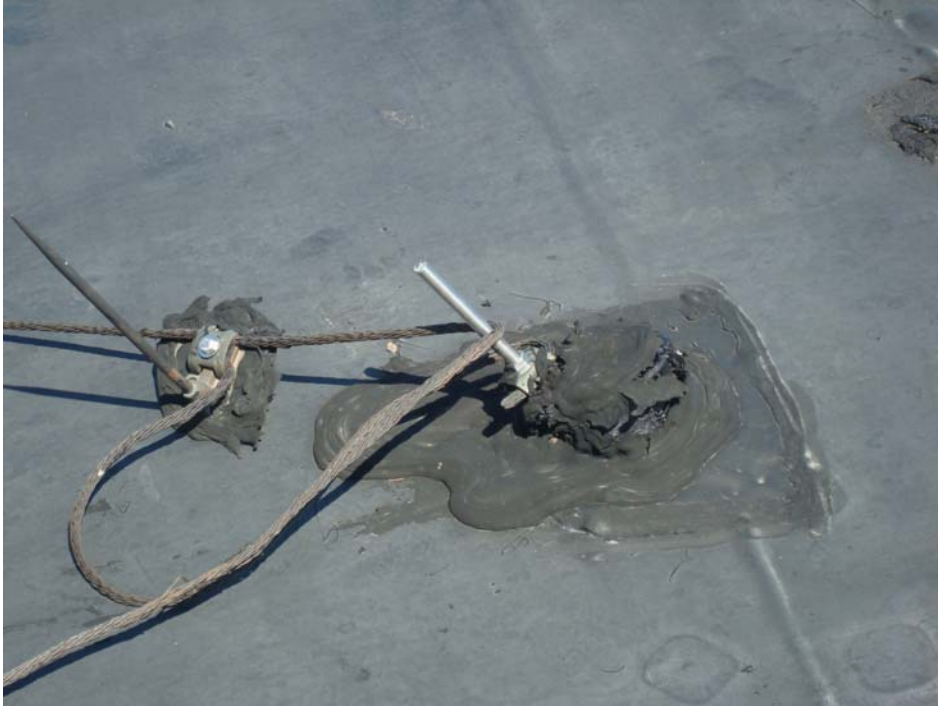
Photo No. 05

Description: Lightning protection system of Roof Area No. 6 is damaged and disconnected.

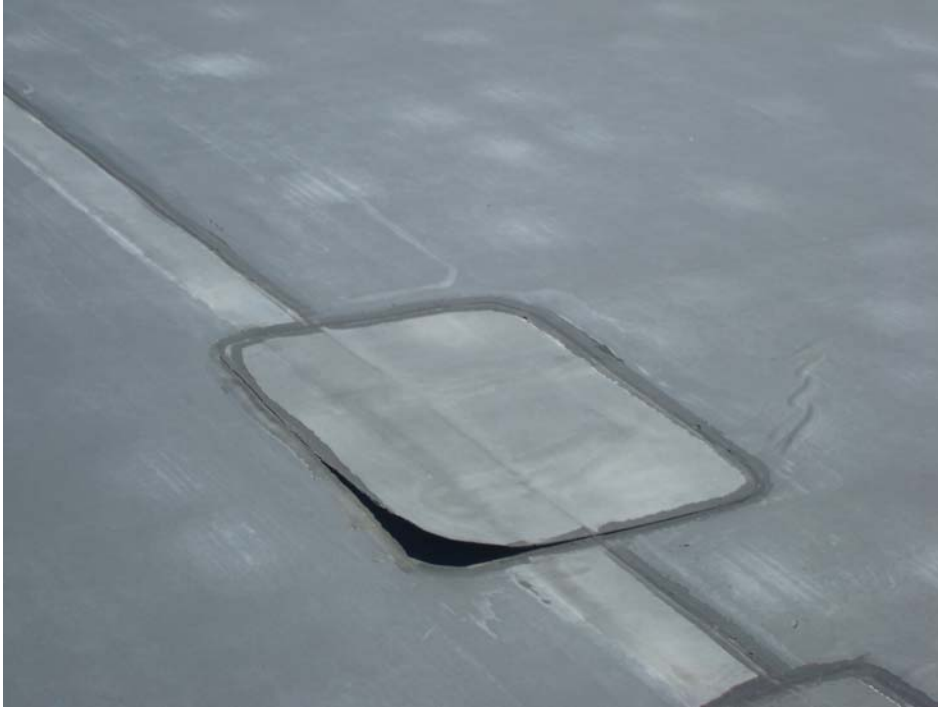
Photo No. 07

Description: Delaminating seam.

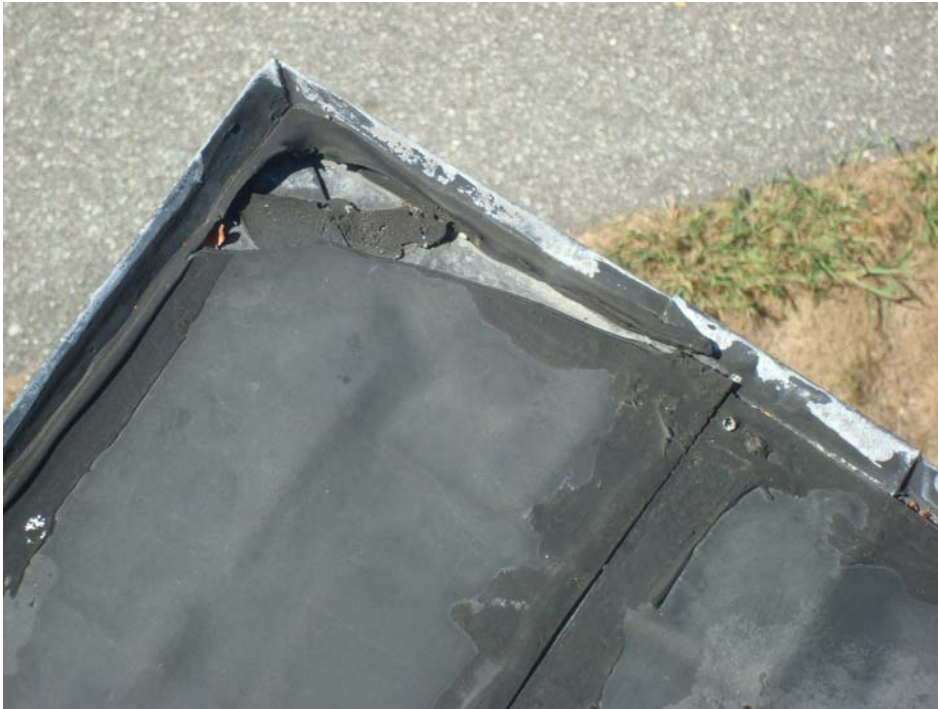
Photo No. 08

Description: EPDM flashing at sheet metal edges is failing.

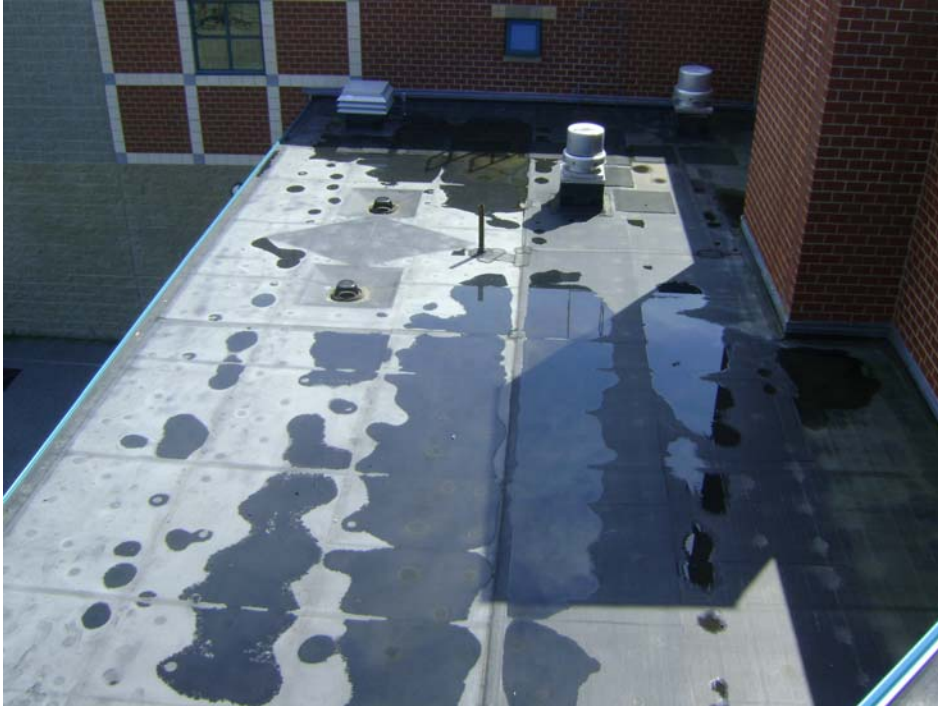
Photo No. 03

Description: Overview of Roof Area No. 14. The ponded water observed indicates slow drainage.

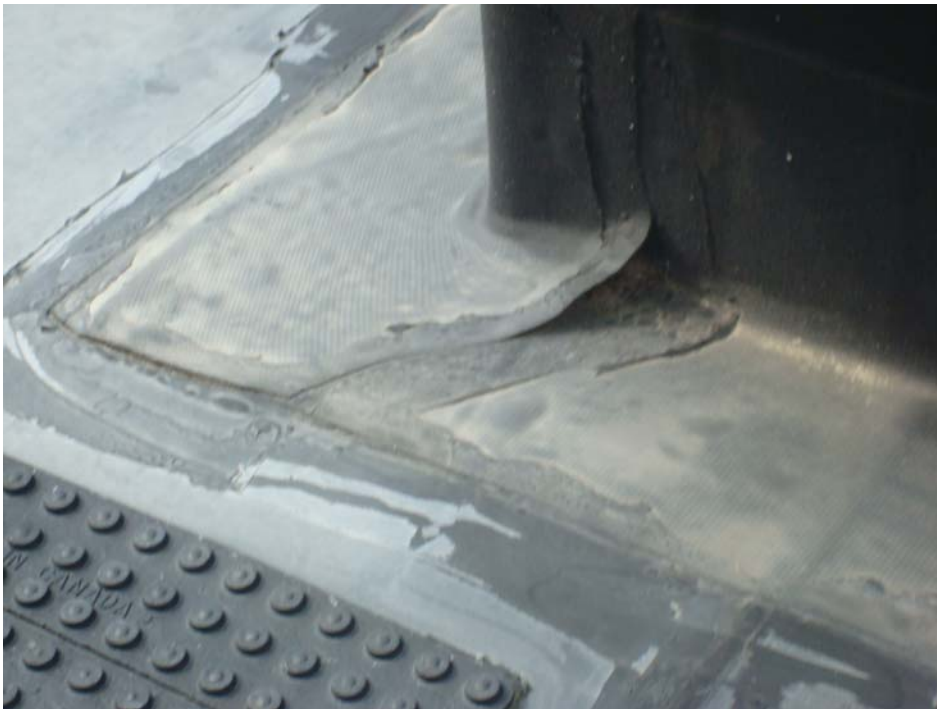
Photo No. 06

Description: Seams are beginning to delaminate.

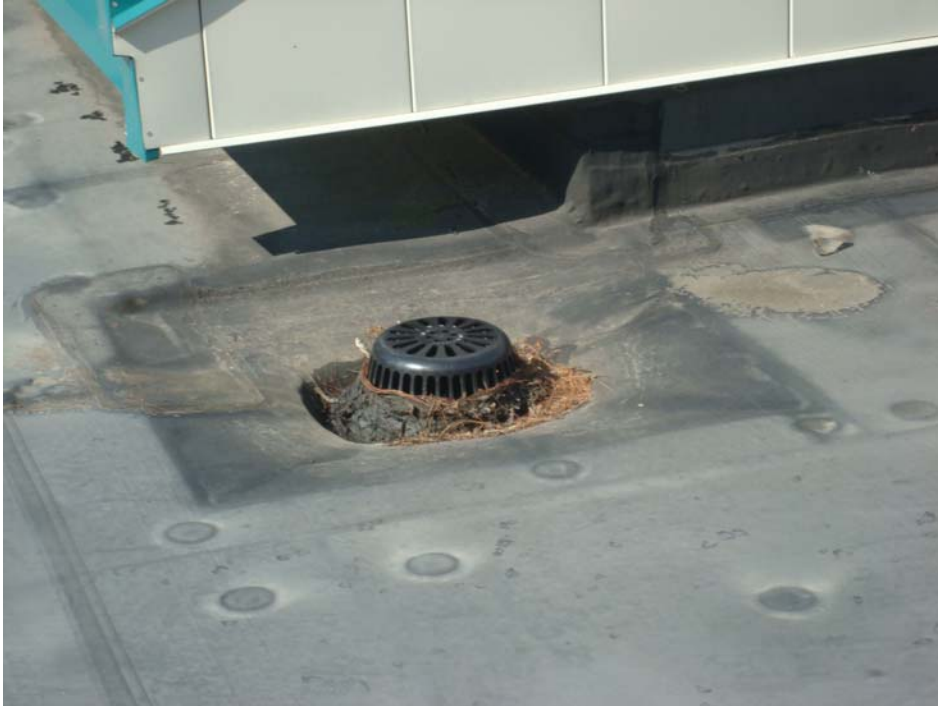
Photo No. 07

Description: Drain strainers required maintenance.

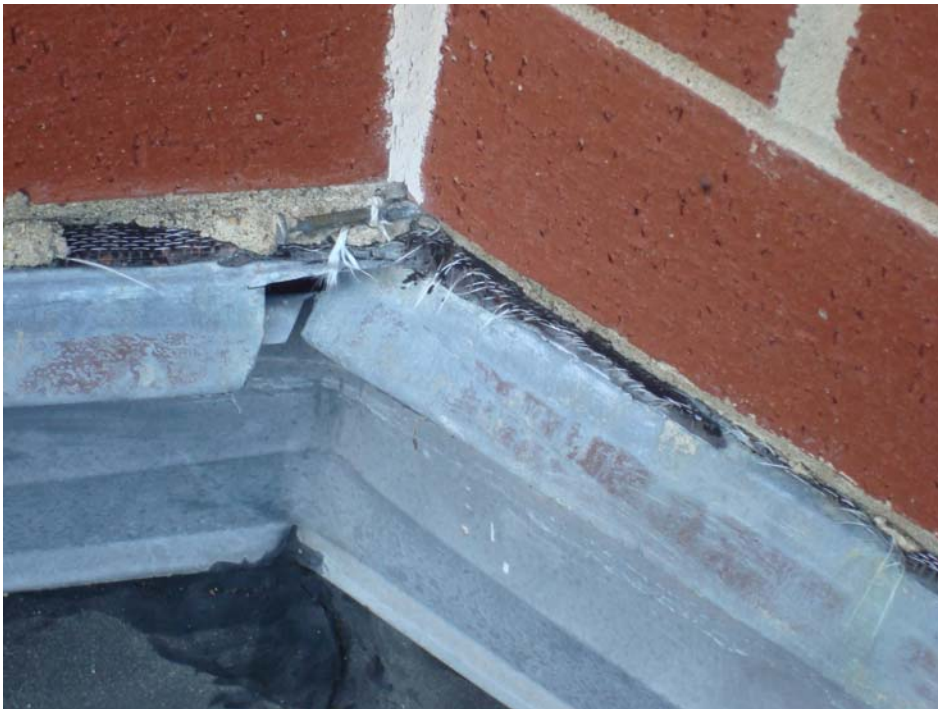
Photo No. 08

Description: Questionable throughwall flashing configurations exist.

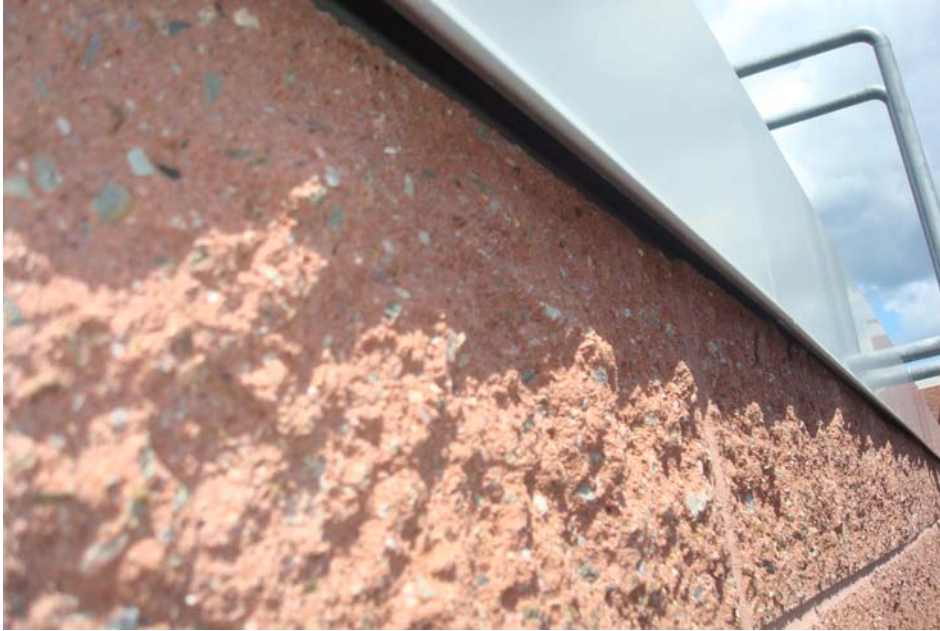
Photo No. 03

Description:
Inadequate sheet metal overlaps onto masonry wall.

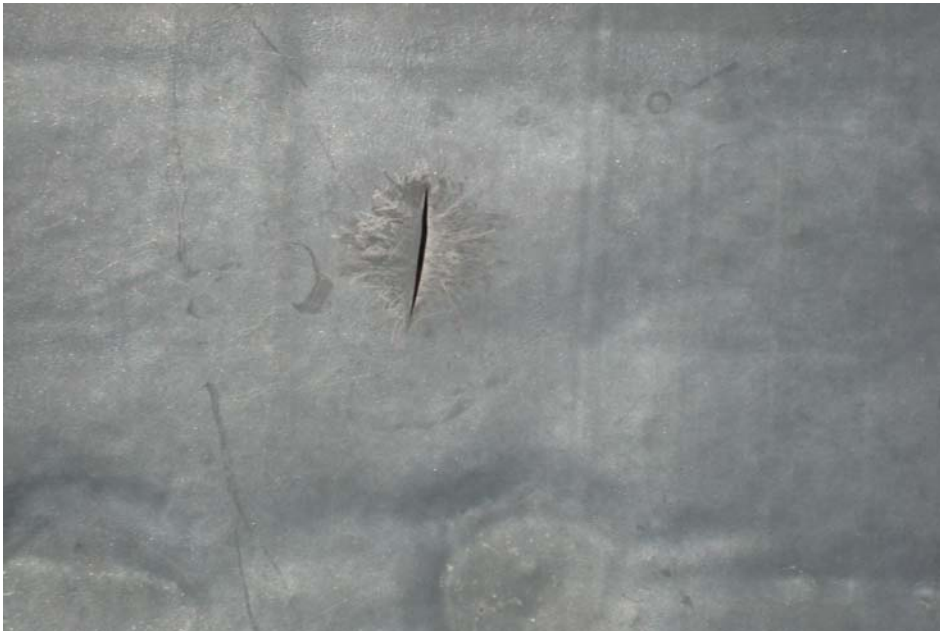
Photo No. 04

Description:
EPDM membrane puncture.

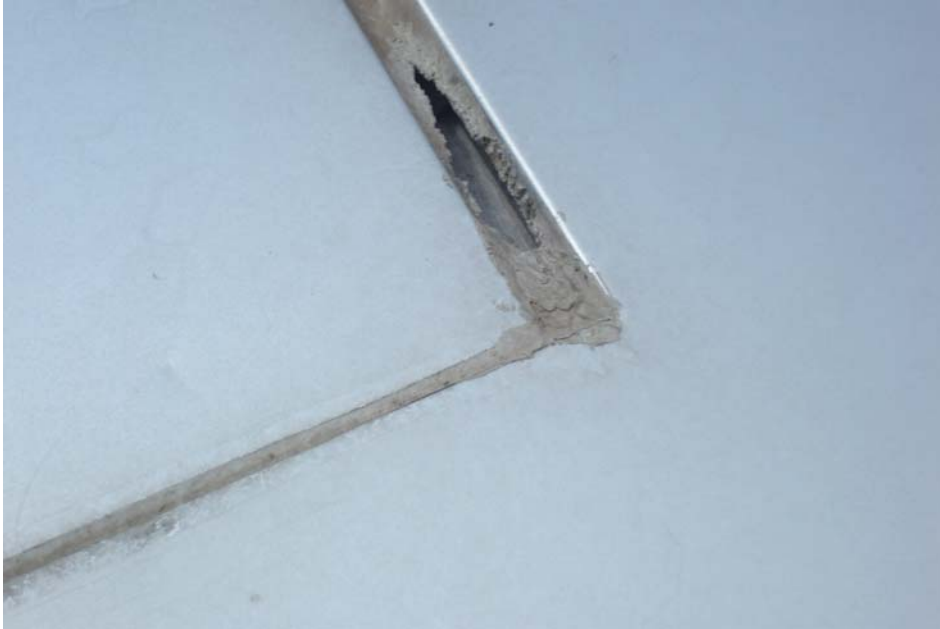
Photo No. 05

Description: Failed
sealant joint.

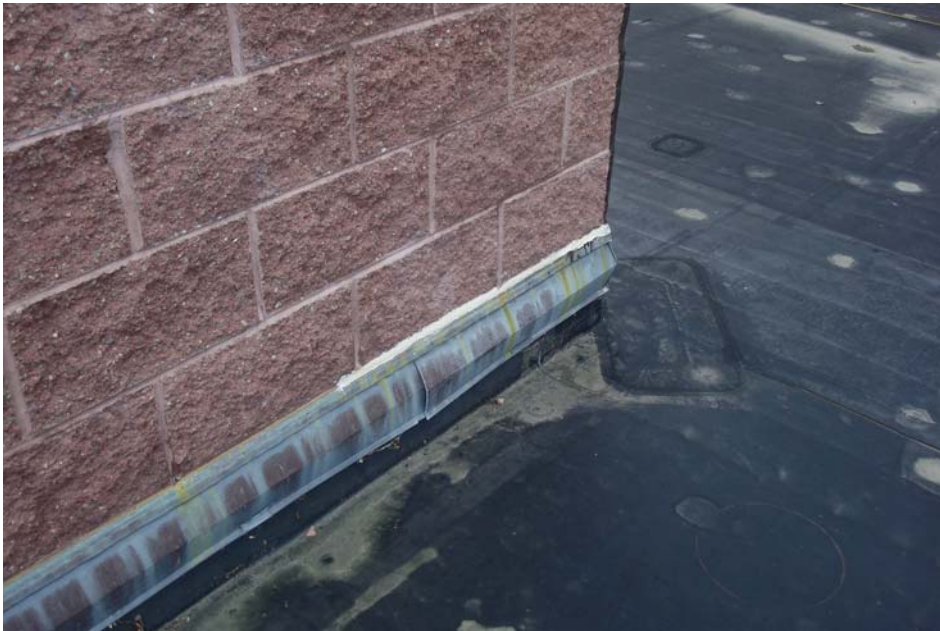
Photo No. 06

Description: Low
flashing height.

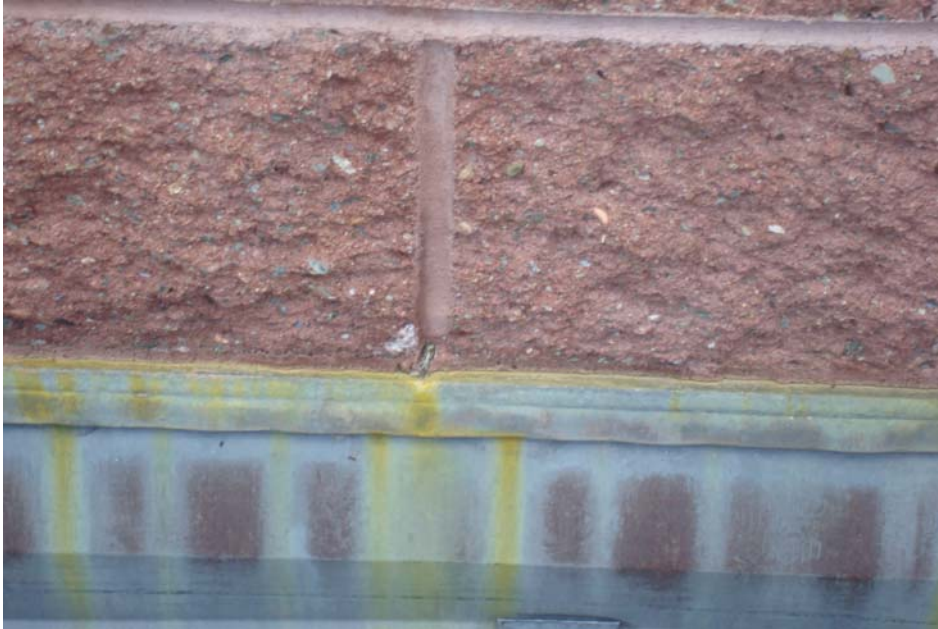
Photo No. 07

Description:
Partially blocked
weep hole.

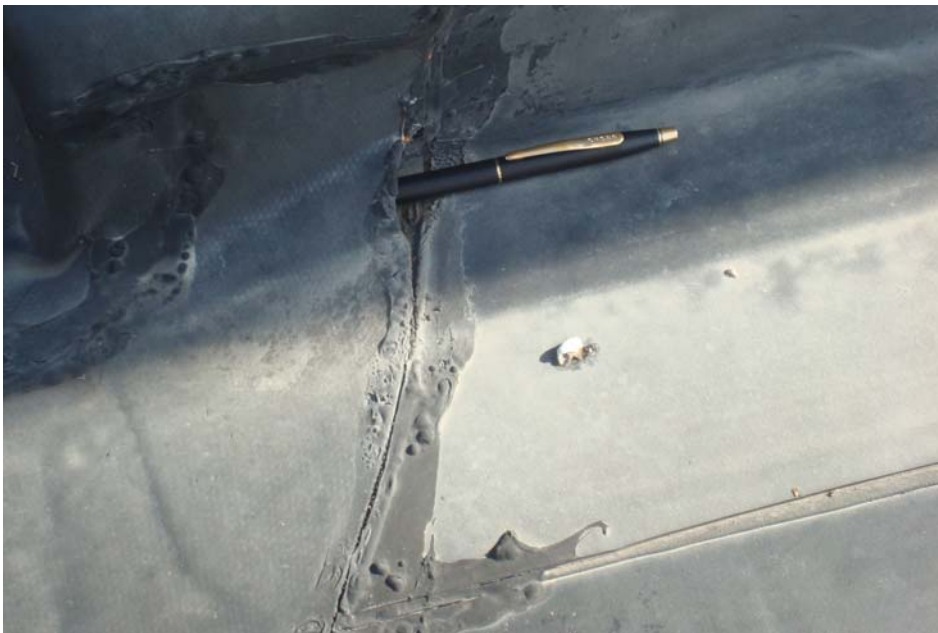
Photo No. 08

Description:
Failing EPDM
seam.
